**Region 6 - Enforcement & Compliance Assurance Division**  
**INSPECTION REPORT**

| Company Name: | <b>Calgary Energy, LLC</b> | |
| Facility Name: | <b>Tidal Osage</b> | |

EPA Region 6 Inspector, Matthew Allen, arrived at the Calgary Energy, LLC / Tidal Osage Lease (EPA ID No. OKU000893) at 12:30 PM on 02/09/2023 for a follow-up inspection. This was an EPA follow-up inspection in response to a National Response Center Spill Report (NRC No. 1357149) which was received by EPA Region 6. The initial spill inspection was conducted by EPA on 01/09/2023 with follow-up inspections being conducted 01/13/2023 and 02/07/2023. The purpose of the follow-up inspection was to observe any progress which may have been achieved by Calgary Energy, LLC in reducing pollution impacts to waters along the impacted tributary. The inspection was conducted by the authority of the Clean Water Act (CWA) to determine compliance with Environmental Protection Agency (EPA) regulations. There was no other federal, state, or local agency representative present at the time of the inspection.

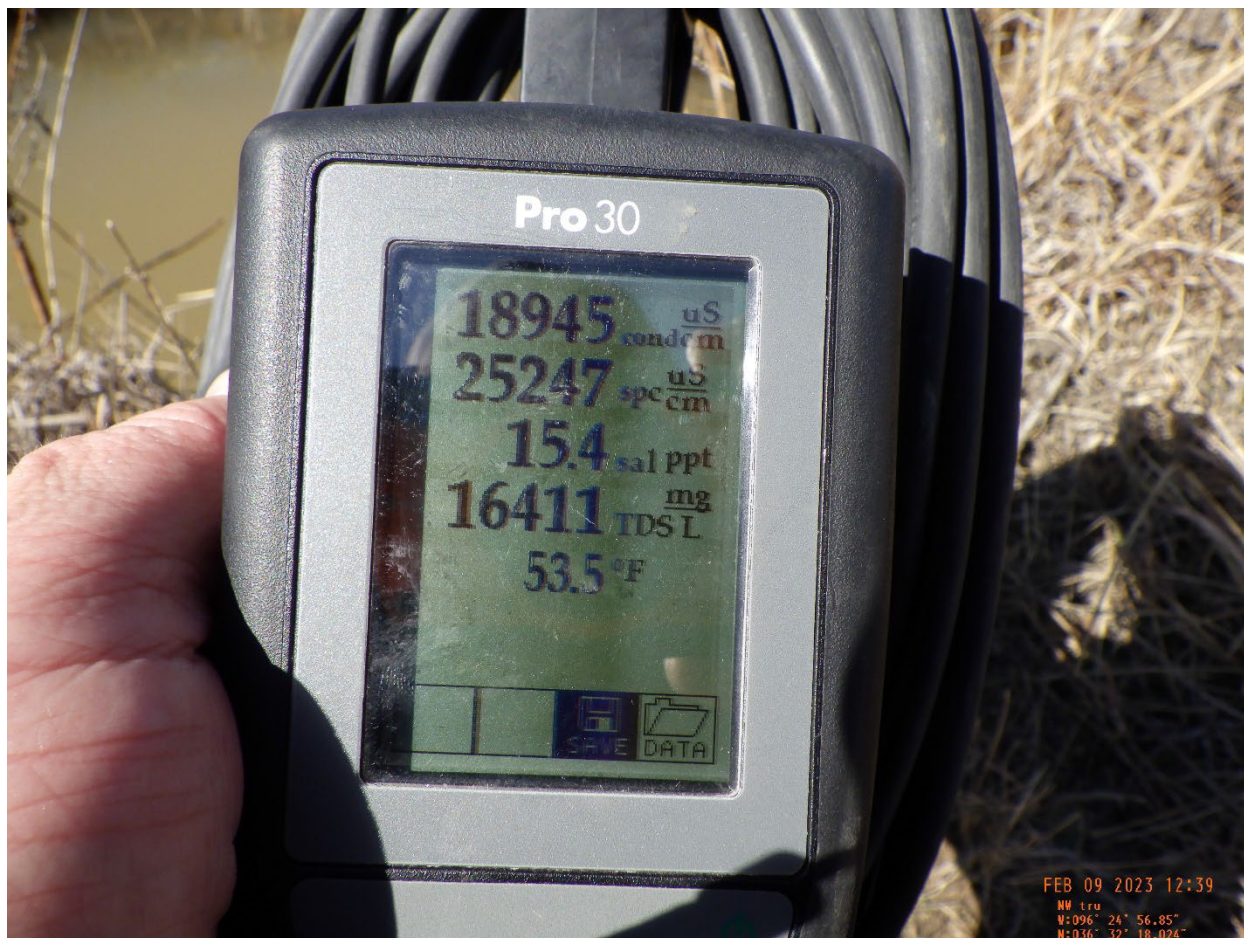
I observed and elevated TDS field reading of 16,411 mg/L (GPS 36.538443, -96.415800) in the main channel of the impacted tributary of Little Hominy Creek, this field reading is documented in Photo No. 1 of Appendix 1 (Photo Log). This was the highest observed TDS field reading of the inspection.

**Description:** This was an elevated TDS field reading of 16,411 mg/L taken in the main channel of the impacted unnamed tributary of Little Homing Creek.

Calgary Energy, LLC should ensure an appropriate amount of manpower is maintained daily along the impacted area. Calgary Energy, LLC should continue removing elevated TDS waters from the impacted tributary. The flowpath from the release point to the point of entry should be cleaned. Cleanup activities should continue until background TDS readings are observed along the impacted tributary.

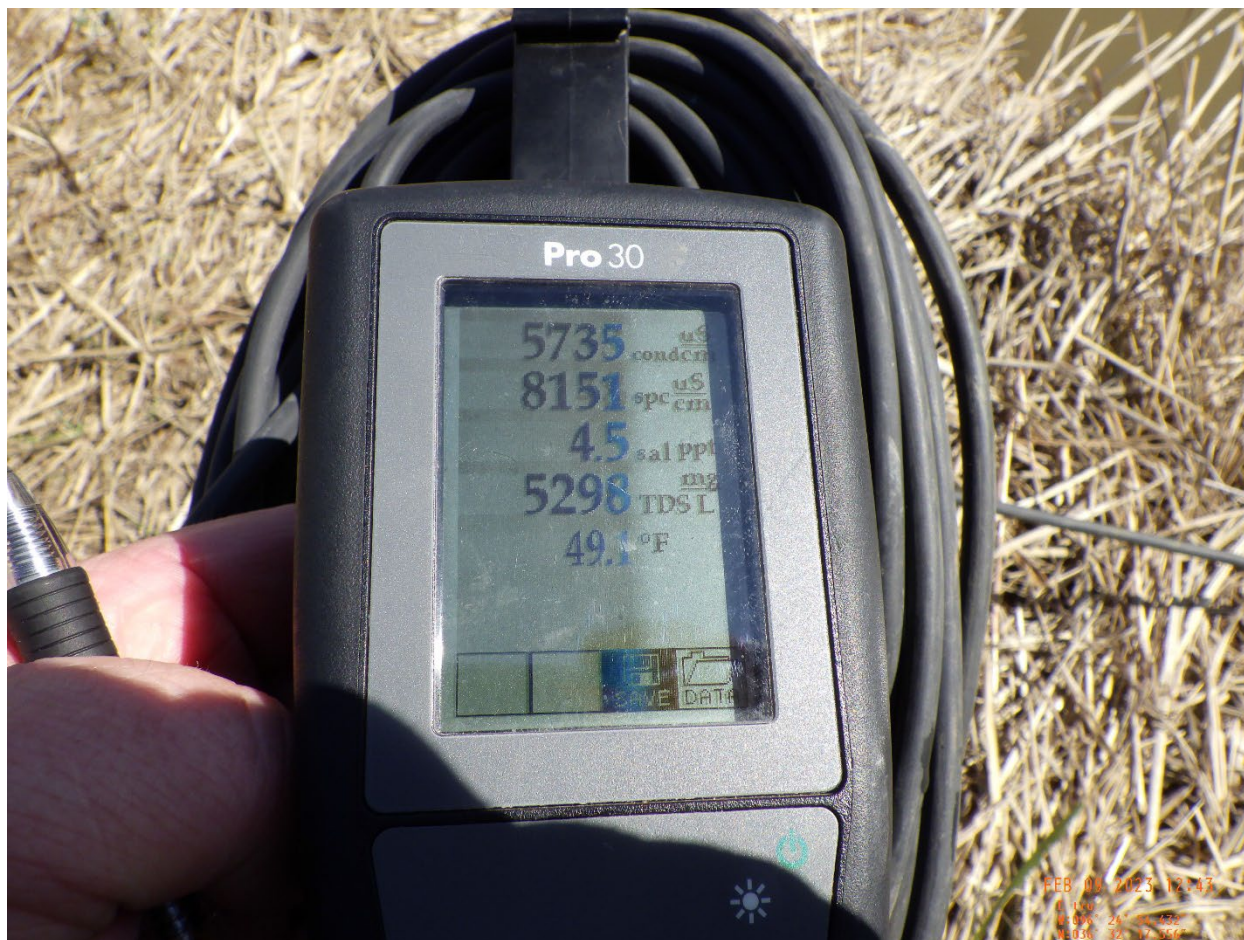
Photo No. 2

Continuing downstream, I observed an elevated TDS field reading of 5,298 mg/L (GPS 36.538199, -96.415087) in the main channel of the impacted tributary. See photo No. 2.

**Description:** This was an elevated TDS field reading of 5,298 mg/L taken in the main channel of the impacted tributary.

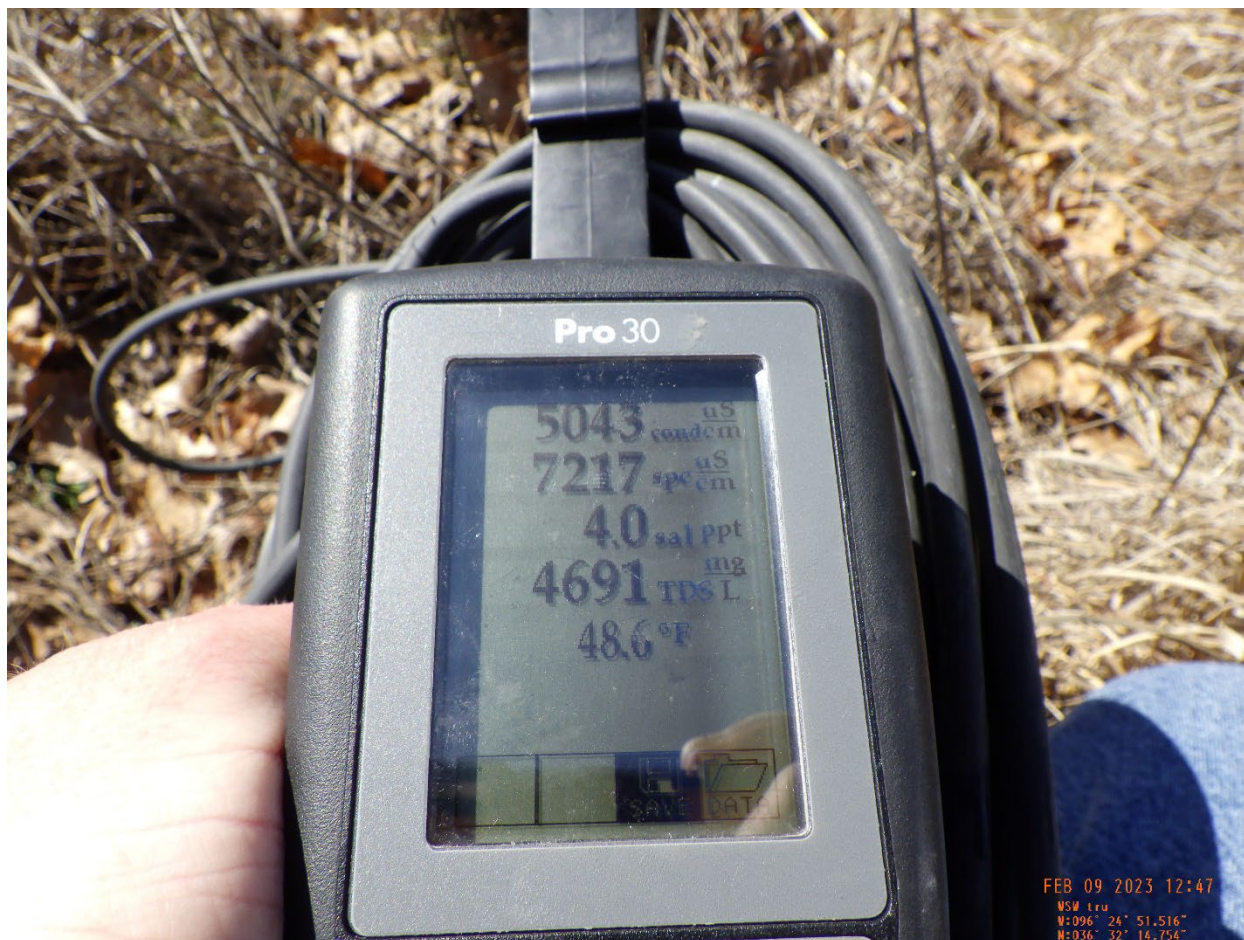
Photo No. 3

I observed and elevated TDS field reading of 4,691 mg/L (GPS 36.537469, -96.414301) along the impacted tributary. See photo No. 3.

**Description:** This was an elevated TDS field reading of 4,691 mg/L taken in the main channel of the impacted tributary.

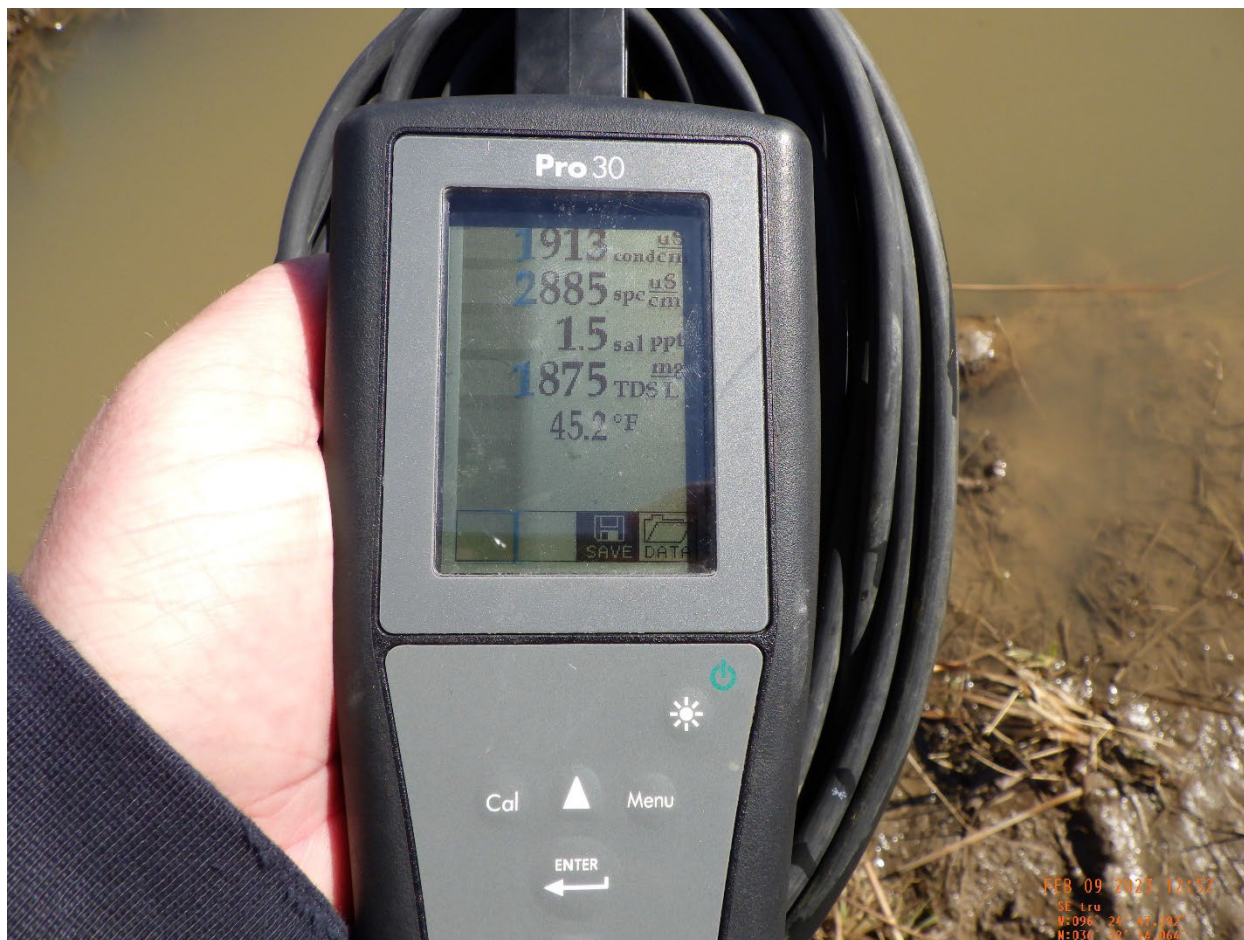
Photo No. 4

At the lowermost temporary containment dam, I observed a TDS field reading of 1,875 mg/L (GPS 36.537254, -96.413136) in the unnamed tributary. This represented the lowest observed TDS field reading of the inspection. See photo No. 4.

**Description:** This was a TDS field reading of 1,875 mg/L taken at the lower containment dam which had been placed by the operator to prevent further downstream migration of impacted waters.
