**CASE HISTORIES  
OF  
ACCIDENTS  
IN THE  
CHEMICAL INDUSTRY**

**MANUFACTURING CHEMISTS ASSOCIATION**

**VOLUME TWO**

**JANUARY 1966**

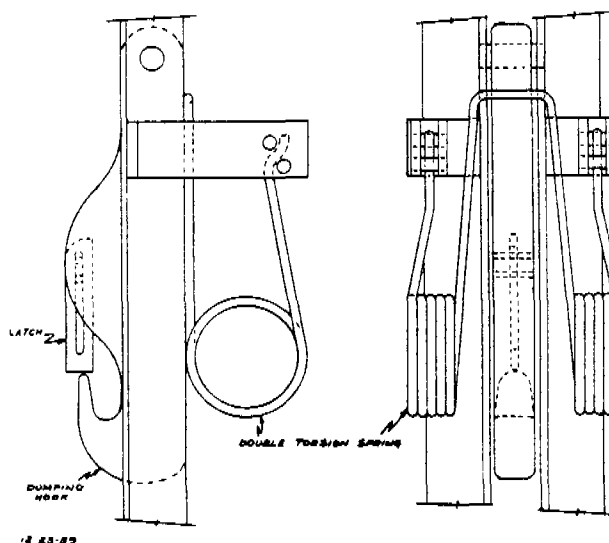
Type of hook and spring involved in accident.

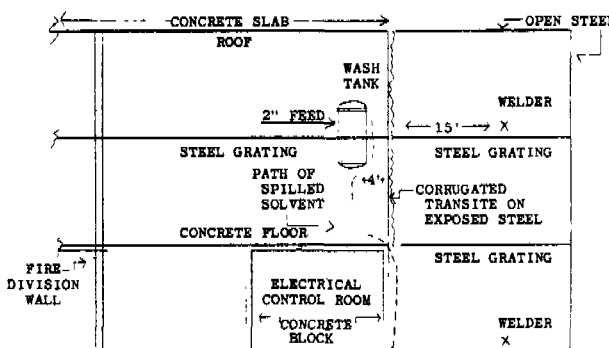
**Pertinent Facts:** The end(north) section of the three-story building is of unprotected steel and steel grating floor construction. (See sketch) The adjacent section is unprotected steel with concrete floor at second level and open steel grating at the third level. The wall between these sections is concrete block to the second floor and corrugated transite from the second floor to the roof. The roof is concrete slab and two sides of the enclosed section are also corrugated transite. A concrete block wall from ground level to roof on the south side of the enclosed area separates it from other sections of the building. This wall and the concrete block wall enclosing the electrical and instrument control room at ground level were quite effective in preventing the spread of fire from the area of origin.

A 250 gallon cylindrical vessel, indicated on sketch as "wash tank", is used to recover valuable process components from spent filter sections. Solvent is fed into and through the vessel from a two-inch supply line at approximately 50 psig. The vessel is emptied through two valved sections connected to a drain line leading to another area, with appropriate valves at that point which are kept closed when the line is not being used. It was also equipped with a rupture disc with vent line extended outside the building, steam and nitrogen purge lines, and other necessary gauges, connections, etc.

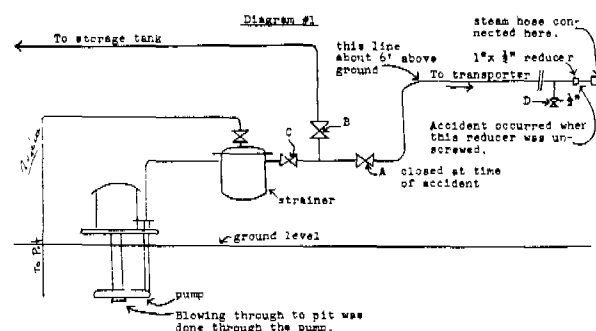
A steam hose was then run from inside Building 60 about 50 feet and attached to the flange at the end of the unitrace line, which is used to load the sulfur transporter (see attached diagram #1).

The steam was turned on and the line was blown through to the storage tank, through Valves A and B on the diagram. Valve B was closed and Valve C opened to blow through to the sulfur pit. This was continued until a froth began to build up on the sulfur, at which time the steam valve in Building 60 was closed and when the pressure was bled off, Valve A was closed. Valve D was then cautiously opened to check for pressure in the line, but it was apparently plugged.

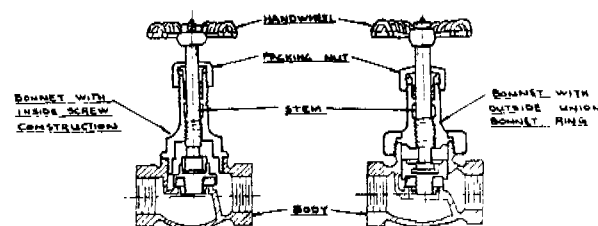
OLC FIG. 200  
OLD TYPE

Cause: This valve is an old design having internal threads in the valve body for holding the bonnet in place. Examination after failure disclosed that the bonnet threads were worn or corroded permitting the bonnet to slip out of position. Plant engineering practice has revised specifications to use an outside union bonnet design valve for steam service up to 125 psi. (See sketch)

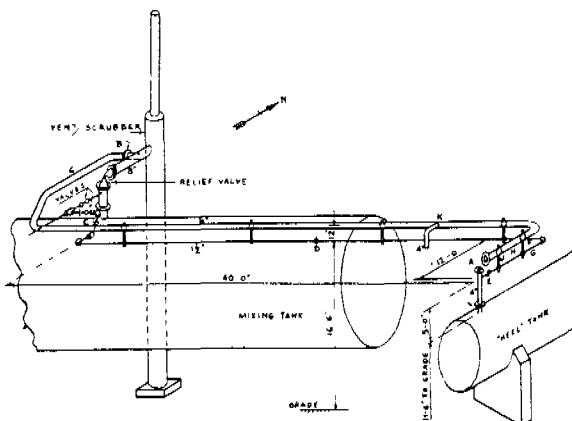
The welder states that after completing work on the tie-in to the 6 inch relief line the pipefitter said "let's get this 1-1/2 inch line down". Standing on the top of the heel tank, the bolts securing the pipe hangers at points 'J' and 'H' were burned loose. Since the union was disconnected at point 'E', this left about a 12 foot length of the 1-1/2 inch pipe unsupported at the south end. The pipefitter instructed the welder to burn the pipe in two at point 'F'. The pipefitter was standing on the heel tank facing west and supporting the pipe in the crook of both elbows. As the welder applied his torch at point 'F', the explosion occurred immediately, before the torch had actually burned into the pipe. The center of the explosion seems to

have been at about point 'G' and it propagated in a southerly direction toward point 'E'. The pipe at point 'F' was not ruptured. There was about 4 feet of line left unruptured north of point 'E'. Although the pipe was empty at point 'E' when the pipefitter looked into it, it was plugged solid some 2 feet north of this. The plugging material analyzed 58% ammonium nitrate, 34% iron oxide, 4% urea, and 0.1% oil. The force of the explosion fractured the line adjacent to the union at point 'D'. The line was plugged solid at this point and the material analyzed 32% ammonium nitrate, 55% iron oxide, 3.2% urea, and 0.6% oil.

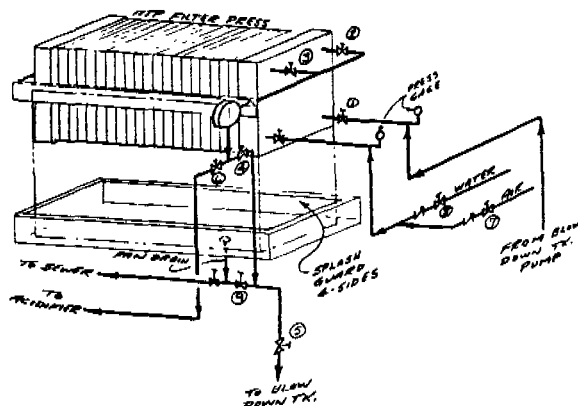
The normal procedure after the press is blown dry is to close valves Nos. 2, 3, 4 and 7, and then open the press pan valve No. 9 to return the press drippings to the blow down tank. Before shutting off the air valve the employee closed valve No. 5 to the blow down tank which caused pressure to build up in the line. When employee

opened the press pan valve No. 9 he was splashed in the eye and face with alkaline press drippings.

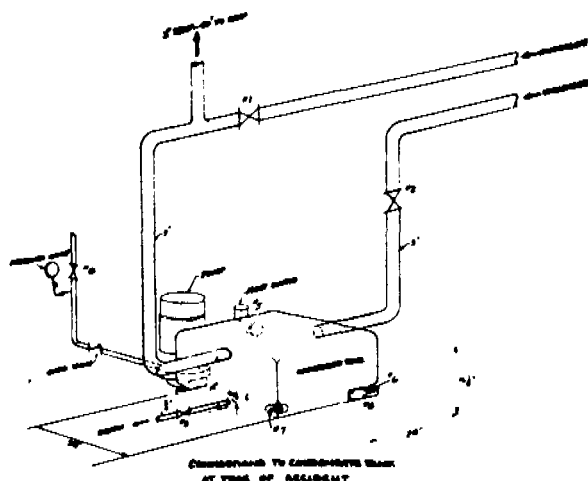
**Description:** On the morning of the accident, the work assignment was the first given to Mechanic "A" and Mechanic "B". The equipment concerned was a condensate return set, consisting of a cast iron receiving tank (28 in. x 28 in. x 16 in. high) and an external pump with

float control. The tank had two crack leaks at the south retaining lugs (#6 and #7 on sketch).
