**Region 6 - Enforcement & Compliance Assurance Division**  
**INSPECTION REPORT**

| Company Name: | <b>Calgary Energy, LLC</b> | |
| Facility Name: | <b>Tidal Osage</b> | |
| Identification/Permit Number: | OKU002161 | |

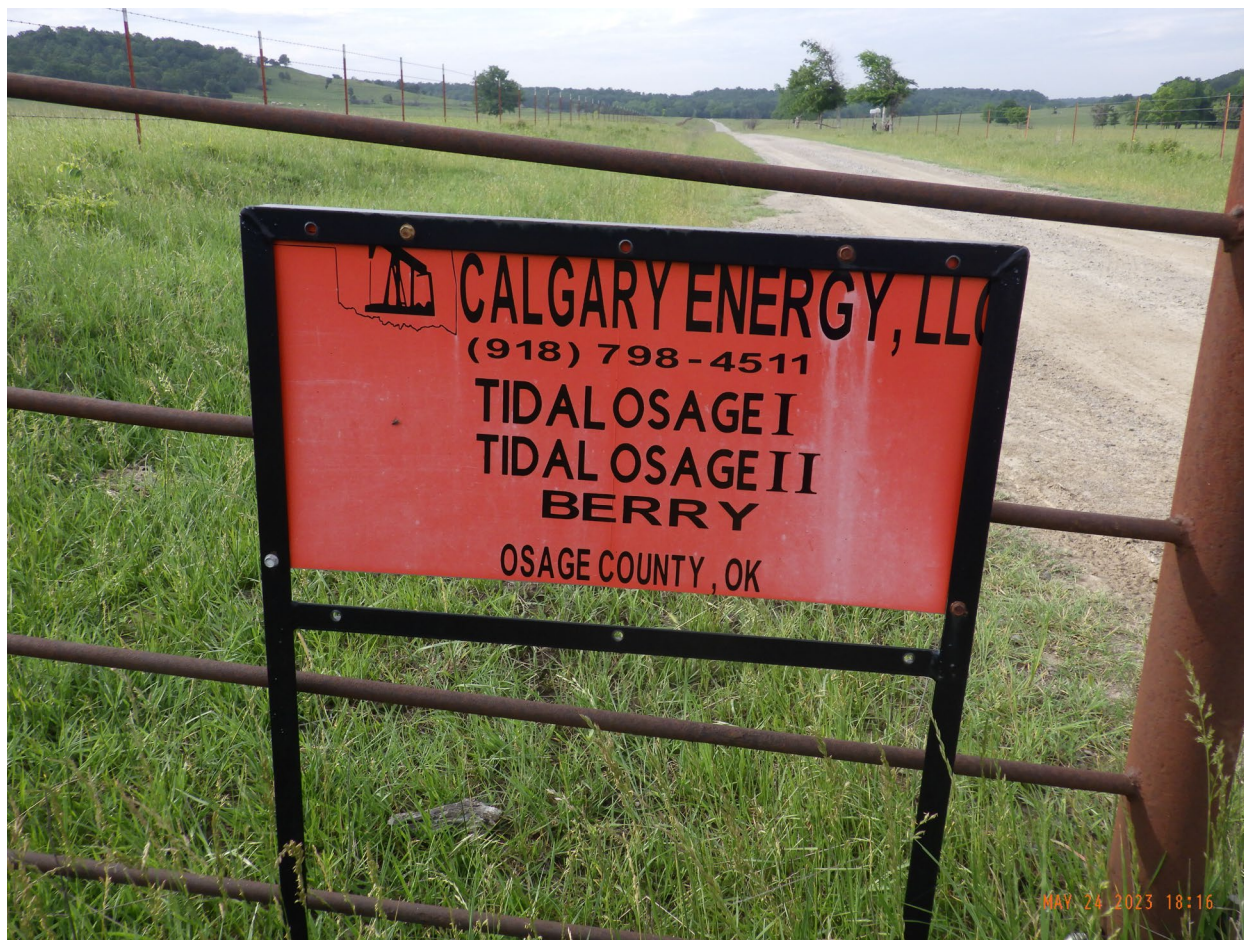
Photo No. 1

I observed the lease identification sign upon entry into the lease, see Appendix 1 (photo log), photo No. 1. For additional GPS location and photo metadata, see Appendix 1.

**Description:** Calgary Energy, LLC Tidal Osage I and Tidal Osage II lease gate entry sign.

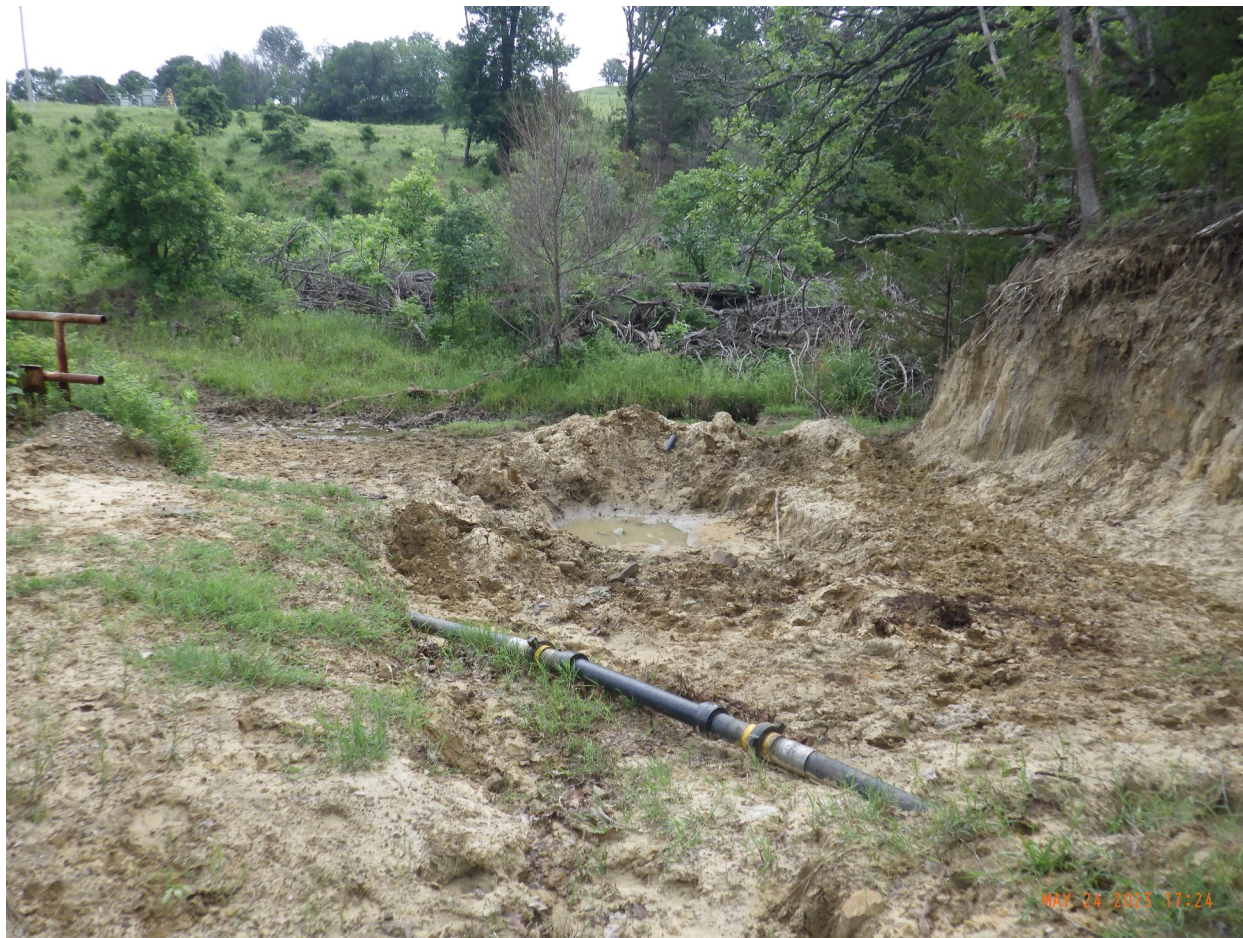
Photo No. 2

I observed the repaired section of 3-inch poly flowline which had ruptured. This section of repaired flowline was the Release Point of the Spill (36.529327, -96.411303). Oil staining and brine impacts were observed near the release point. See photos No. 2 and 3 of the photo log.

**Description:** This was the repaired section of 3-inch diameter poly flowline where the spill originated (release point). The operator stated there was a poly "butt weld" exposed, which developed a crack, causing the oil and brine to be released.

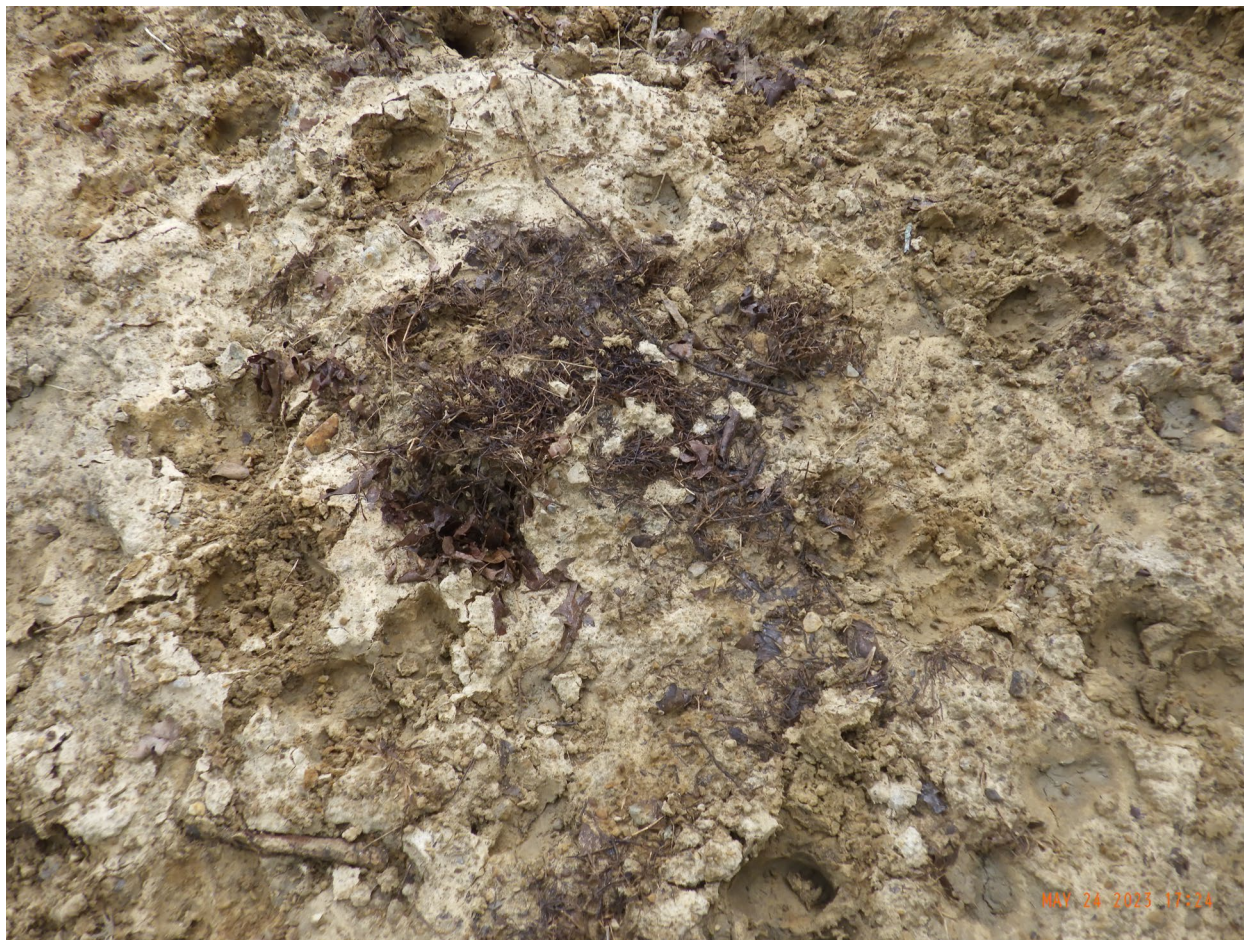
Photo No. 3

**Description:** This photo of oil caught in debris is next to the 3-inch diameter poly flowline release point.

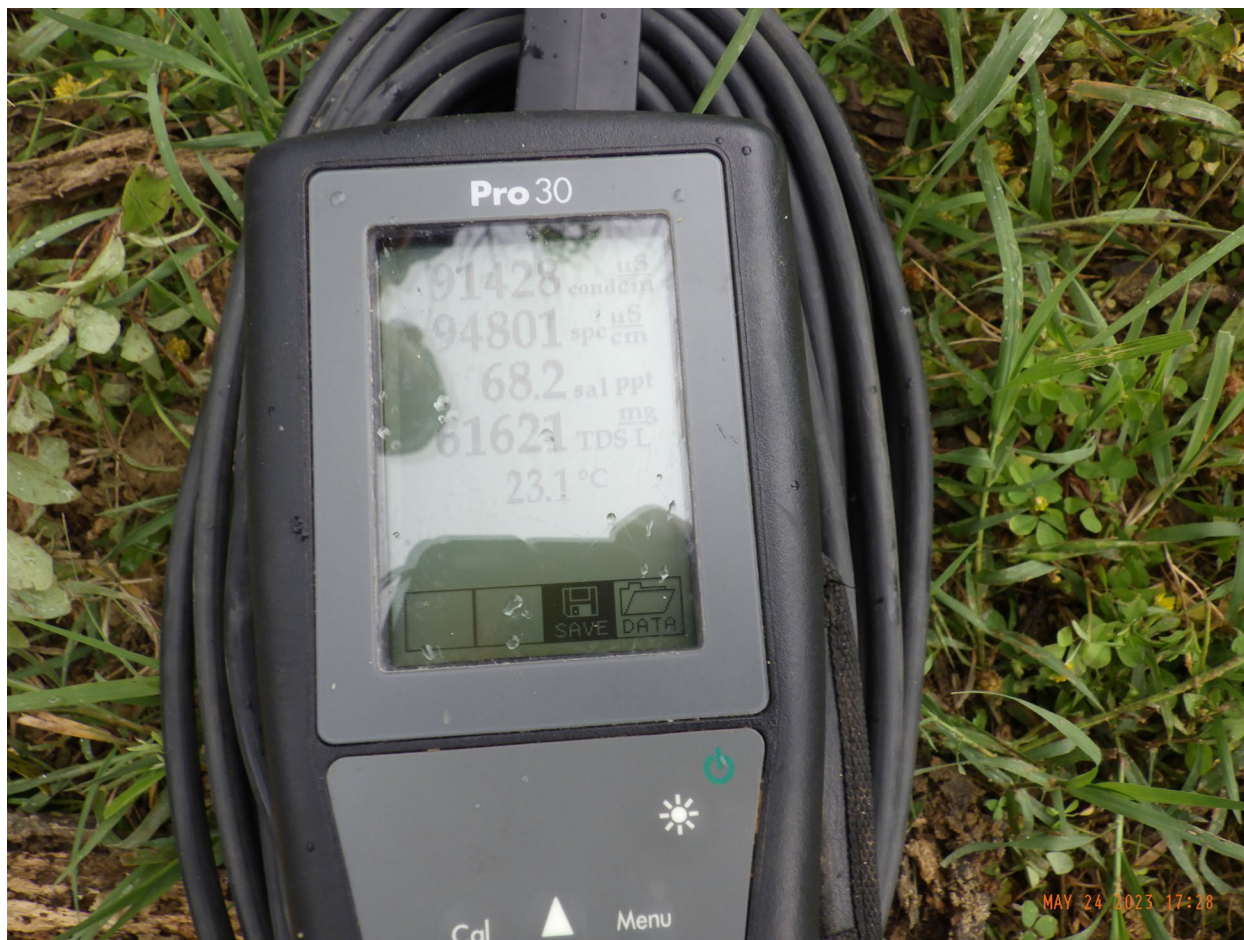
Photo No. 4

I observed an elevated TDS field reading of 61,621 mg/L in the main channel of the impacted tributary at the Point of Entry (POE), this location was approximately 35 feet from the release point (36.529259, -96.411136). See photos No. 4 through 7.

**Description:** This was an elevated TDS field reading of 61,621 mg/L taken at the POE into the impacted tributary of Little Hominy Creek. This was the highest TDS level observed during the inspection.

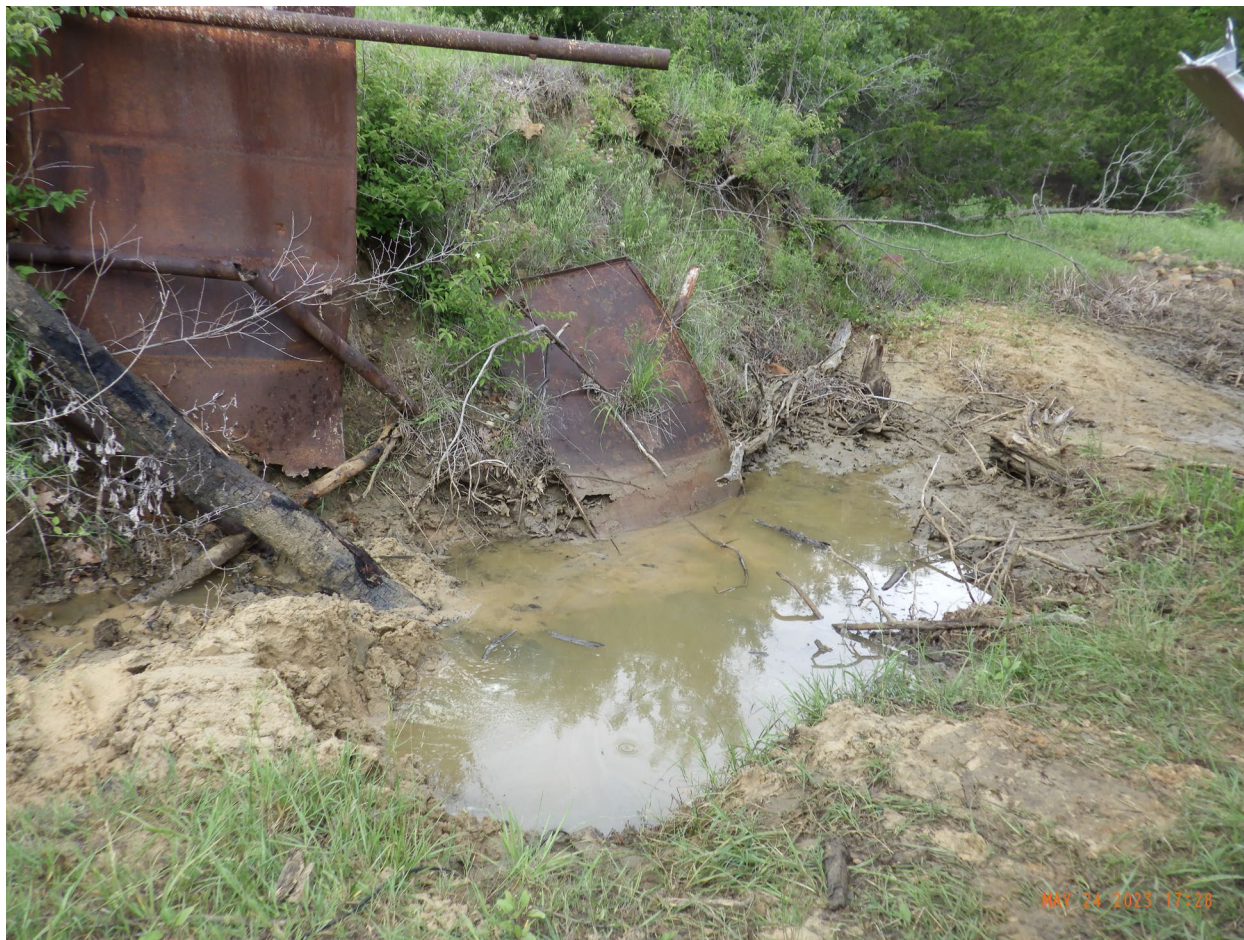
Photo No. 5

**Description:** This was the pool of water where the elevated TDS of 65,862 mg/L measurement was taken at the POE, with a view looking downstream. Oil sheen was also present at the POE.

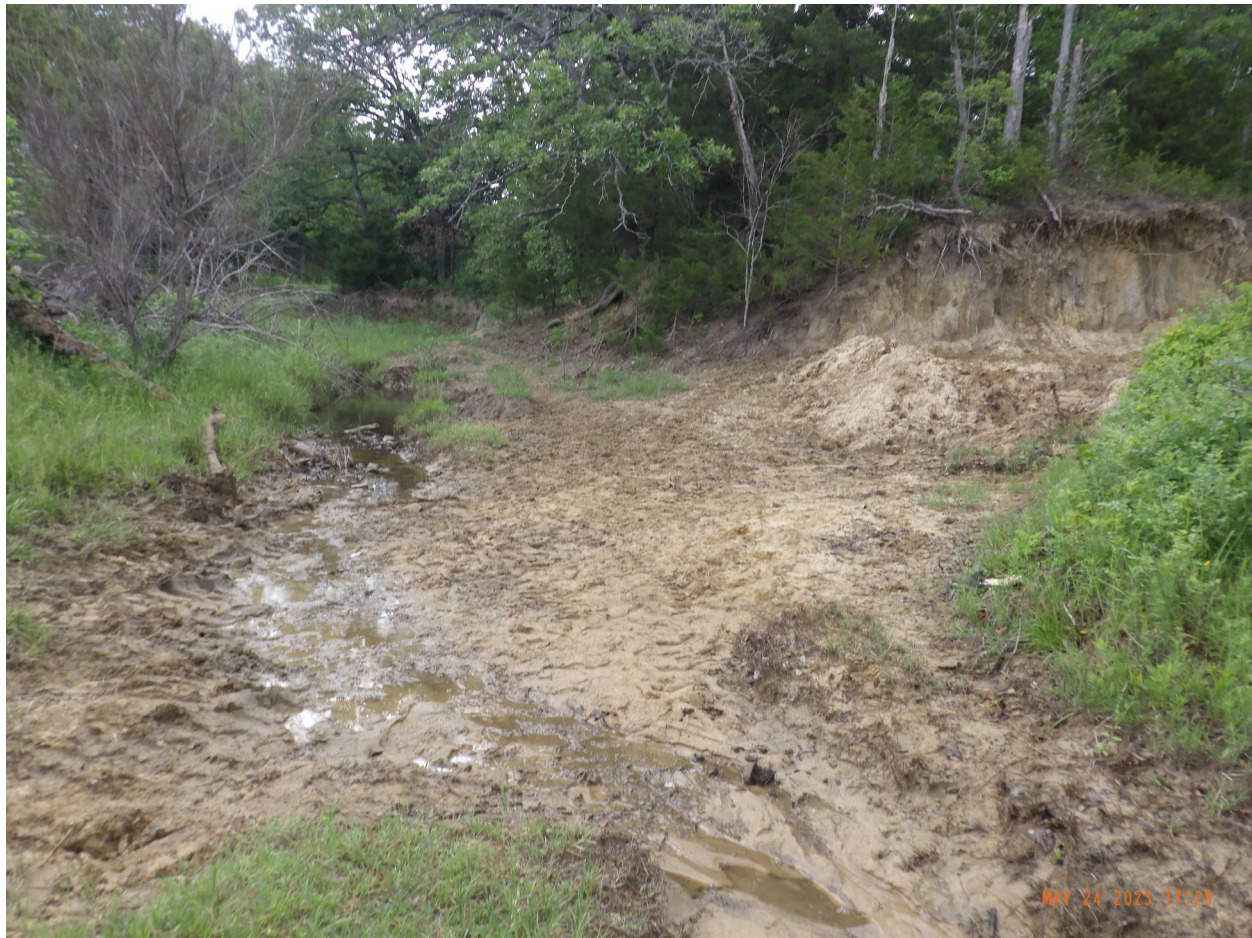
Photo No. 6

**Description:** This was a photo standing at the POE with a view to the SW or upstream.

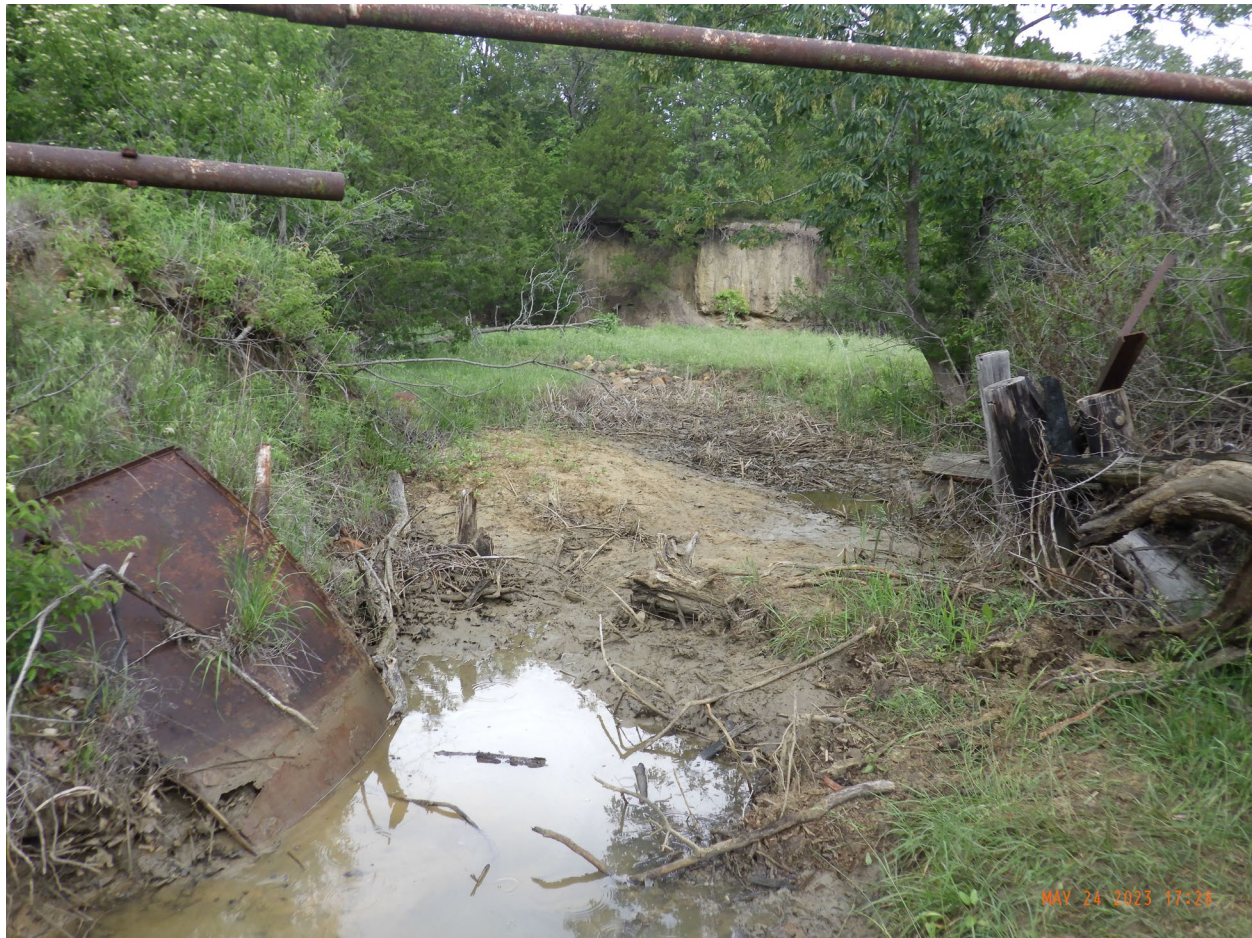
Photo No. 7

**Description:** This was a photo standing at the POE with a view to the NE or downstream.

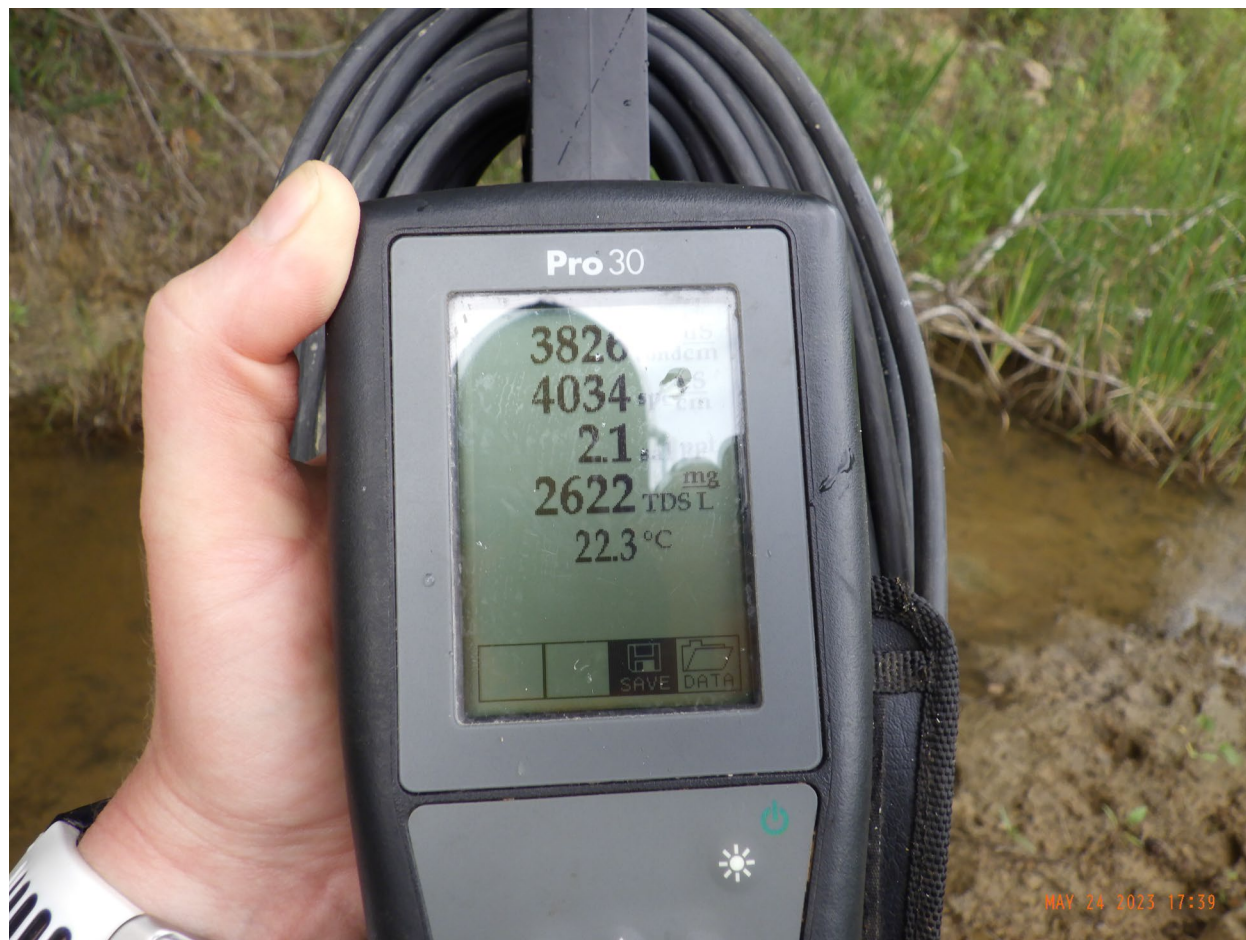
Photo No. 8

Working downstream, I observed an elevated TDS field reading of 2,622 mg/L as well as the bed and bank features of the tributary at the sample location. See photos No. 8, 9 and 10.

**Description:** This was an elevated TDS field reading of 2,622 mg/L taken downstream from the POE.

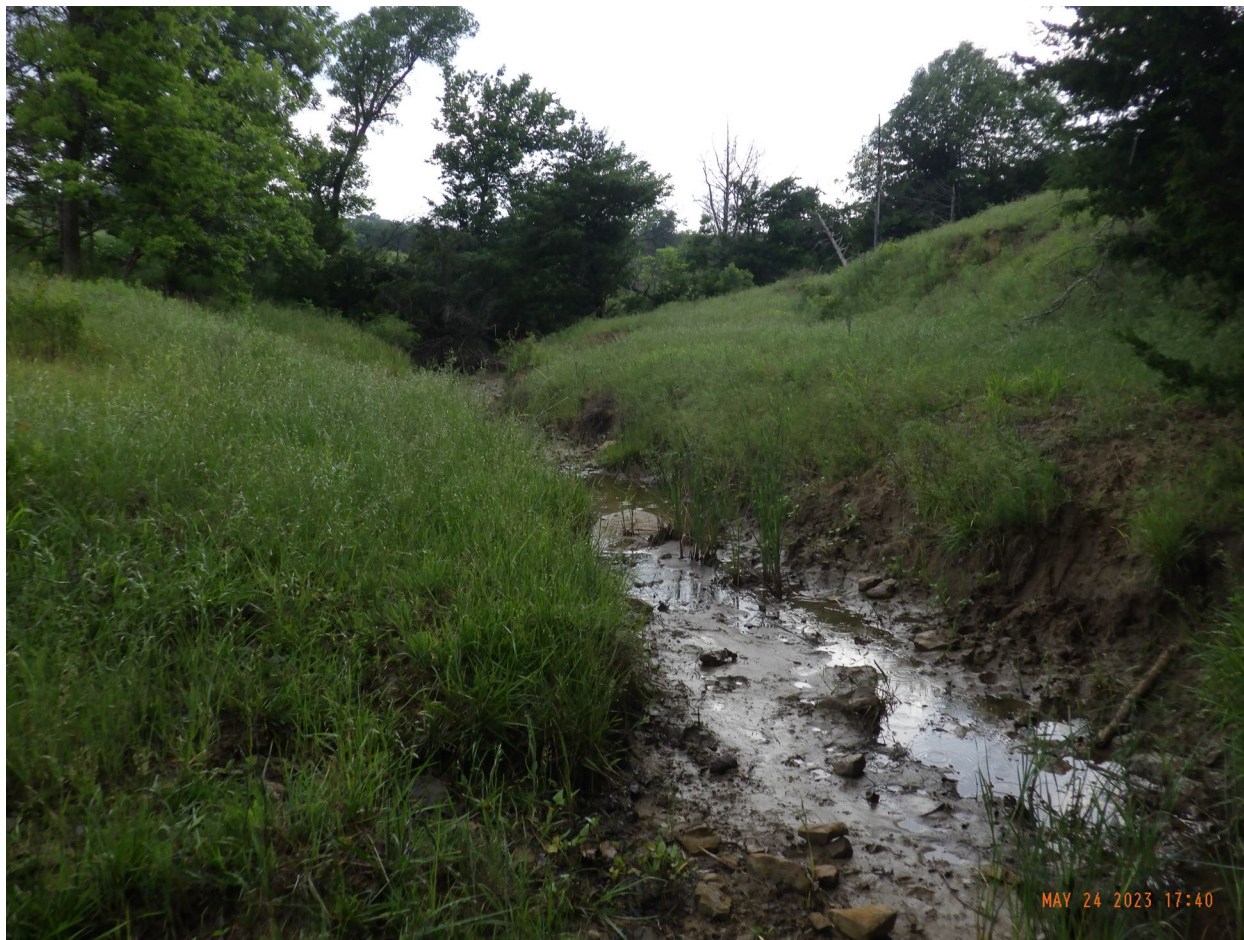
Photo No. 9

**Description:** This was a photo taken at the same location as Photo No. 8 on the previous page. This is a view looking E or upstream, this photo shows the topography of the impacted tributary.

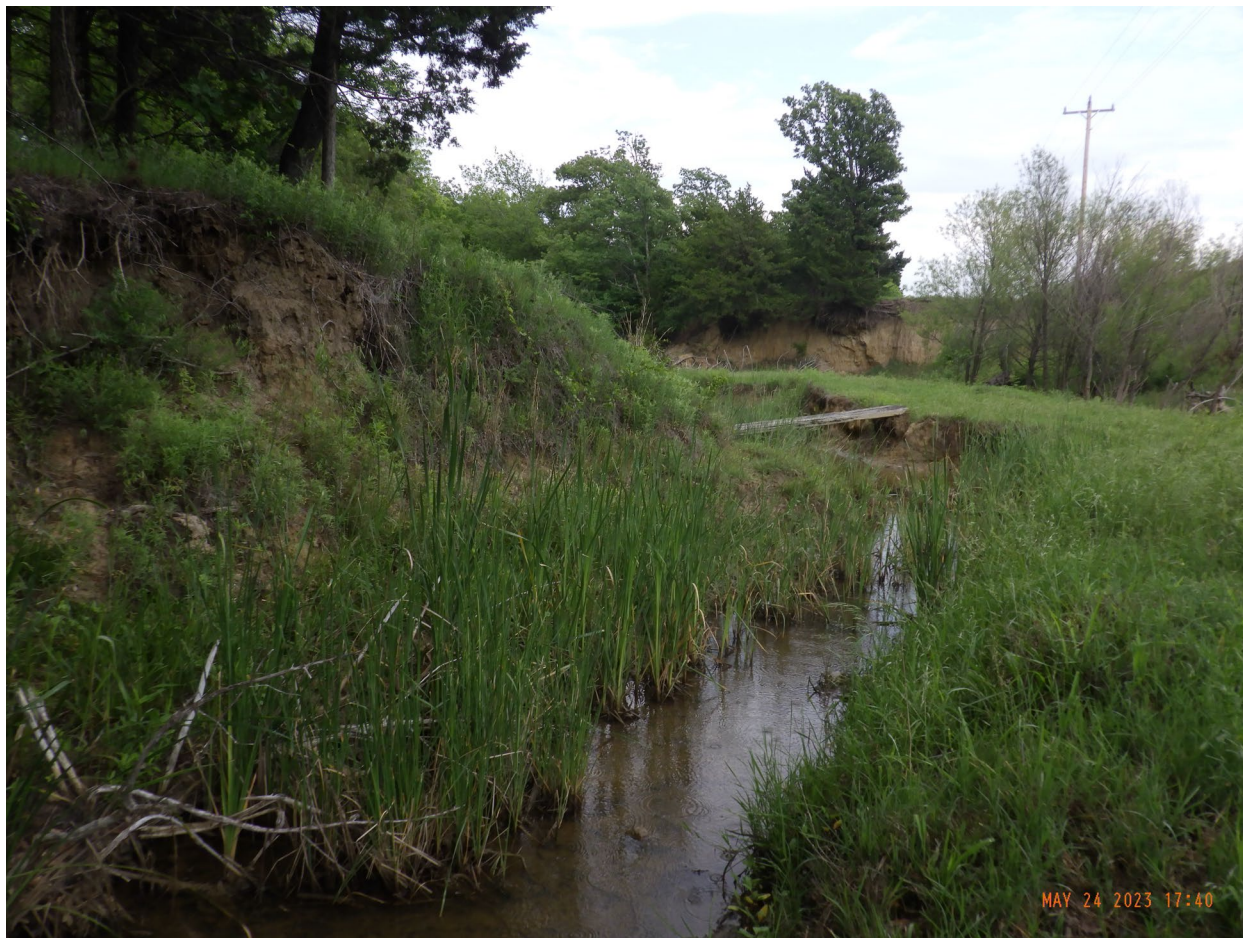
Photo No. 10

**Description:** This was a photo taken from the same location as photos No. 8 and 9. This was a photo with a W or downstream view, showing the topography of the tributary.

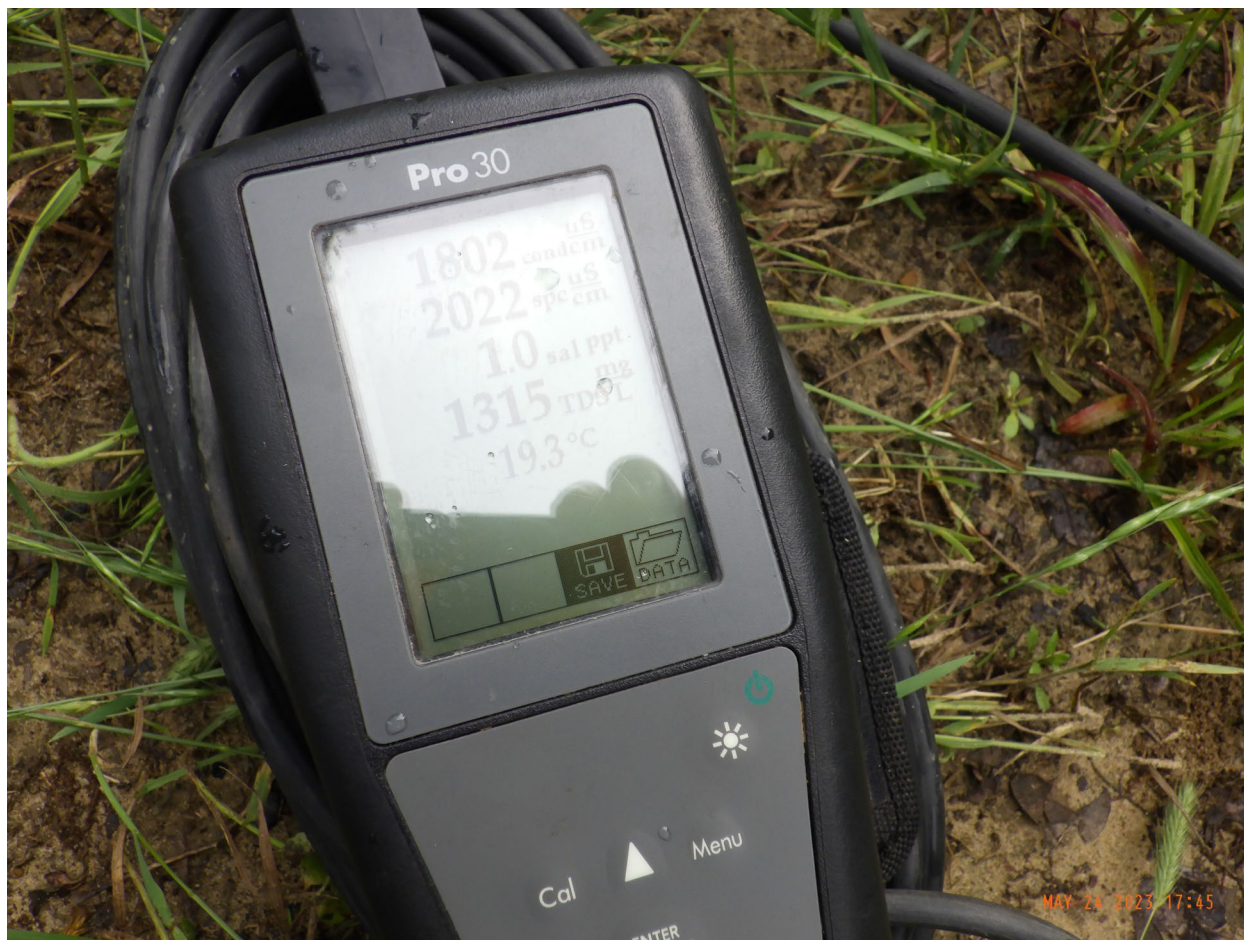
Photo No. 11

Further downstream, I observed a slightly elevated TDS field reading of 1,315 mg/L as well as the bed and bank features of the tributary. A transfer pump was present in this section of the tributary but was not active. See photo No. 11 through 14.

**Description:** This was an elevated TDS field reading of 1,315 mg/L taken downstream from the POE along the main channel of the impacted tributary.

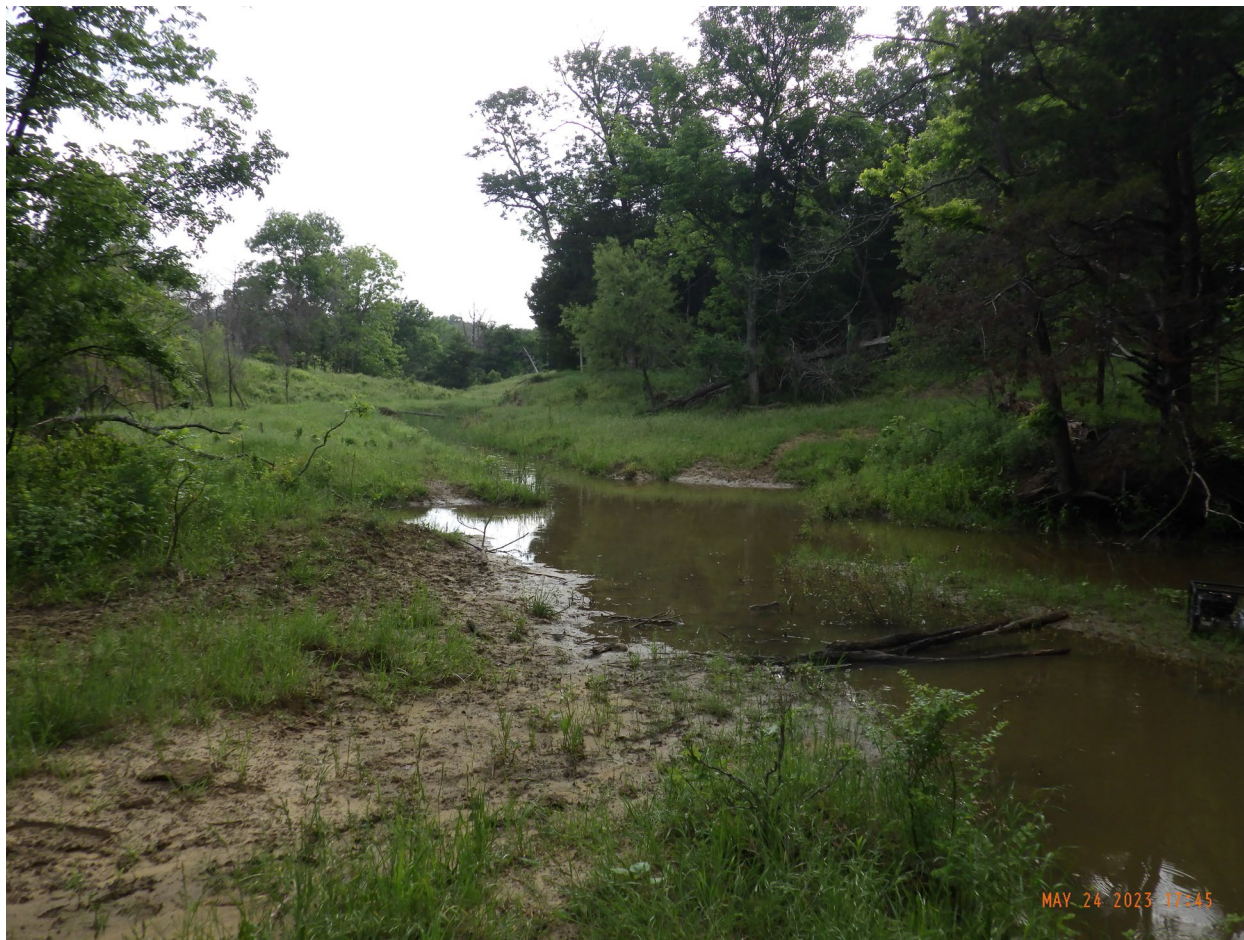
Photo No. 12

**Description:** This was a photo taken from the same location as Photo No. 11. This was a view looking W or upstream showing the bed and bank features of the impacted tributary.

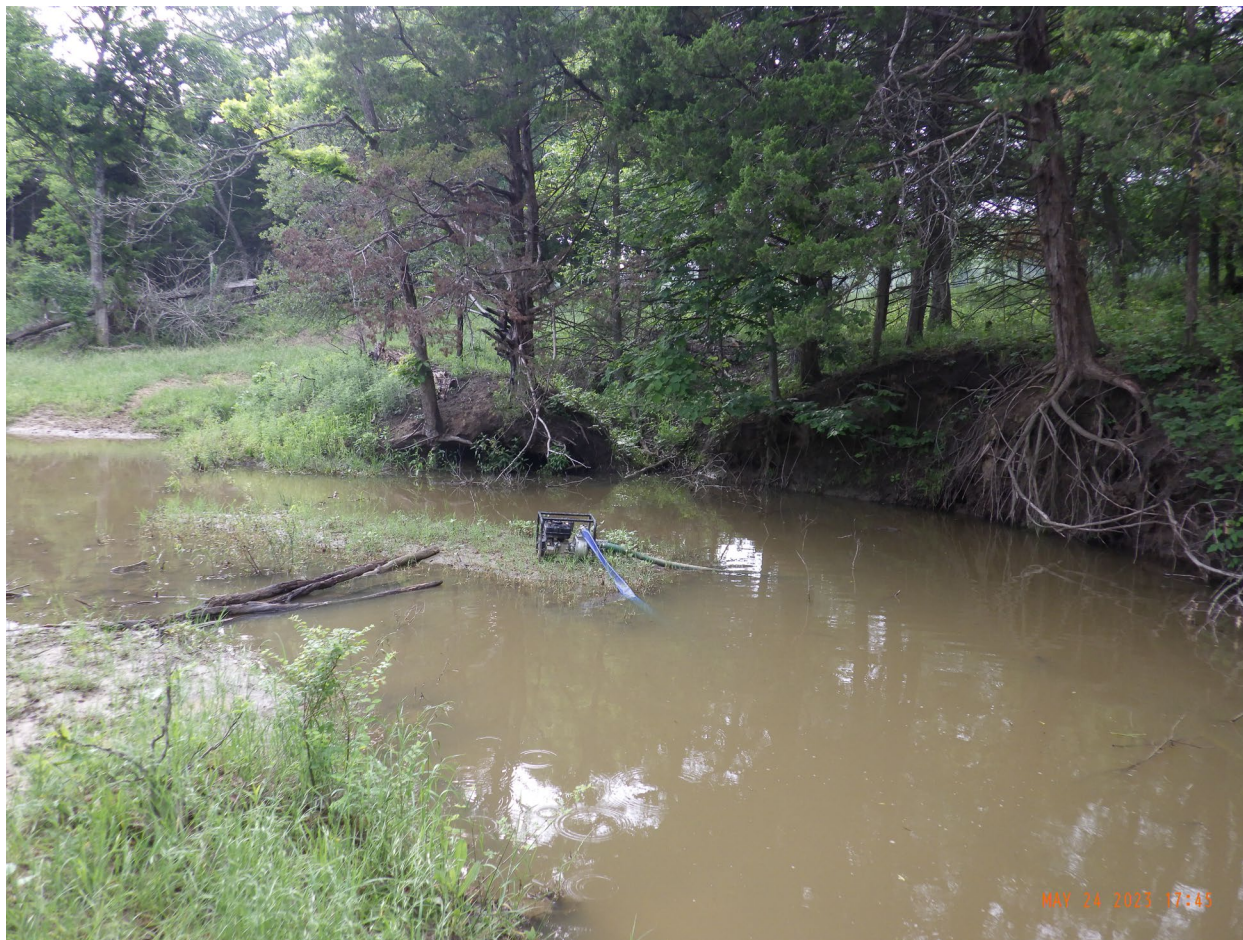
Photo No. 13

**Description:** This was a photo taken from the same location as Photo No. 11 and 12. This was a view looking NW across the tributary showing the inactive transfer pump.

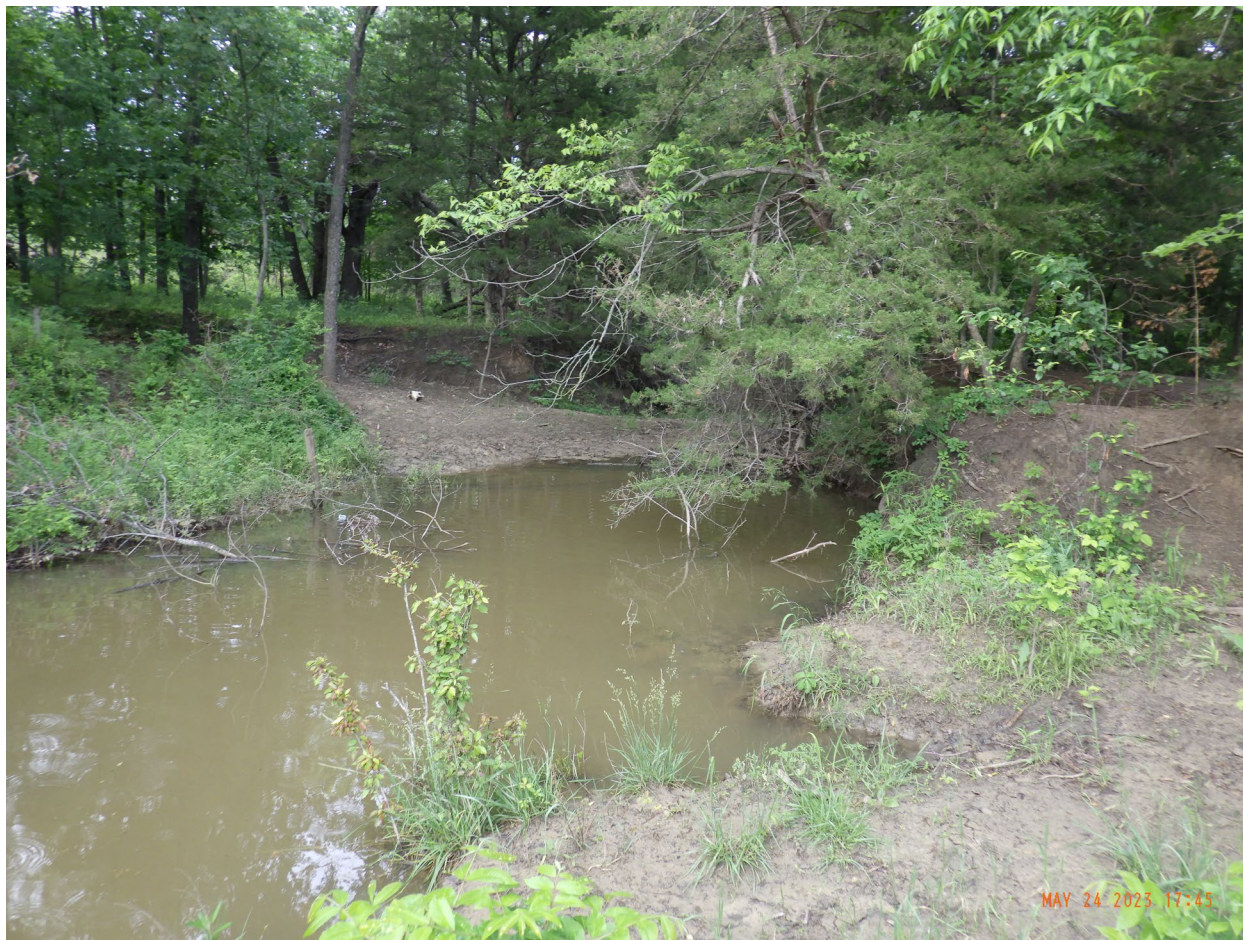
Photo No. 14

**Description:** This was a photo taken from the same location as Photos No. 11, 12, and 13. This was a view looking NE or downstream showing the bed and bank features of the impacted tributary.

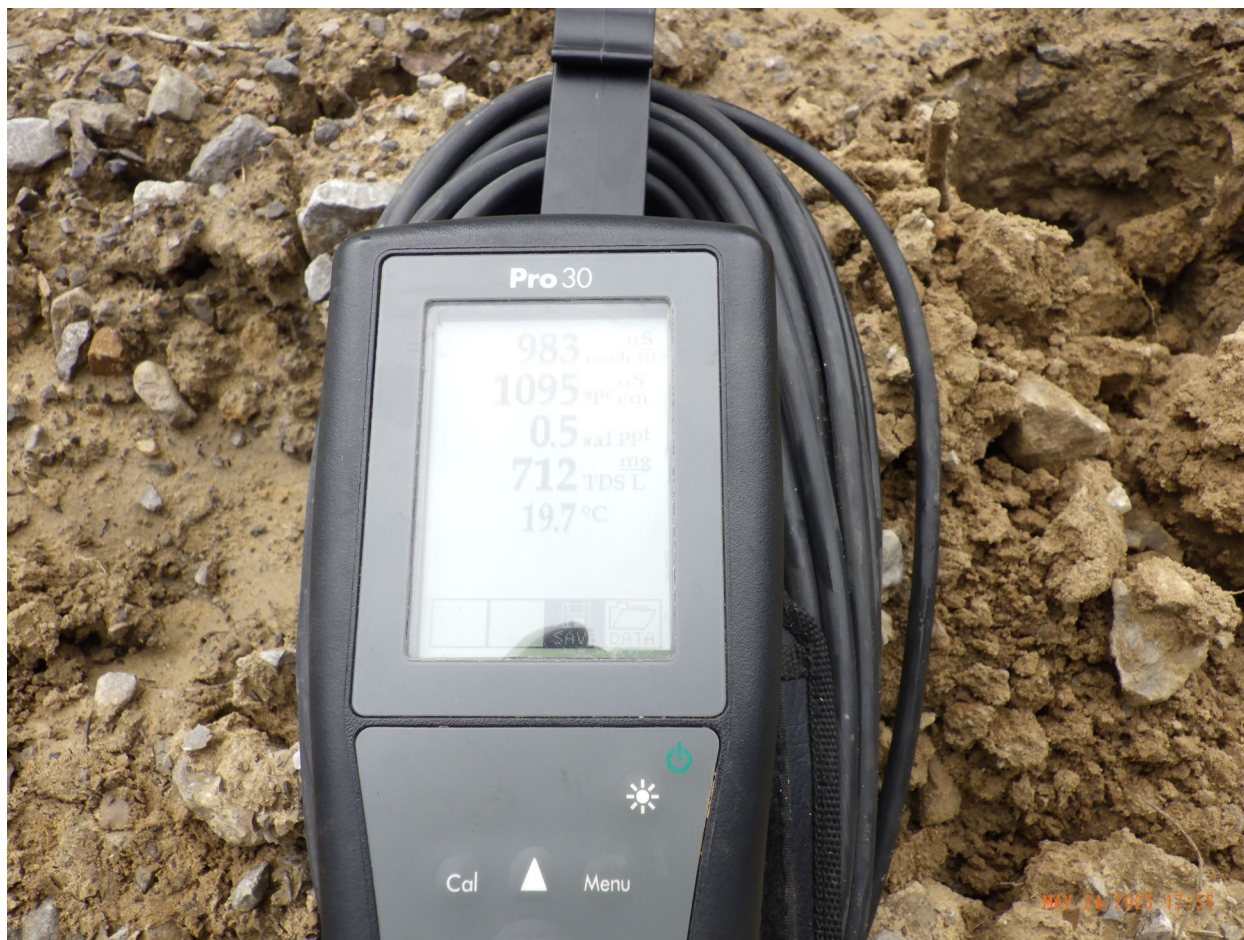
Photo No. 15

At the lowermost containment dam (36.531594, -96.403942), I observed a below background TDS field reading of 712 mg/L, this was the lowest TDS field reading observed during the inspection. At the same

**Description:** This was a below background TDS field reading of 712 mg/L taken in the lowermost pool of the impacted tributary. This field reading was taken in the pool of water immediately upstream from the lower, temporary containment dam which had been placed by the operator to prevent further downstream migration of impacted waters.

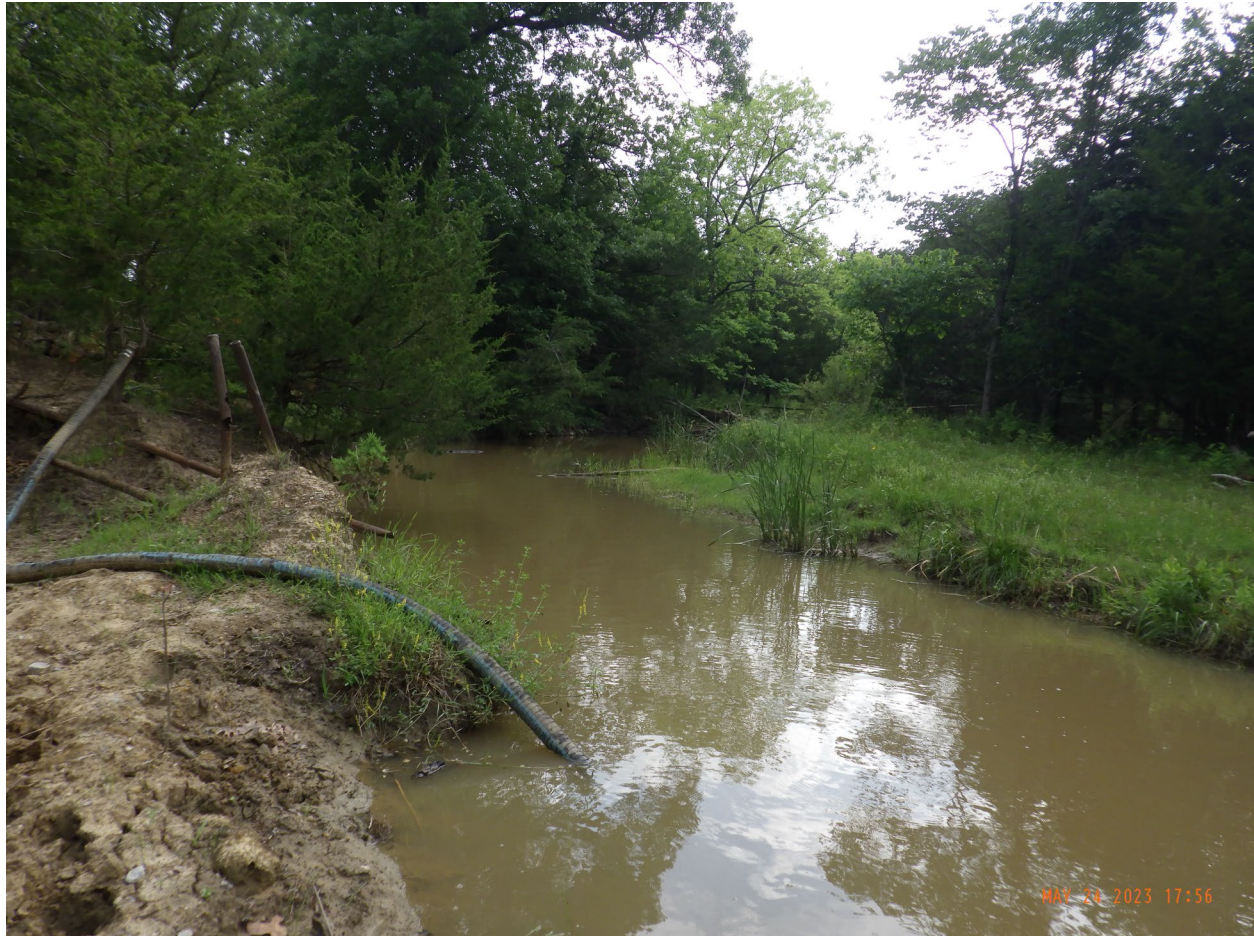
Photo No. 16

location, I observed a vacuum truck load hose which was not being used at the time of the inspection. See photos No. 15 through 17.

**Description:** This was a photo taken from the same location as photo No. 15. This was the lowermost pool of water immediately upstream from the lower, temporary containment dam which had been placed by the operator to prevent further downstream migration of impacted waters. The vacuum truck loading hose in the photo was not operating at the time of inspection.

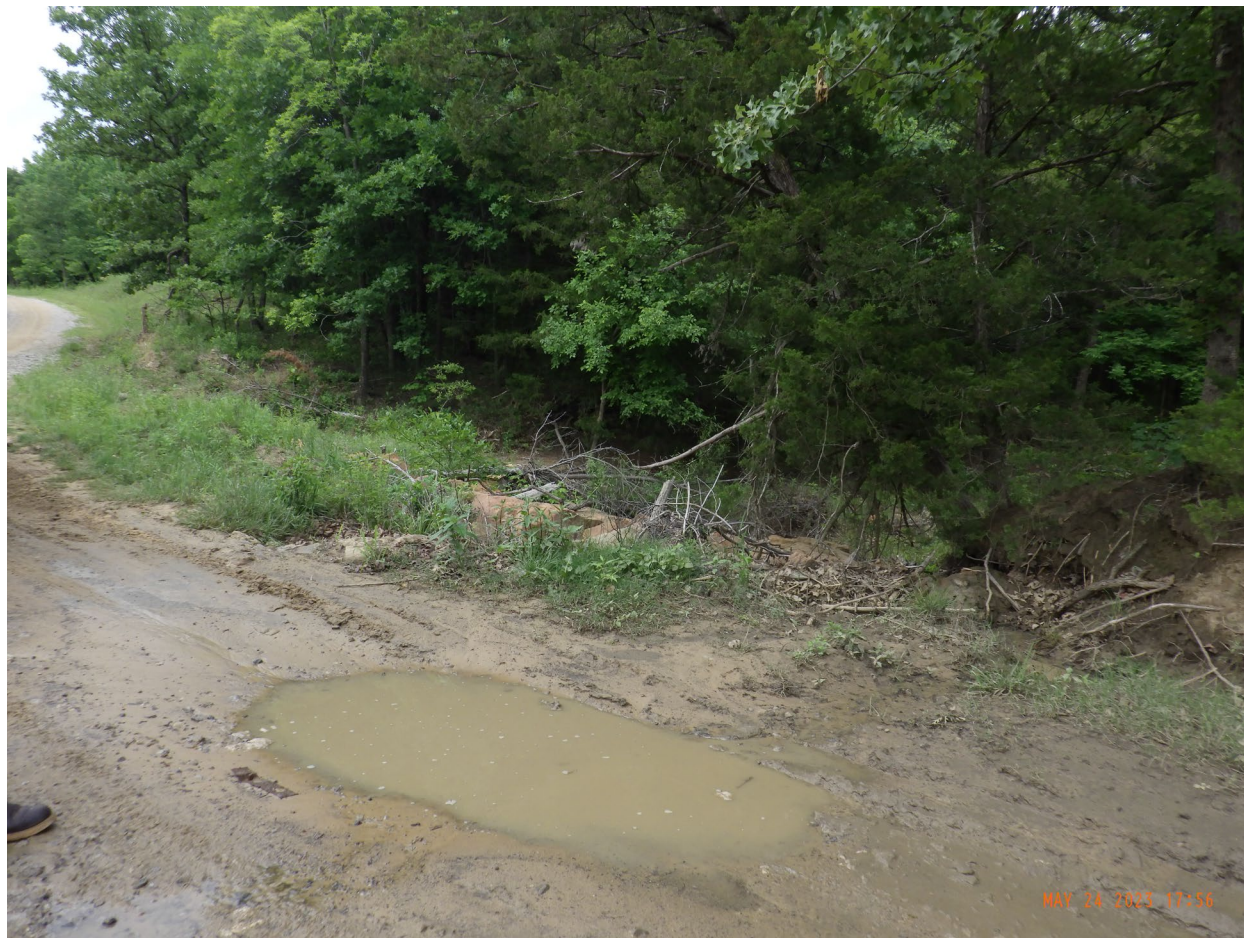
Photo No. 17

**Description:** This was a photo taken from the same location as photo No. 15 and 16. This is a downstream view toward the east. I did not observe spill impacts at any point downstream from the temporary containment dam at the time of the inspection.
