**Well Inspection**  
**Osage DNR / Environmental Protection Agency**  
**1201 Elm Street, Suite 500**  
**Dallas, Texas 75270**

| | | <b>Lease Name</b> | O.I.R | | |
| | | <b>Well ID</b> | 8 | | |
| <b>Inspection Reason</b> | Plugging Witnessed | | <b>Responsible Company at Time of Inspection</b> | CEP Mid-Continent | |

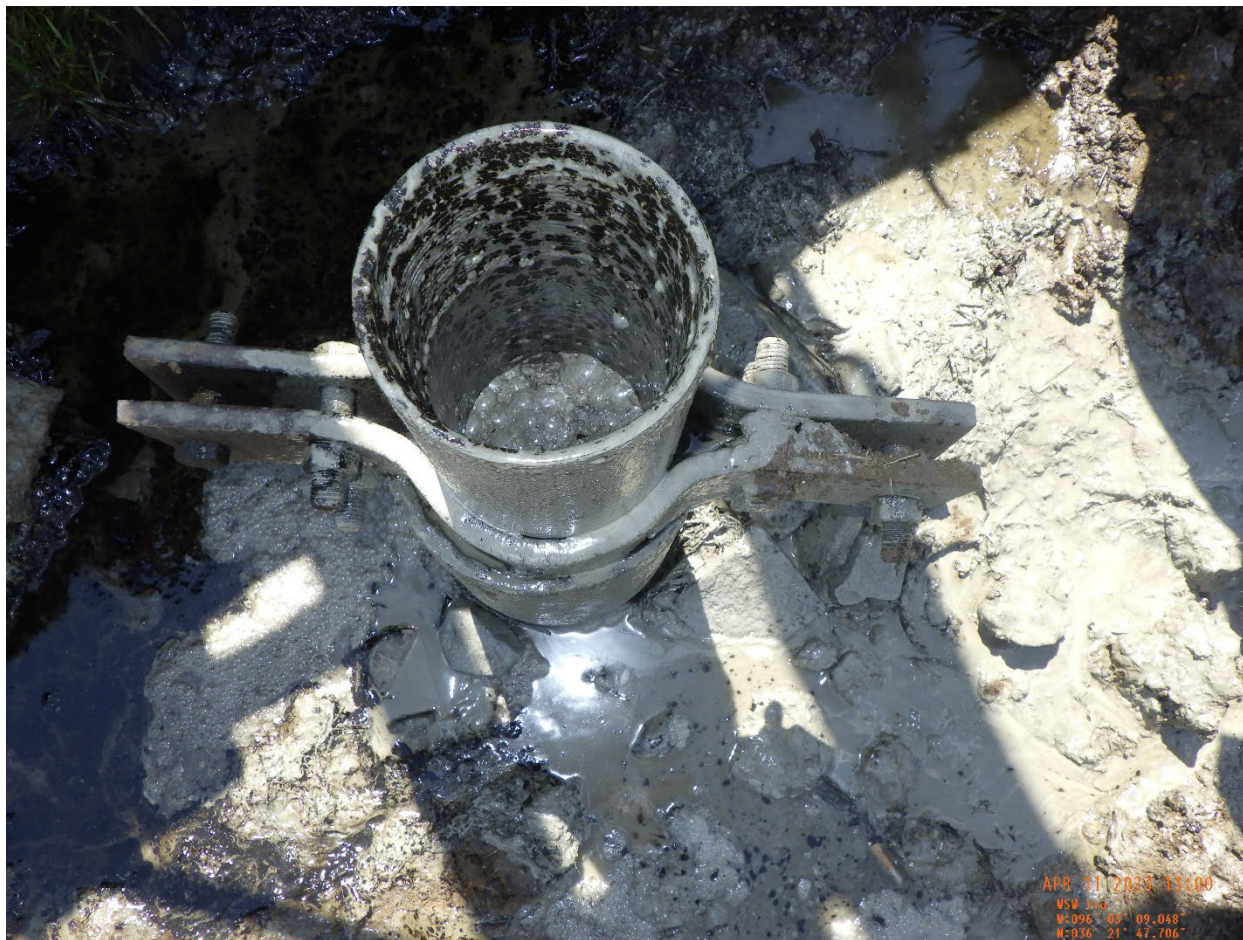
Photo No. 1

**Description:** Well OS5307000 with cement circulated to surface. No areas of concern at the time of the inspection.
