## Region 6 - Enforcement & Compliance Assurance Division

### INSPECTION REPORT

| Regulatory Program(s) | NPDES Stormwater/CWA 402 | |
| Facility Name: | Ora Bell Russell Elementary School | |

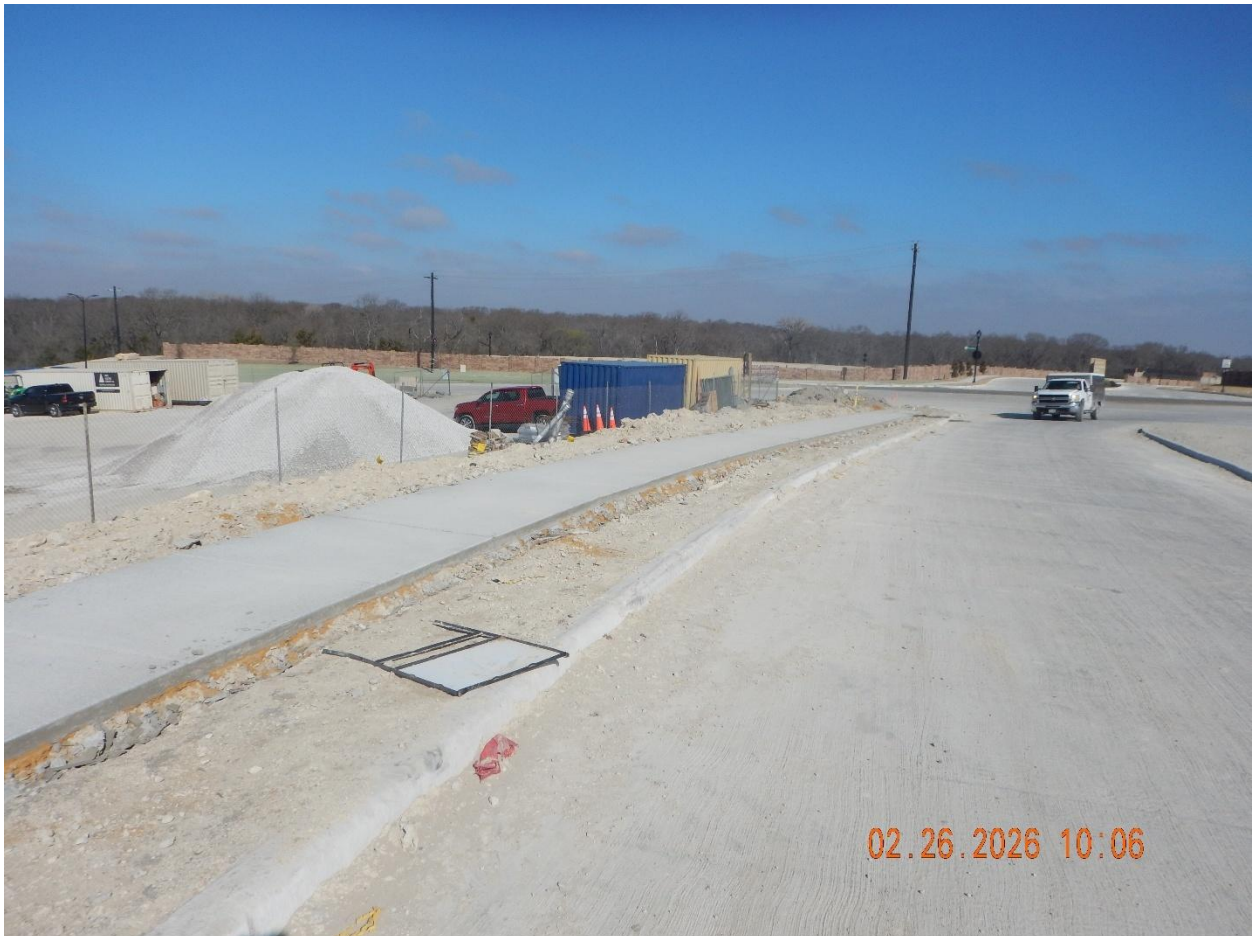
Photo no. 1

1. The construction entrance(s) were not stabilized with BMPs to minimize sediment track-out (**Appendix 1, Photo 3**).
2. The CSNs were not properly posted for public view (**Appendix 1, Photo 1**).

Description: The Construction Site Notices (CSNs) knocked over on the ground near the sidewalk on Winding Shore Lane.

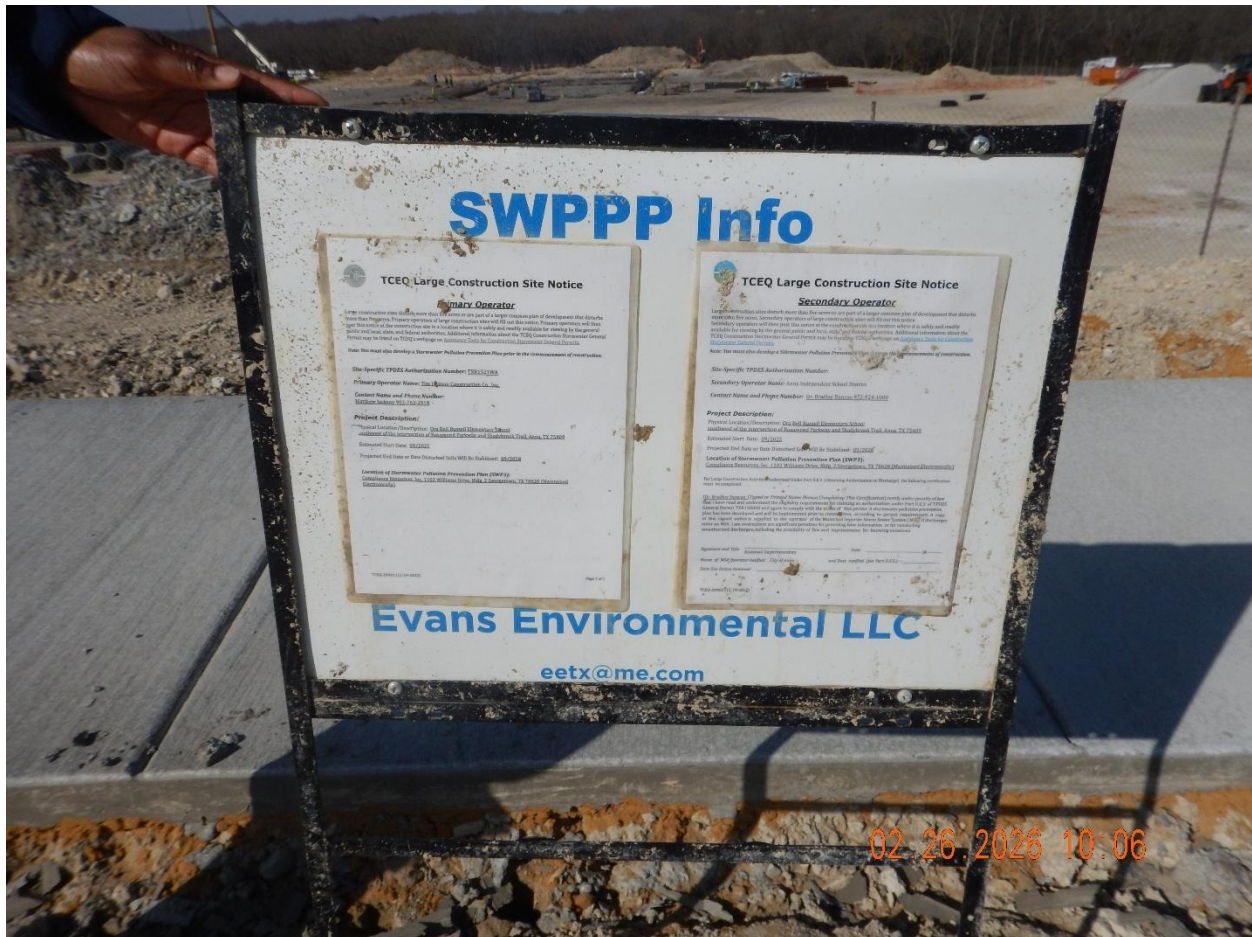
Photo no. 2

Description: Up close view of the site's CSNs from Photo 1. Tim Jackson Construction is listed as the primary operator and Anna Independent School District is listed as the secondary operator.

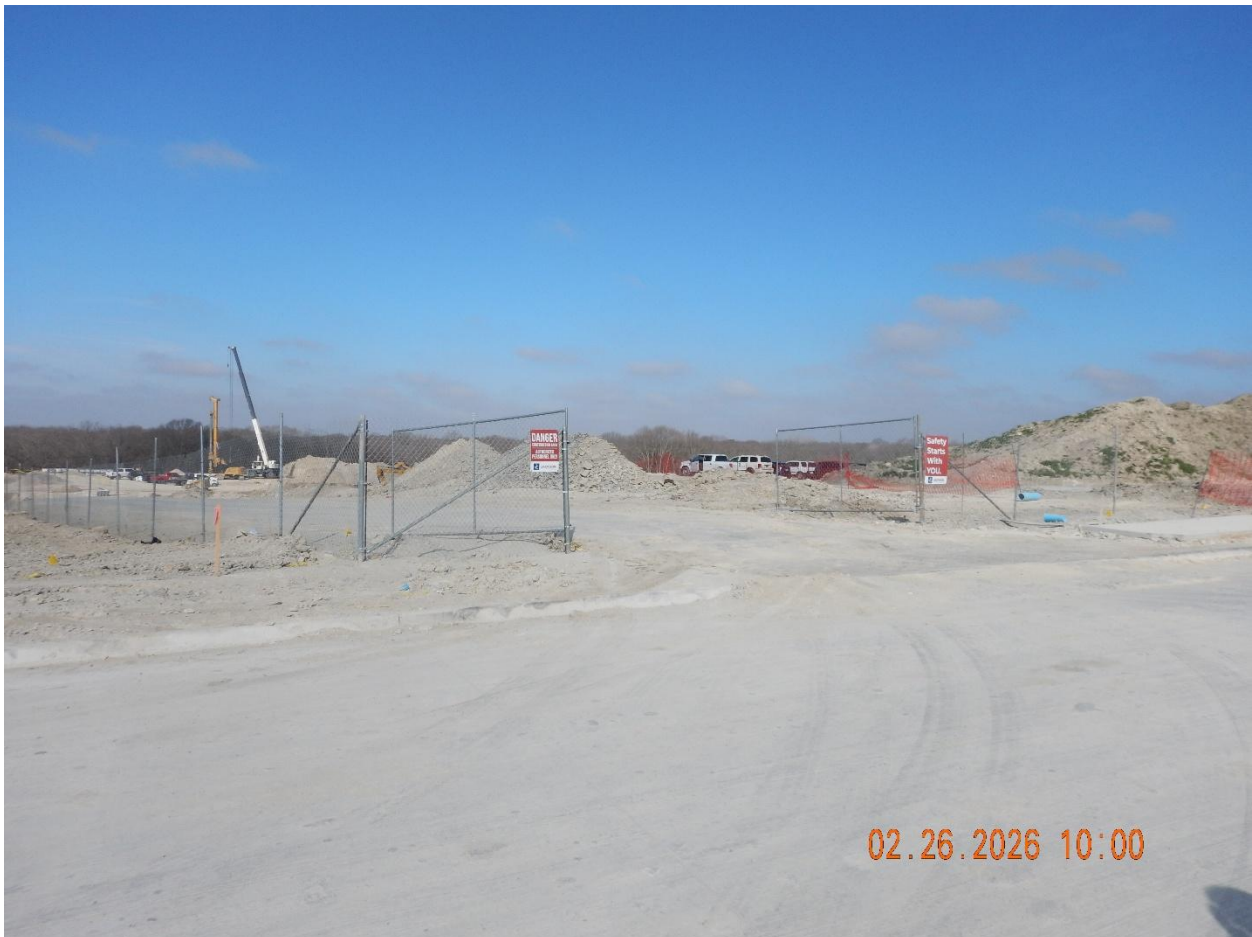
Photo no. 3

Description: The construction entrance on Winding Shore Lane with no BMPs installed to minimize sediment track-out.

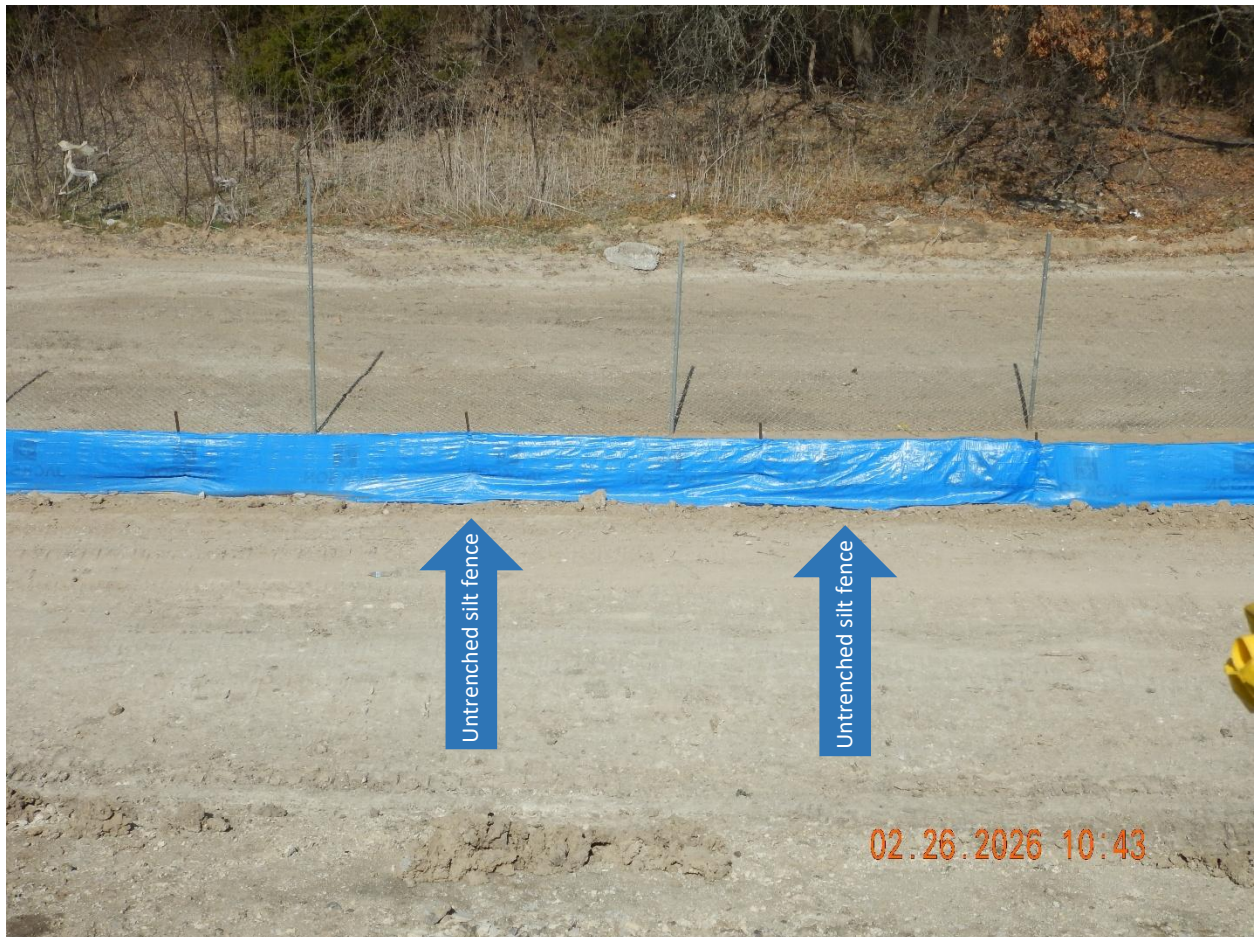
Photo no. 4

3. Silt fence along the western perimeter of the site was not properly installed (not trenched/buried) in multiple areas (**Appendix 1, Photo 4**).
4. Silt fence along the western perimeter of the site had sediment buildup in exceedance of 50% of its above-ground height in multiple areas (**Appendix 1, Photos 5-6**). Maintenance is required and excess sediment must be removed per TPDES General Permit No. TXR150000 Part III, Section F 6(c).

Description: Silt fence along the west perimeter of the site. The silt fence was improperly installed (not trenched/buried) in multiple areas.

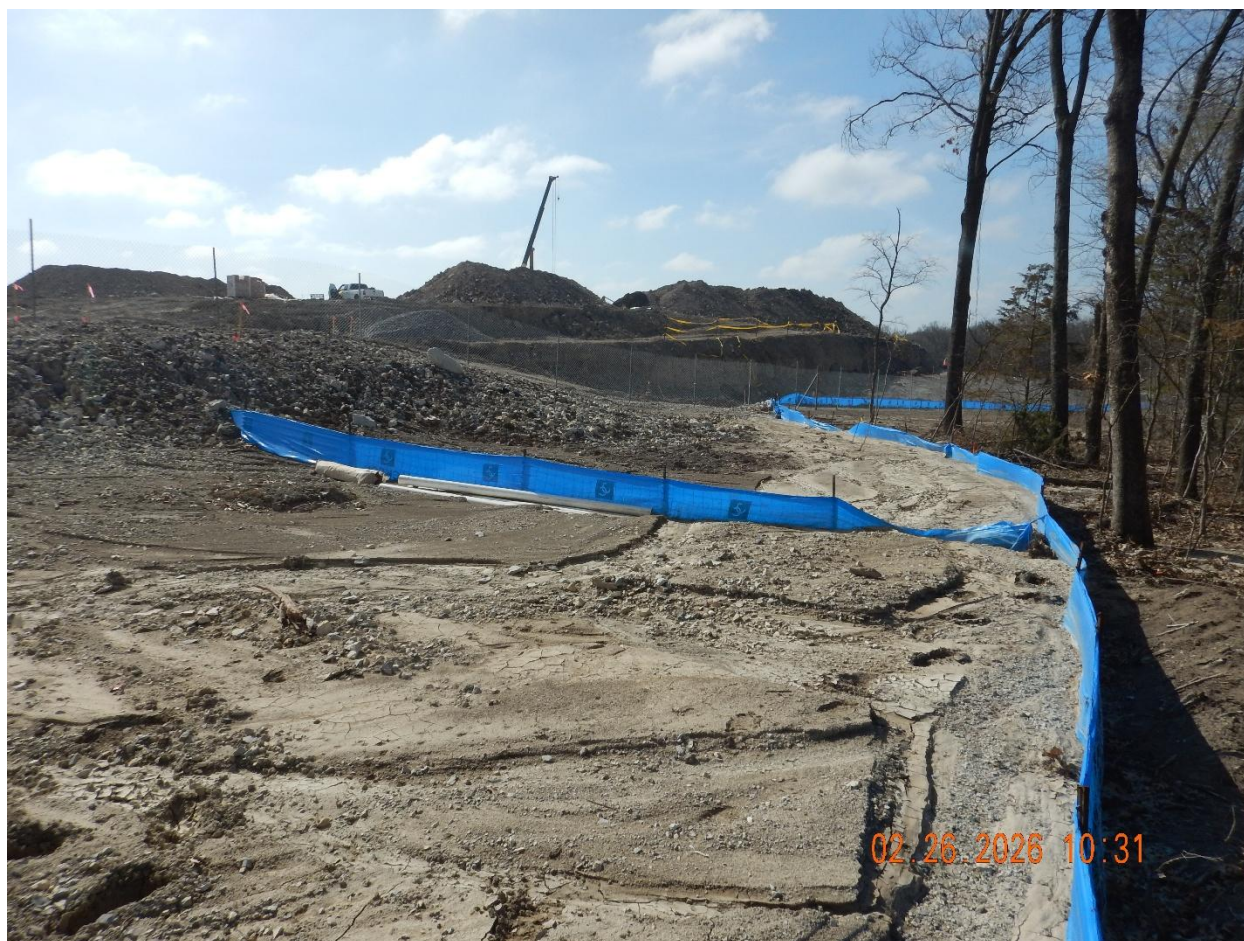
Photo no. 5

Description: Photo taken from the northwest corner of the site facing south. Sediment buildup along the western perimeter silt fence was in exceedance of 50% of its above-ground height. Also pictured are the large quantity of exposed sediment and the site's steep slope downwards/westwardly towards Hurricane Creek.

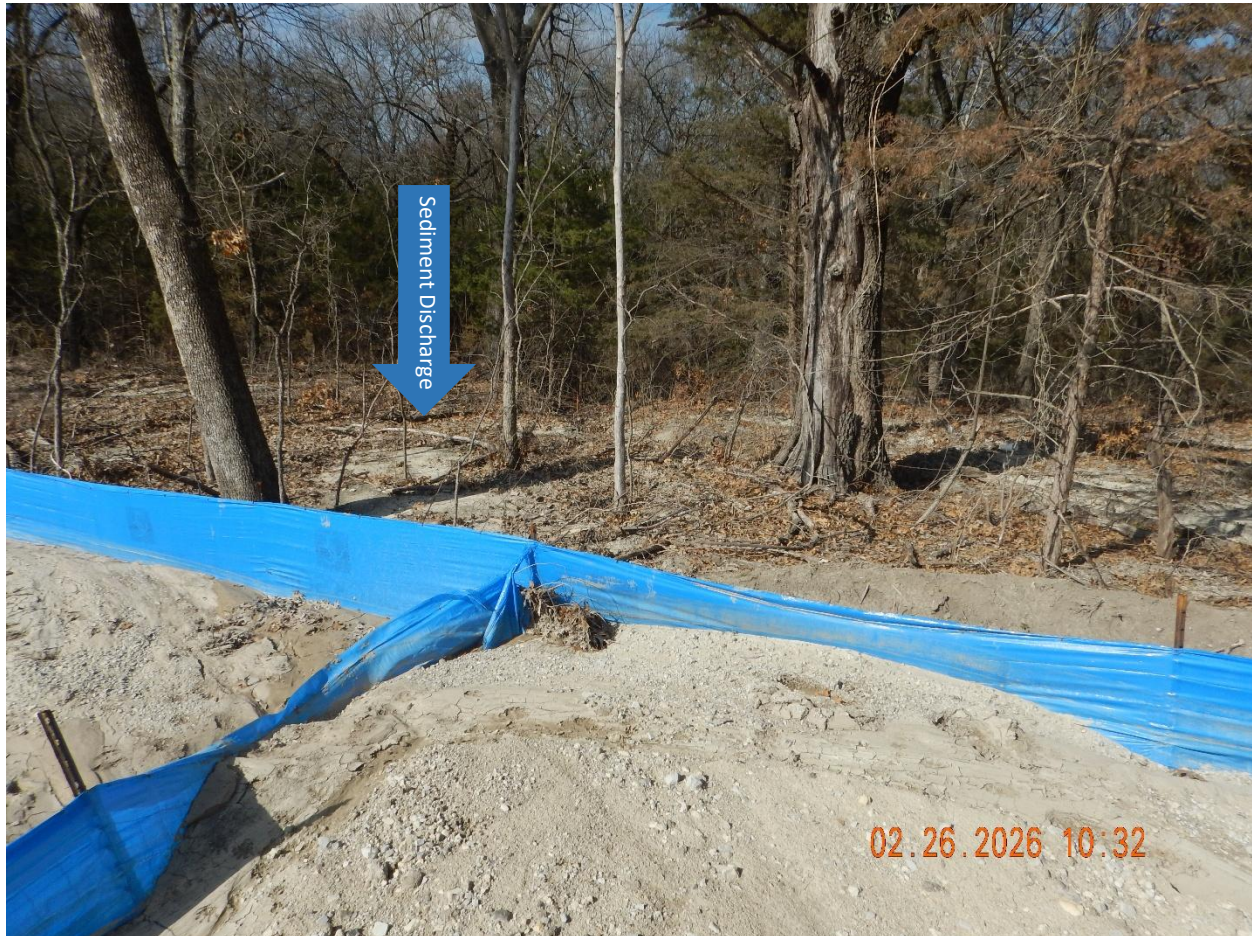
Photo no. 6

5. Silt fence in the northwest and southwest corners of the site had been ran over/damaged (**Appendix 1, Photo 7**).
6. There was visible evidence of a sediment discharge outside of the western perimeter silt fence at the time of the inspection (**Appendix 1, Photo 6**). Photos provided by Kenneth Evans of Evans Environmental, LLC on March 4, 2026, also show the trail of discharged sediment outside the western perimeter BMPs (**Appendix 2, Photo 4**). A rainfall event has the potential to wash the discharged sediment directly into Hurricane Creek.

Description: Photo taken from the northwest corner of the site facing west (towards Hurricane Creek). Sediment buildup along the western perimeter silt fence was in exceedance of 50% of its above-ground height. Also pictured is a trail of sediment outside of the perimeter silt fence leading towards Hurricane Creek, indicating off-site sediment discharge (also seen in the photo provided by Tim Jackson Construction representative, Mr. Evans, on March 4, 2026 (Appendix 2, Photo 4)).

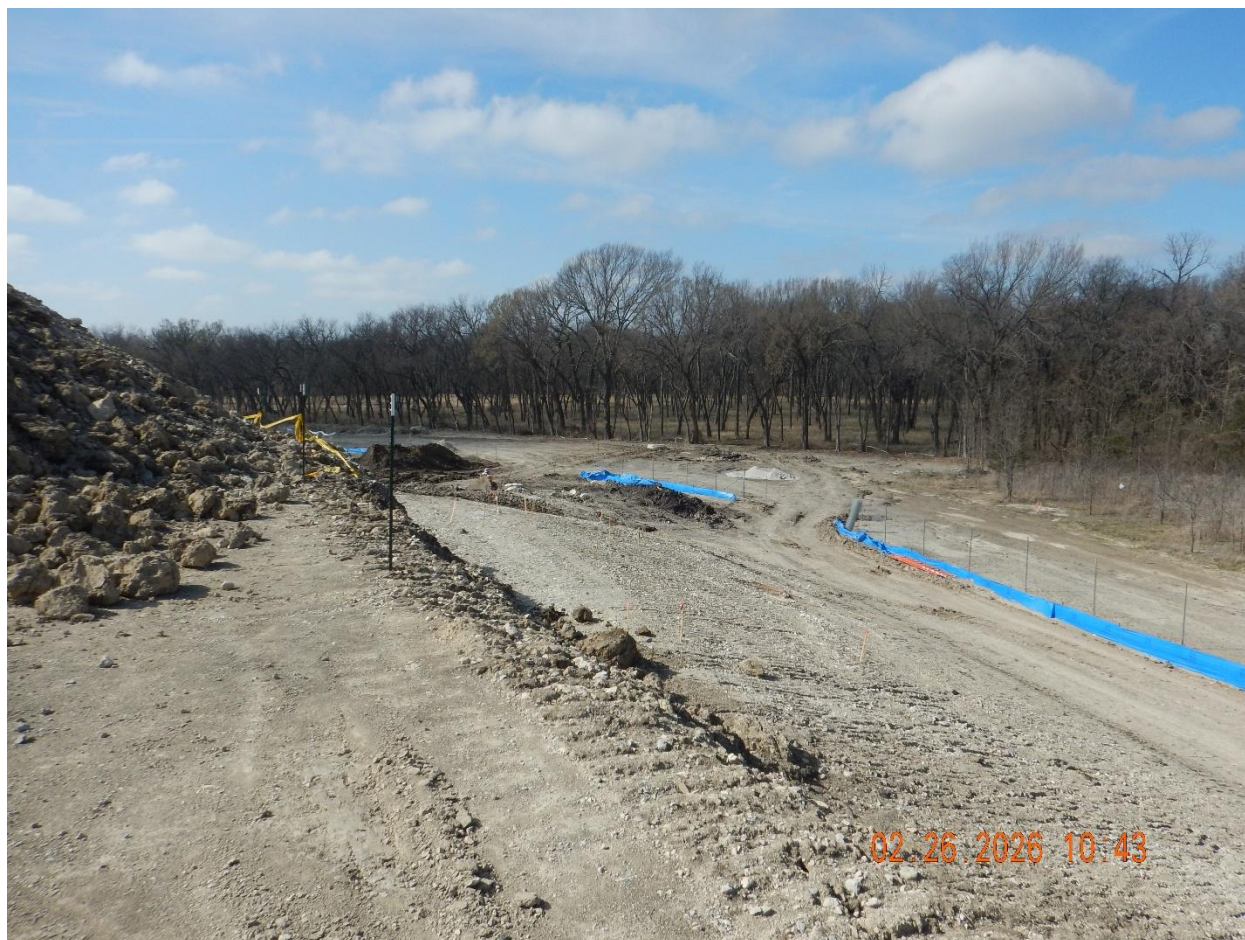
Photo no. 7

Description: Damaged silt fence (likely run over by equipment, machinery, or a vehicle) near the southwest corner of the site. Also note the site slopes downward westwardly towards Hurricane Creek.

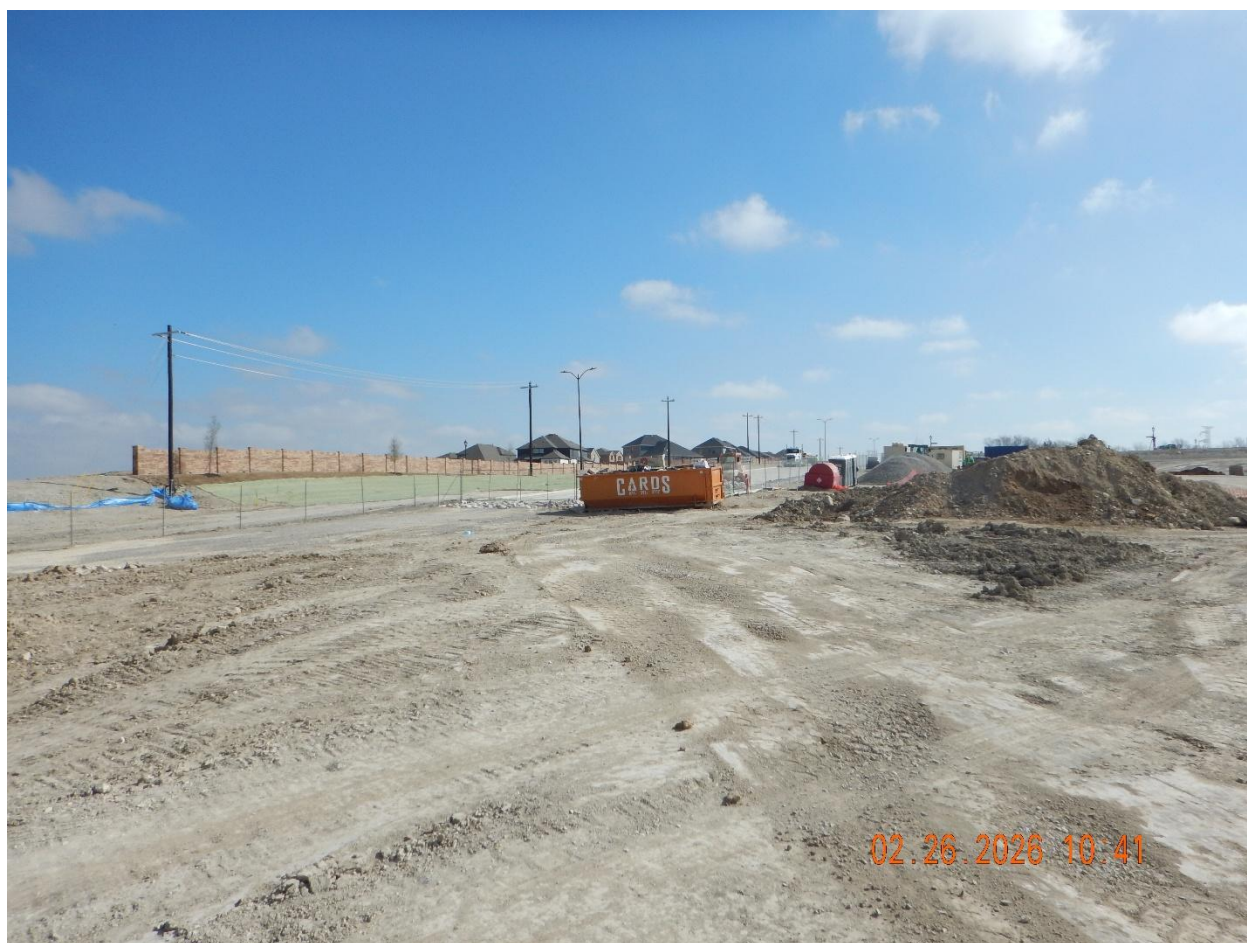
Photo no. 8

Description: Red fuel storage tank near the northern perimeter with no evidence of leakage. Also pictured is an orange roll-off dumpster. No blowable trash was observed on-site.

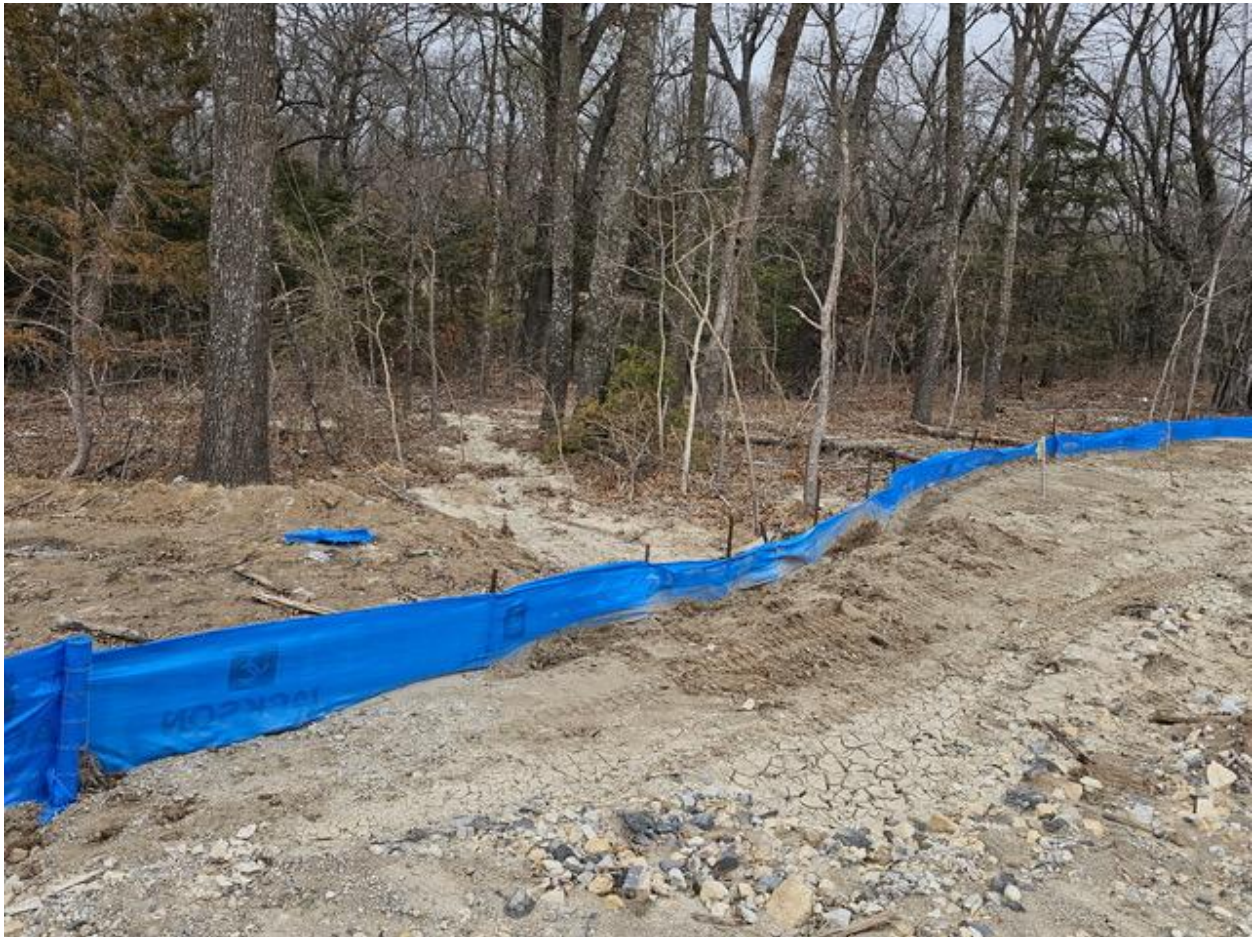
Photo no. 4

Description: Photo taken by a Tim Jackson Construction representative corresponding with Photo 5 in Appendix 1. Sediment buildup along the silt fence still appears close to or in exceedance of 50% of its above ground height in some areas. Additional maintenance is required. Also note the discharged sediment on the other side of the western perimeter silt fence leading to Hurricane Creek.

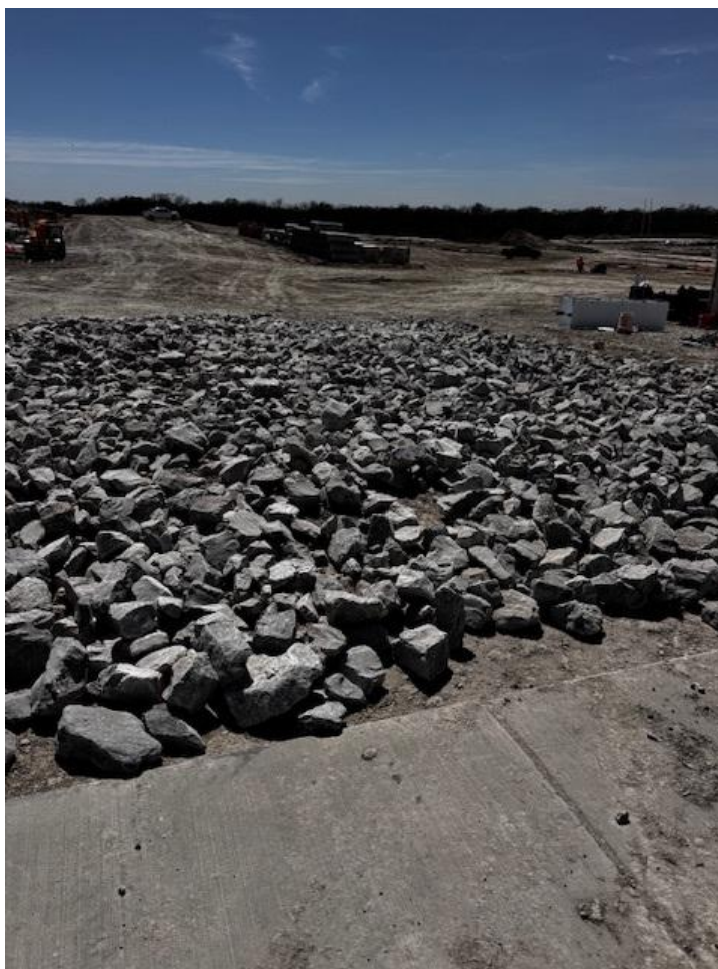
Photo no. 5

Description: Photo taken by a Tim Jackson Construction representative illustrating that rock/gravel has been installed at the construction entrance. It does not appear that a geotextile filter fabric was installed underneath the rock.
