**ATTACHMENT C**  
**Goose Pond Site Inspection Report**

Ludowici, Georgia  
June 16, 2021

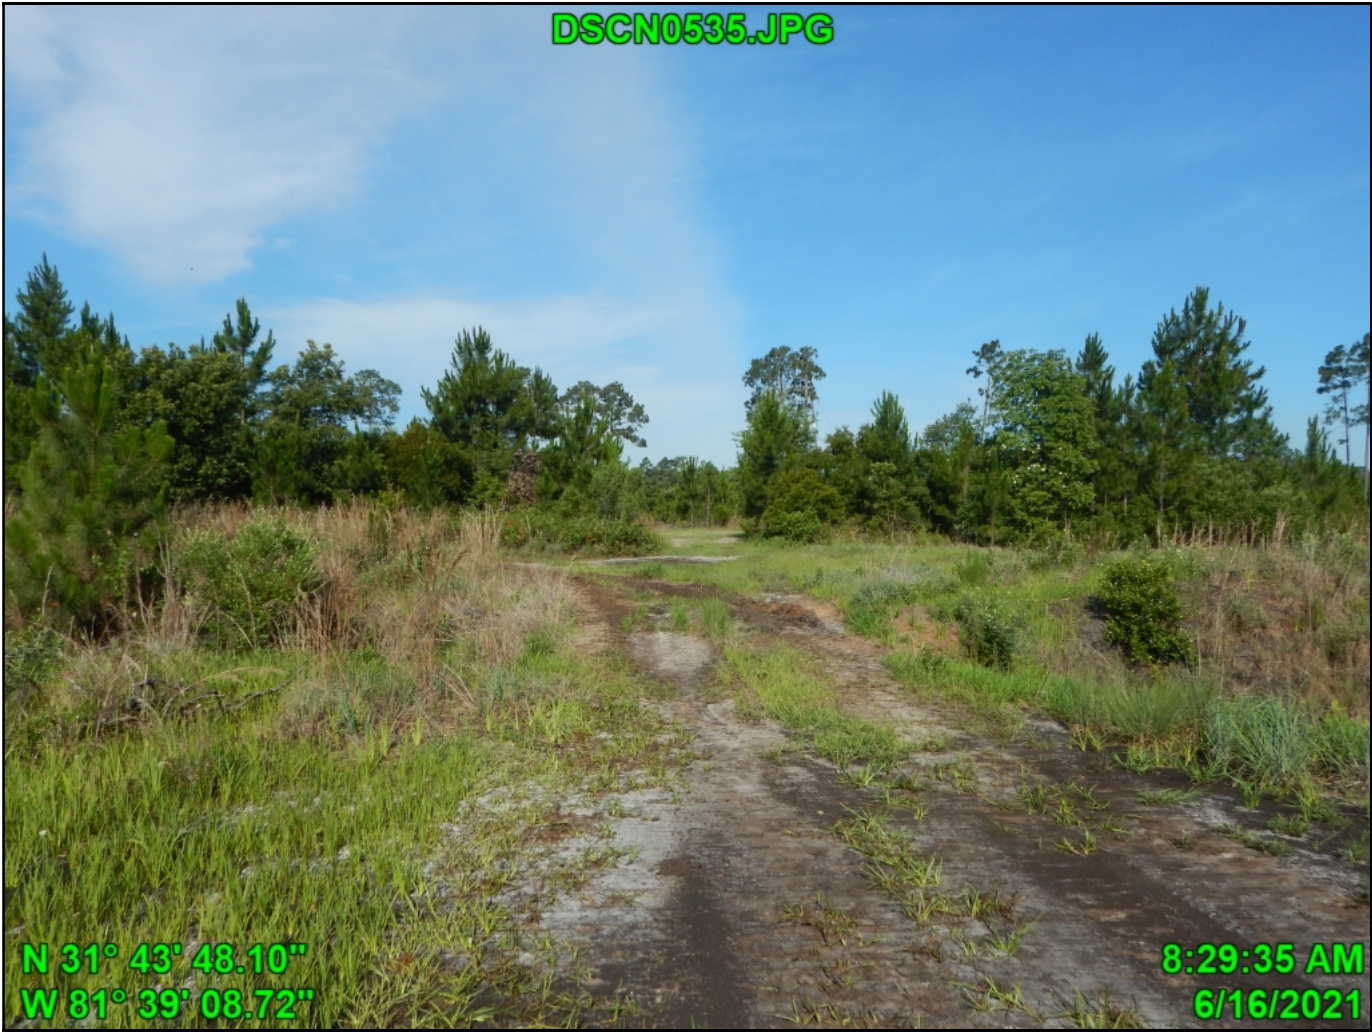
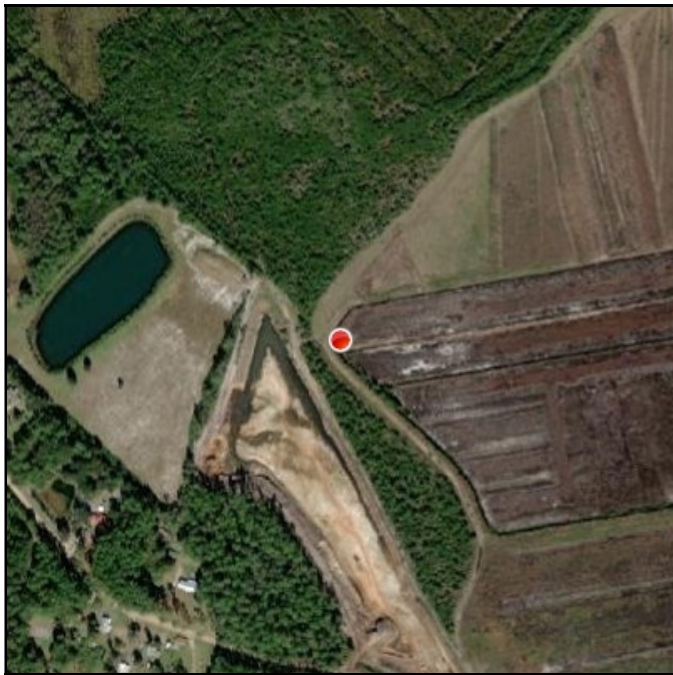
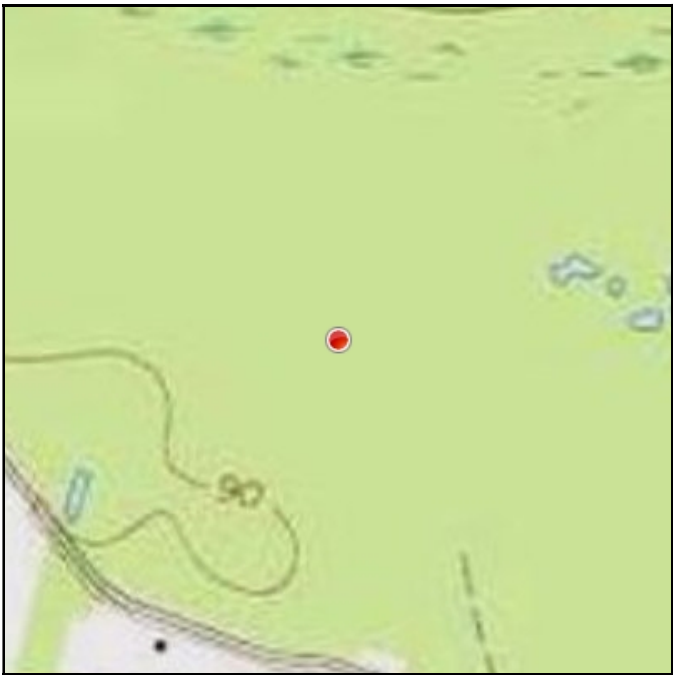
| Attributes | |
|---|---|
| Title | Photo 1 |

| Attributes | |
|---|---|
| Description | Road leading to lake that is pumped, looking from Carolina Bay; striking west. |

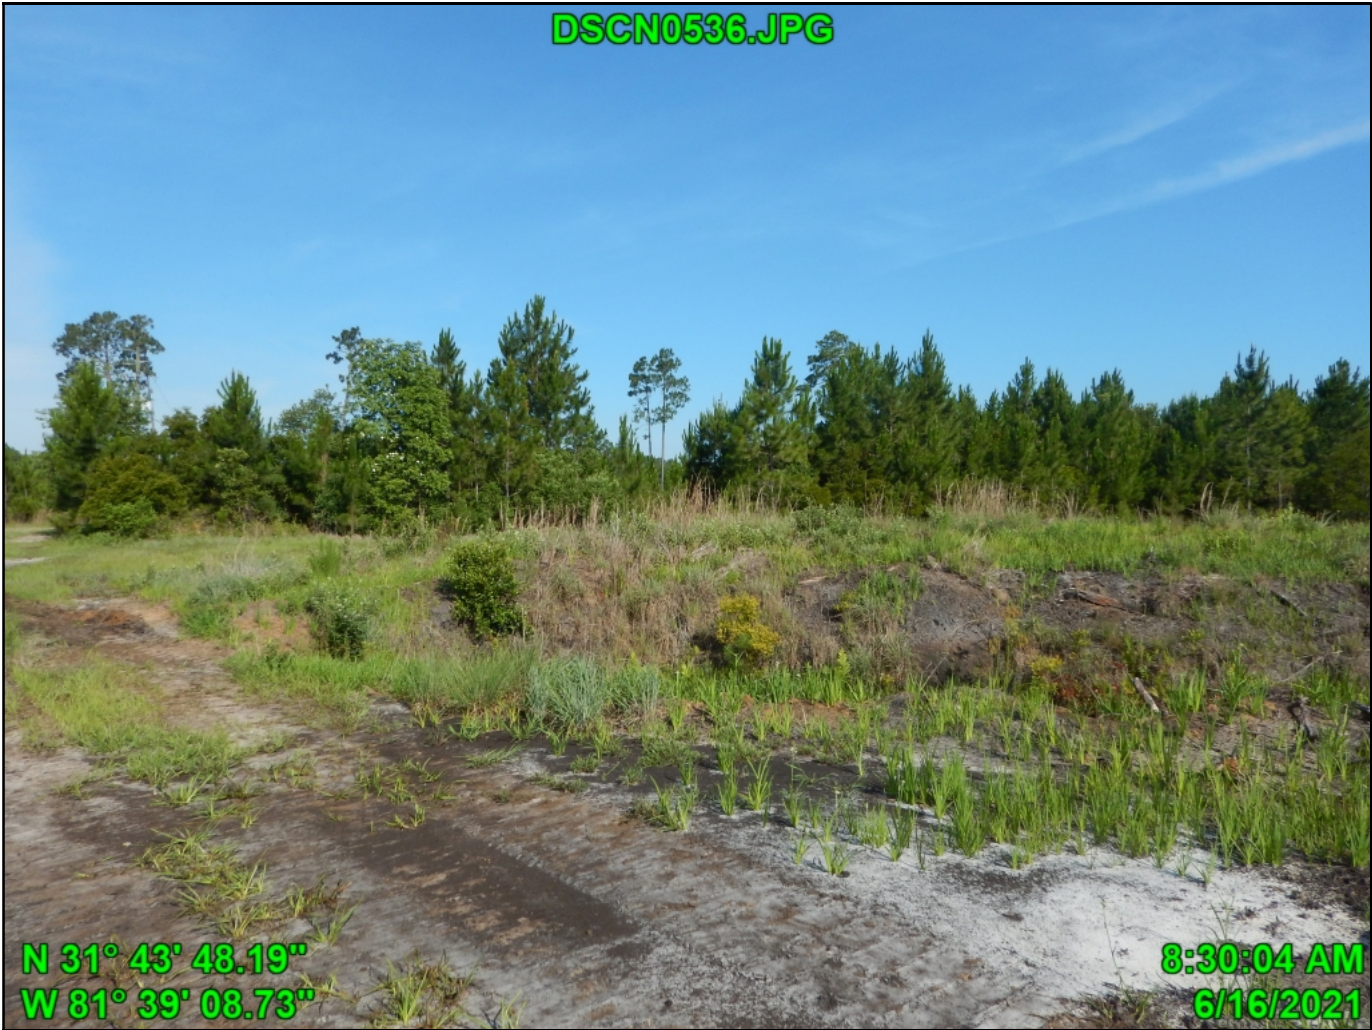
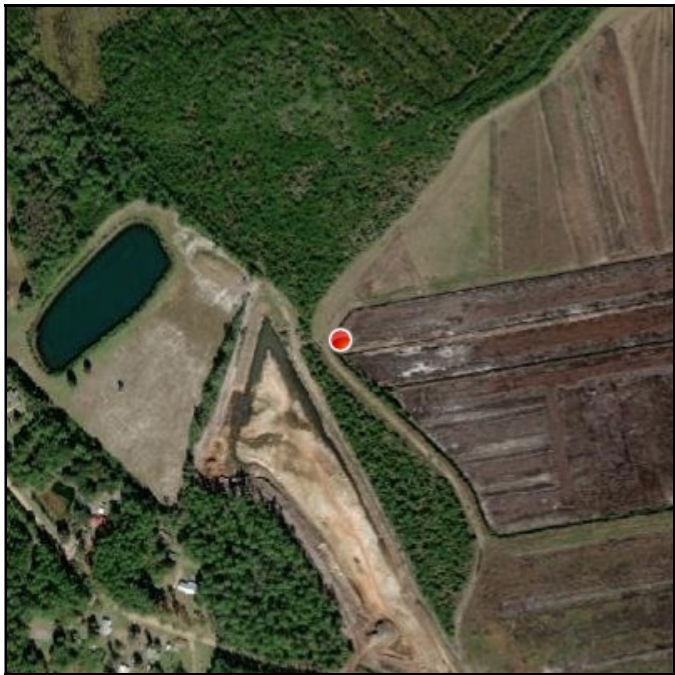
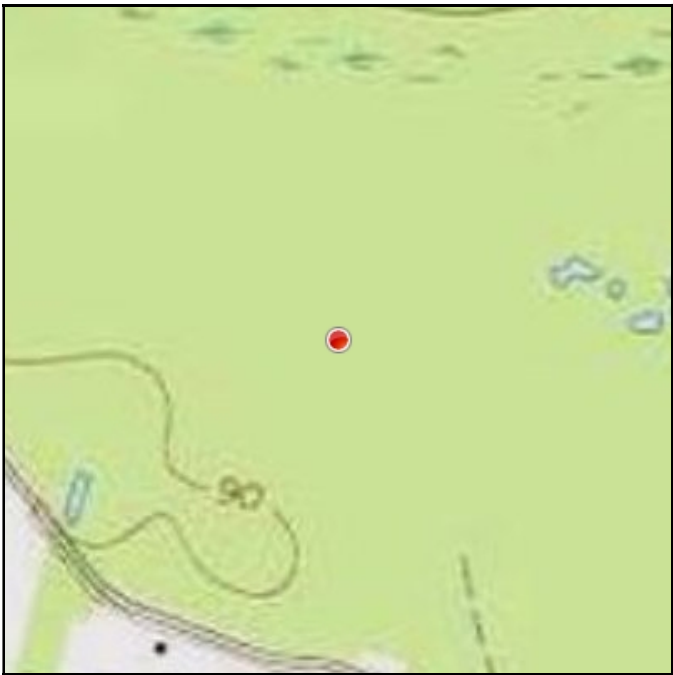
| Attributes | |
|---|---|
| Title | Photo 2 |

| Attributes | |
|---|---|
| Description | Road to pumped lake, looking toward sand ridge; striking northwest. |

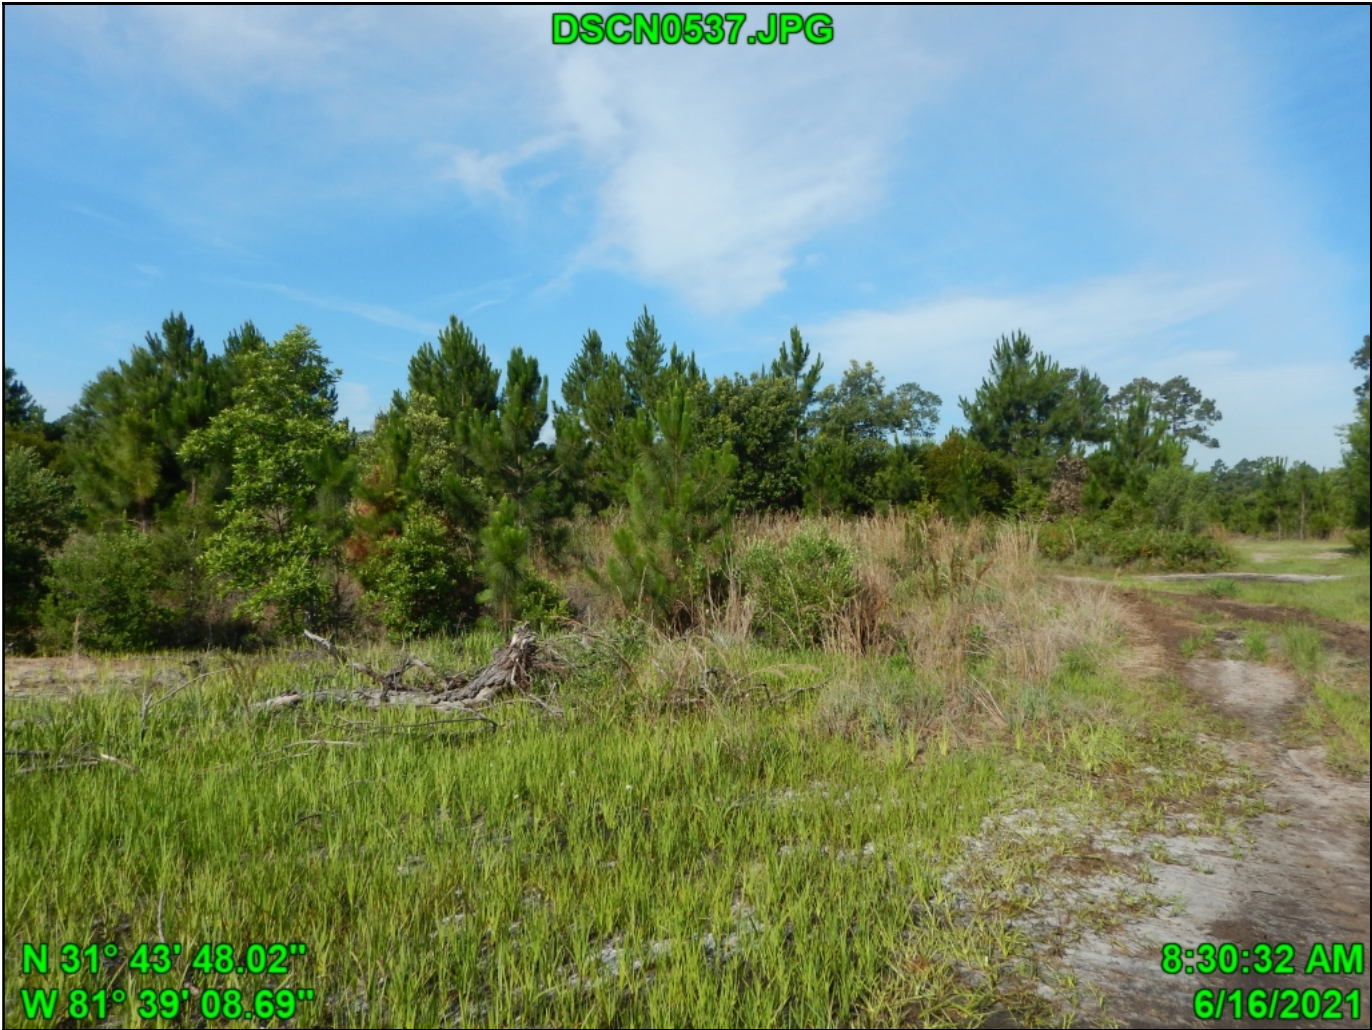
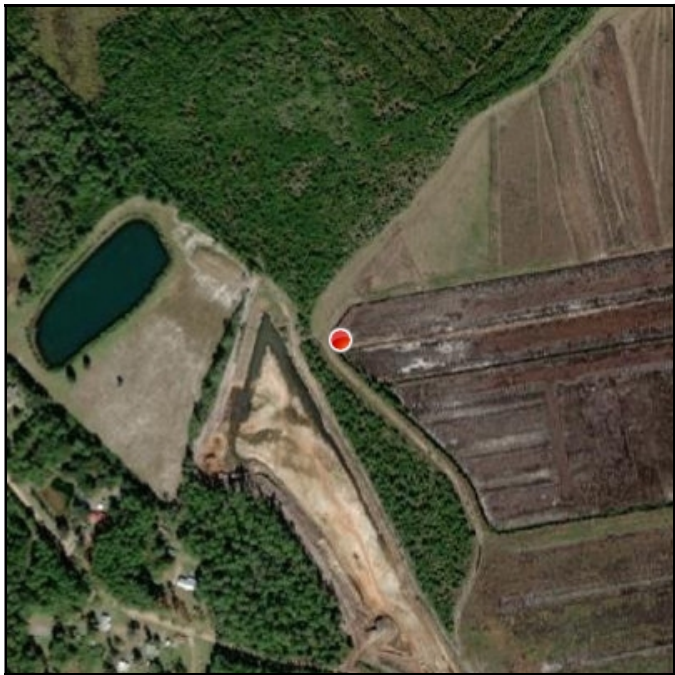
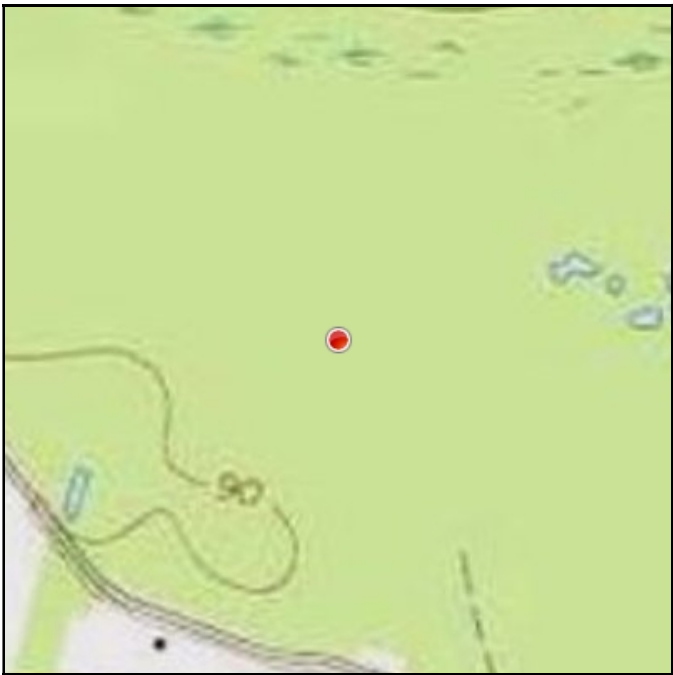
| Attributes | |
|---|---|
| Title | Photo 3 |

| Attributes | |
|---|---|
| Description | Road to pumped lake, looking toward sand ridge; striking southwest. |

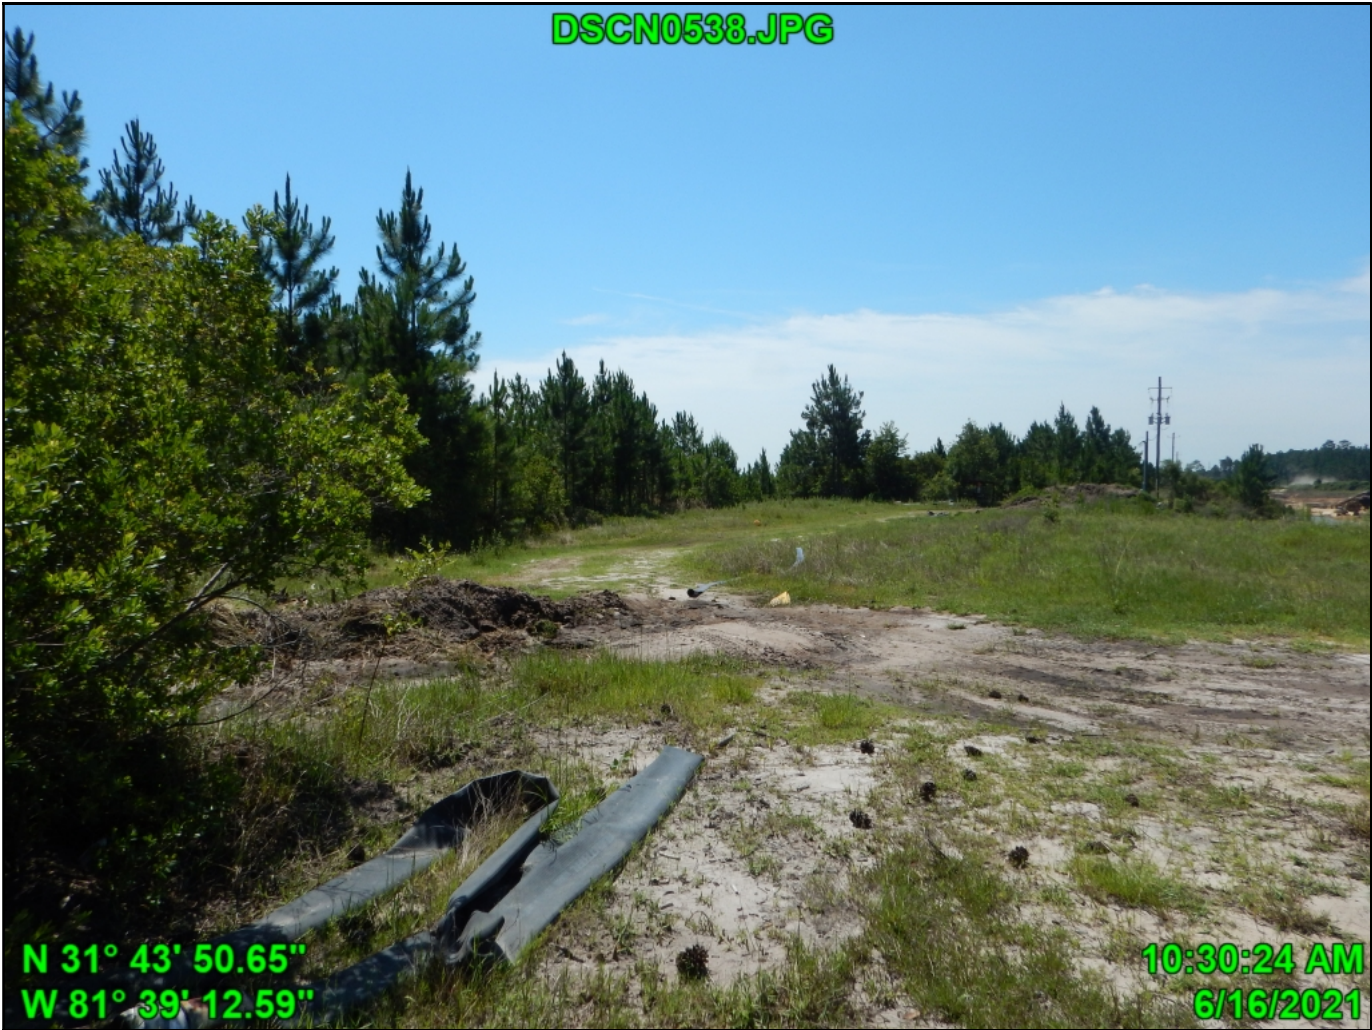
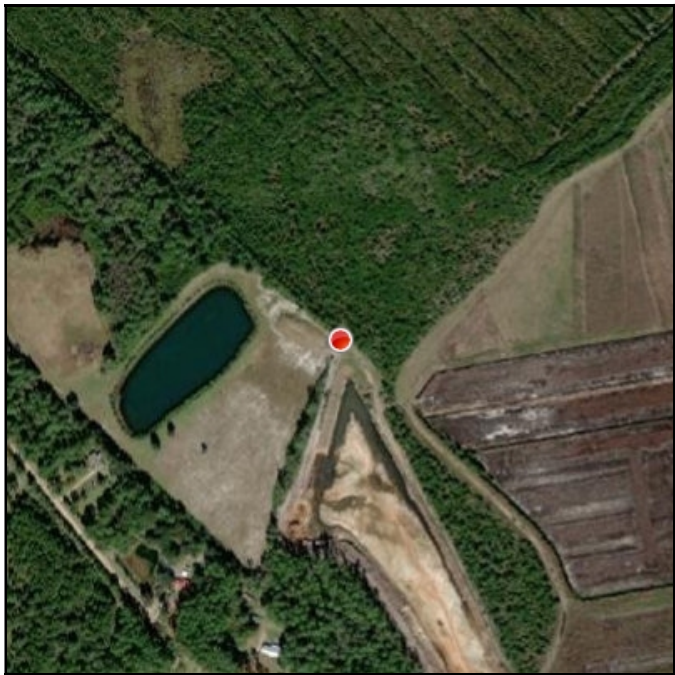
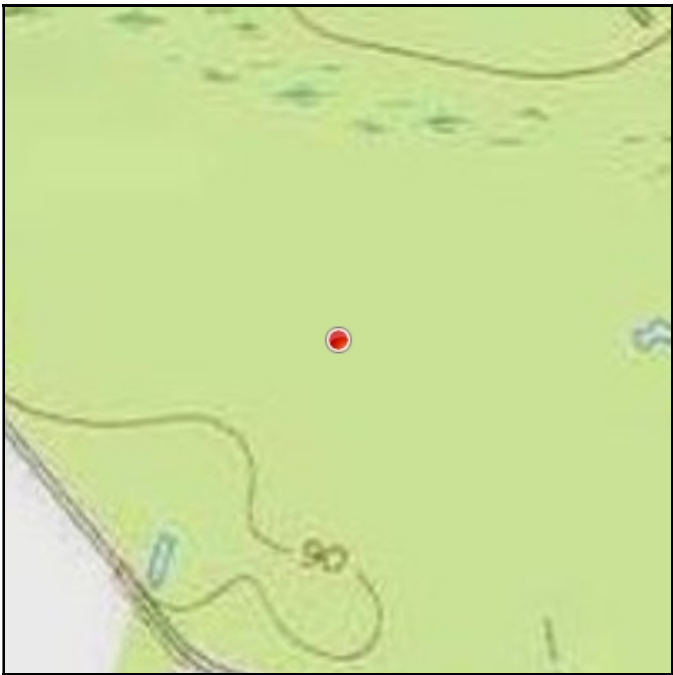
| Attributes | |
|---|---|
| Title | Photo 4 |

| Attributes | |
|---|---|
| Description | Head of ditch looking toward mine/Bay from upland position; striking southeast-south. |

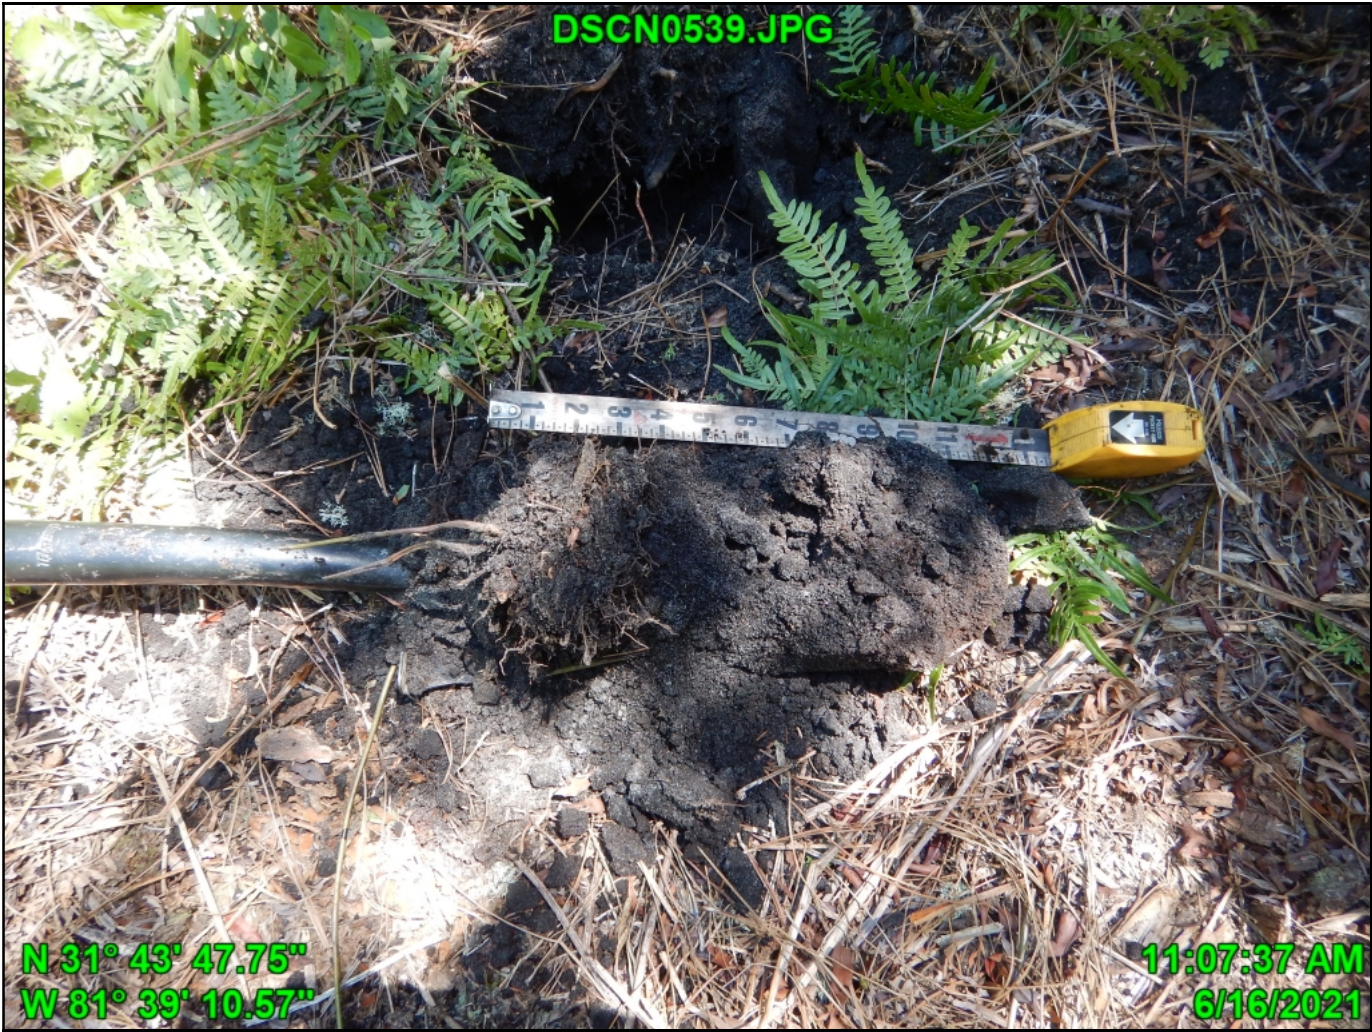
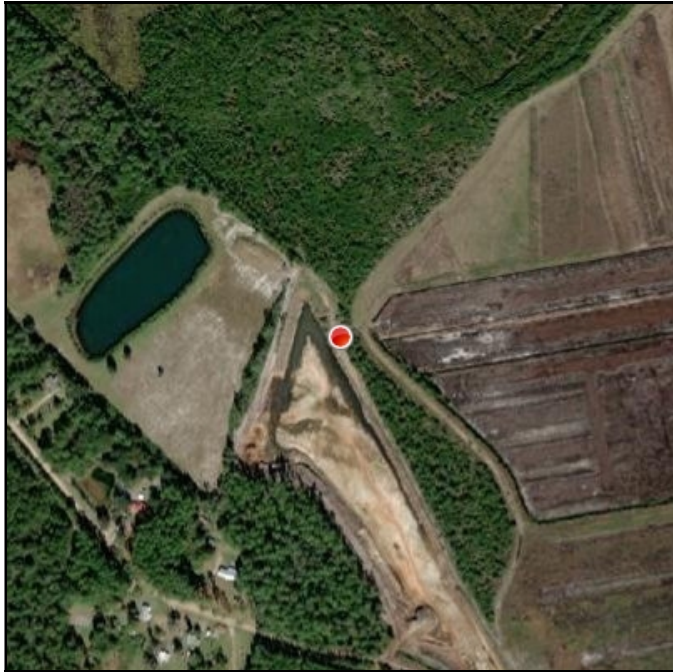
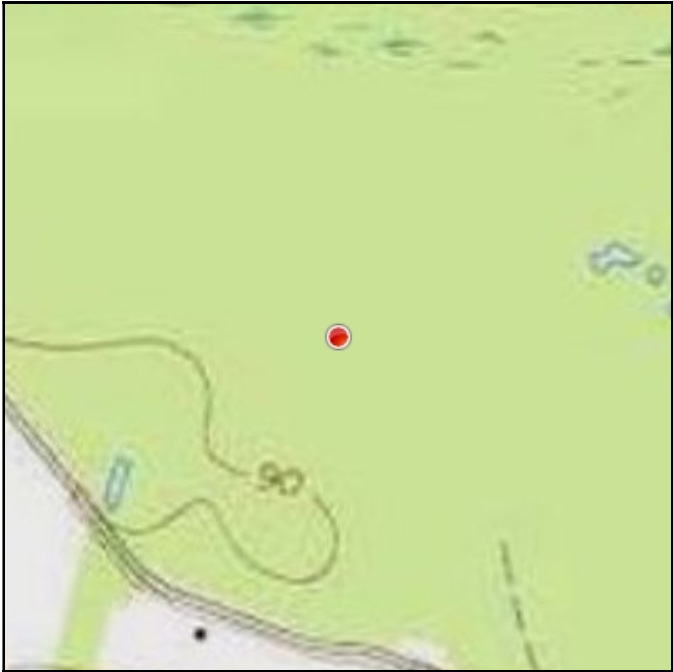
| Attributes | |
|---|---|
| Title | Photo 5 |

| Attributes | |
|---|---|
| Description | Soil profile of sample location A4. |

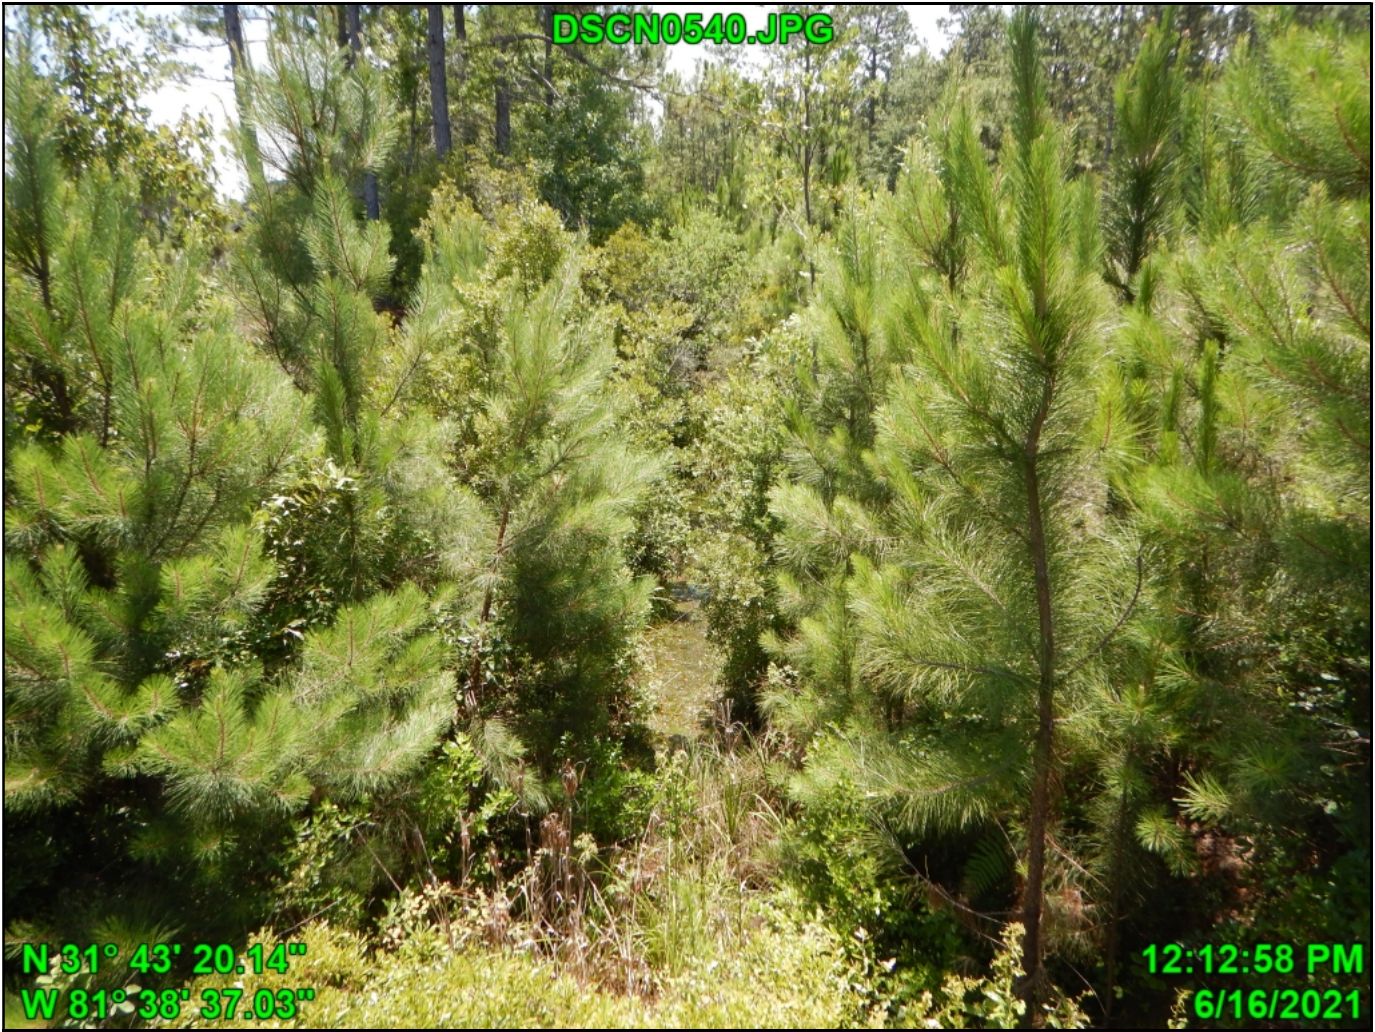
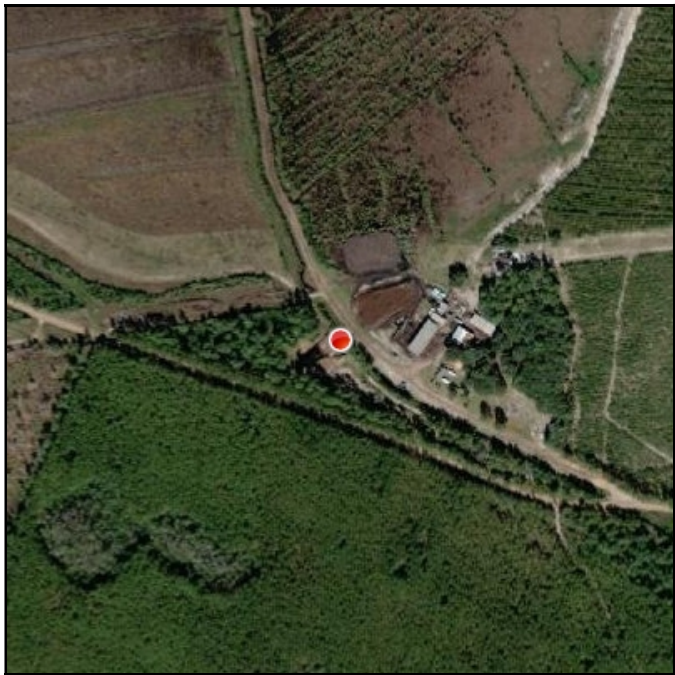
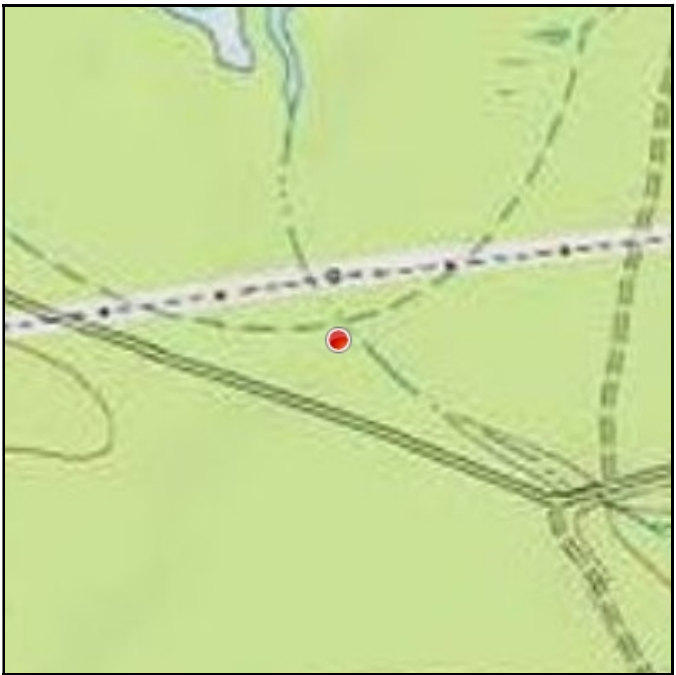
| Attributes | |
|---|---|
| Title | Photo 6 |

| Attributes | |
|---|---|
| Description | Ditch, which flows into Bull Swamp Creek, viewed from top of earthen plug; striking southeast. |

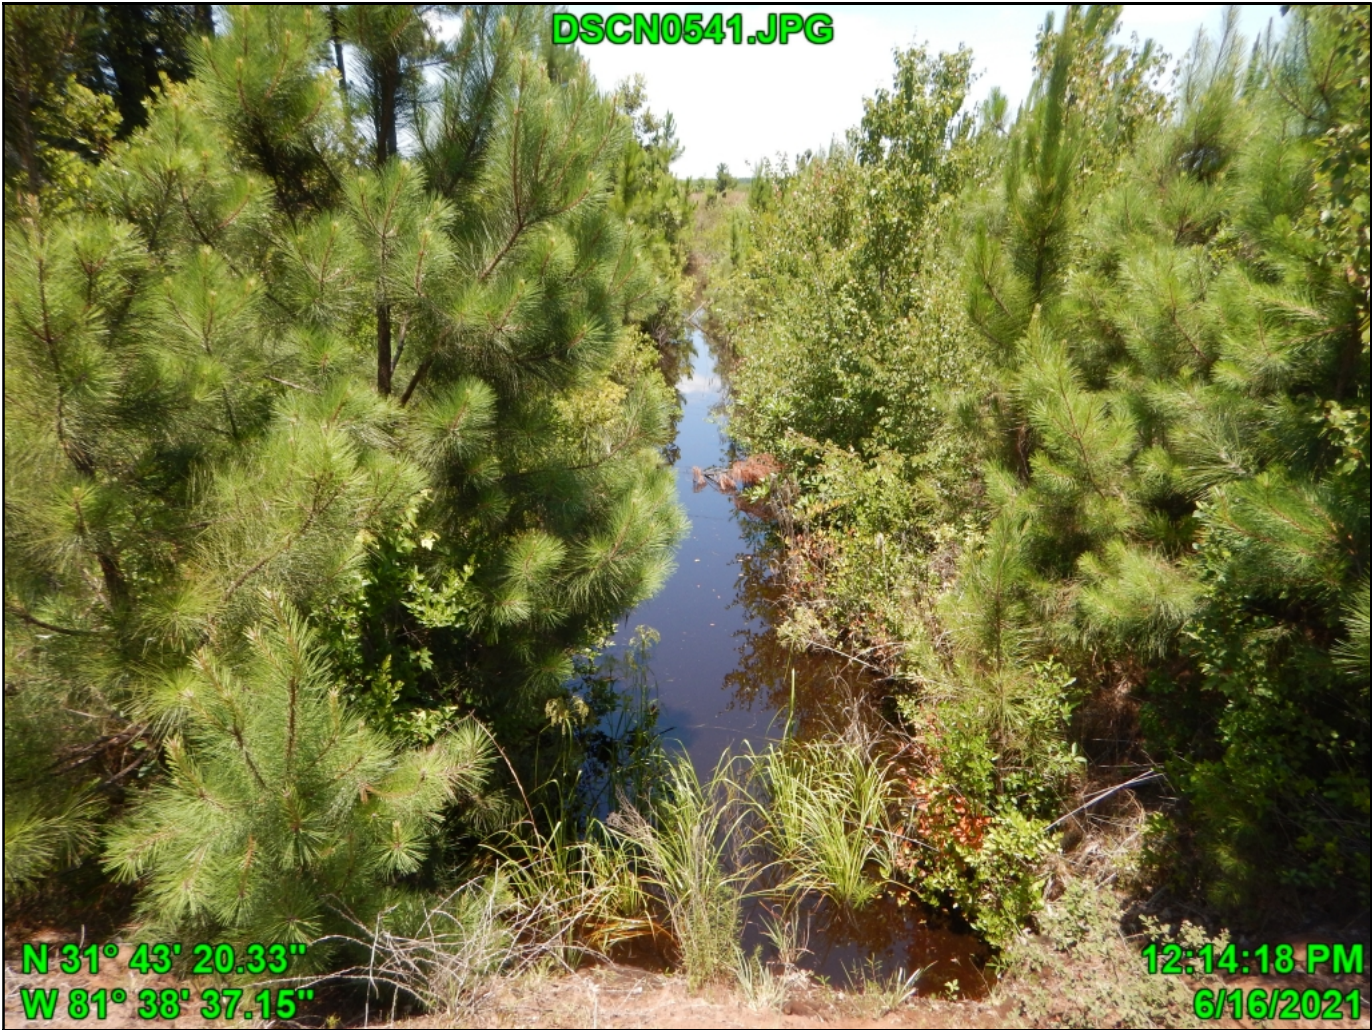
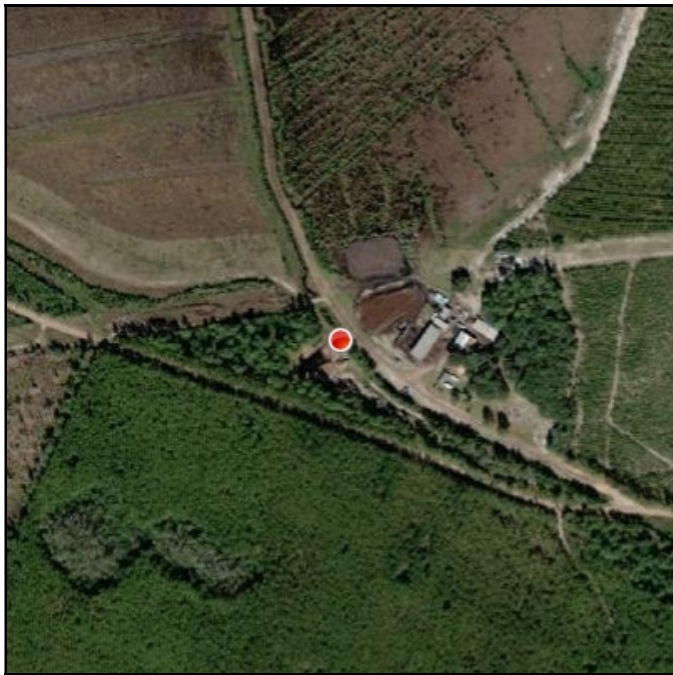
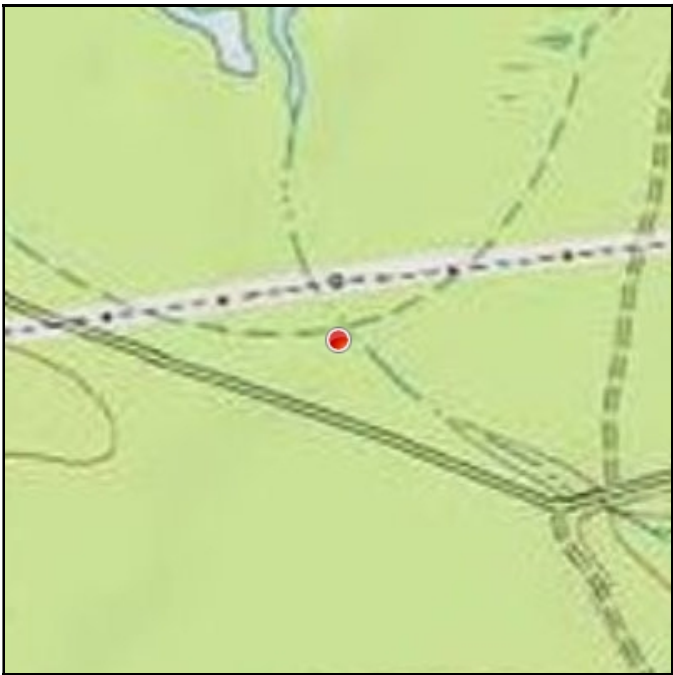
| Attributes | |
|---|---|
| Title | Photo 7 |

| Attributes | |
|---|---|
| Description | Ditch viewed from top of earthen plug; striking north. |

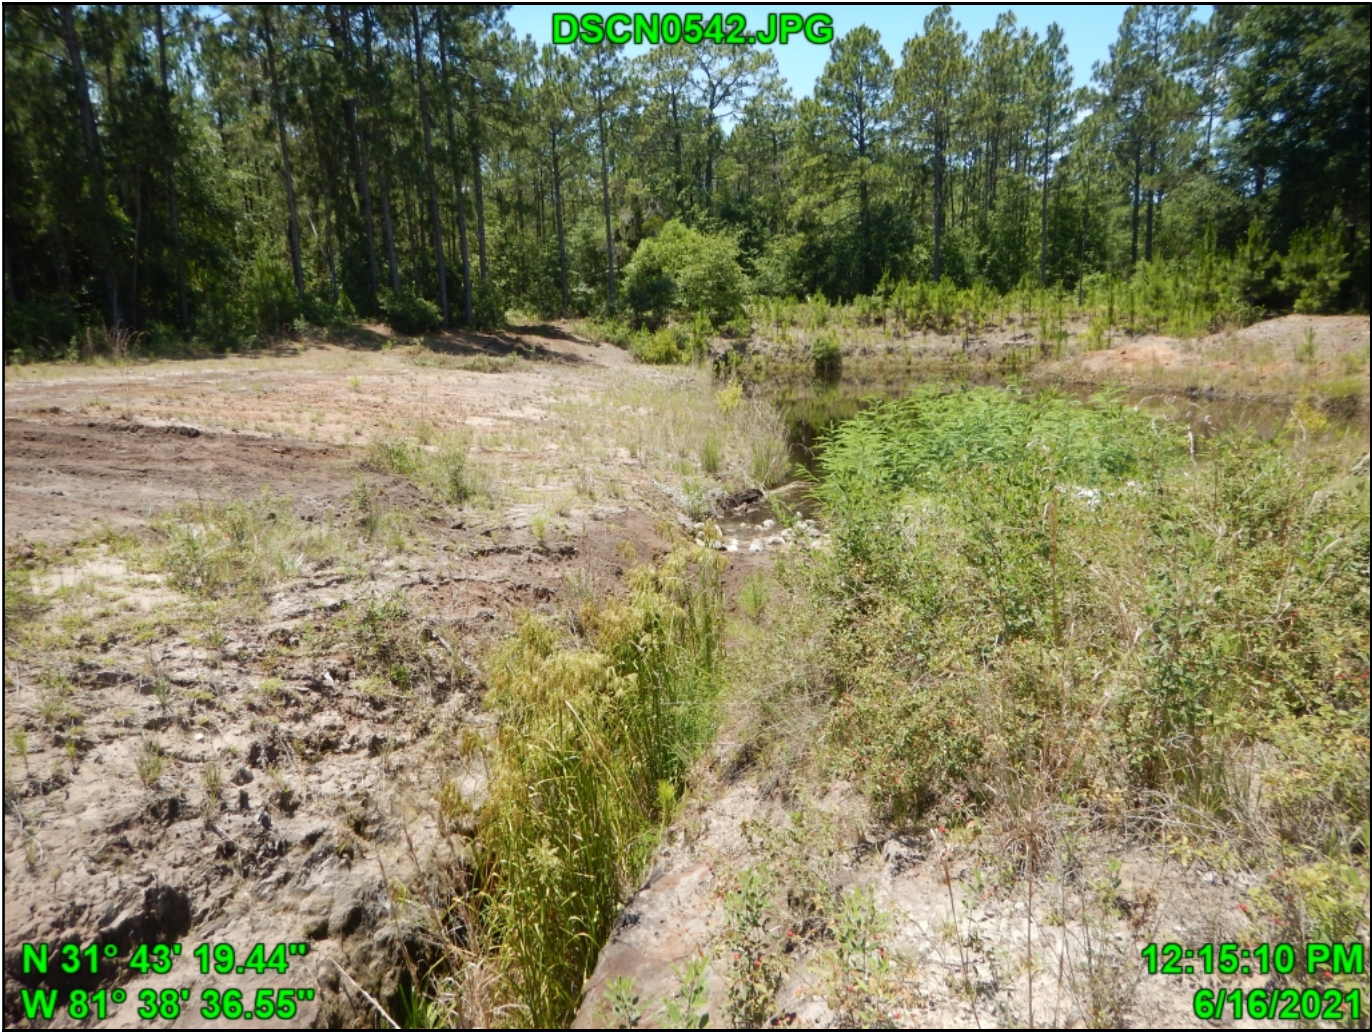
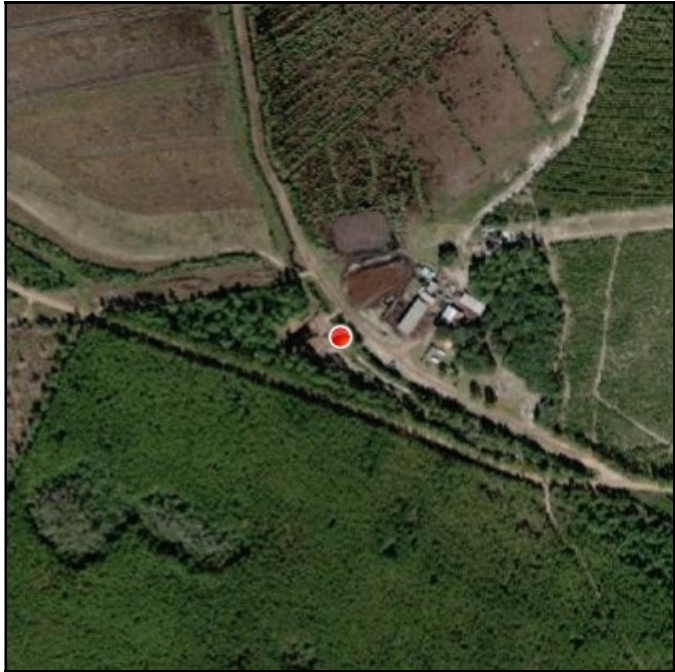
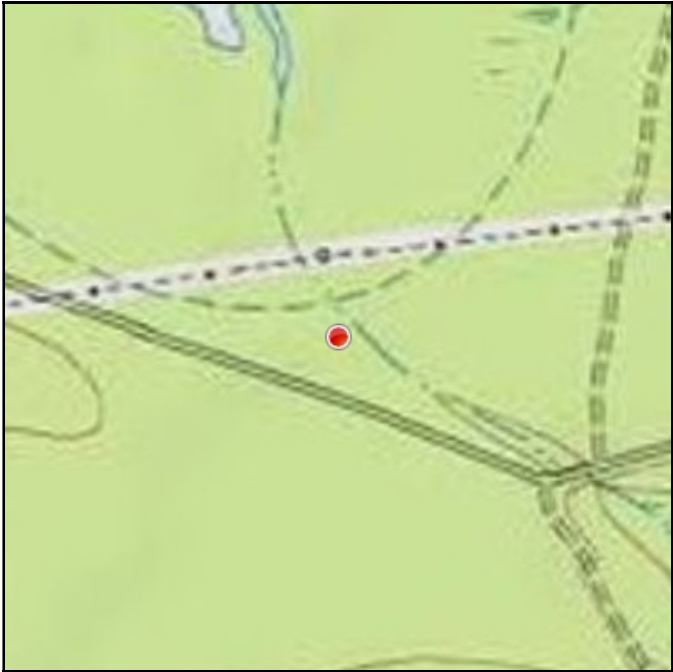
| Attributes | |
|---|---|
| Title | Photo 8 |

| Attributes | |
|---|---|
| Description | Second ditch located closer to overflow pond; striking west. |

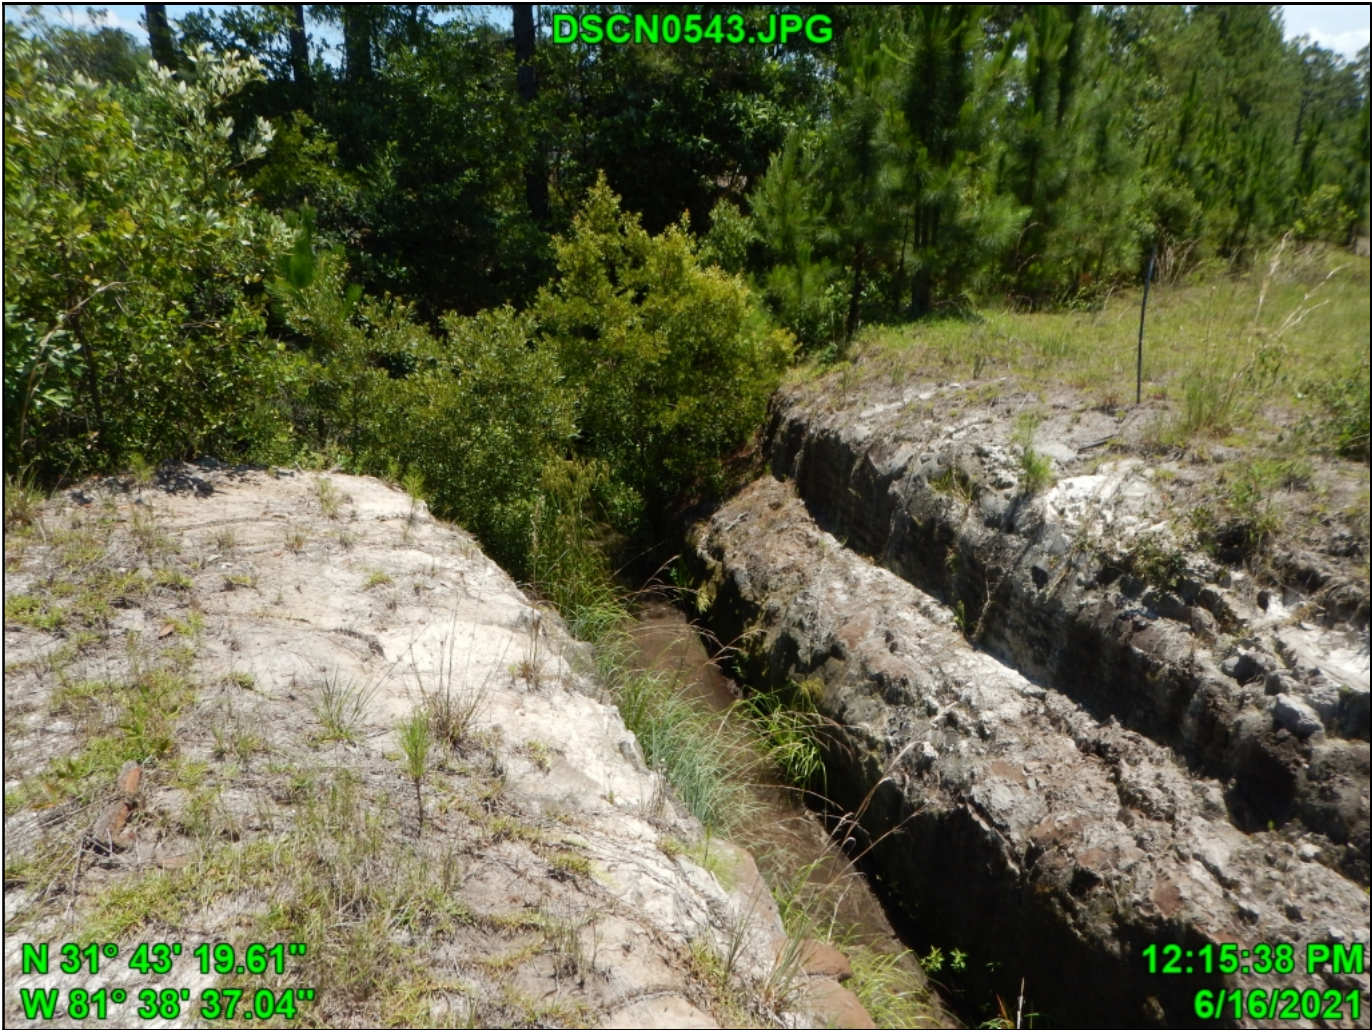
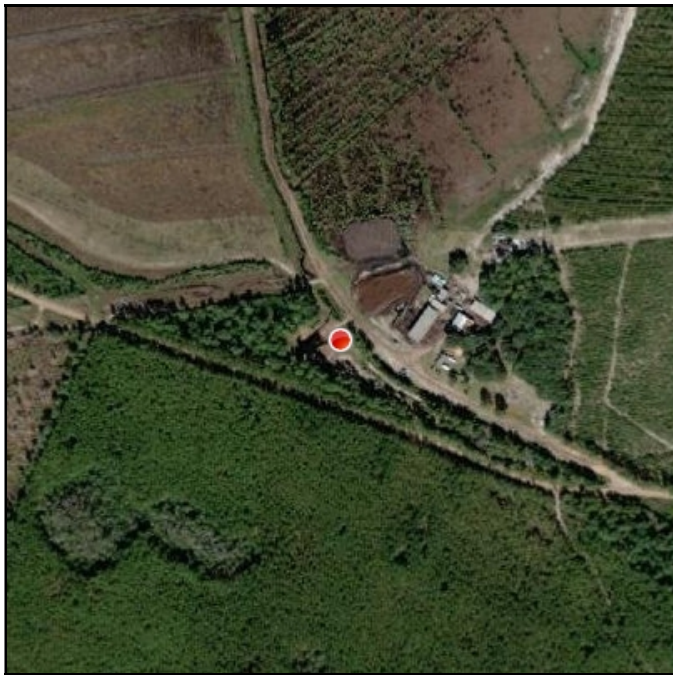
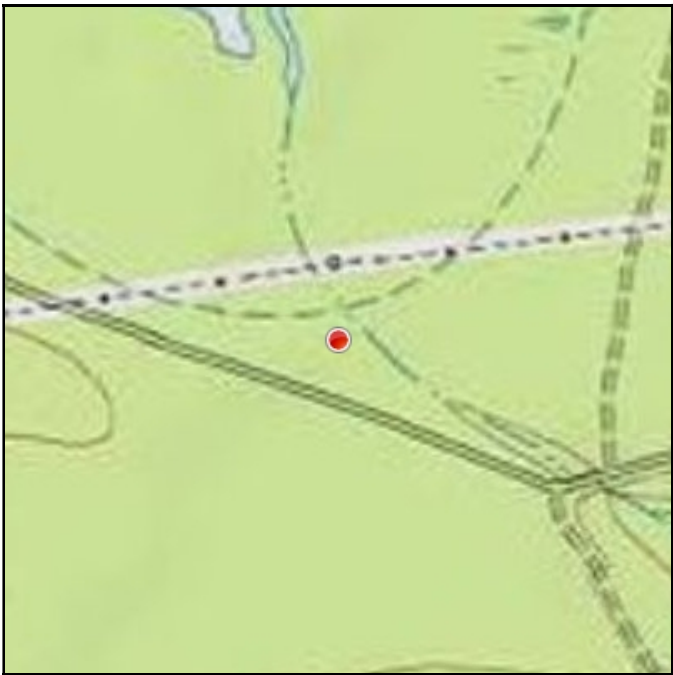
| Attributes | |
|---|---|
| Title | Photo 9 |

| Attributes | |
|---|---|
| Description | Looking from ledge and downwards toward second ditch with stagnant water; striking east. |
