**ATTACHMENT C**  
**Goose Pond Site Inspection Report**

Ludowici, Georgia  
June 16, 2021

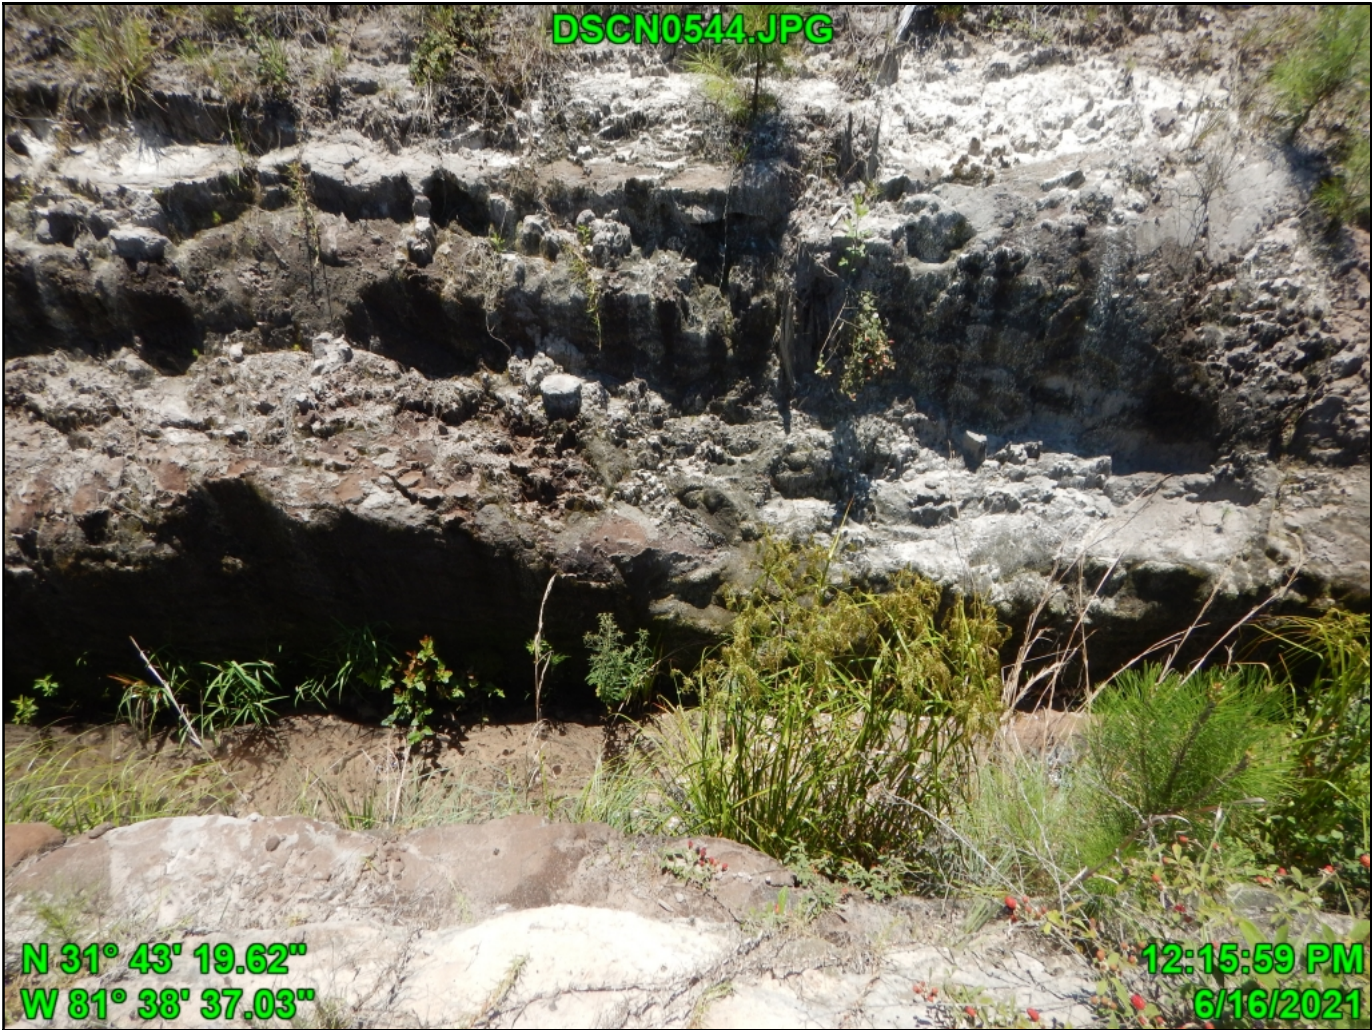
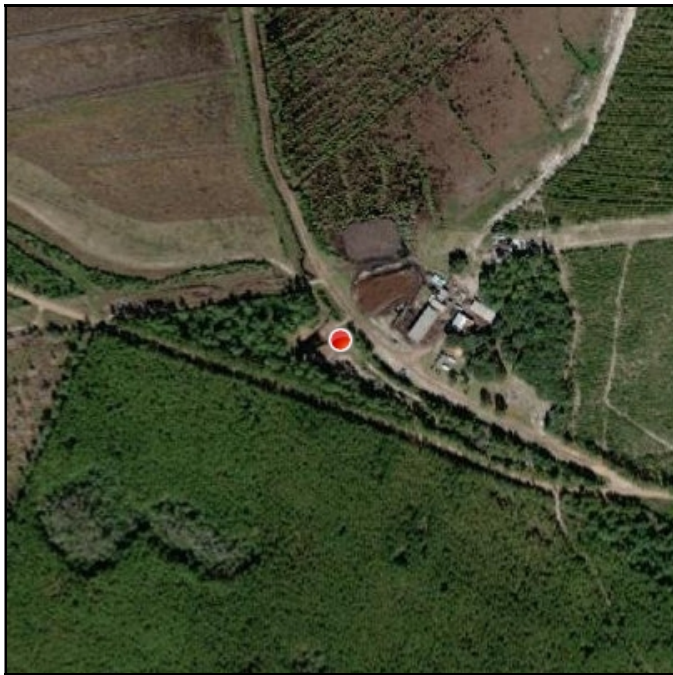
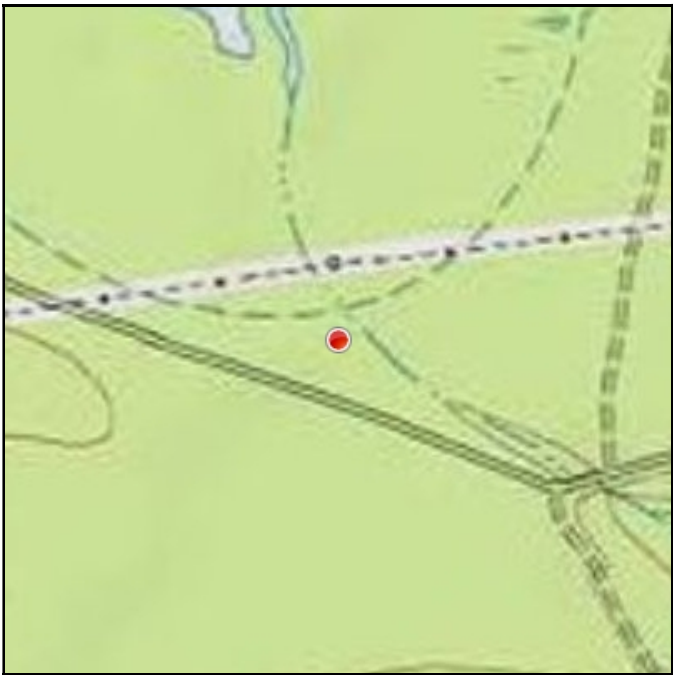
| Attributes | |
|---|---|
| Title | Photo 10 |

| Attributes | |
|---|---|
| Description | Looking from ledge and downwards toward second ditch; striking southeast. |

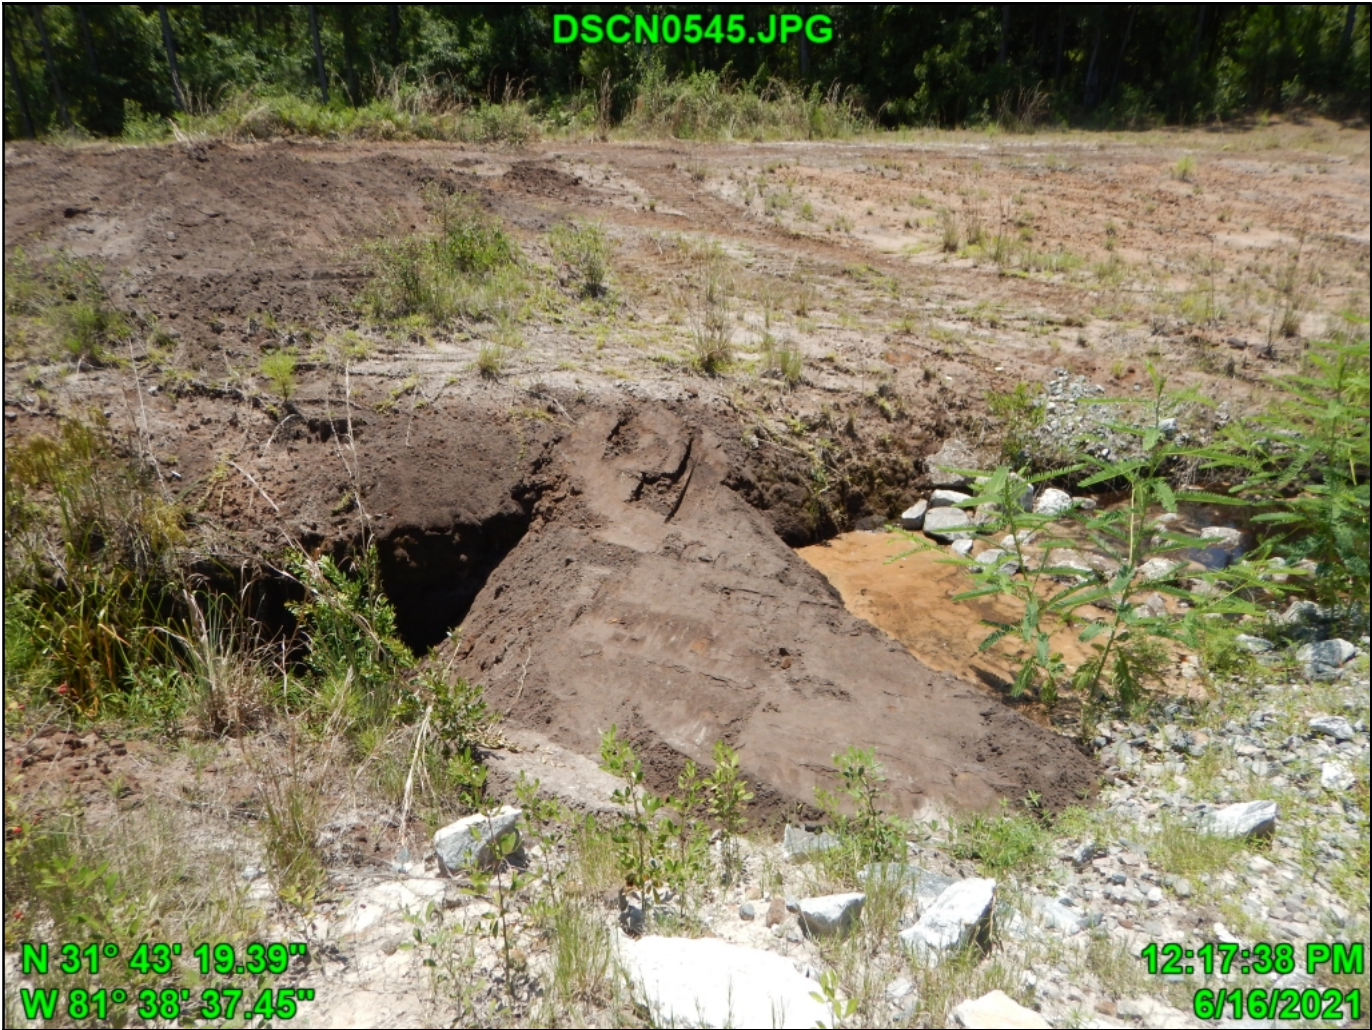
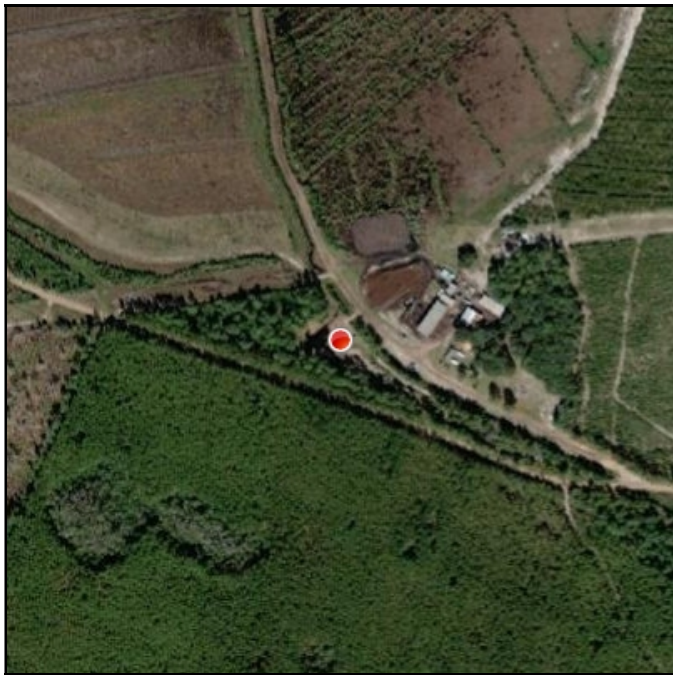
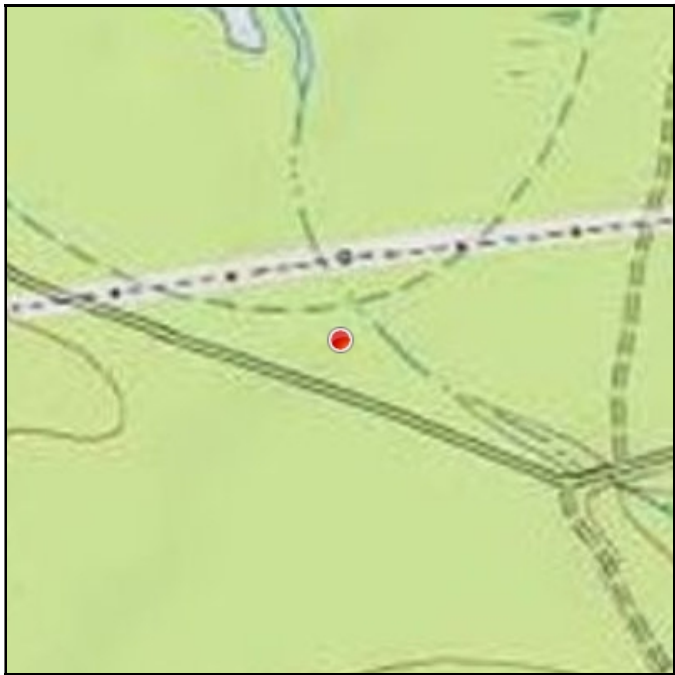
| Attributes | |
|---|---|
| Title | Photo 11 |

| Attributes | |
|---|---|
| Description | Unfamiliar plug in second ditch; striking south-southeast. |

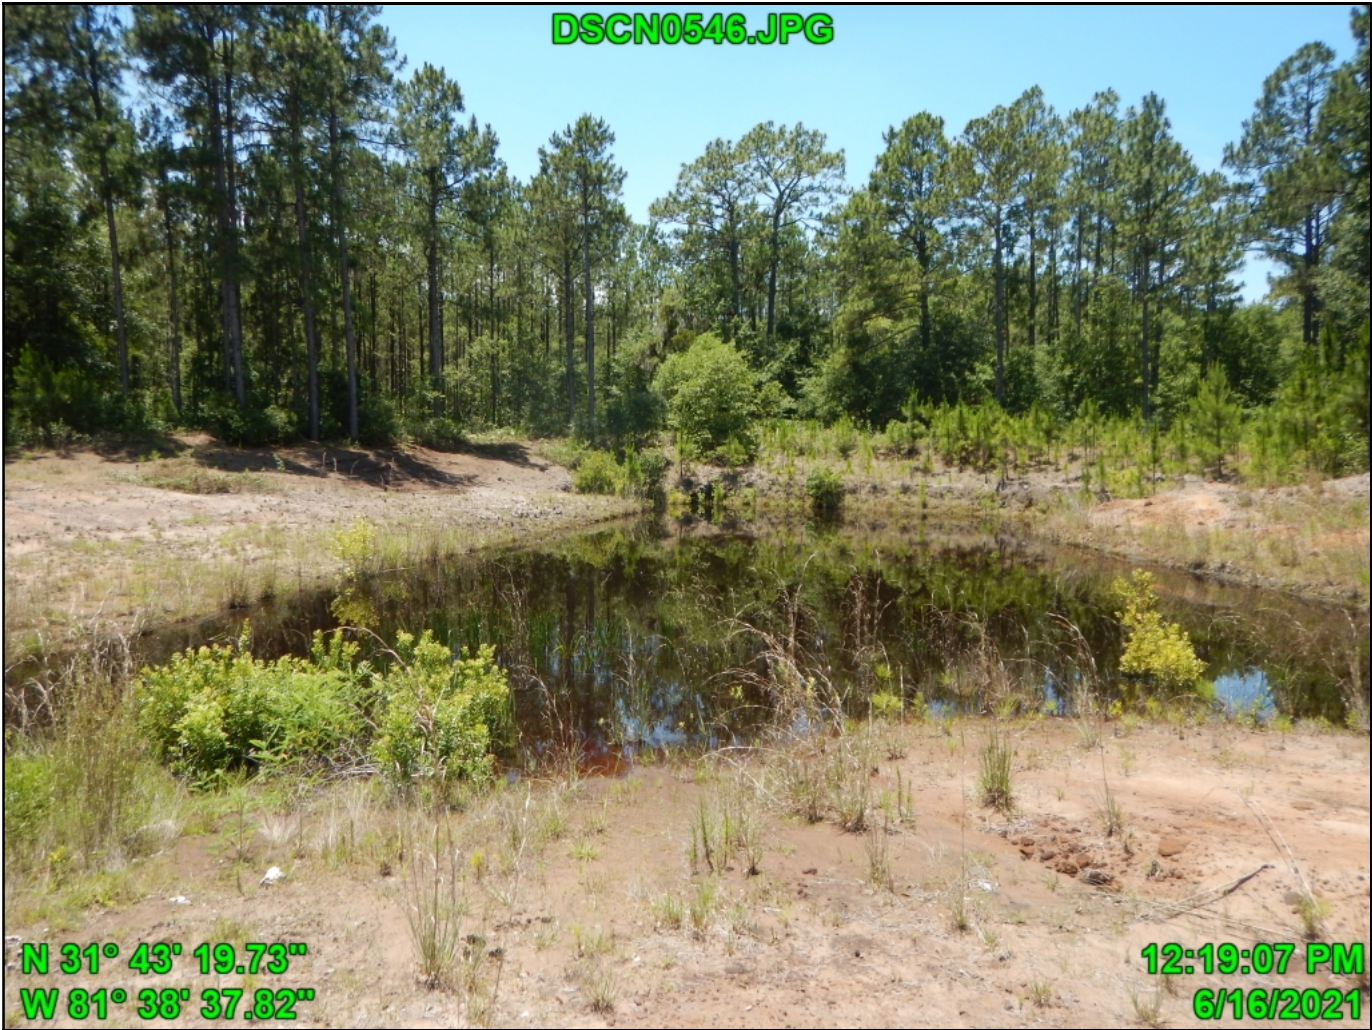
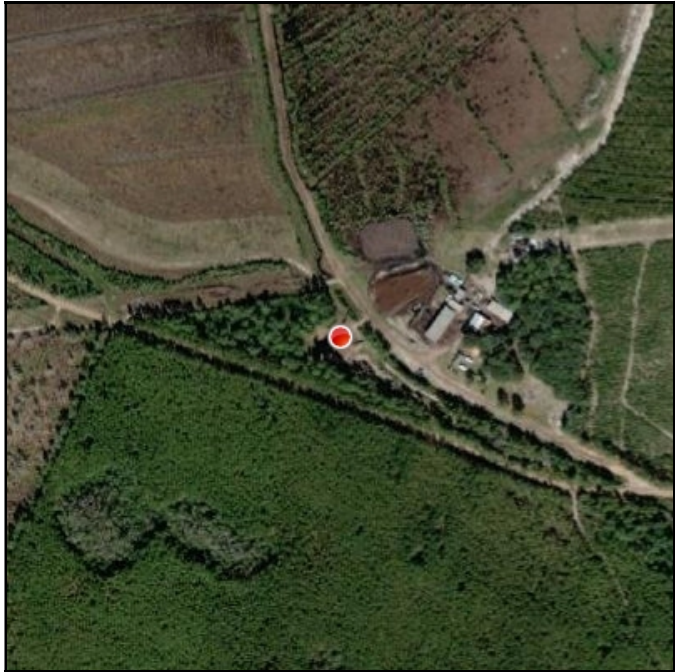
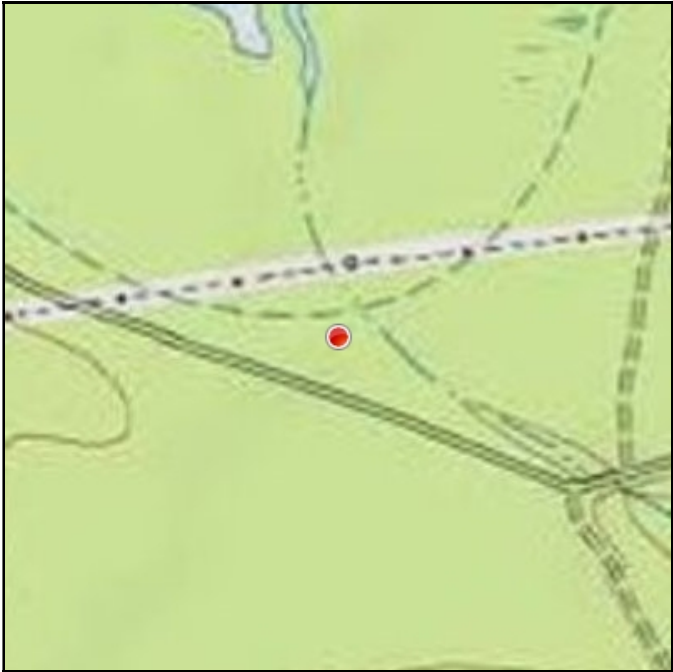
| Attributes | |
|---|---|
| Title | Photo 12 |

| Attributes | |
|---|---|
| Description | Overflow pond; striking southwest. |
