## Region 6 - Enforcement & Compliance Assurance Division

### INSPECTION REPORT

| Company Name: | <b>MidAmerica Environmental Holdings, LLC</b> | |
| Facility Name: | <b>USA Disposal – El Dorado</b> | |

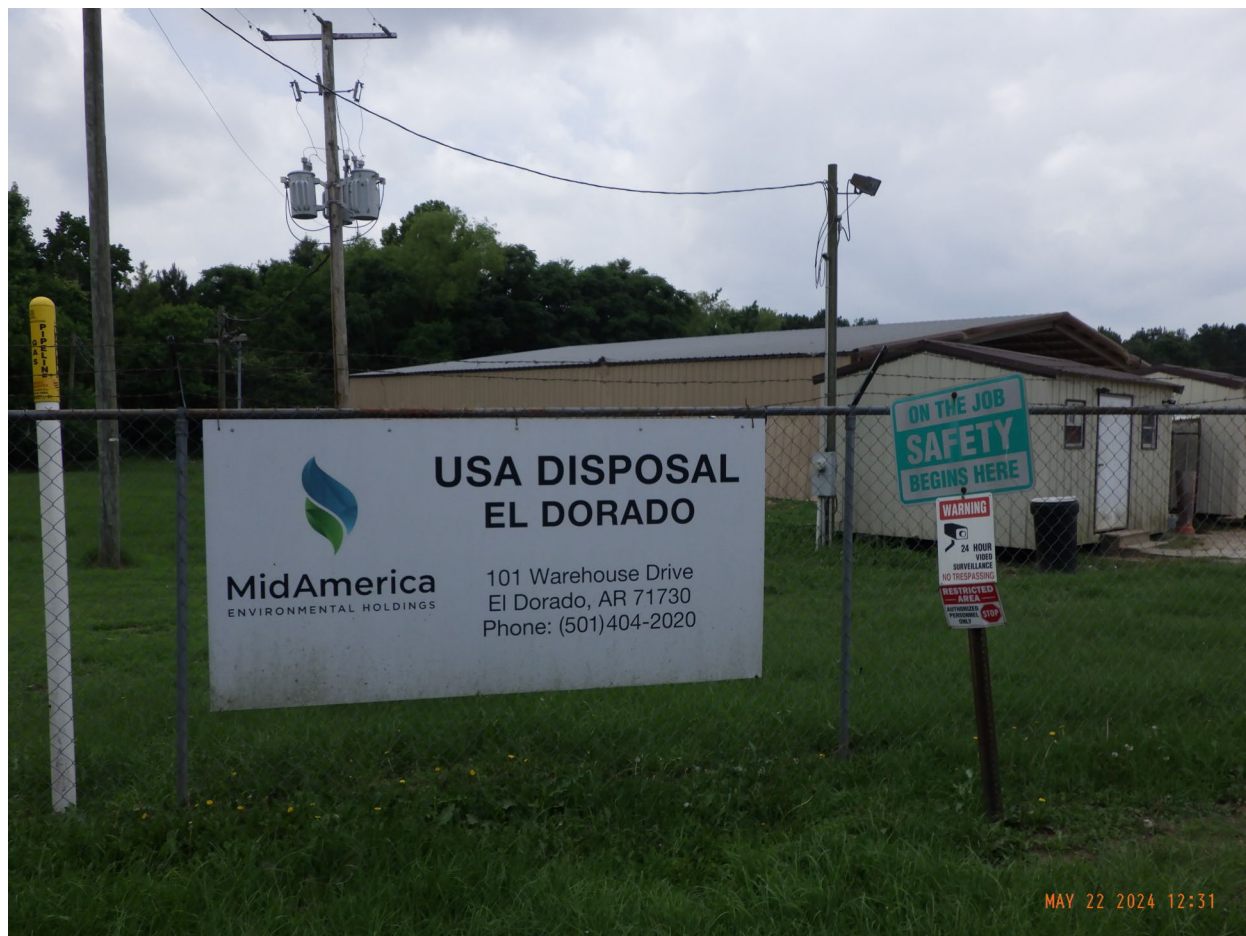
Photo No. 1

**Description:** Looking SW, this photo showed the signage for the facility.

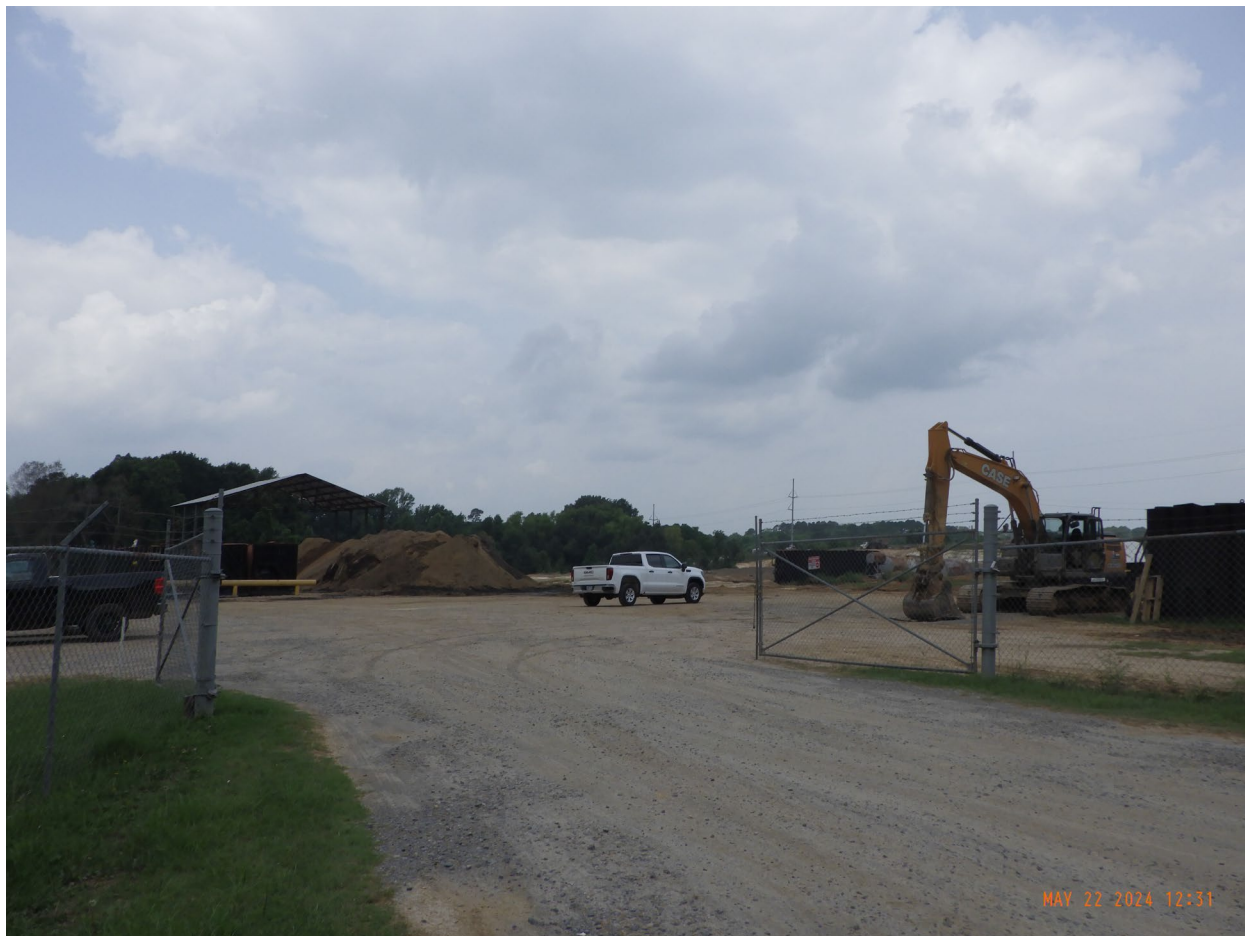
Photo No. 2

**Description:** Looking NW, this photo showed the overview of the facility. This area is part of the original Construction Stormwater General Permit (CGP) issued by the State of Arkansas in September 2009.

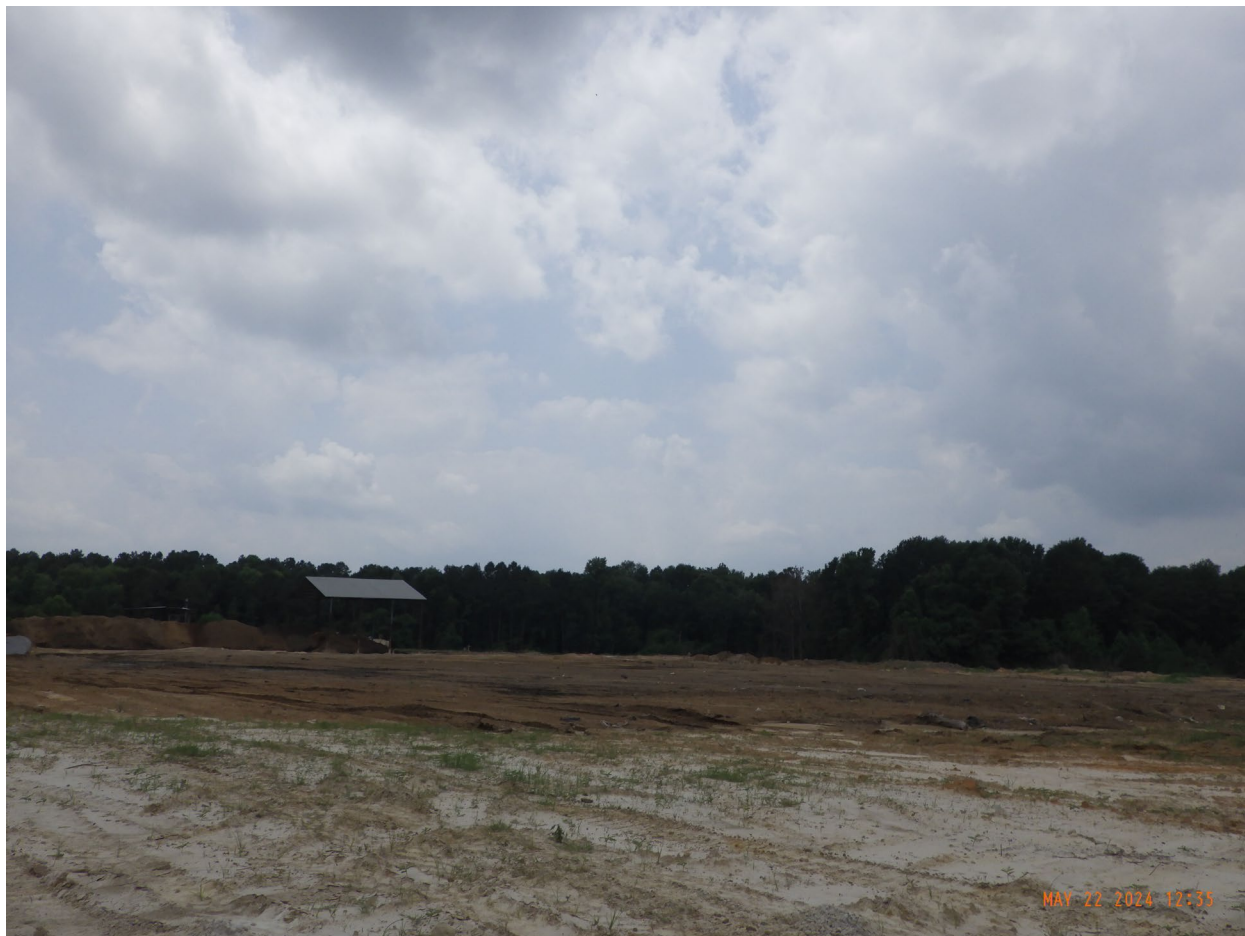
I observed disturbed soil associated with land filling and land applying activities. See Photo No. 3 through No. 5.

**Description:** Looking SW, this photo showed disturbed soil at the facility. Land filling and land applying has occurred at the facility.

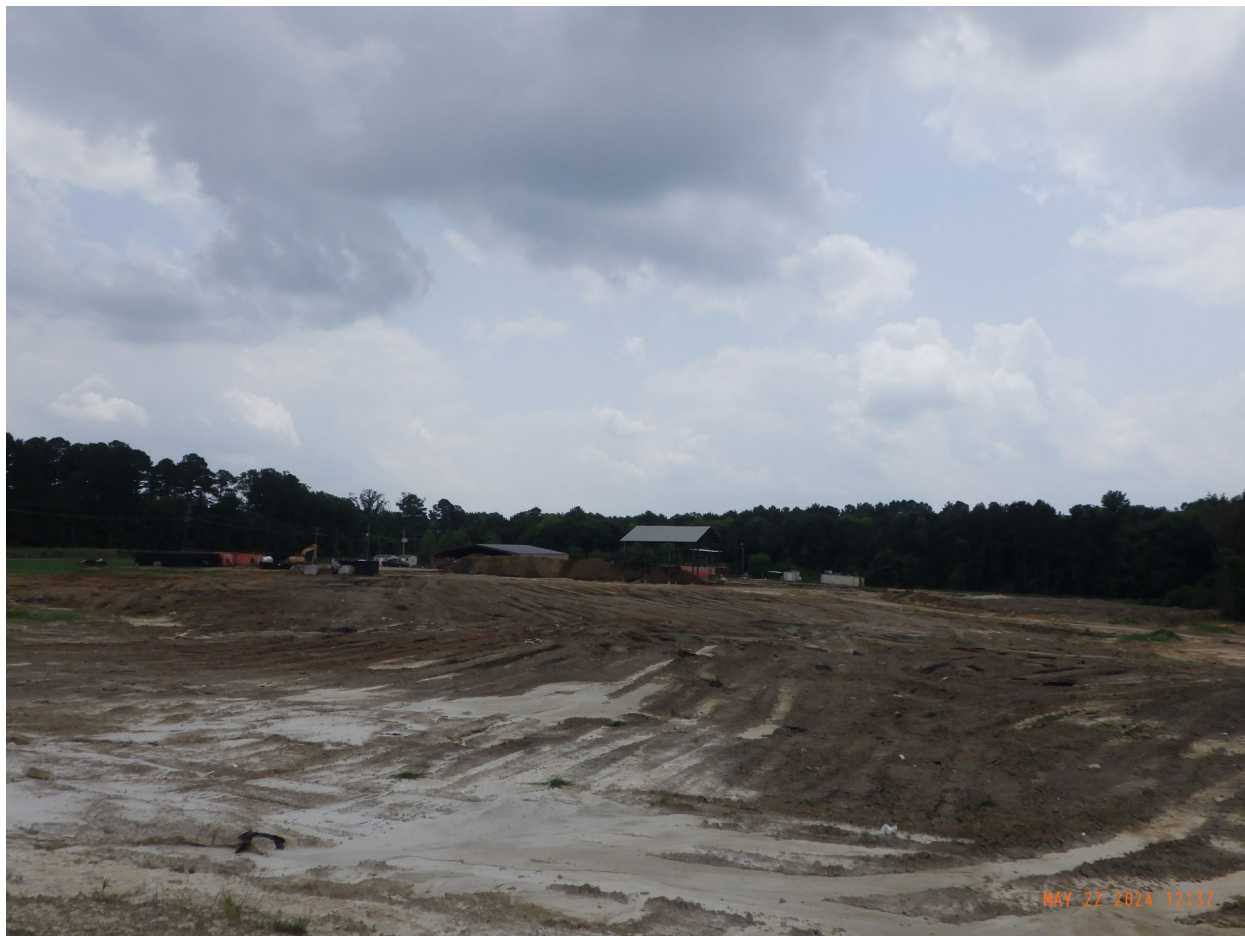
Photo No. 4

**Description:** Looking S-SW, this photo showed disturbed soil at the facility. Location was formally a mining site and borrow pit for clay soil.

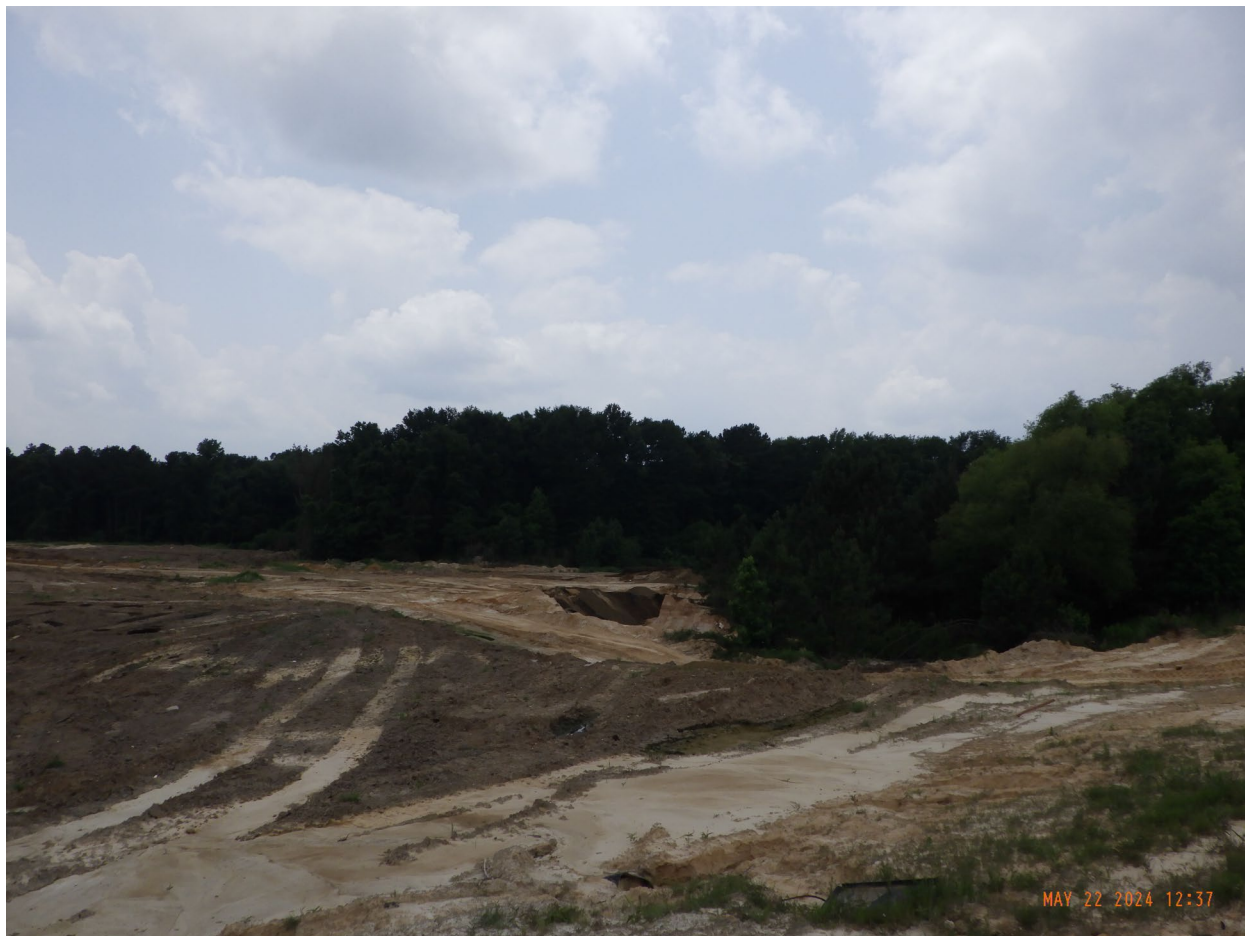
Photo No. 5

**Description:** Looking S-SW, this photo showed disturbed soil at the facility. Location was formally a mining site and borrow pit for clay soil.

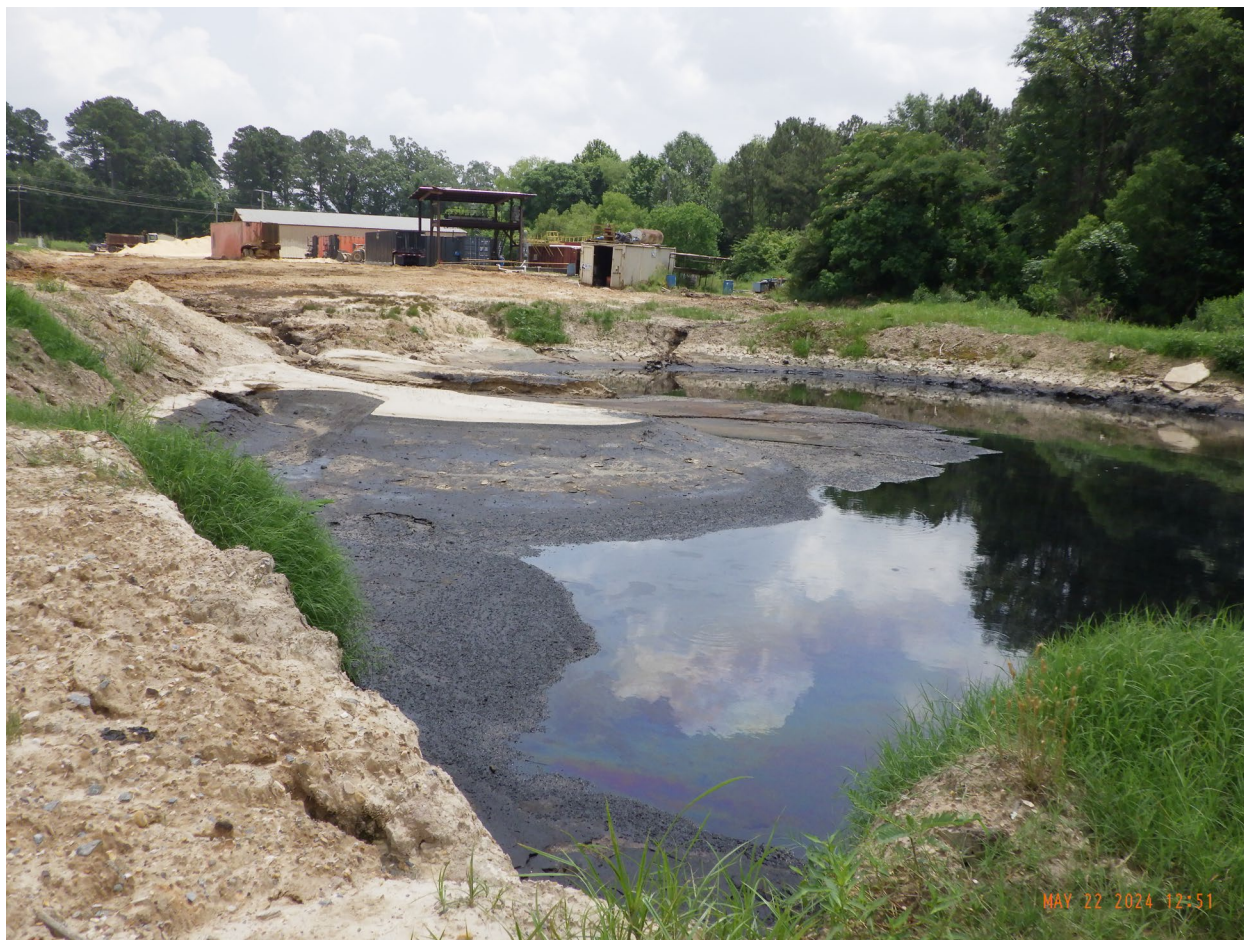
Photo No. 6

I observed the sedimentation pond associated with the original CGP converted into a stormwater pond. The stormwater pond contained unknown liquid wastes and sediment. Black staining, a hydrocarbon sheen, gas bubbles, and an odor were noted at the stormwater pond. See Photo No. 6.

- An active discharge from the stormwater pond via opened drainpipe of stormwater commingled with unknown liquid wastes, see CGP Part I, Section B., Condition 11, B.;

**Description:** Looking SW, this photo showed the stormwater pond utilized by the facility, which is permitted under NPDES permit ARR001445. Sedimentation pond from the CGP has been converted.

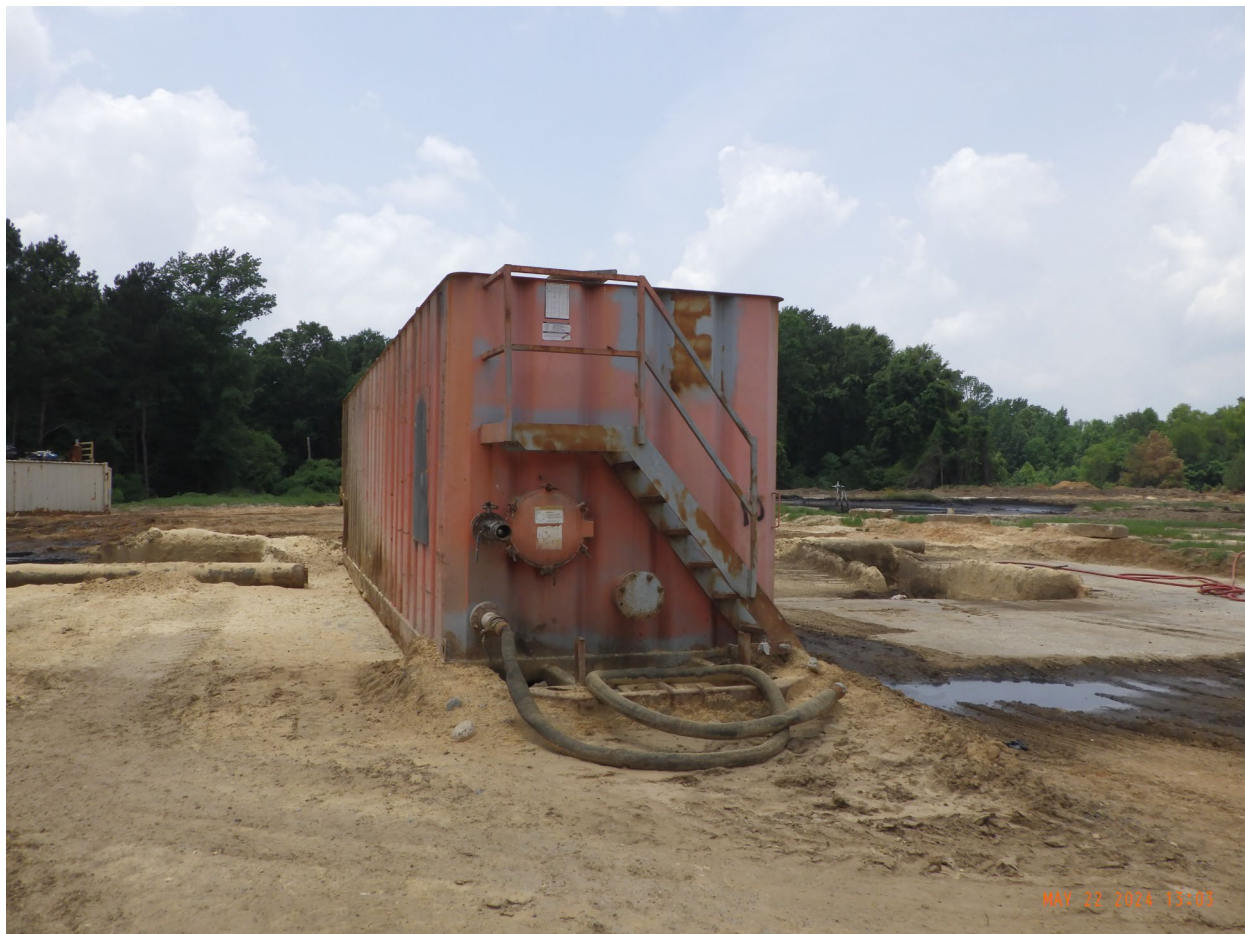
Photo No. 7

**Description:** Looking W-NW, this photo showed a frac tank stored between two (2) subsurface, concrete pits. This area was covered under the original CGP.

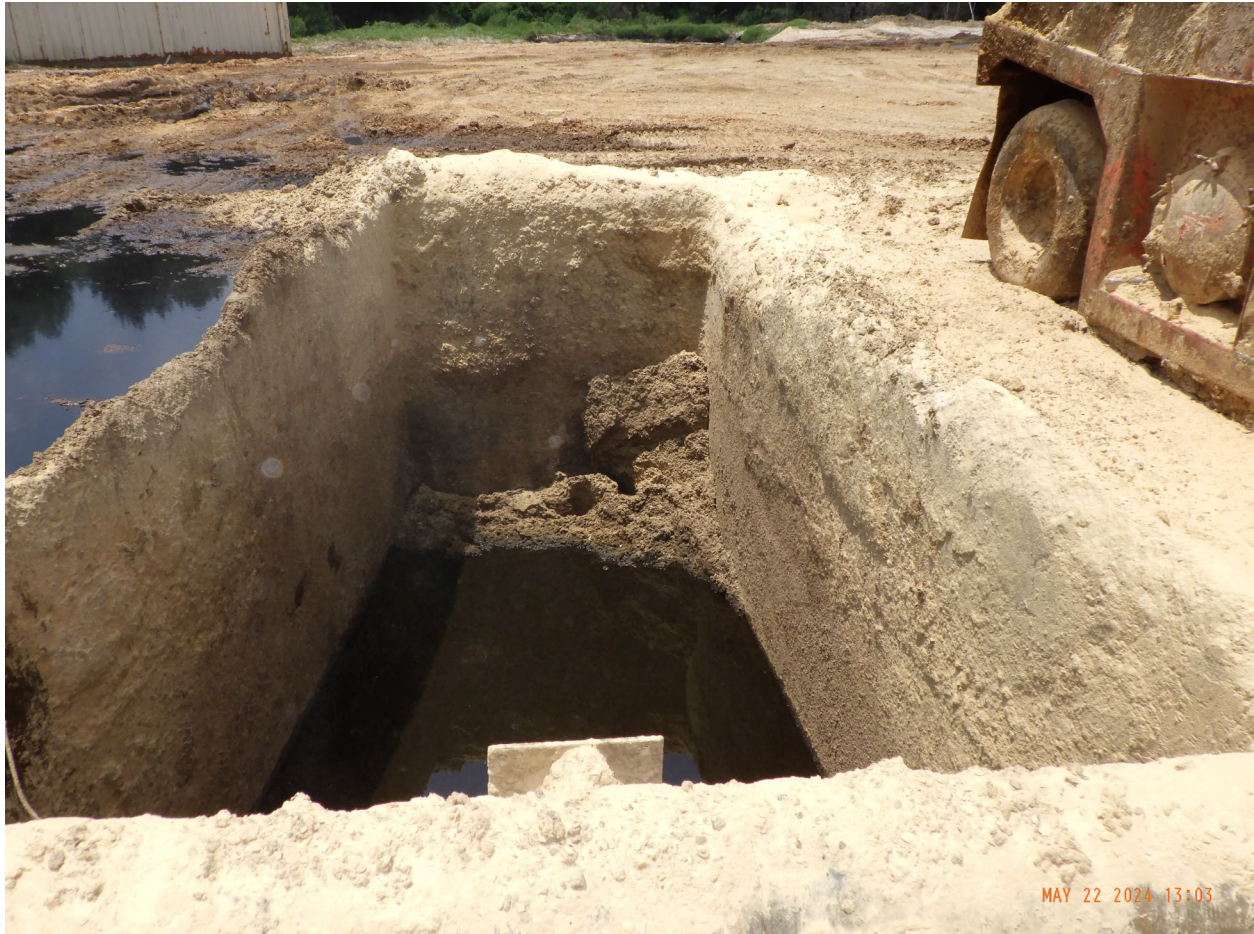
Photo No. 8

**Description:** Looking W, this photo showed the subsurface, concrete pit to the left of the frac tank in Photo No. 7. This area was covered under the original CGP.

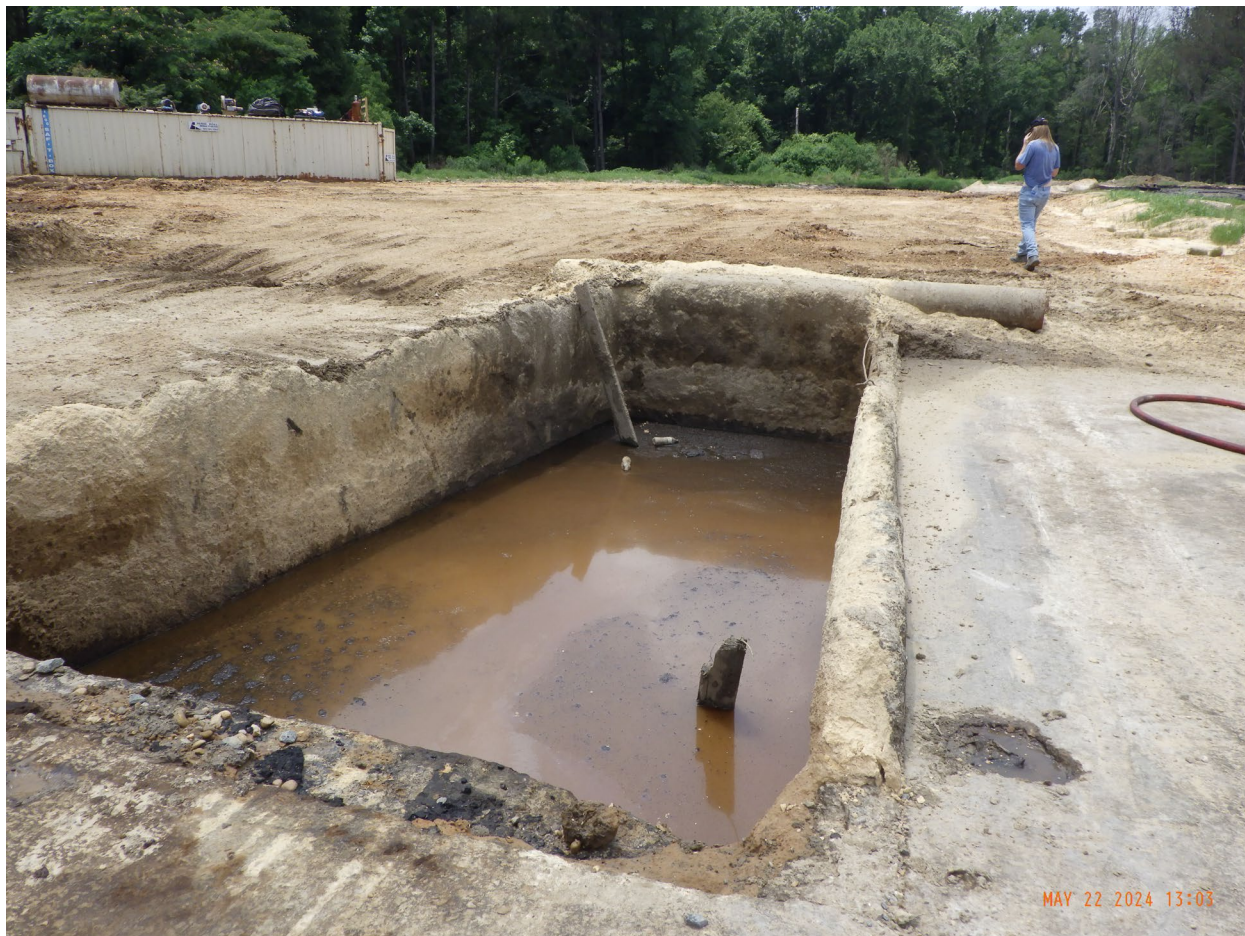
Photo No. 9

**Description:** Looking W-SW, this photo showed the subsurface, concrete pit to the right of the frac tank in Photo No. 7. This area was covered under the original CGP.

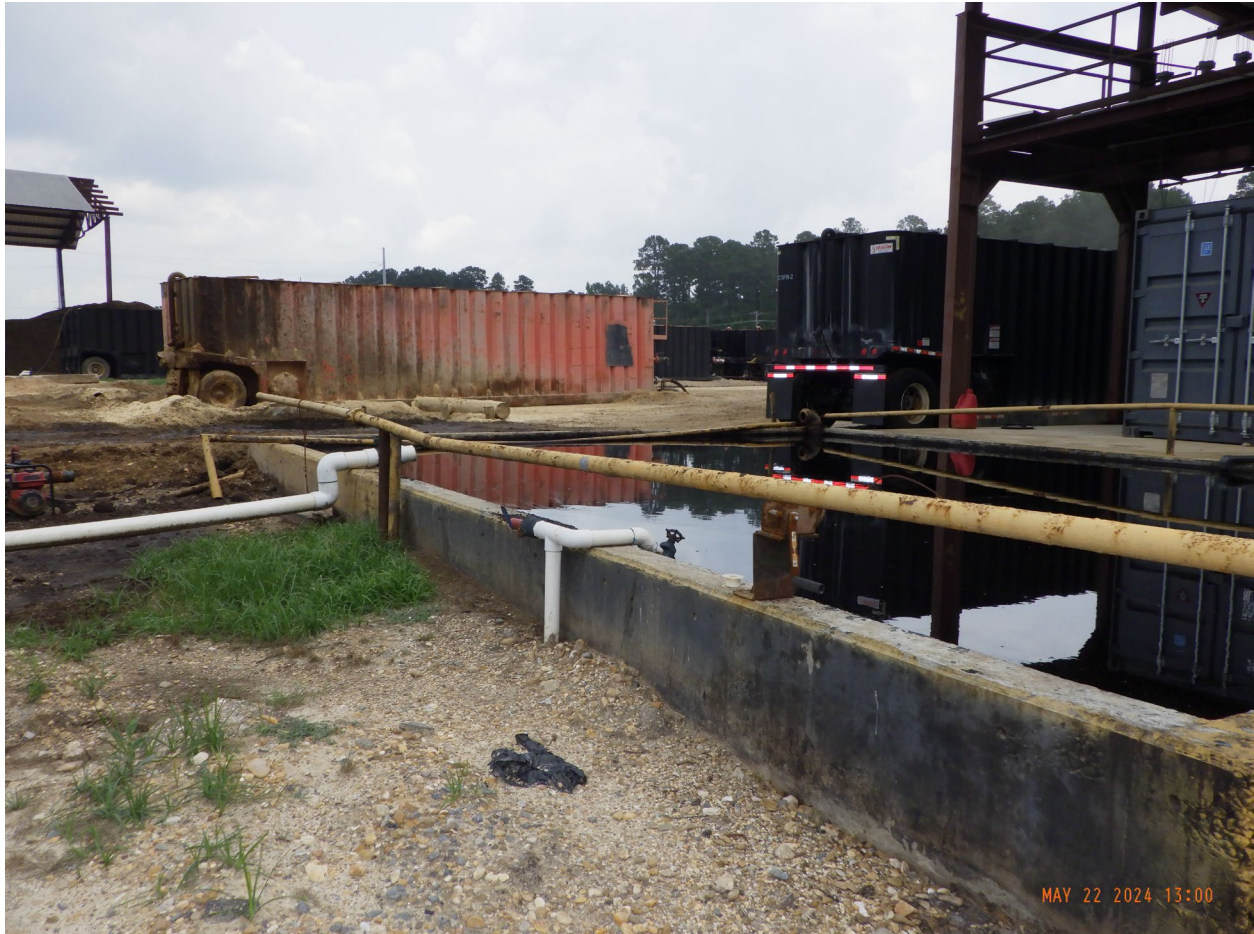
Photo No. 10

**Description:** Looking NE, this photo showed a large, concrete pit used for storing liquid wastes (contents unknown). This area was covered under the original CGP.

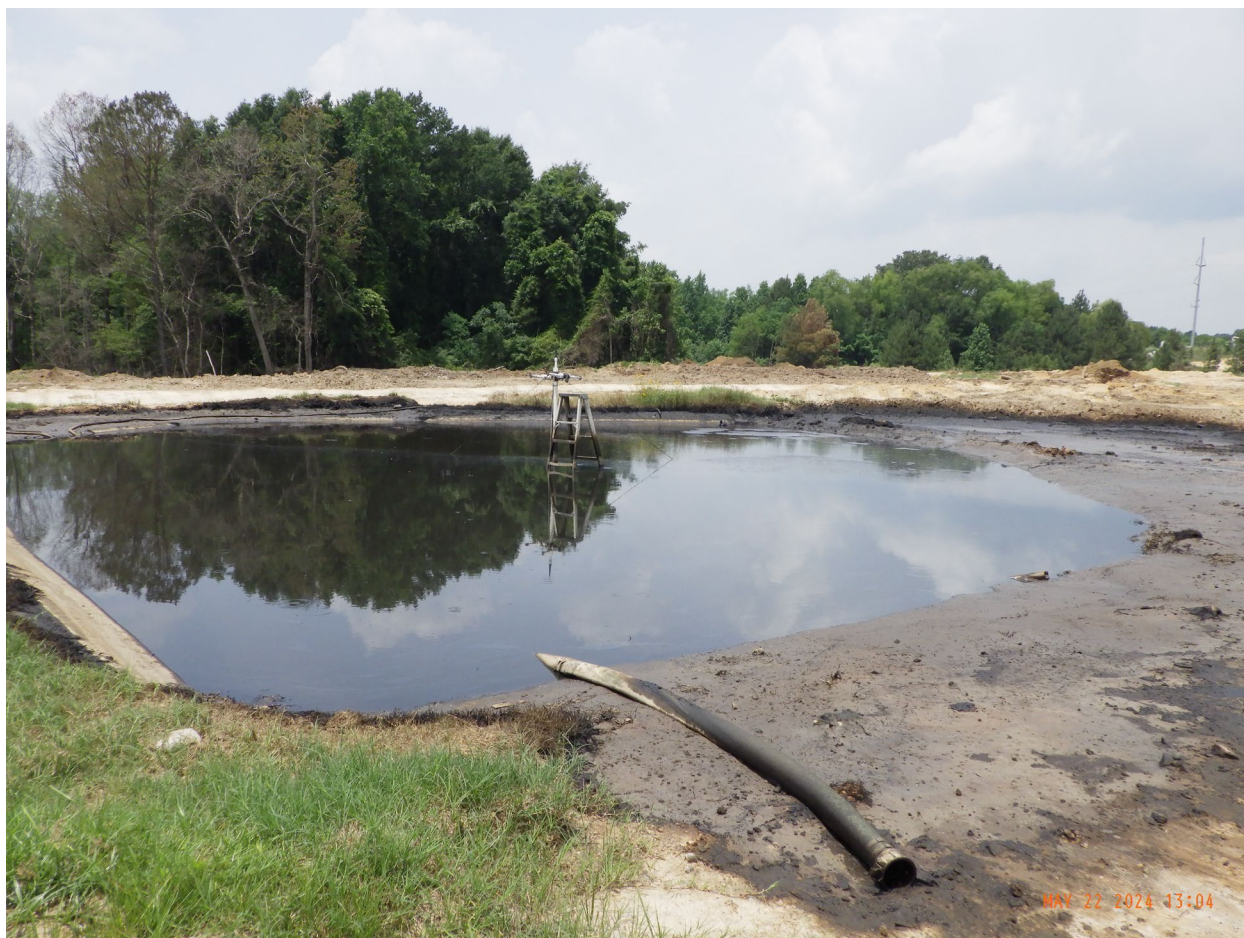
Photo No. 11

**Description:** Looking NW, this photo showed a large, concrete pit used for storing liquid wastes (contents unknown). This area was covered under the original CGP.

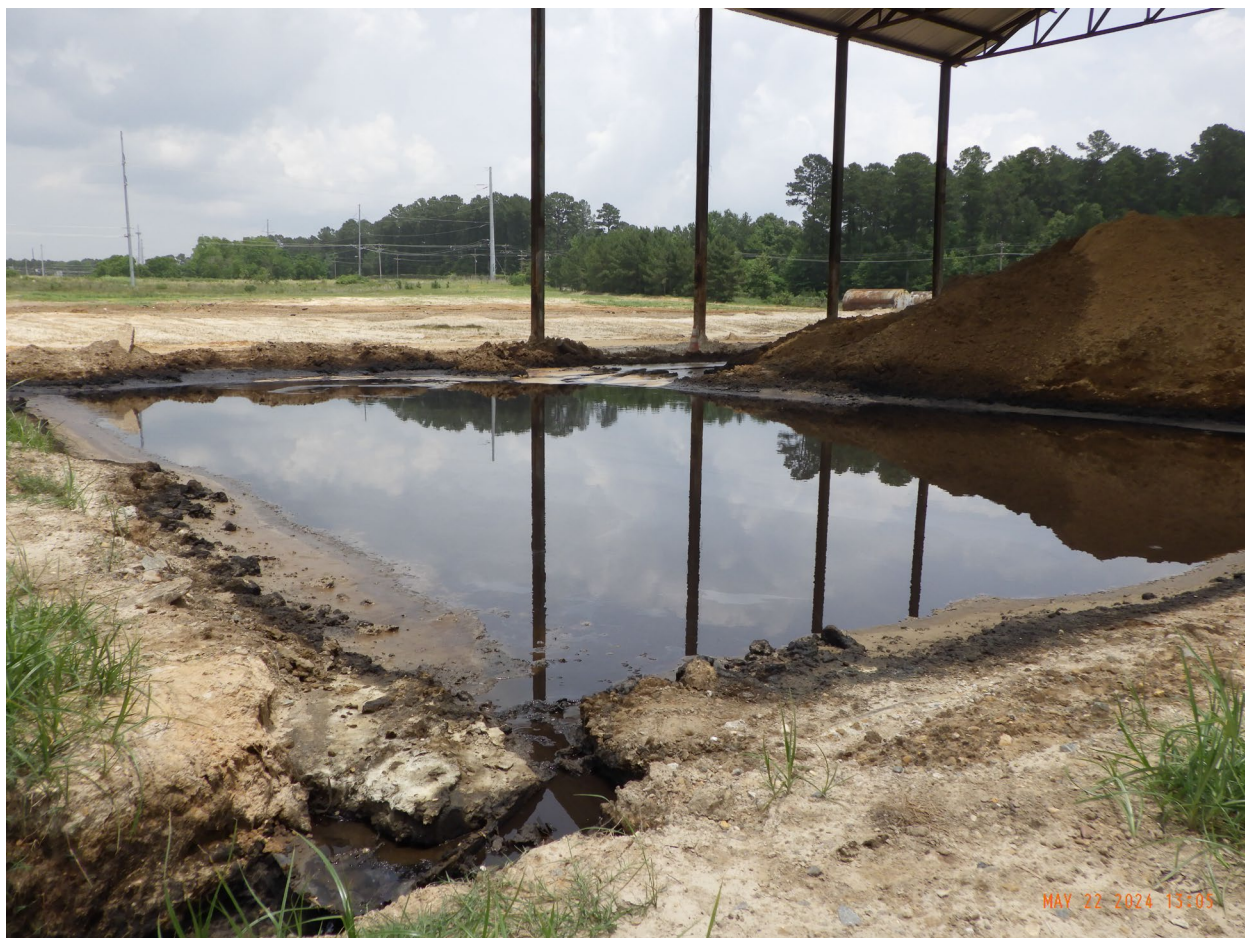
Photo No. 12

**Description:** Looking N-NE, this photo showed another large, concrete pit used to catch leachate from bulked material. Soil used to make an earthen berm. This area was covered under the original CGP.

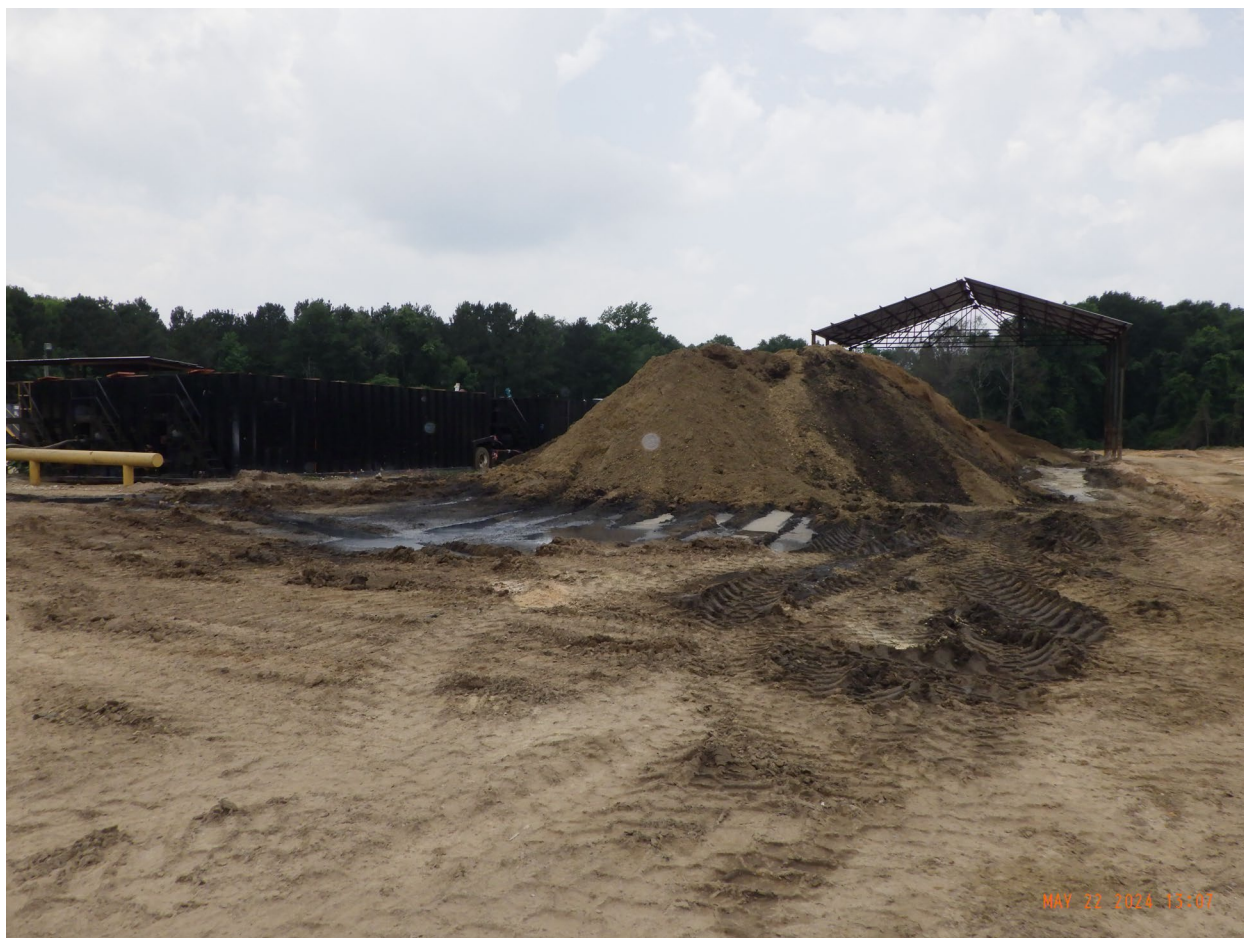
Photo No. 13

**Description:** Looking W-SW, this photo showed an overview of the mixing area with liquid wastes in frac tanks (photo left), and bulked material stockpiled. This area was covered under the original CGP.

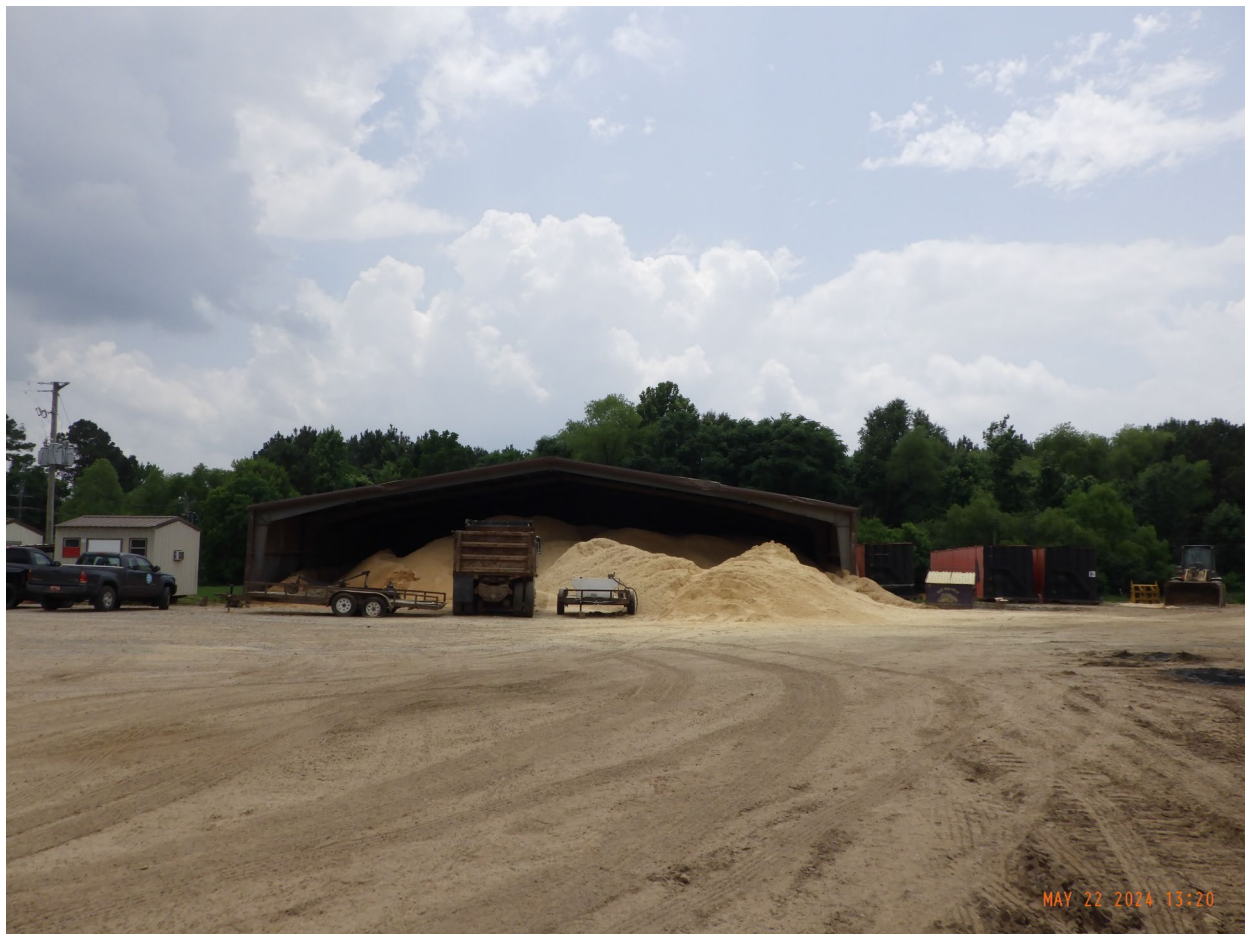
Photo No. 14

**Description:** Looking S, this photo showed an overview of the bulking material (sawdust) storage area and outbuilding for an office. This area was covered under the original CGP.
