## REGION 10 Enforcement Division

### INSPECTION REPORT

| <b>Inspection Date(s):</b> | 01/10/2022 and 01/24/2022 | Announced: No | |
| <b>Facility or Site Name:</b> | Carlile Transportation Systems, LLC | | |

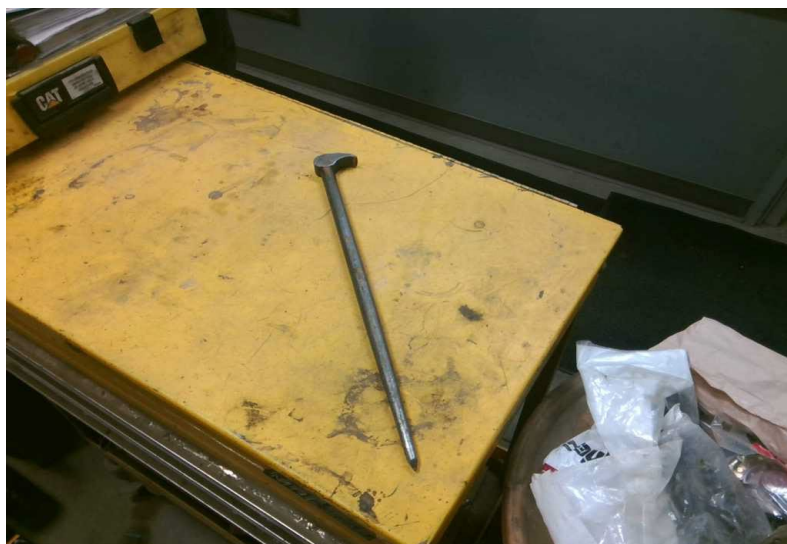
IMG-202201101117191719866180.jpg

While in the trailer shop, I saw a fiberboard container that was labeled with the words "Used Aerosols Cans Only." While in the shop, I met Mr. Patrick Quiambao, Anchorage Shop Manager. I looked in the fiberboard container and saw approximately five aerosol cans. I inquired about the aerosols and Mr. Quiambao said that aerosol cans are punctured in the fiberboard container using a "Crowfoot."

According to Mr. Quiambao, the shop generates approximately five waste aerosol cans each week.

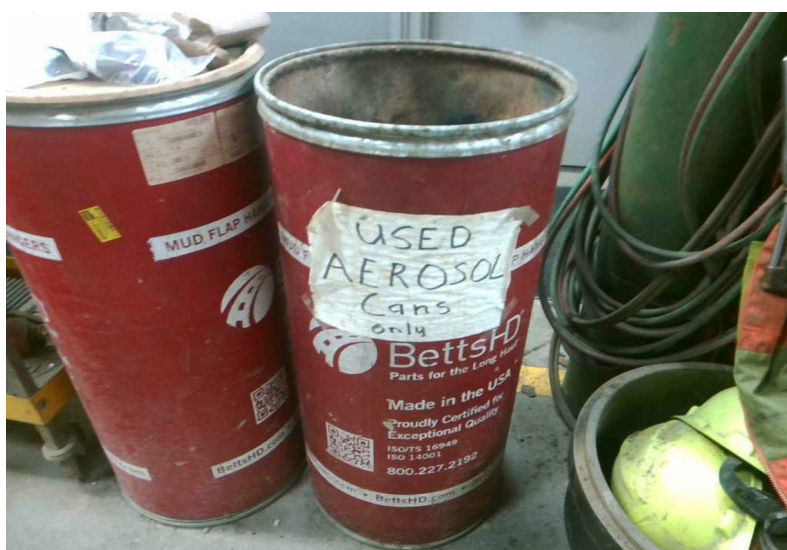
IMG-2022011011173717371021257.jpg

While in the trailer shop, I saw a fiberboard container that was labeled with the words "Used Aerosols Cans Only." While in the shop, I met Mr. Patrick Quiambao, Anchorage Shop Manager. I looked in the fiberboard container and saw approximately five aerosol cans. I inquired about the aerosols and Mr. Quiambao said that aerosol cans are punctured in the fiberboard container using a "Crowfoot."

According to Mr. Quiambao, the shop generates approximately five waste aerosol cans each week.

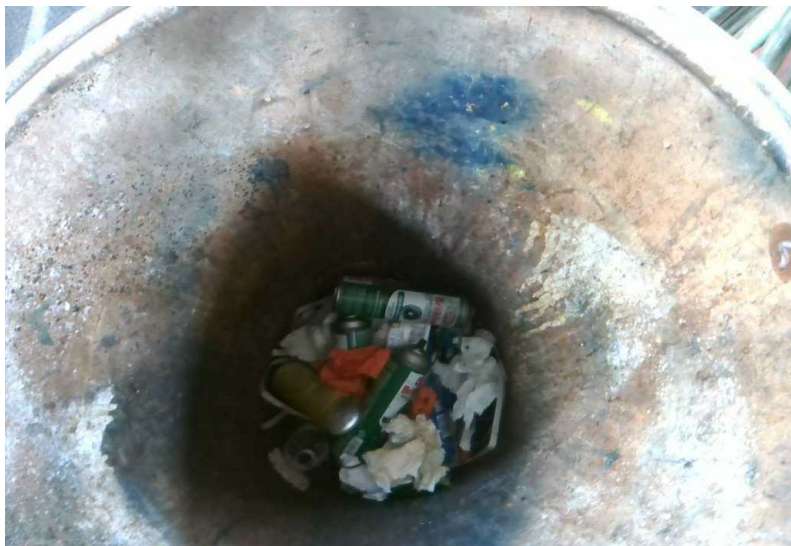
| <p>While in the trailer shop, I saw a fiberboard container that was labeled with the words "Used Aerosols Cans Only." While in the shop, I met Mr. Patrick Quiambao, Anchorage Shop Manager. I looked in the fiberboard container and saw approximately five aerosol cans. I inquired about the aerosols and Mr. Quiambao said that aerosol cans are punctured in the fiberboard container using a "Crowfoot."</p> <p>According to Mr. Quiambao, the shop generates approximately five waste aerosol cans each week.</p> | |

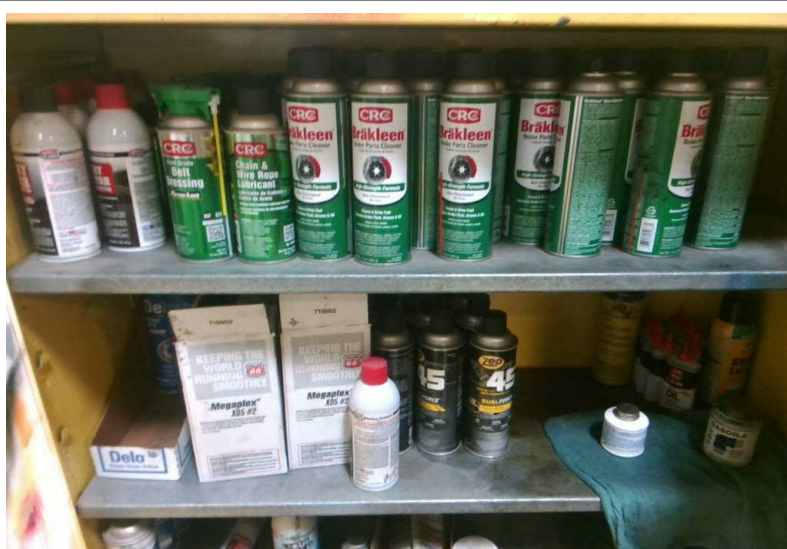
IMG-2022011011233723371039126.jpg

I looked in the flammable storage cabinets to view the aerosols that were in use, to see the various types of products used.

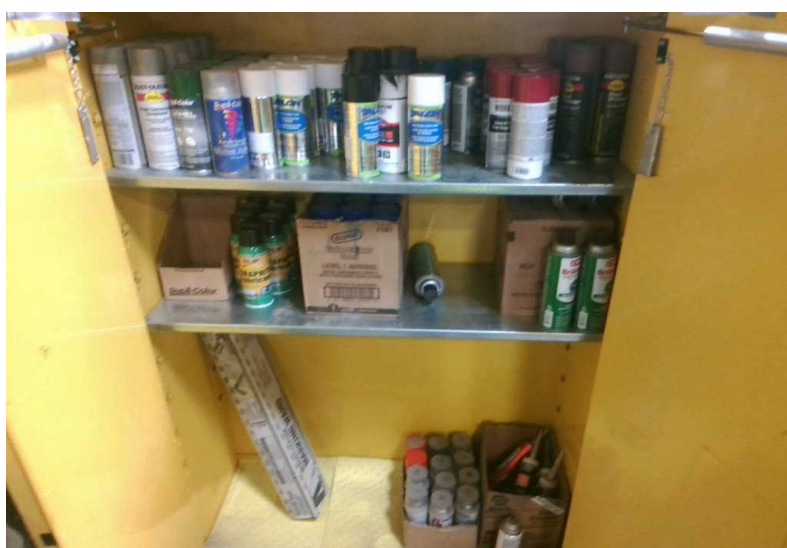
IMG-20220110112409249832030.jpg

I looked in the flammable storage cabinets to view the aerosols that were in use, to see the various types of products used.

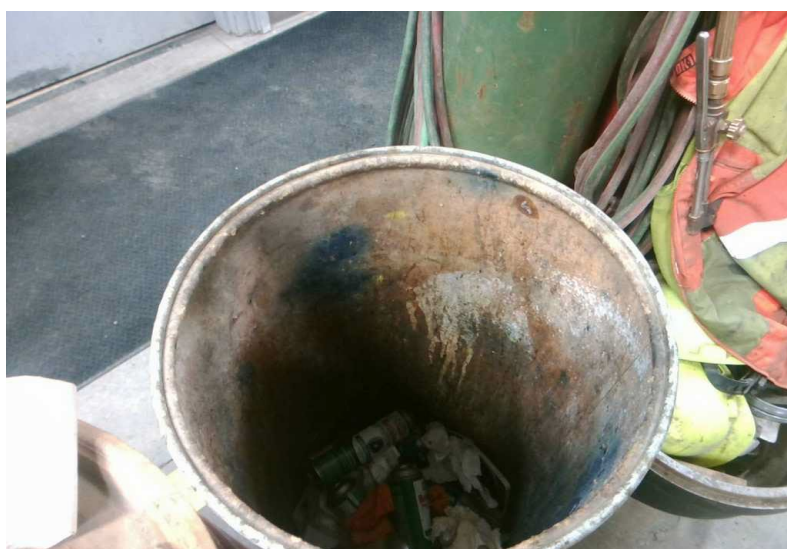
IMG-202201101128492849996822.jpg

| <p>While in the trailer shop, I saw a fiberboard container that was labeled with the words "Used Aerosols Cans Only." While in the shop, I met Mr. Patrick Quiambao, Anchorage Shop Manager. I looked in the fiberboard container and saw approximately five aerosol cans. I inquired about the aerosols and Mr. Quiambao said that aerosol cans are punctured in the fiberboard container using a "Crowfoot."</p> <p>According to Mr. Quiambao, the shop generates approximately five waste aerosol cans each week.</p> | <p><b>Regulation:</b></p> <p>273.13(e)(4)</p> | <p><b>Sections:</b></p> |

According to Mr. Quiambao aerosols are punctured when empty and sometimes if they stop working, they are still punctured into the fiberboard container. At the time of the inspection, the inside of the fiberboard container appeared to be stained with residue from waste aerosol cans.

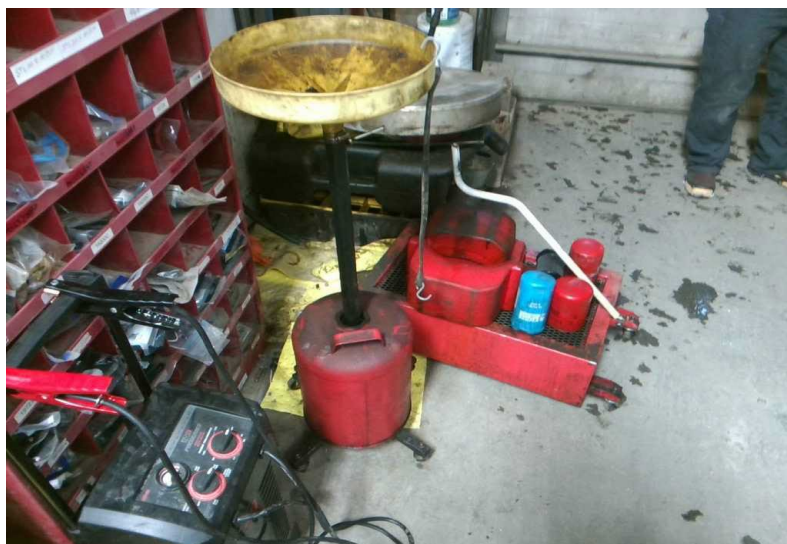
IMG-2022011011515251521126057.jpg

| <b>Building:</b> Trailer Shop | <b>Area:</b> Bay #1 | <b>Sub-area:</b> |
|---|---|---|
| At the time of the inspection, I saw a wheeled drain pan and a spill pallet on the east side of Bay #1, adjacent to the Bay roll-up door. Both the drain pan and the spill pallet held used oil which was confirmed by Mr. Quiambao. Neither the drain pan nor the spill pallet were labeled with the words "Used Oil." | <b>Regulation:</b><br>279.22(c)(1) | <b>Sections:</b> |

At the time of the inspection, I saw a wheeled drain pan and a spill pallet on the east side of Bay #1, adjacent to the Bay roll-up door. Both the drain pan and the spill pallet held used oil which was confirmed by Mr. Quiambao. Neither the drain pan nor the spill pallet were labeled with the words "Used Oil."

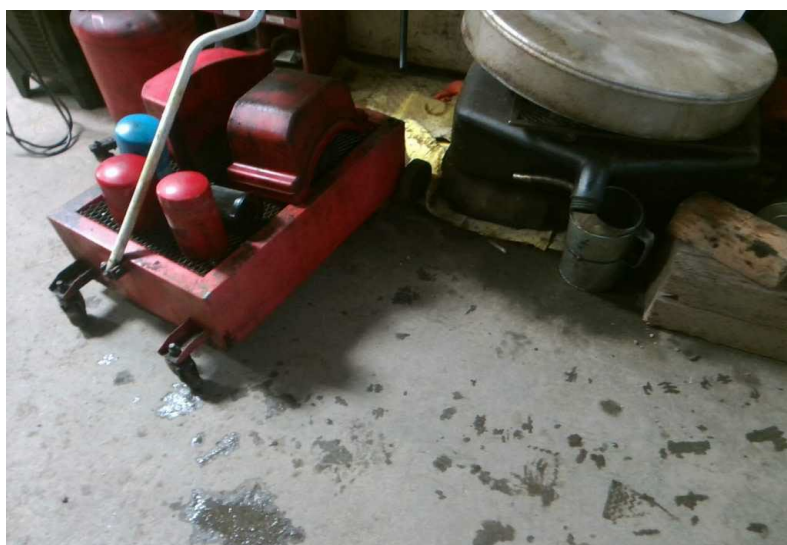
IMG-202201101152155215826495.jpg

At the time of the inspection, I saw a wheeled drain pan and a spill pallet on the east side of Bay #1, adjacent to the Bay roll-up door. Both the drain pan and the spill pallet held used oil which was confirmed by Mr. Quiambao. Neither the drain pan nor the spill pallet were labeled with the words "Used Oil."

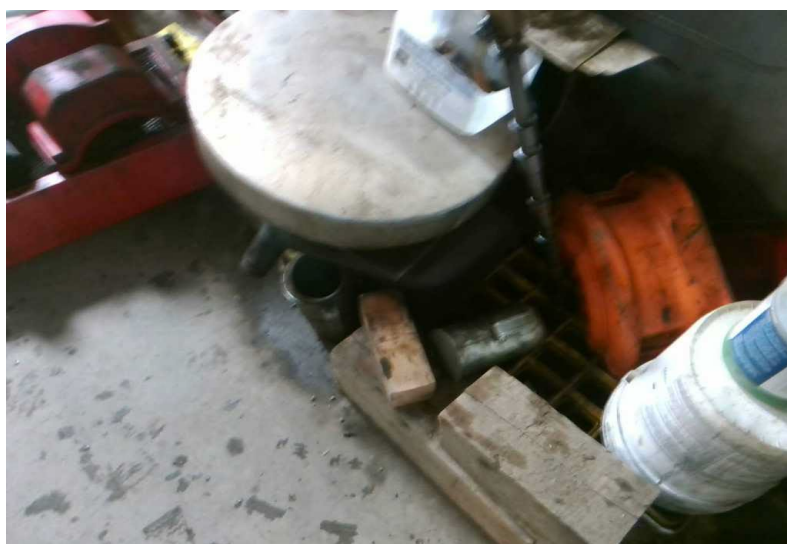
IMG-202201101152265226733799.jpg

At the time of the inspection, I saw a wheeled drain pan and a spill pallet on the east side of Bay #1, adjacent to the Bay roll-up door. Both the drain pan and the spill pallet held used oil which was confirmed by Mr. Quiambao. Neither the drain pan nor the spill pallet were labeled with the words "Used Oil."

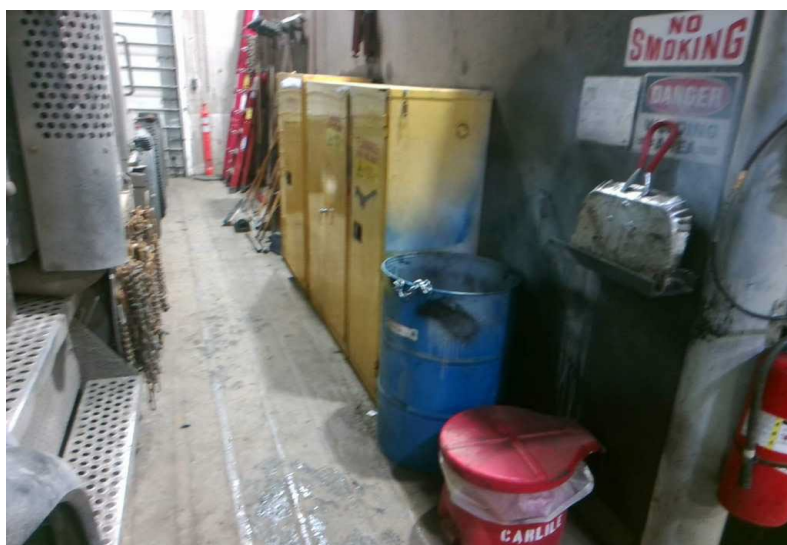
IMG-20220110120810810901991.jpg

| <b>Building:</b> Trailer Shop | <b>Area:</b> Bay #1 | <b>Sub-area:</b> |
|---|---|---|
| While in the truck shop, Mr. Quiambao took me to where the waste aerosol cans are being punctured. At the time of the inspection, there were approximately 30 - 40 punctured aerosol cans in an open 55-gallon container.<br><br>According to Mr. Quiambao the waste aerosol cans are being managed in the same way that they are being managed in the trailer shop. The flammable storage cabinets contain the same hazardous materials as the trailer shop too. | <b>Regulation:</b><br>273.13(e)(4) | <b>Sections:</b> |

While in the truck shop, Mr. Quiambao Took me to where the waste aerosol cans are being punctured. At the time of the inspection, there were approximately 30 - 40 punctured aerosol cans in an open 55-gallon container.

According to Mr. Quiambao the waste aerosol cans are being managed in the same way that they are being managed in the trailer shop. The flammable storage cabinets contain the same hazardous materials as the trailer shop too.

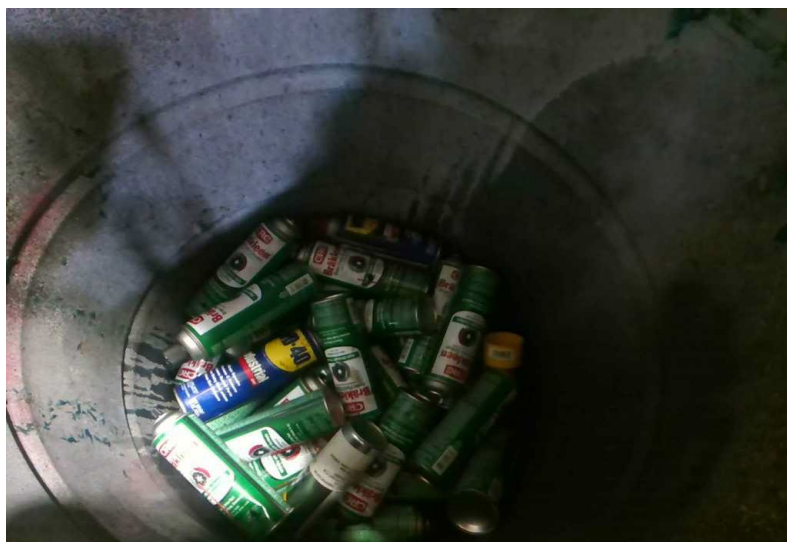
| IMG-20220110120926926690153.jpg |

| While in the truck shop, Mr. Quiambao Took me to where the waste aerosol cans are being punctured. At the time of the inspection, there were approximately 30 - 40 punctured aerosol cans in an open 55-gallon container. |
| According to Mr. Quiambao the waste aerosol cans are being managed in the same way that they are being managed in the trailer shop. The flammable storage cabinets contain the same hazardous materials as the trailer shop too. |

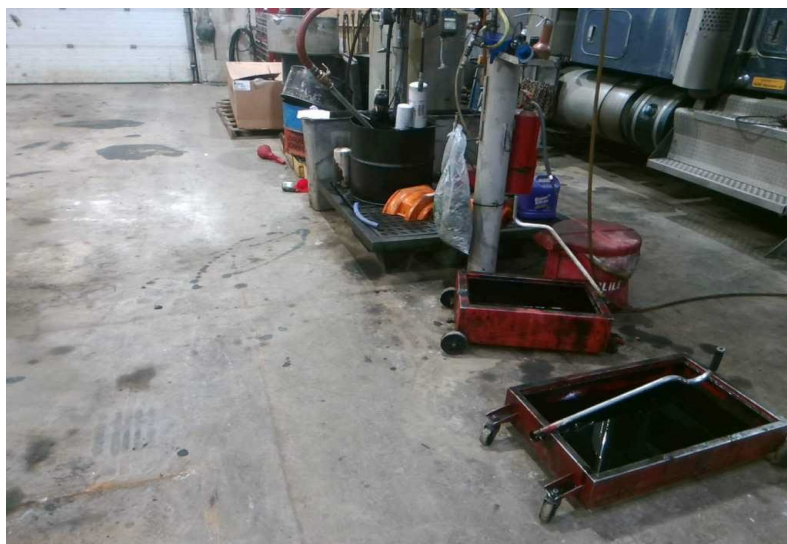
| IMG-202201101217471747896353.jpg |

| <b>Building:</b> Trailer Shop | <b>Area:</b> Bay #1 | <b>Sub-area:</b> |
|---|---|---|
| At the time of the inspection, I saw two, wheeled drain pans, a half of a 55-gallon container, and three spill pallets. All contained various amounts of used oil, and none were labeled with the words "Used Oil." | <b>Regulation:</b><br>279.22(c)(1) | <b>Sections:</b> |

| View of the drain pans, half container and spill pallets that are not labeled with the words Used Oil. |

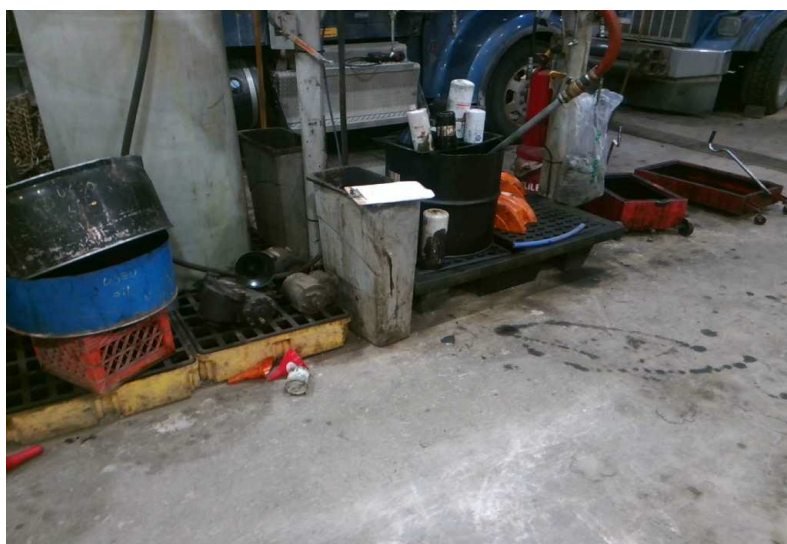
| IMG-202201101218191819907484.jpg |

| View of the drain pans, half container and spill pallets that are not labeled with the words Used Oil. |

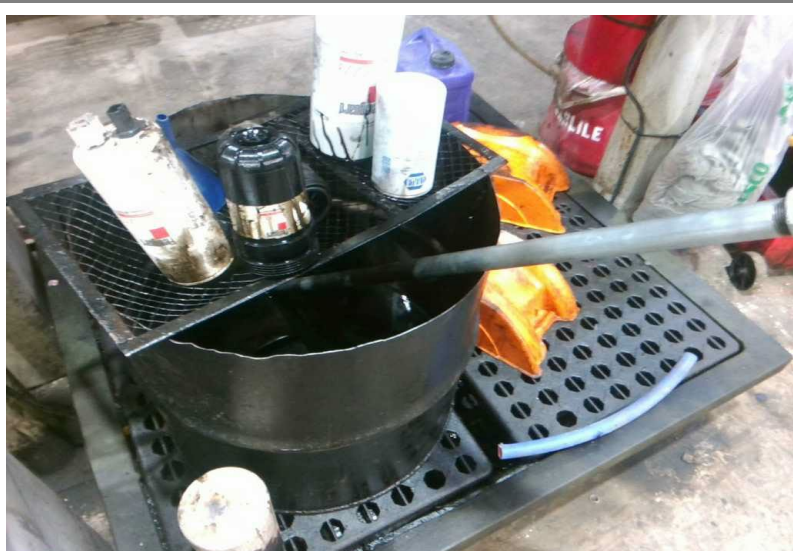
| IMG-2022011012184118411052897.jpg |

| View of the drain pans, half container and spill pallets that are not labeled with the words Used Oil. |
