## WASHINGTON CAFO INSPECTION REPORT

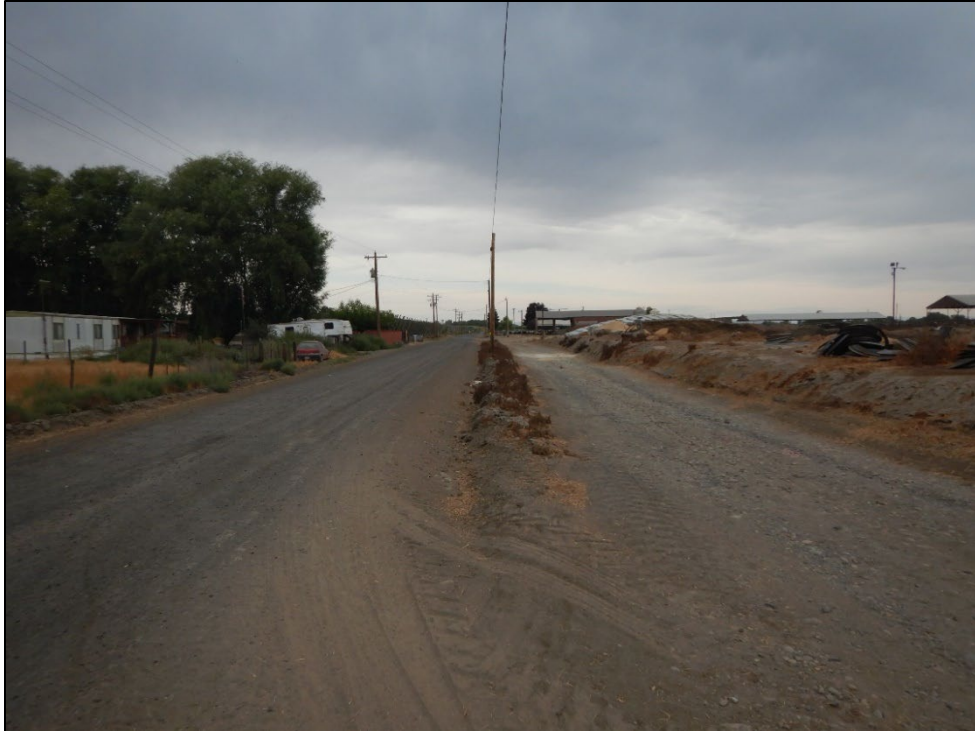
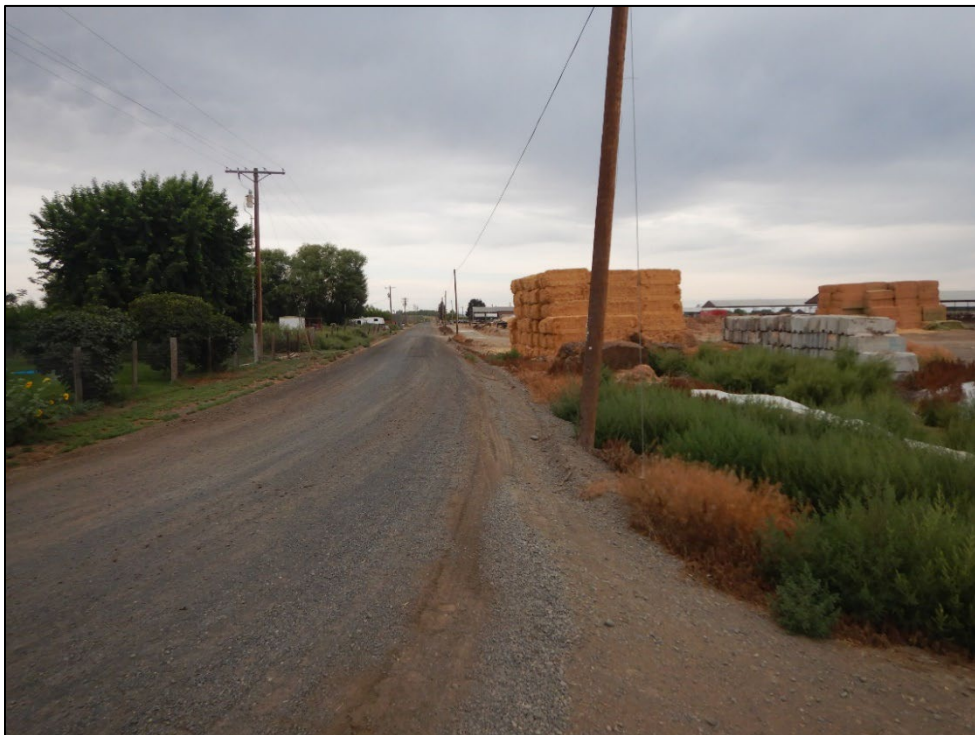
- During the site tour of the production area, the inspection team observed residual silage in the ditch along Vance Road. The ditch was dry at the time of the inspection and appeared to dead-end at the corner of the production area. The ditch did not appear to be connected to a WOTUS; however, the inspection team recommended the facility maintain residual silage within the production area and out of the ditch to prevent any process-generated wastewater from leaving the production area.

The inspection team observed residual silage in the ditch along Vance Road (Photographs 3 and 4). The ditch was dry at the time of the inspection and appeared to dead-end at the corner of the production area. It did not appear to be connected to a WOTUS; however, the inspection team recommended the facility keep residual silage out of the ditch to prevent any process-generated wastewater from leaving the production area.

Photograph 3. View looking west along the southern production area boundary and Vance Road, from a point near the southeast corner of the production area.

Photograph 4. View looking west along the southern production area boundary and Vance Road, from the southeast corner of the production area.

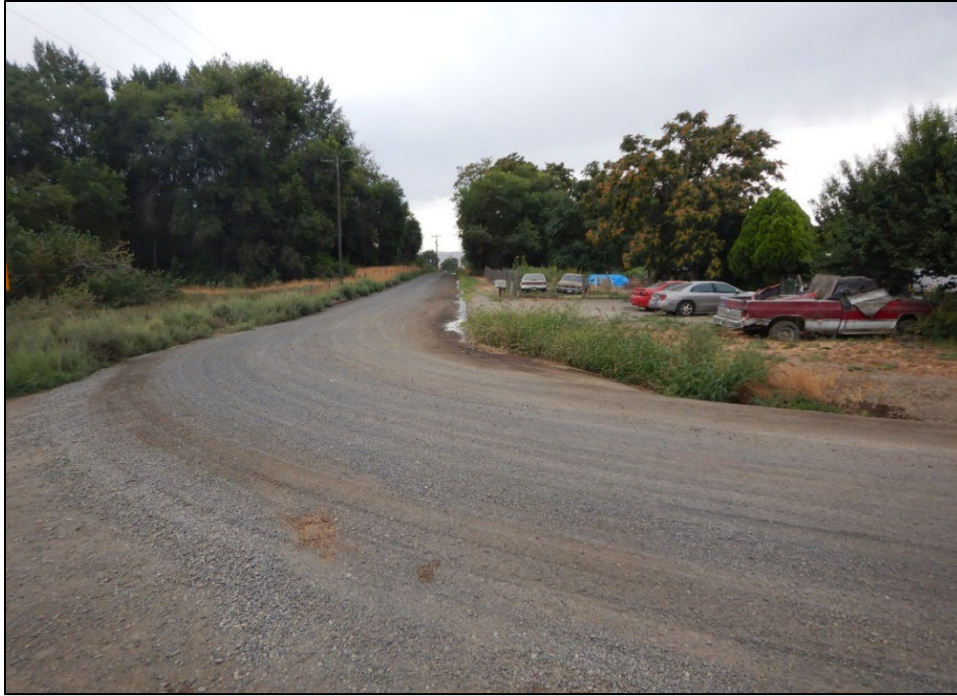
Photograph 5. View looking south along Ferry Rd from the southeast corner of the production area. The inspection team observed that the swale next to Ferry Rd, which contained stormwater runoff, was upgradient of the production area, and it did not appear to be connected to the ditch along the north side of Vance Road.

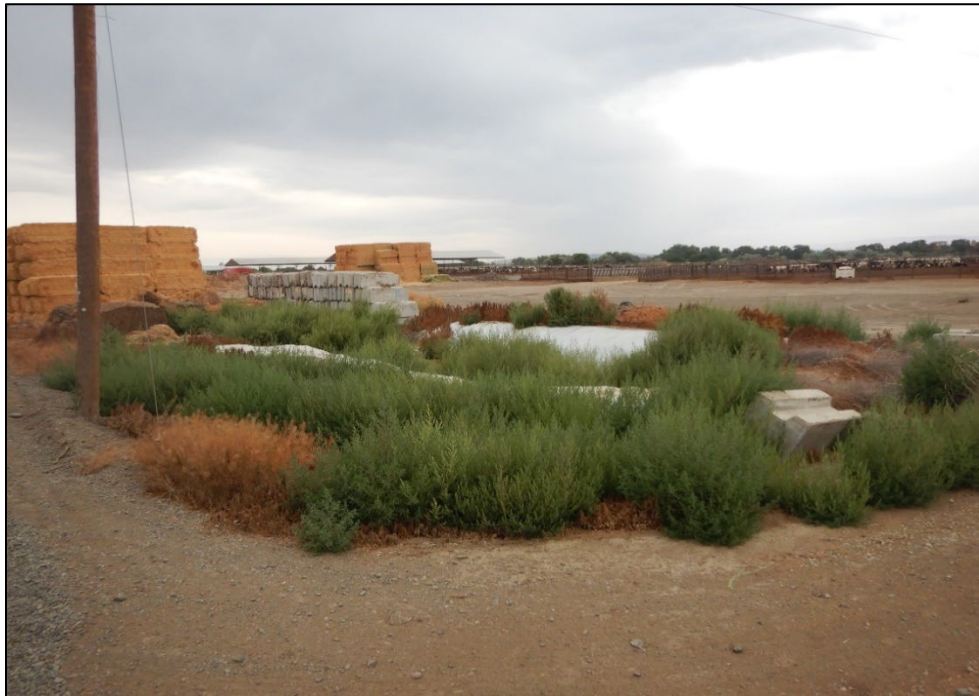
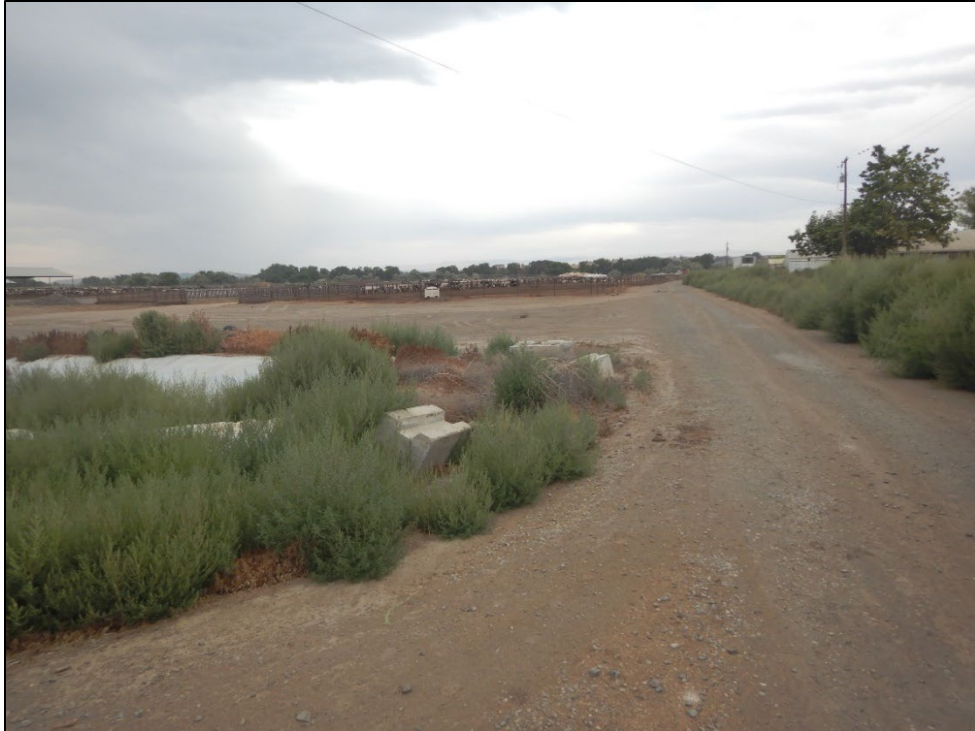
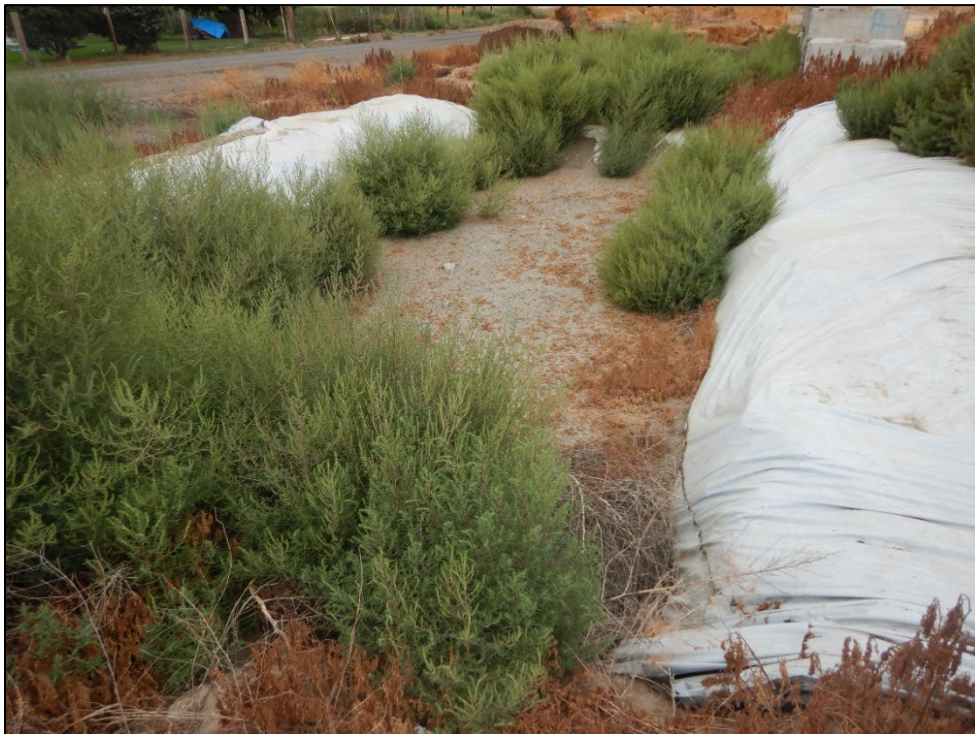
The inspection team observed heavy vegetation on multiple impoundments, including the east silage pit, Lagoon 1, and Lagoon 2 (Photographs 6-8, 15, and 19-20). The east silage pit had a plastic liner and the vegetation was growing on top of or through the liner (Photographs 6-8). The inspection team also observed a tear in the plastic liner in the Pen 4 Pit (Photograph 22). Following the inspection, on September 13, 2024, the facility representative emailed the inspection team the photos in Attachment 1 below of impoundments where vegetation had been removed.

Photograph 6. View looking northwest of the East Silage Pit located at the southeast corner of the production area. The East Silage Pit was lined with a plastic liner, however, the inspection team heavy vegetation growing within the pit.

Photograph 8. Additional view looking west across the East Silage Pit shown in [Photographs 6 & 7](#). Note the heavy vegetation growing within the pit.

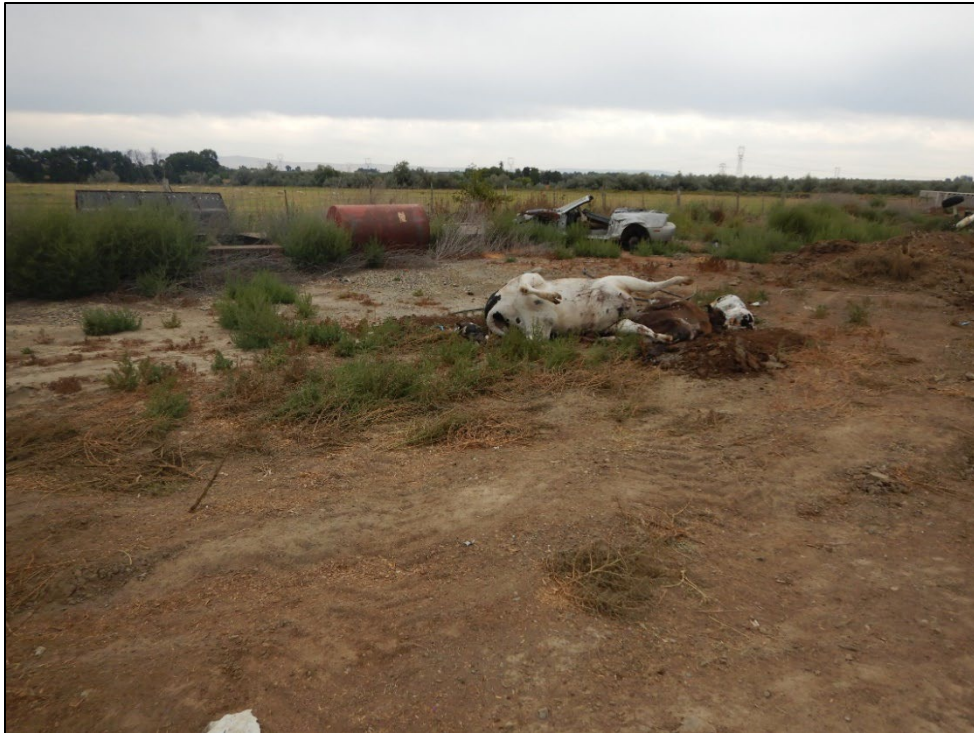
The inspection team observed mortalities in the temporary storage location near the northern production area boundary (Photograph 13). Based on the local topography, it does not appear to the inspectors that runoff would enter an impoundment.

- No 42. All open surface impoundments and terminal storage tanks have depth markers which clearly indicate the minimum capacity necessary to contain the runoff and direct precipitation of the 25-year, 24-hour rainfall event? [40 CFR 412.37(a)(2)]
- The impoundments did not contain depth markers.
- Yes 43. Mortalities remain in the production area until disposal, are not disposed in liquid manure or process wastewater treatment systems, and are handled to prevent discharge of pollutants to surface waters? [40 CFR 412.37(a)(4)]
- The inspection team observed mortalities in the temporary storage location near the northern production area boundary (Photograph 13), northeast of Lagoon 2.

Photograph 13. View looking northeast at the temporary mortality storage area.

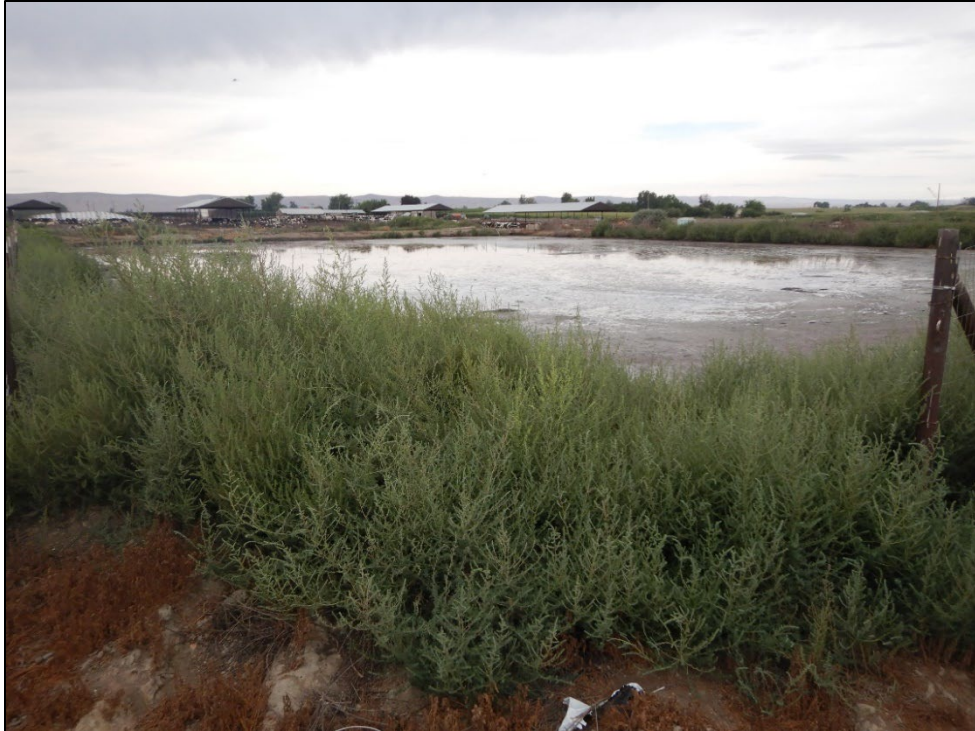
Photograph 15. View looking southwest across Lagoon 2. Note the heavy vegetation growing on the embankments.

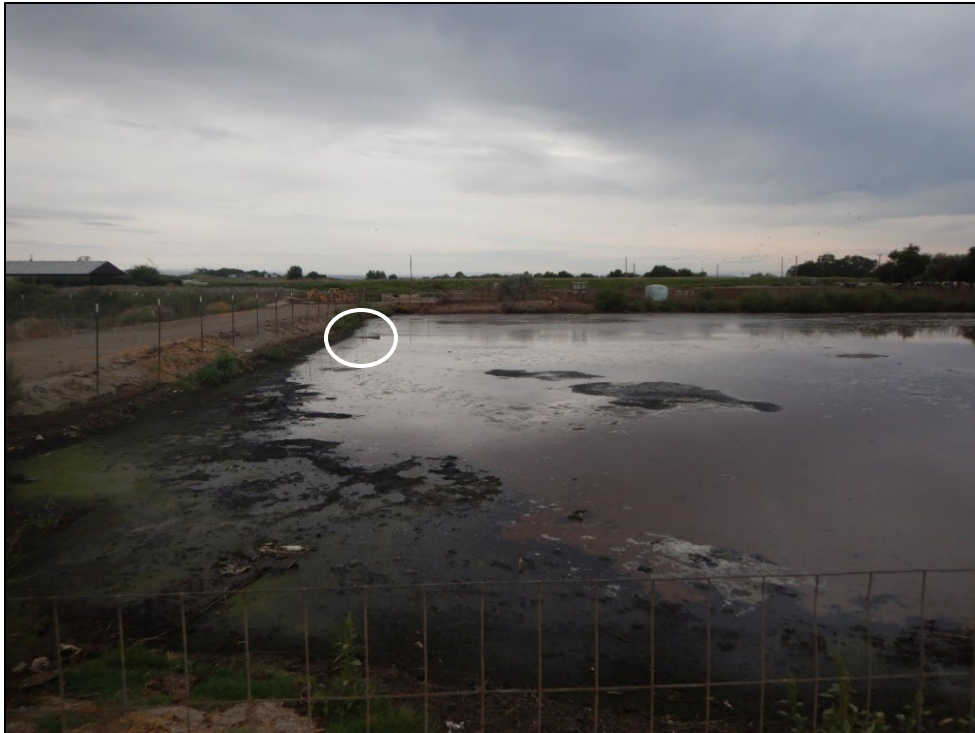
Photograph 17. View looking west across the southern portion of Lagoon 2. The PVC pipe (circled) is the overflow pipe between Lagoon 1 and Lagoon 2.

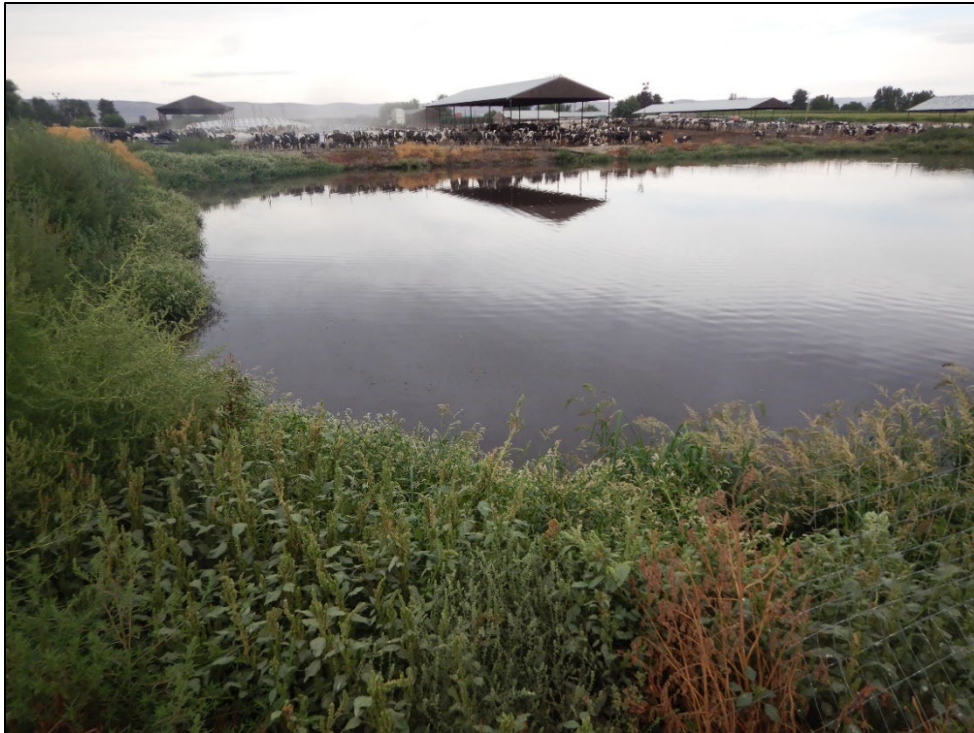
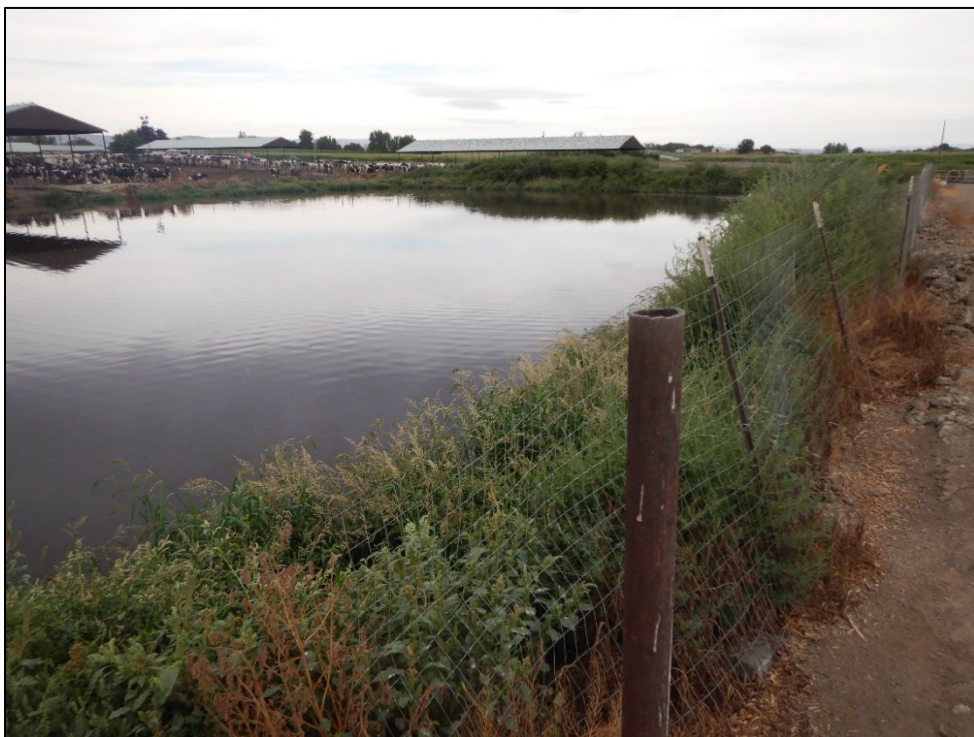
Photograph 19. View looking southwest across Lagoon 1. Note the heavy vegetation growing on the embankments.

Photograph 20. View looking west along the northern edge of Lagoon 1. Note the heavy vegetation growing on the embankments.

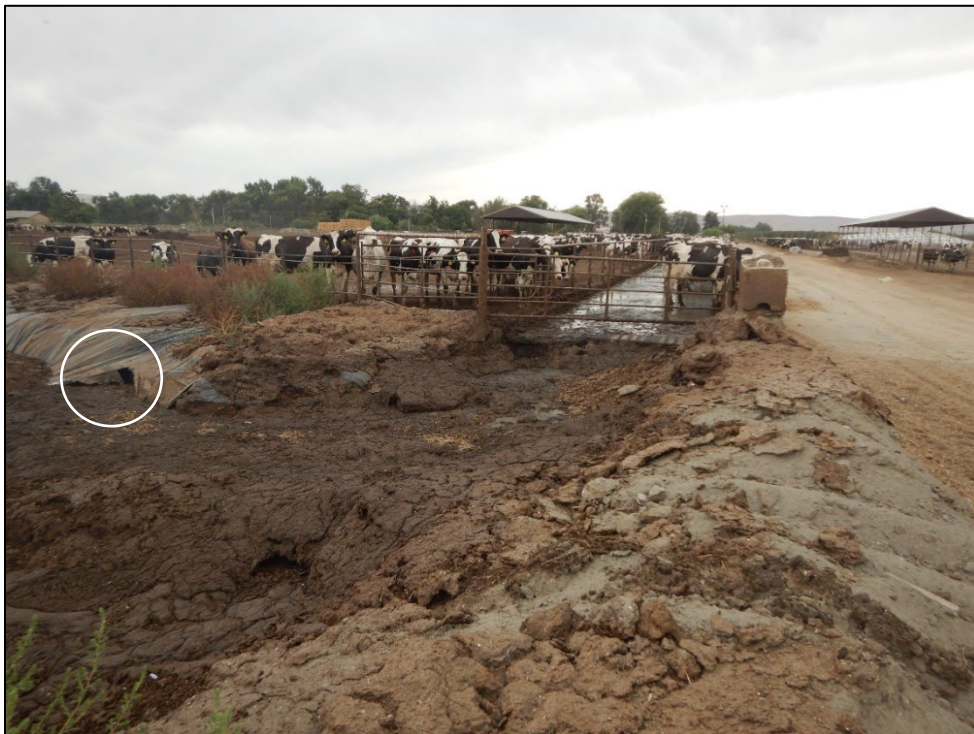
Photograph 22. View looking south along the western edge of the Pen 4 Pit and the Pen 4 feed alley. The inspection team observed a tear in the plastic liner (circled).

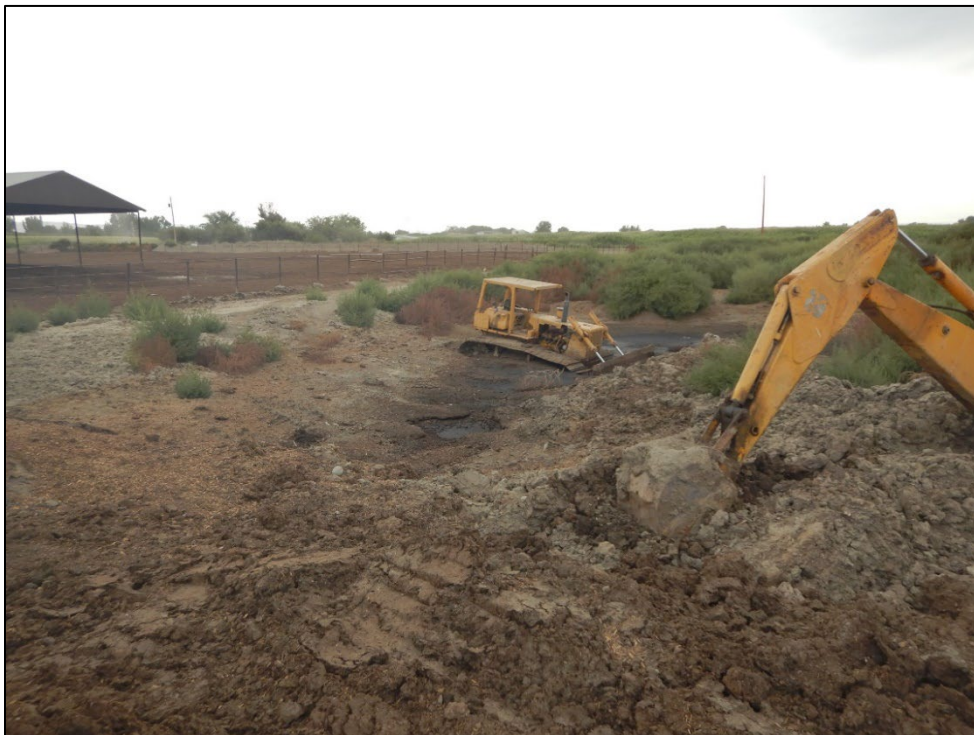
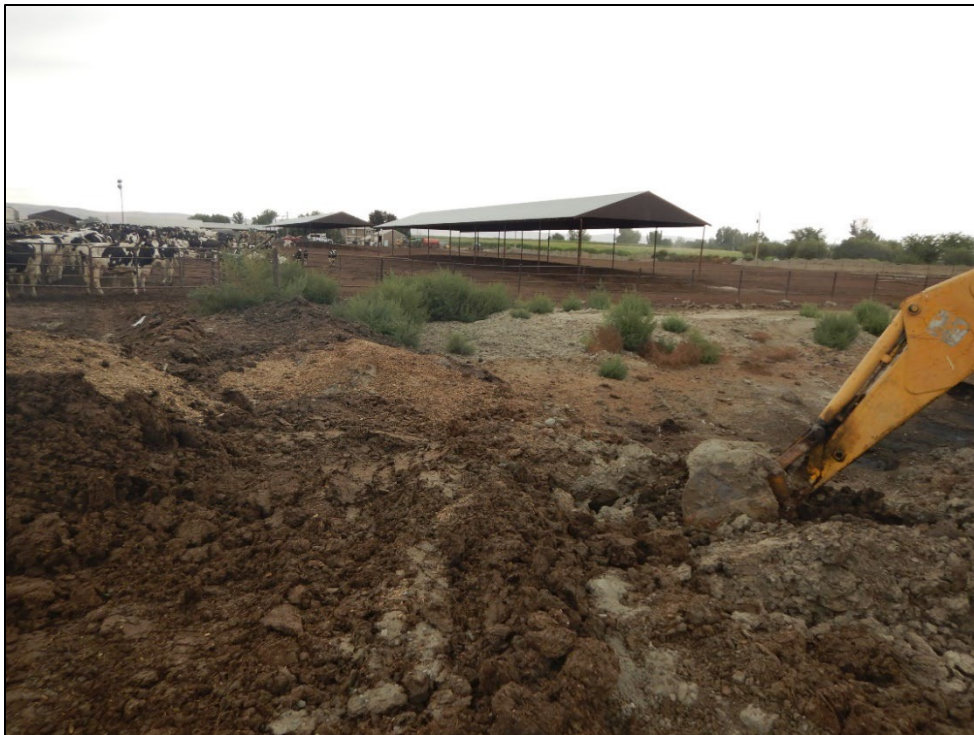
Immediately west of the Settling Pit, the inspection team observed a low spot and an excavator positioned in this area (Photographs 28-29). According to the facility representative, the facility was planning to make this area into a new impoundment.

Photograph 28. View looking southwest at the low spot located west of the Settling Pit.

Photograph 29. Additional view looking southwest of the low spot shown in [Photograph 27](#).

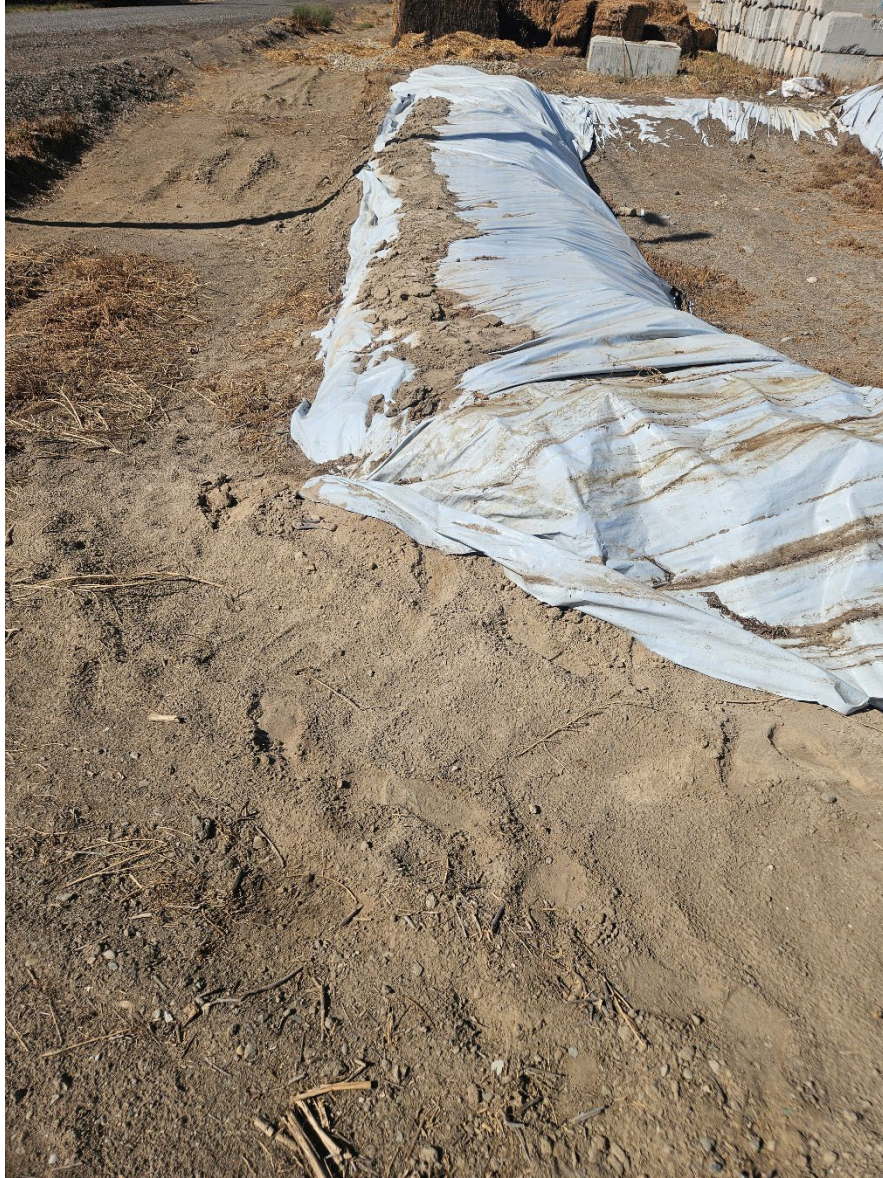
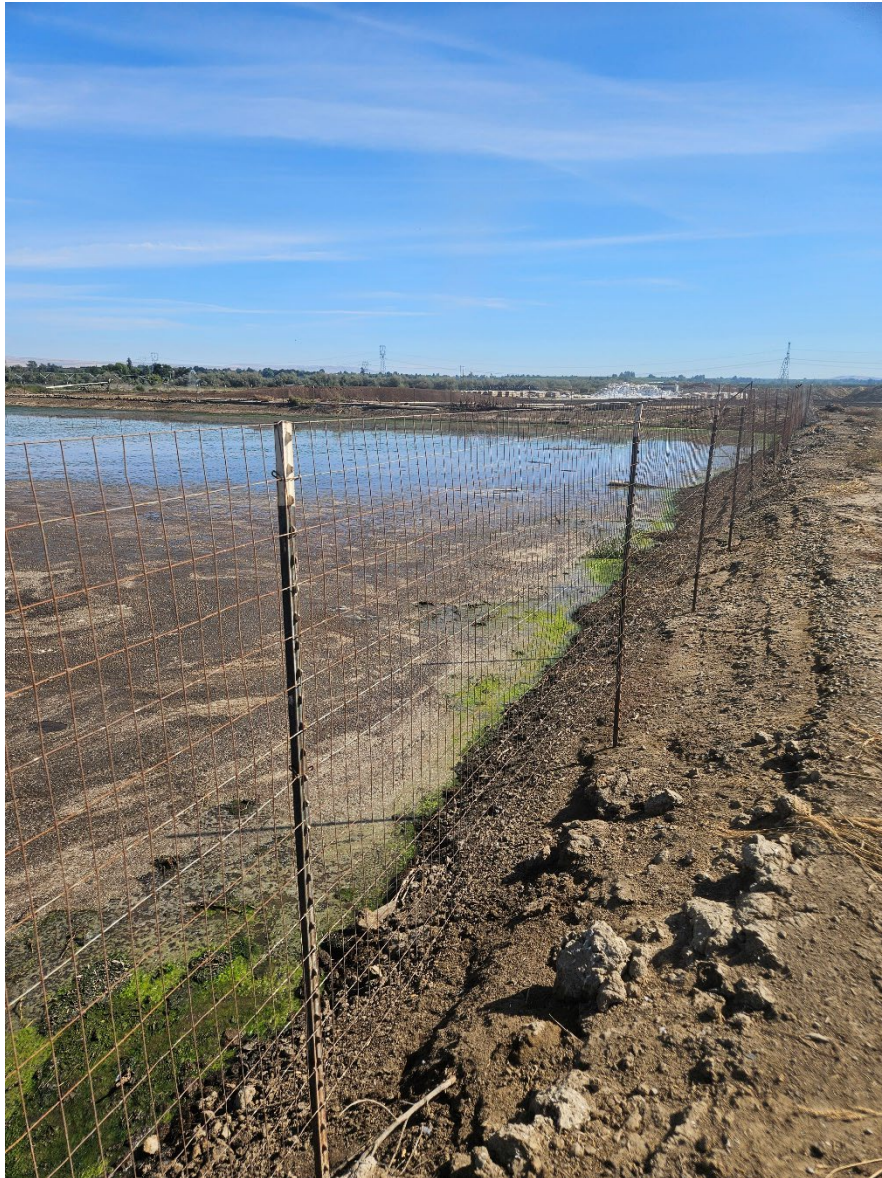
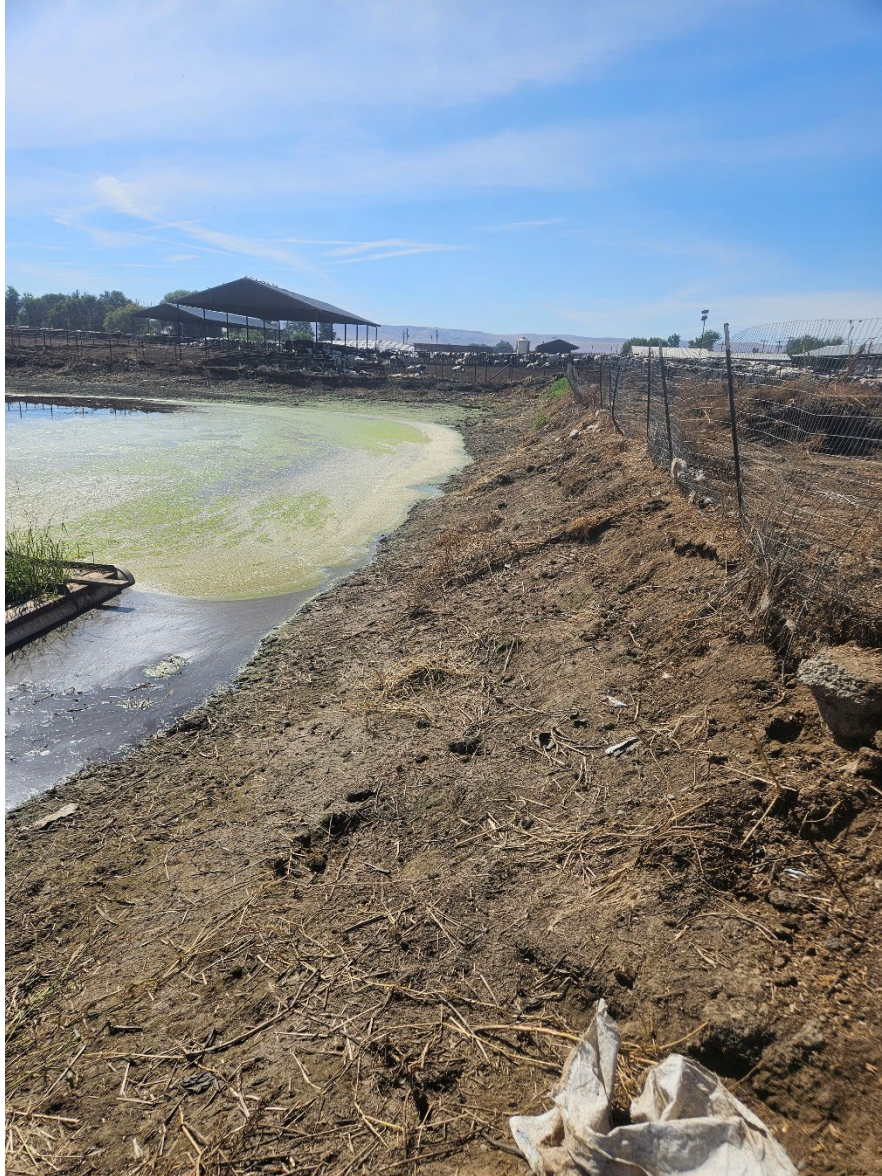
Photograph 1. View of the East Silage Pit. Note the absence of vegetation compared to the photographs taken during the inspection site tour.

Photograph 2. View of Lagoon 2. Note the absence of vegetation compared to the photographs taken during the inspection site tour.

Photograph 3. View of Lagoon 1. Note the absence of vegetation compared to the photographs taken during the inspection site tour.
