## INSPECTION REPORT

<b>Inspection Date(s):</b>	02/15/2022 - 02/16/2022	Announced: No
<b>Time:</b>	Entry: 07:56 AM (ET)	Exit: 02:45 PM (ET)
<b>Media:</b>	Water	
<b>Statute(s)/Program(s):</b>	Clean Water Act, NPDES, Industrial	
<b>Type of inspection:</b>	CEI - Compliance Evaluation Inspection	
<b>Access:</b>	Granted	
<b>Permittee Name:</b> Gavin Power LLC		
<b>Facility or Site Name:</b> General James M. Gavin Power Plant		
<b>Facility/Site Physical Address:</b> 7397 North State Route 7		
<b>(City, state, zip code)</b> Cheshire, Ohio45620		
<b>County/Parish:</b> Gallia		
<b>Facility GPS Coordinates:</b> 38.936219, -82.114259		
<b>Facility/Site Identifier:</b> Gavin		
<b>Permit Number:</b> OH0028762		
<b>SIC or NAICS:</b> 4911

The General James M. Gavin Power Plant or, Gavin Power Plant (the “Site” or “Facility”), is a coal-fired power plant located in Cheshire, Ohio. It is owned by Lightstone Generation LLC, a 50–50 joint venture of The Blackstone Group L.P. and ArcLight Capital Partners. The Site is the largest coal-fired power facility in Ohio, and one of the largest in the United States. The Facility operates two coal-fired units. The total generation capacity of the two units i

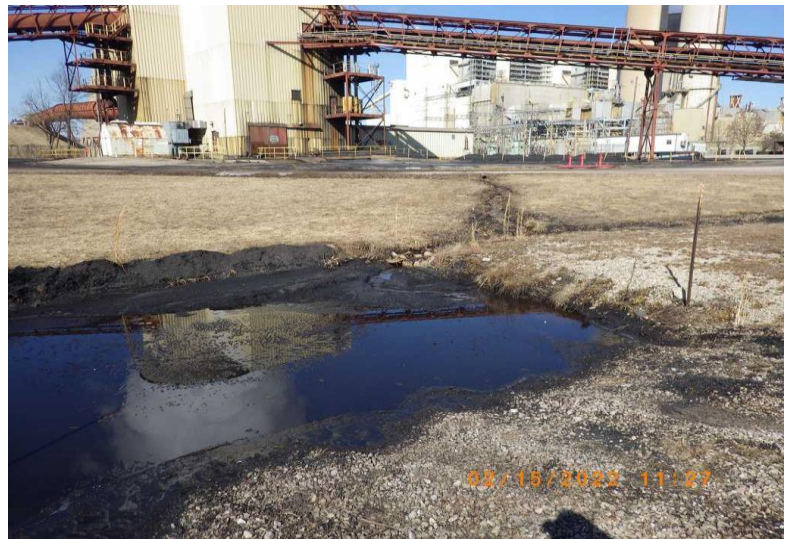
Puddle with runoff from the transfer stations  
 RIMG2400.JPG  
 02/15/2022 11:27 AM (ET)  
 Andi Hodaj  
 Coal loading and transfer area/Gavin Power Plant  
 No CBI  
 No PII  
 The puddle/depression area in the photo, collects runoff from the areas around the coal transfer stations and flows into a catch basin a couple hundred feet south that discharges into Ohio River through a pipe.

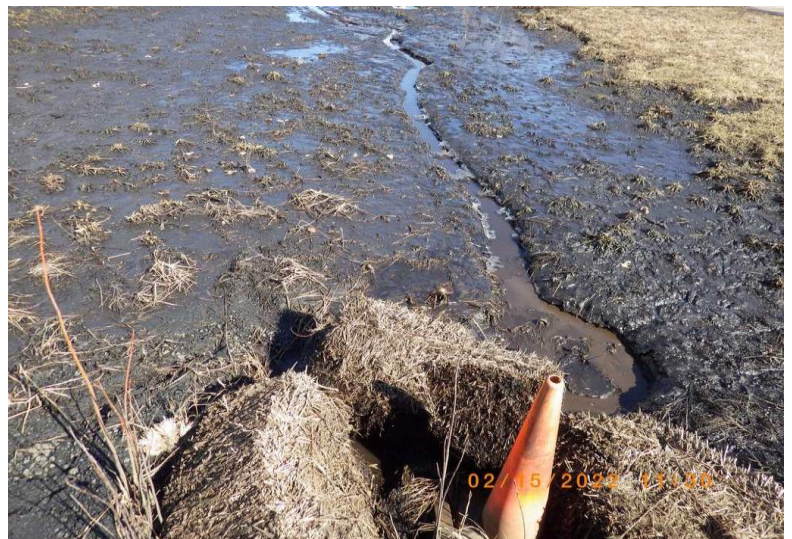
Catch basin that discharges into Ohio River  
 RIMG2401.JPG  
 02/15/2022 11:30 AM (ET)  
 Andi Hodaj  
 Coal loading and transfer area/Gavin Power Plant  
 No CBI  
 No PII  
 The photo shows runoff from the coal transfer station area that enters a catch basin/manhole that discharges into Ohio River via an underground pipe.

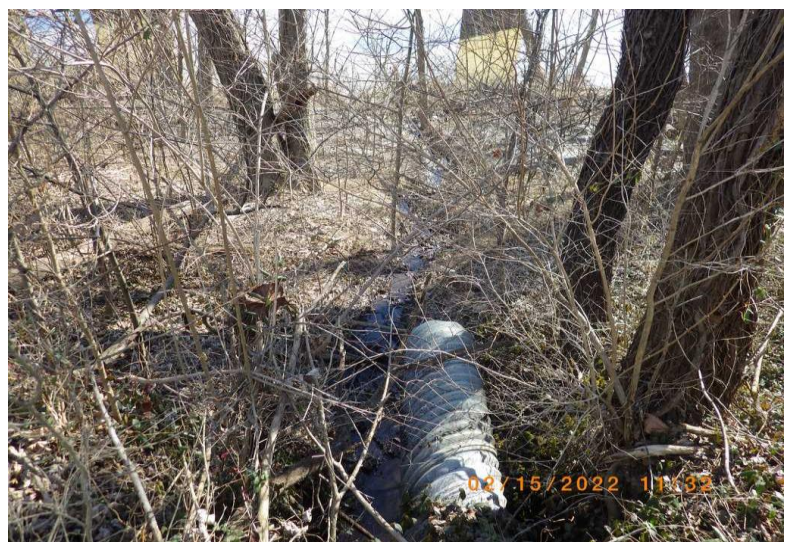
On February 15, 2022, EPA observed a pipe that was discharging into the Ohio River. The discharge was not permitted. The pipe was an approximately 18" metal corrugated pipe that was not shown in any of the Facility's maps. At the time of the inspection, the Facility claimed that it was not aware of the pipe's existence. The pipe was discharging runoff from the lower areas of the north and south coal conveying transfer stations. The coal conveying transfer stations transport coal from barges in Ohio River to the coal yard or directly to the power generating units at the Facility. The coal conveying transfer stations have sump pits that collect stormwater. This stormwater comes into contact with coal and coal dust. Two of these sump pits were overflowing into a catch basin that eventually discharged into the Ohio River through the 18" metal pipe, mentioned above. The catch basin received runoff from the wider area east of the transfer stations where coal dust was present. During the inspection, EPA observed runoff, through several gullies, that was discharging into the catch basin.

Pipe discharging into Ohio River  
 RIMG2402.JPG  
 02/15/2022 11:33 AM (ET)  
 Andi Hodaj  
 Coal loading and transfer area/Gavin Power Plant  
 No CBI  
 No PII  
 The pipe in the photo was discharging at the time of the inspection. It was discharging the runoff from the area around the coal transfer stations.

On February 28, 2022, Gavin sent a follow-up email and letter that stated " On February 15, 2022, Gavin began repair and clean-up of the sumps. Clean-up of the coal yard at the barge unloaders began on February 21, 2022, and will be completed over the next two to three weeks. Gavin is evaluating removal of the piping and culvert that drains stormwater in contact with coal to the river or permitting the discharge."

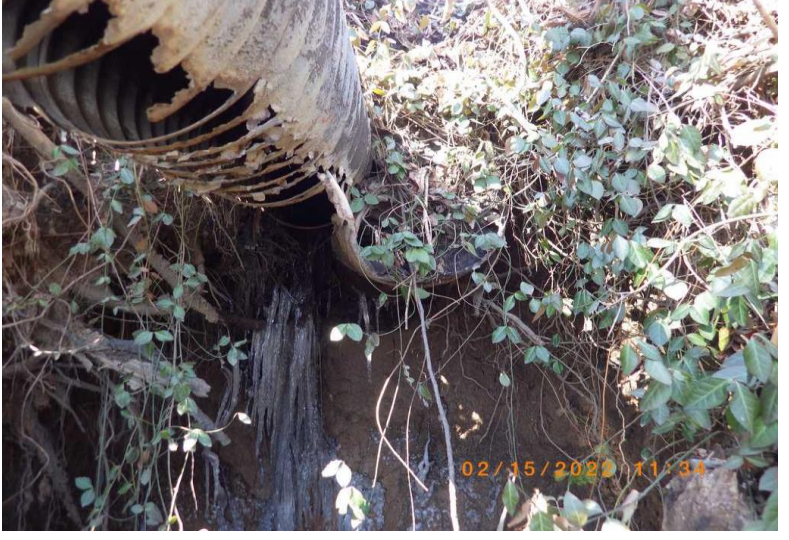
<p>02/15/2022 11:34 AM (ET)</p>	
<p>Andi Hodaj</p>	
<p>Coal loading and transfer area/Gavin Power Plant</p>	
<p>No CBI</p>	
<p>No PII</p>	
<p>The pipe was discharging runoff from the coal transfer stations area into Ohio River. Camera direction is West.</p>	
<p>Pipe discharge</p>

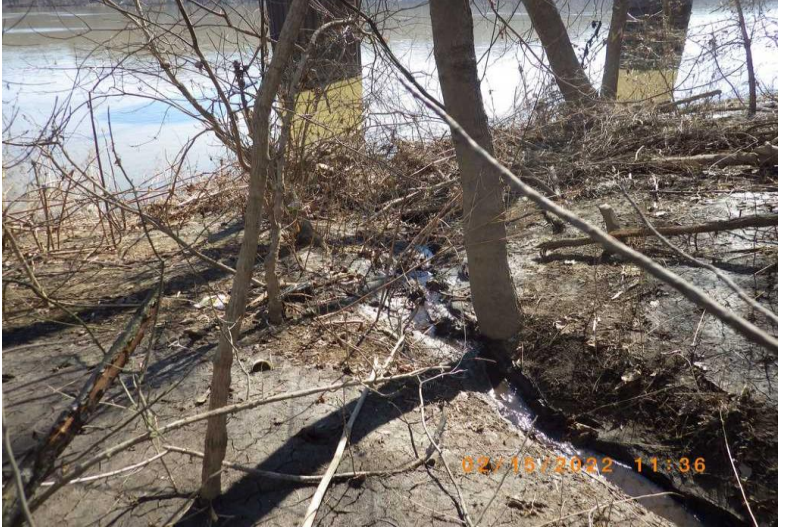
<p>A photograph showing a pipe discharge on the banks of the Ohio River. The pipe is lying on the ground, surrounded by a large amount of dry, tangled brush and debris. The river is visible in the background, and the sky is overcast.</p>
<p>RIMG2406.JPG</p>	
<p>02/15/2022 11:36 AM (ET)</p>	
<p>Andi Hodaj</p>	
<p>Coal loading and transfer area/Gavin Power Plant</p>	
<p>No CBI</p>	
<p>No PII</p>	
<p>The discharge from the pipe flowing on the banks of Ohio River.</p>

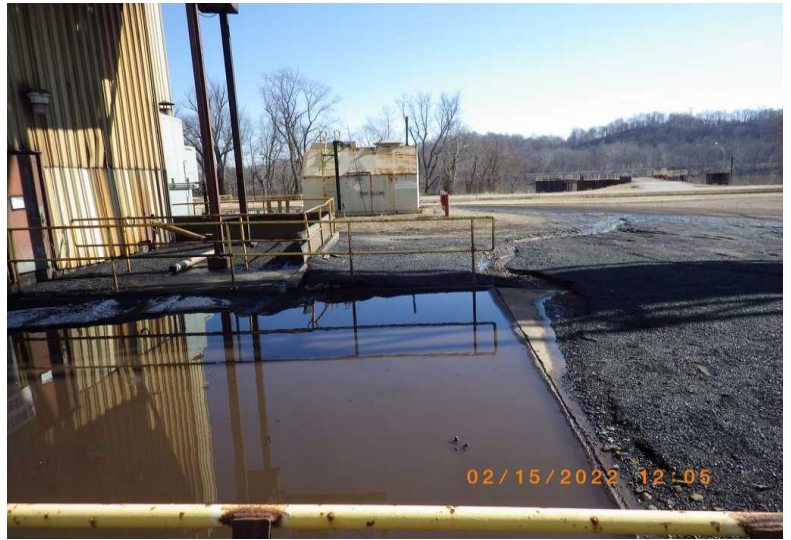
Overflowing sump at coal transfer station  
 RIMG2415.JPG  
 02/15/2022 12:05 PM (ET)  
 Andi Hodaj  
 Coal loading and transfer area/Gavin Power Plant  
 No CBI  
 No PII  
 The sump at coal transfer station 2 west was overflowing at the time of the inspection. It was flowing east towards the Ohio River and being captured by a catch basin before eventually flowing into Ohio River.

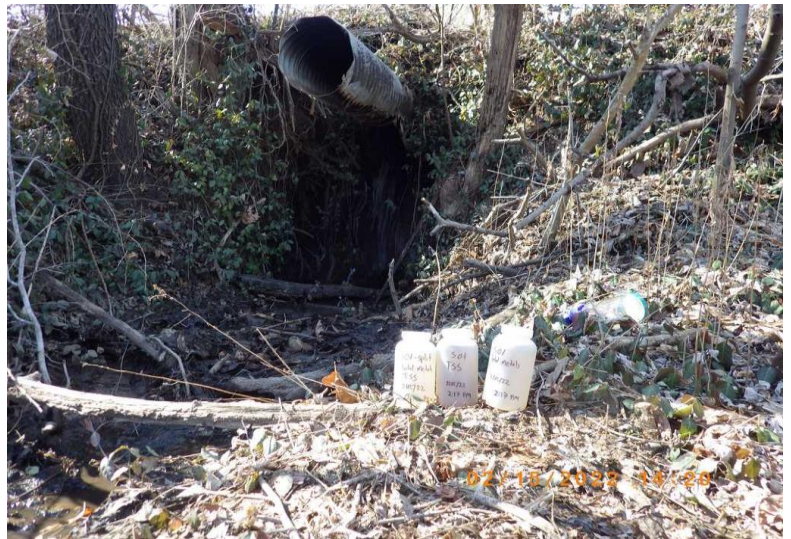
Samples taken from the discharging pipe  
 RIMG2417.JPG  
 02/15/2022 14:20 PM (ET)  
 Andi Hodaj  
 Coal loading and transfer area/Gavin Power Plant  
 No CBI  
 No PII  
 Samples taken by EPA from the discharging pipe. EPA gave Gavin a split sample.

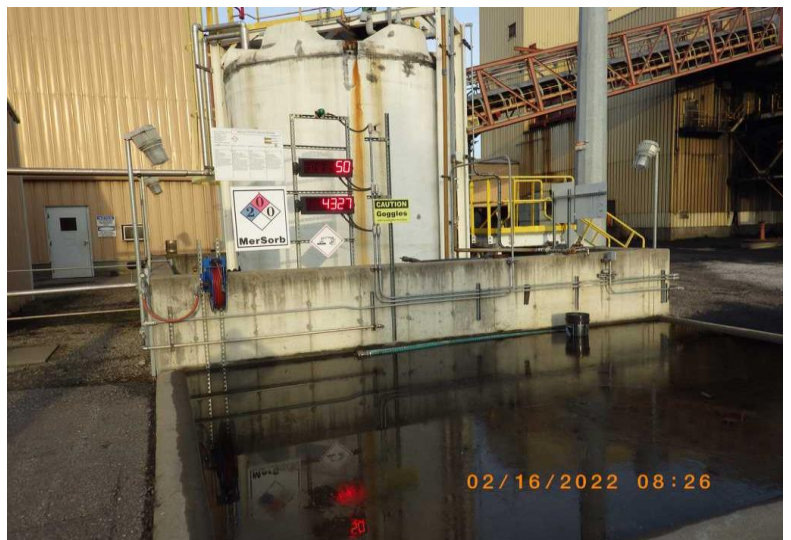
<p><b>Unit:</b> Coal yard area</p>	
<p><b>AH2-OB-006</b></p>	
<p>On February 16, 2022, EPA observed the sump containment pit of the Calcium Bromide tank at the coal treatment facility to be full of water. Overflowing water from this pit can reach Kyger Creek and the Ohio River through the stormwater catch basins. The Facility could not say at the time of the inspection where and how the sump pit was being managed. At the time of the inspection, EPA noticed an</p>	<p><b>Citation: NPDES Permit OH0028762 Part IV,C.4.</b></p>

Calcium Bromide tank  
 RIMG2431.JPG  
 02/16/2022 08:26 AM (ET)  
 Andi Hodaj  
 Coal loading and transfer area/Gavin Power Plant  
 No CBI  
 No PII  
 The Calcium Bromide tank's sump at the coal treatment facility was full at the time of the inspection.

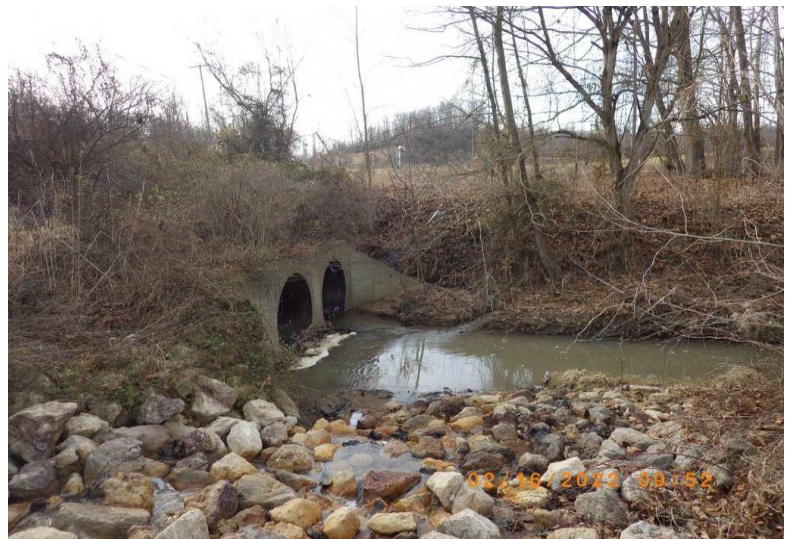
Runoff into Turkey Run  
 RIMG2444.JPG  
 02/16/2022 09:52 AM (ET)  
 Andi Hodaj  
 Landfill/Gavin Power Plant  
 No CBI  
 No PII  
 Runoff was entering Turkey Run on the opposite bank from where outfall 007 was discharging. The runoff was from a broken pipe at the landfill area that provided water for the dust suppression tree.

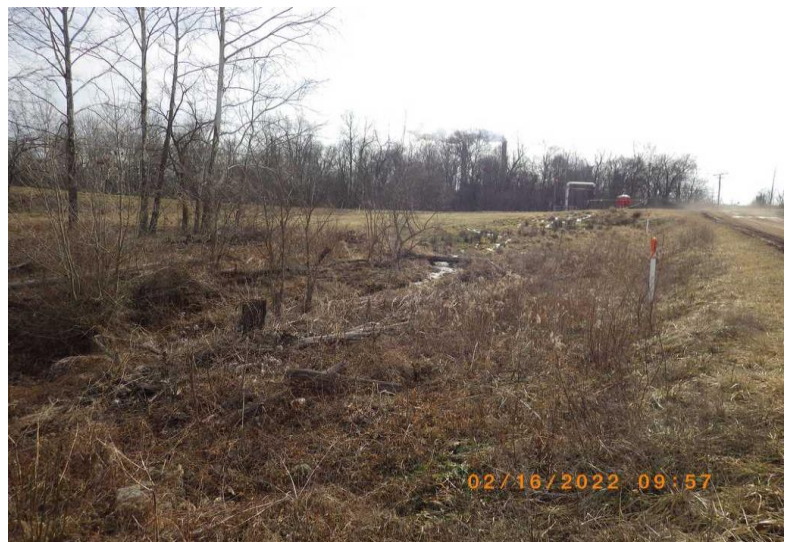
At the time of the inspection, EPA observed a discharge into Turkey Run at the landfill area. The discharge was of significant volume and resulted from an underground, broken pipe that was part of the piping system conveying Ohio River water to the landfill for dust suppression activities. The Facility could not tell when the discharge began. In a February 28, 2022, follow-up email, the Facility stated that it had installed a shut-off valve to stop the discharge and was evaluating plans for repairs of the underground pipe.

Runoff from the broken pipe at the landfill  
 RIMG2445.JPG  
 02/16/2022 09:57 AM (ET)  
 Andi Hodaj  
 Landfill/Gavin Power Plant  
 No CBI  
 No PII  
 Runoff from a broken pipe at the landfill flowing into Turkey Run.

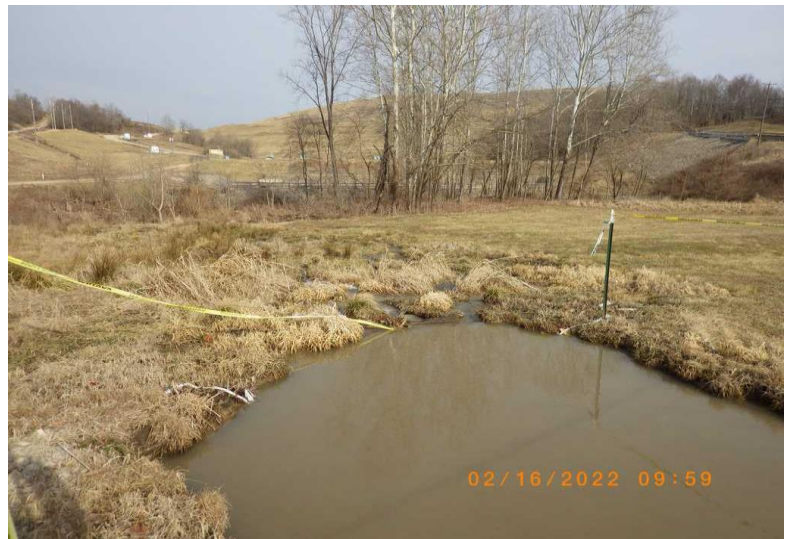
Broken pipe location at the landfill
RIMG2446.JPG
02/16/2022 09:59 AM (ET)
Andi Hodaj
Landfill/Gavin Power Plant
No CBI
No PII
Location of the underground broken pipe from where water was flowing into Turkey Run.

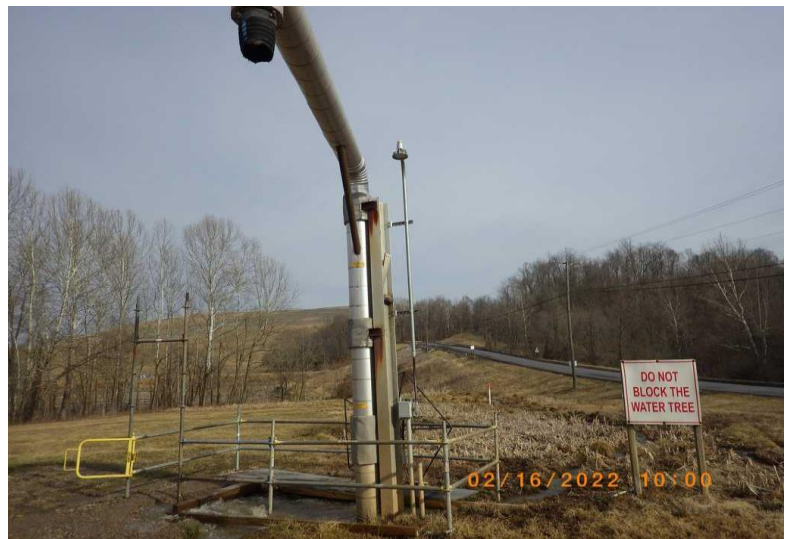
Dust suppression water tree
RIMG2447.JPG
02/16/2022 10:00 AM (ET)
Andi Hodaj
Landfill/Gavin Power Plant
No CBI
No PII
A dust suppression water tree at the landfill area. Trucks park under the water tree and fill the tank that is used for spraying.

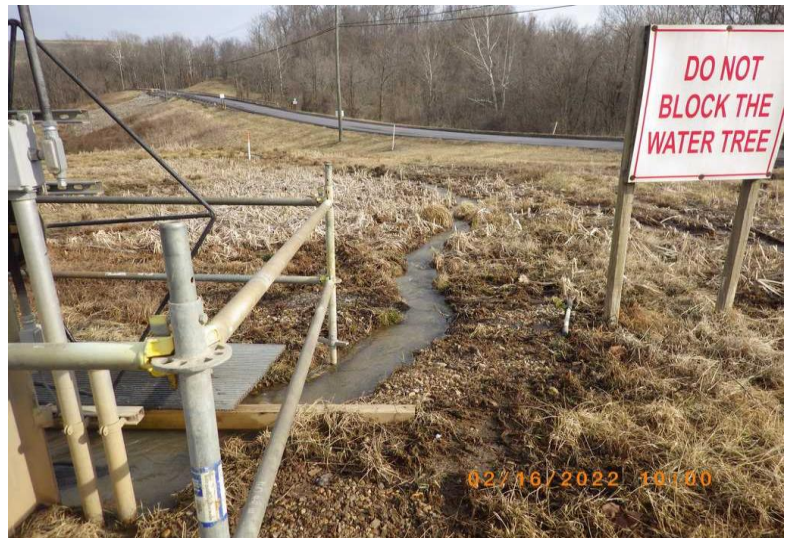
Channelized flow into Turkey Run
RIMG2448.JPG
02/16/2022 10:00 AM (ET)
Andi Hodaj
Landfill/Gavin Power Plant
No CBI
No PII
Flow from the broken pipe at the landfill has created a flow path to the Turkey Run.

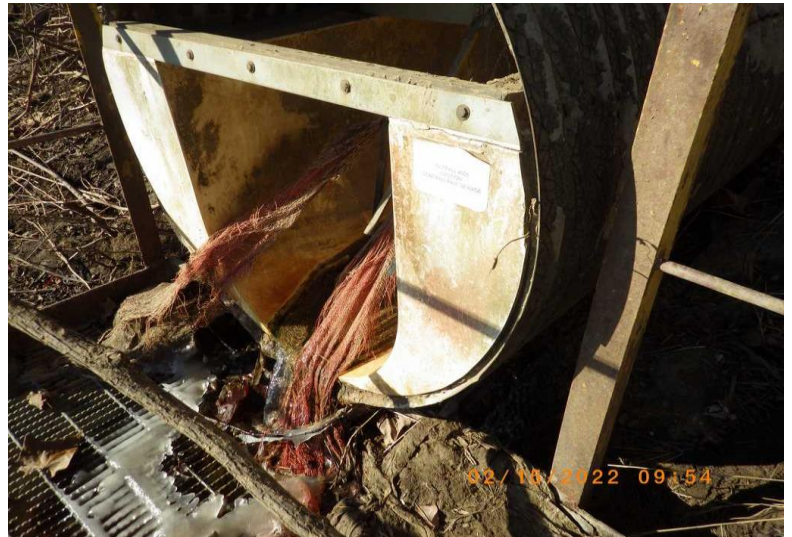
<p><b>Unit:</b> Lime loading area/Outfall 003</p>	
<p><b>AH2-OB-003</b></p>	
<p>According to the Facility, NPDES permitted Outfall 003 also discharges untreated sanitary sewage from the Village of Cheshire. This untreated sanitary sewage enters the Facility's stormwater sewer before discharging through Outfall 003.</p>	<p><b>Citations: Section 301(a) of the CWA, 33 U.S.C. § 1311(a), discharge of pollutants, from a point source without a permit to do so.</b></p>

Outfall 003
RIMG2376.JPG
02/15/2022 09:54 AM (ET)
Andi Hodaj
Lime loading area/Outfall 003/Gavin Power Plant
No CBI
No PII
Outfall 003 is permitted to discharge stormwater into Ohio River. However, untreated sewage is also being discharged through this outfall into Ohio River.

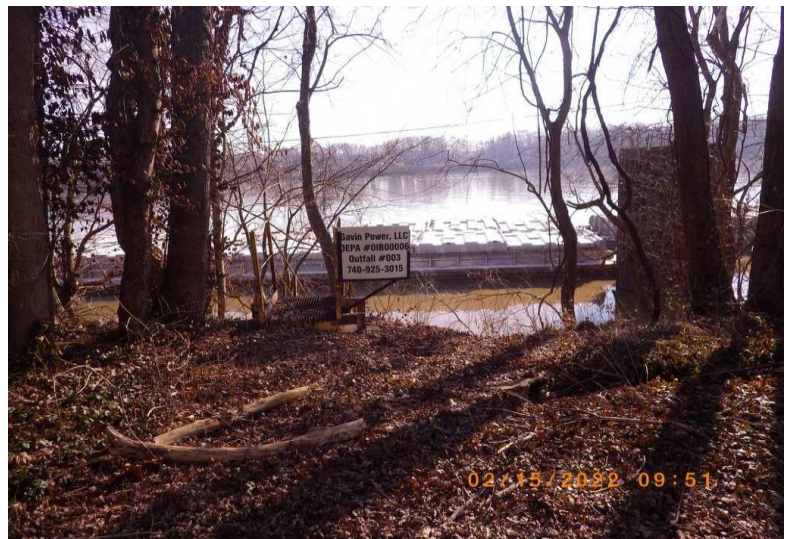
Outfall 003
RIMG2375.JPG
02/15/2022 09:51 AM (ET)
Andi Hodaj
Lime loading area/Outfall 003/Gavin Power Plant
No CBI
No PII
Signage for stormwater outfall 003. Outfall 003 discharges into Ohio River.

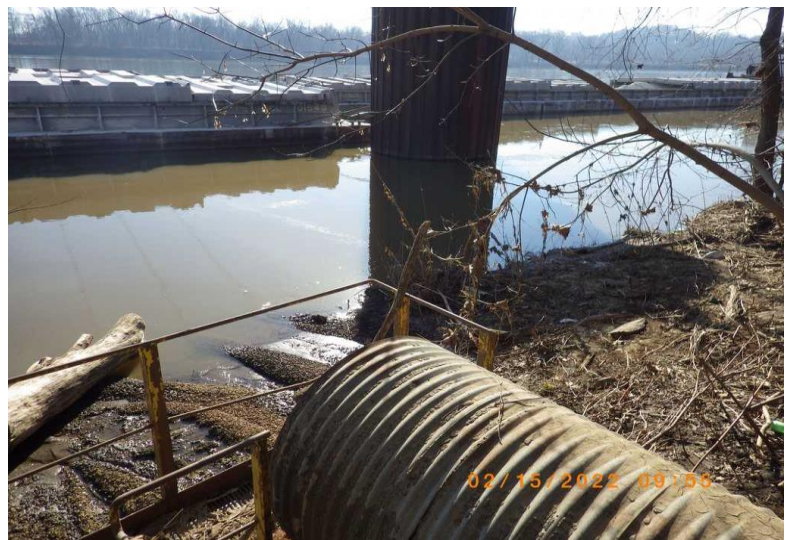
Outfall 003
RIMG2377.JPG
02/15/2022 09:56 AM (ET)
Andi Hodaj
Lime loading area/Outfall 003/Gavin Power Plant
No CBI
No PII
Stormwater Outfall 003 discharges into Ohio River. According to the Facility, in addition to stormwater from the plant, it also discharges untreated sewage from the village of Cheshire.

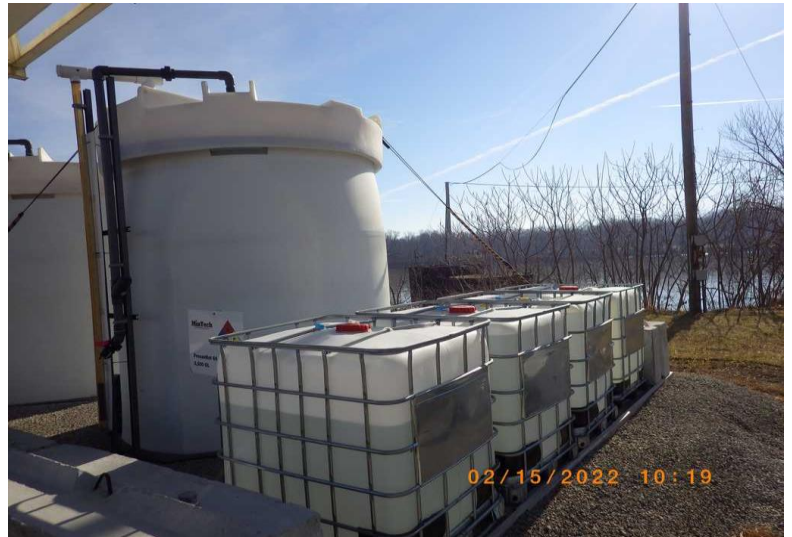
<b>AH2-OB-004</b>	
<p>EPA observed three containers with a dust suppressing material for the limestone dust generated from the lime transport from Ohio River to the plant, stored in an area next to the lime transfer dock and by the Ohio River. The name of the chemical is DUSTNOT SYN, a synthetic liquid that is sprayed on the roads for dust suppression instead of water. The containers were not in secondary containment.</p>	<p><b>Citation: NPDES Permit OH0028762 Part IV,C.4.</b></p>
<p><b>Unit:</b> Main plant area</p>	
<b>AH2-OB-005</b>	
<p>EPA observed multiple catch basins around the main plant area that captured stormwater runoff and conveyed it to the Ohio River through Outfalls 003, 004 and 005. EPA also observed sediment and coal ash around and within these catch basins. According to the Facility at the time of the inspection, stormwater from these catch basins is not treated prior to discharge into the Ohio River.</p>	<p><b>Citation: NPDES Permit OH0028762 Part IV,C.6.</b></p>

DUSTNOT SYN tanks
RIMG2380.JPG
02/15/2022 10:19 AM (ET)
Andi Hodaj
Lime loading area/Outfall 003/Gavin Power Plant
No CBI
No PII
Dust suppressing material for limestone dust generated from the lime transport from Ohio River to the plant, stored in an area next to the lime transfer dock and by the Ohio River.

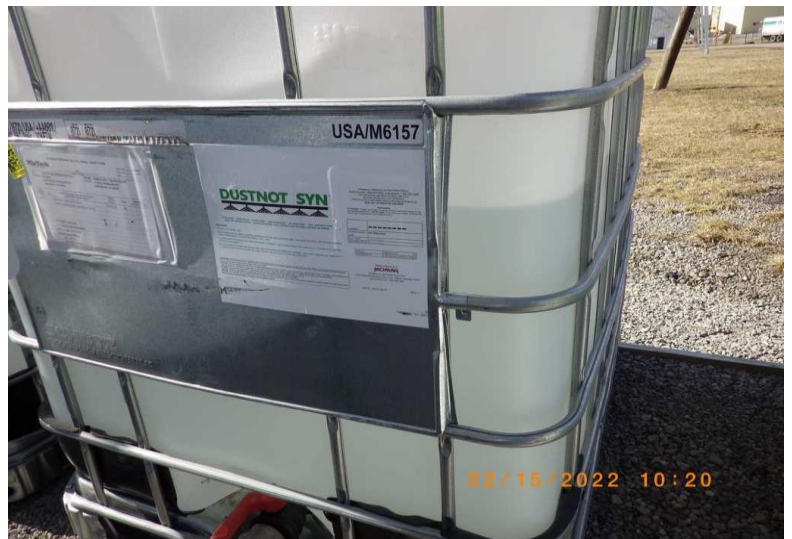
DUSTNOT SYN
RIMG2381.JPG
02/15/2022 10:20 AM (ET)
Andi Hodaj
Lime loading area/Outfall 003/Gavin Power Plant
No CBI
No PII
Label on one of the tanks containing the dust suppression chemical, DUSTNOT SYN.

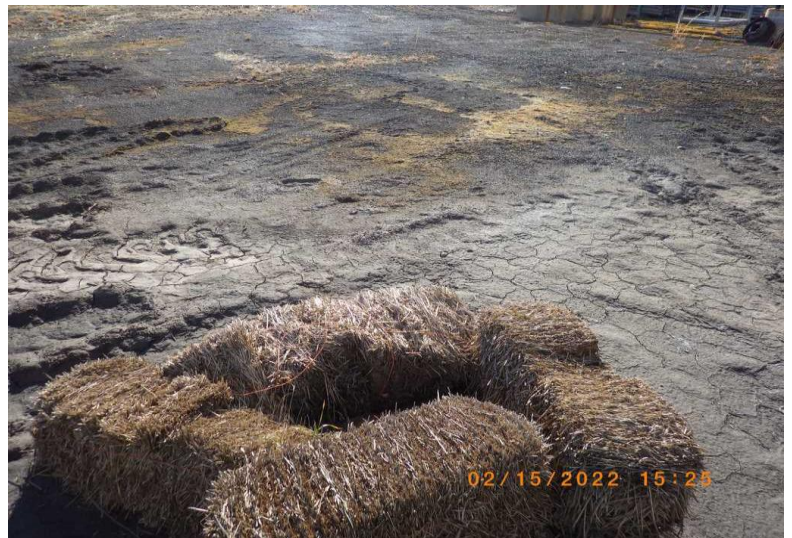
Throughout the inspection, EPA observed multiple catch basins around the main plant area that captured stormwater runoff and conveyed it to the Ohio River through Outfalls 003, 004 and 005. EPA also observed sediment and coal ash around and within these catch basins. According to the Facility, stormwater from these catch basins is not treated prior to discharge into the Ohio River. At the time of the inspection the Facility had placed hay bales around some of the catch basins to prevent material from going into them; however some did not have any hay bales and others had hay bales moved to the side. The Facility had placed signage next to a few of these catch basins, indicating that these basins drain into the Ohio River to raise awareness among the employees. In a February 28, 2022, follow-up email, the Facility stated that it had contacted a third-party to clean the catch basins and install more protective measures.

Stormwater catch basin
RIMG2426.JPG
02/15/2022 15:25 PM (ET)
Andi Hodaj
Main plant area/Gavin Power Plant
No CBI
No PII
Stormwater catch basin at the main plant area that discharges runoff into the Ohio River via outfall 005. Facility had placed hay bales around the catch basin cover to prevent solids from entering the catch basin.

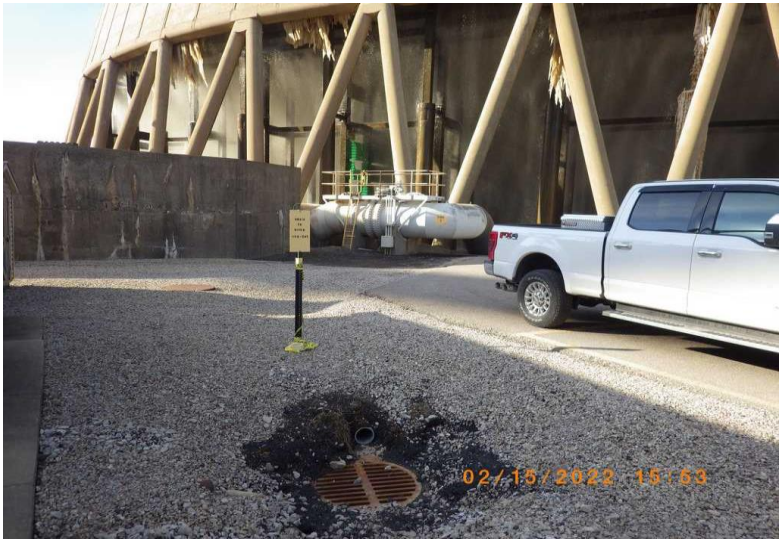
RIMG2427.JPG	
02/15/2022 15:53 PM (ET)	
Andi Hodaj	
Main plant area/Gavin Power Plant	
No CBI	
No PII	
Stormwater catch basin next to one of the cooling towers that discharges into Ohio River through outfall 004. Facility had placed signage next to the basin to raise awareness among its employees.
