## Region 6 - Enforcement & Compliance Assurance Division

### INSPECTION REPORT

| Company Name: | CapturePoint, LLC | |
| Facility Name: | North Burbank Unit (NBU) 31 Battery | |

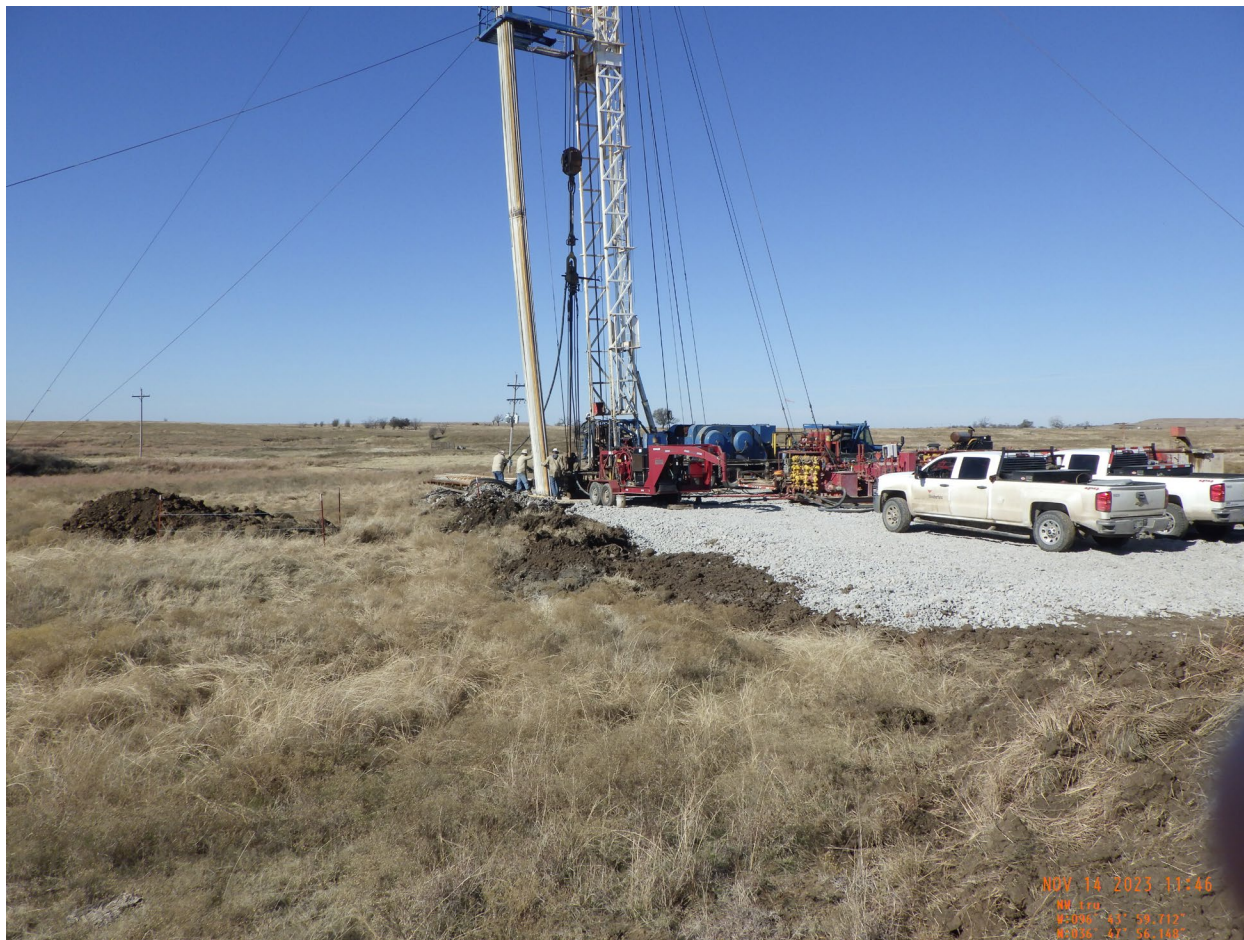
Photo No. 1

I observed the release point of the spill which was well NBU 49-31. At the time of the inspection there was a workover rig present on the well. At the time of the inspection, inspector maintained a safe distance from the release point due to the ongoing well workover. NBU 49-31 and the workover rig can be seen in photo No.1 of appendix 1 (photo log) which is attached to this report. For GPS location information and additional meta data, please see the photo log.

**Description:** This was a photo of a workover rig on well NBU 49-31. This was the release point of the spill. At the time of the inspection the operator was working to repair the casing leak in the well.

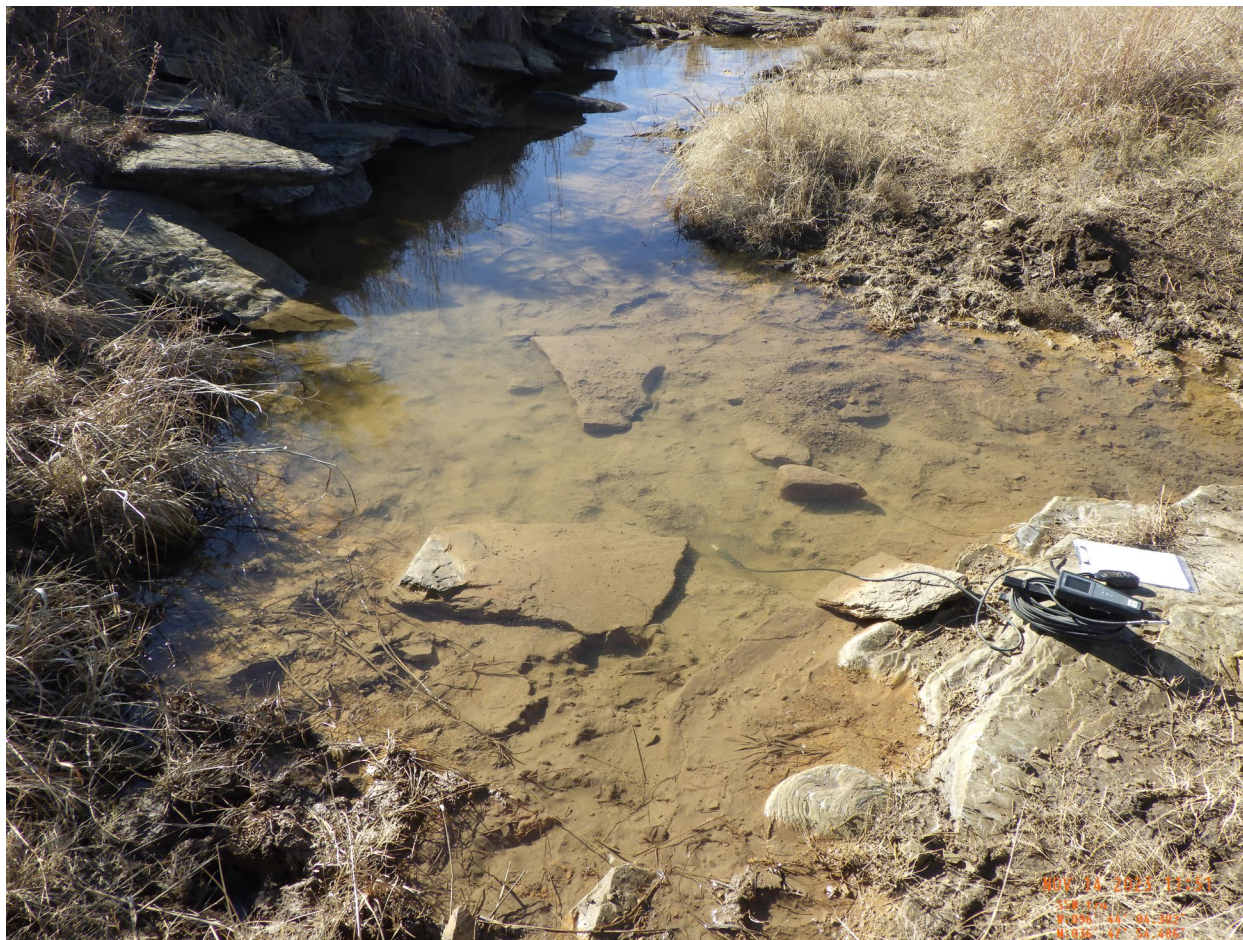
Photo No. 2

**Description:** This was the Point of Entry (POE) into Mud Creek.

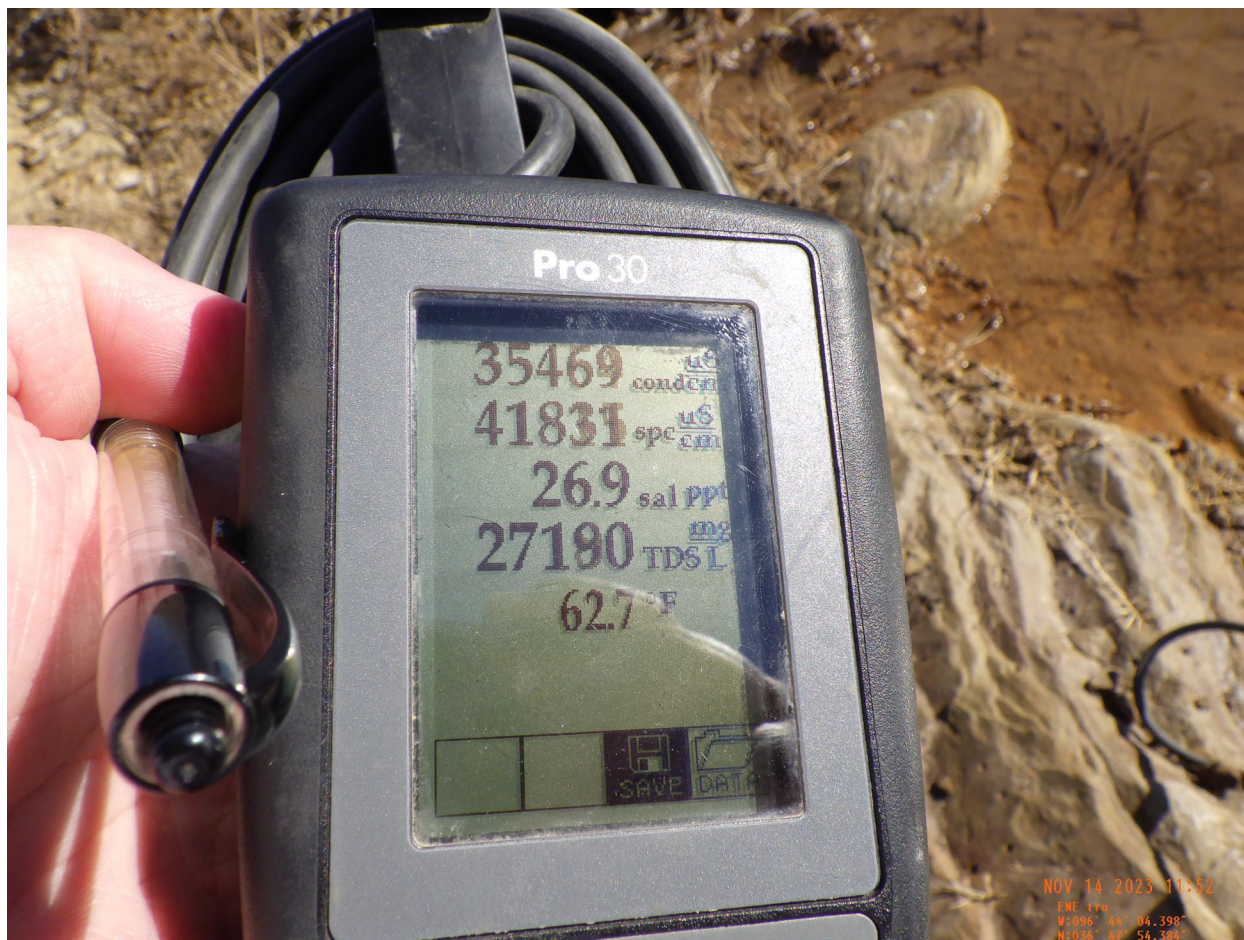
Photo No. 3

I observed the Point of Entry (POE) into Mud Creek. At the same location I observed an elevated Total Dissolved Solids (TDS) field reading of 27,190 mg/L, this was the highest TDS reading observed during the inspection. The POE and associated field reading can be seen in Photos No. 2 and 3 of the photo log. All TDS field readings observed during the inspection were taken with a properly calibrated YSI Pro 30 Conductivity Meter.

**Description:** This was an elevated TDS field reading of 27,190 mg/L observed at the POE into Mud Creek. This was the highest TDS level observed during the inspection.

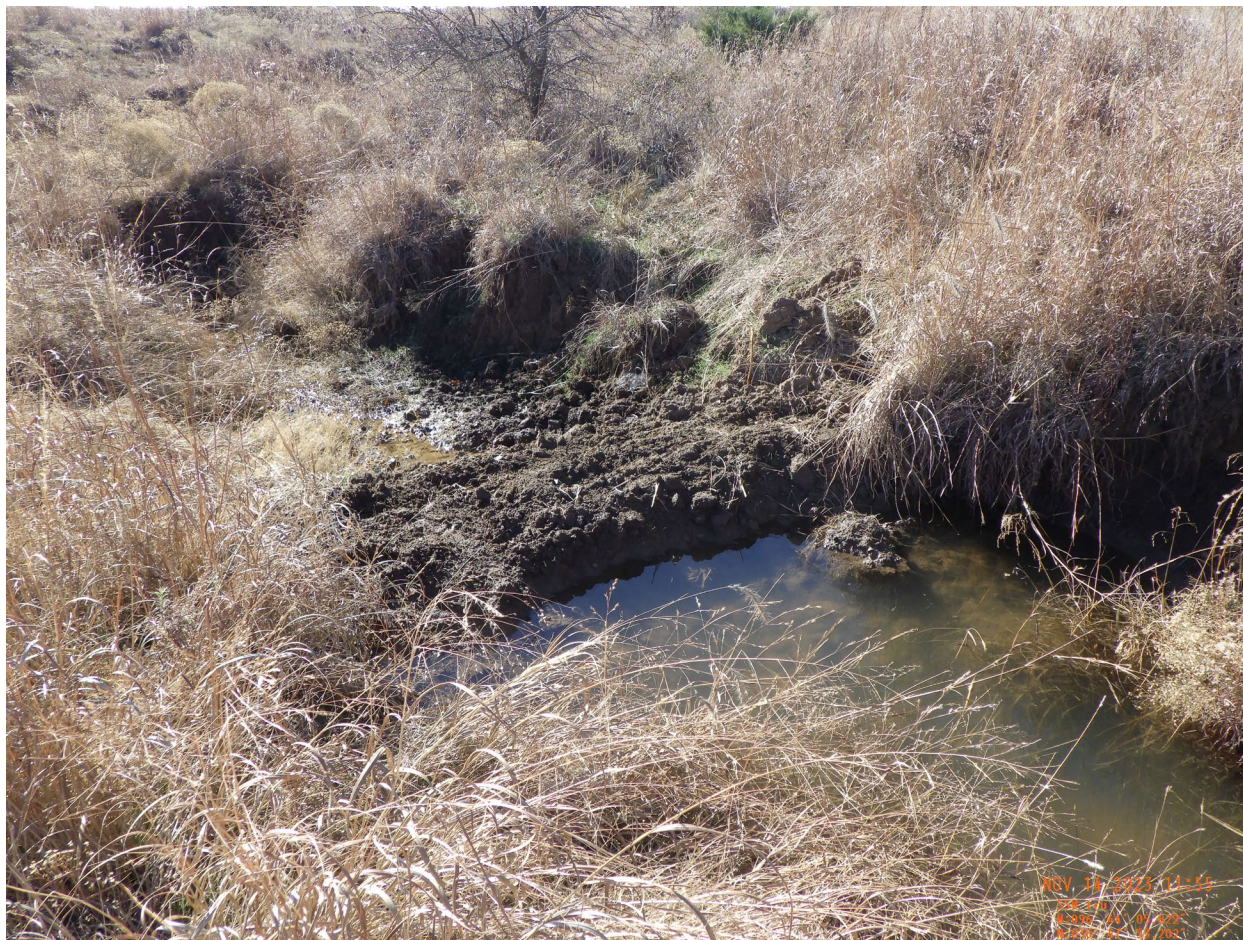
Photo No. 4

I observed a temporary containment dam which had been placed by the operator to prevent downstream migration of impacted waters. At the same location I observed an elevated TDS field reading of 9,189 mg/L. The dam and associated TDS observation are documented in photos No. 4 and 5 of the photo log.

**Description:** This was the first temporary downstream containment dam placed by the operator to prevent further downstream migration of impacted waters.

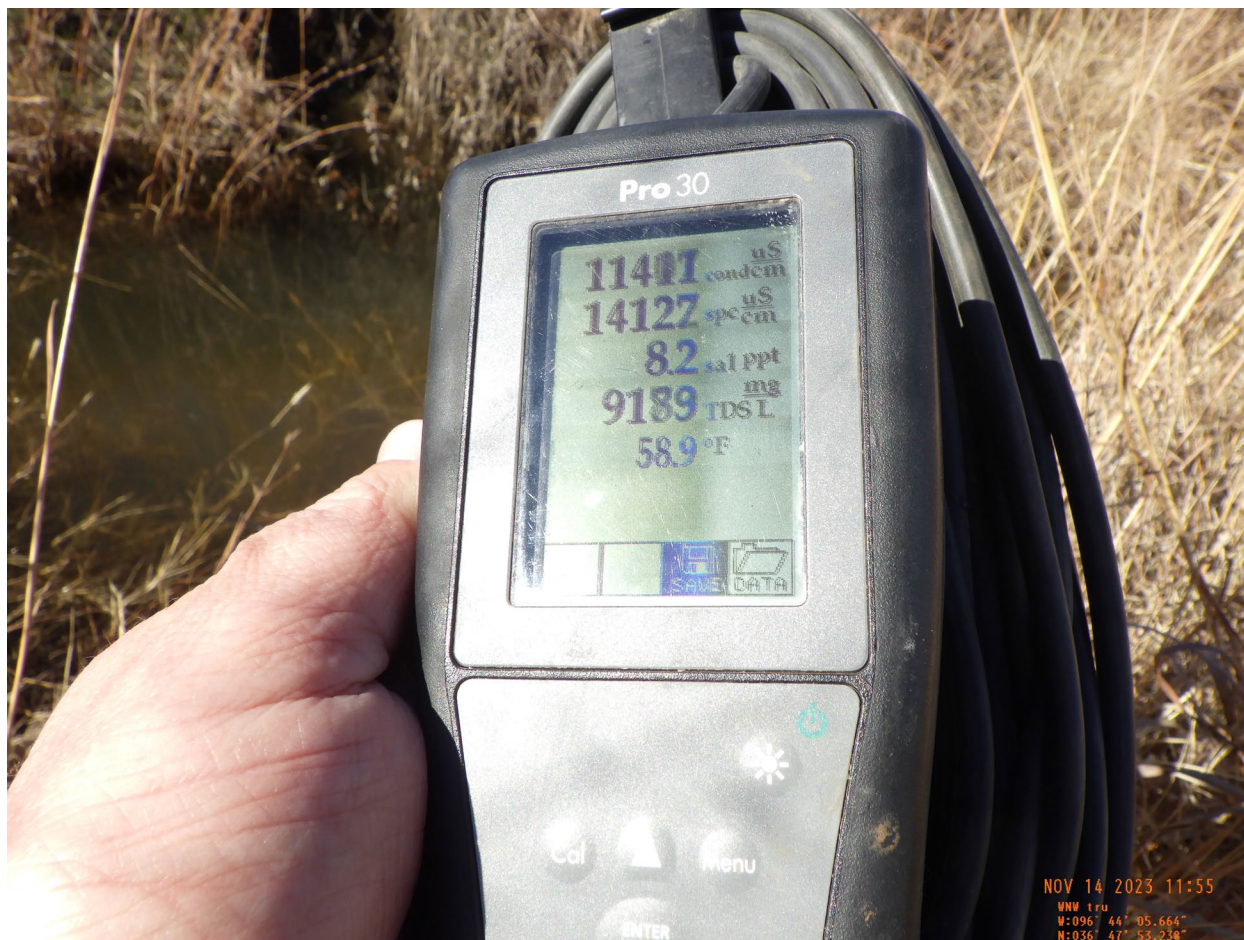
Photo No. 5

**Description:** This was an elevated TDS field reading of 9,189 mg/L. This was taken in the main channel of the impacted stream, immediately upstream from the first temporary containment dam.

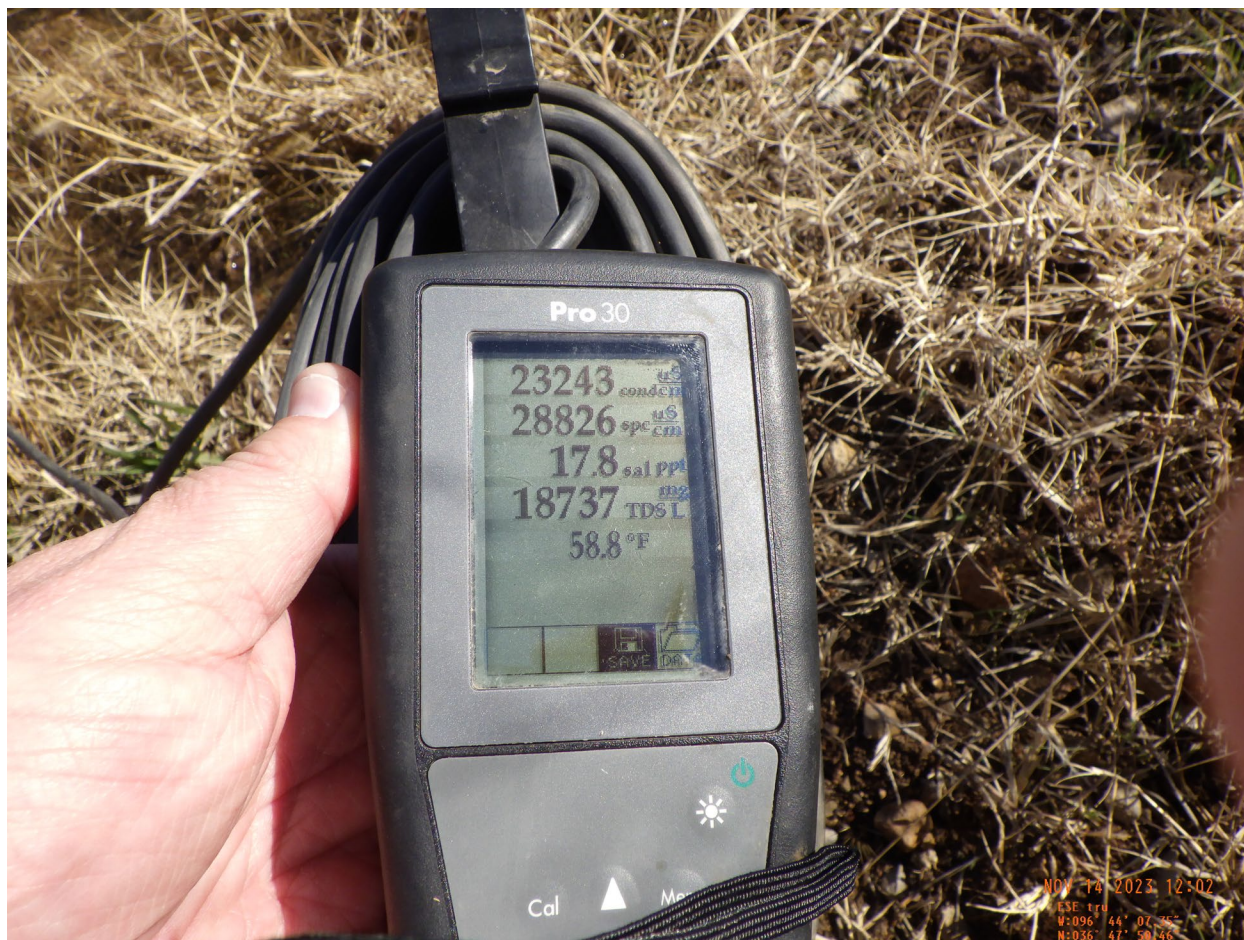
Photo No. 6

Continuing downstream, I observed the 2<sup>nd</sup> temporary containment dam and a TDS field reading of 18,737 mg/L. These observations can be seen in Photos No. 6 and 7.

**Description:** This was an elevated TDS field reading of 18,737 mg/L taken in the main channel of the impacted stream, immediately above the 2<sup>nd</sup> temporary containment dam.

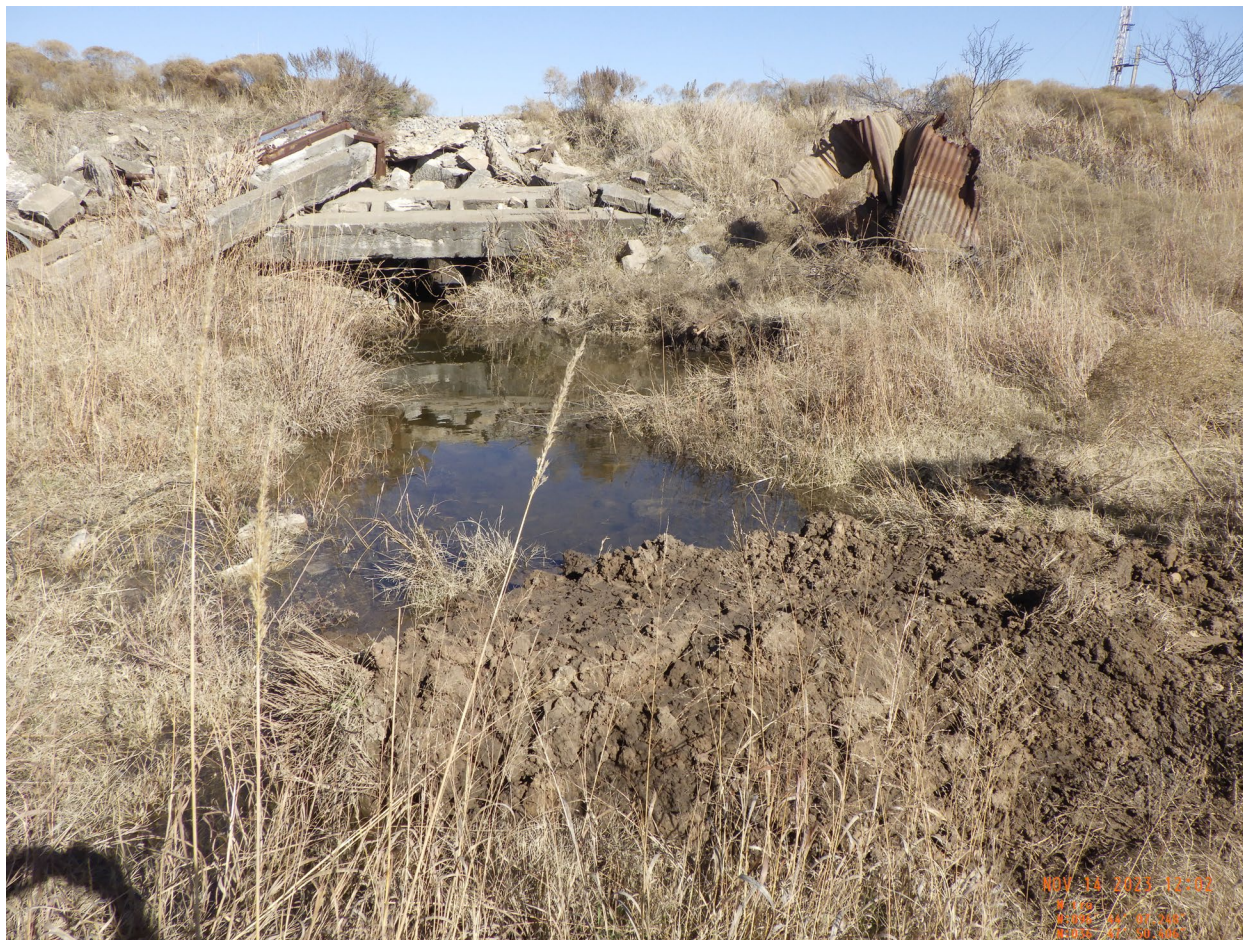
Photo No. 7

**Description:** This was the 2<sup>nd</sup> temporary containment dam at the time of the inspection.

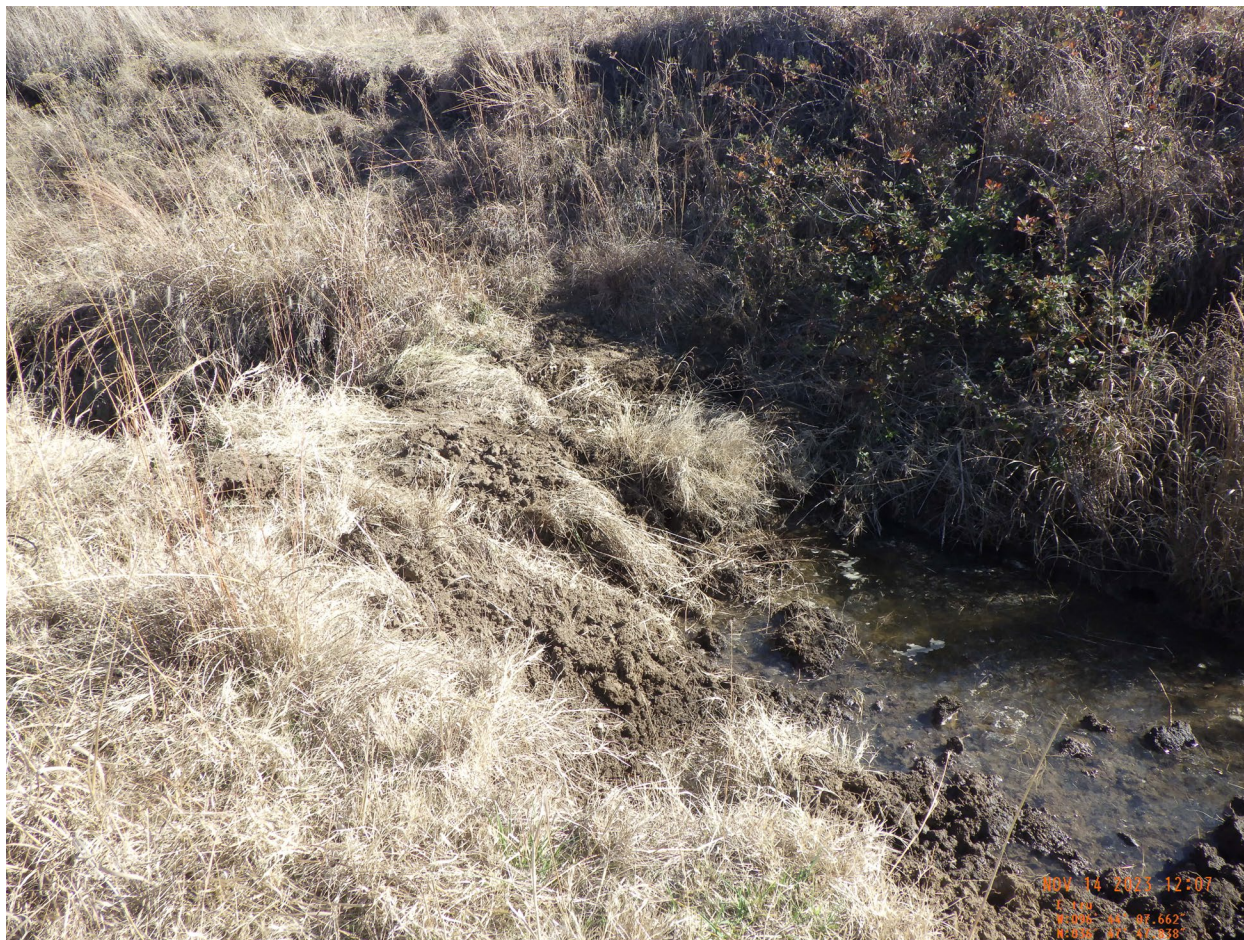
Photo No. 8

Further downstream I observed the 3<sup>rd</sup> temporary containment dam which is documented in Photo No. 8.

**Description:** This was the 3<sup>rd</sup> temporary containment dam placed by the operator to prevent further downstream migration of elevated TDS waters.

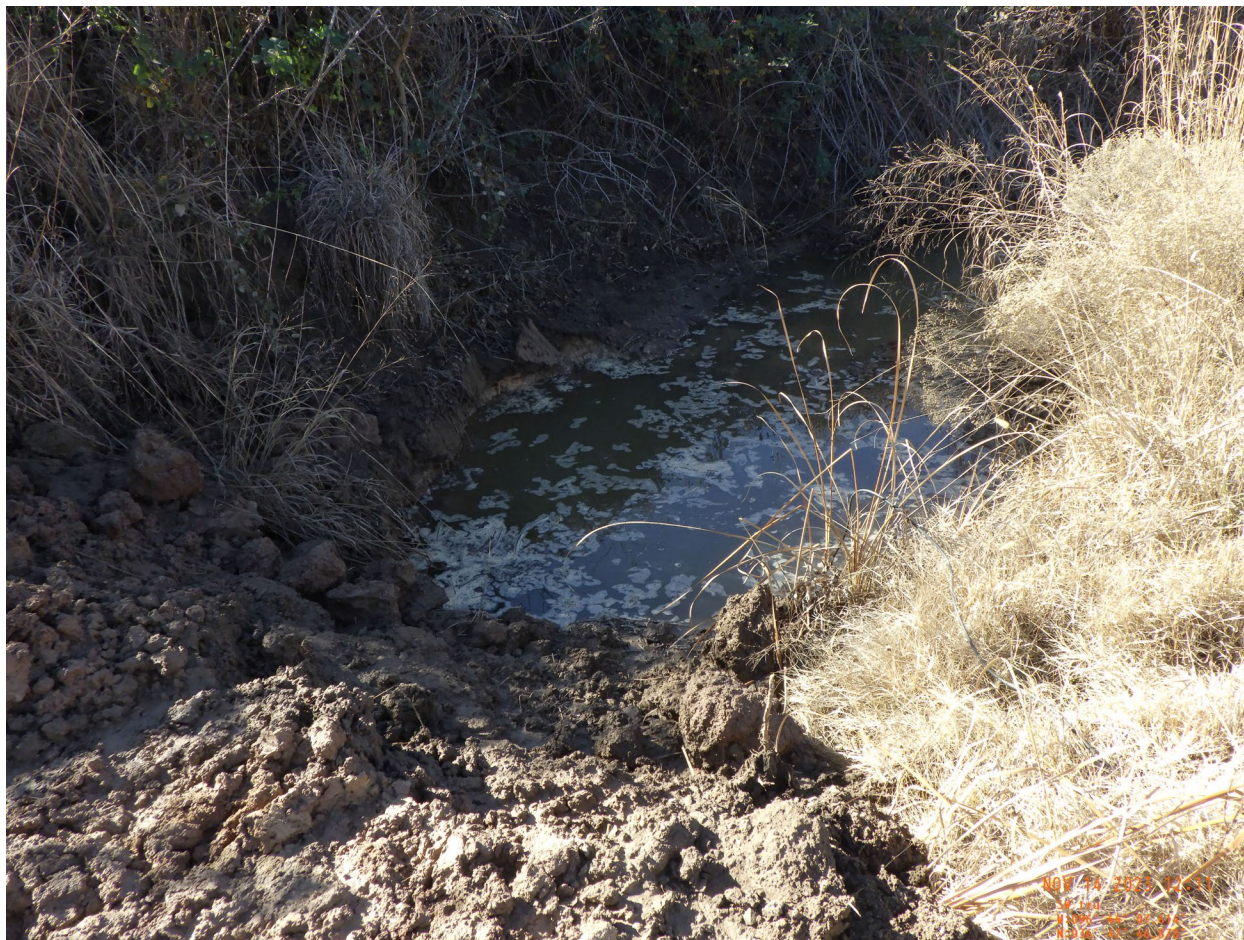
Photo No. 9

**Description:** This was the 4<sup>th</sup> and lowermost temporary containment dam placed by the operator. The dam was properly placed and was preventing downstream migration of impacted waters. The impacted streambed was dry downstream from this dam at the time of the inspection.

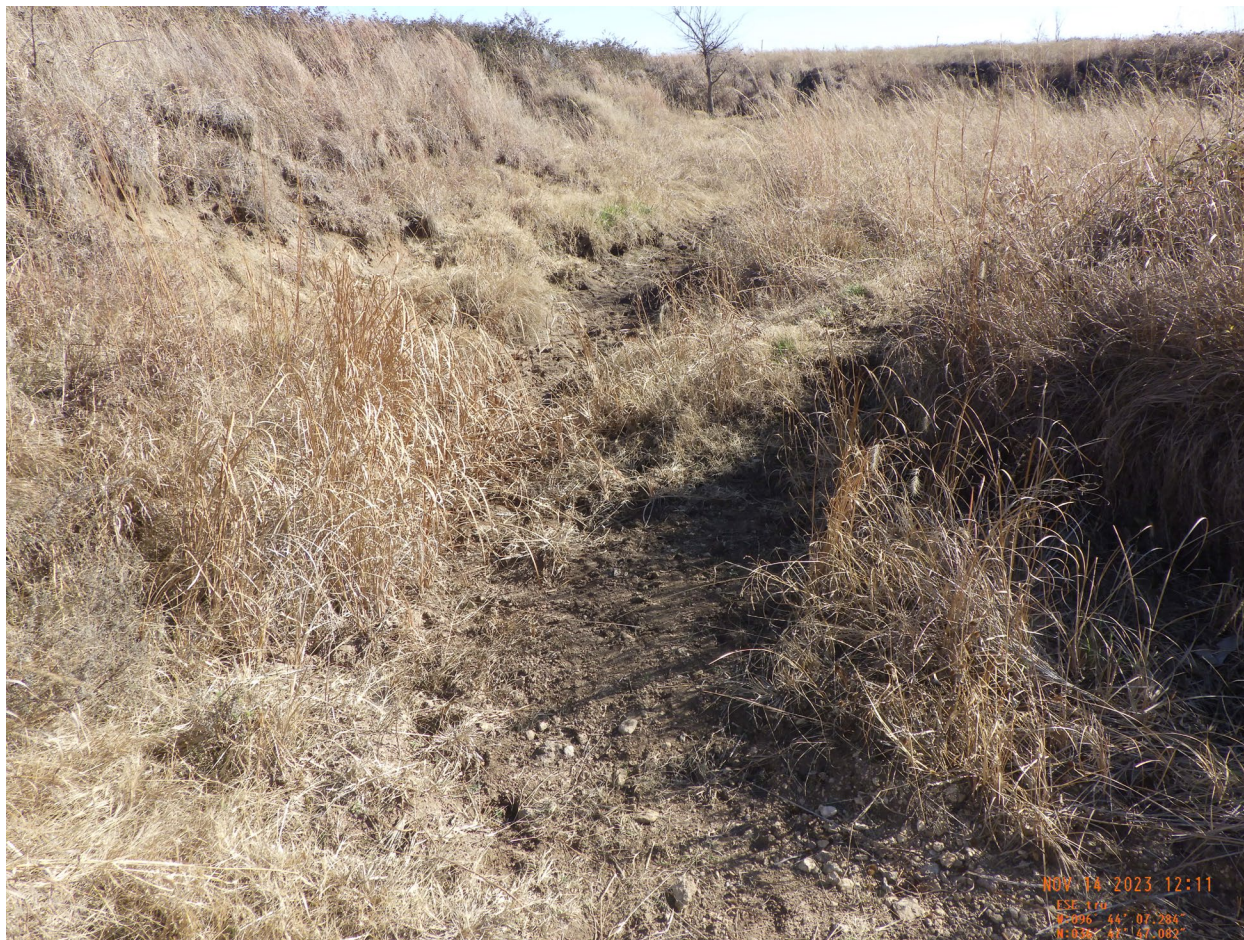
Photo No. 10

**Description:** This was a photo of the dry main channel of the impacted stream downstream from the 4<sup>th</sup> temporary containment dam.

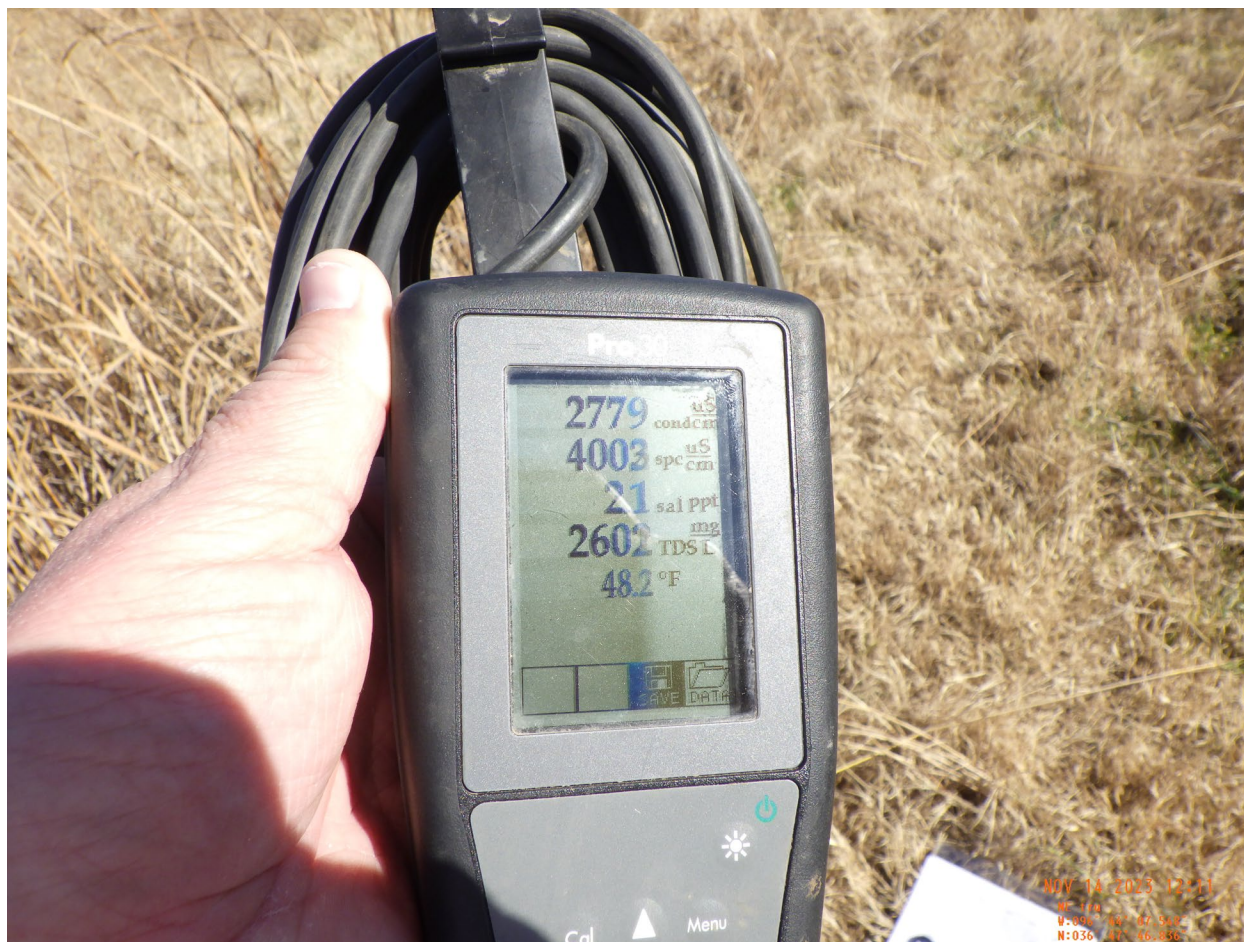
Photo No. 11

I observed the 4<sup>th</sup> and final temporary containment dam which can be seen in Photo No. 9. I observed an elevated TDS field reading of 2,602 mg/L on the upstream side of the dam which can be seen in Photo No. 11. At the same location I observed the dry bed of the impacted creek behind the 4<sup>th</sup> and final dam, see Photo No. 10. There were no additional downstream spill impacts to document.

**Description:** This was an elevated TDS field of 2,602 mg/L reading taken immediately upstream from the 4<sup>th</sup> temporary containment dam.
