**UNITED STATES ENVIRONMENTAL PROTECTION AGENCY REGION 2**  
**Enforcement and Compliance Assurance Division**  
**Region 2 Water Compliance Branch**  
**Clean Water Act (CWA) Inspection Report**

| <b>Program:</b> Industrial Individual Permit | <b>Inspection Type:</b> Compliance Evaluation Inspection |
| <b>Permittee Name:</b> Finch Paper, LLC | <b>NPDES/ICIS No.:</b> NY0005525 |
| <b>Inspection Entry Date:</b> April 25, 2024<br><b>Inspection Entry Time:</b> 9:30 AM | <b>Inspection Exit Date:</b> April 26, 2024<br><b>Inspection Exit Time:</b> 4 : 3 0 P M |

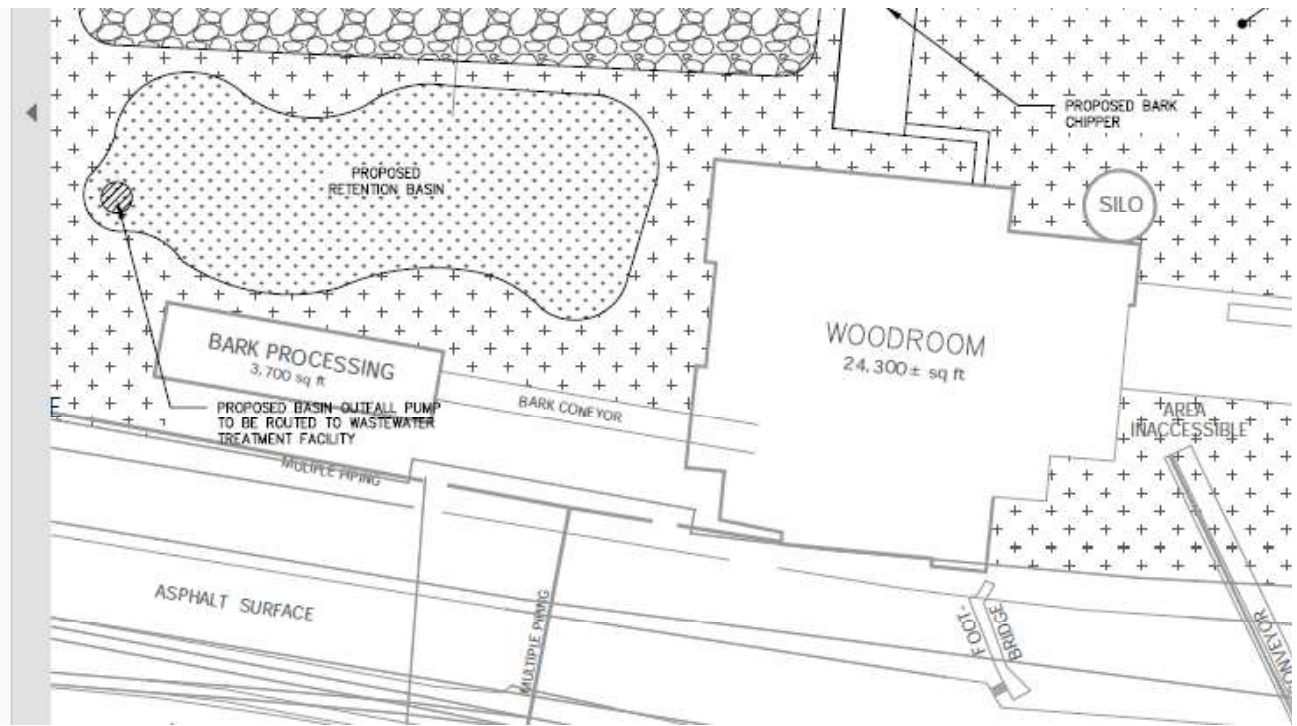
- a. There were material storage piles south of the bark processing facility near the feeder canal as shown in Photo DSCN4123 ("123"). During the inspection the Facility began removing the woody material back inside the bark storage area berm. The wood room area, inside the berms, was said to have a sump and pump station to pump water from this area into the wastewater treatment system. Note that stormwater outside of the berm such as in the photos 123 and 126 (Att. 1) would not be collected in the sump and pump station. The 2019 BMP Plan states that the 2023 SWPPP should be referred to for Best Management Practices pertaining to Stormwater Discharges in this area. The SWPPP does not identify wood or bark storage south of the of the debarker, or southwest of the wood room, as shown in the SWPPP Site Map below.

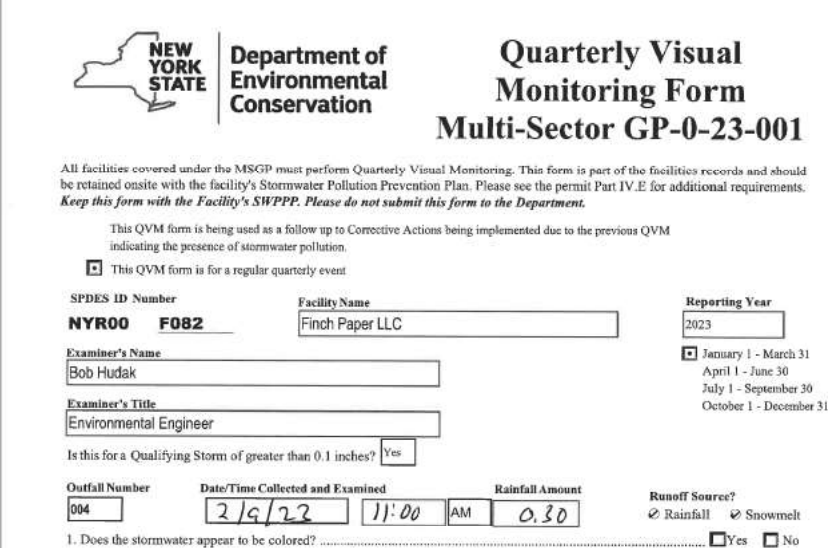
20. Finch submitted Quarterly Visual Monitoring Reports for 2023 for MSGP outfalls 003 and 004. The Forms are labelled with the Permit NYR00F082, however Finch's MSGP Permit ID No. is NYR00F582.

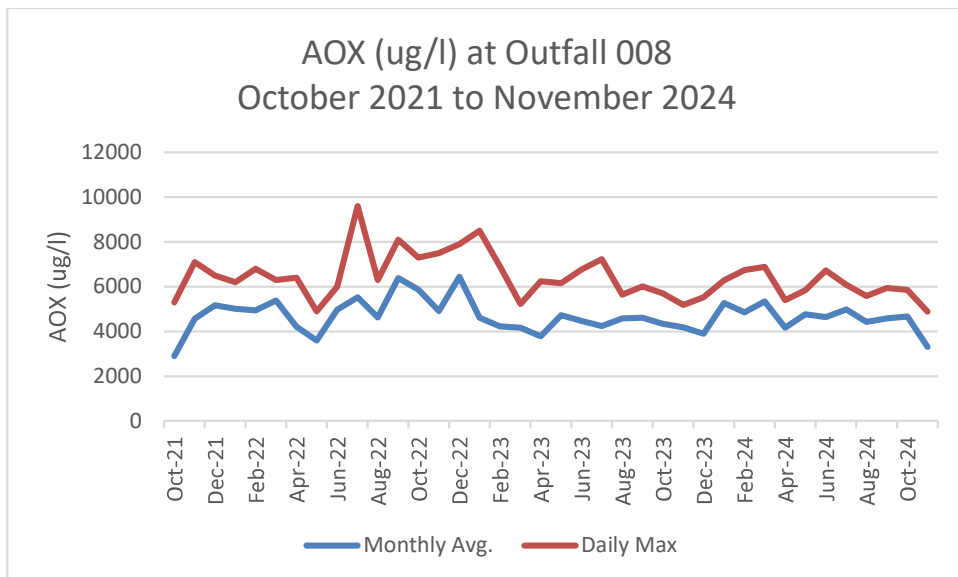
- a. The Facility is conducting daily Adsorbable Organic Halides ("AOX") monitoring as required by the Permit and 40 CFR §430, Subpart E. There are currently no effluent limits or action levels associated with AOX contained in the Permit. The Facility was interested in reducing its monitoring frequency for AOX to reduce costs. 40 CFR §430.02, Monitoring Requirements, contains procedures for obtaining reduction in monitoring frequencies for parameters required by 40 CFR§430. The figure below shows AOX monthly average and daily maximum data for the period October 2021 to November 2024.
