INSPECTION REPORT

<b>Inspection Entry Date/Time</b>	12/13/2022 08:00 AM (ET)	Announced: No	
<b>Inspection Exit Date/Time</b>	12/13/2022 02:05 PM (ET)	Access: Granted	
<b>Weather</b>	Cloudy		
<b>Media</b>	Water		
<b>Statute(s)/Program(s)</b>	Clean Water Act, National Pollutant Discharge Elimination System (NPDES), Industrial		
<b>Type of Inspection</b>	CEI - Compliance Evaluation Inspection		
<b>Permittee Name</b>			
Eramet Marietta Metallurgical Plant			
<b>Facility or Site Name</b>			
Eramet Marietta Metallurgical Plant			
<b>Facility/Site Physical Address</b>			
16705 Rt 7 South, Riverview			
<b>City, State, Zip Code</b>			
Marietta, Ohio 45750			
<b>County/Borough/Parish</b>			
Washington County			
<b>Facility GPS Coordinates</b>

## Eramet Marietta Metallurgical Plant

Inspection Date: December 13, 2022

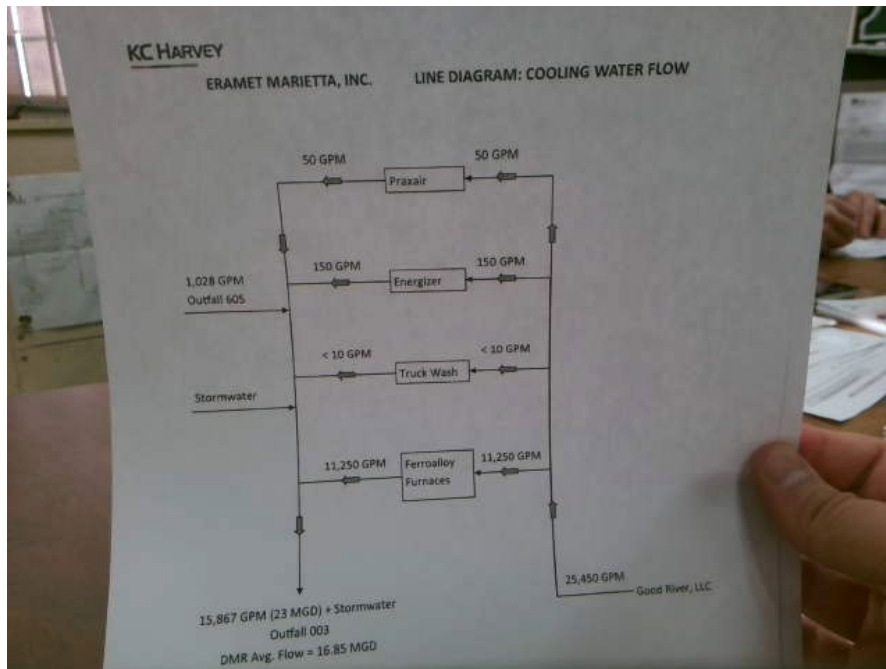
Line Diagram: cooling water flow		
<b>Photo(s)</b>		
1. <a href="#">IMG-20221213095642564294117.jpg</a>		
<b>Record:</b> Process Description/Flow Diagram		<b>AOC:</b> No
<b>Ref #:</b> JB4-RR-001	<b>Reviewed By:</b> Jake Berger	<b>Reviewed Date:</b> 12/13/2022
Industrial process wastewater flows		
<b>Photo(s)</b>		
1. <a href="#">IMG-2022121309520452490124.jpg</a>

Diagram of Cooling Water Flow	IMG-20221213095642564294117.jpg	
12/13/2022 09:56 AM EST	Photographer: Jake Berger	
	No CBI	No PII

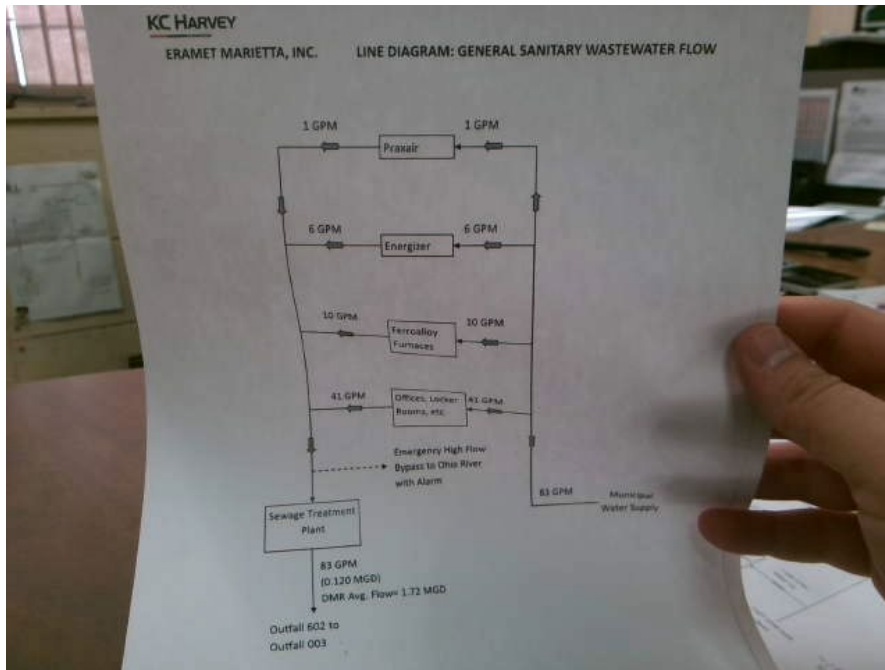
Reviewed Quarterly Visual Stormwater Assessments to satisfy NPDES permit requirements.		
<b>Record:</b> Process Description/Flow Diagram	<b>AOC:</b> No	
<b>Ref #:</b> JB4-RR-003	<b>Reviewed By:</b> Jake Berger	<b>Reviewed Date:</b> 12/13/2022
Line Diagram: General sanitary wastewater flow		
<b>Photo(s)</b>

Diagram of General Sanitary Wastewater Flow	IMG-20221213095800580103364.jpg	
12/13/2022 09:58 AM EST	Photographer: Jake Berger	
	No CBI	No PII

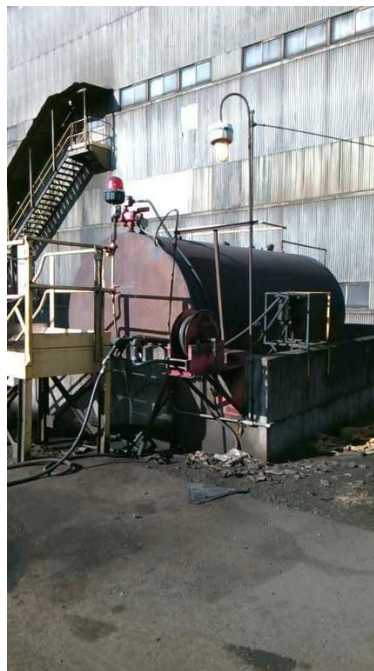
ERAMET MARIETTA METALLURGICAL PLANT		
<b>Observation #:</b> JB4-OB-008	<b>Date:</b> 12/13/2022	<b>Weather:</b>
Diesel refueling tank with containment		
<b>Photo(s)</b>		
1. <a href="#">IMG-202212131227292729591548.jpg</a>

Diesel refueling tank	IMG-202212131227292729591548.jpg	
12/13/2022 12:27 PM EST	Photographer: Jake Berger	
	No CBI	No PII

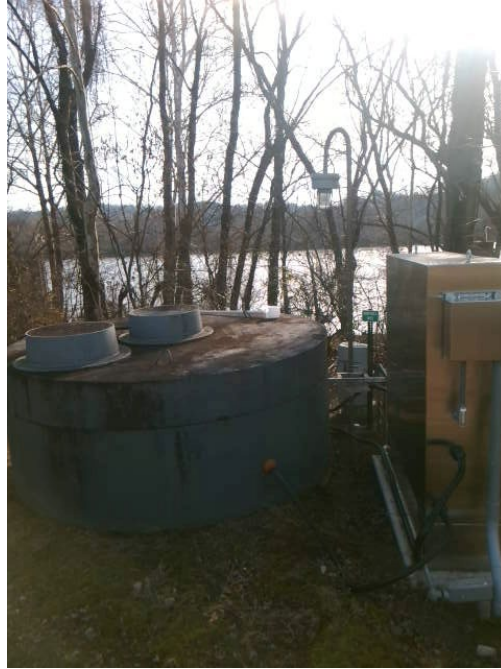
IMG-202212131124142414209316.jpg	
12/13/2022 11:24 AM EST	Photographer: Jake Berger	
Outfall 003	No CBI	No PII

<b>Observation #:</b> JB4-OB-002	<b>Date:</b> 12/13/2022	<b>Weather:</b>
Sampling location for Outfall 003, including monitoring for chlorine and pH. Flow rate at 003 is calculated as the sum of GRD (Good River Distribution) intake for Eramet + flow at 605 + flow at 602 + flow at 603.		
<b>Photo(s)</b> 1. <a href="#">IMG-202212131124142414209316.jpg</a>

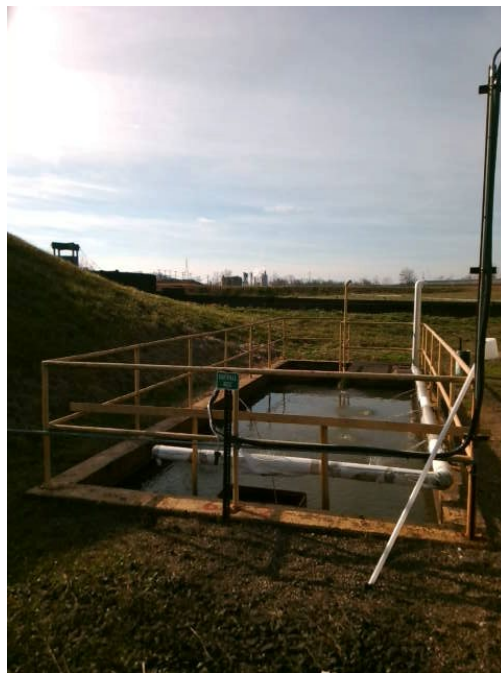
IMG-202212131132143214199766.jpg	
12/13/2022 11:32 AM EST	Photographer: Jake Berger	
Outfall 602	No CBI	No PII

<b>Location:</b> Outfall 602		
<b>Observation #:</b> JB4-OB-003	<b>Date:</b> 12/13/2022	<b>Weather:</b>
Sampling location for 605, acting as a clarifier, which then flows to 003.		
<b>Photo(s)</b> 1. <a href="#">IMG-202212131132143214199766.jpg</a>

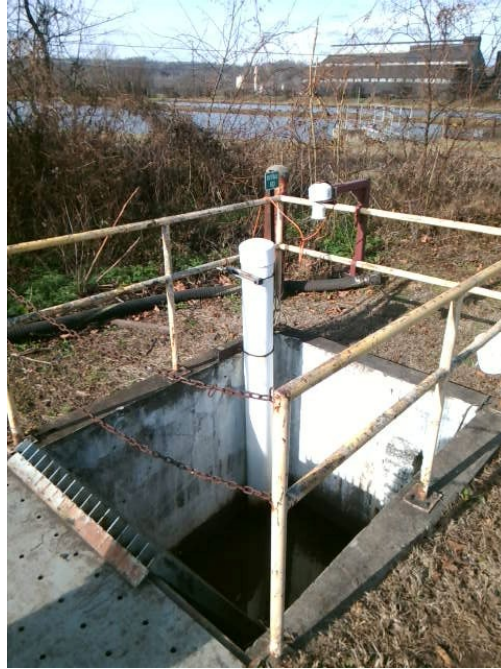
IMG-202212131143534353288116.jpg	
12/13/2022 11:43 AM EST	Photographer: Jake Berger	
Outfall 603	No CBI	No PII

<b>Location:</b> Outfall 603		
<b>Observation #:</b> JB4-OB-004	<b>Date:</b> 12/13/2022	<b>Weather:</b>
Outfall 603, containing scrubber recycle water.		
<b>Photo(s)</b> 1. <a href="#">IMG-202212131143534353288116.jpg</a>

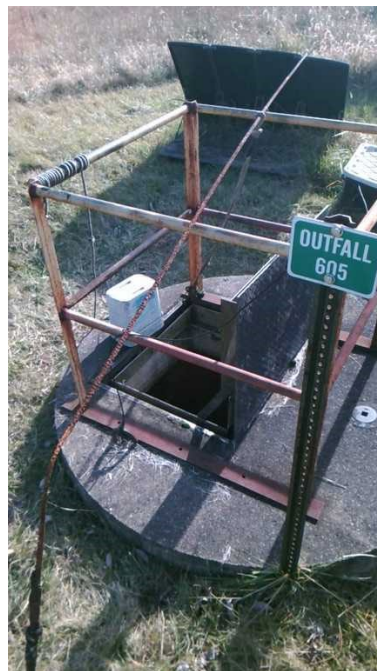
IMG-20221213120353353677965.jpg	
12/13/2022 12:03 PM EST	Photographer: Jake Berger	
Outfall 605	No CBI	No PII

<b>Location:</b> Outfall 605		
<b>Observation #:</b> JB4-OB-006	<b>Date:</b> 12/13/2022	<b>Weather:</b>
Outfall 605, flow monitoring and composite sampling		
<b>Photo(s)</b> 1. <a href="#">IMG-20221213120353353677965.jpg</a>

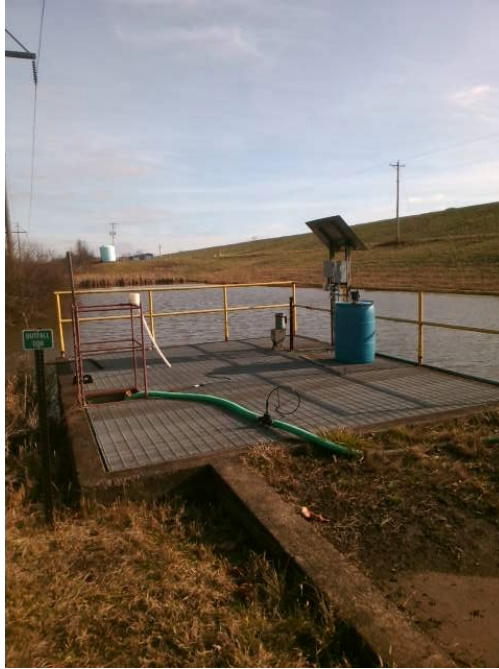
IMG-20221213110656656208986.jpg	
12/13/2022 11:06 AM EST	Photographer: Jake Berger	
Settling Ponds	No CBI	No PII

<b>Location:</b> Settling Ponds		
<b>Observation #:</b> JB4-OB-001	<b>Date:</b> 12/13/2022	<b>Weather:</b>
Addition of ferrosulfate in setting pond recirculation to induce a reduction reaction of chrome 6 to chrome 3. Sampling occurs here at location 008.		
<b>Photo(s)</b>		
1. <a href="IMG-20221213110656656208986.jpg">IMG-20221213110656656208986.jpg</a>

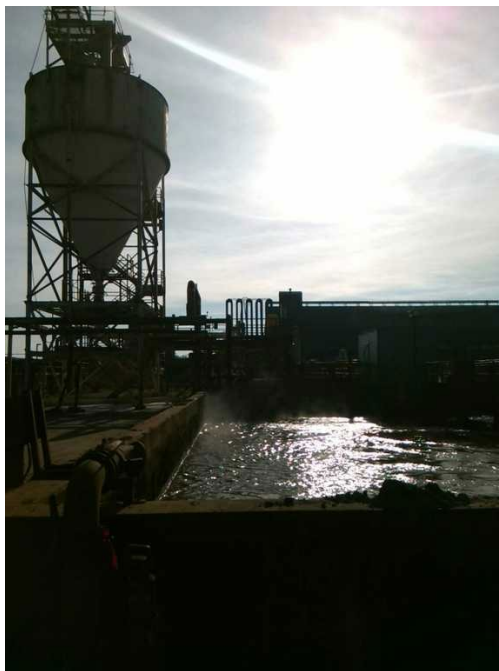
IMG-202212131154125412559719.jpg	
12/13/2022 11:54 AM EST	Photographer: Jake Berger	
UNOX wastewater treatment system	No CBI	No PII

<b>Location:</b> UNOX wastewater treatment system		
<b>Observation #:</b> JB4-OB-005	<b>Date:</b> 12/13/2022	<b>Weather:</b>
UNOX treatment system		
<b>Photo(s)</b> 1. <a href="#">IMG-202212131154125412559719.jpg</a>

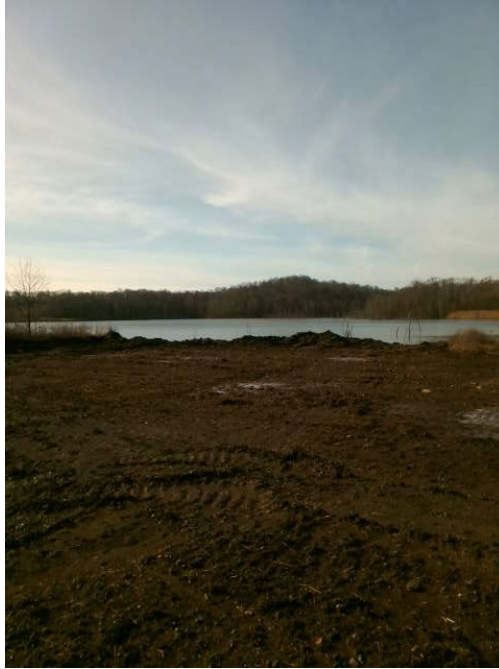
IMG-20221213121209129179269.jpg	
12/13/2022 12:12 PM EST	Photographer: Jake Berger	
Wastewater solids north impoundment	No CBI	No PII

<b>Location:</b> Wastewater solids north impoundment		
<b>Observation #:</b> JB4-OB-007	<b>Date:</b> 12/13/2022	<b>Weather:</b>
Final resting place for manganese hydroxide.
