### INSPECTION REPORT

| Inspection Date(s): | 3/5/2025 | |
| Company Name: | <b>Arklatx Operating Company, Inc.</b> | |
| Facility Name: | <b>Lisbon Lease Tank Battery</b> | |

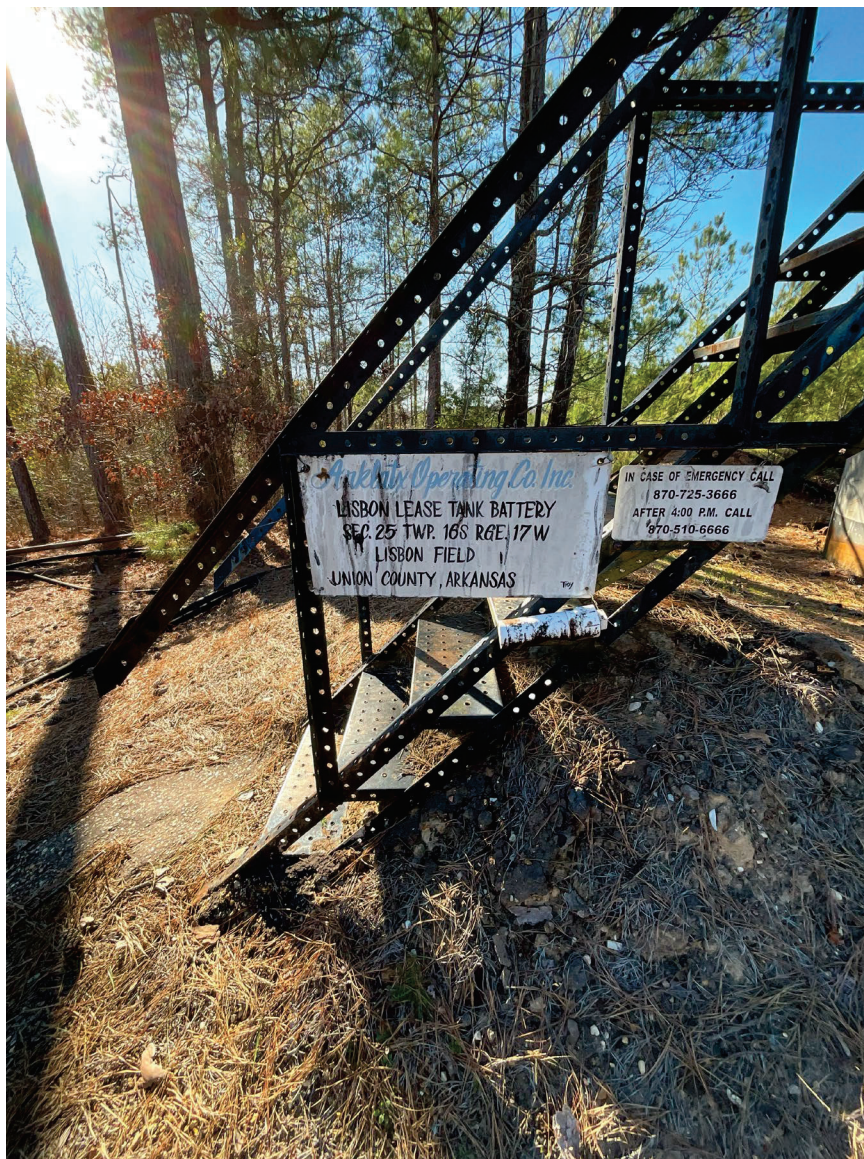
Photo No. 1

**Description:** This photo was taken looking west and shows the facility sign.

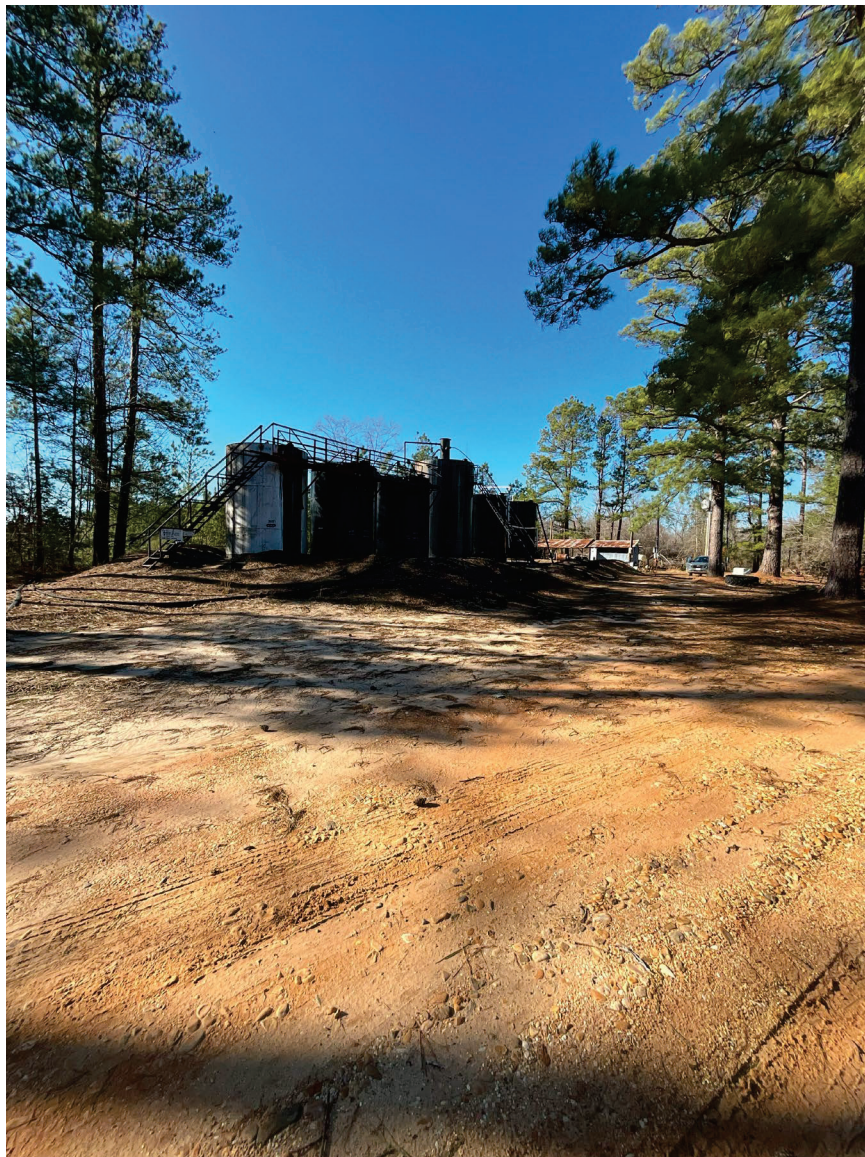
Photo No. 2

**Description:** This photo was taken looking north and shows an overview of the facility.

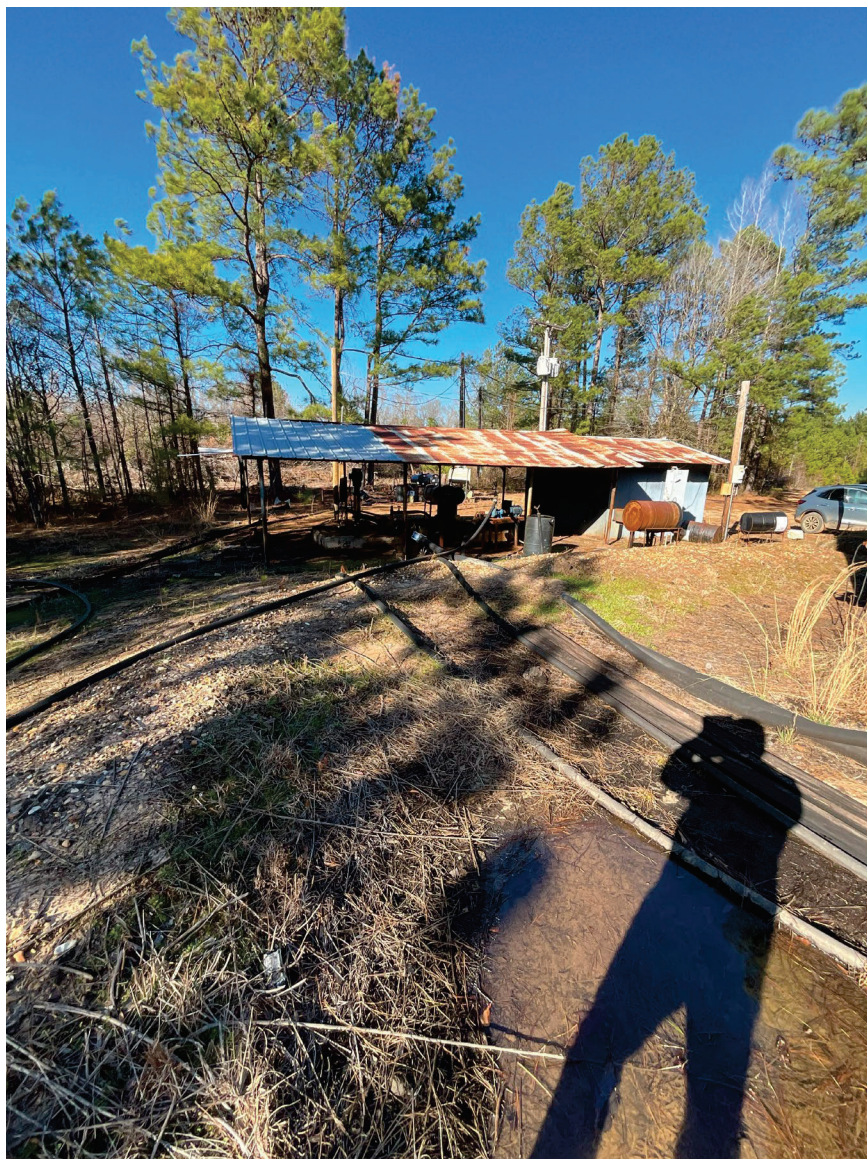
Photo No. 3

**Description:** This photo was taken looking north and shows an overview of the injection facility.

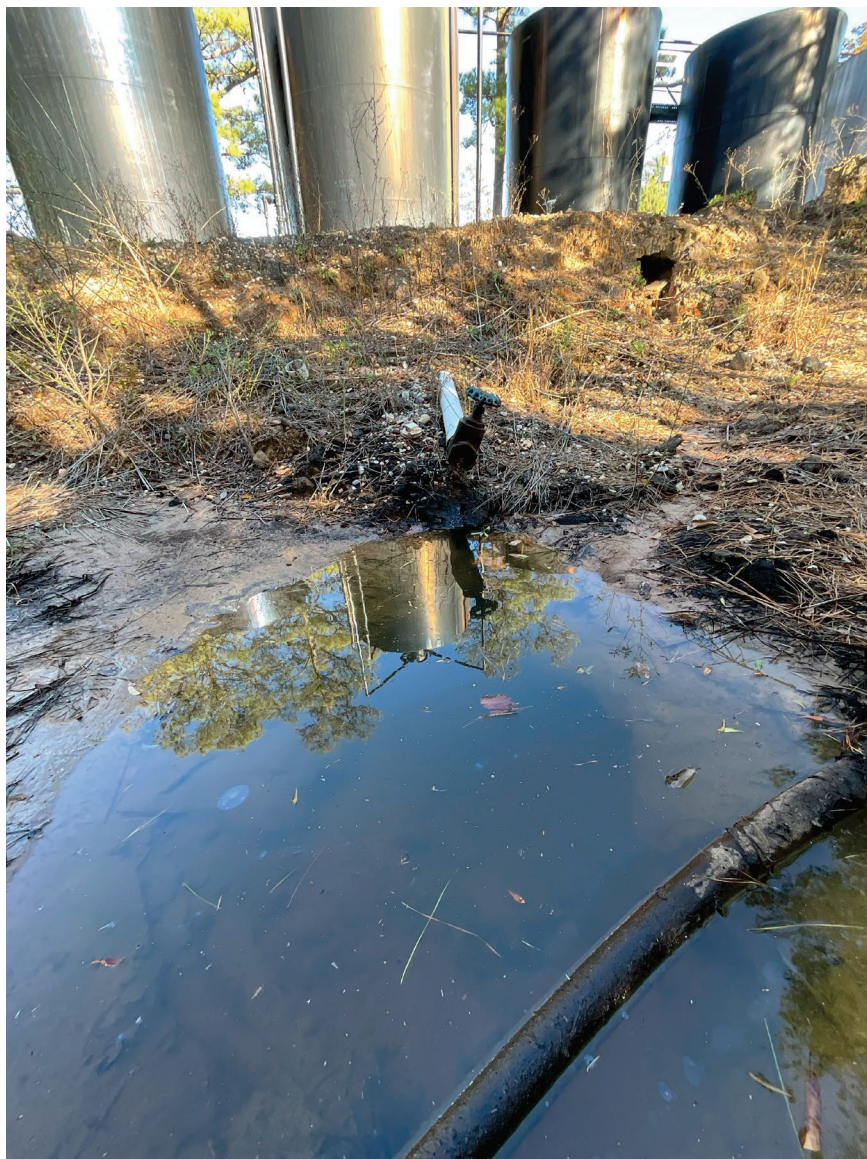
Photo No. 4

I observed an active leak from the secondary containment discharge pipe outside of secondary containment, see photo No. 4.

No closing conference was held due to no Arklatx Operating Company, Inc. staff being present during the inspection. Areas of concern at the time of the inspection include leaking secondary containment discharge valve and woody vegetation growing into the secondary containment berm.

**Description:** This photo was taken looking east and shows the secondary containment discharge valve actively leaking.

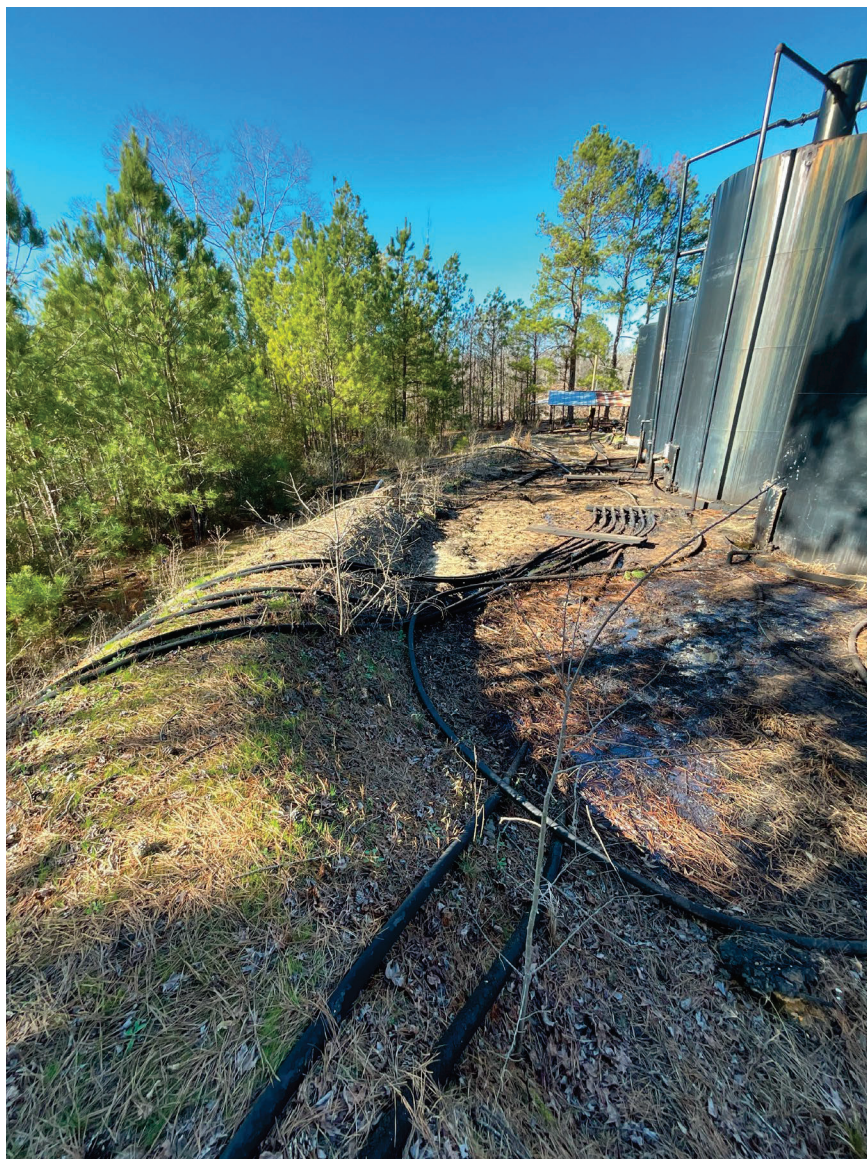
Photo No. 5

I observed woody vegetation growing into the secondary containment berm, see photo No. 5.

**Description:** This photo was taken looking north and shows a woody vegetation growing into the secondary containment berm.
