**UNITED STATES ENVIRONMENTAL PROTECTION AGENCY  
REGION 8  
RESOURCE CONSERVATION AND RECOVERY ACT**

**Facility Name:** Oilfield Disposal Services      **Facility Location:** 44.042009, -107.559782  
**RCRA ID:** WYR000201673      **Mailing Address:** 8185 N Highway 14-16,  
Gillette, Wyoming 82716  
**Notification Status:** Non-notifier      **Facility Contact:** Reuben Tarver,  
307-689-6275  
**Date of Inspection:** May 18, 2021      **Arrival Time:** 2:21 p.m.  
**Departure Time:** 3:04 p.m.  
**Lead Inspector:** Annette Maxwell, U.S. EPA

**Type and Purpose of Inspection:** Compliance Evaluation Inspection

**Facility Type:** Commercial Oilfield Waste Disposal Facility (COWDF)

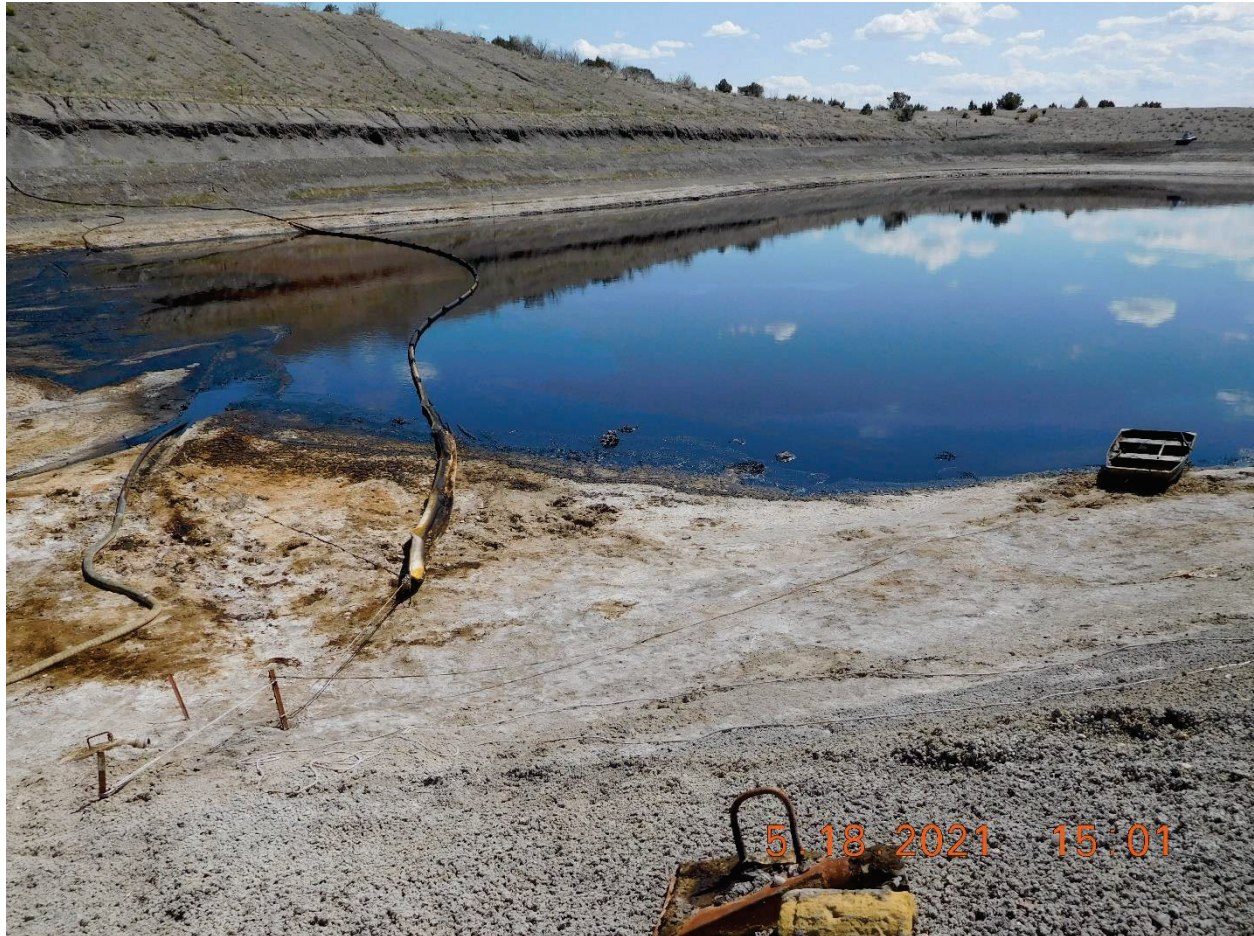
**Data Collected and Observations:** During the inspection I observed that that a small amount of oil had accumulated at the eastern edge of the evaporation pond. Photo 1398.

Oily waste that is not physically restricted from access by birds and other wildlife is a concern because of the potential for injury or mortality. Specifically, the small amount of oil on the evaporation pond and open buckets/pooled oil in the tank battery pose a potential threat to birds and other wildlife.

Photo 1398, DSCN1398.jpg, photo of evaporation pond facing southwest. Photo shows small amount of oil along the eastern edge of the evaporation pond.

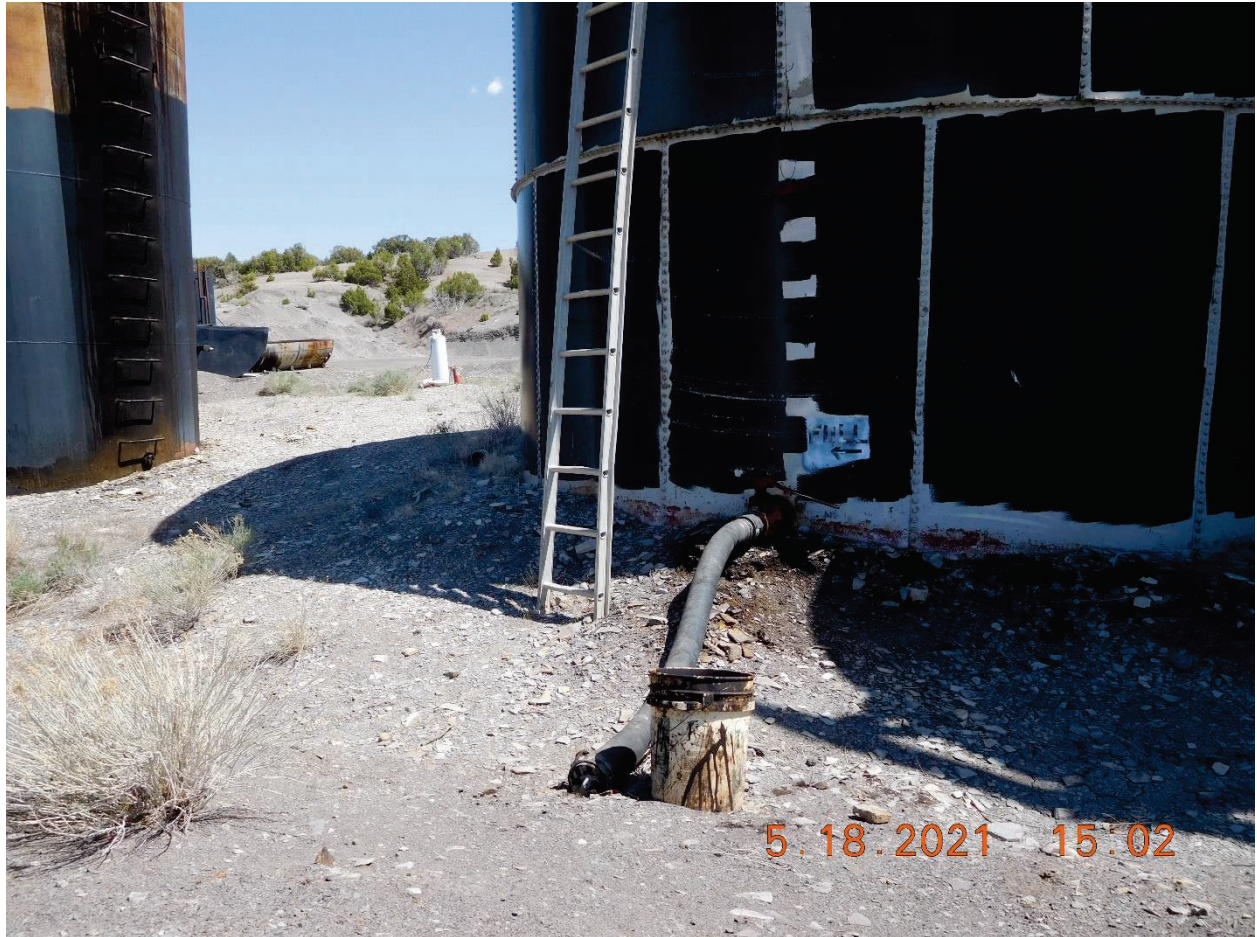
In the tank battery I observed two buckets containing liquid oil that were not covered with a closure device or physical barrier such as netting. I also observed a small amount of pooled oil on the ground inside secondary containment. Photos 1399 to 1402. Pooled oil in buckets and puddles that are not physically contained by covers or netting can present risk of harm to birds and other wildlife.

Photo 1399, DSCN1399.jpg, photo of tank battery. Close up of bucket is included in next photo.

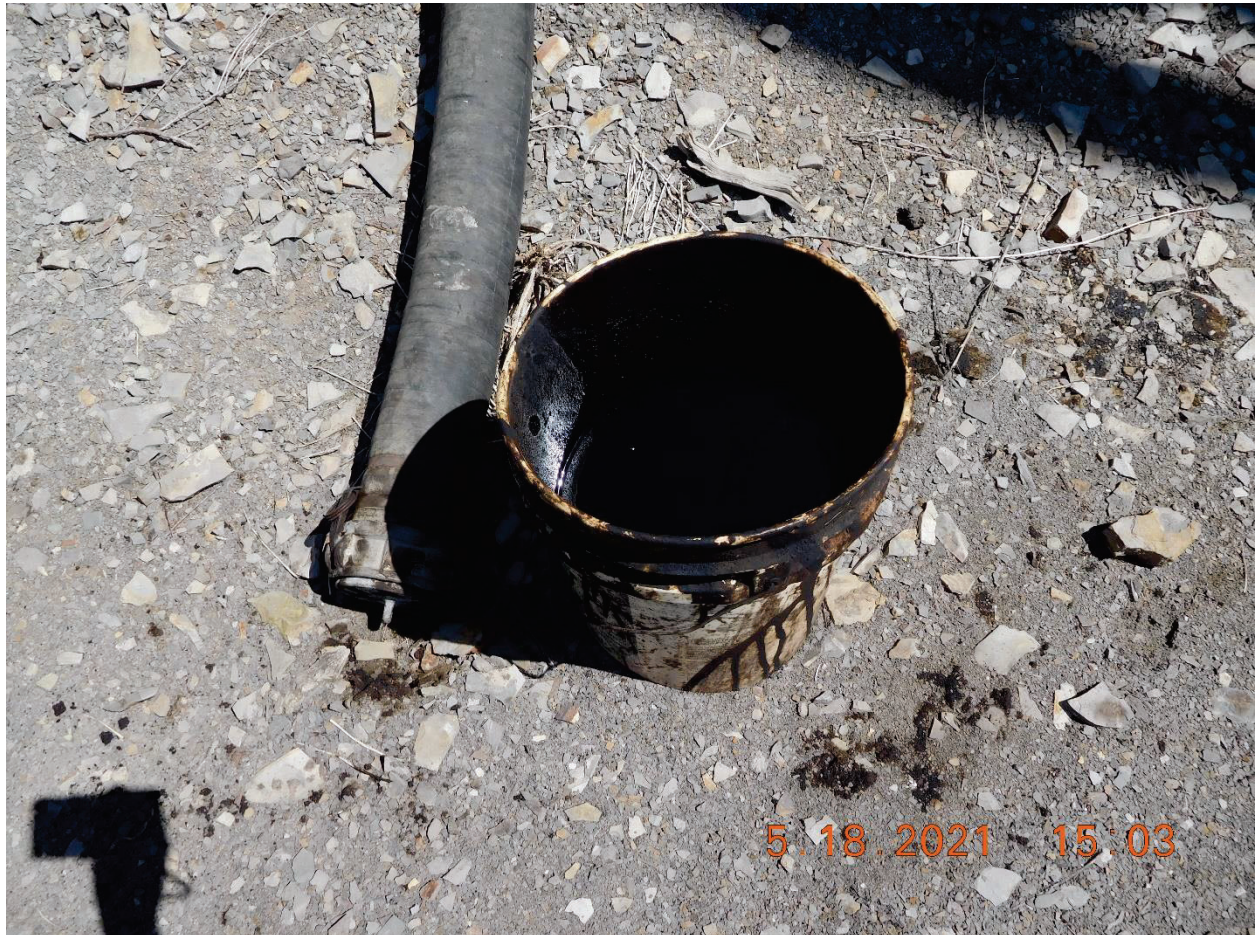
Photo 1400, DSCN1400.jpg, photo of bucket shown in photo 1399. Bucket is not netted or covered and contains liquid oil.

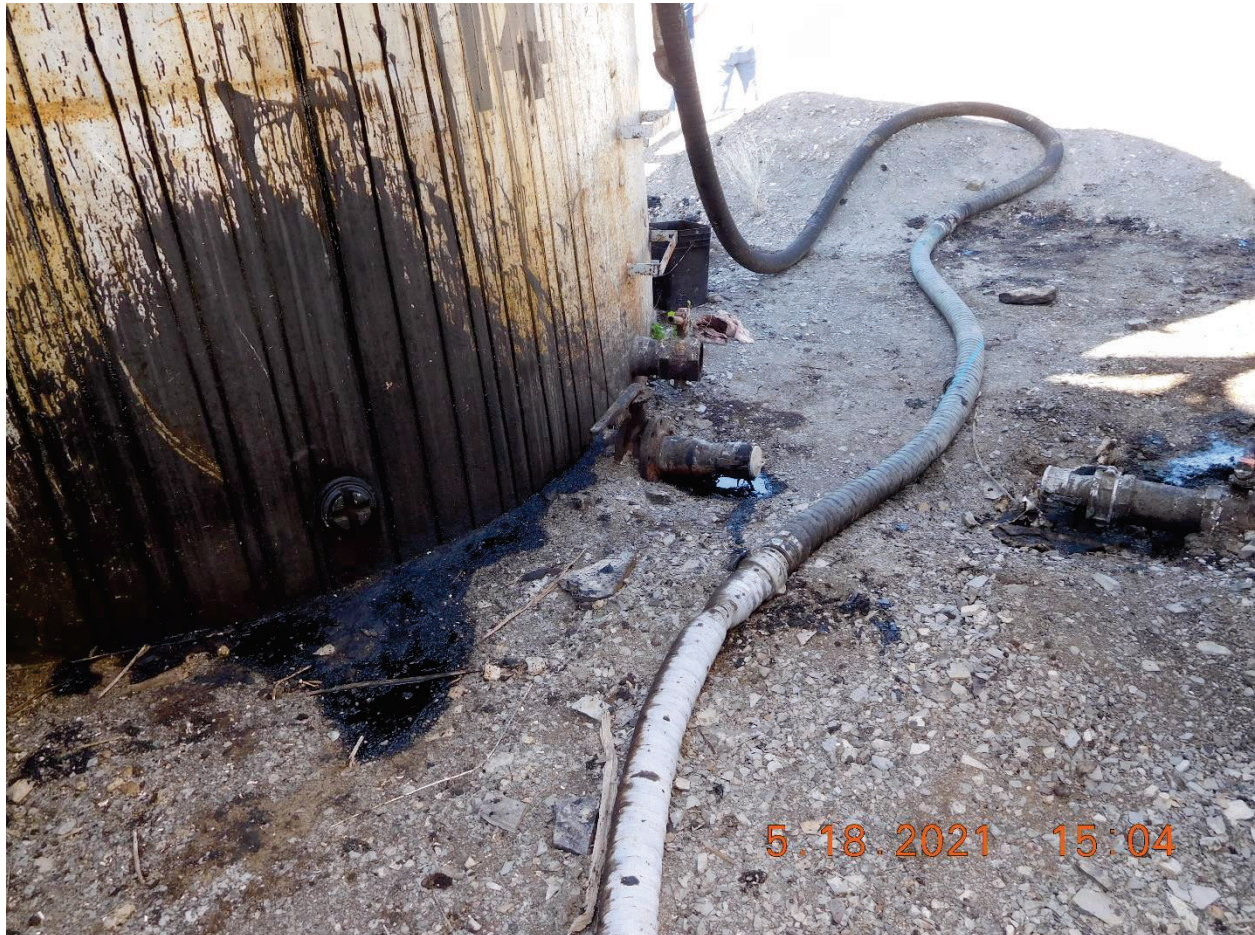
Photo 1401, DSCN1401.jpg, photo of tank battery with pooled oil in foreground and a second uncovered bucket in background.

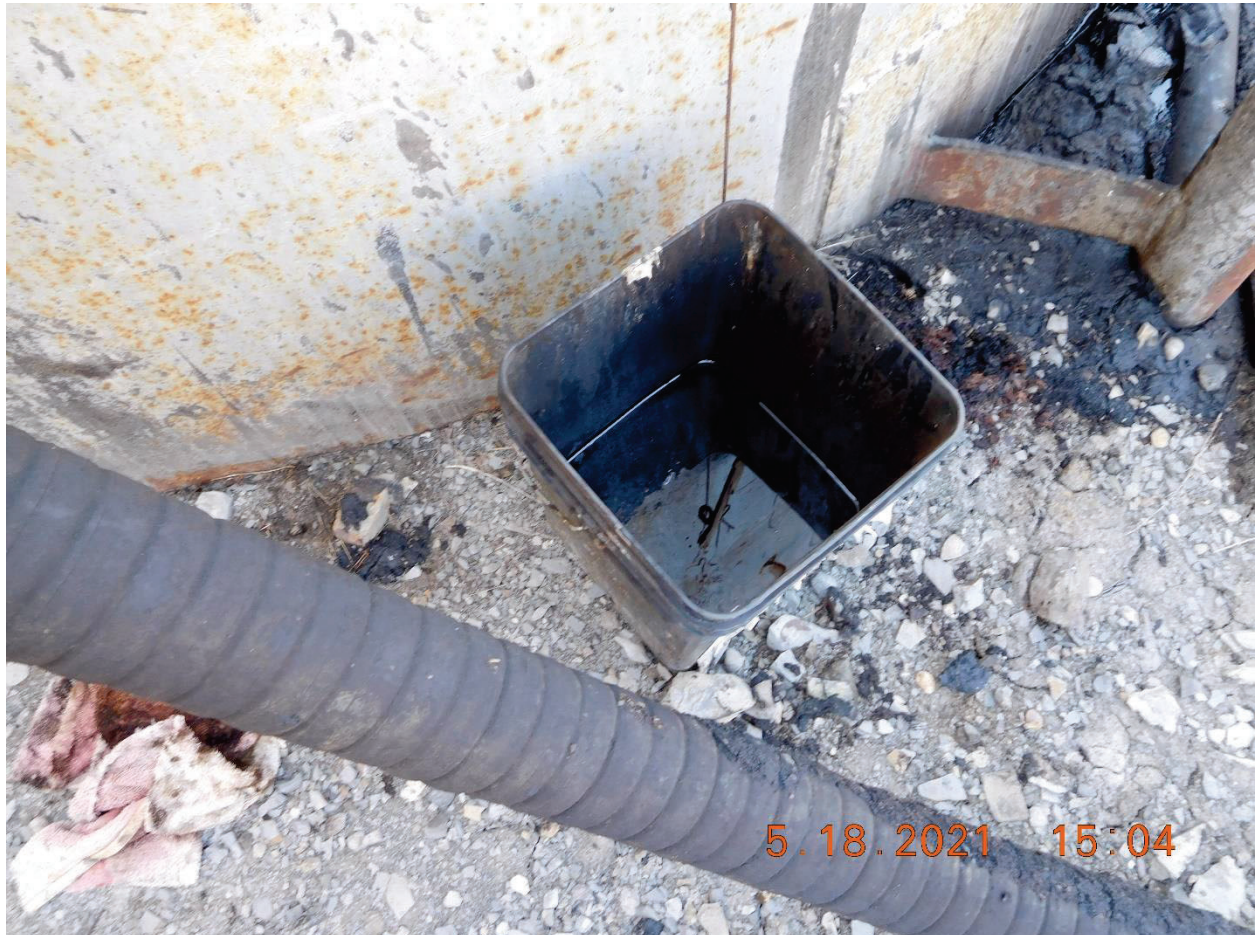
Photo 1402, DSCN1402.jpg, close-up photo of bucket shown in photo 1402. Bucket is not netted or covered and contains liquid oil.
