## Region 6 - Enforcement & Compliance Assurance Division

### INSPECTION REPORT

| Company Name: | <b>ArklaTx Operating Co., Inc.</b> | |
| Facility Name: | <b>Elder CV Lease Tank Battery</b> | |

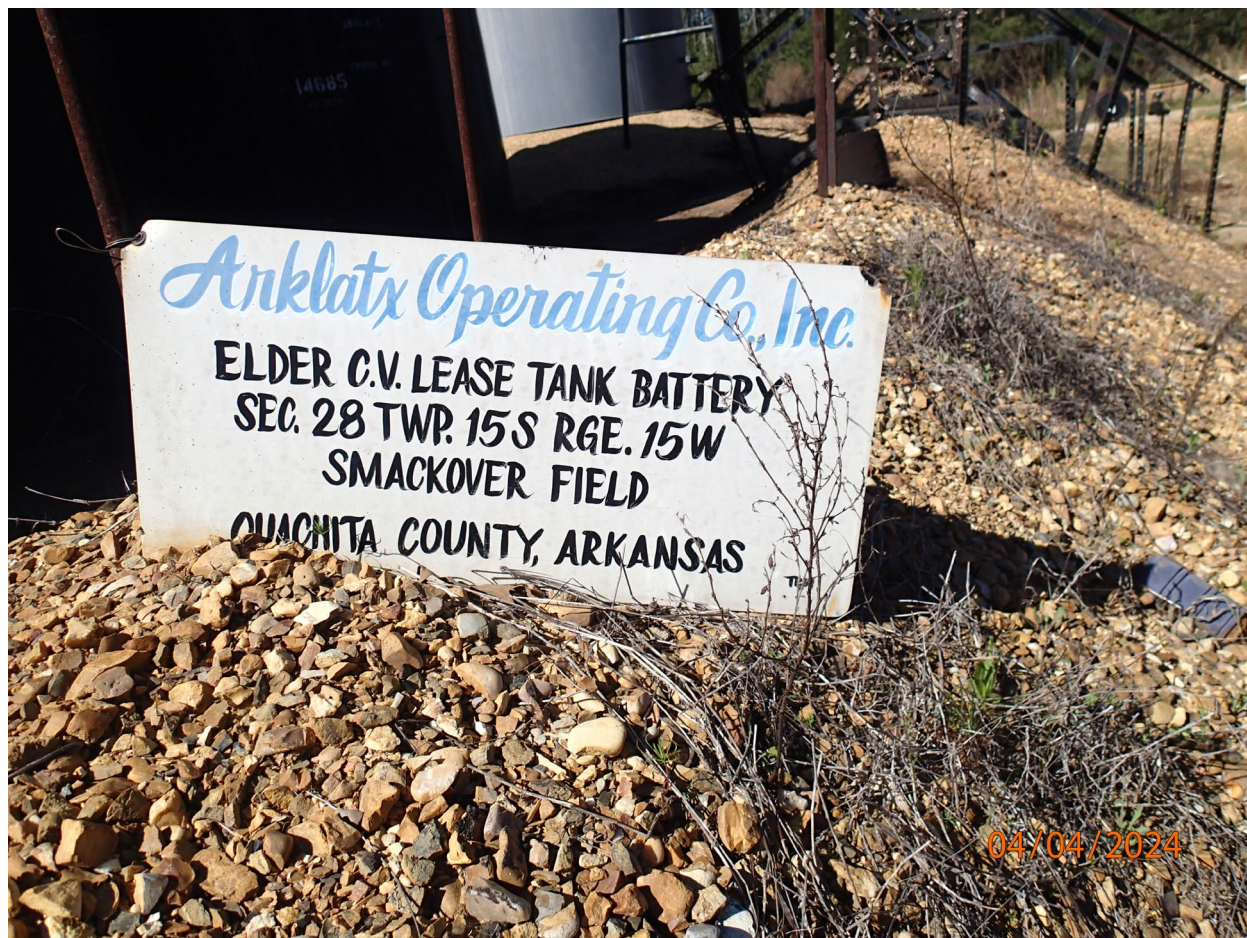
I observed the facility sign, secondary containment, pipes and valves, and storage tanks located at the facility; see Appendix 1 (Photographs Log), Photo No. 1 through No. 2 and No. 6. For additional GPS location and photo metadata, see Appendix 1.

Description: Looking SE, this photo showed the signage at the facility.

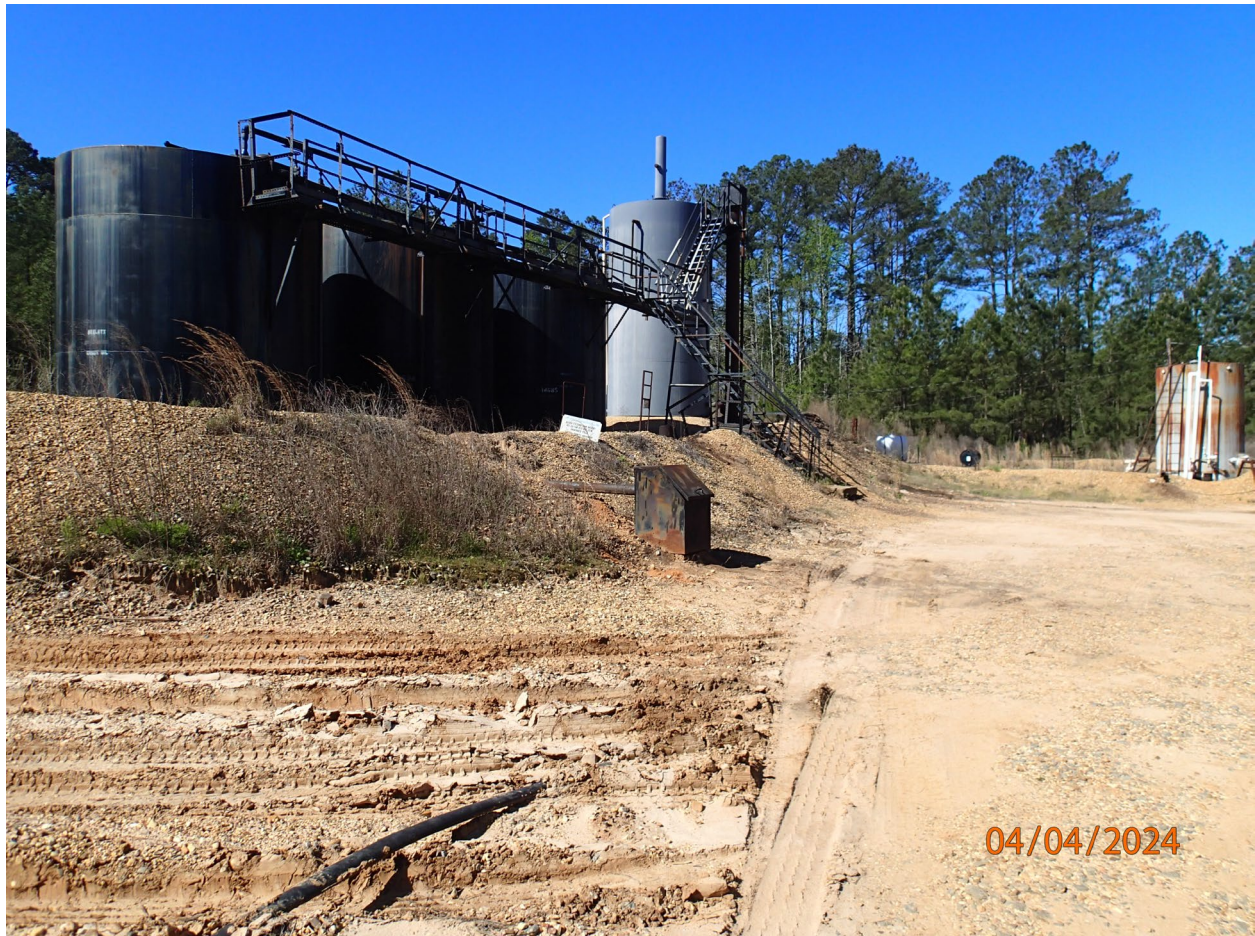
Photo No. 2

**Description:** Looking SE, this photo showed an overview of the main tank battery; three (3) tank batteries onsite.

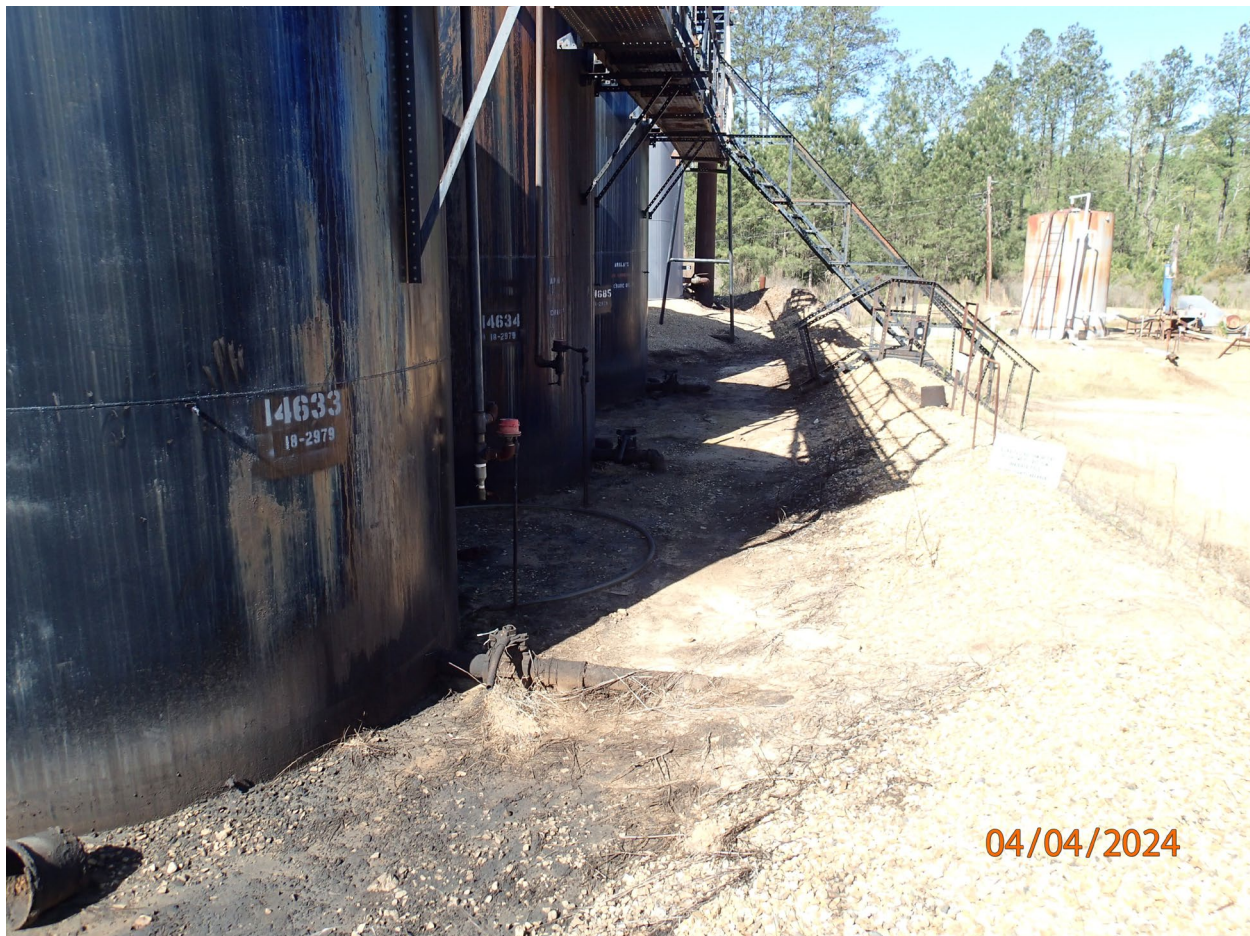
I observed loose oil inside the secondary containment for the crude oil storage firewall, see Photo No. 3 and No. 4.

**Description:** Looking SE, this photo showed loose oil inside the secondary containment (at the front) for the main tank battery.

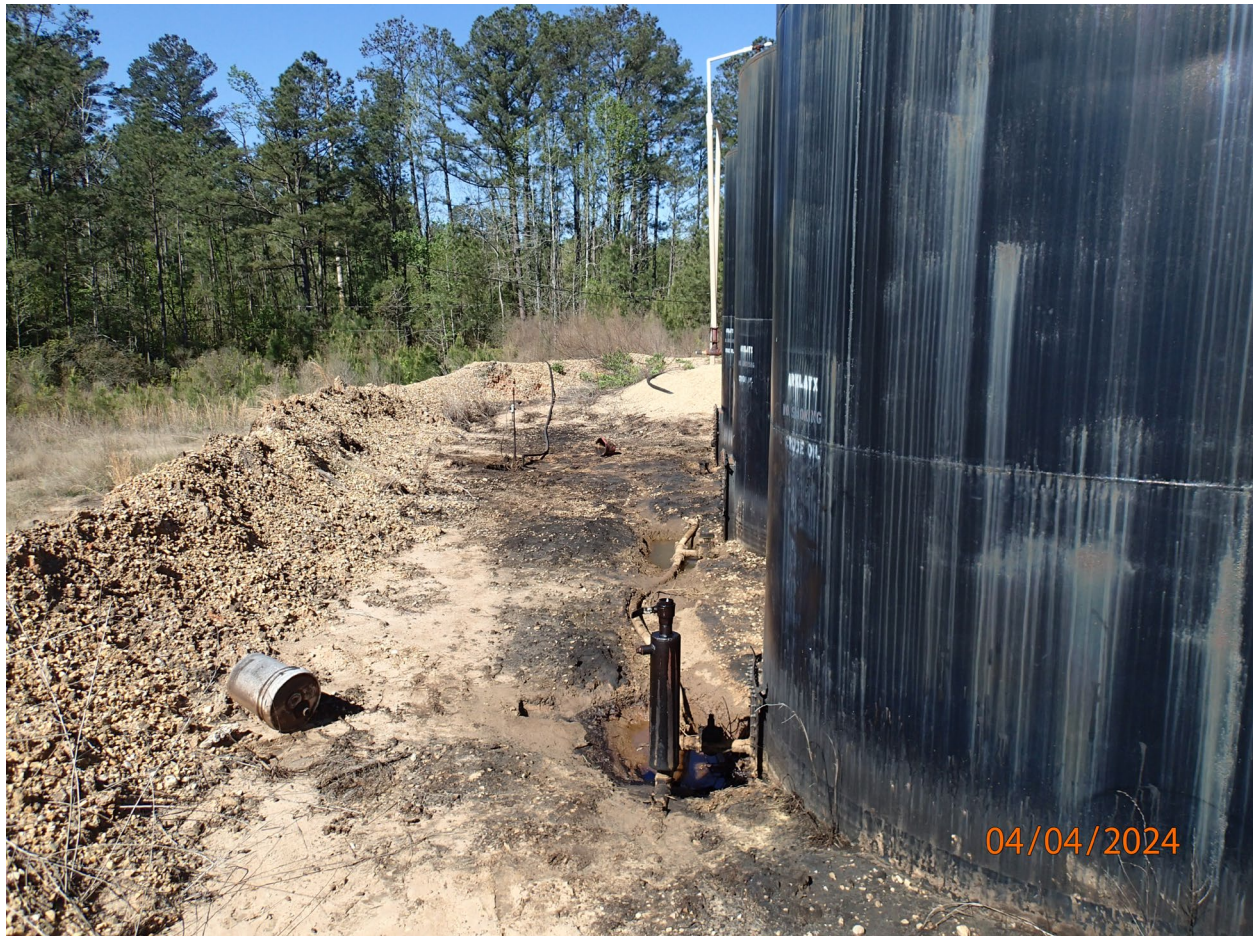
Photo No. 4

**Description:** Looking SE, this photo showed loose oil inside the secondary containment (at the back) for the main tank battery.

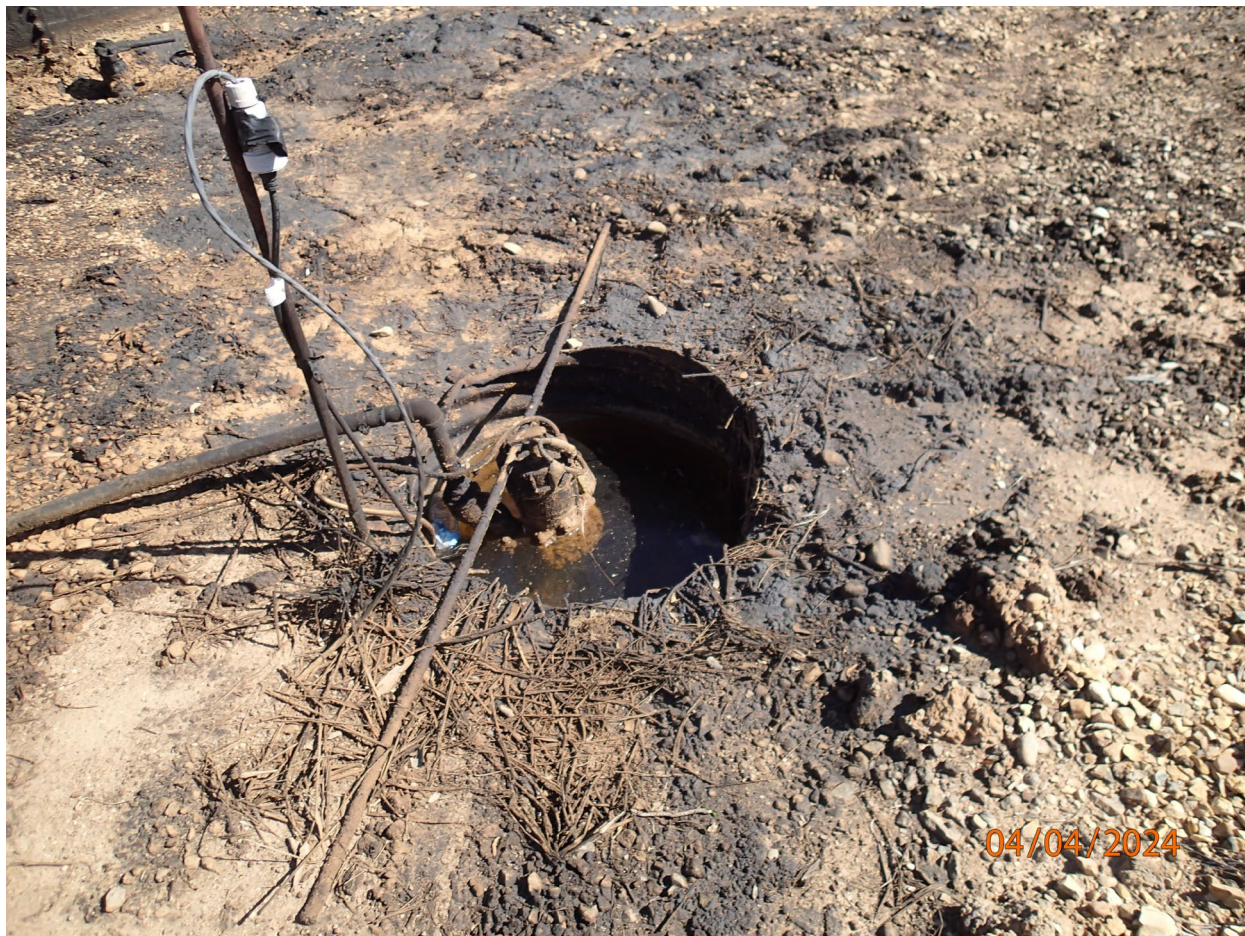
Photo No. 5

I observed the sump pump used in the secondary containment for the crude oil storage firewall to route fluids back through the system, see Photo No. 5.

**Description:** Looking NW, this photo showed a sump pump installed inside the secondary containment for the main tank battery to route fluids back into the system.

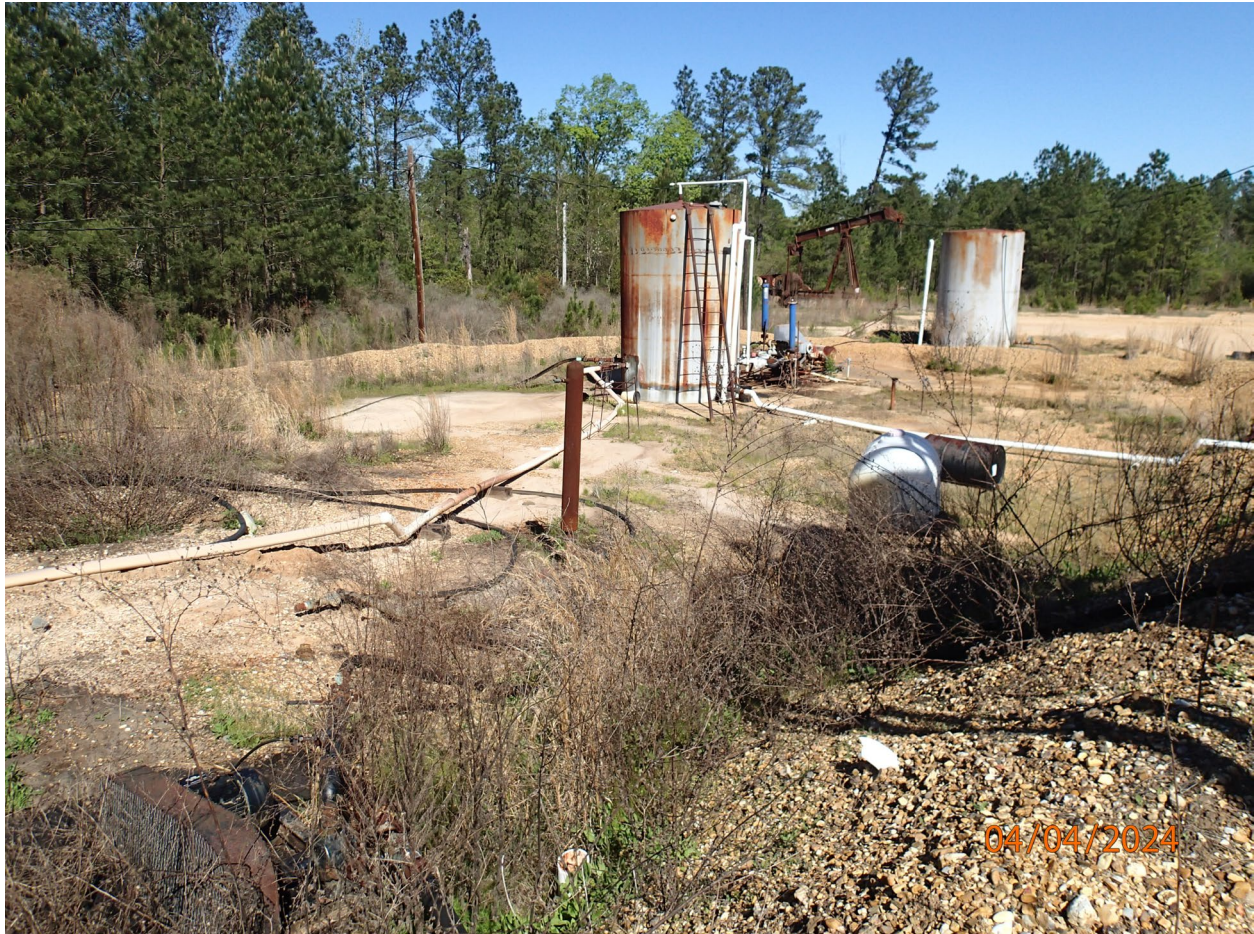
Photo No. 6

**Description:** Looking E-NE, this photo showed an overview of the other two (2) tank batteries onsite.

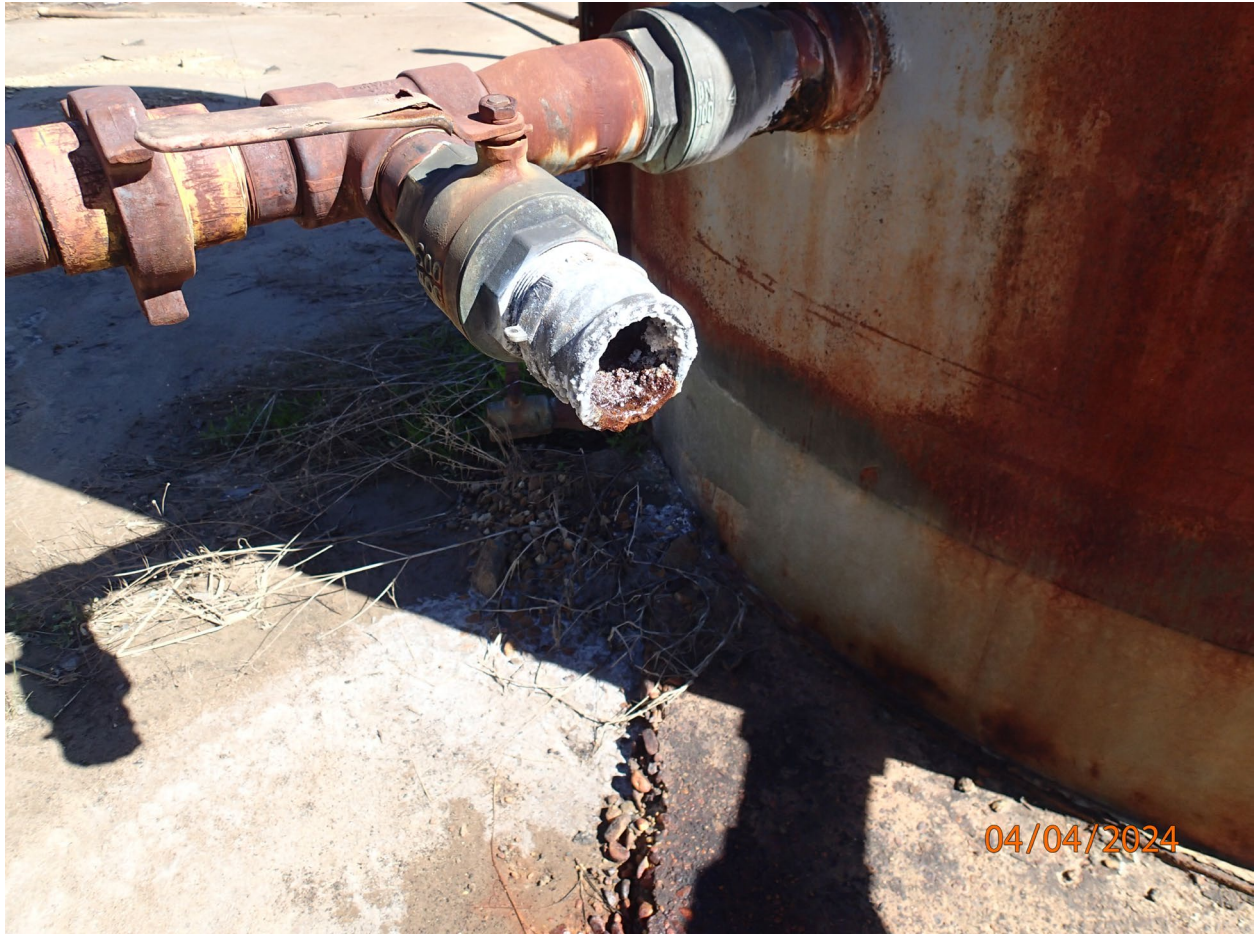
I observed a pipe at a saltwater storage tank with a closed valve with no cap with an active saltwater leak and salt crystals coating the opening of the pipe and forming on the ground, see Photo No. 7 and No. 8.

**Description:** Looking E-NE, this photo showed an active leak from a storage tank pipe inside the secondary containment from the middle tank battery; I noted salt crystals around pipe and on the ground.

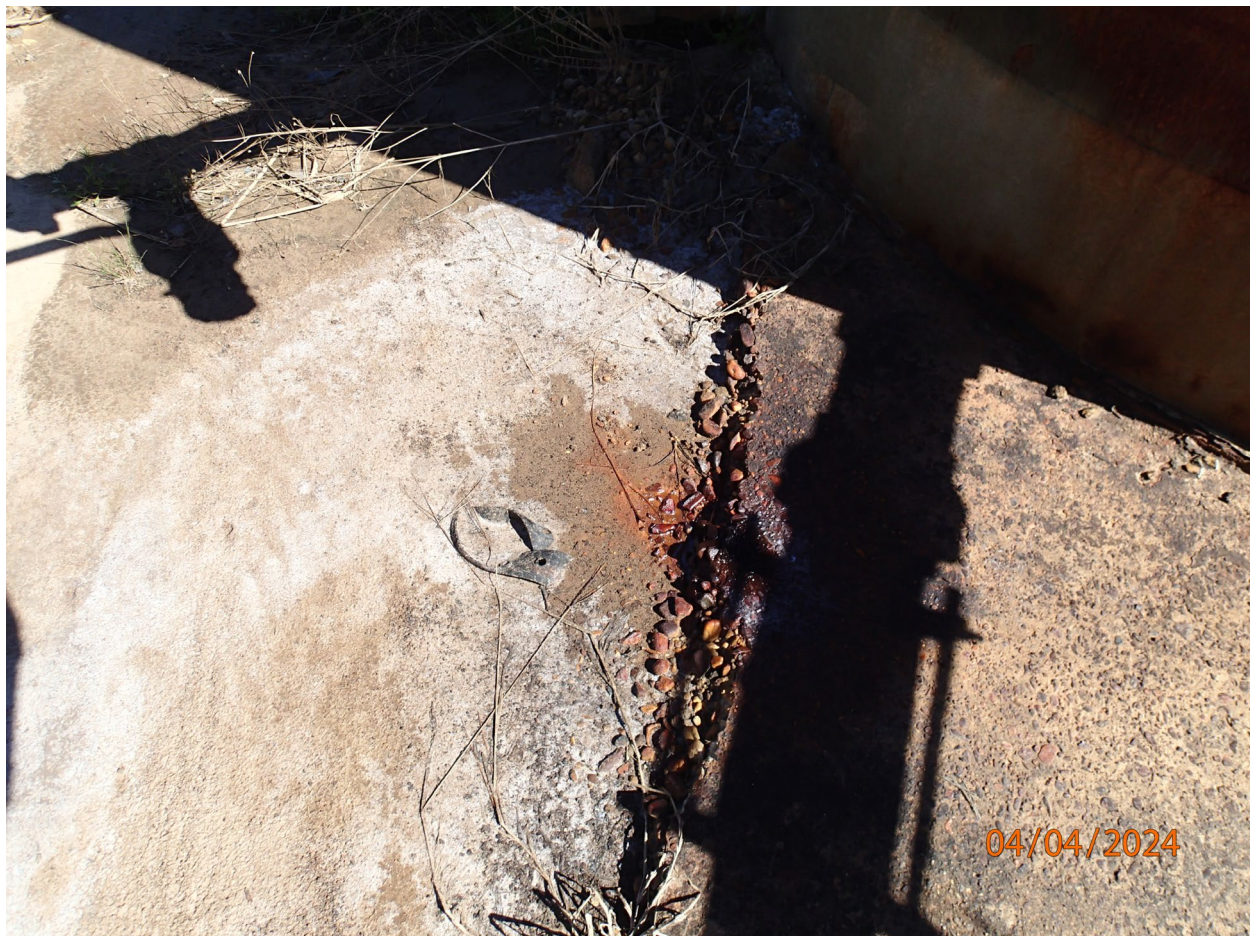
Photo No. 8

**Description:** Looking N-NE, this photo showed a closeup of the active leak from a storage tank pipe from Photo No. 7.

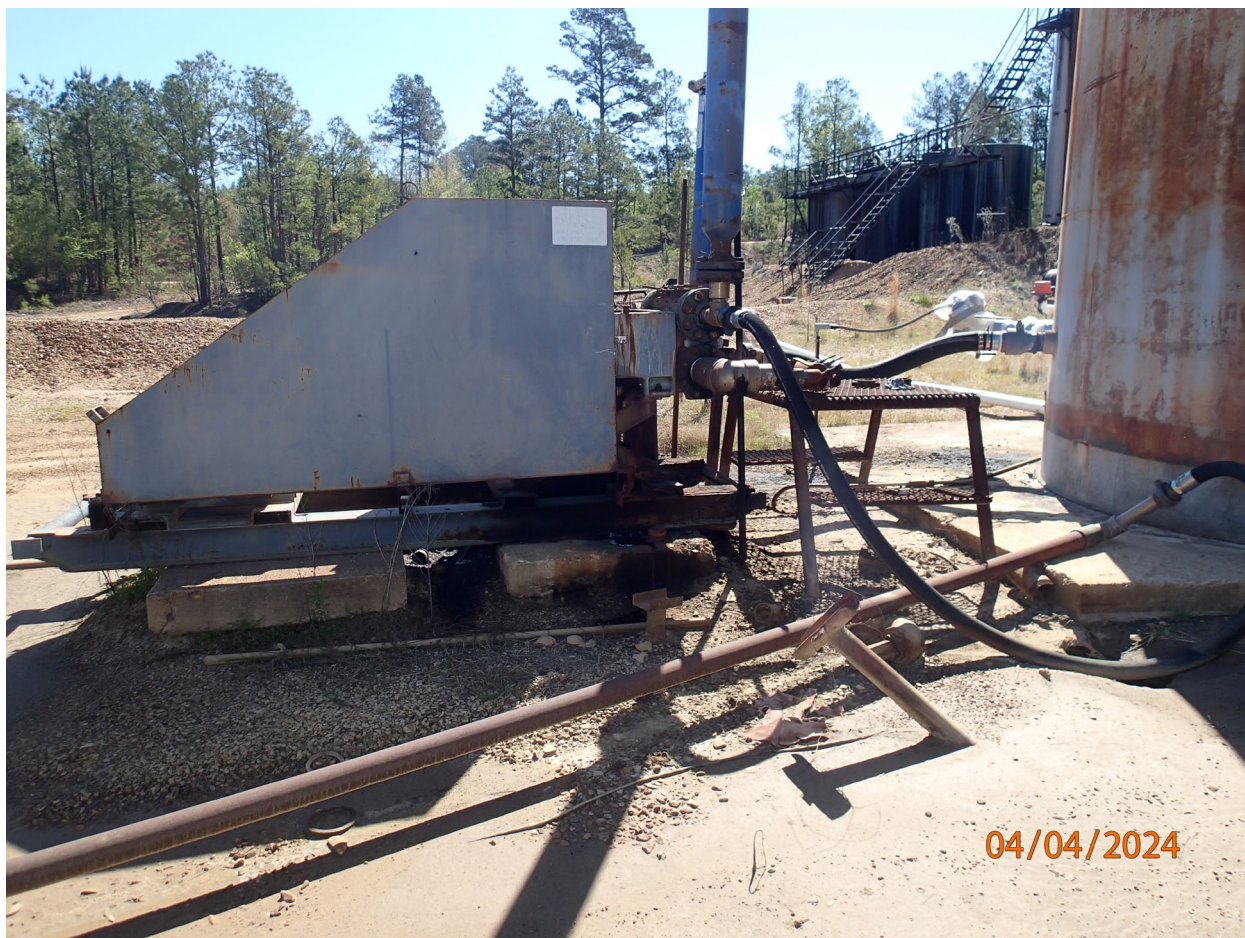
I observed the pump for the SWD well with an active leak of saltwater inside secondary containment, see Photo No. 9 and No. 10.

**Description:** Looking W-SW, this photo showed a pump connected to the storage tank inside secondary containment for the middle tank battery; pump line routed to the saltwater disposal (SWD) well.

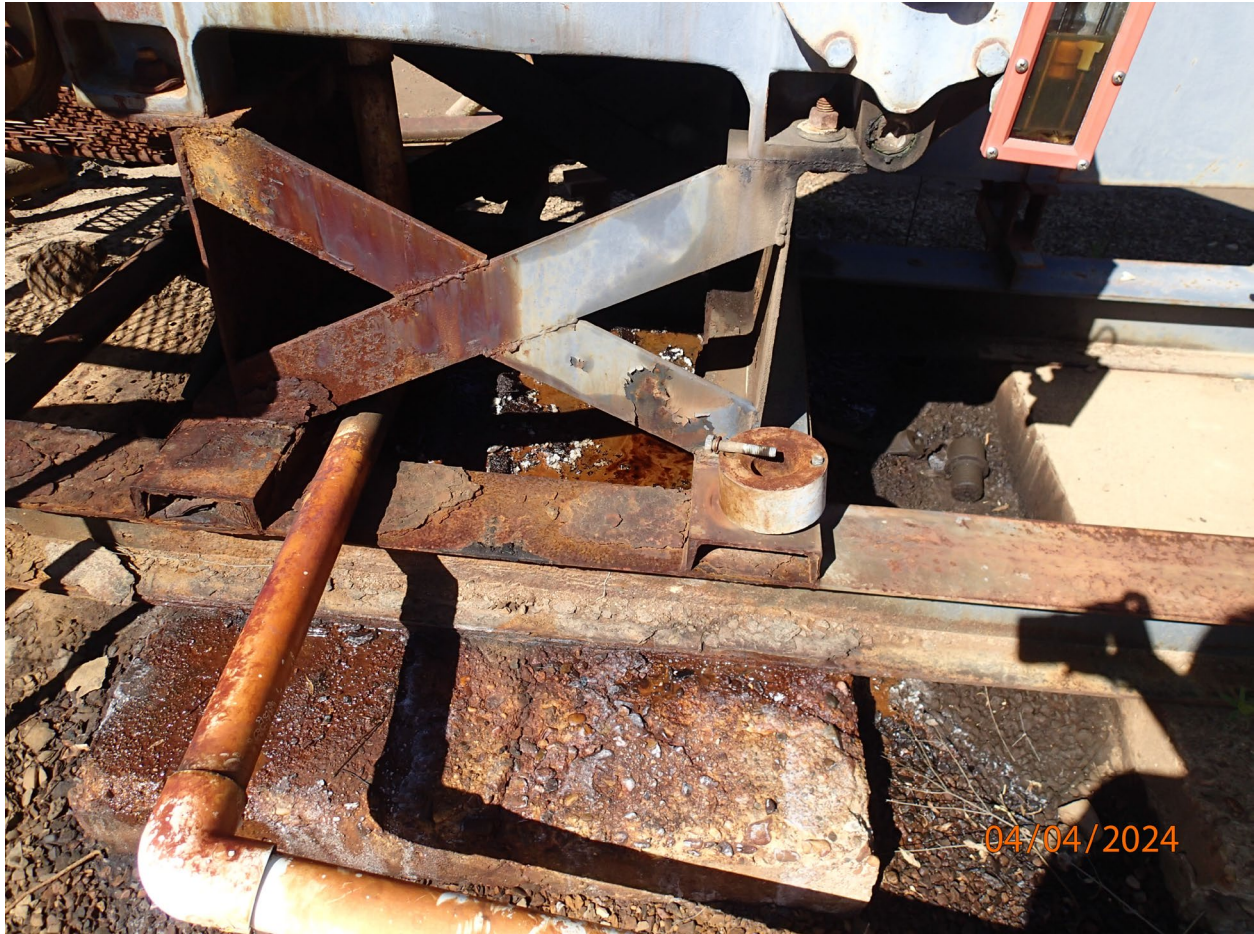
Photo No. 10

Description: Looking SE, this photo showed an active leak at the pump in Photo No. 9.

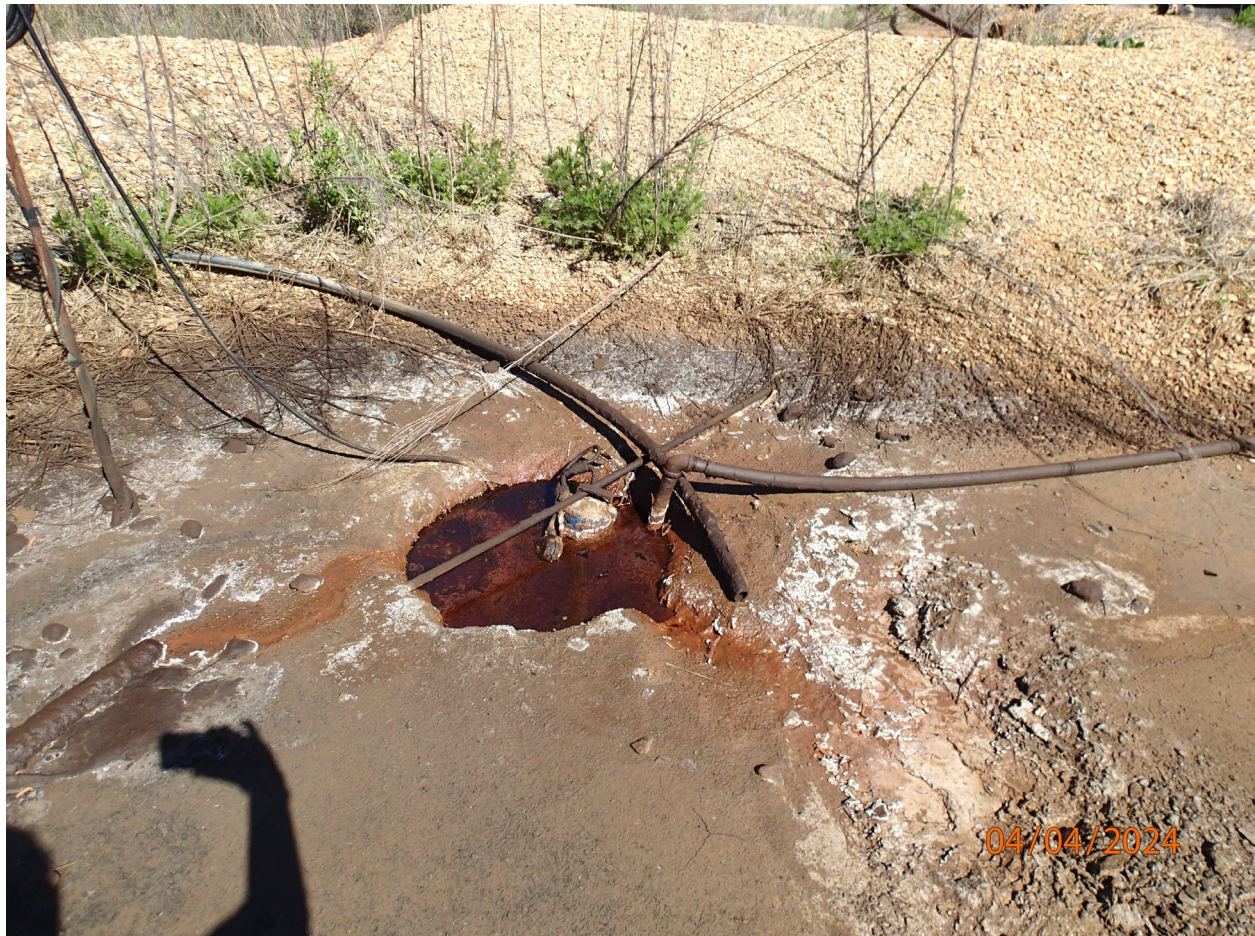
Photo No. 11

I observed the sump pump used in the secondary containment for the saltwater storage firewall to route fluids back through the system, see Photo No. 11.

**Description:** Looking E-NE, this photo showed a sump pump installed inside the secondary containment for the middle tank battery; I noted staining and salt crystals on the ground.

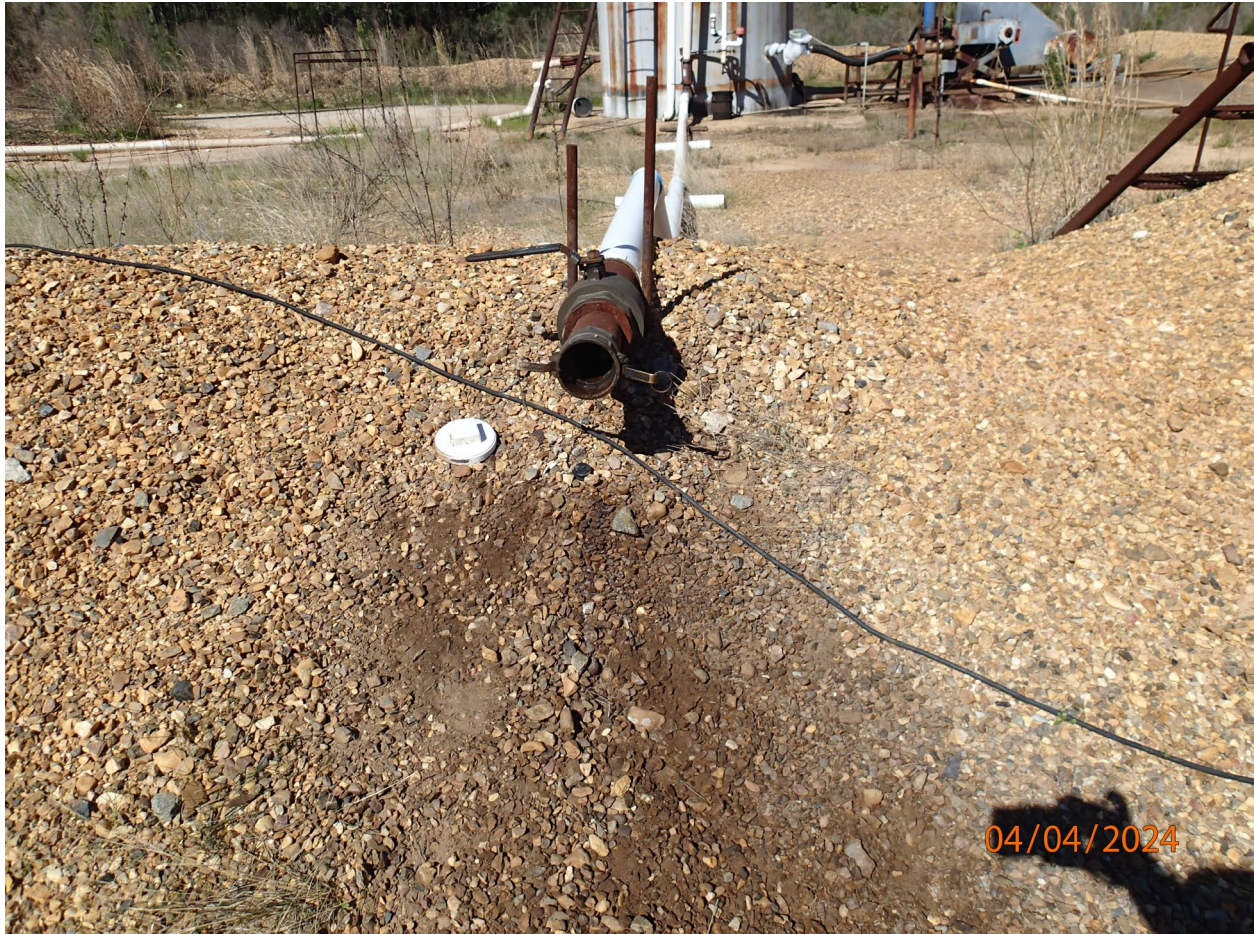
I observed the transfer pipe through secondary containment for one of the saltwater storage firewalls without a catch bucket and the cap removed; residual saltwater was noted on the ground at the transfer pipe; see Photo No. 12 and No. 13.

**Description:** Looking E-SE, this photo showed a transfer pipe connected to the storage tank in the middle tank battery without a cap on the pipe; I noted the valve was closed.

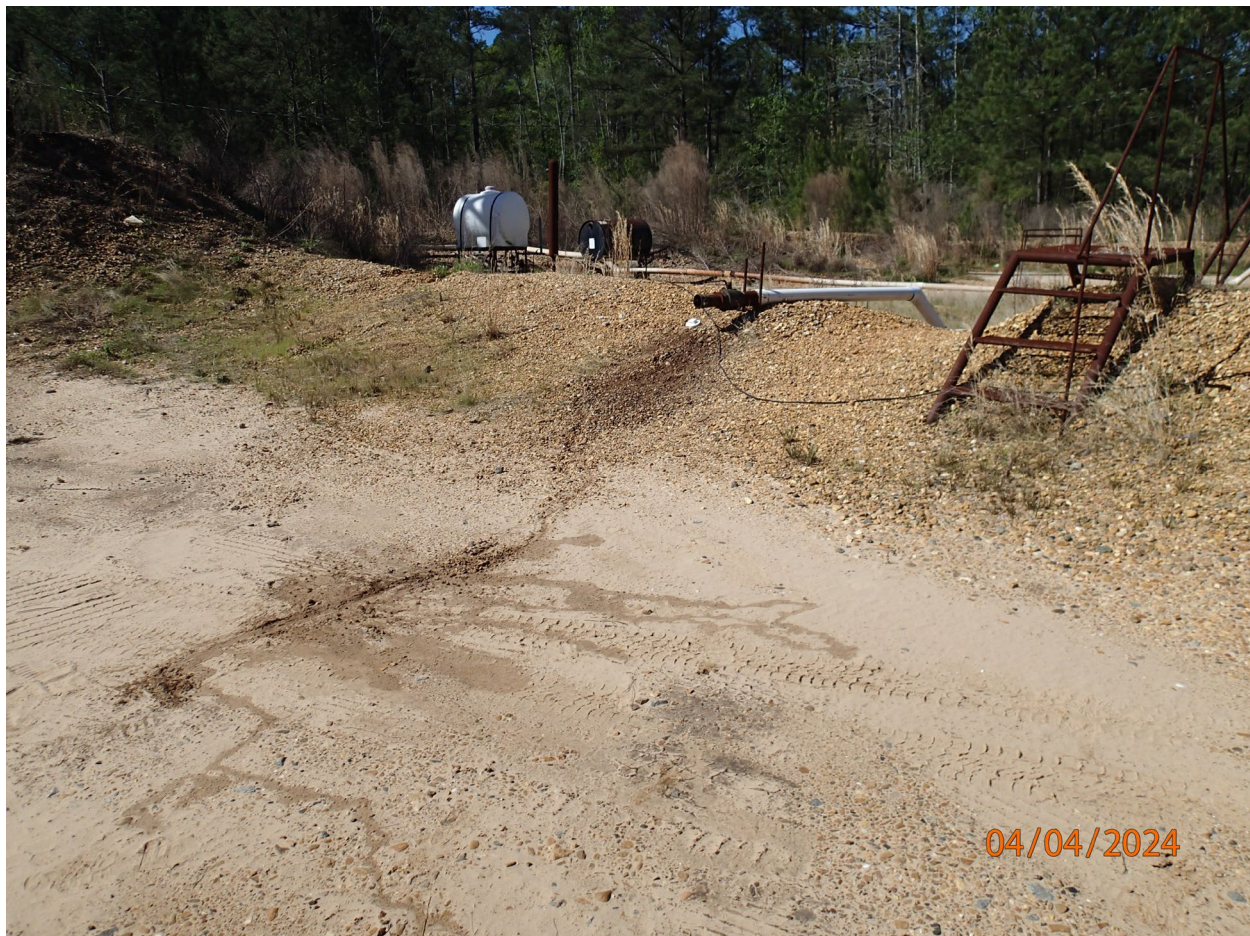
Photo No. 13

**Description:** Looking S-SE, this photo showed a recent release from the transfer pipe in Photo No. 12.; I noted flow indicators and damp sand (darker color).

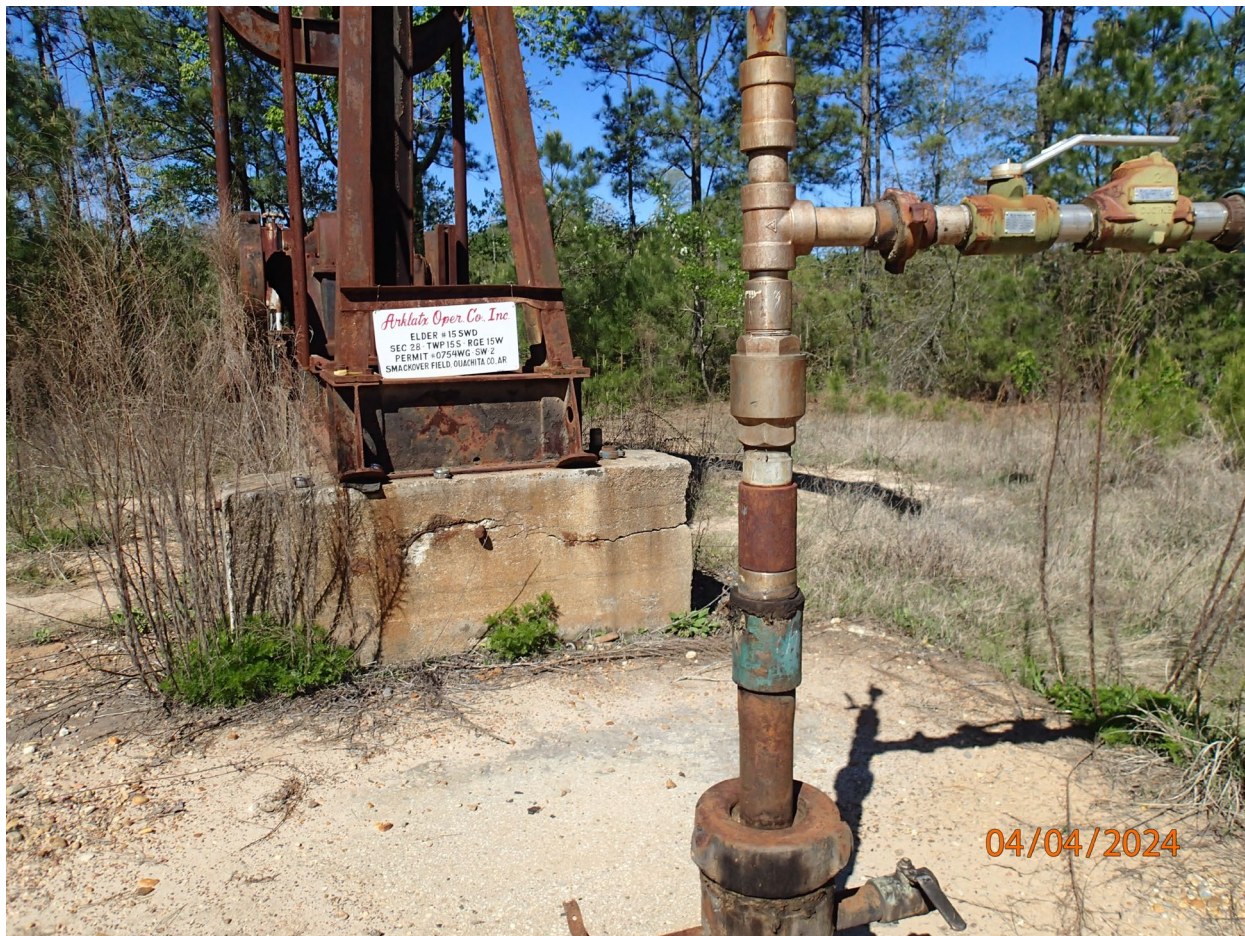
Photo No. 14

I observed the SWD well located onsite to be connected and injecting from the system, see Photo No. 14.

Description: Looking W-NW, this photo showed the Elder #15 SWD well utilized at the facility.
