INSPECTION REPORT

| <b>Type of Inspection</b> | Industrial Stormwater Inspection (ISI) | | |
| <b>Permittee Name</b> | Kuhlman Corporation | | |
| <b>Facility or Site Name</b> | Kuhlman Corporation Yard #1 | | |

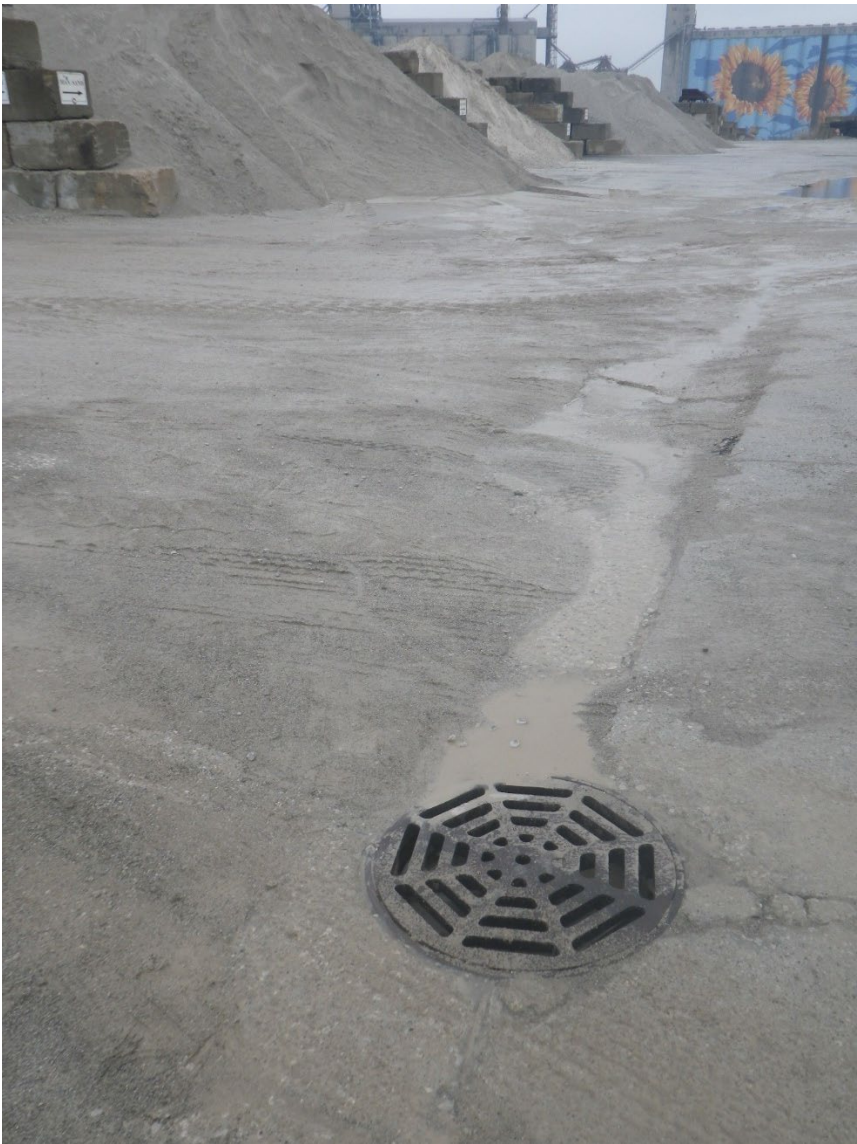
| During the inspection, EPA observed runoff from storage bunkers. The runoff was flowing to the storm drain inlet in the photograph. | | |

There are material storage areas where the exposure of materials is not minimized. See photographs.

| Photograph 1. Runoff from the direction of the piles into the storm drain inlet at Kuhlman Corporation yard #1. Uncovered storage piles can be seen at the top of the photograph | | | IMGP0001.JPG |

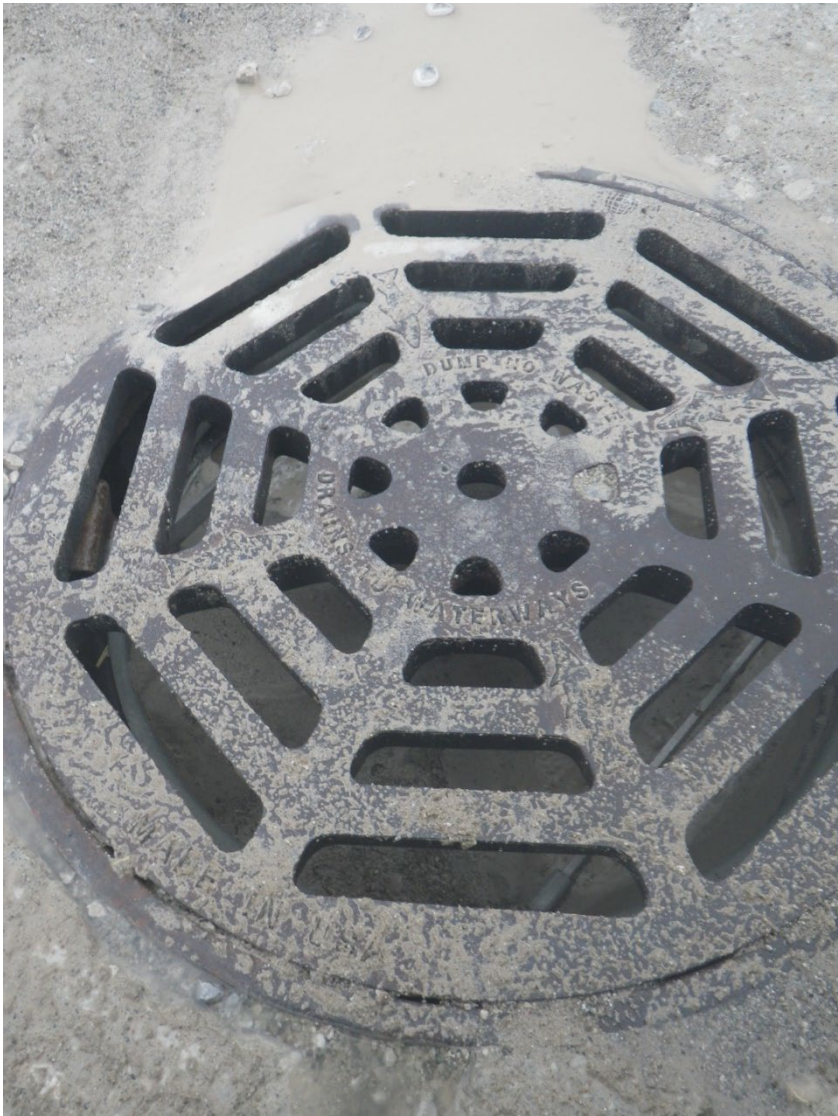
EPA noted inlet filters were not cleaned, nor was housekeeping maintained.

| Photograph 2. Closeup view of manhole shown in photograph 1. Inlet protection can be seen inside the manhole. The inlet protection is full to the top of the container with sediment. | | | IMGP0002.JPG |

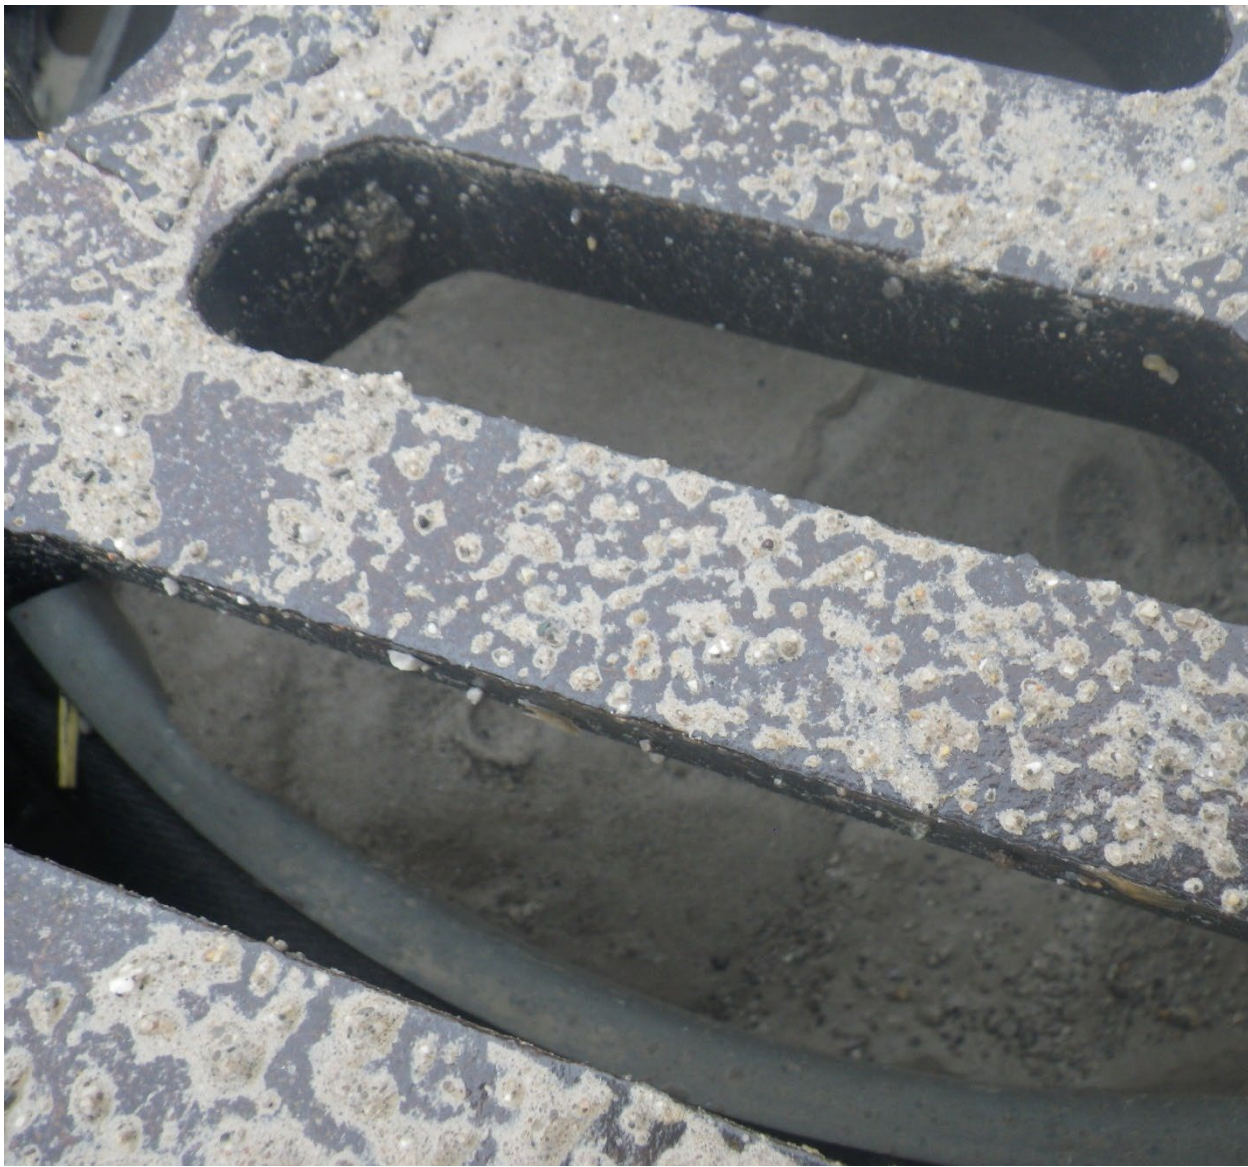
| Photo 3. Closeup view of manhole shown in photographs 1 and 2. Inlet protection can be seen inside the manhole. The inlet protection is full to the top with sediment. | | | IMGP0003.JPG |

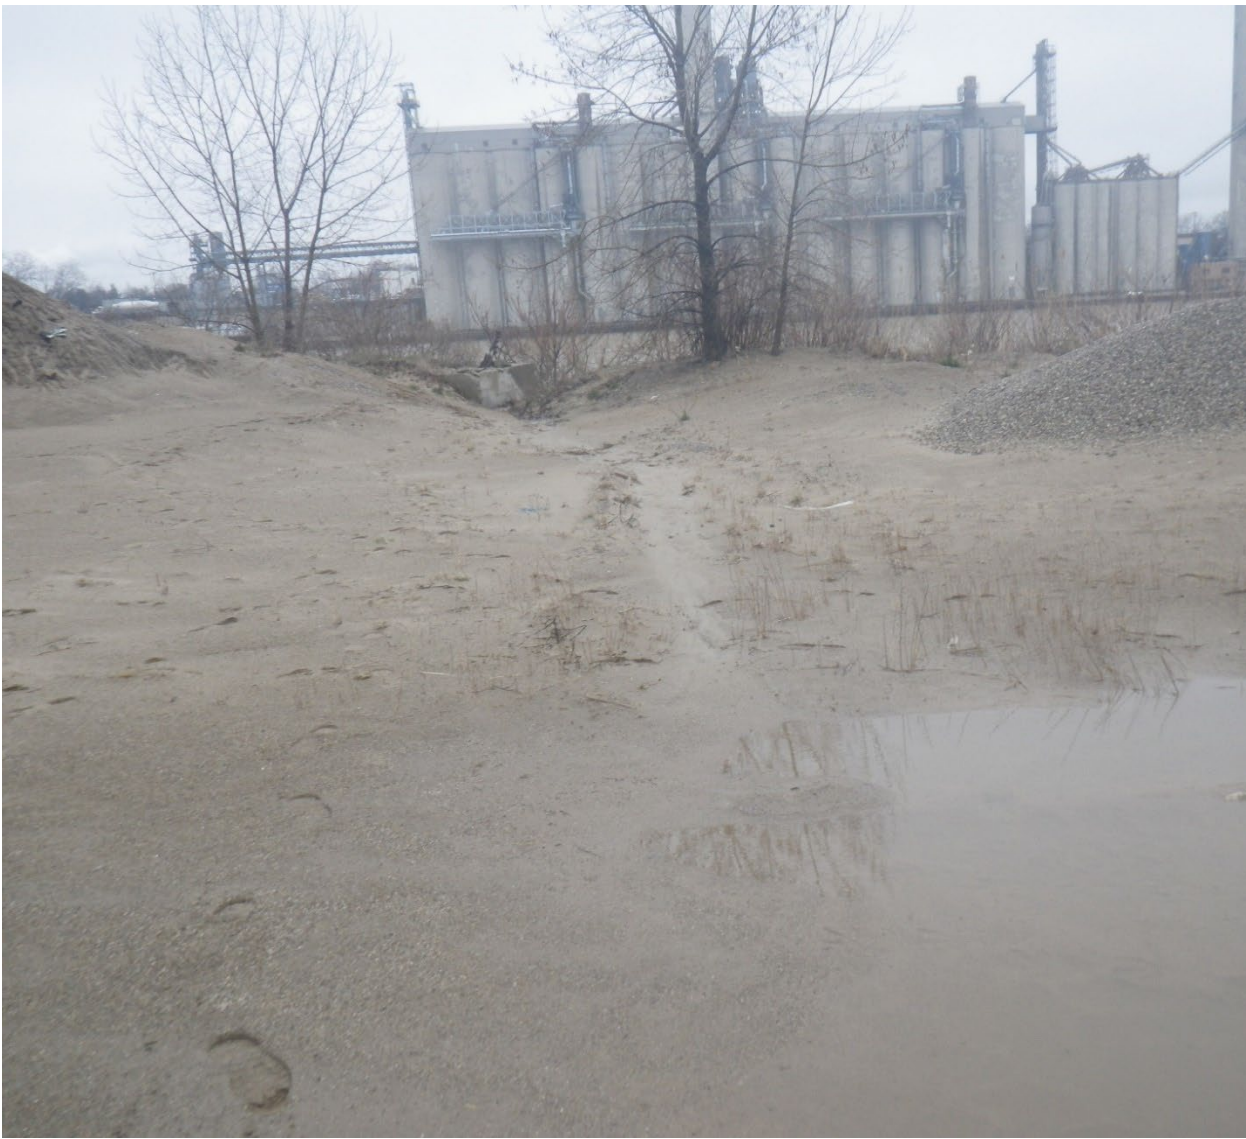
| During the inspection, EPA observed an area to the east of the storage piles where storm water can flow through a conveyance to the edge of the property leading to the Maumee River. | | |

SWPPP is dated March 2021. There is an outfall by the stockpile yard with raw materials that does not appear to be included.

| Photograph 4. Area on east portion of site by uncovered storage piles showing the direction water flows when it runs off towards the Maumee River. This is near where the stacker ring is show on the attached drawing. | | | IMGP0004.JPG |

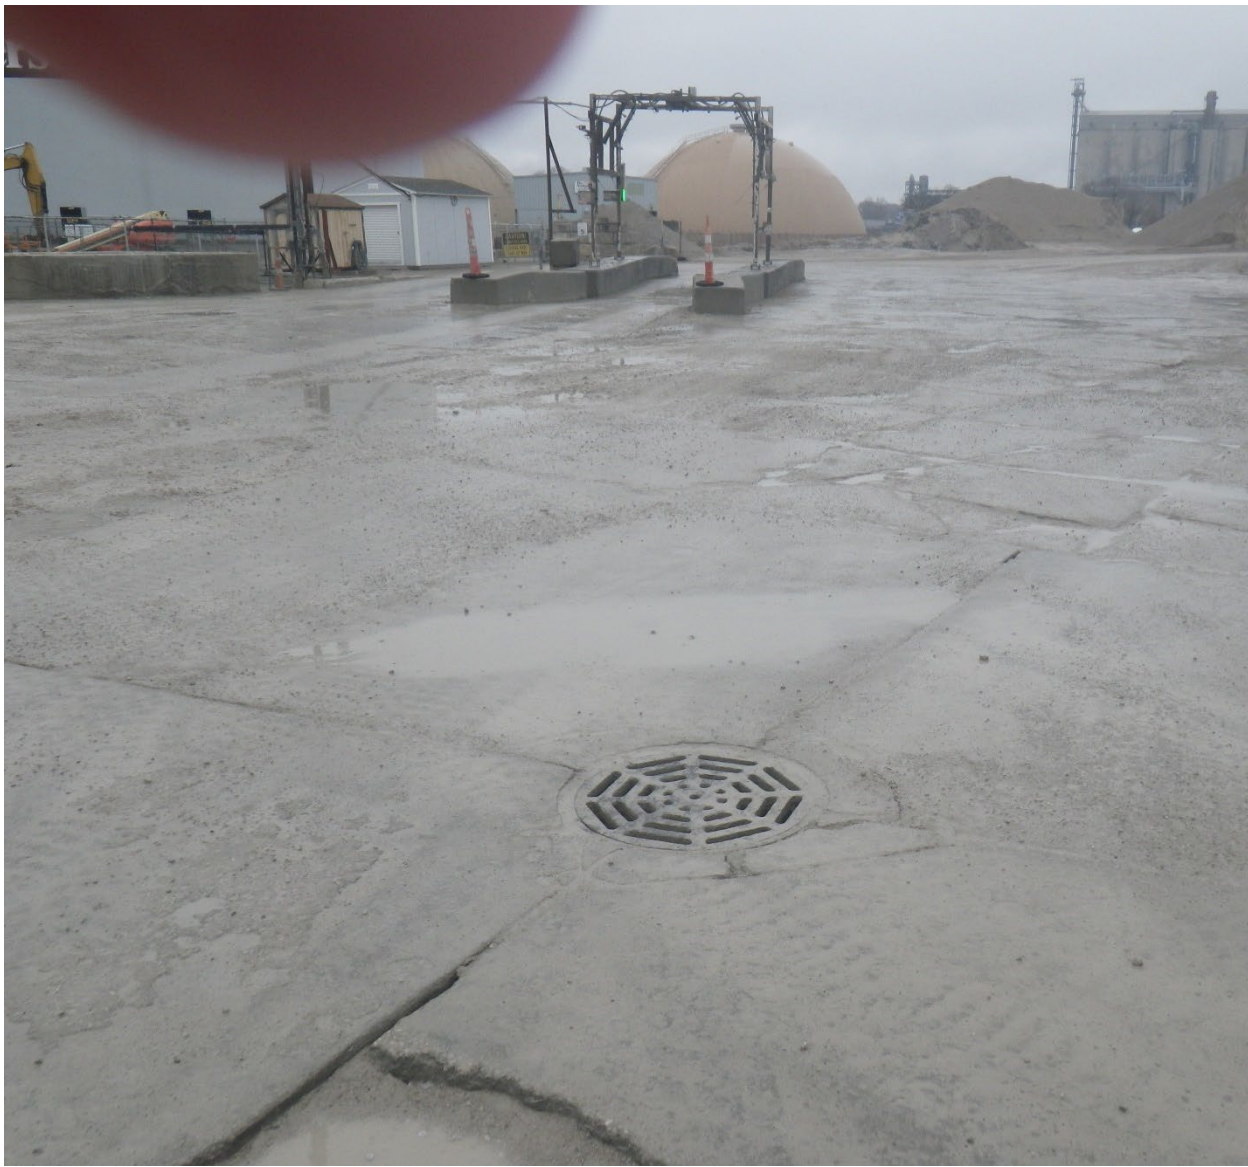
| During the inspection, EPA observed a manhole. Near the manhole was ponded water that was grayish in color. This was also present on top of the storm water manhole lid. | | |

| Photo 5. Manhole by truck washout station | | | IMGP0005.JPG |

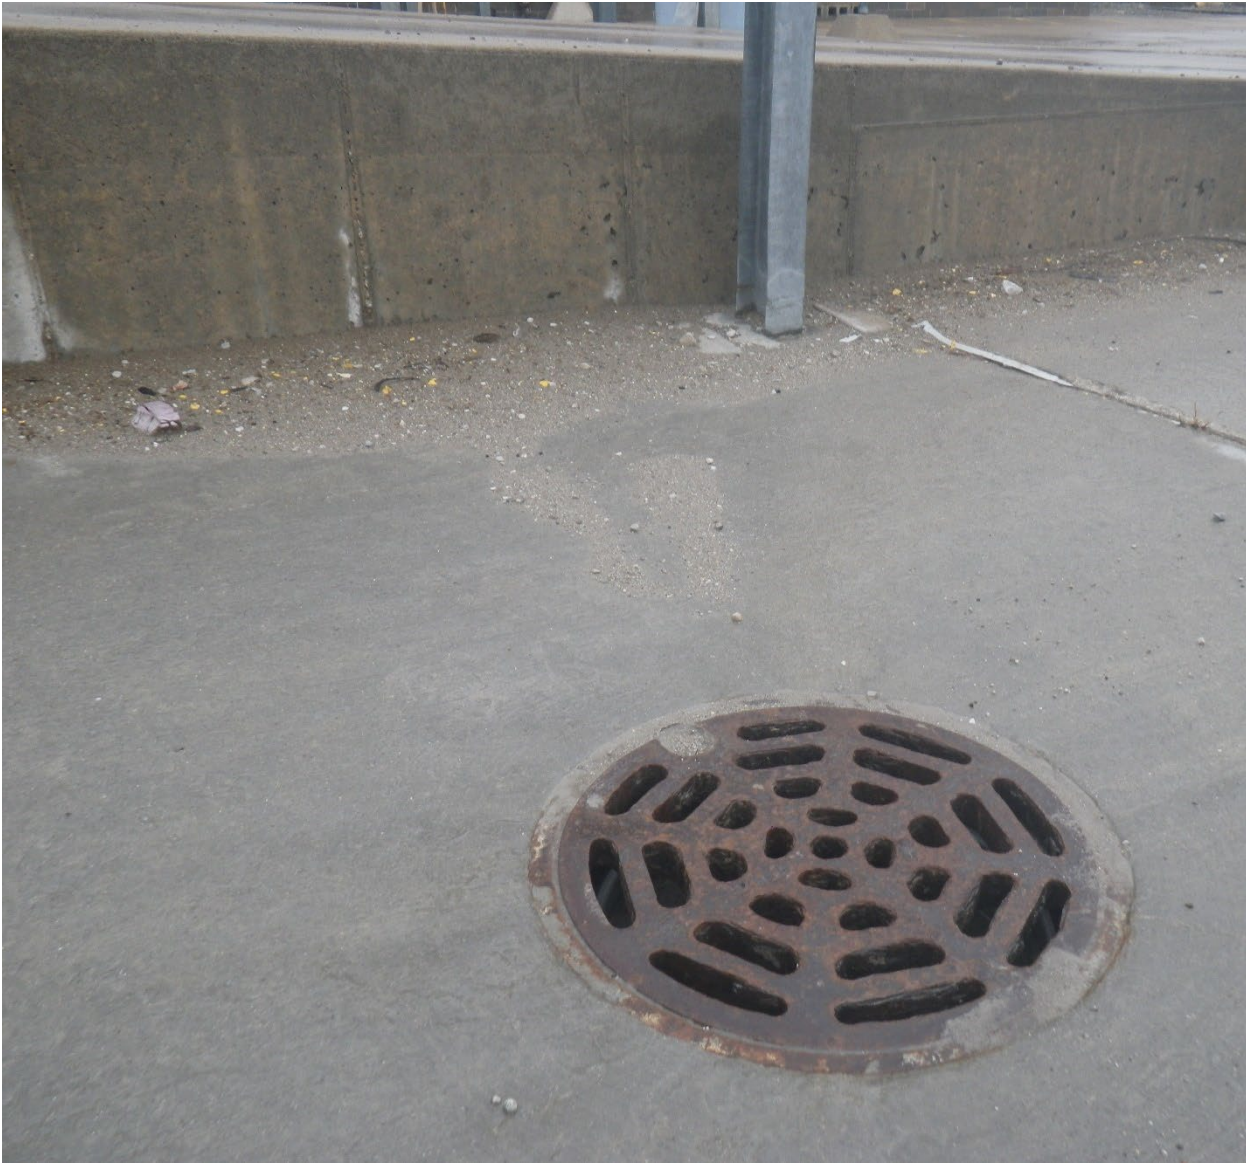
| EPA observed a manhole near the scale with a control device that was full of sediment. | | |

| Photograph 6. Manhole on site near ramp to scale.<br>Sediment can be seen along side the ramp wall near the top of the photograph. | | | IMGP0006.JPG |

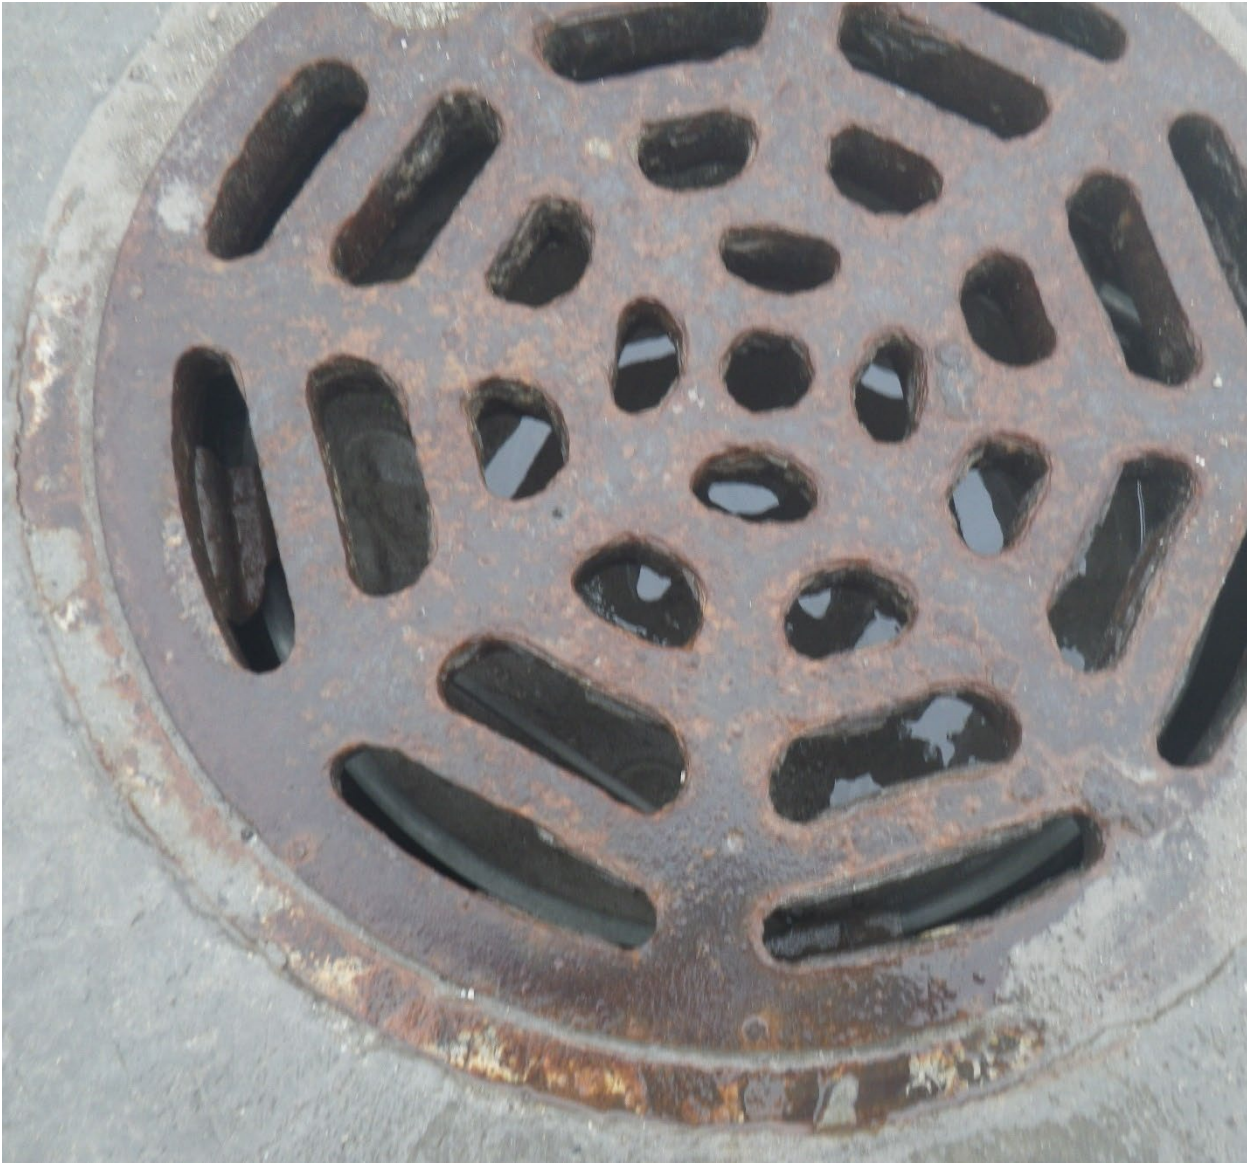
| Photograph 7. Close up of manhole on site near ramp to scale. This is also show in photo 6. Inlet protection appears to be full of sediment to the top of the container. | | | IMGP0007.JPG |

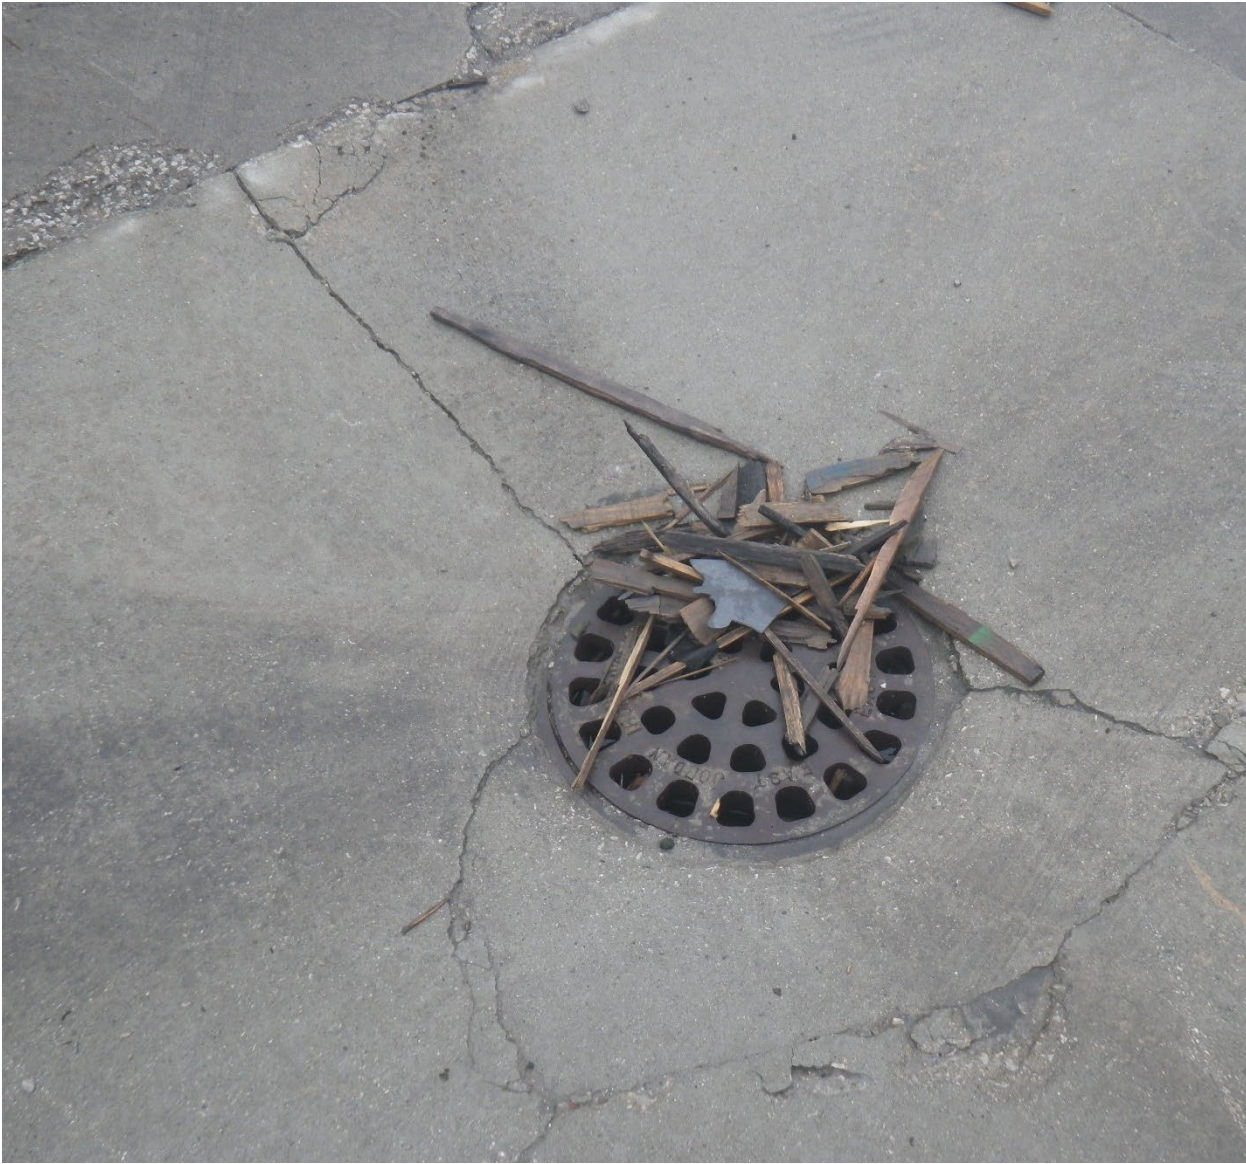
EPA observed a manhole near the facility entrance that had scrap bits of wood material on top of it.

| Photograph 8. Inlet near entrance to facility. Wood debris have accumulated on top of the inlet. | | | IMGP0008.JPG |

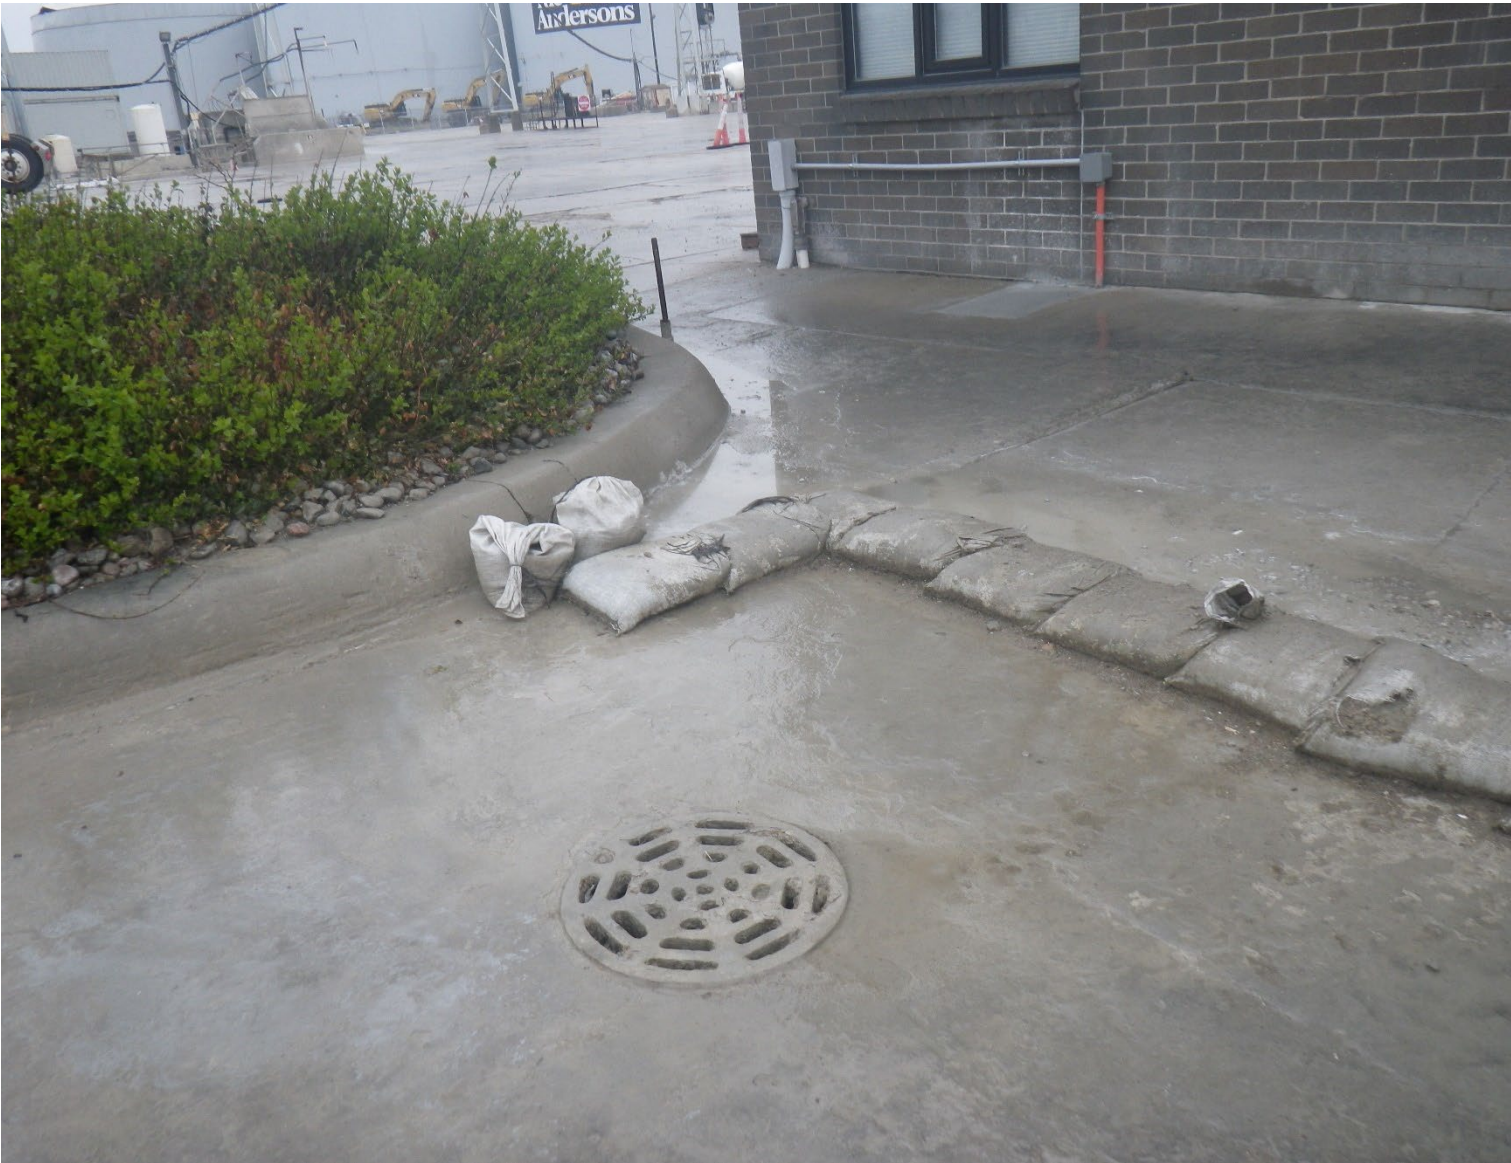
EPA observed a manhole near the facility's lab that was partially surrounded by sandbags. Loose material was seen on the downslope edges of the sandbags and one of the sandbags had ripped open. Mr. Benecke noted that the staff tests new concrete mixes inside the lab and wash it out upslope of the bags and then it drains to the storm sewer.

Pursuant to Section 1.1.3 of the General Permit, non-stormwater discharges, do not include releases of test concrete from the facility lab near the sandbagged storm drain inlet.

| Photograph 9. Manhole with laboratory concrete washout area above it and sand bags between it. Concrete is dumped between the sandbags and the building after the lab tests it. Staining can be seen on the ground between the sand bags and the inlet. This area is also shown in photographs 10 and 11. | | | IMGP009.JPG |

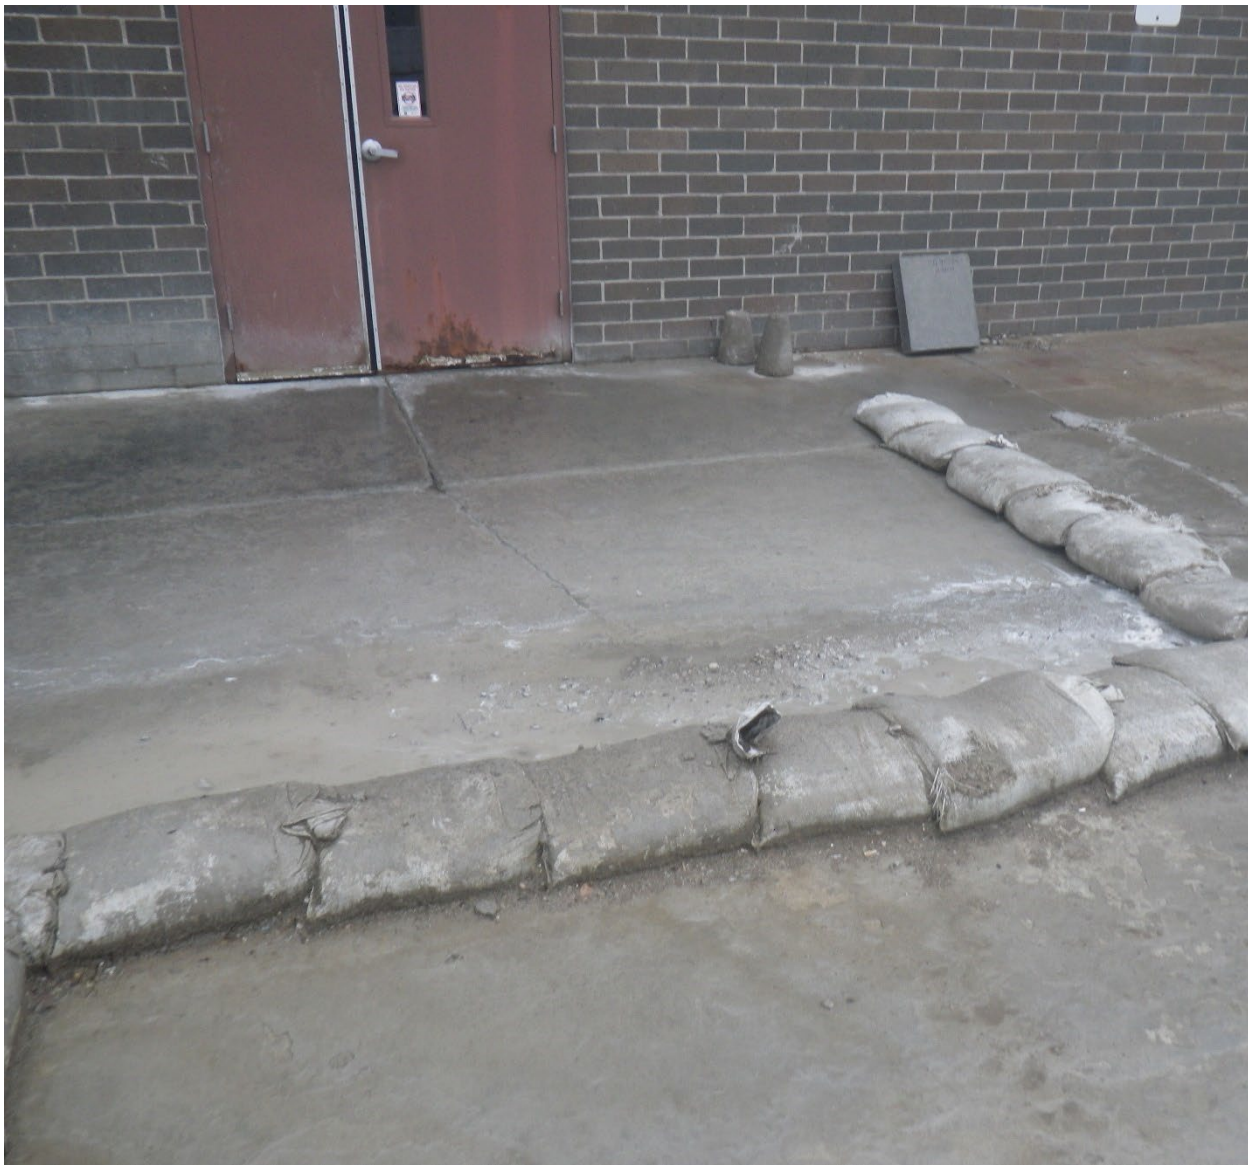
| Photograph 10. Laboratory concrete washout area between the building and sandbags. Concrete is dumped between the sandbags and the building after the lab tests it. This is also shown in photograph 9 and 11. | | | IMGP0010.JPG |

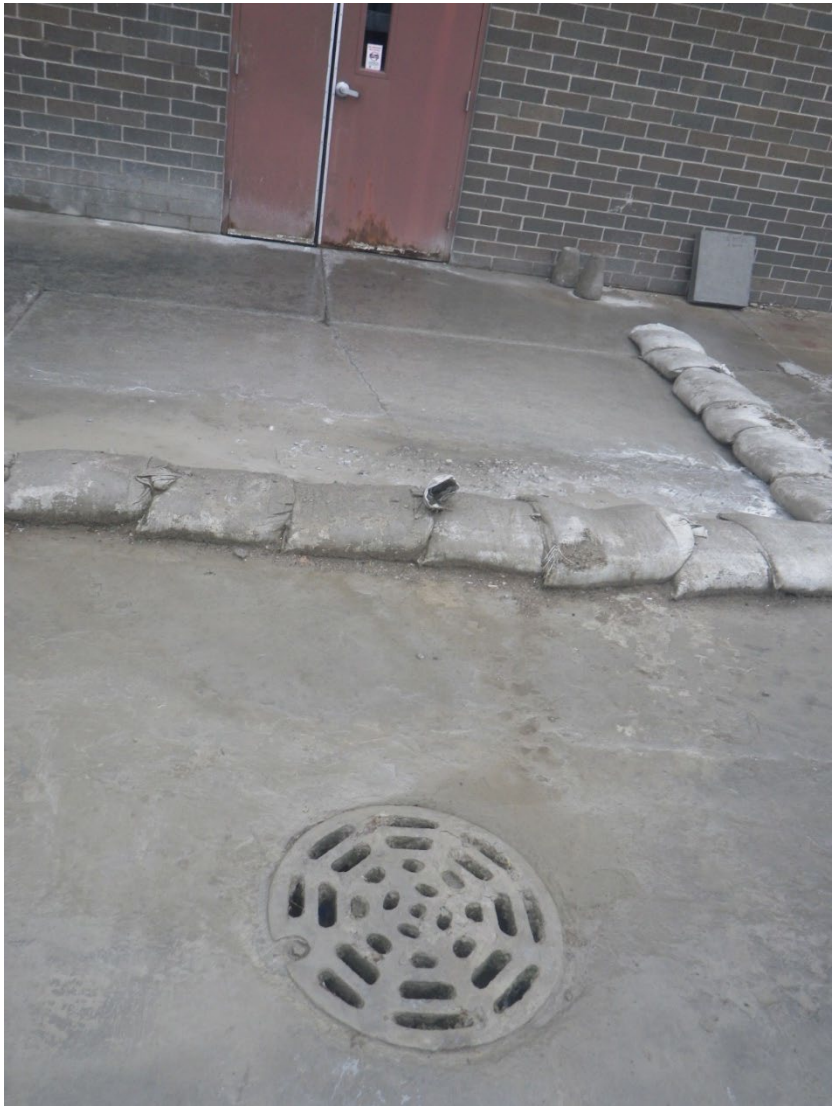
| Photograph 11. Laboratory concrete washout area between the building and sandbags. Concrete is dumped between the sandbags and the building after the lab tests it. Staining can be seen on the ground between the sandbags and the storm drain inlet. This is also shown in photograph 9 and 10. | | | IMGP0011.JPG |
