U.S. Environmental Protection Agency, Region 4  
61 Forsyth Street SW, Atlanta, GA 30303  
**Water Compliance Inspection Report**

**Facility Name:** American Woodmark Corporation – Jackson Operations

**American Woodmark Corporation – Jackson Operations**  
**Stormwater CEI – August 13, 2024**

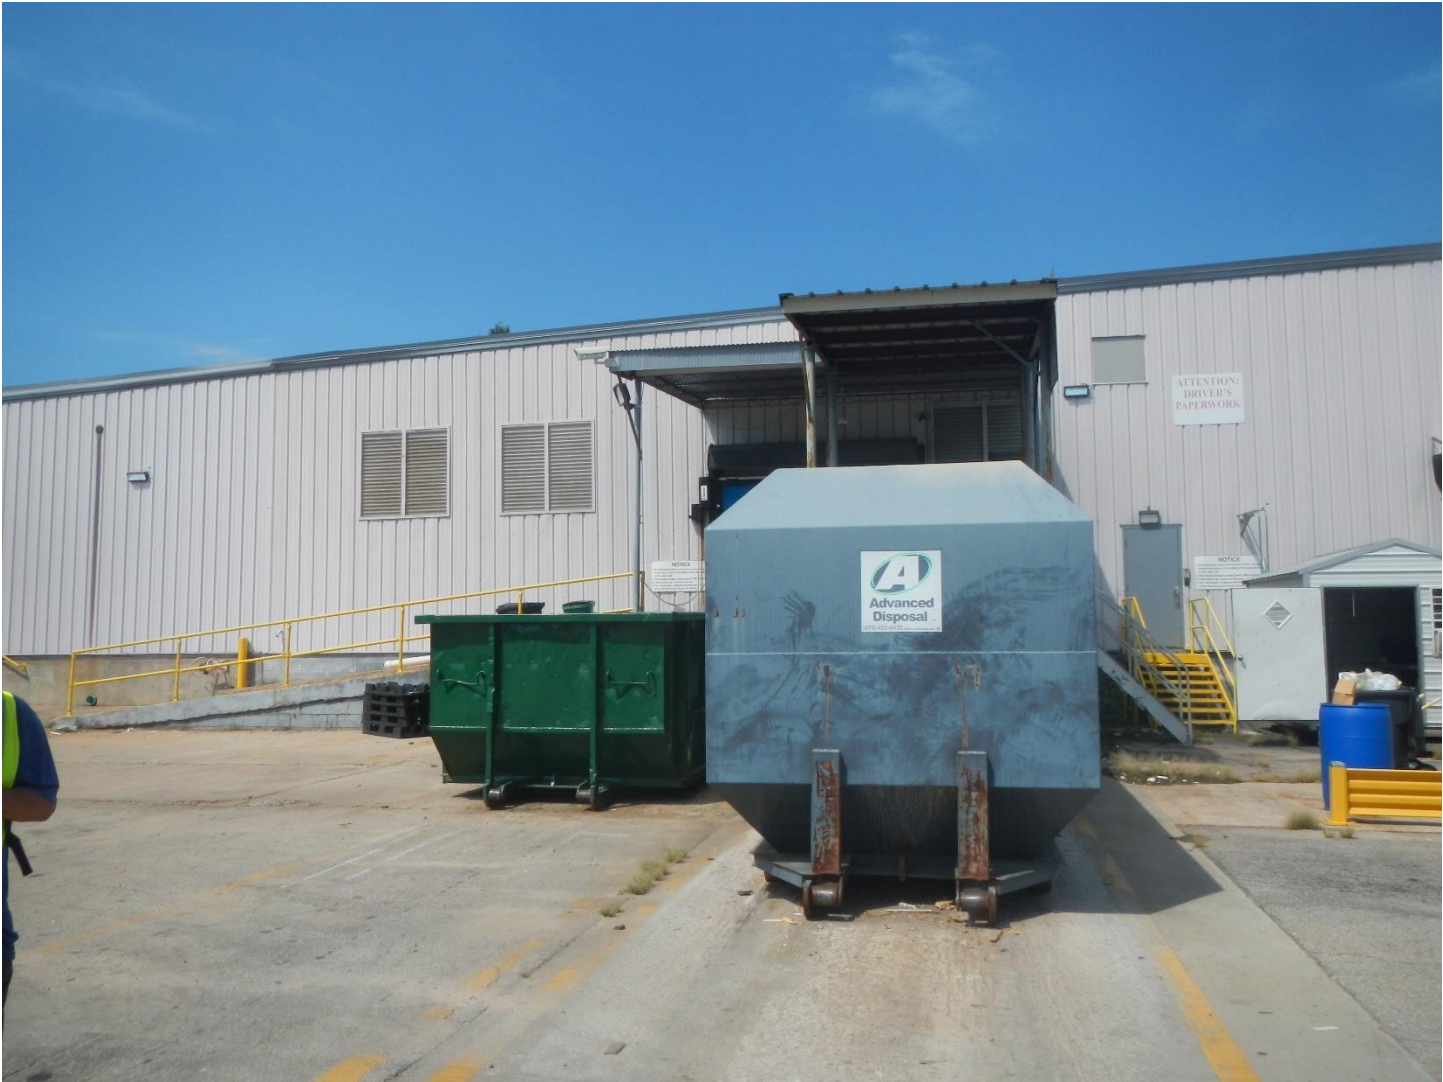
| Attributes | |
|---|---|
| Description | View of the loading area on the south side of the building. The open top dumpster is used for cabinet waste, and the compactor is used for solid trash. |

- *Dumpsters should either be covered or otherwise managed using an equivalent BMP.*
- *Maintenance activities/corrective actions, such as when the Facility cleaned out of the storm drain system after a sawdust spill, should also be tracked or recorded.*
- *An electronic copy of the SWPPP was emailed to inspectors during the inspection.*

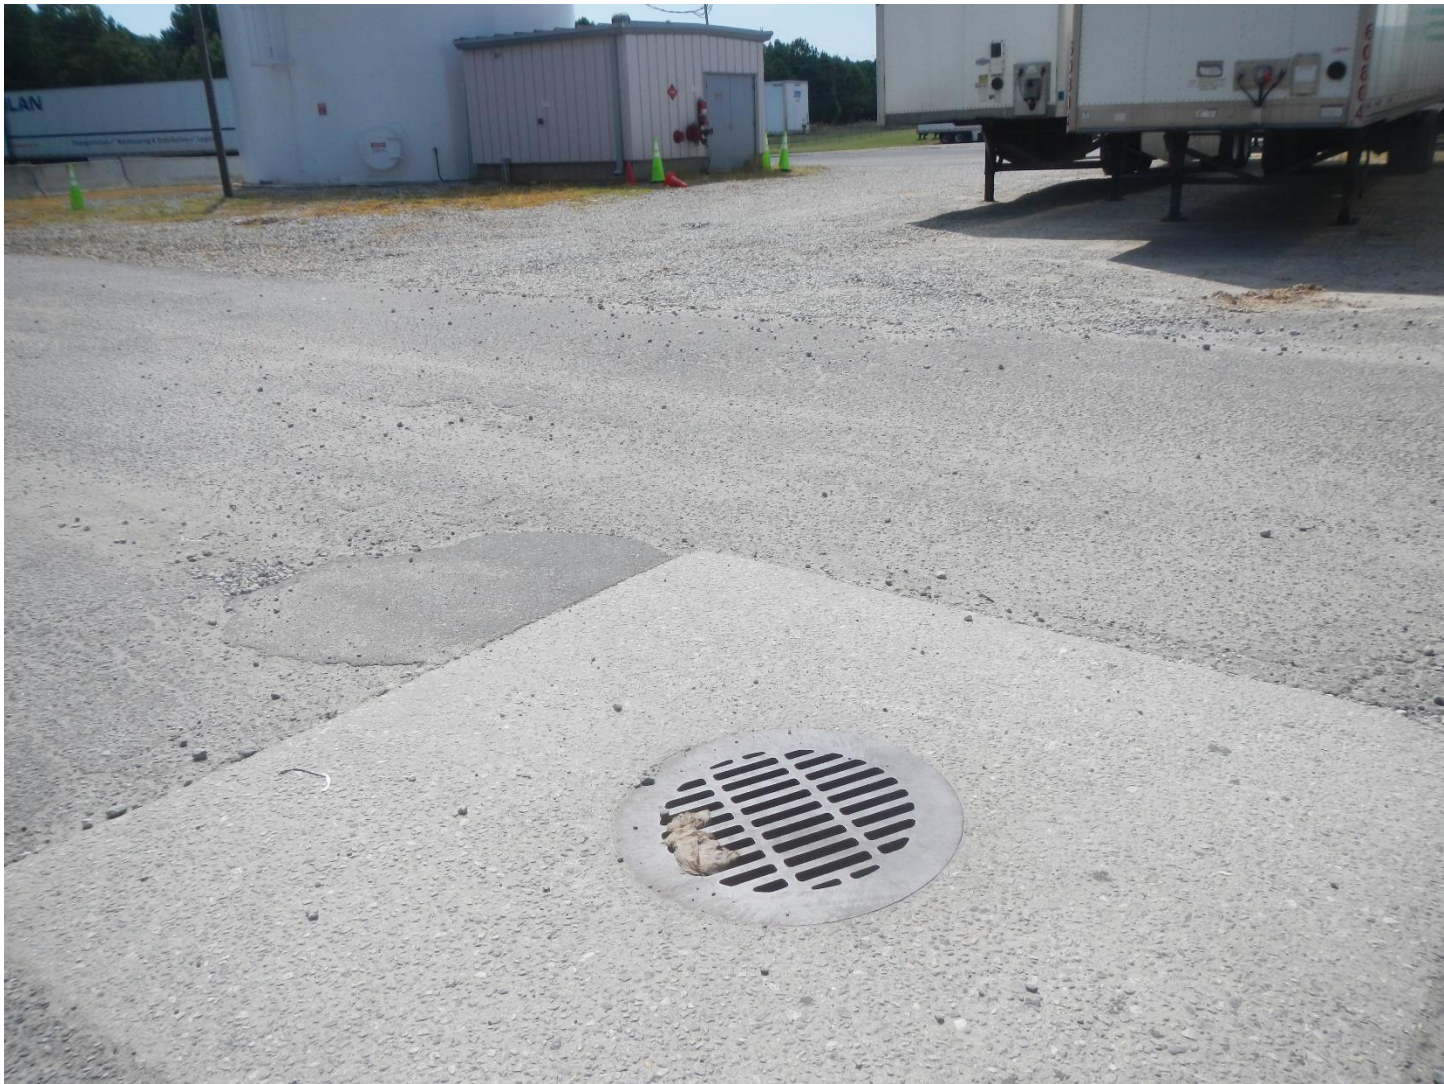
| Attributes | |
|---|---|
| Description | Location of a storm drain inlet. Water drains northerly (approximately towards photographer's right). Tower visible in the background stores water for emergency fire suppression purposes. |

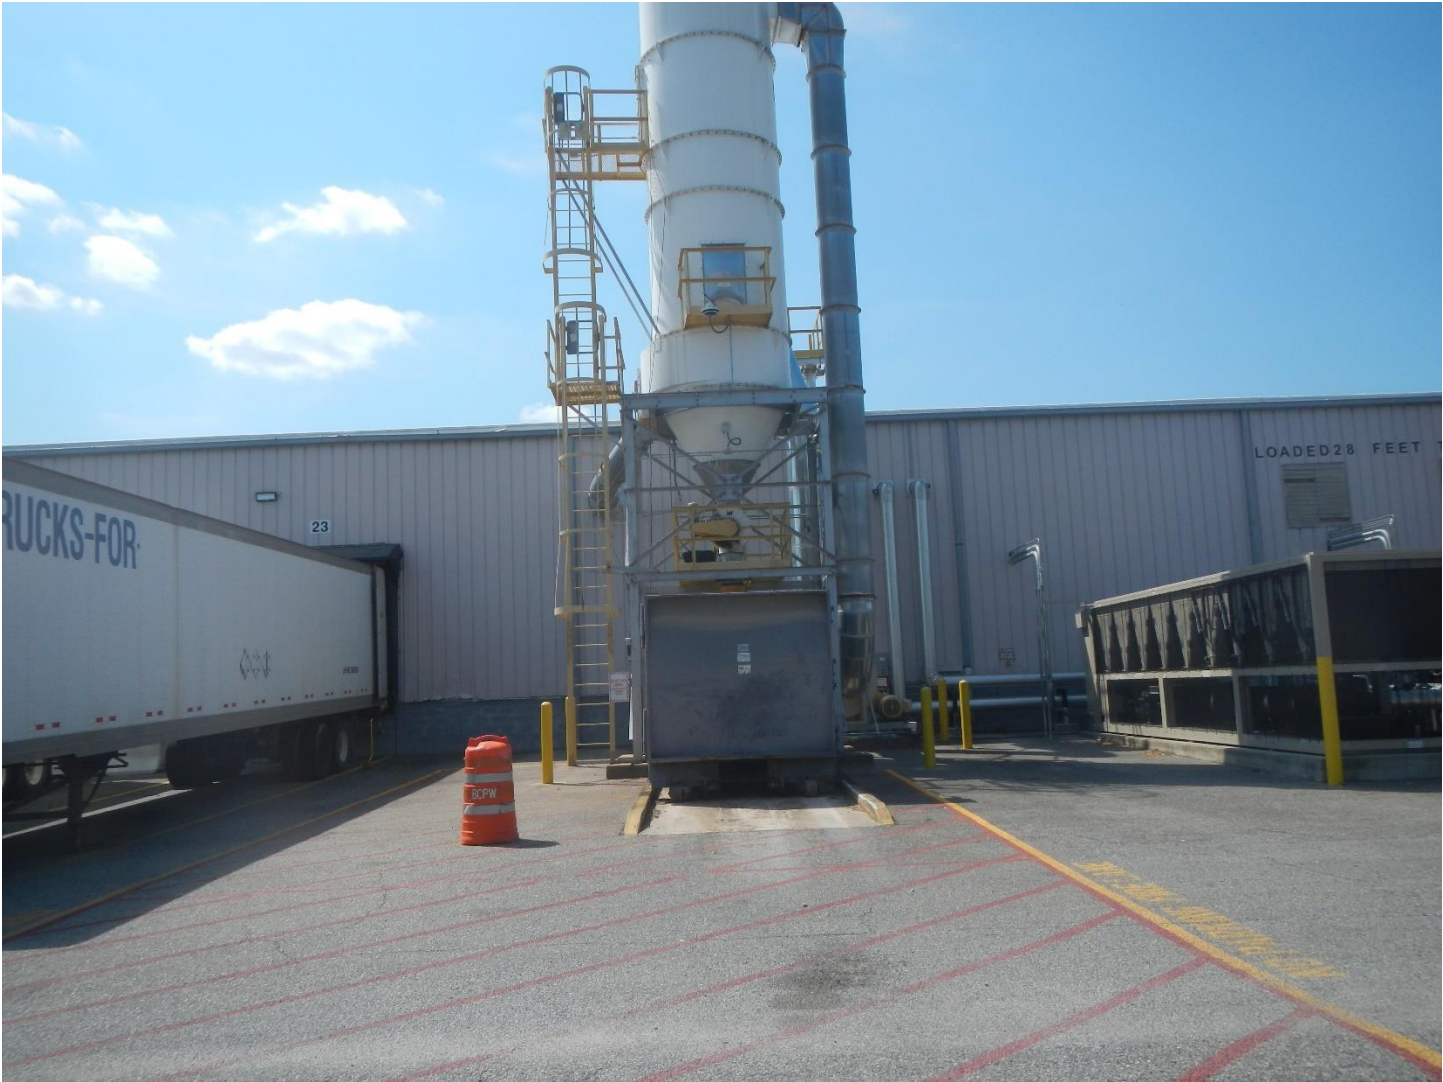
| Pollutant Sources | Note location, quantitative description, design issue, O&M deficiencies, and pollutants offsite |
|---|---|
| <b>Loading/Unloading Area</b> | <i>Everything is shipped in/out on trucks. Sawdust collected from the assembly line is loaded directly into a compactor, as shown in photo DSCN3013. Sawdust from the indoor mill is collected and loaded into a compactor at the location shown in photo DSCN3014.</i> |

| Attributes | |
|---|---|
| Description | Sawdust collection system for the assembly line loads sawdust into a compactor and hauled offsite. There was no sawdust spillage at the time of the inspection. |

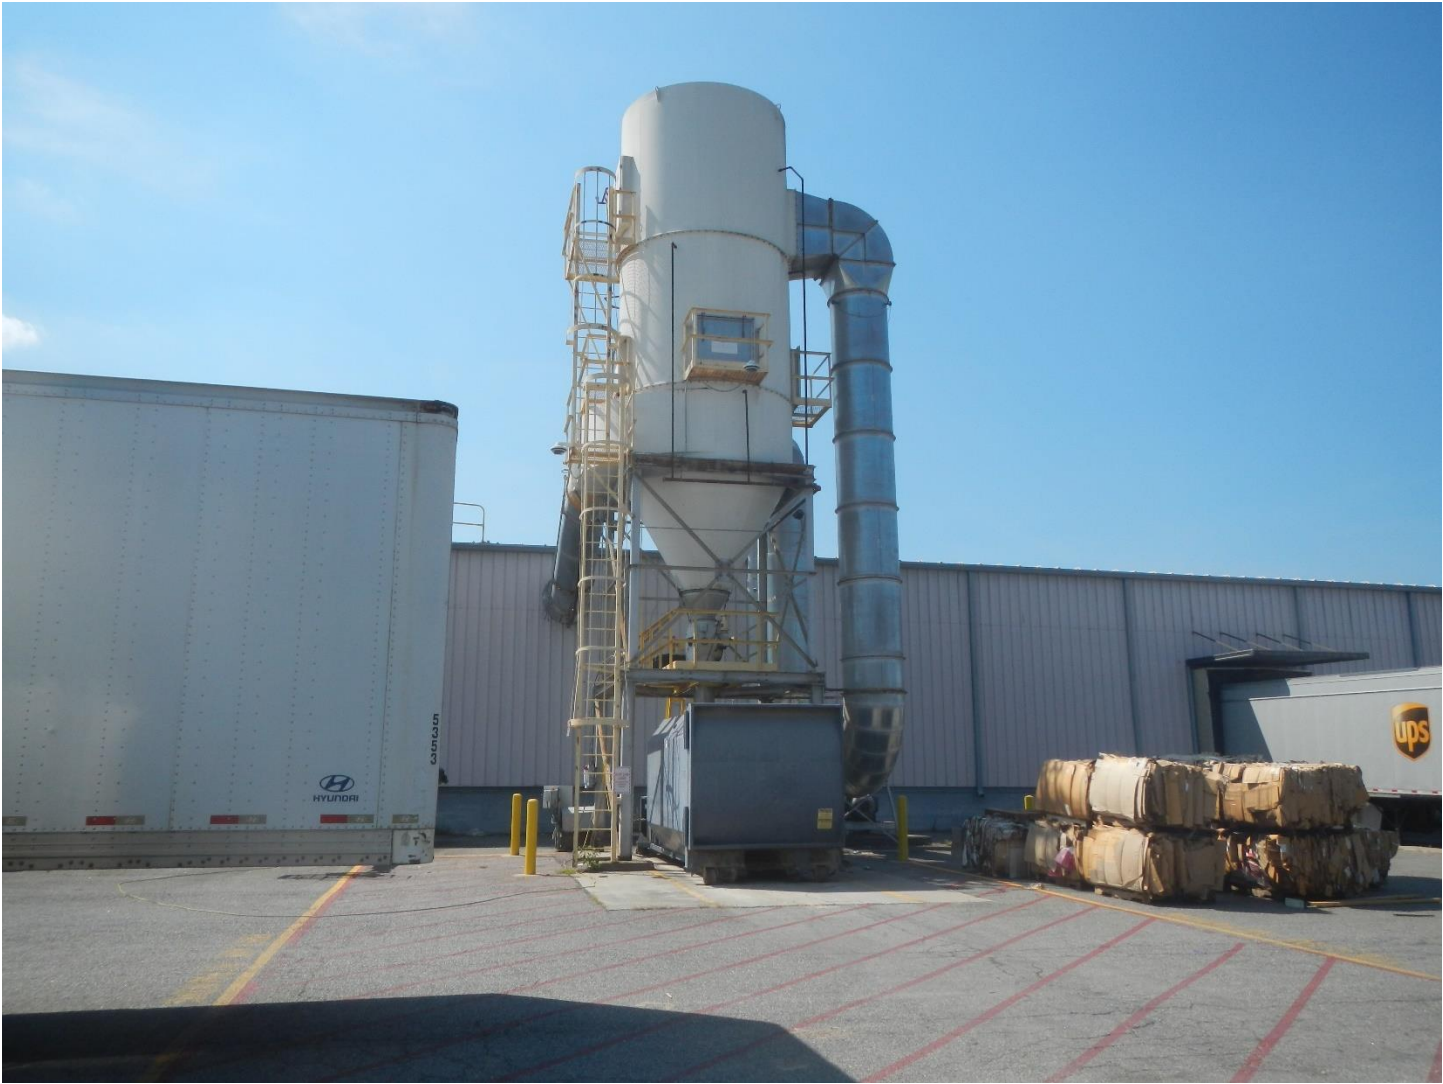
| Attributes | |
|---|---|
| Description | View of the dust collection system for the indoor mill. Sawdust is loaded into a compactor. |

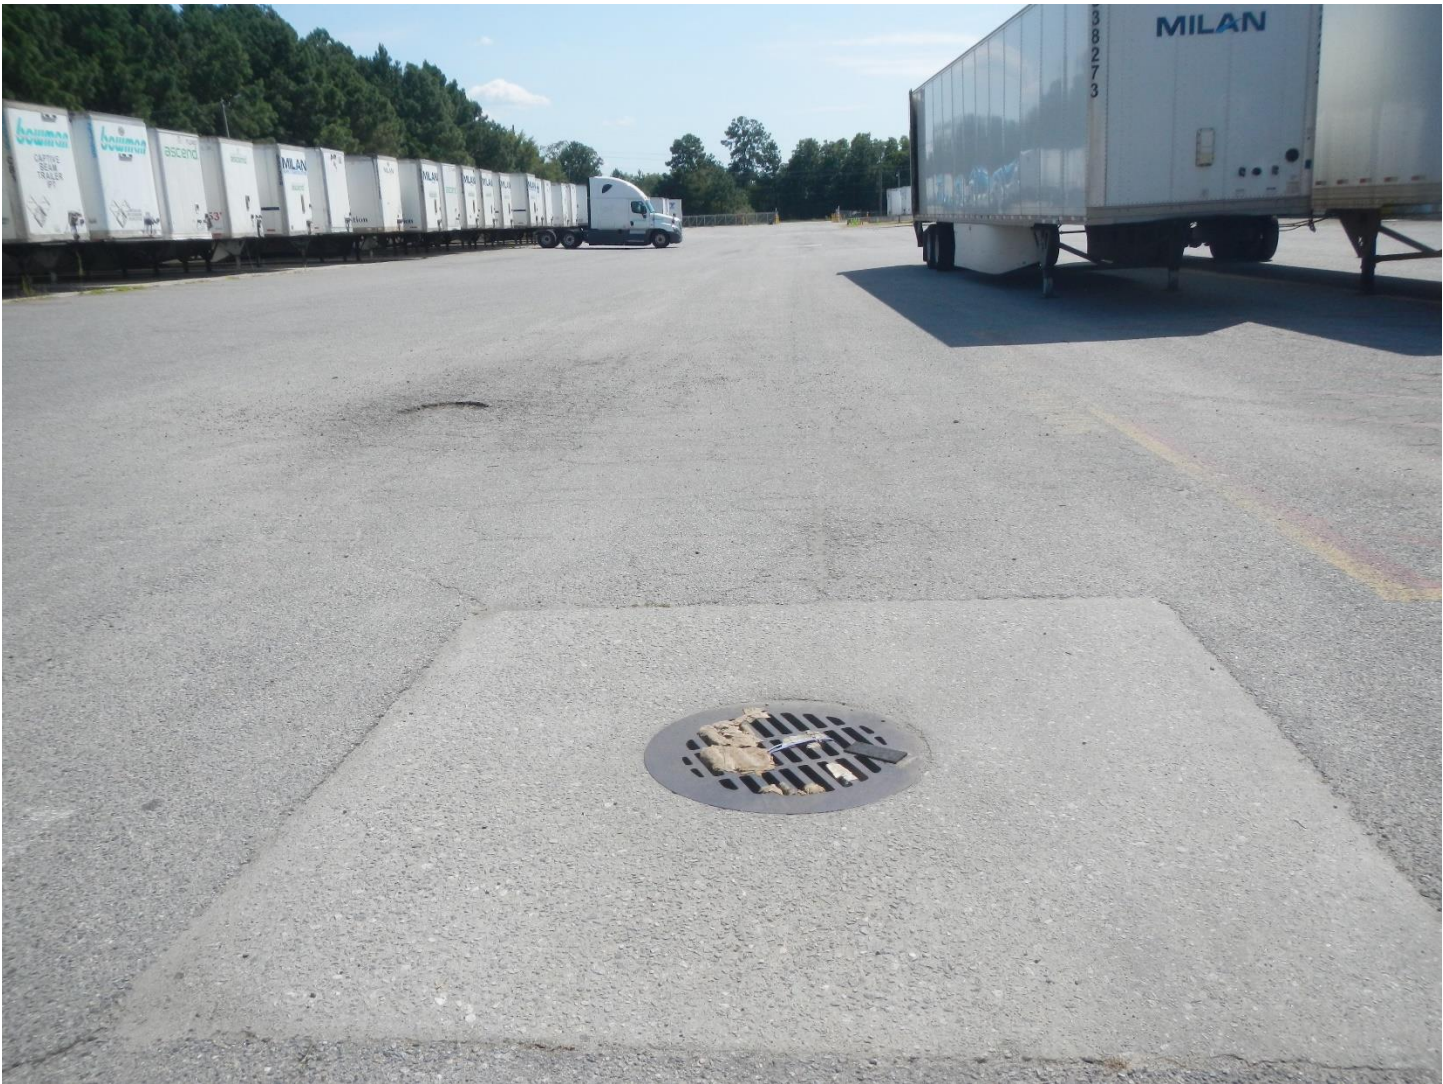
| Attributes | |
|---|---|
| Description | View of a storm drain inlet on the eastern side of the building. Debris had accumulated on the grate and was in need of cleaning. Water flows opposite of camera direction. Trailers are stored in the yard here. |

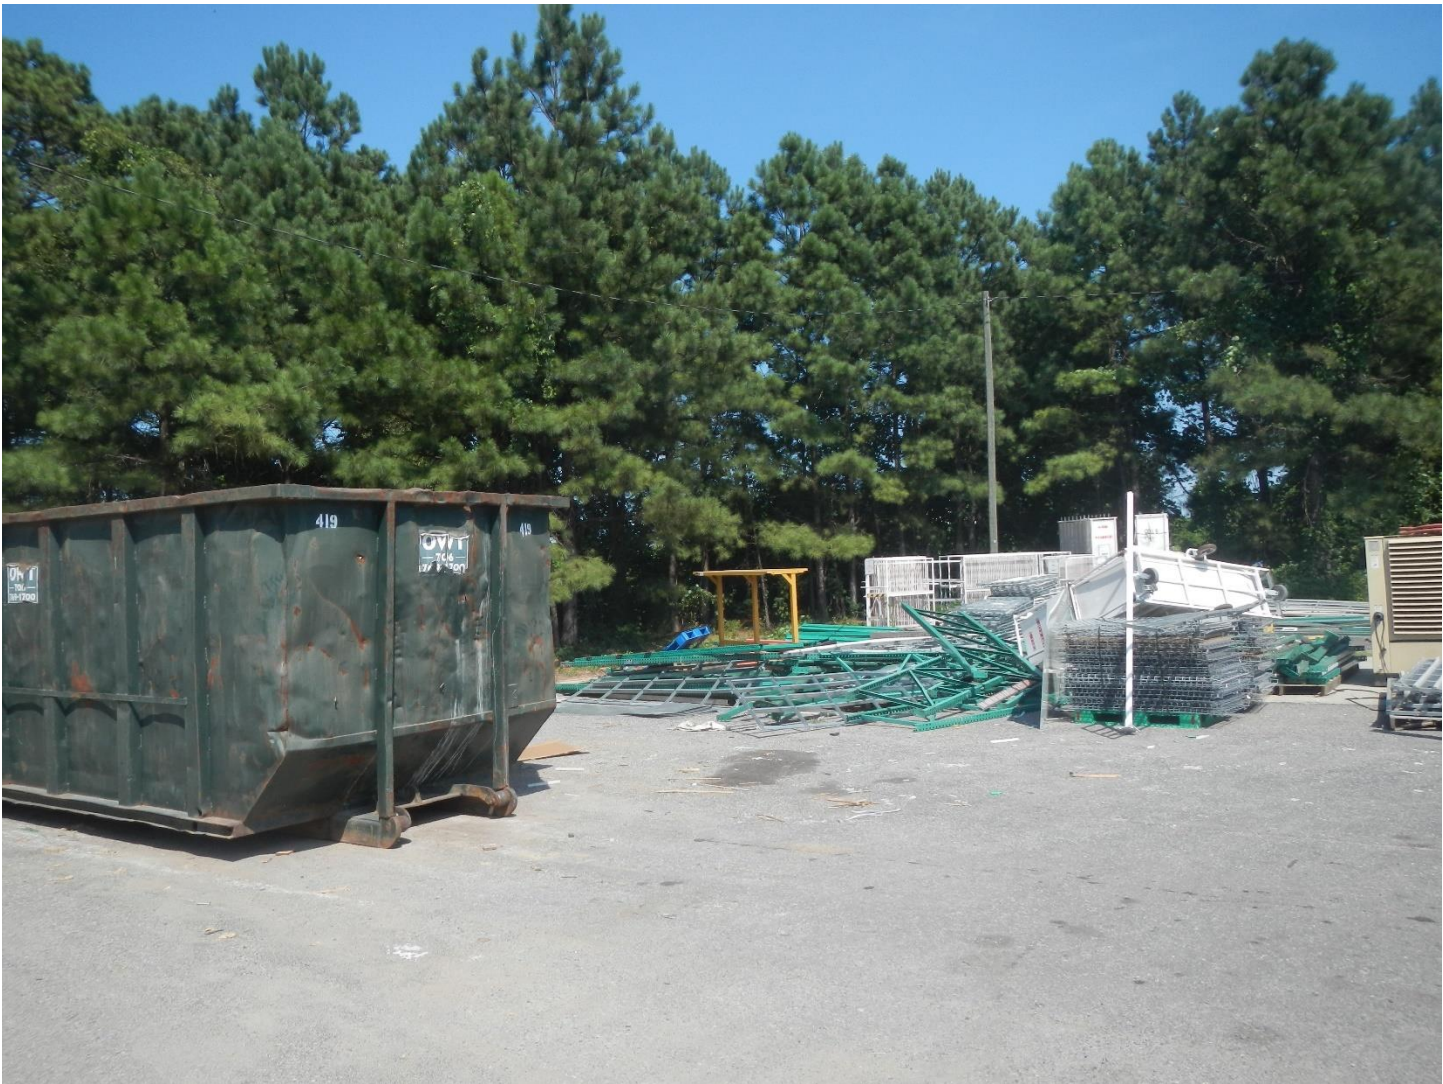
| <b>Outdoor Storage</b> | <i>Metal rack material is stored outdoors as shown in photo DSCN3016. According to Facility personnel, unusable metals will be moved into the open top dumpster at the other end of the Facility for recycling. Recycling is collected approximately monthly. Cardboard is bailed and stored outside (see for example DSCN3014) while it awaits pickup for recycling.</i> |

| Attributes | |
|---|---|
| Description | View of outdoor storage area. Metals are used for rack work. Waste rack metals will be loaded into the dumpster at the front of the facility for recycling. Recycling pick up is about once per month. See also photo DSCN3017. |

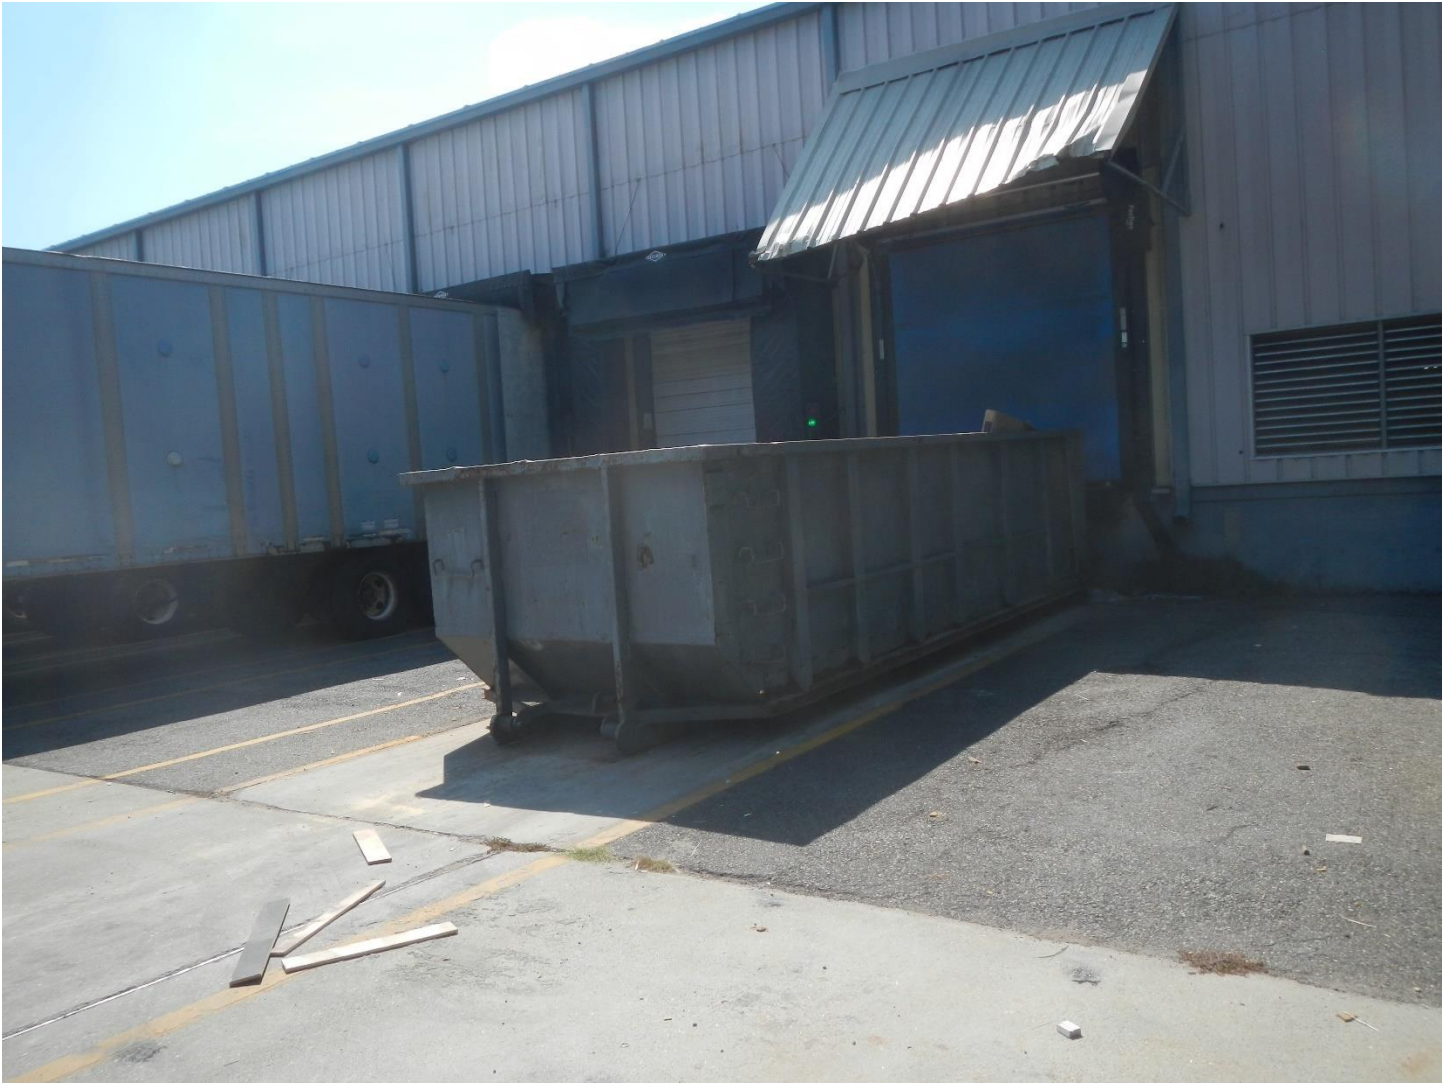
| <b>Waste Treatment/ Storage/Disposal Areas</b> | <i>The open top dumpster shown in photo DSCN3011 is used for cabinet waste and the compactor is used for trash. Facility also utilizes open top dumpsters as shown in photos DSCN3016 and DSCN3017 for pallets from warehouse and remnants from the mill. The dumpsters were not covered.</i> |

| Attributes | |
|---|---|
| Description | The two open top dumpsters on this end of the Facility contain miscellaneous wood debris including pallets from the warehouse and remnants from the mill. |

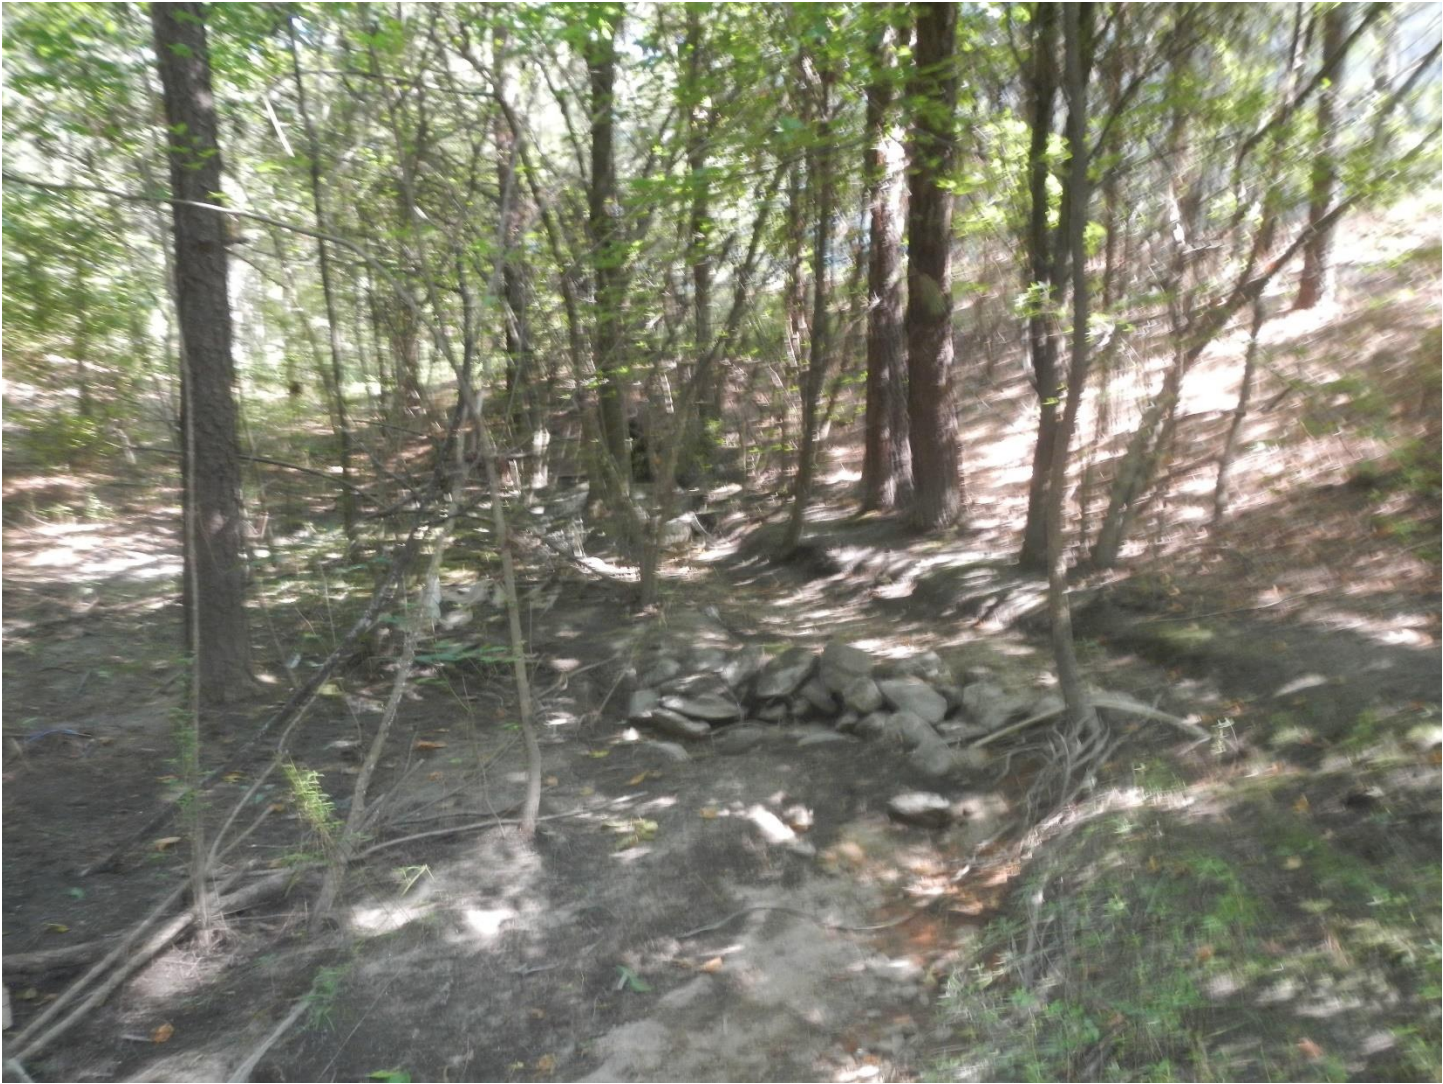
| Attributes | |
|---|---|
| Description | Looking downgradient. Water from the storm drain system on the eastern side of the building discharges in the direction shown into this retention area. |

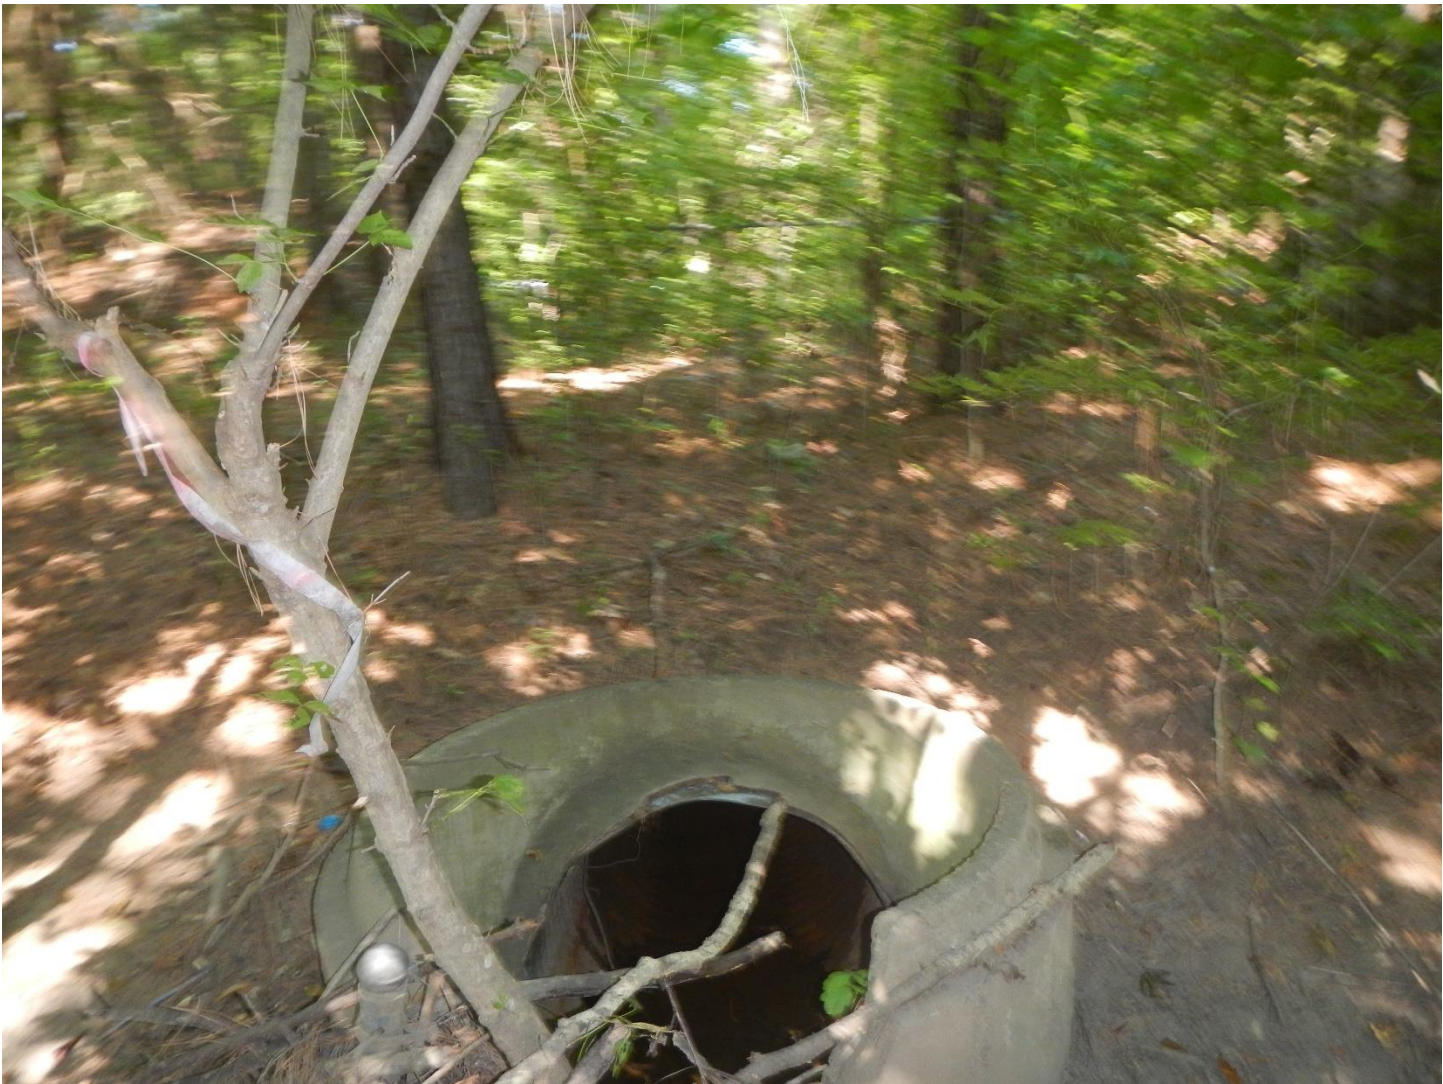
| Attributes | |
|---|---|
| Description | Looking downgradient. Once water in the low retention area reaches a certain height, it discharges through the outlet structure and towards the railroad tracks, in the direction shown in photo DSCN3020. |

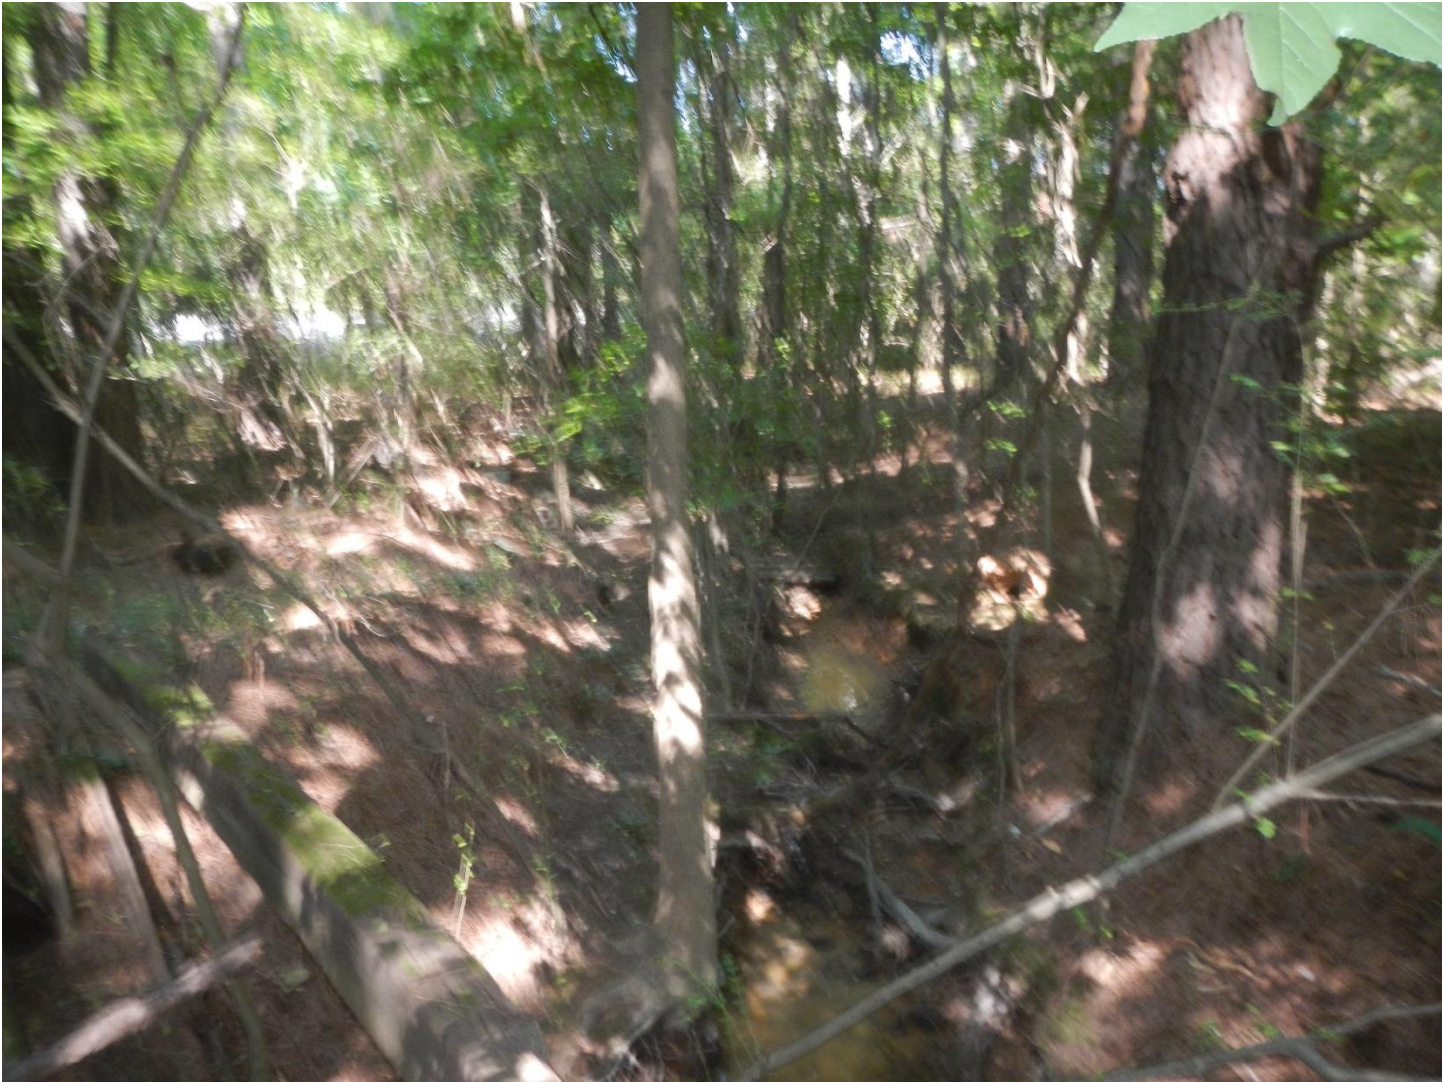
| Attributes | |
|---|---|
| Description | Looking downgradient. Water from the retention area behind the parking lot discharges through the outlet structure and continues towards the railroad, in the direction shown here. |

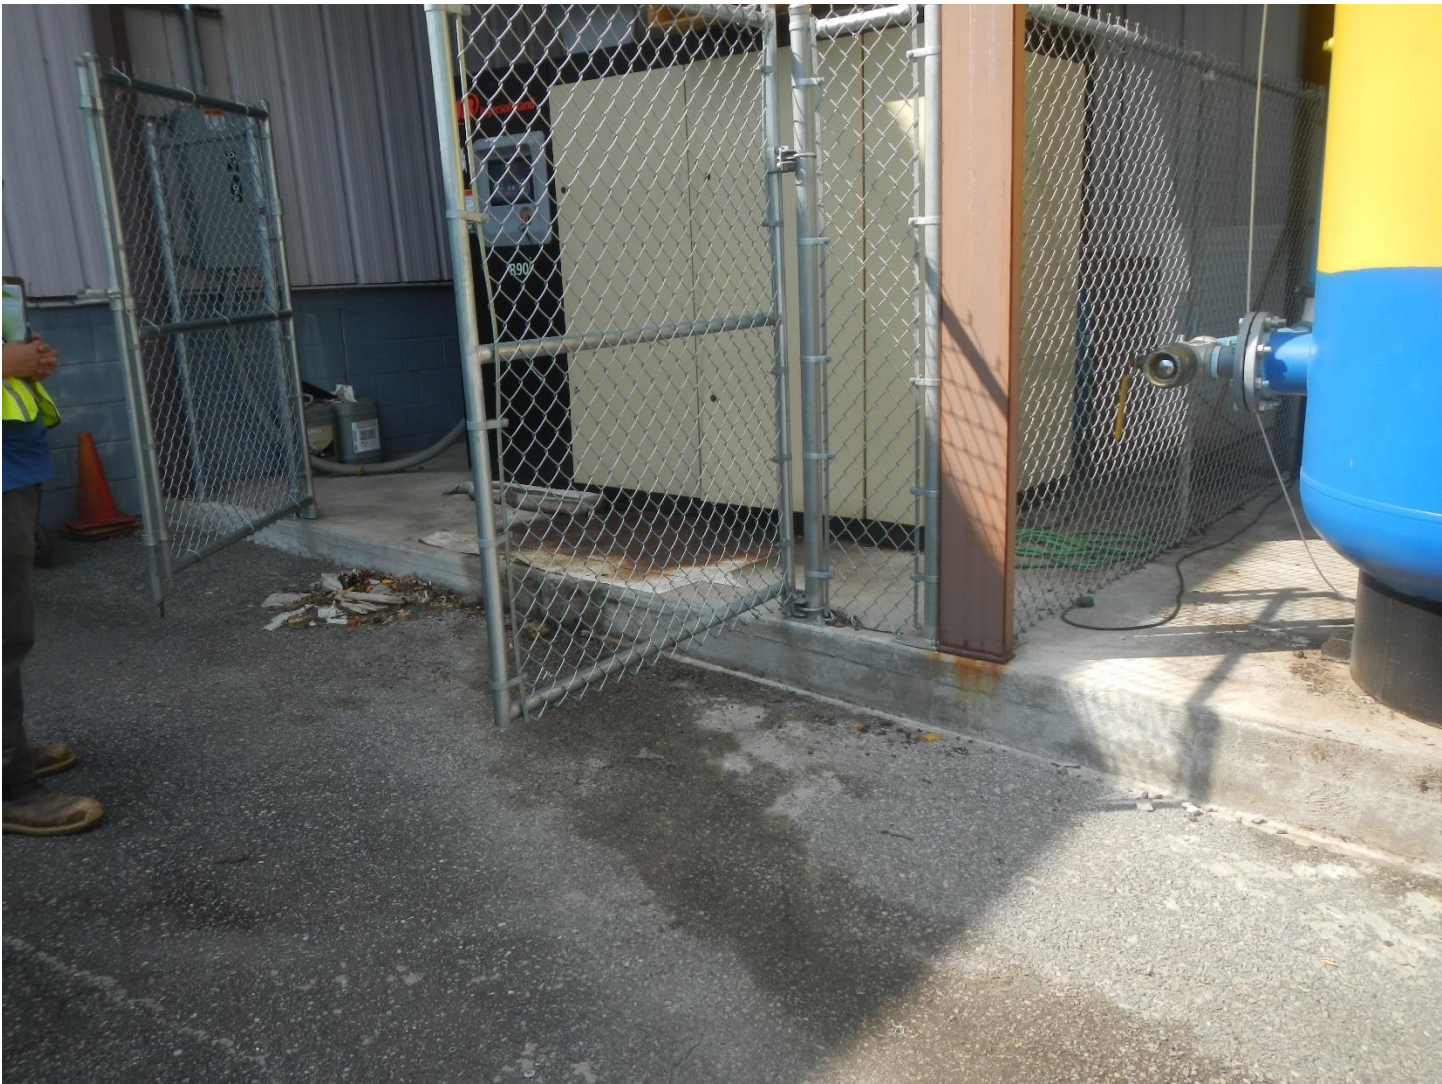
| Attributes | |
|---|---|
| Description | There was a recent oil leak on one of the Facility’s compressors, which Facility personnel stated was cleaned up. Based on the residual staining on the asphalt, the leak did not reach a storm drain inlet. |

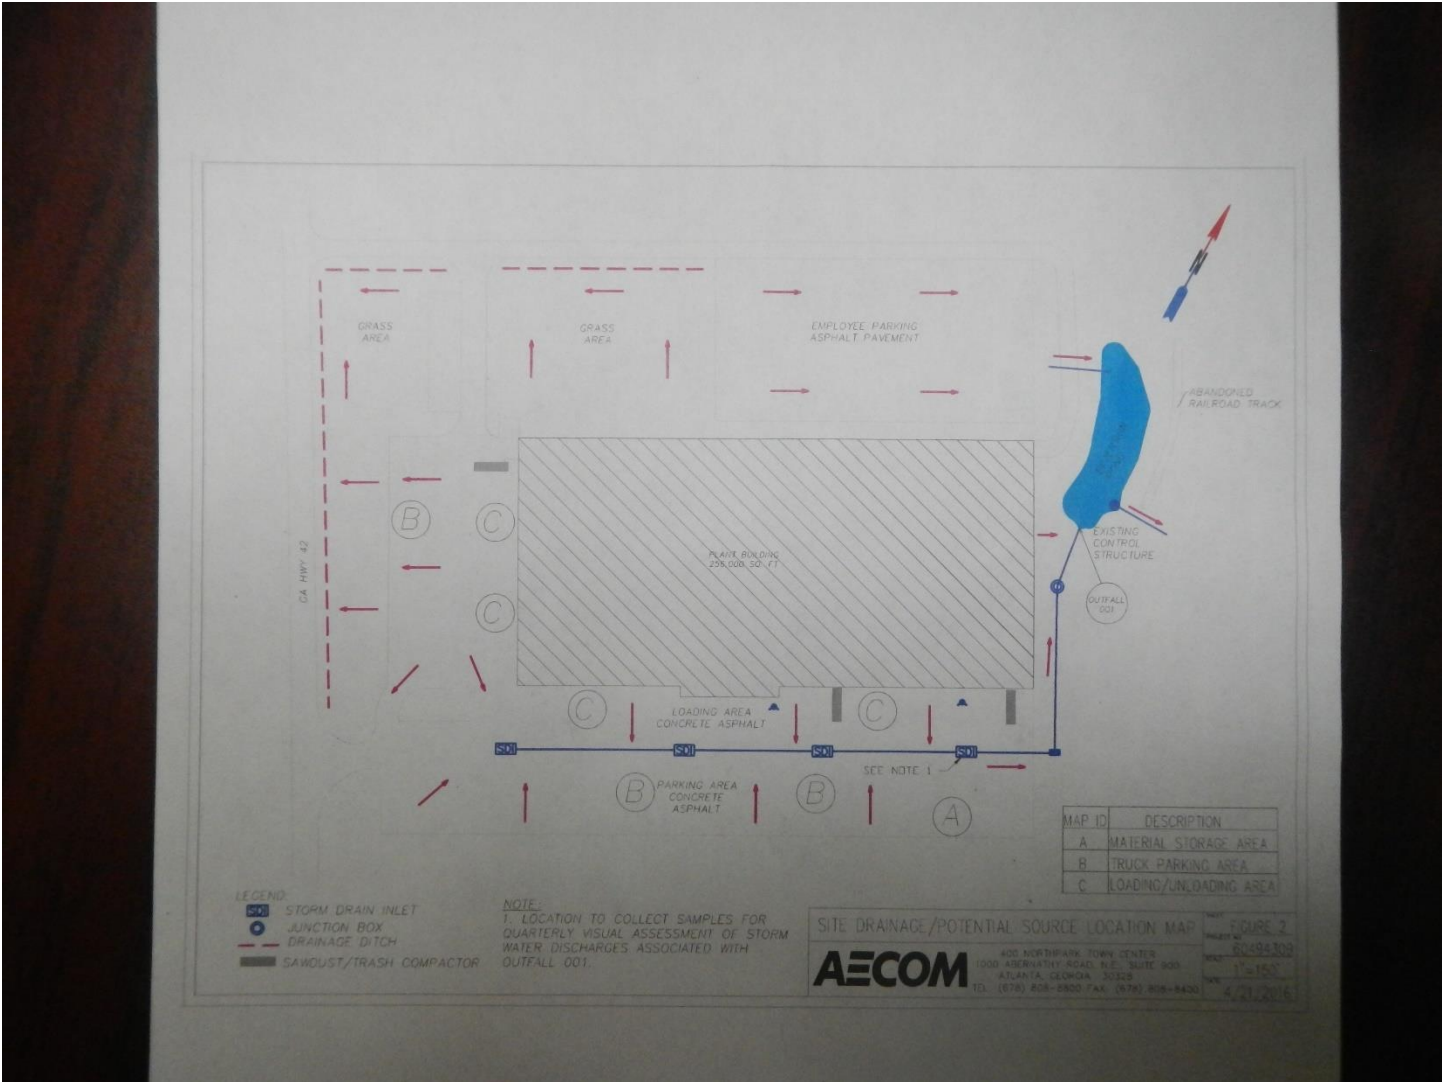
| OUTFALL, STORMWATER, DISCHARGE, & RECEIVING WATER | YES | NO | DESCRIPTION |
|---|---|---|---|
| <b>Number &amp; location of stormwater discharge(s)/outfall(s) consistent with SWP3</b> | <b>X</b> | | <i>Water from the site's drainage system discharges into a retention area, as shown in photo DSCN3022, which is identified as Outfall 001.</i> |

| Attributes | |
|---|---|
| Description | View of the site map from the Facility's SWPPP |

| <b>Representative Sampling</b><br><i>Indicator monitoring has not yet been conducted. If the facility wishes to perform visual sampling and monitoring at the storm drain inlet identified in the SWPPP (see photo DSCN3022) instead of at Outfall 001 for easier access, this location should first be discussed with/approved by GA EPD.</i> | App B.14.1 | | | X |
