**Well Inspection**  
**Osage DNR / Environmental Protection Agency**  
**1201 Elm Street, Suite 500**  
**Dallas, Texas 75270**

| | | <b>Lease Name</b> | LONG | | |
| | | <b>Well ID</b> | 4 | | |
| <b>Inspection Reason</b> | Plugging Witnessed | <b>Responsible Company at Time of Inspection</b> | Calgary Energy, LLC | | |

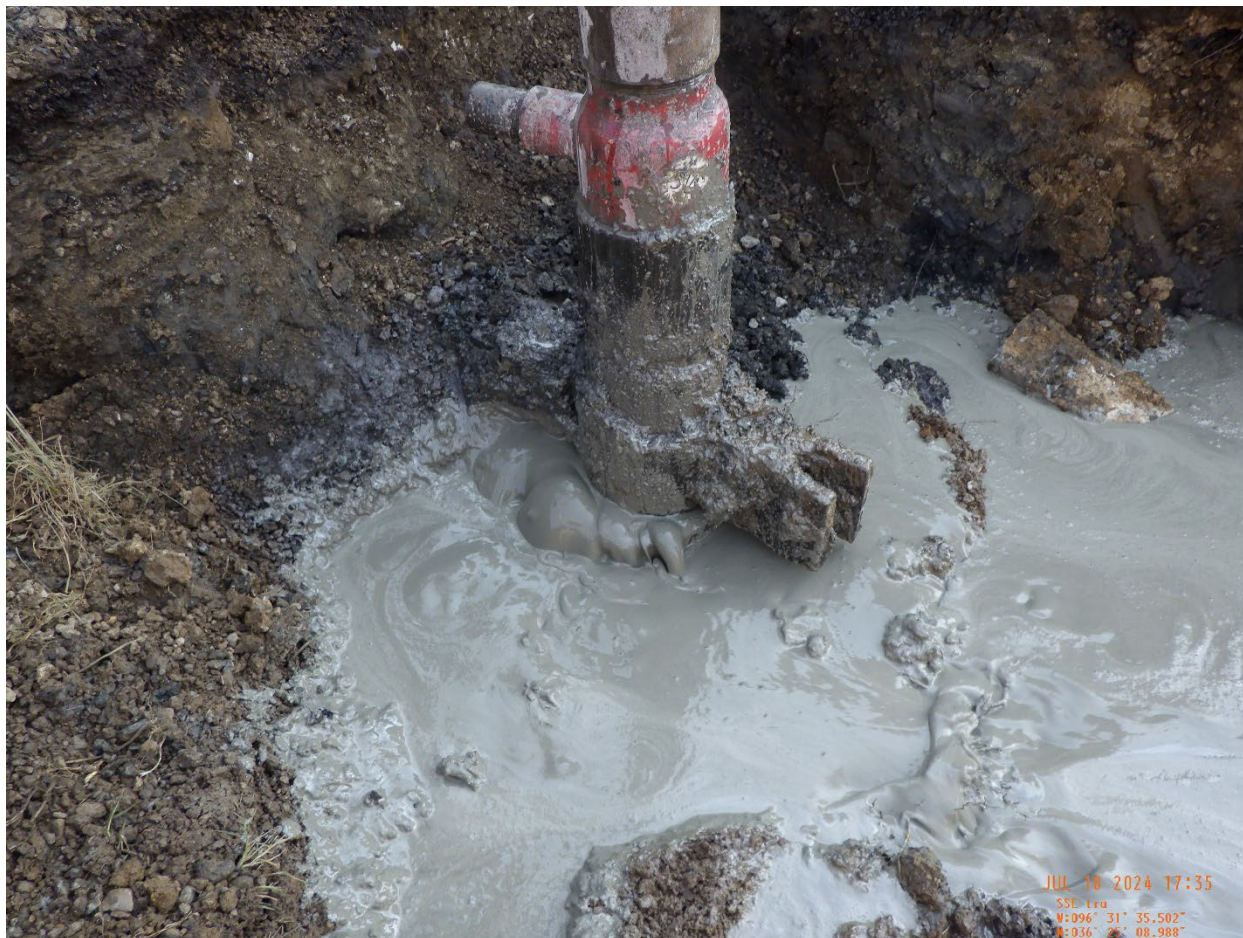
Photo No. 1

| <b>Inspection Comments</b> | Inspector observed Calgary Energy, LLC run in hole and tag the top of the bottom cement plug at 2275 feet below the land surface. Calgary Energy, LLC filled the hole with mud from 2275 feet to 320 feet, then pulled out of the hole and equipped a casing knife on the tubing. Calgary Energy, LLC ran in hole to 320 feet and perforated the casing, then removed the casing knife and ran back into 320 feet below surface. 130 sacks of cement were circulated to the surface. Inspector observed cement standing at the surface with no fall back. | | | | |

**Description:** This was well OS0810000 with cement circulated to the surface.
