**UNITED STATES ENVIRONMENTAL PROTECTION AGENCY  
REGION 8  
RESOURCE CONSERVATION AND RECOVERY ACT**

**Facility Name:** R360 Shute Creek LLC

**Date of Inspection:** May 16, 2023

**Type and Purpose of Inspection:** Compliance Evaluation Inspection

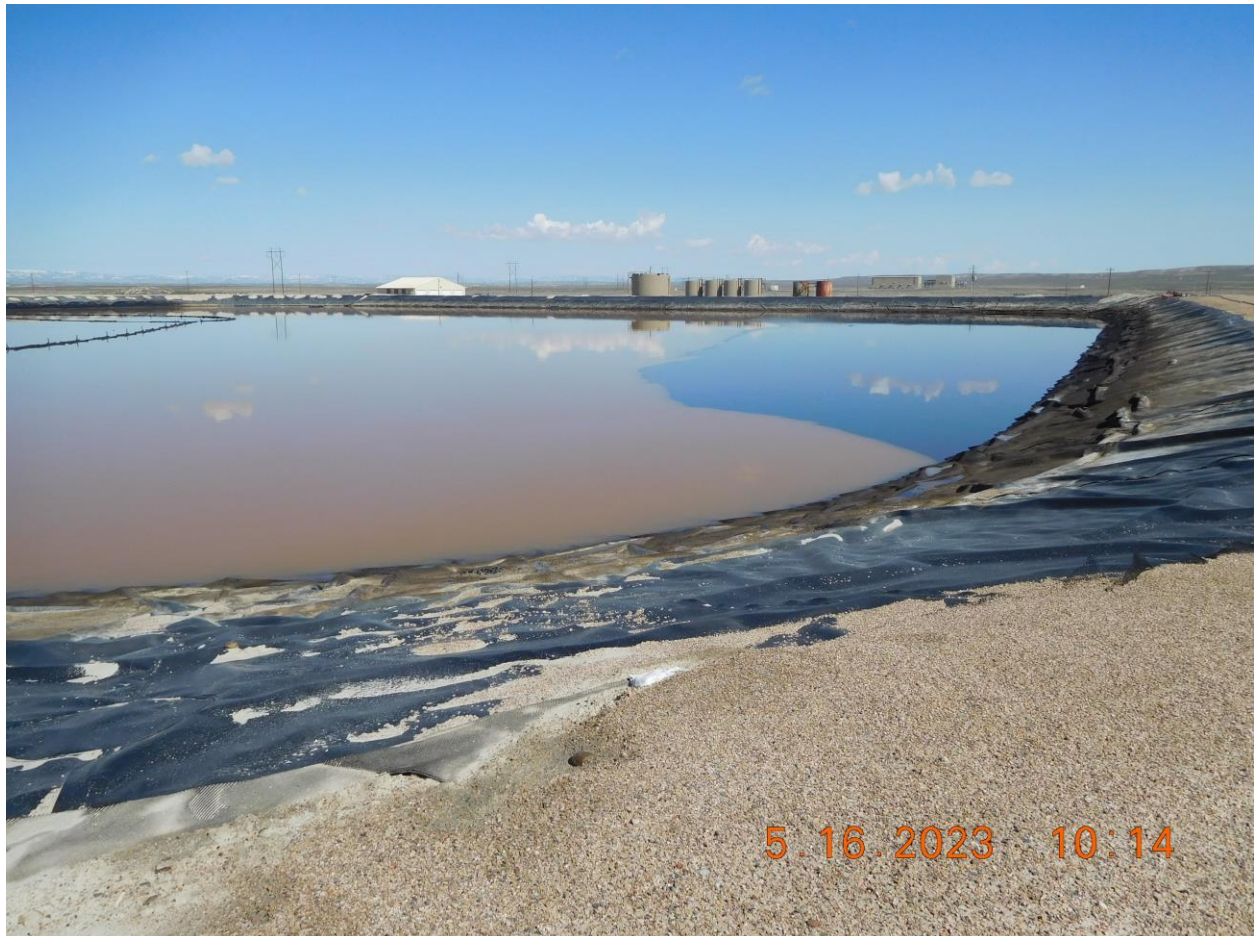
At the evaporation ponds, I observed oil floating on approximately 7% (estimated to be more than 5% but less than 10%) of the surface of pond 3. See Attachment 2 – Photograph Log, photo 2006.

Photo 2006: DSCN2006.jpg – photo of pond 3 from the southeast corner of the pond facing north/northwest with oil floating on the surface of the pond visible to right.

During the closing conference, Mr. Gunter stated that they would use a pump and hose set to pull off the oil from the evaporation ponds and transfer it back to the slop skim pit. He also stated he thought that this material floating on ponds 2 and 4 may also be part algae.

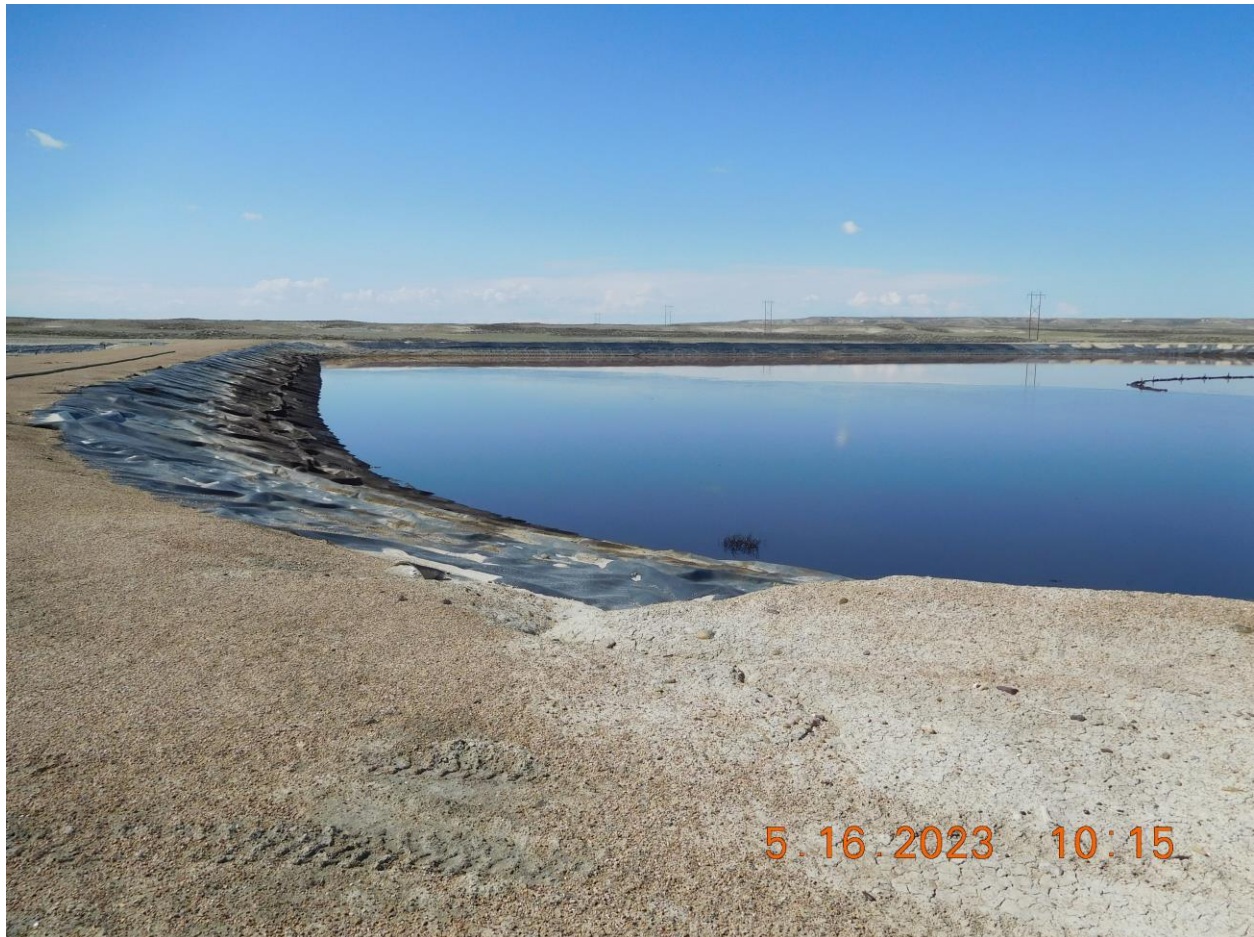
On pond 4, I observed floating oily waste on approximately 20% of the pond surface (photos 2007 and 2008), and on pond 2 approximately 5% of the pond surface (photos 2009-2011).

Photo 2007: DSCN2007.jpg – photo of pond 4 taken from the northeast corner facing south/southwest with oil visible on the surface of the pond.

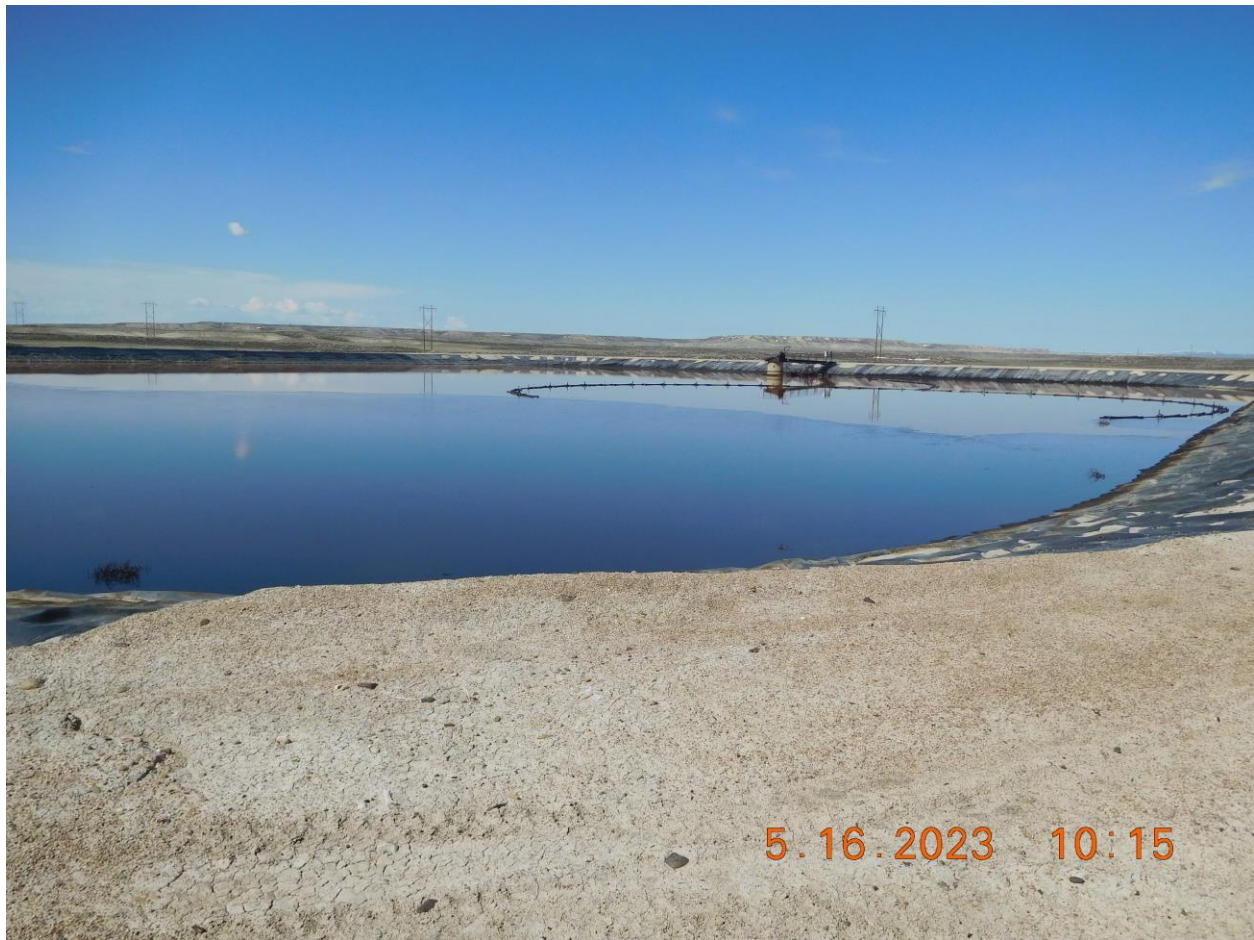
Photo 2008: DSCN2008.jpg – photo of the same area shown in photo 2007, panned right.

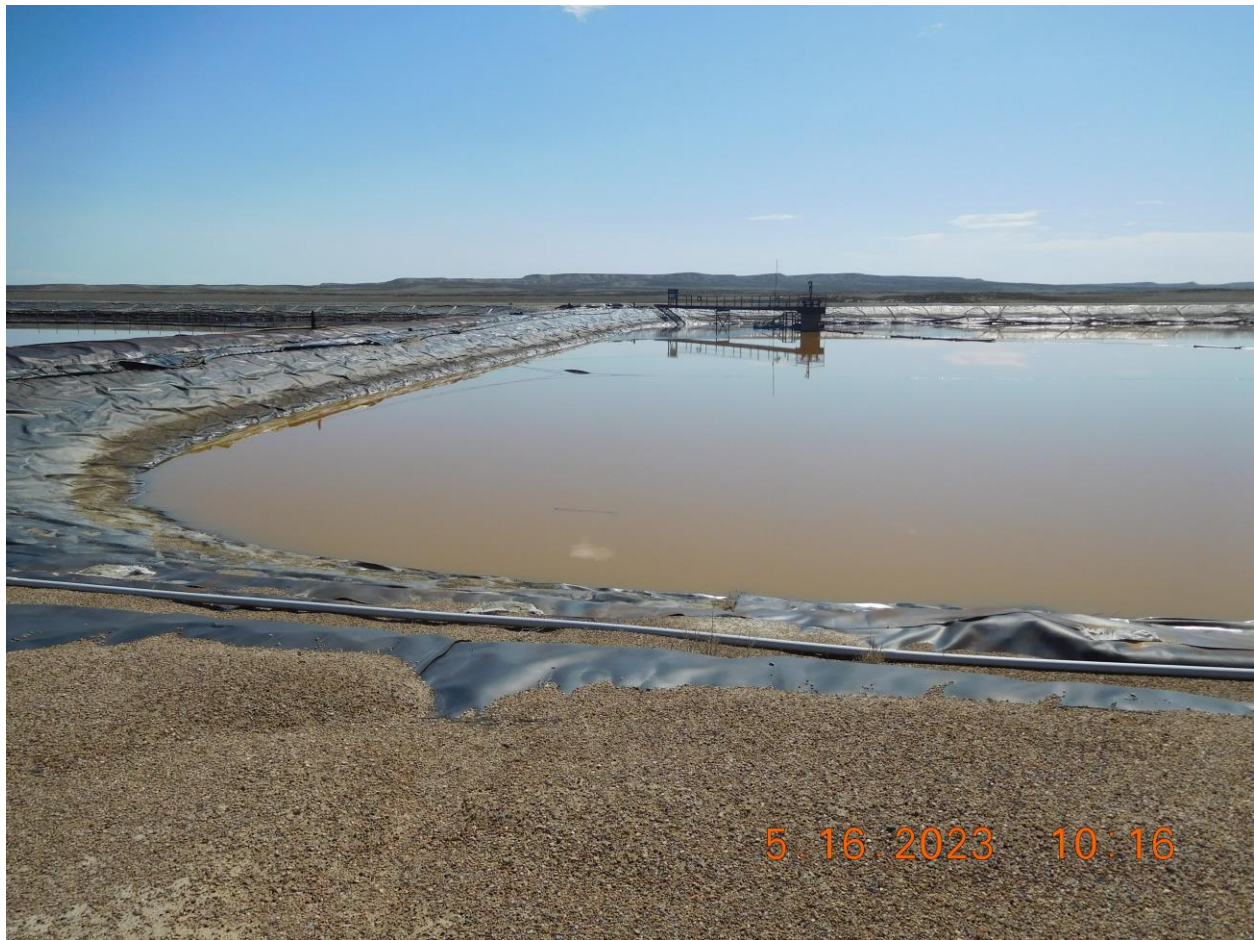
Photo 2009: DSCN2009.jpg – photo of pond 2 taken near the northwest corner facing east.

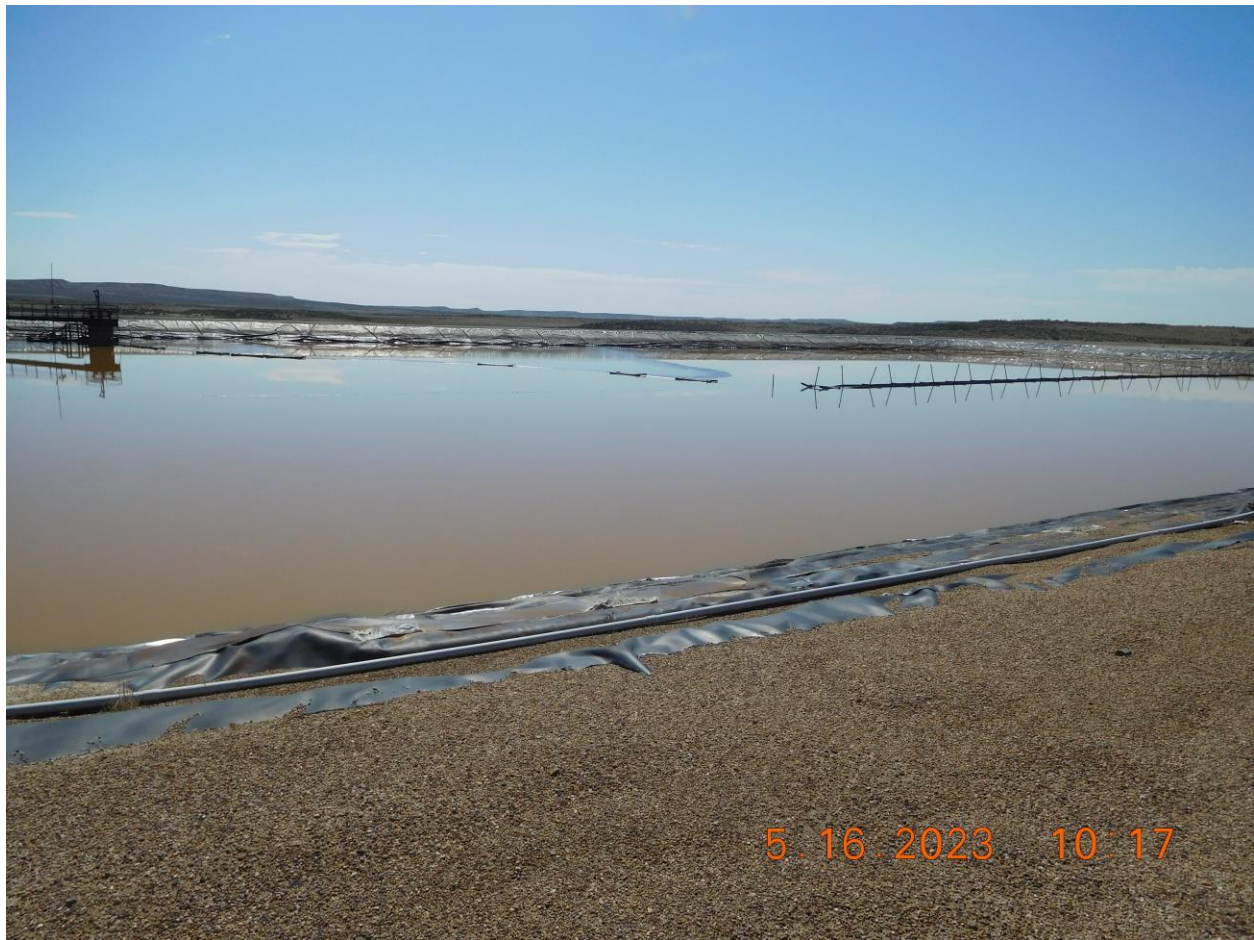
Photo 2010: DSCN2010.jpg – photo of the same area as that shown in photo 2009, panned right.

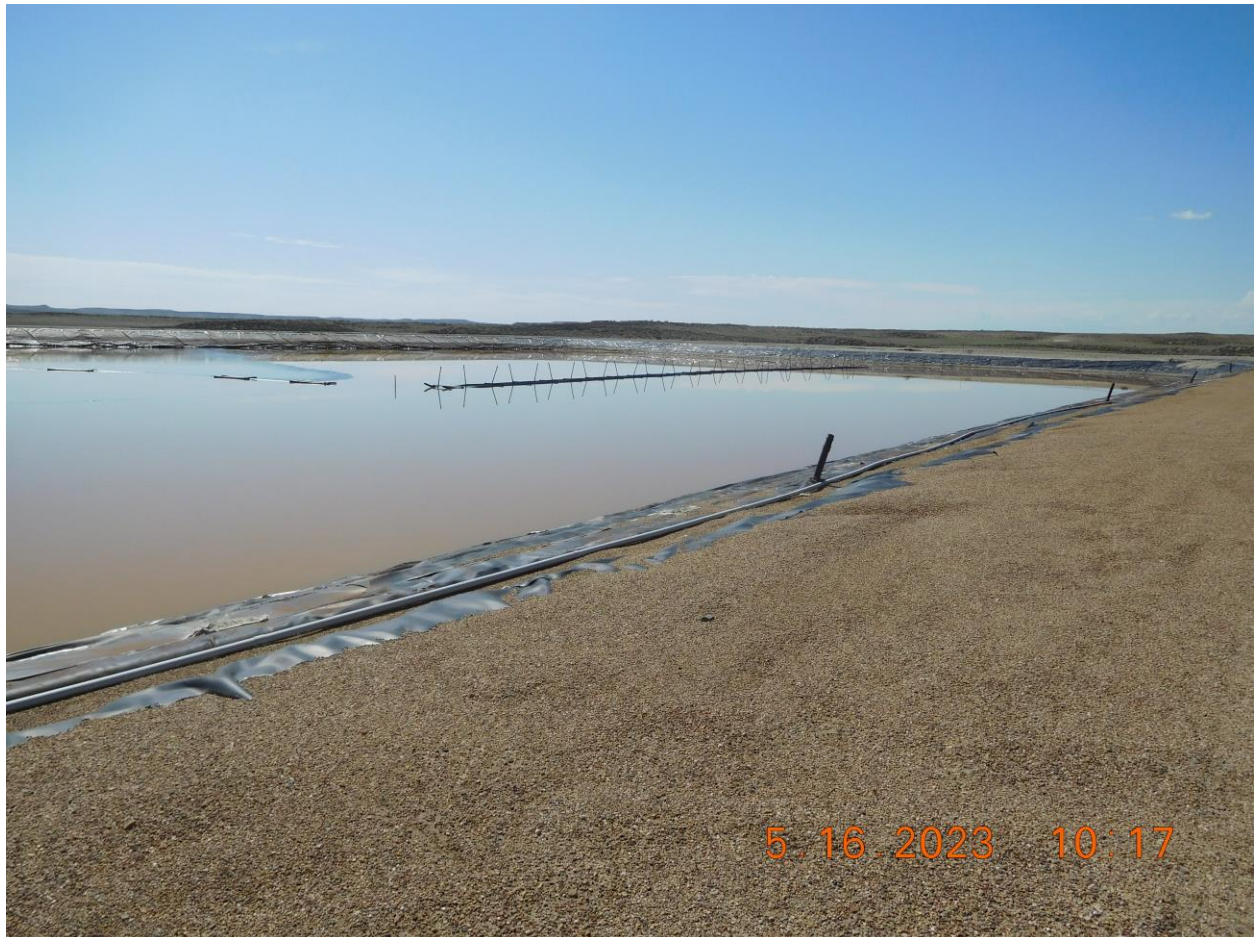
Photo 2011: DSCN2011.jpg – photo of the same area as that shown in photos 2009 and 2010, panned right.
