**Region 6 - Enforcement & Compliance Assurance Division**  
**INSPECTION REPORT**

| Inspection Date(s): | 10/07/2024 | |
| Company Name: | <b>Corley Trust, LLC</b> | |
| Facility Name: | <b>Wilson #7 SWD Tank Battery</b> | |

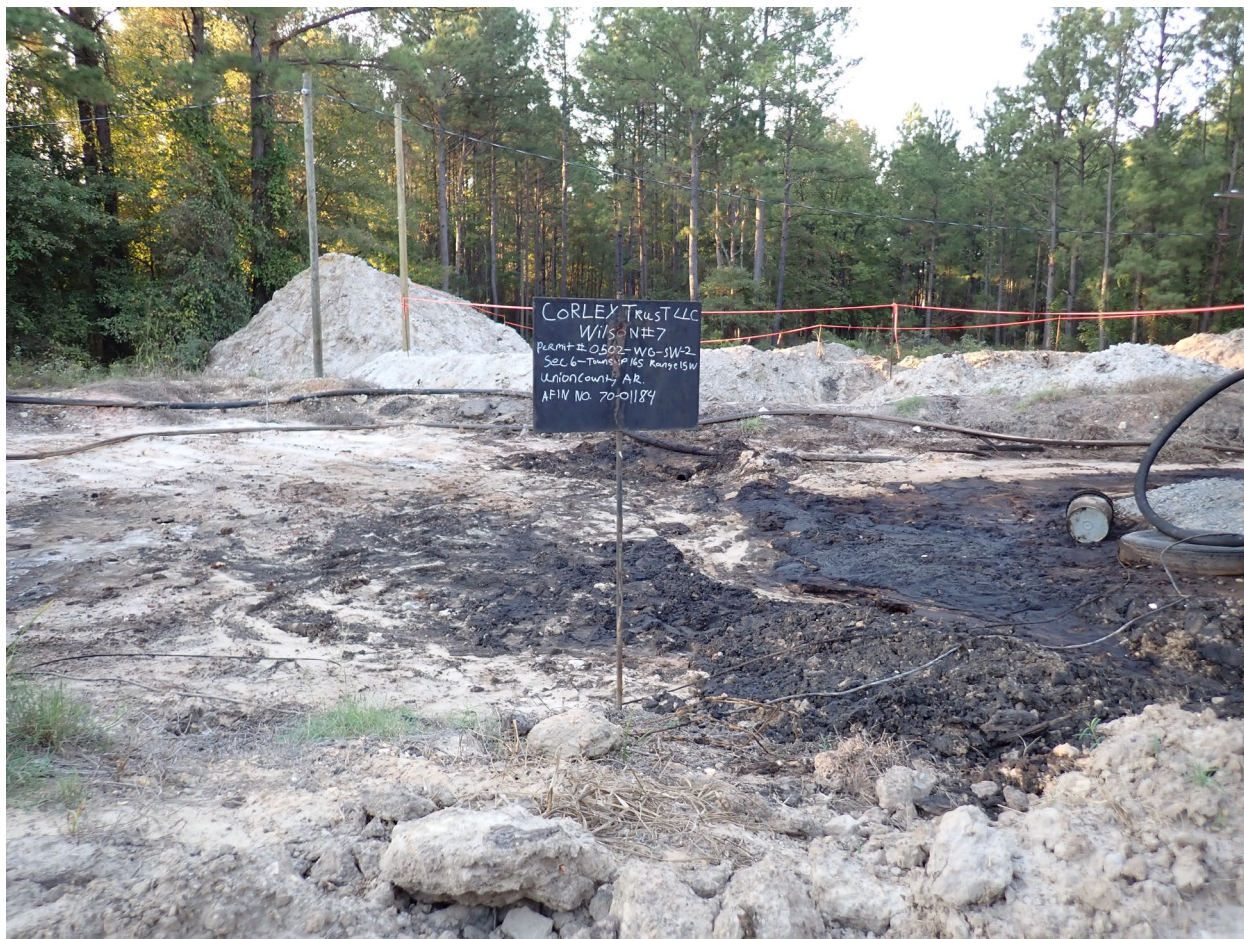
Photo No. 1

**Description:** This photo was taken looking north and shows the facility sign.

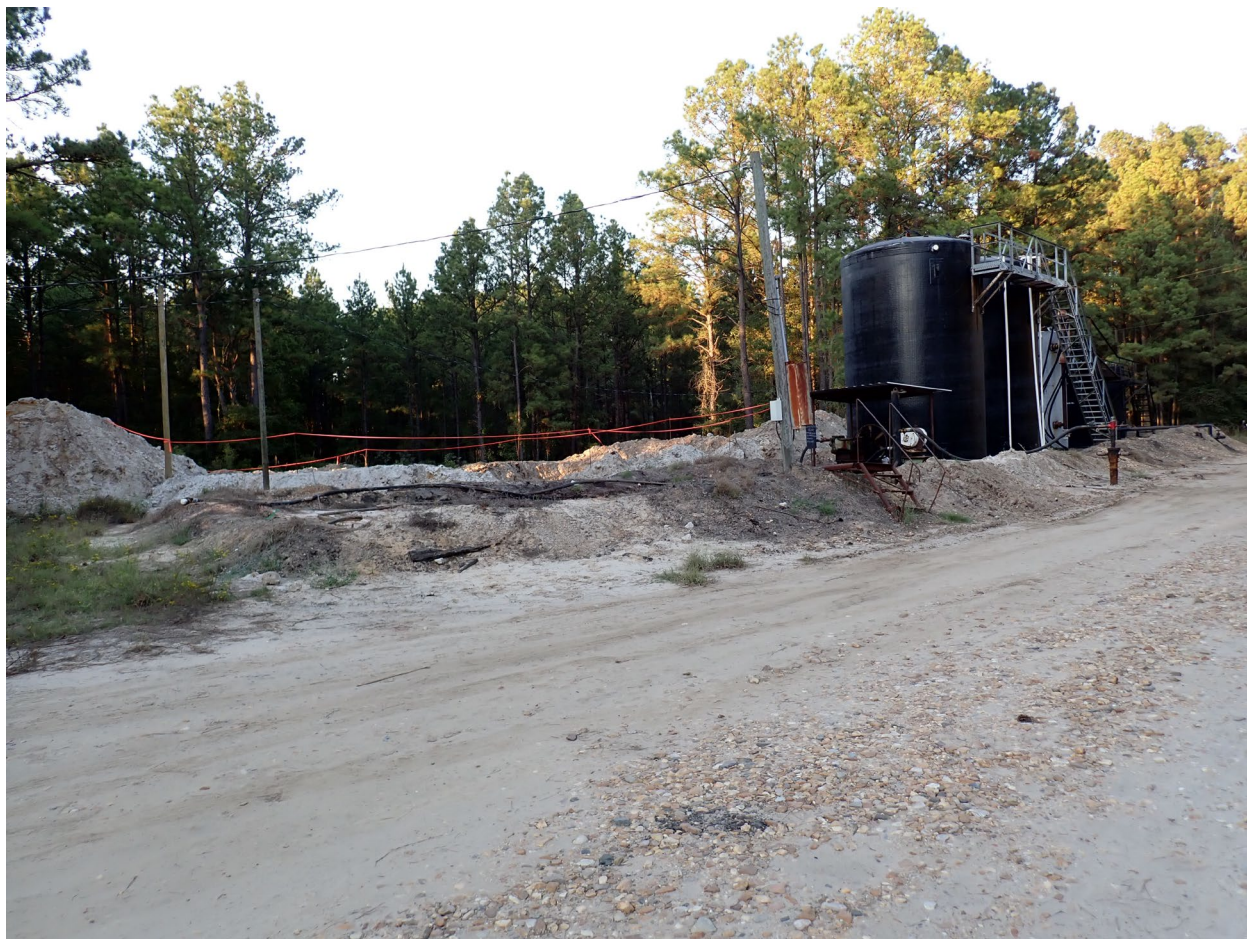
Photo No. 2

**Description:** This photo was taken looking north and shows an overview of the facility.

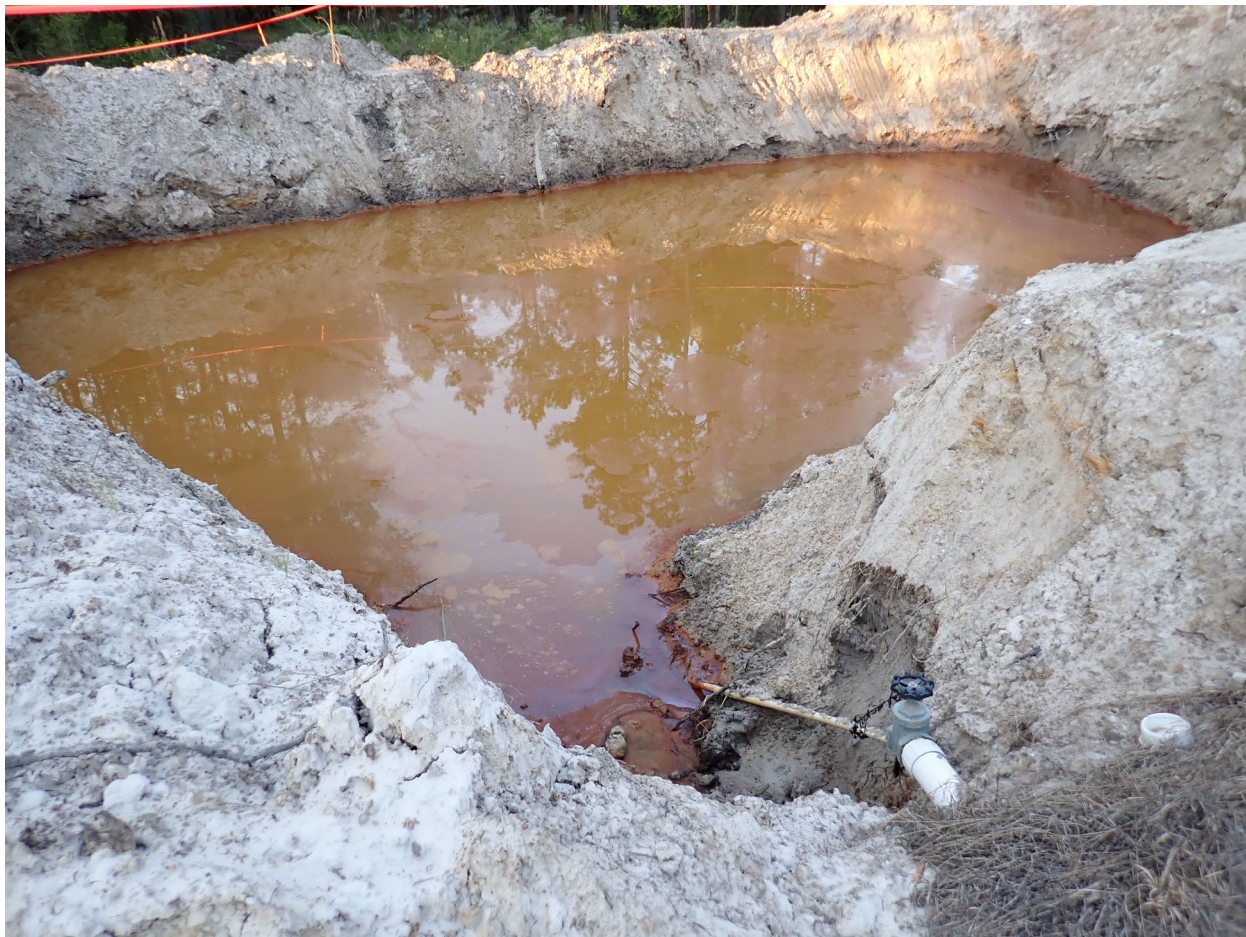
Photo No. 3

I observed loose oil and brine in a workover pit that was outside of secondary containment, see photo No. 3-4. The pit was constructed around the secondary containment discharge valve.

**Description:** This photo was taken looking north and shows a workover pit with loose oil and brine outside of secondary containment.

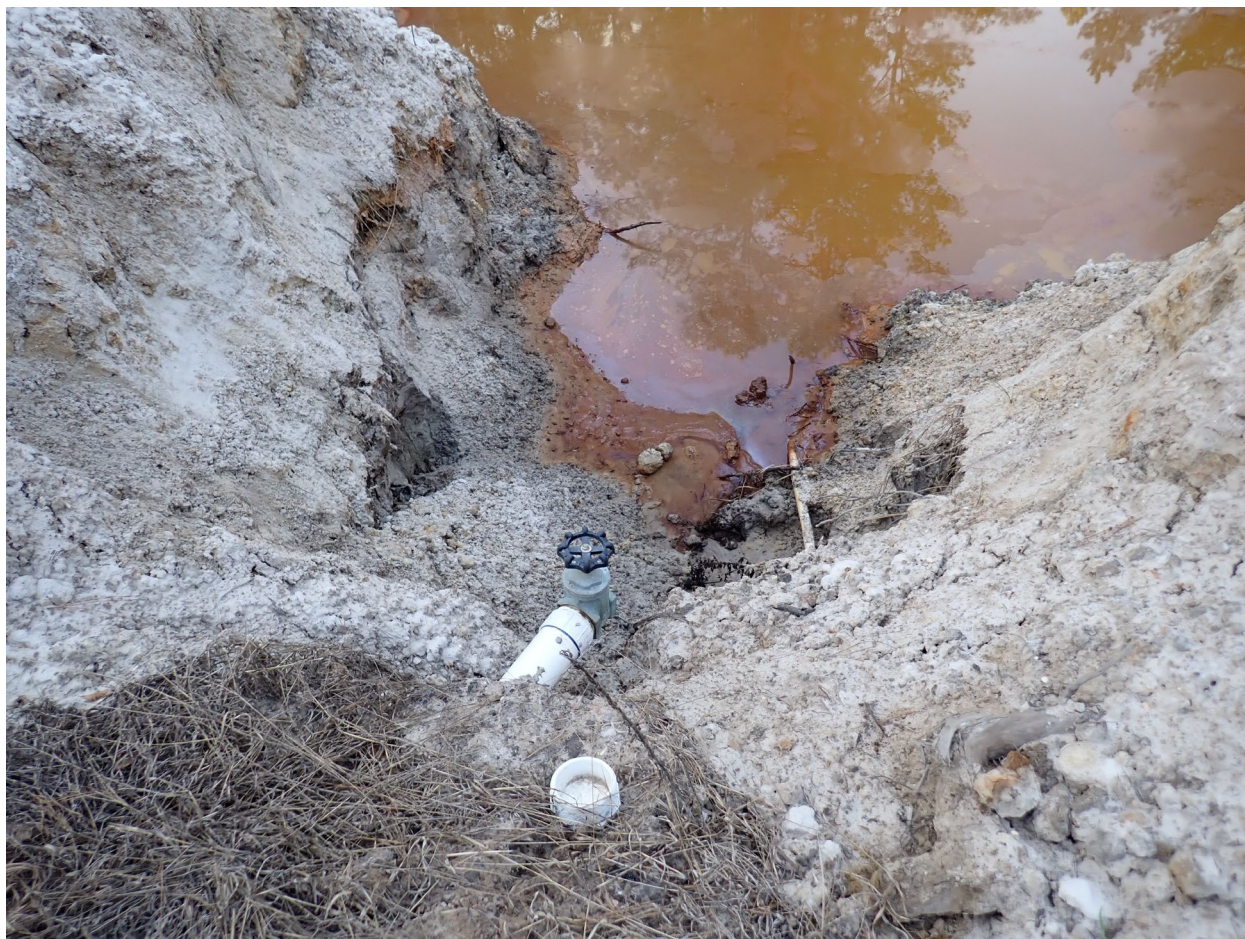
Photo No. 4

**Description:** T This photo was taken looking north and shows a workover pit with loose oil and brine outside of secondary containment. The berm is built around the secondary containment discharge valve.

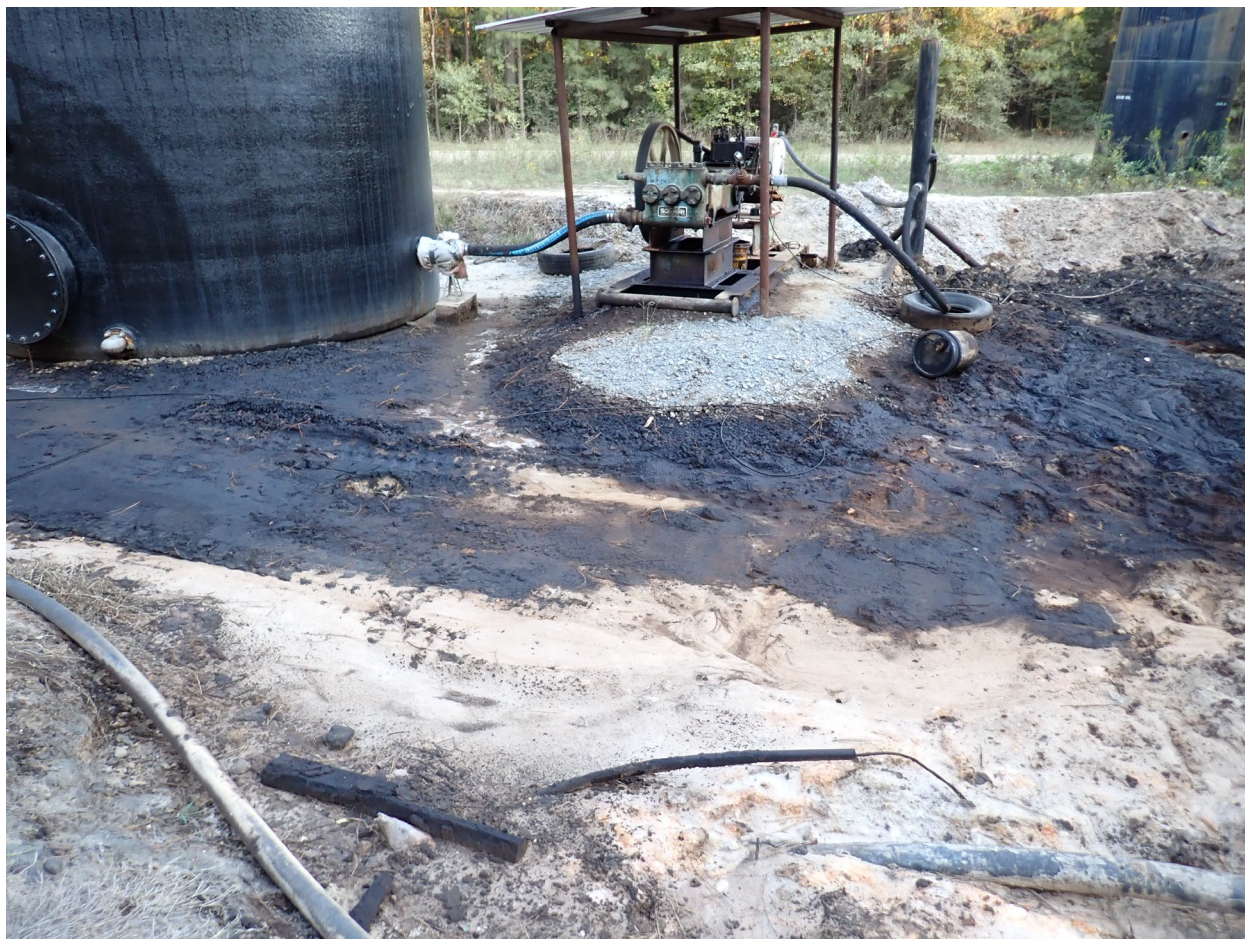
Photo No. 5

I observed loose oil inside secondary containment, see photo No. 5.

**Description:** This photo was taken looking southwest and shows loose oil inside secondary containment.

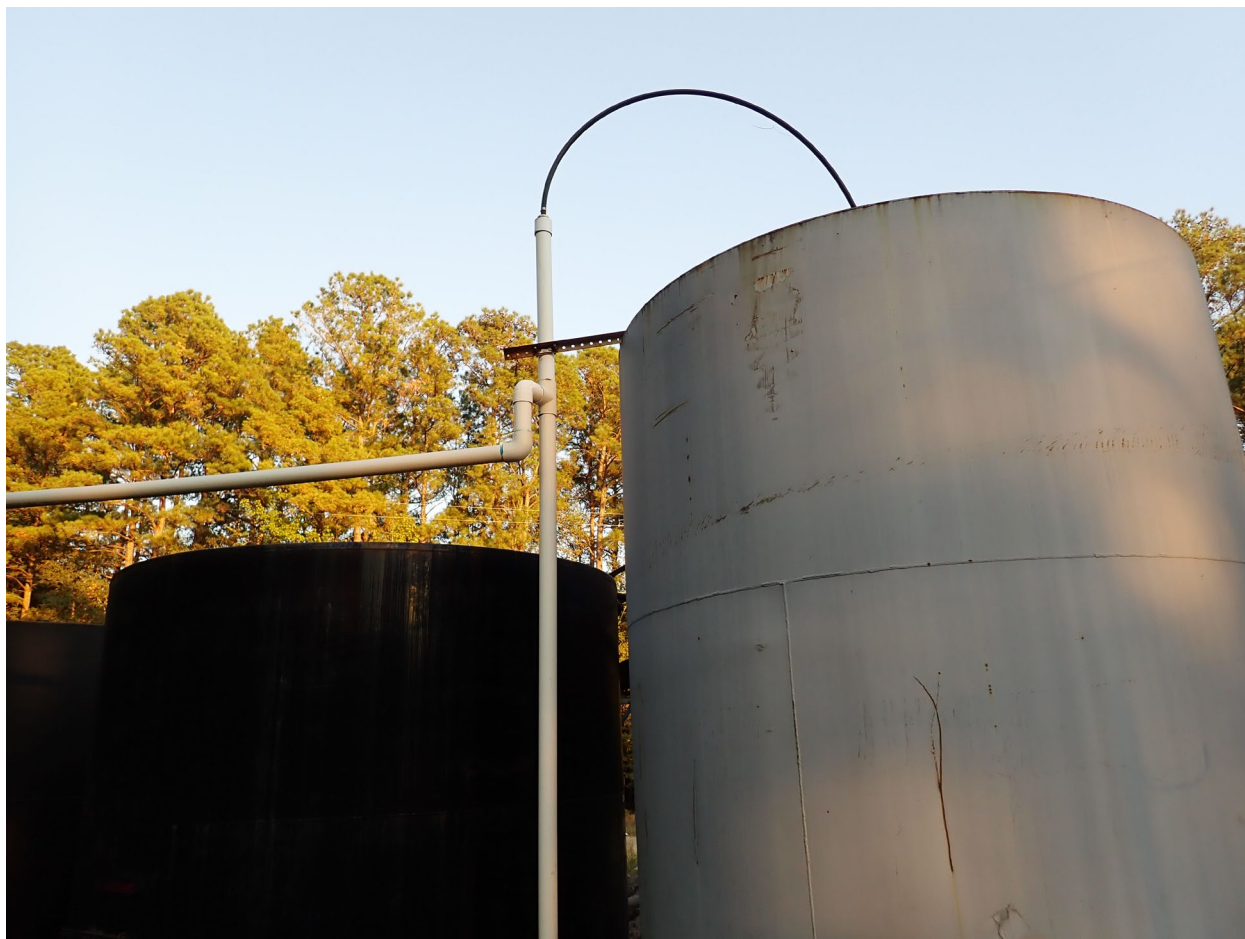
Photo No. 6

I observed an overhead pipe from a tank that was not properly supported, see photo No. 6.

**Description:** This photo was taken looking southwest and shows an overhead pipe without support extending from a tank.

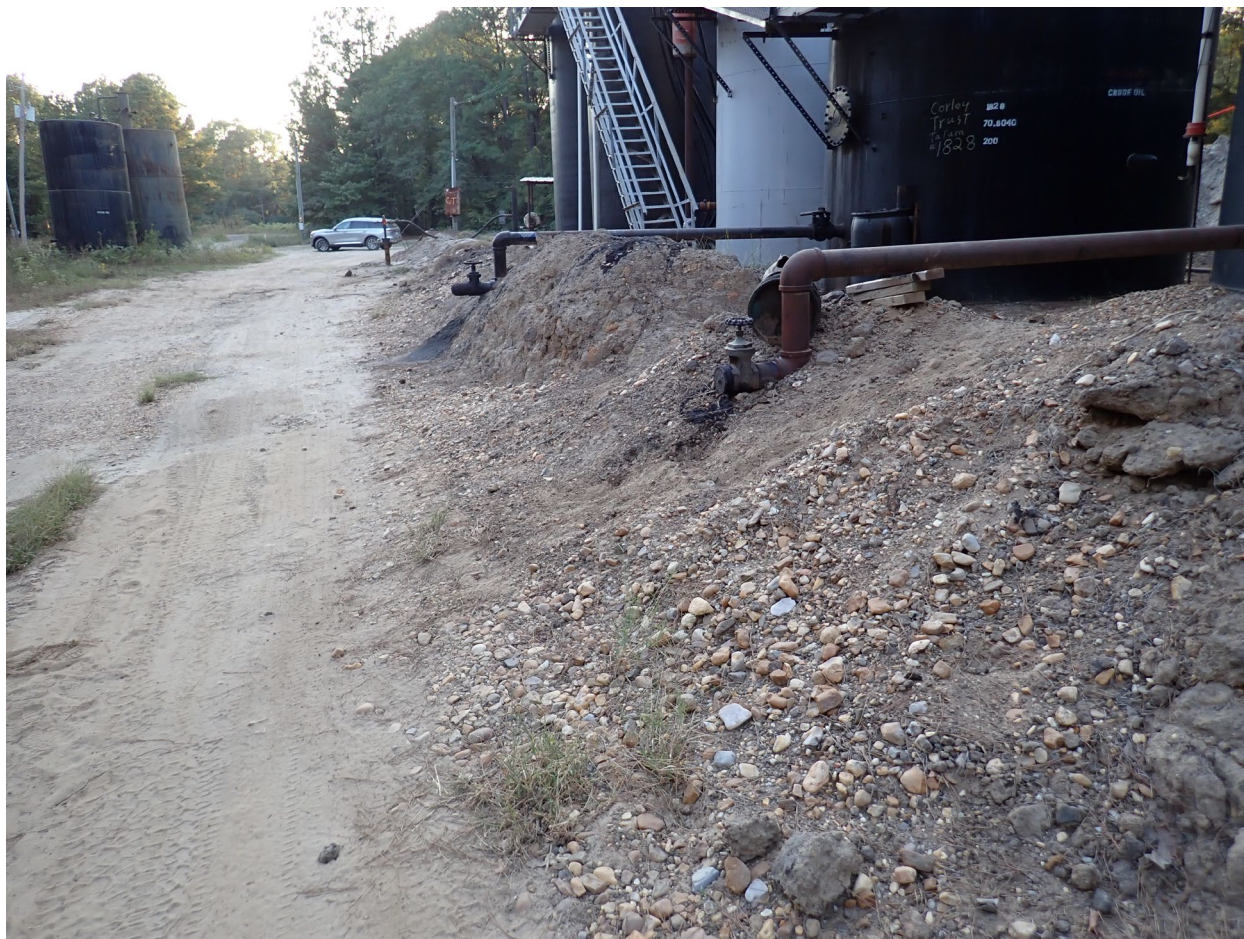
Photo No. 7

**Description:** This photo was taken looking southwest and shows discharge valves with loose oil and no catchment.

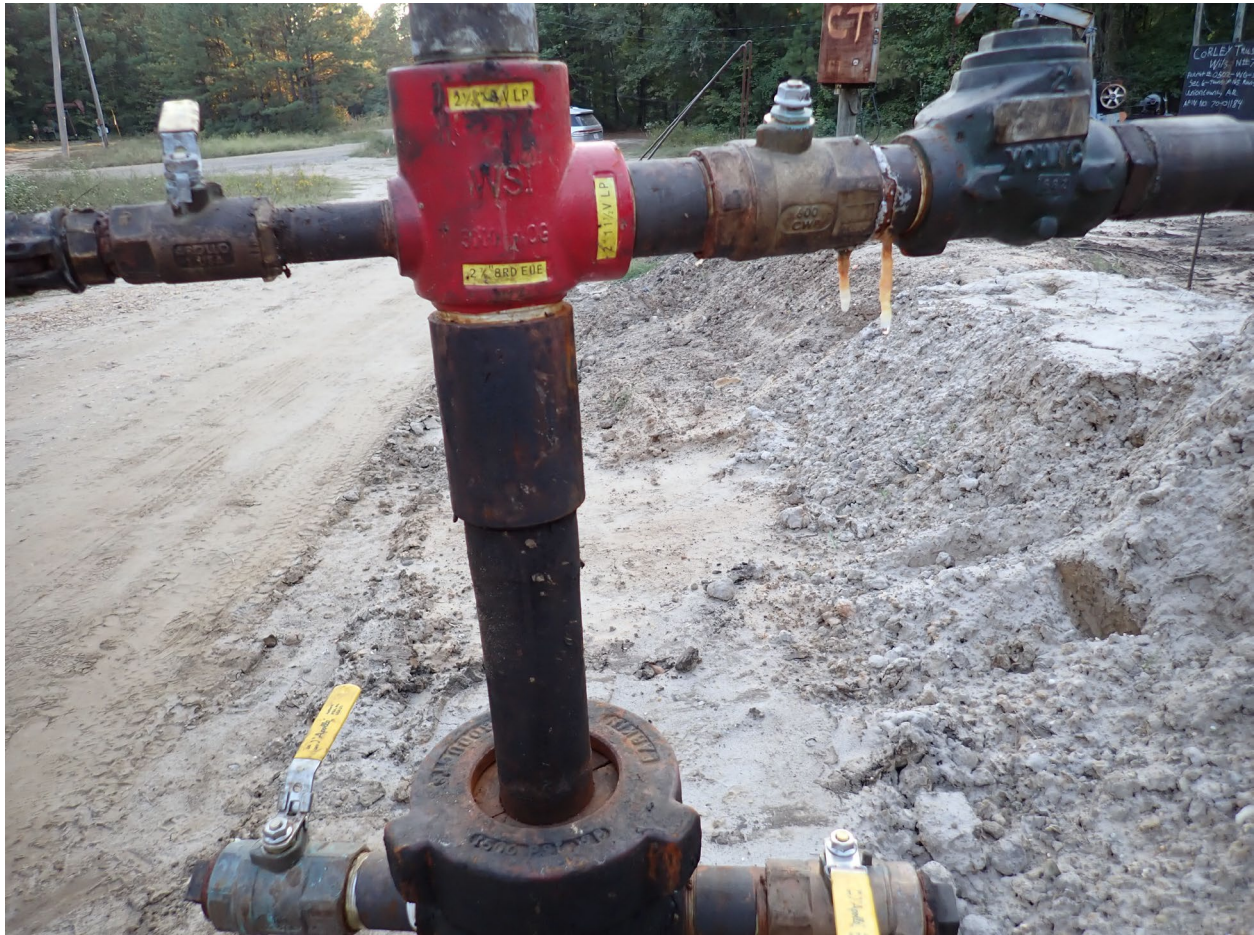
Photo No. 8

**Description:** This photo was taken looking southwest and shows a leak from a connection pipe to the SWD well , where crystal formation was present.

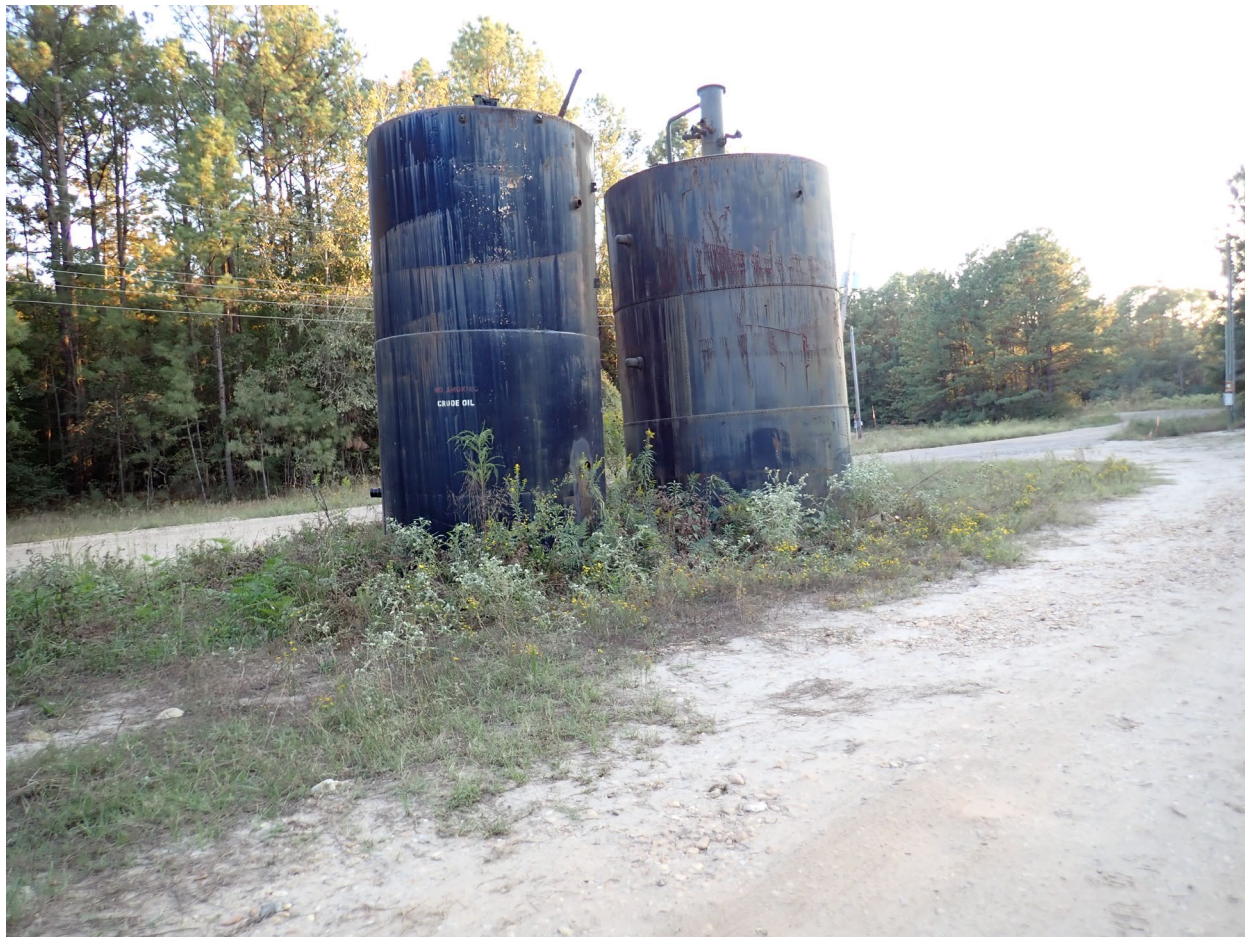
Photo No. 9

I observed tanks without “out of service” labels, see photo No. 9.

**Description:** This photo was taken looking southwest and shows two (2) tanks without "out of service" labels or markings.
