Beverly Port Marina – EPA Inspection 8/20/2024

Beverly Port Marina

43 Water Street  
Beverly, MA

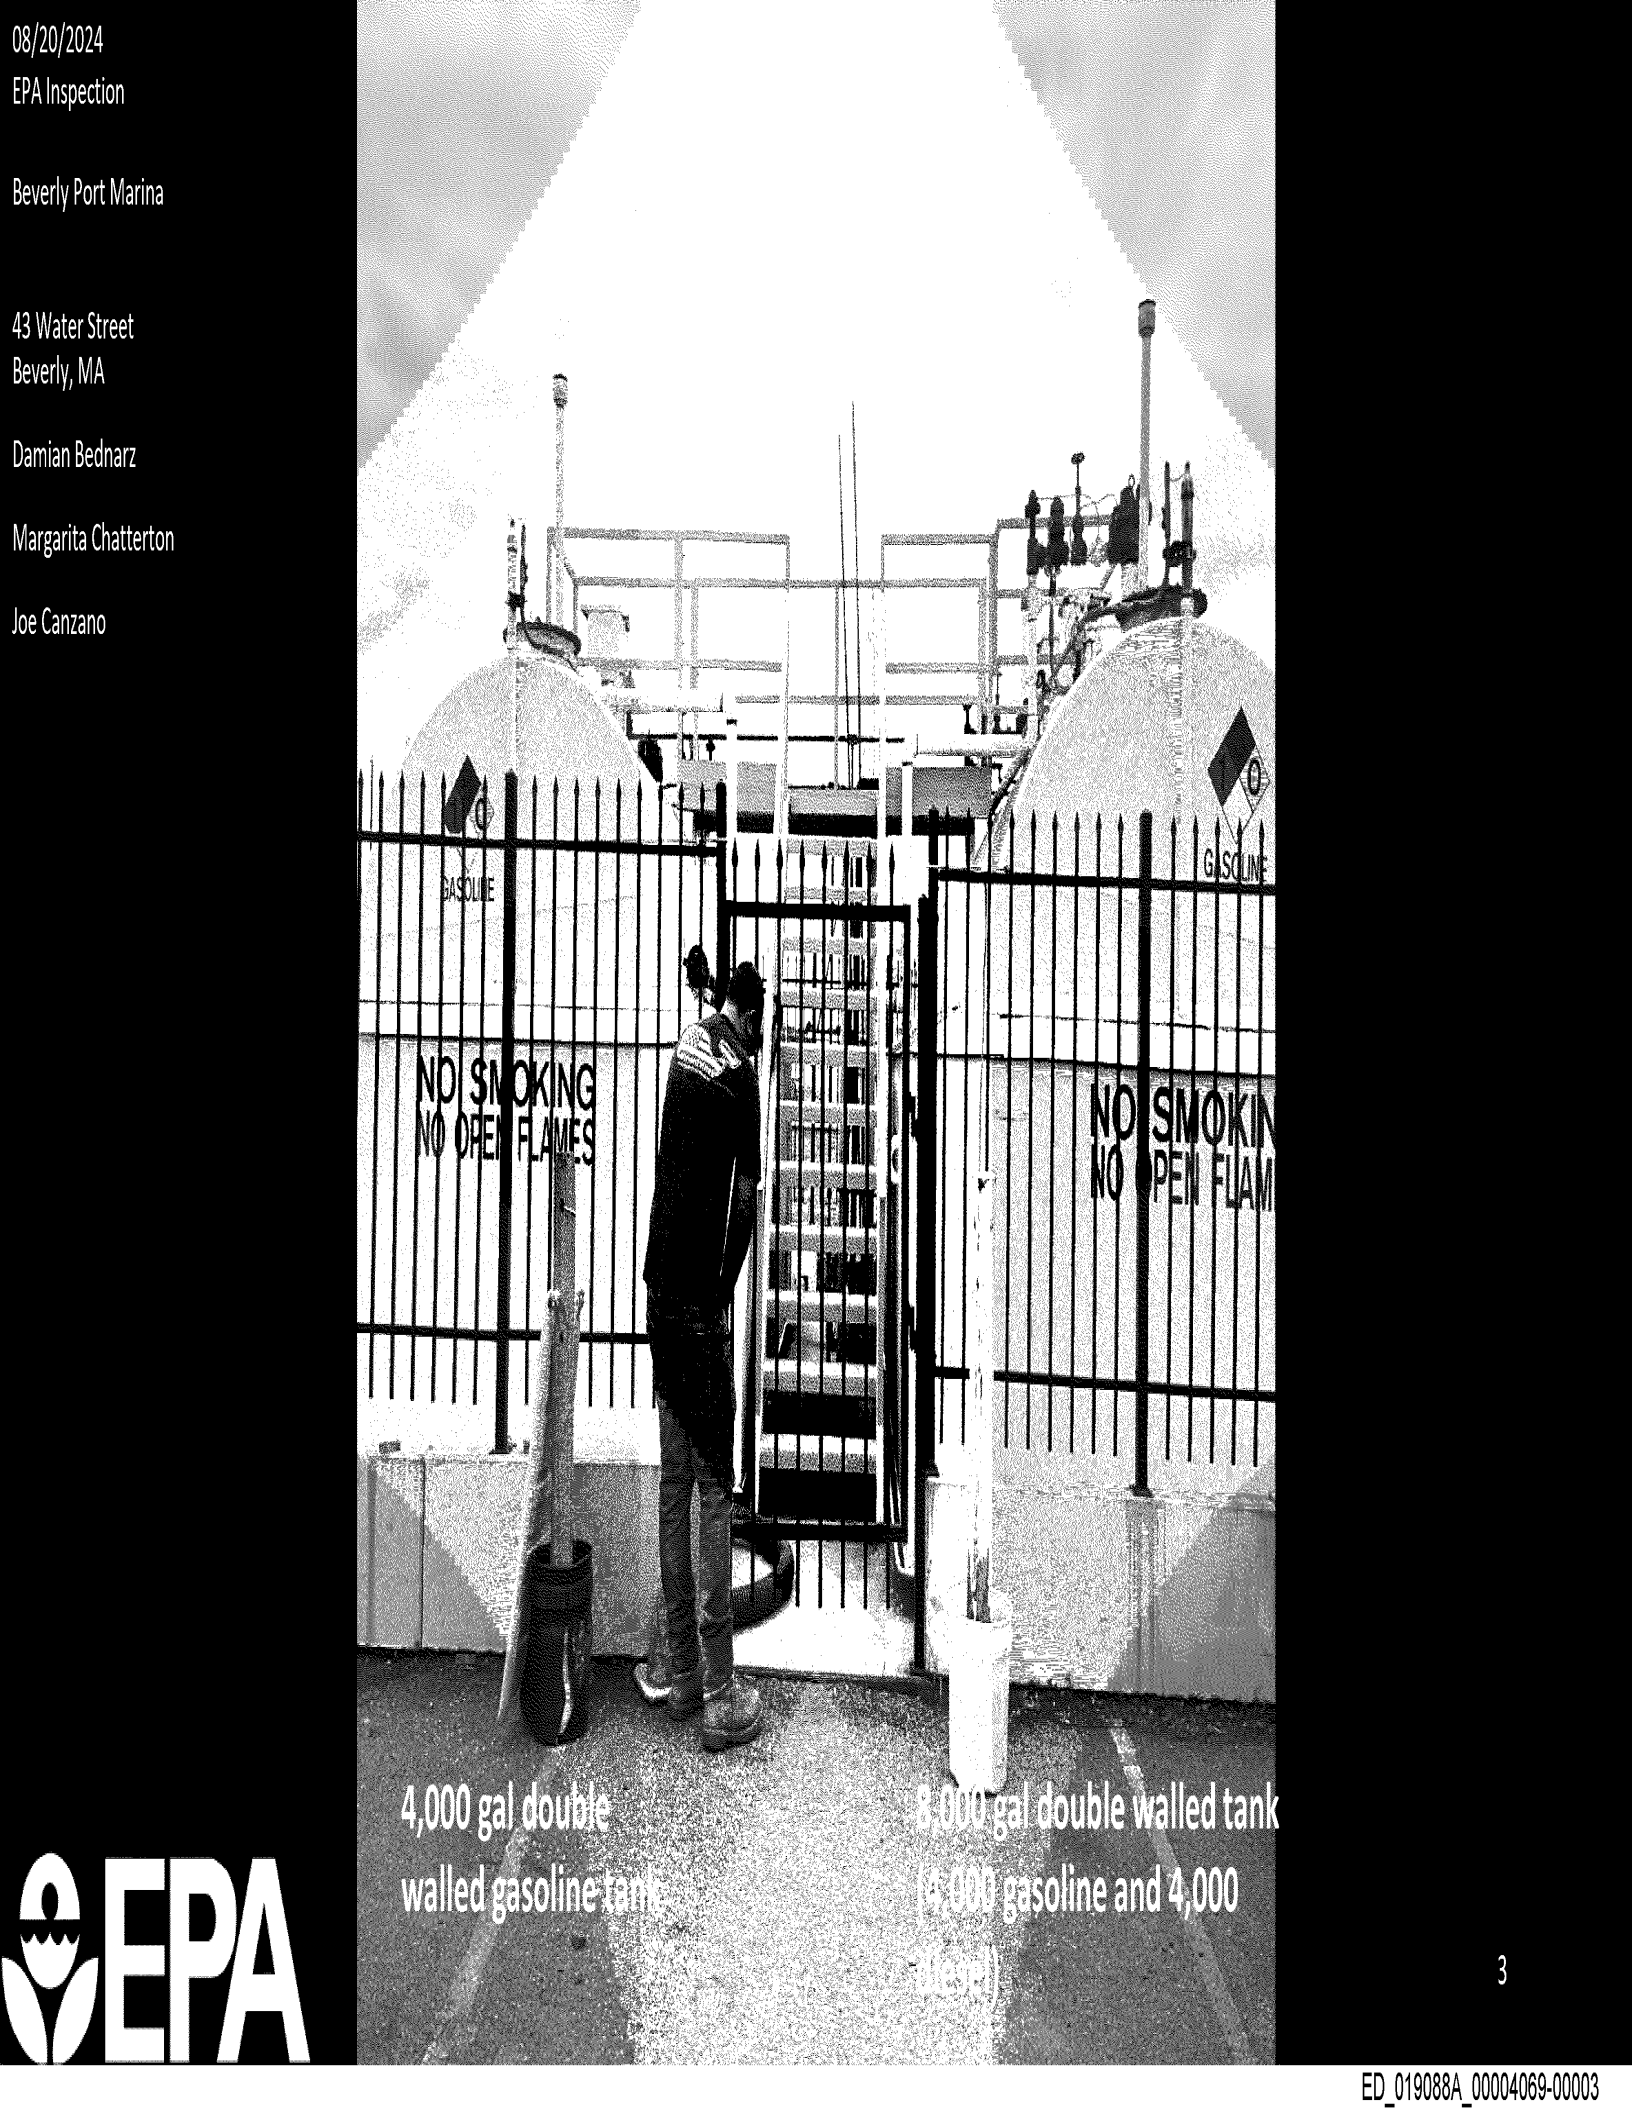
4,000 gal double  
walled gasoline tank

8,000 gal double walled tank  
(4,000 gasoline and 4,000  
oil)

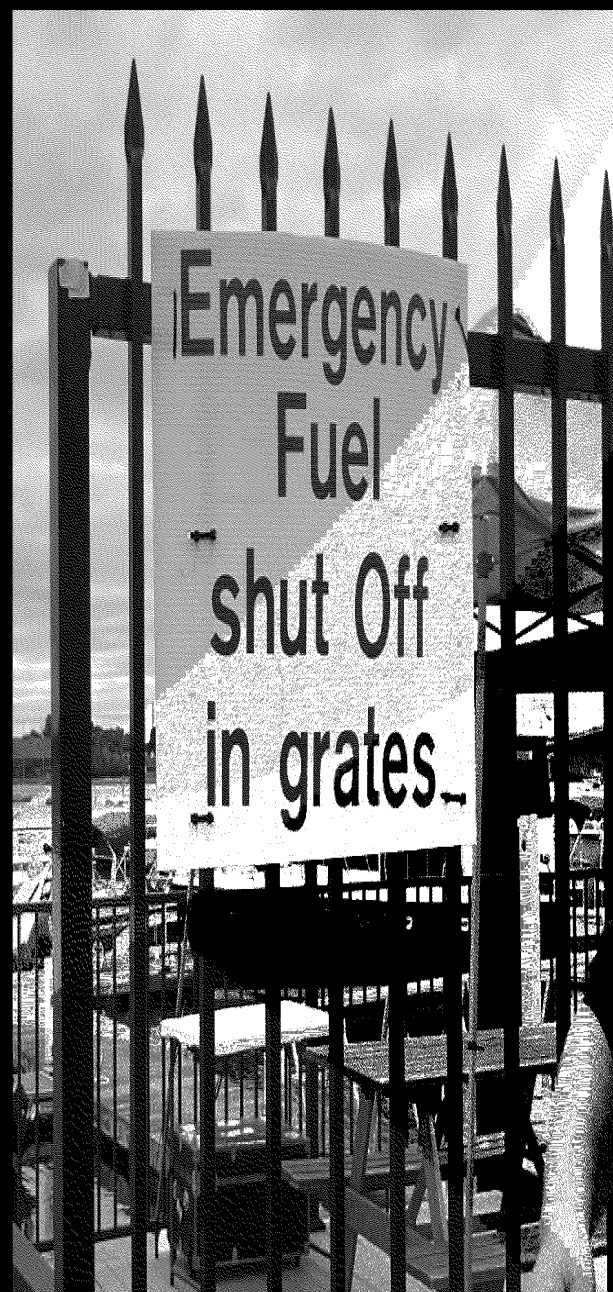
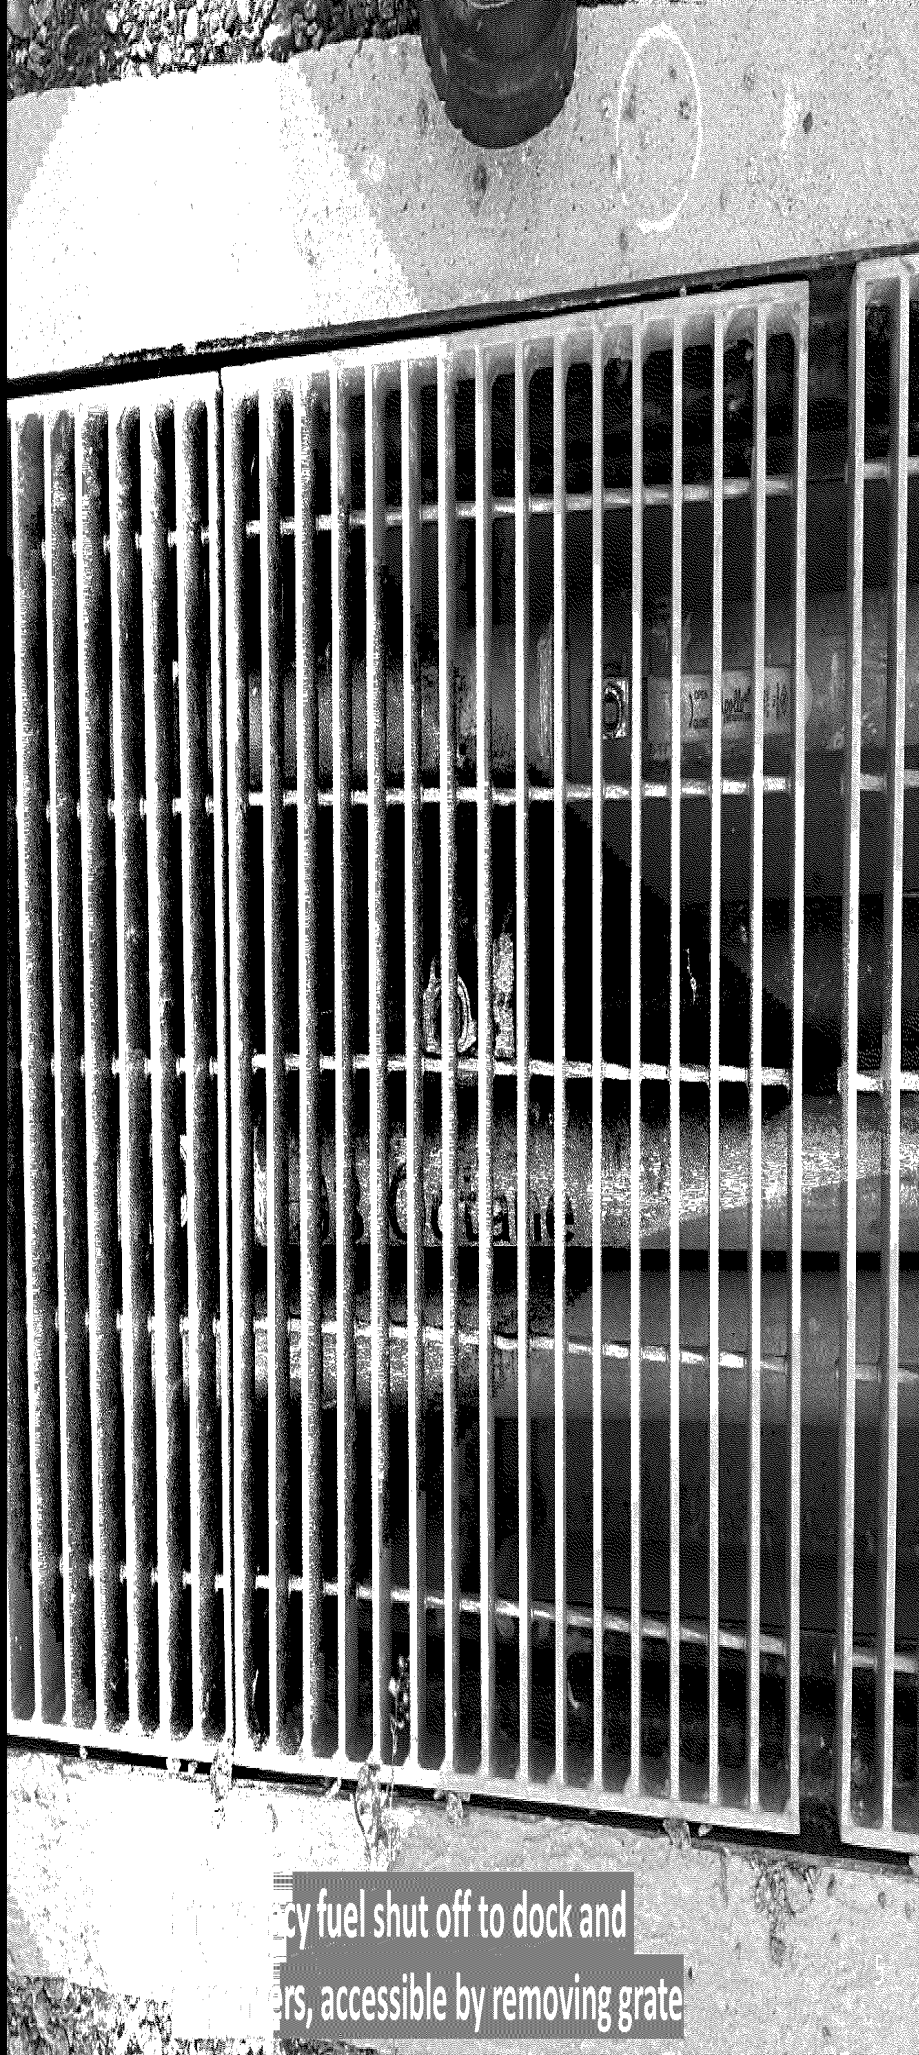
Emergency fuel shut off to dock and  
towers, accessible by removing grate

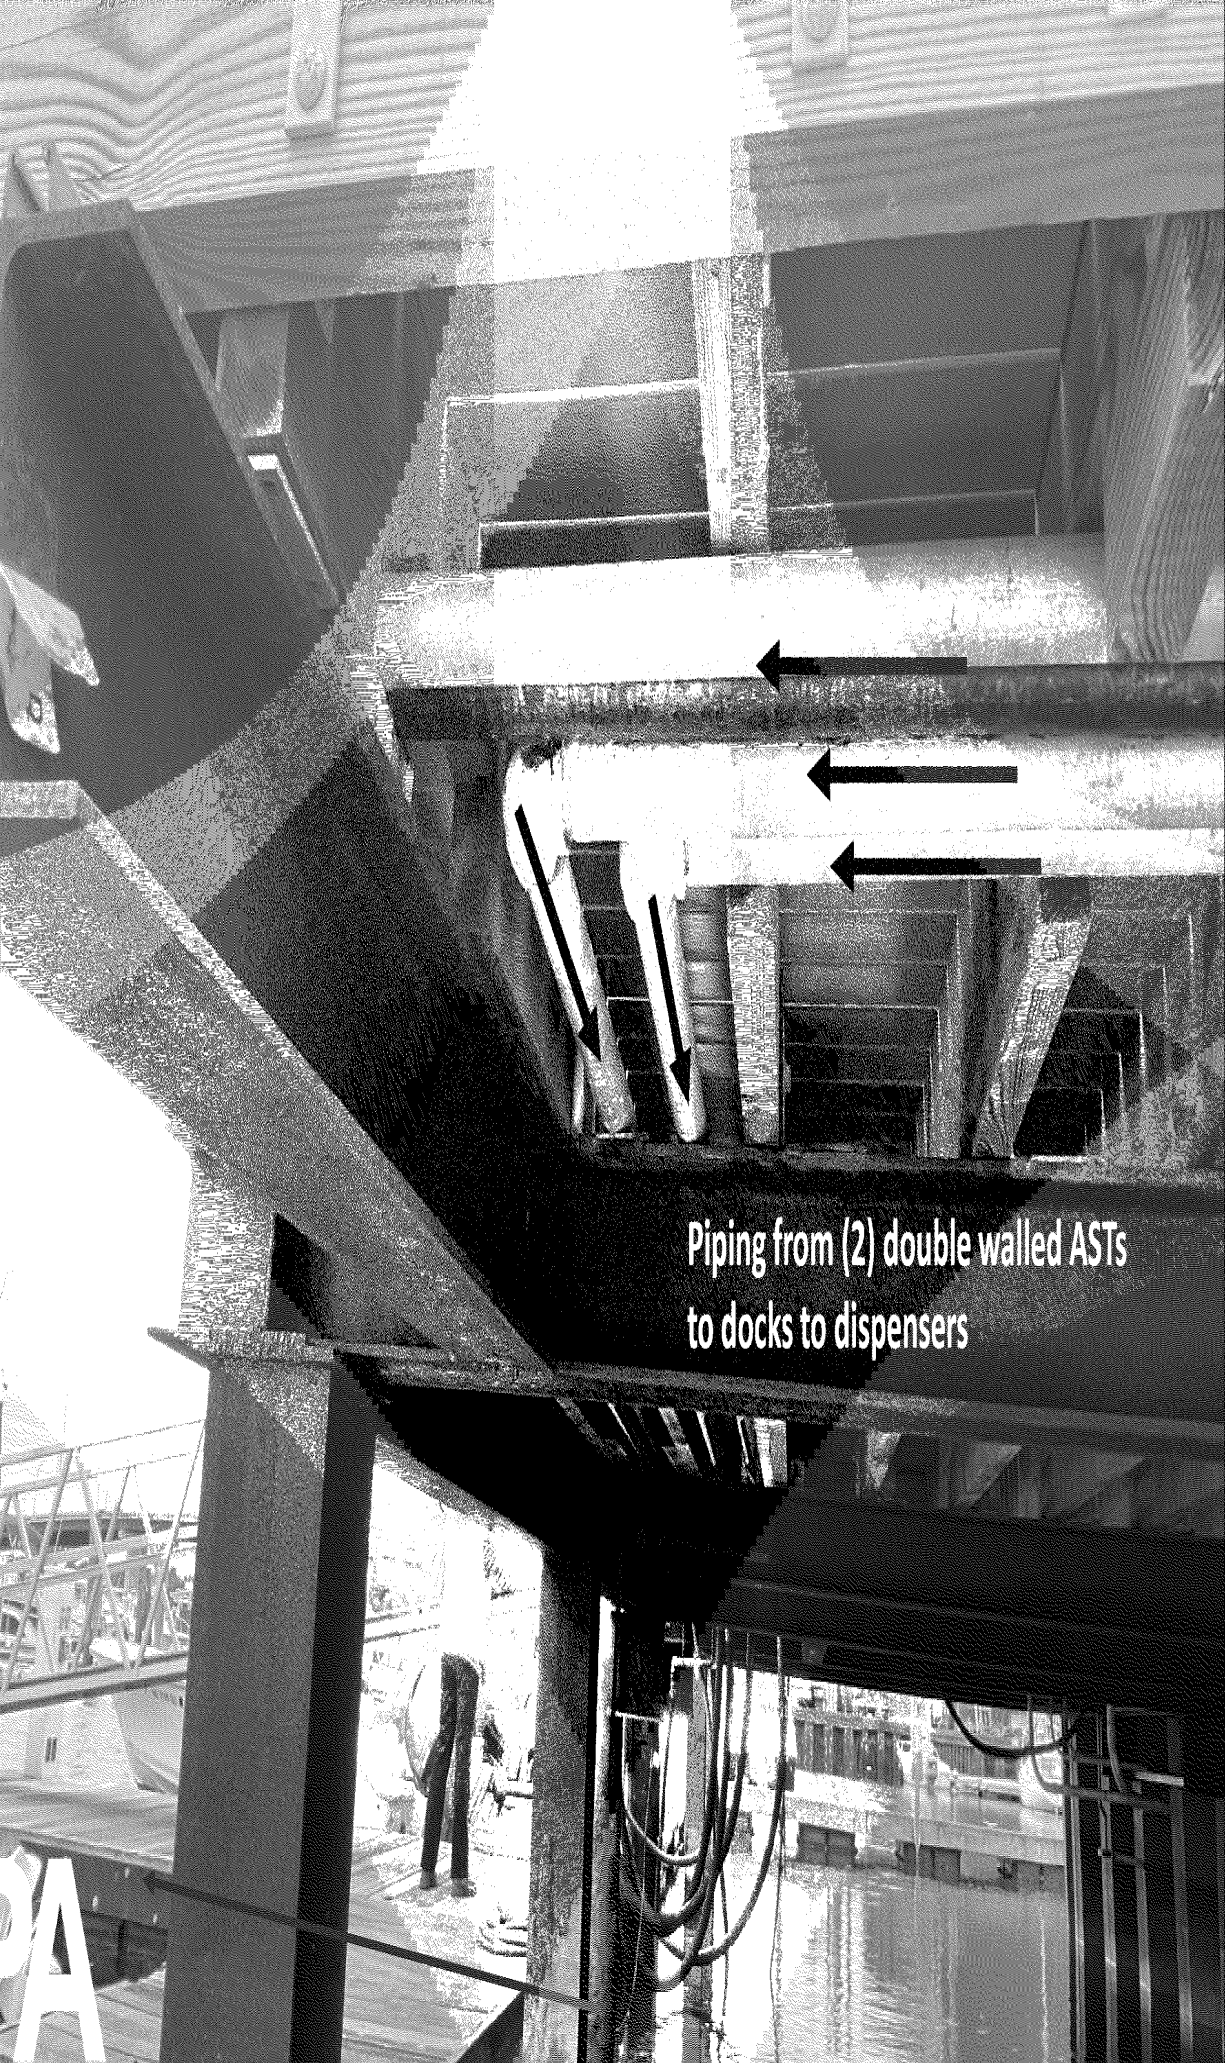
Piping from (2) double walled ASTs  
to docks to dispensers

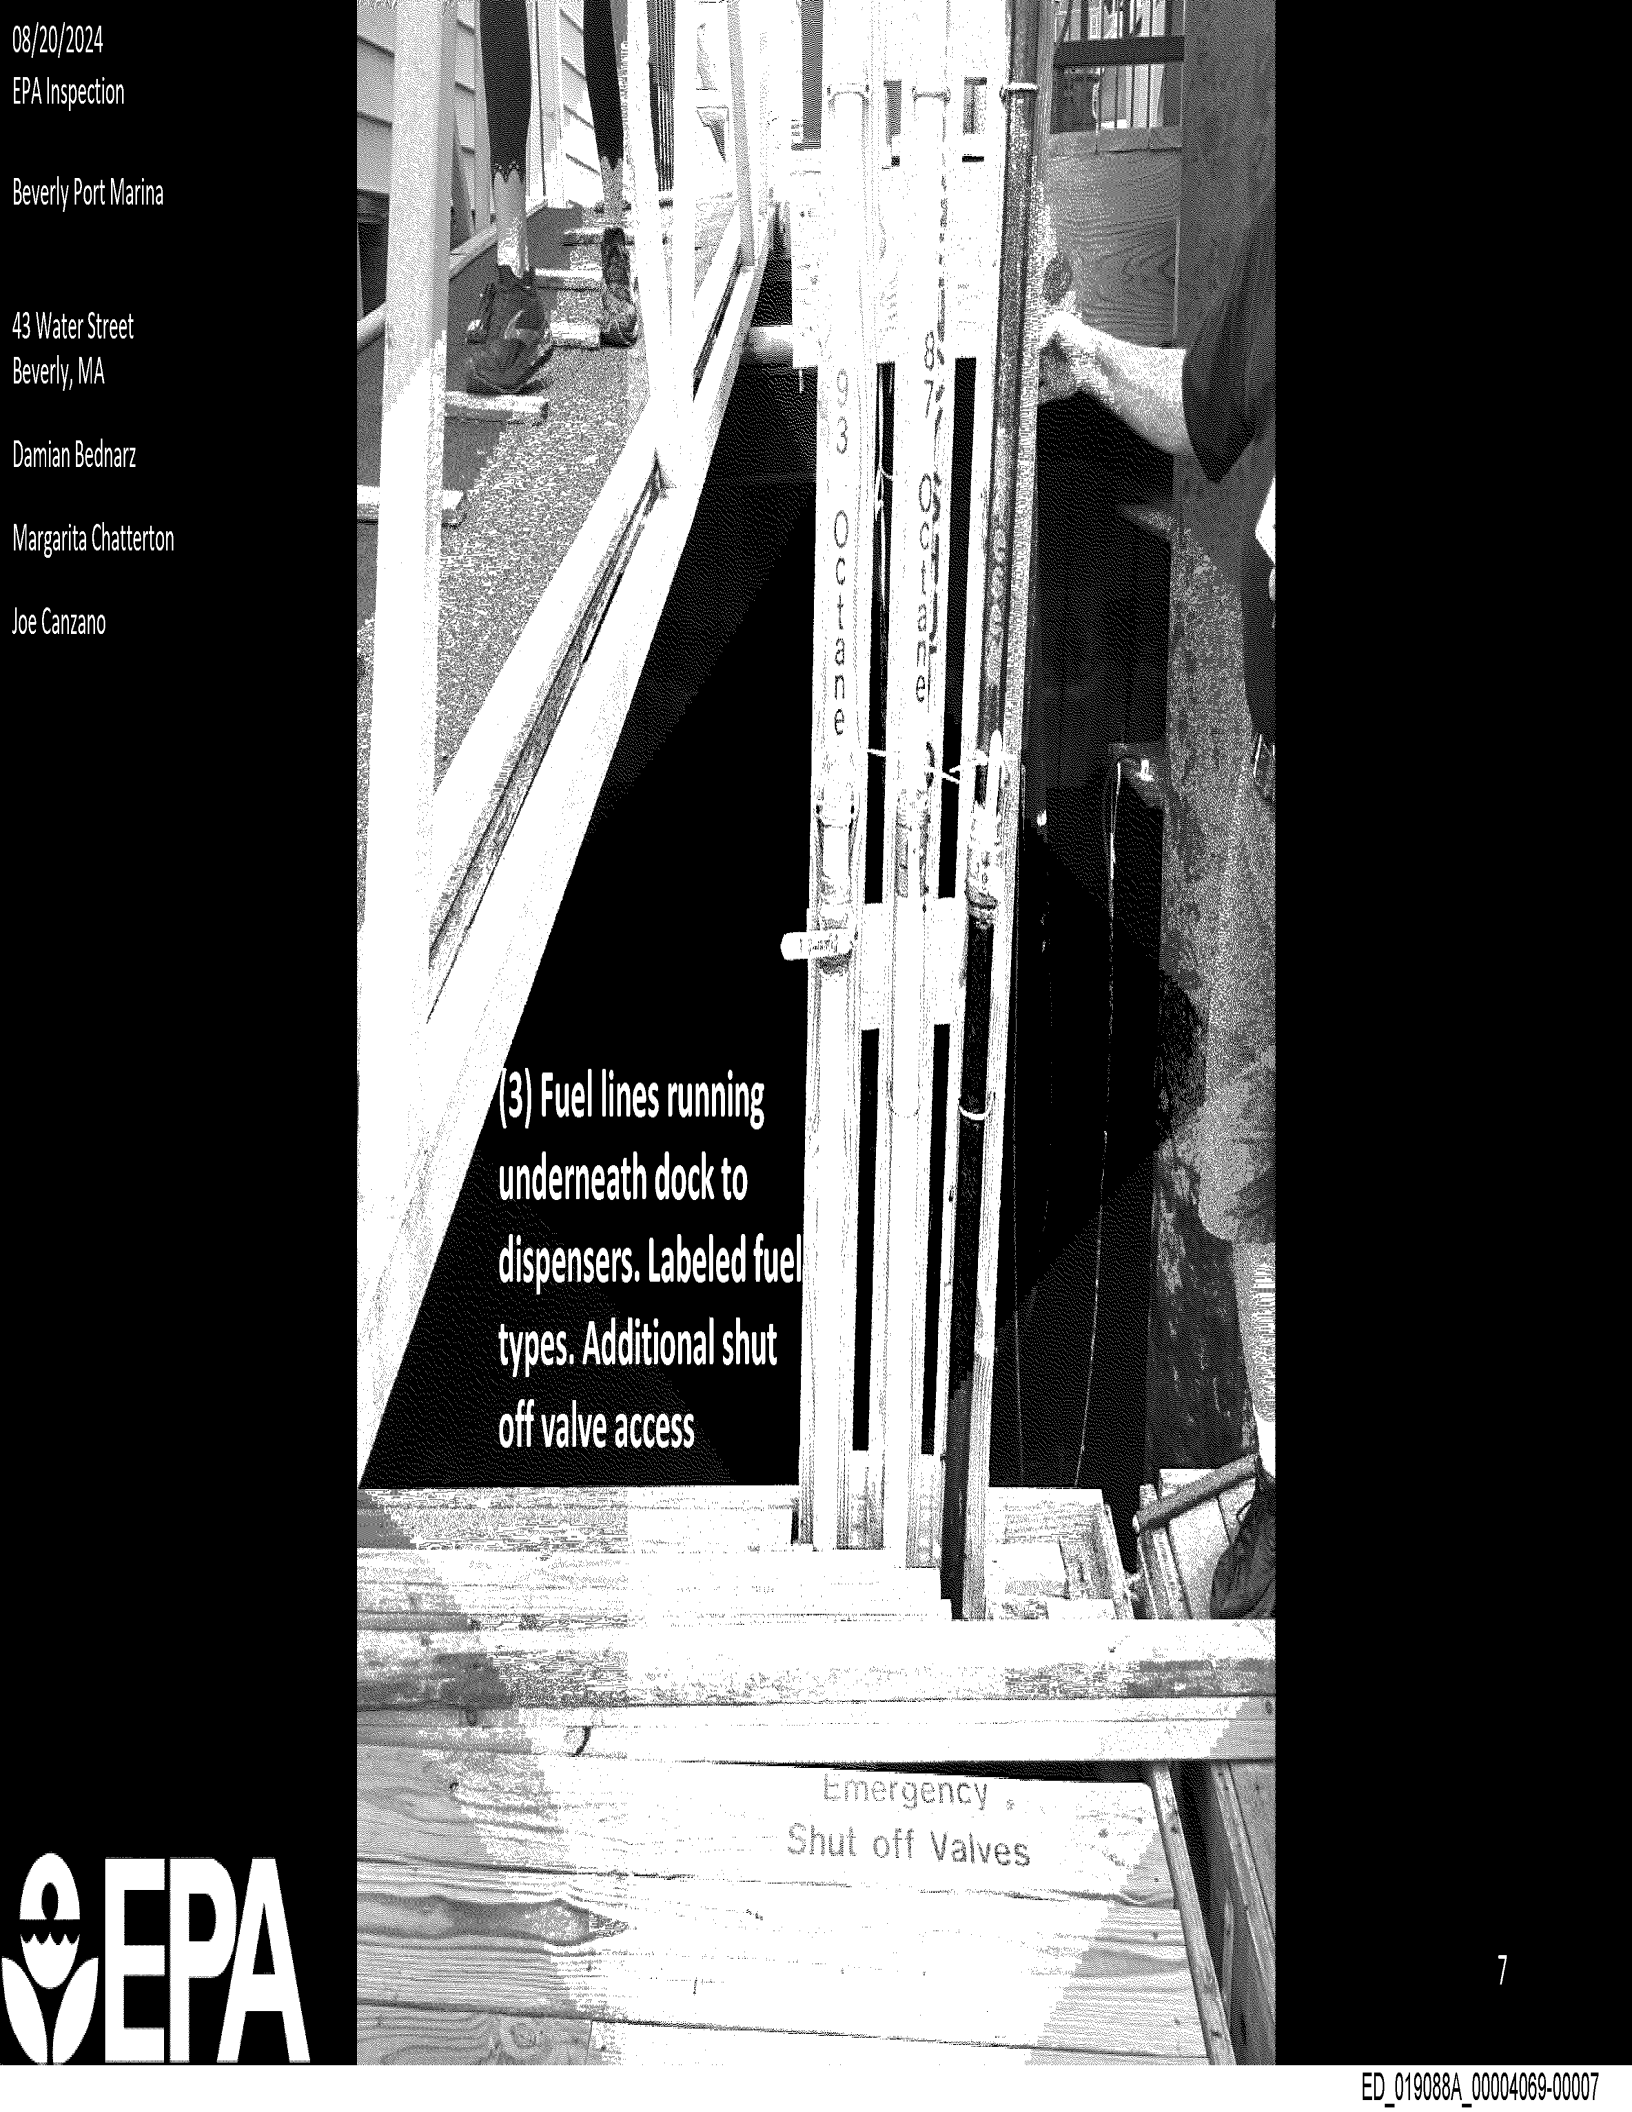
(3) Fuel lines running underneath dock to dispensers. Labeled fuel types. Additional shut off valve access

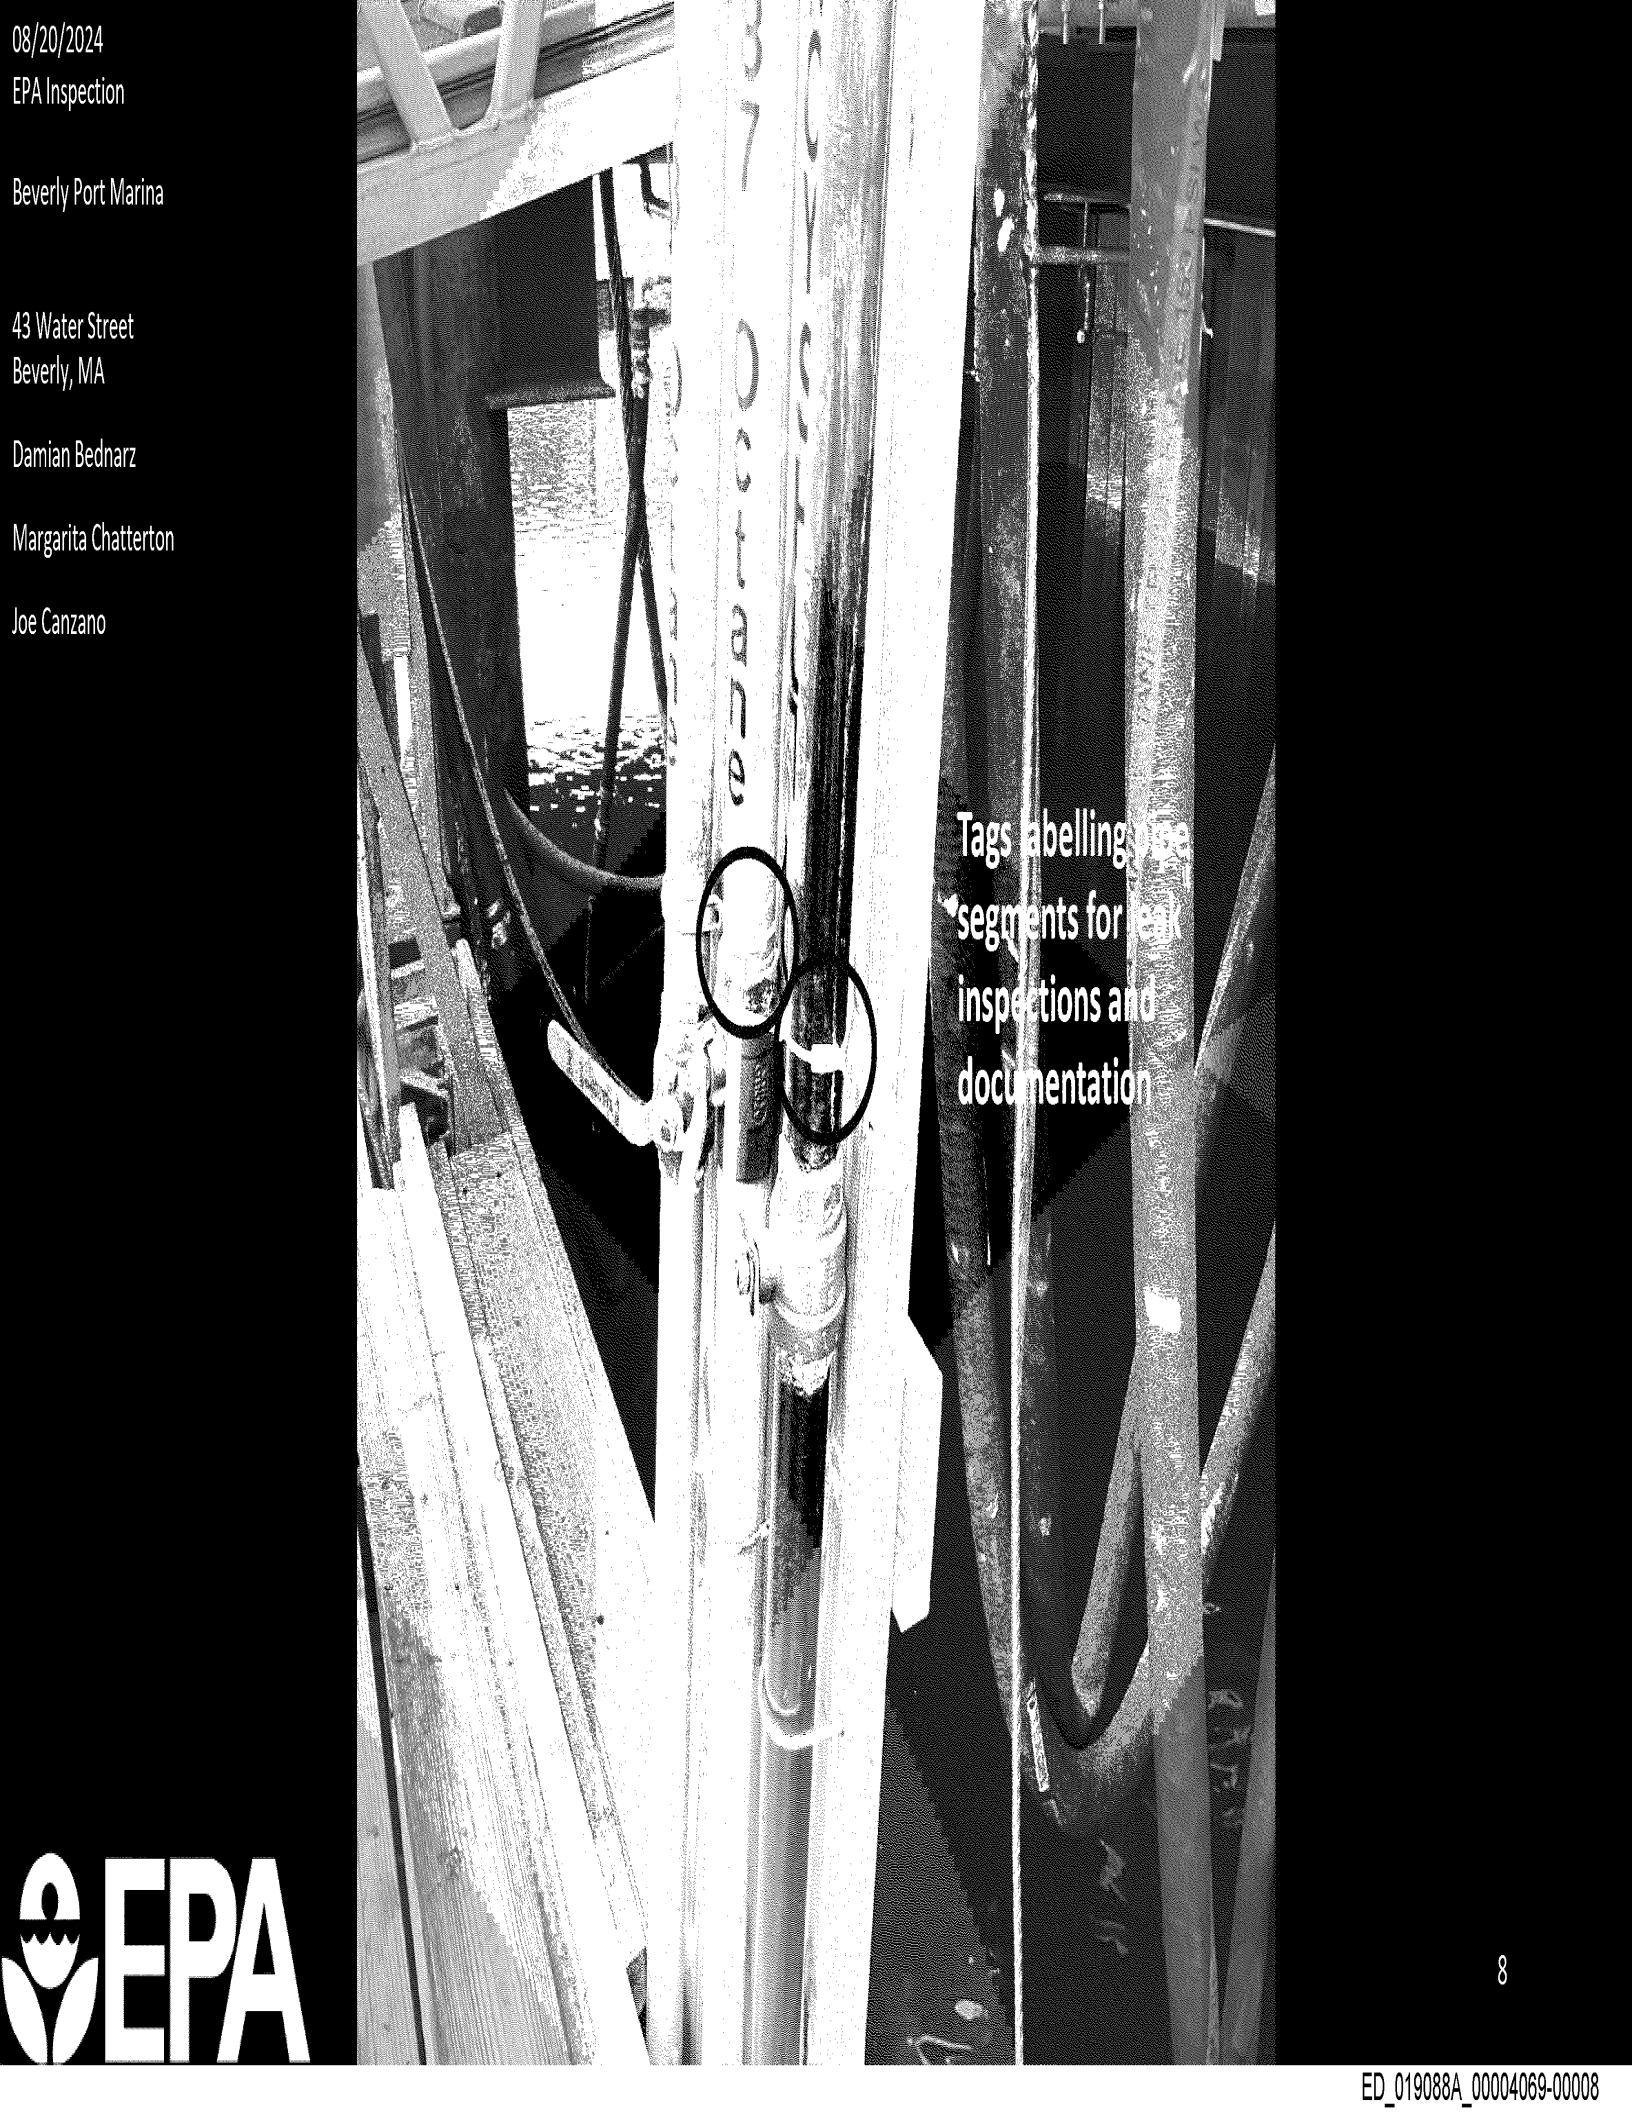
Tags labelling pipe  
segments for leak  
inspections and  
documentation

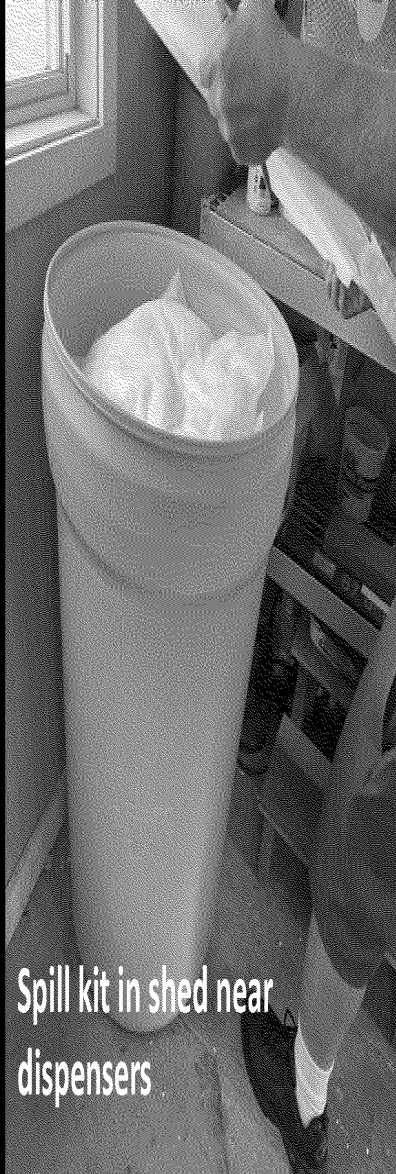
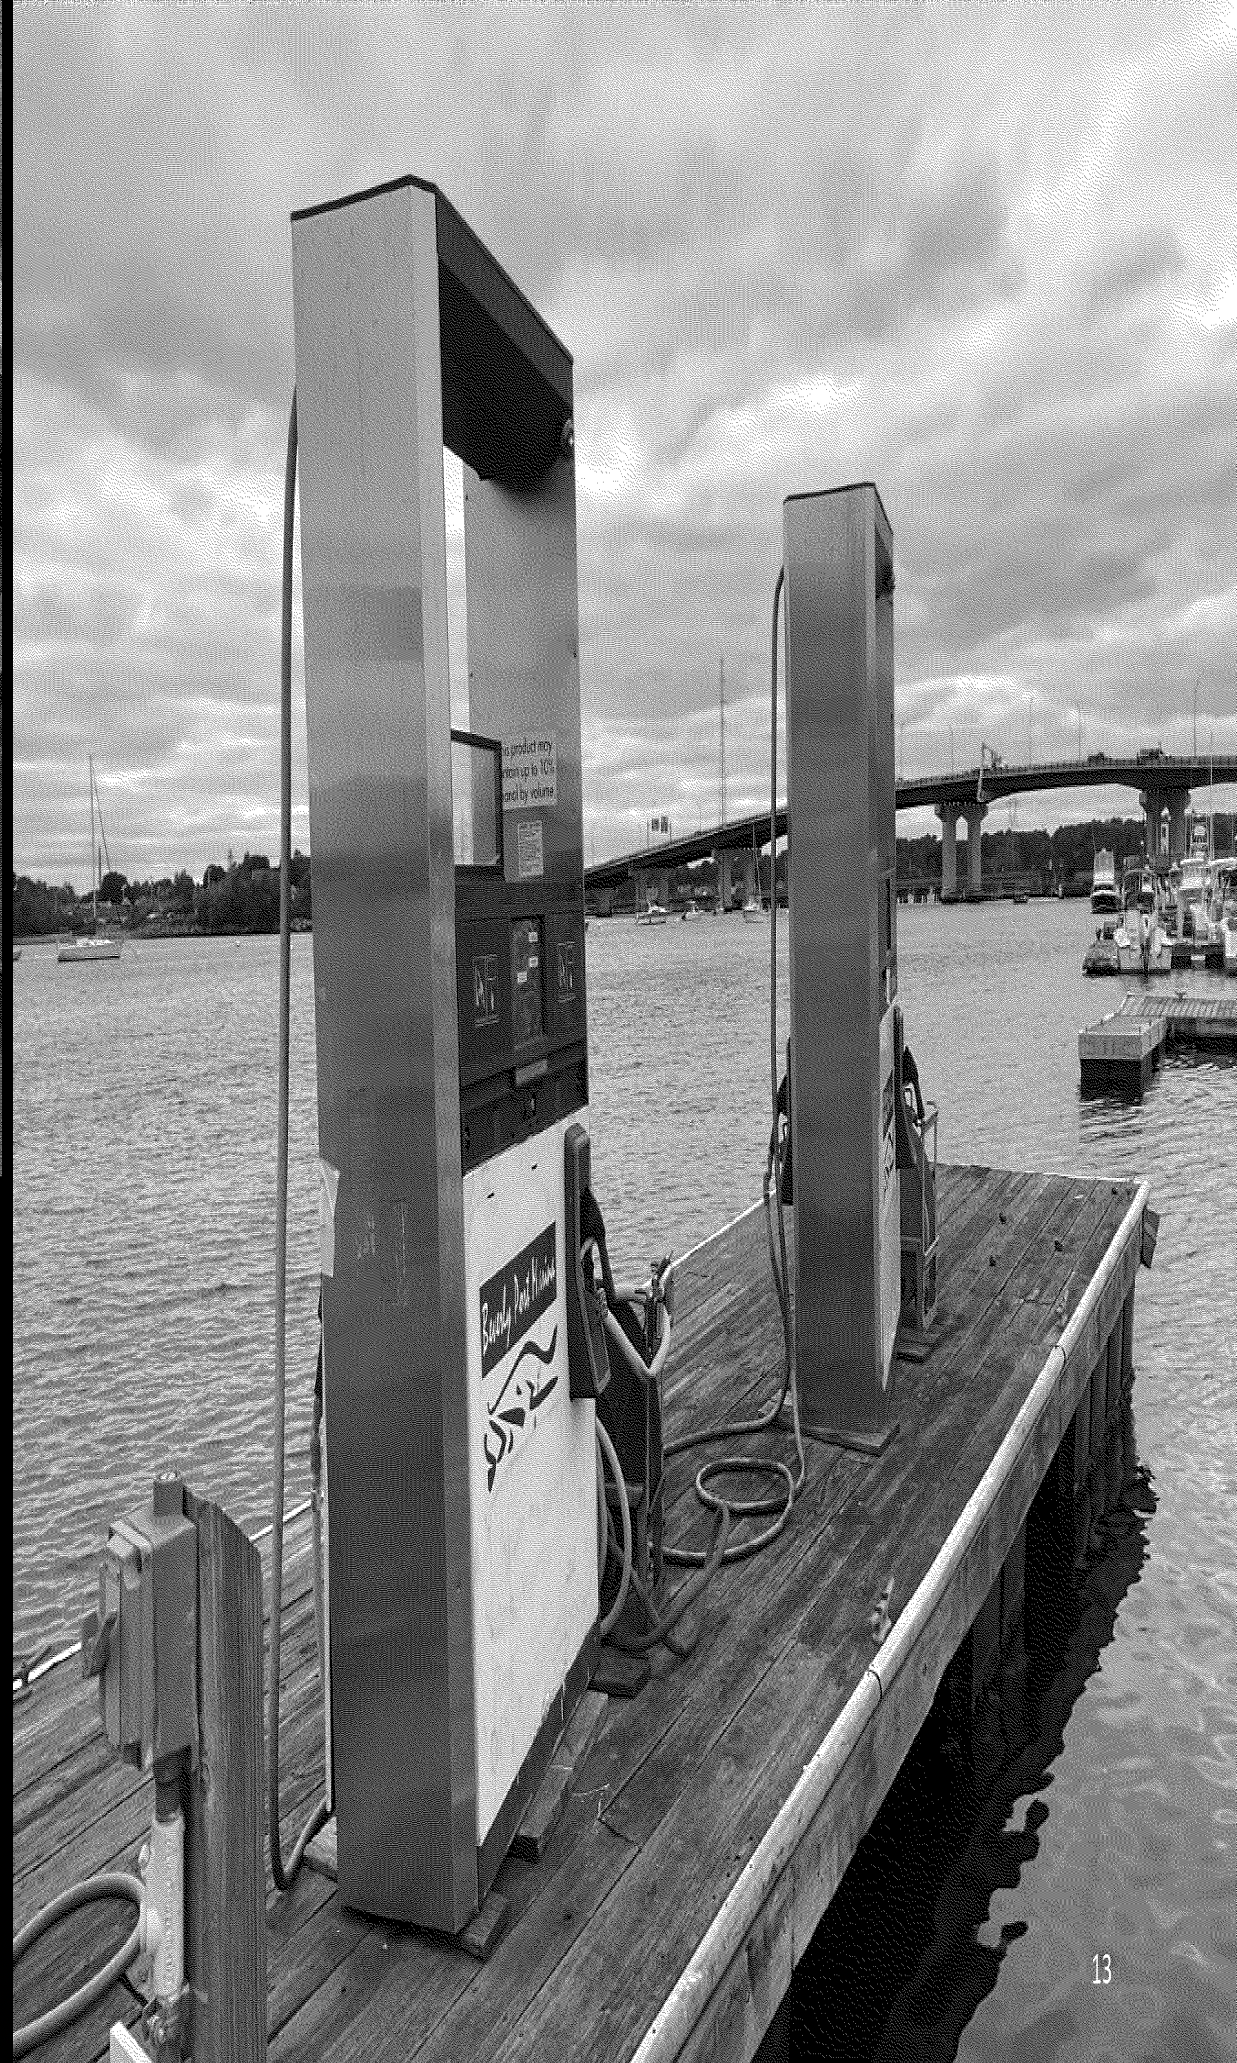
Spill kit in shed near dispensers

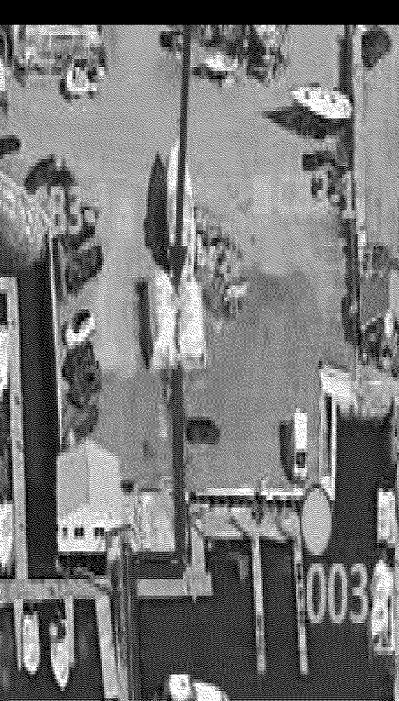
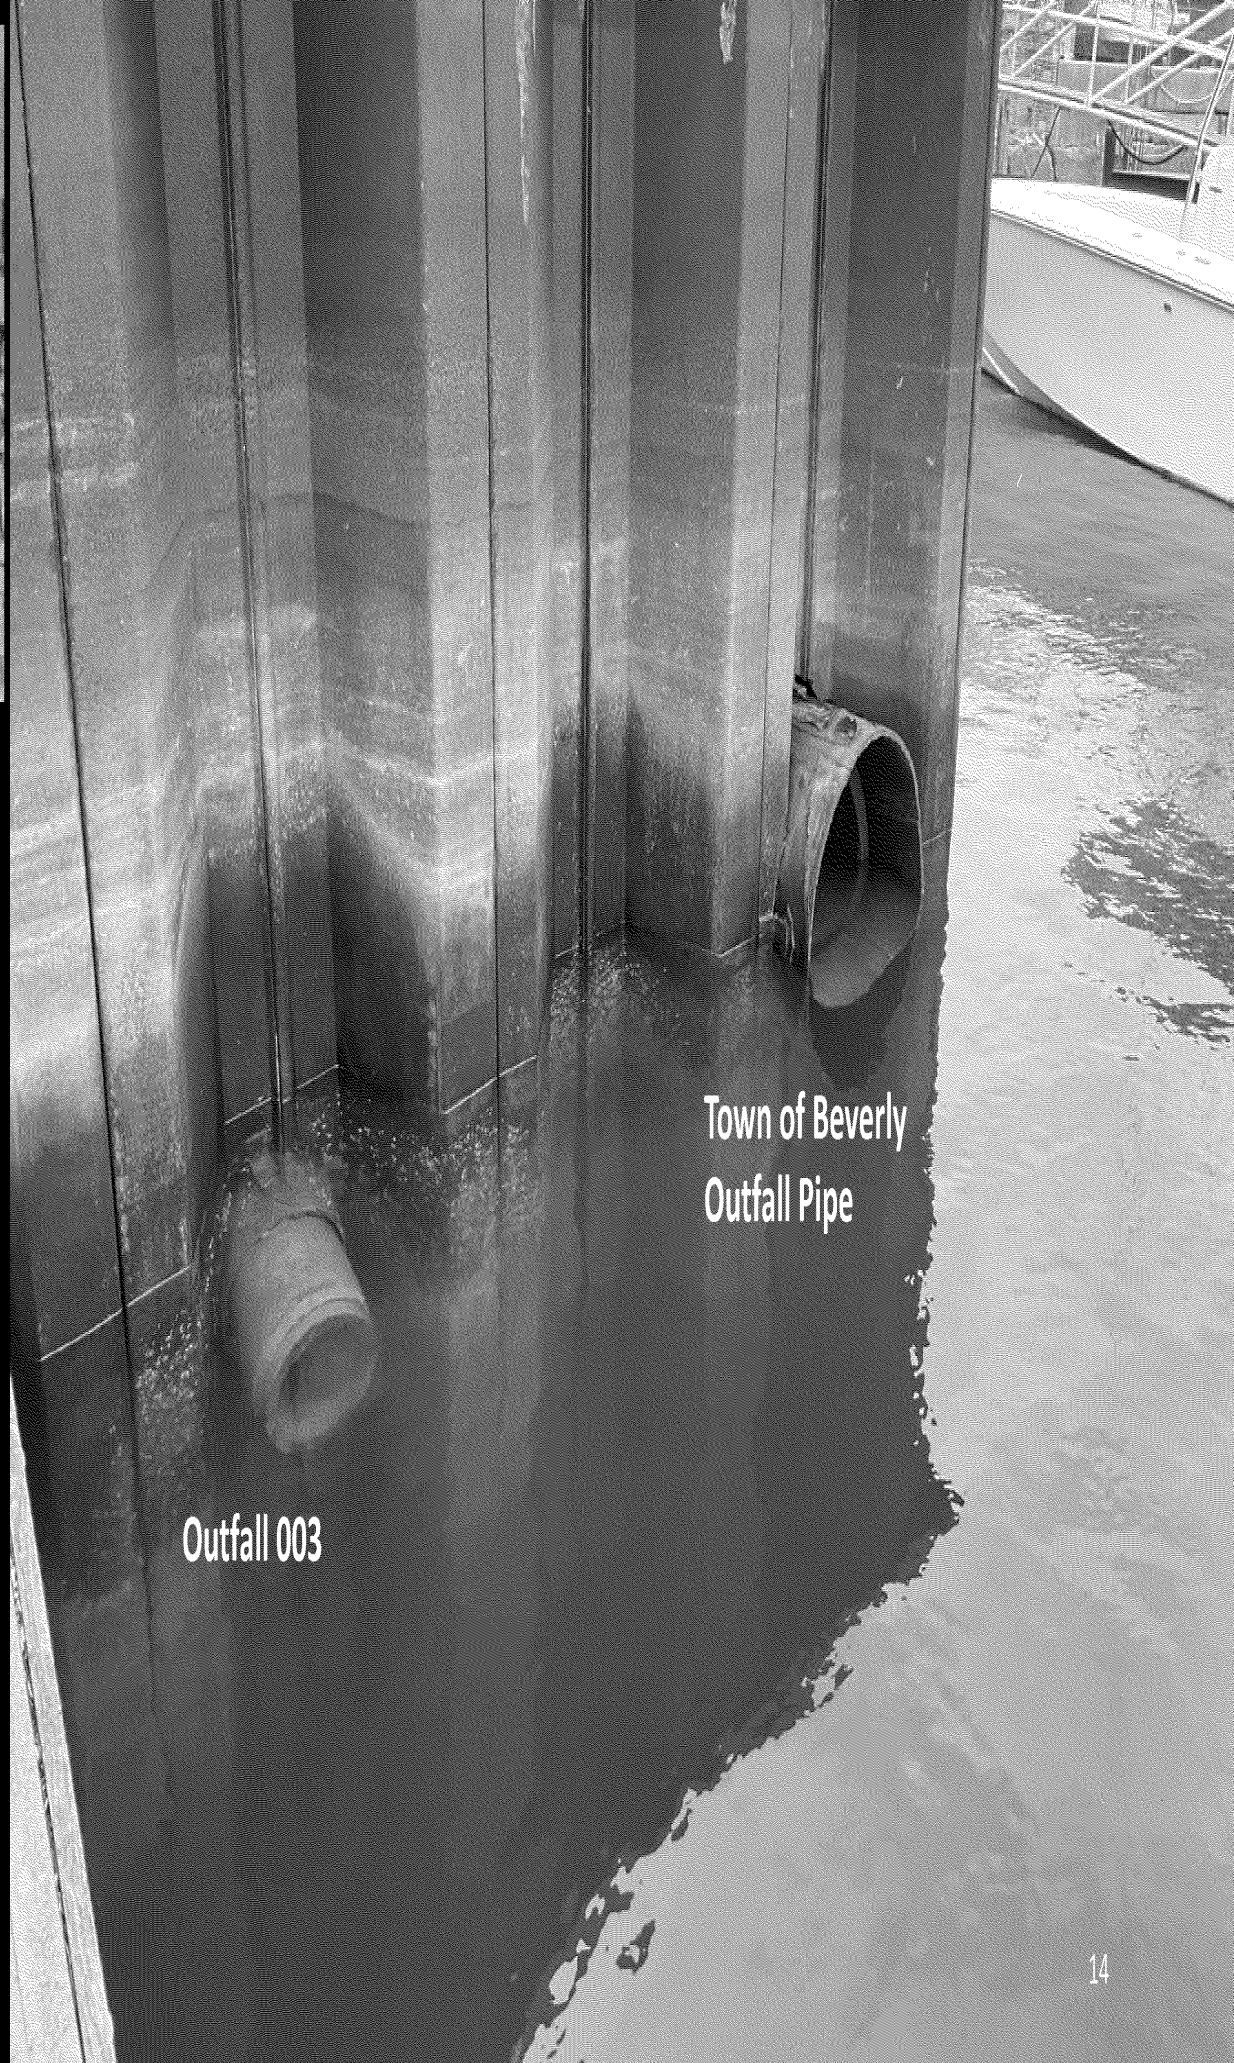
Outfall 003

Town of Beverly  
Outfall Pipe
