Beverly Port Marina – EPA Inspection 8/20/2024

Beverly Port Marina

43 Water Street  
Beverly, MA

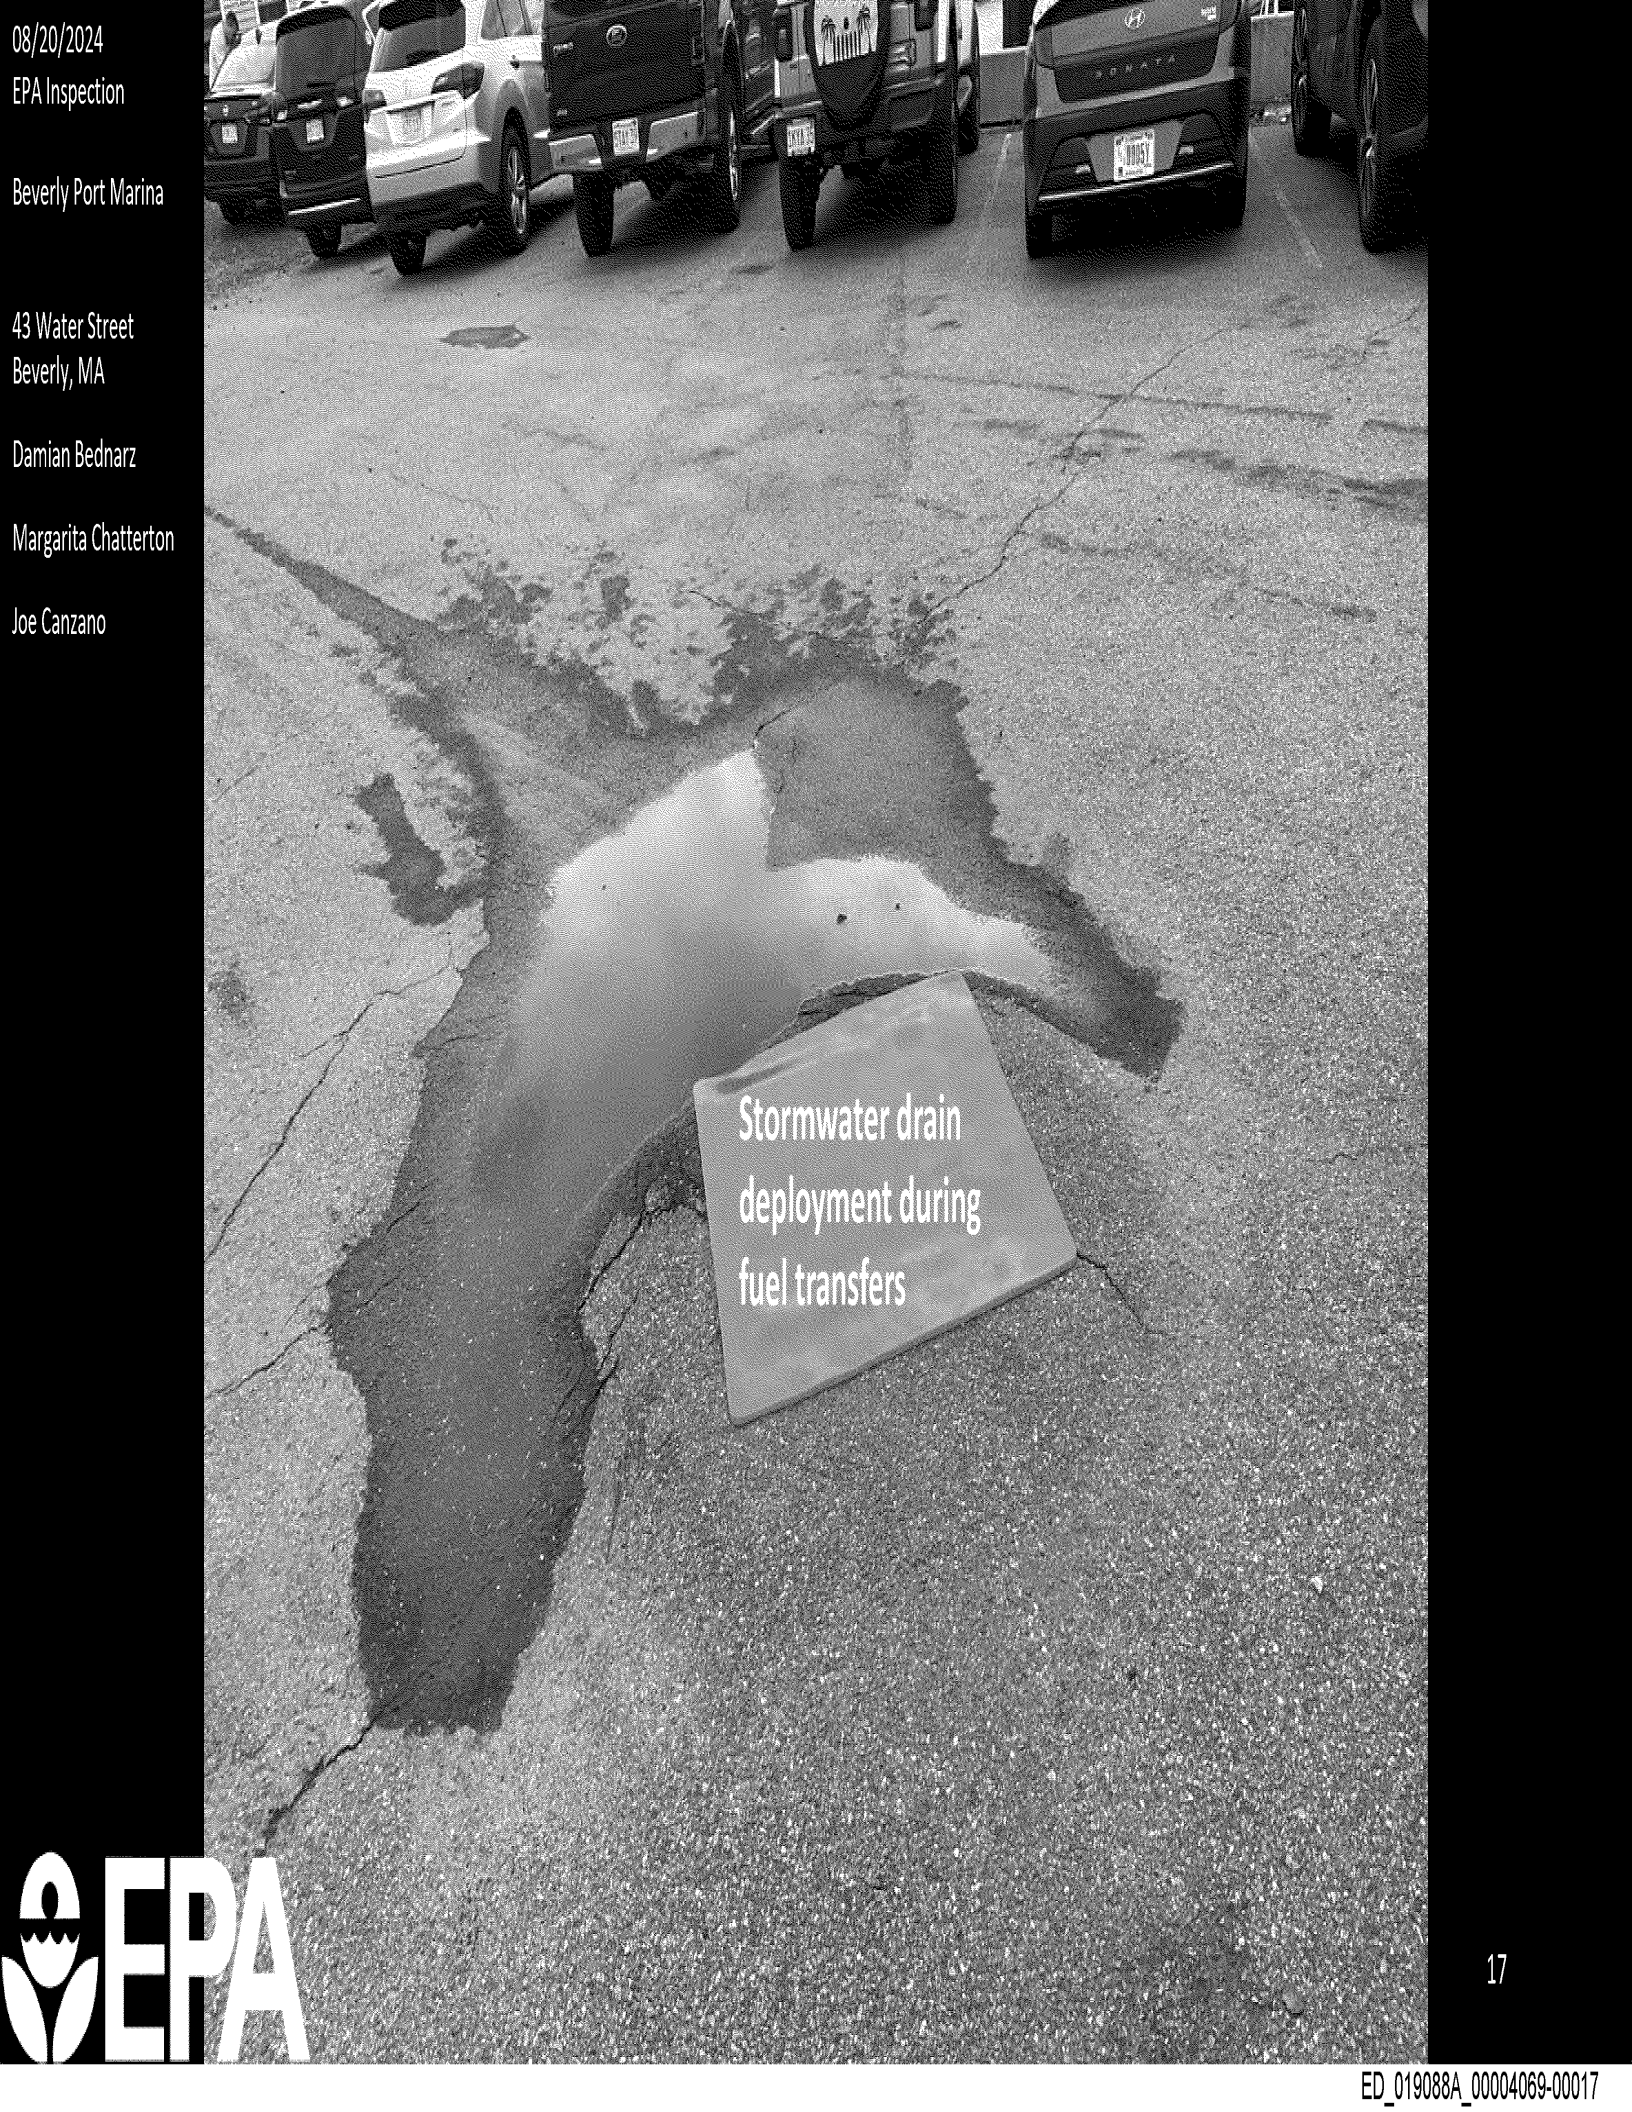
Stormwater drain  
deployment during  
fuel transfers

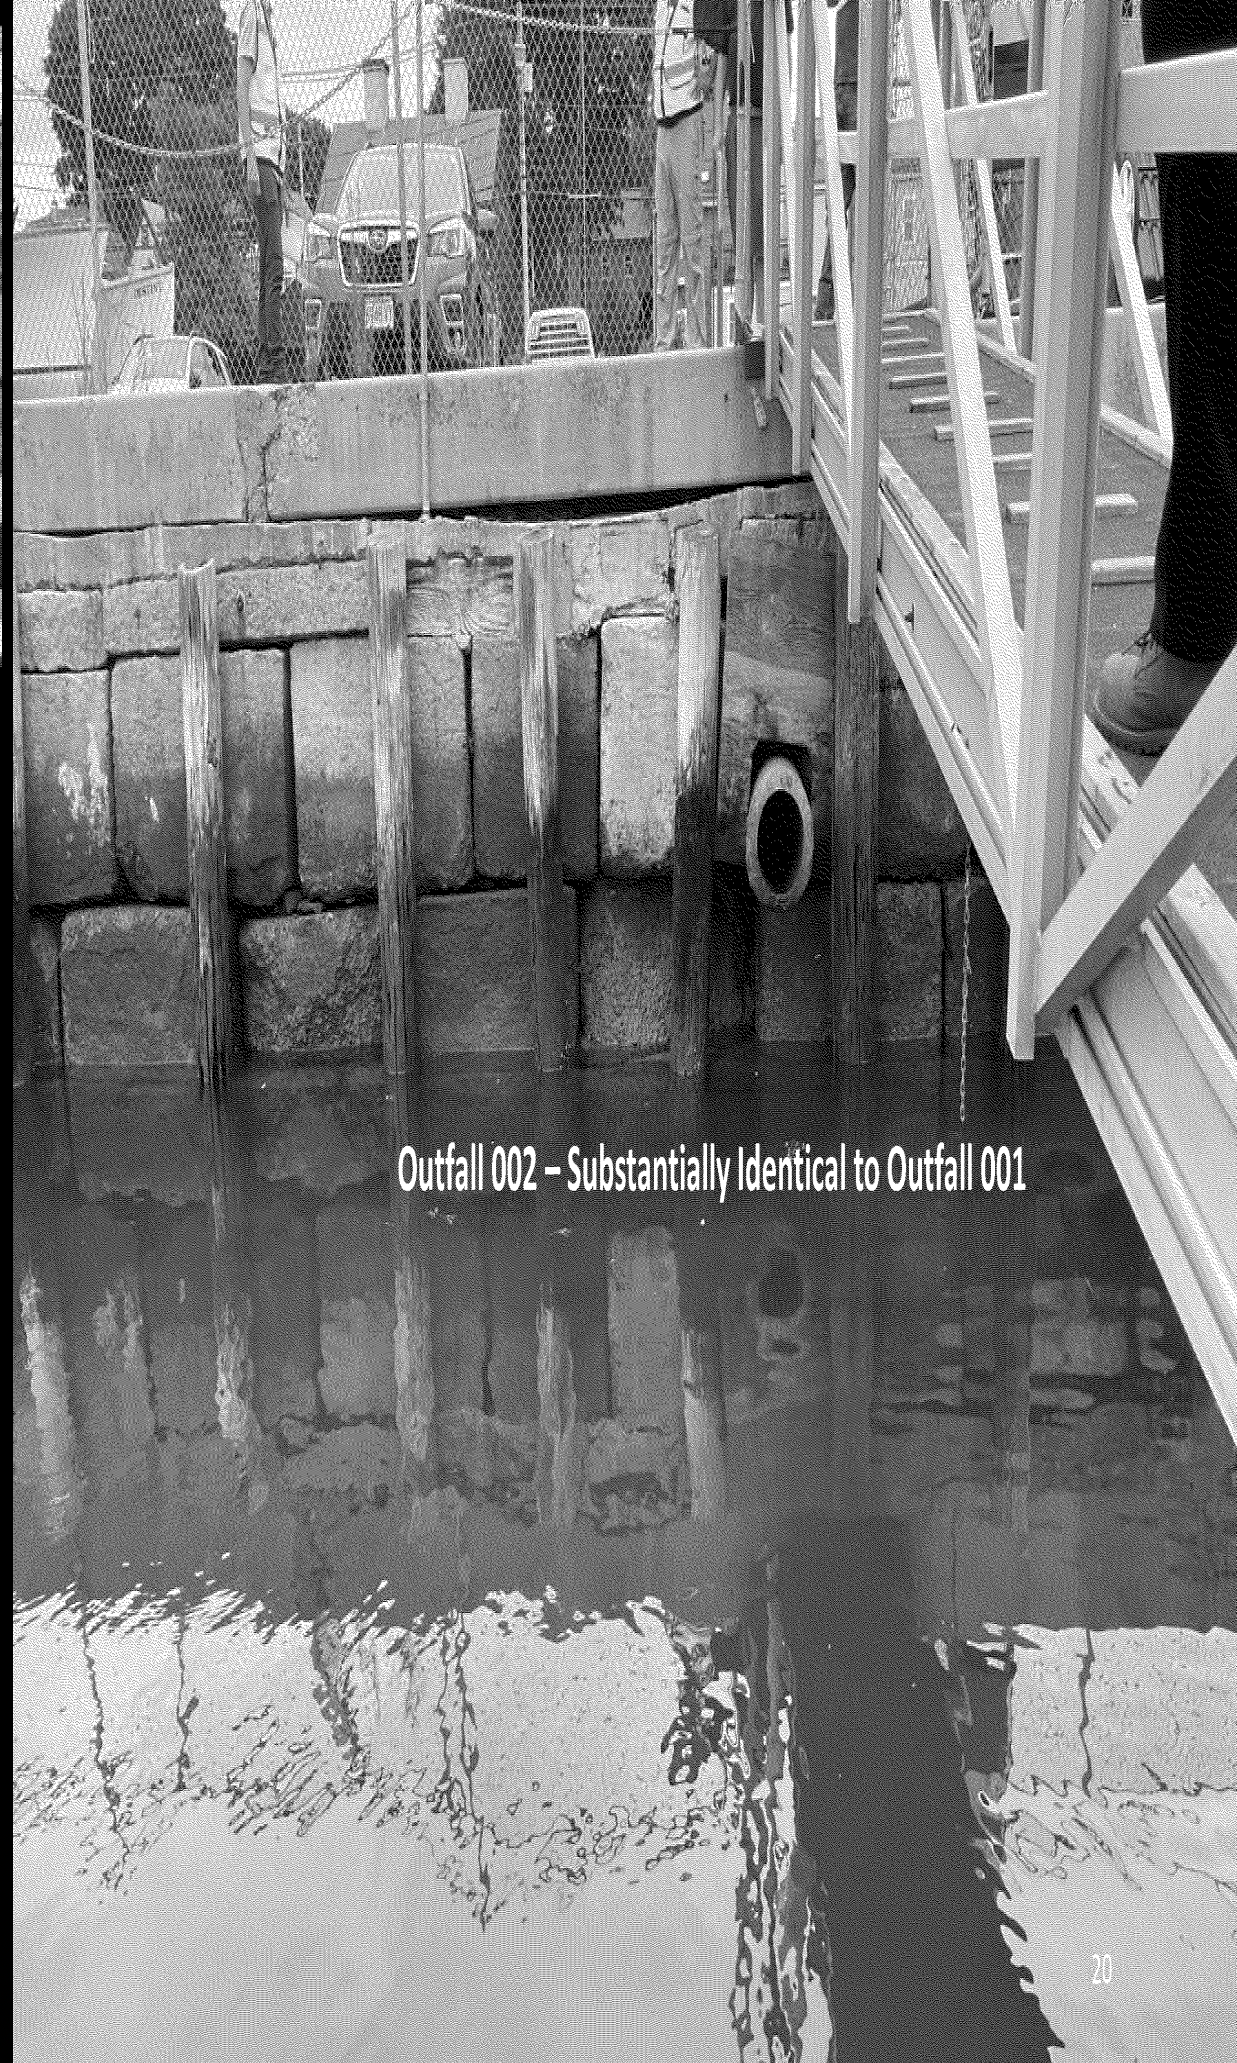
Outfall 002 – Substantially Identical to Outfall 001

Rust staining and discoloration in Outfall 002 drainage area

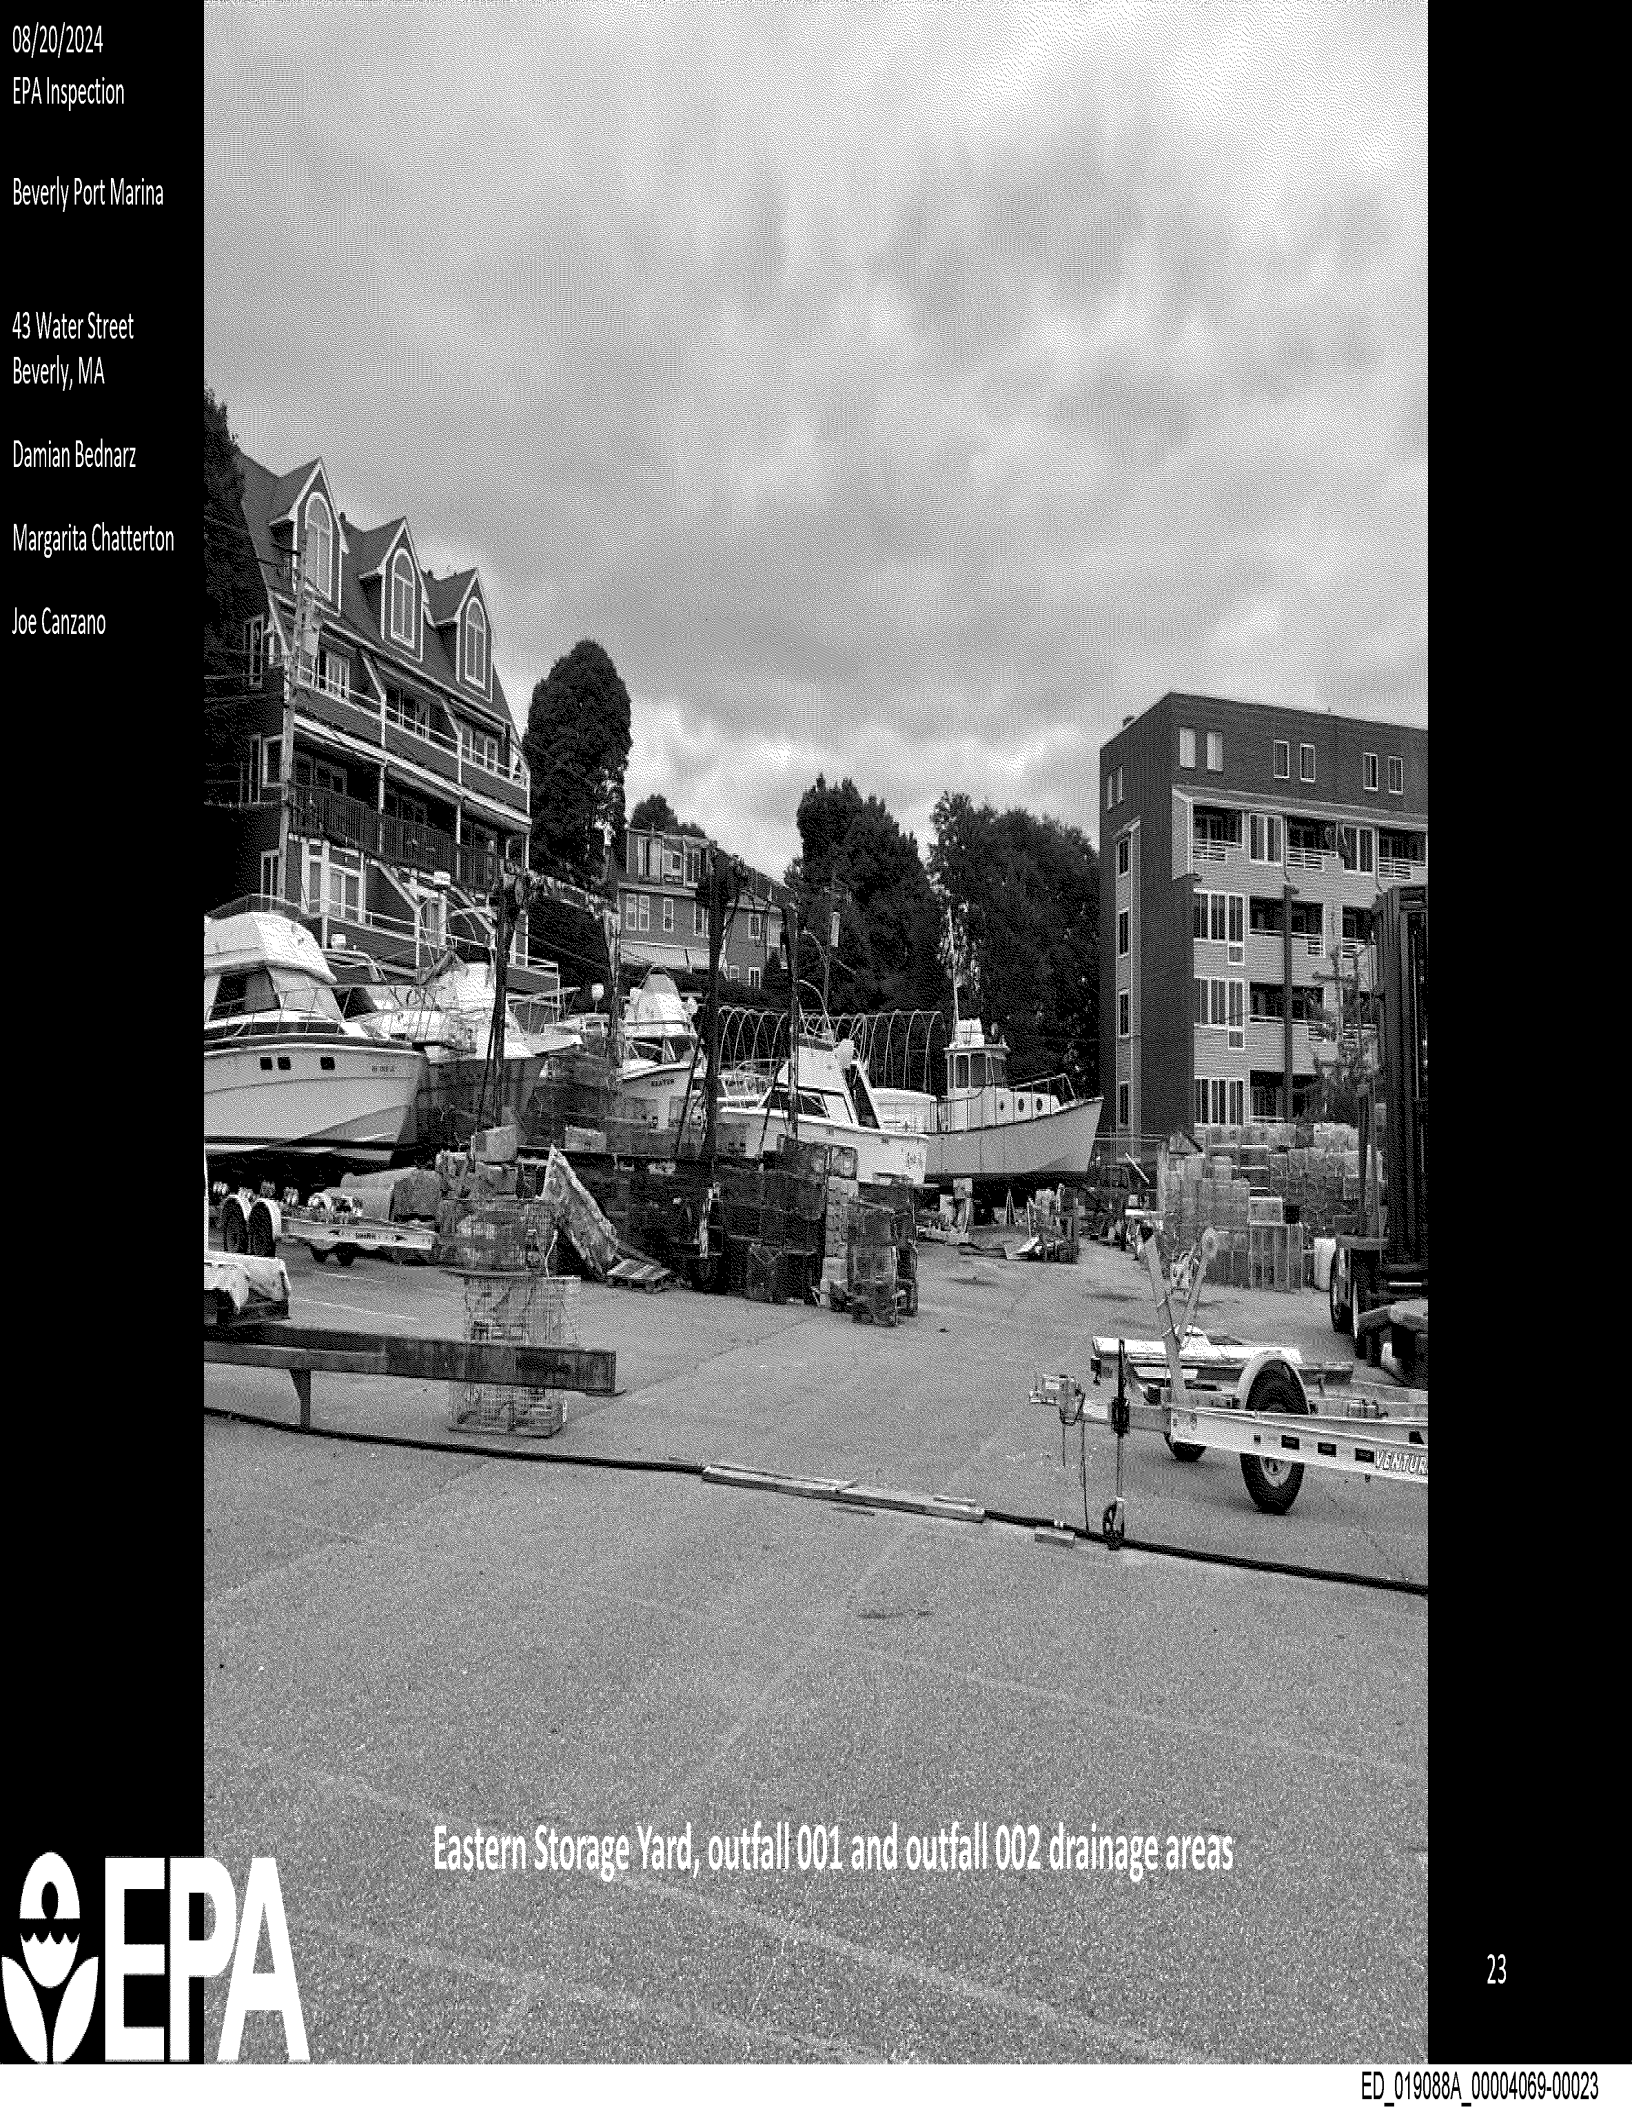
Eastern Storage Yard, outfall 001 and outfall 002 drainage areas

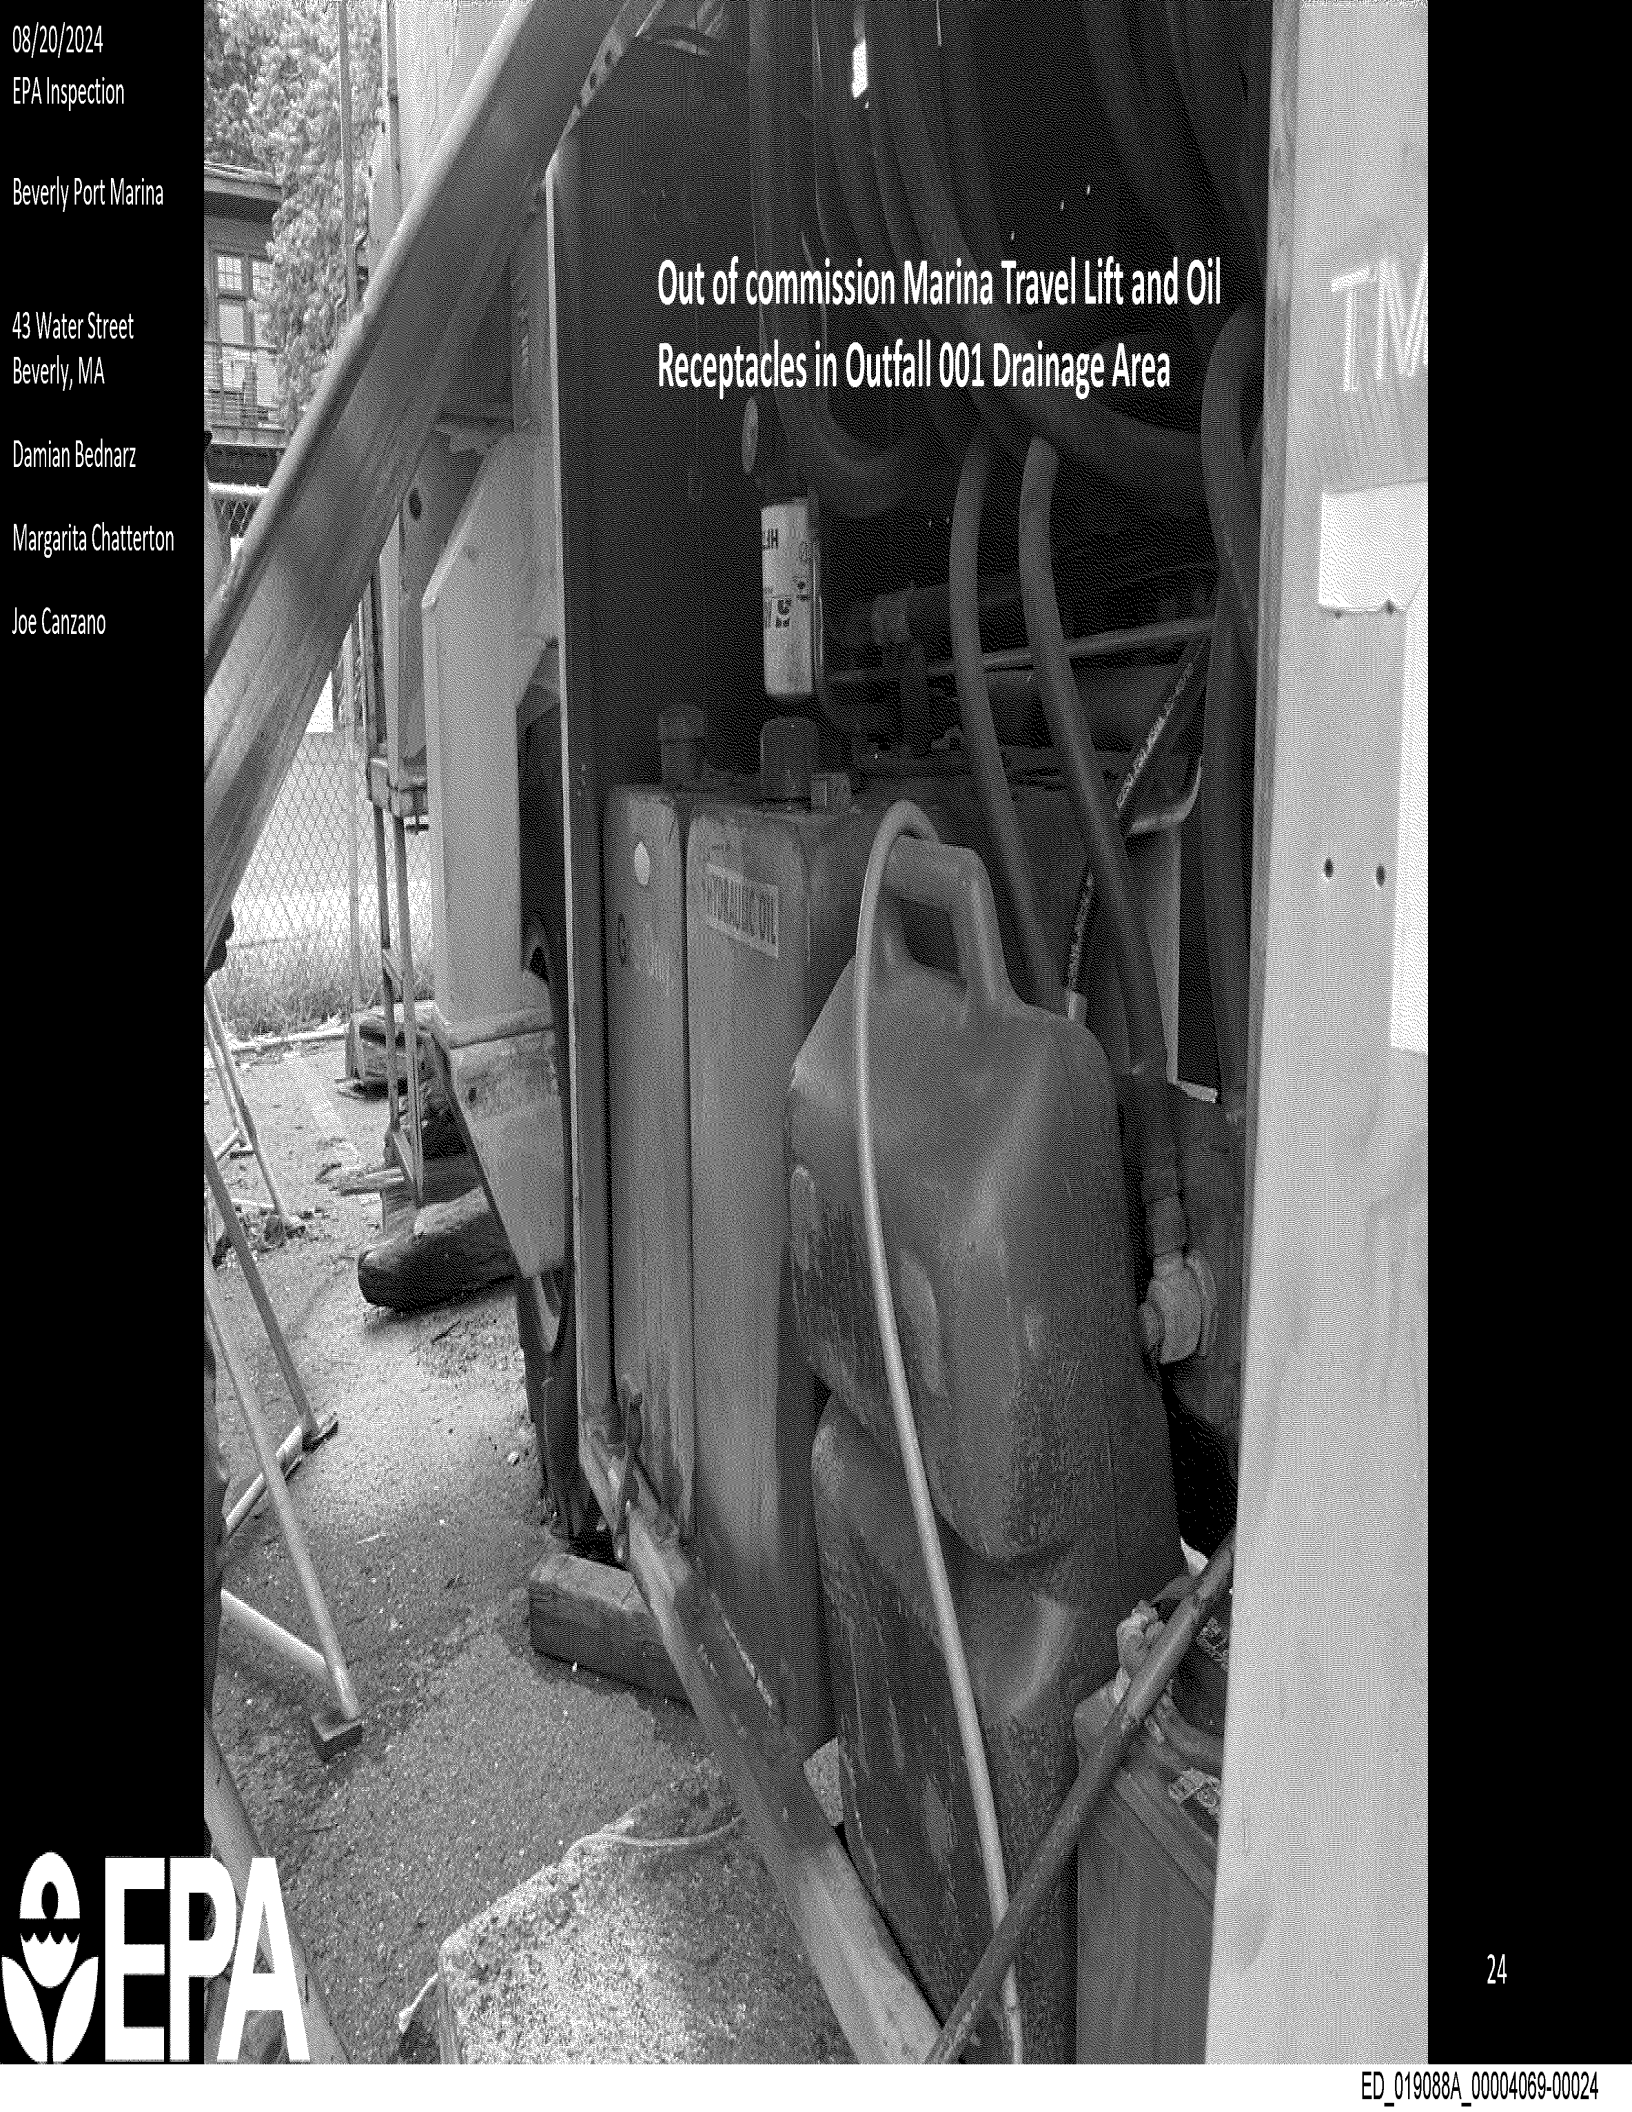
## Out of commission Marina Travel Lift and Oil Receptacles in Outfall 001 Drainage Area

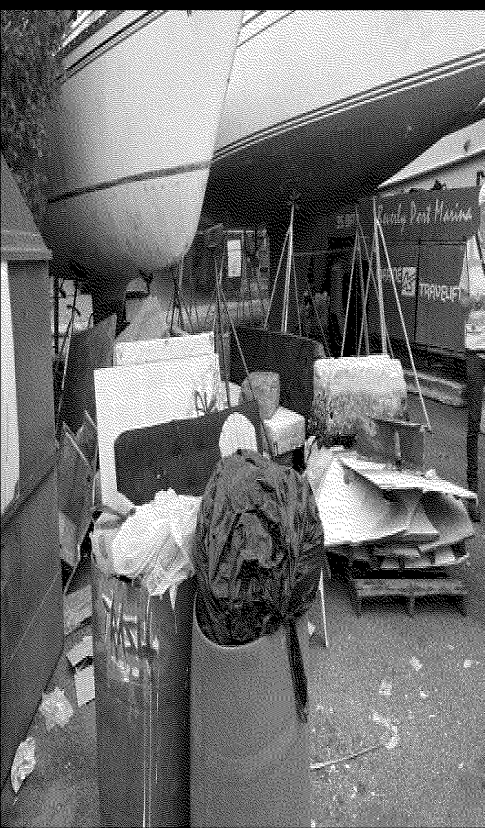
Uncovered waste (overflow)  
behind dumpster

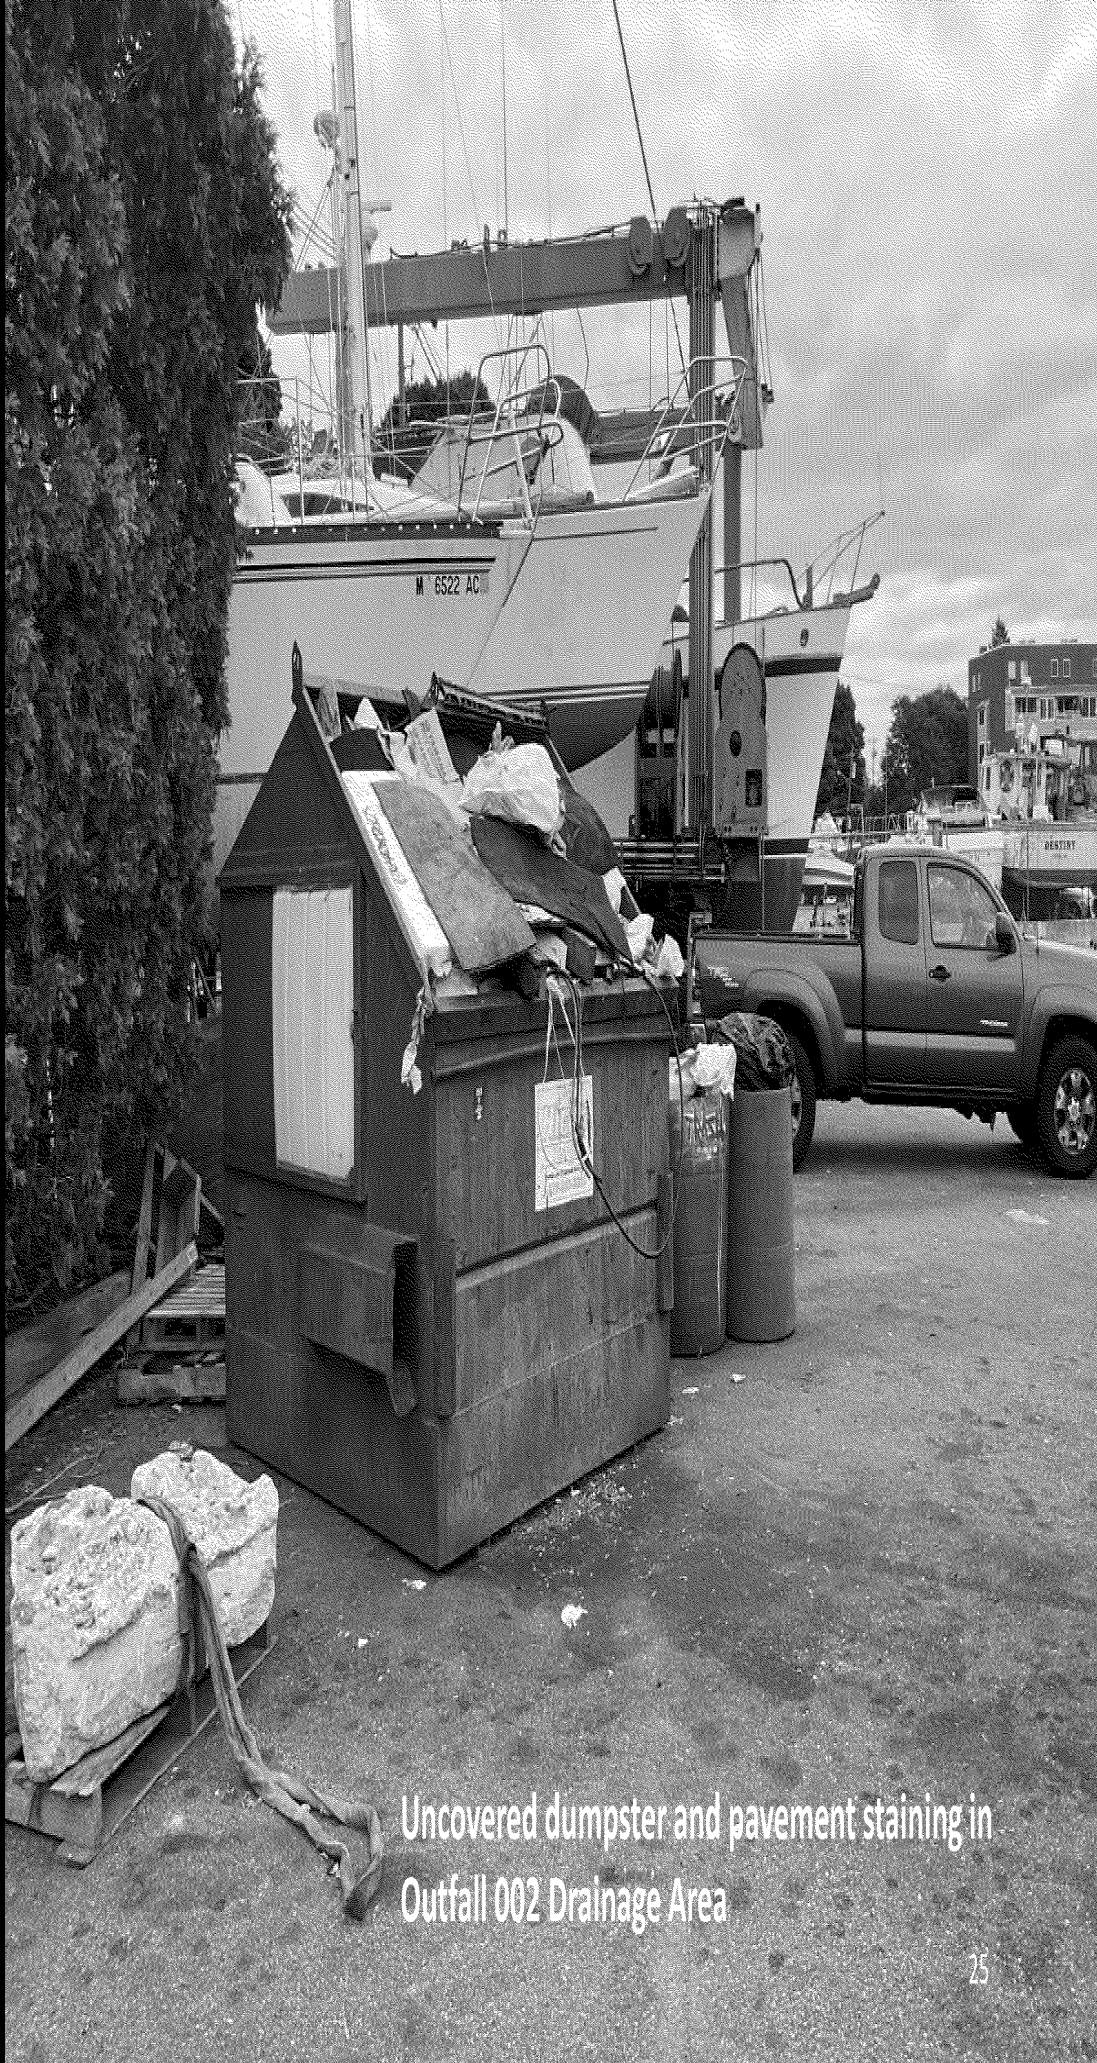
Uncovered dumpster and pavement staining in  
Outfall 002 Drainage Area

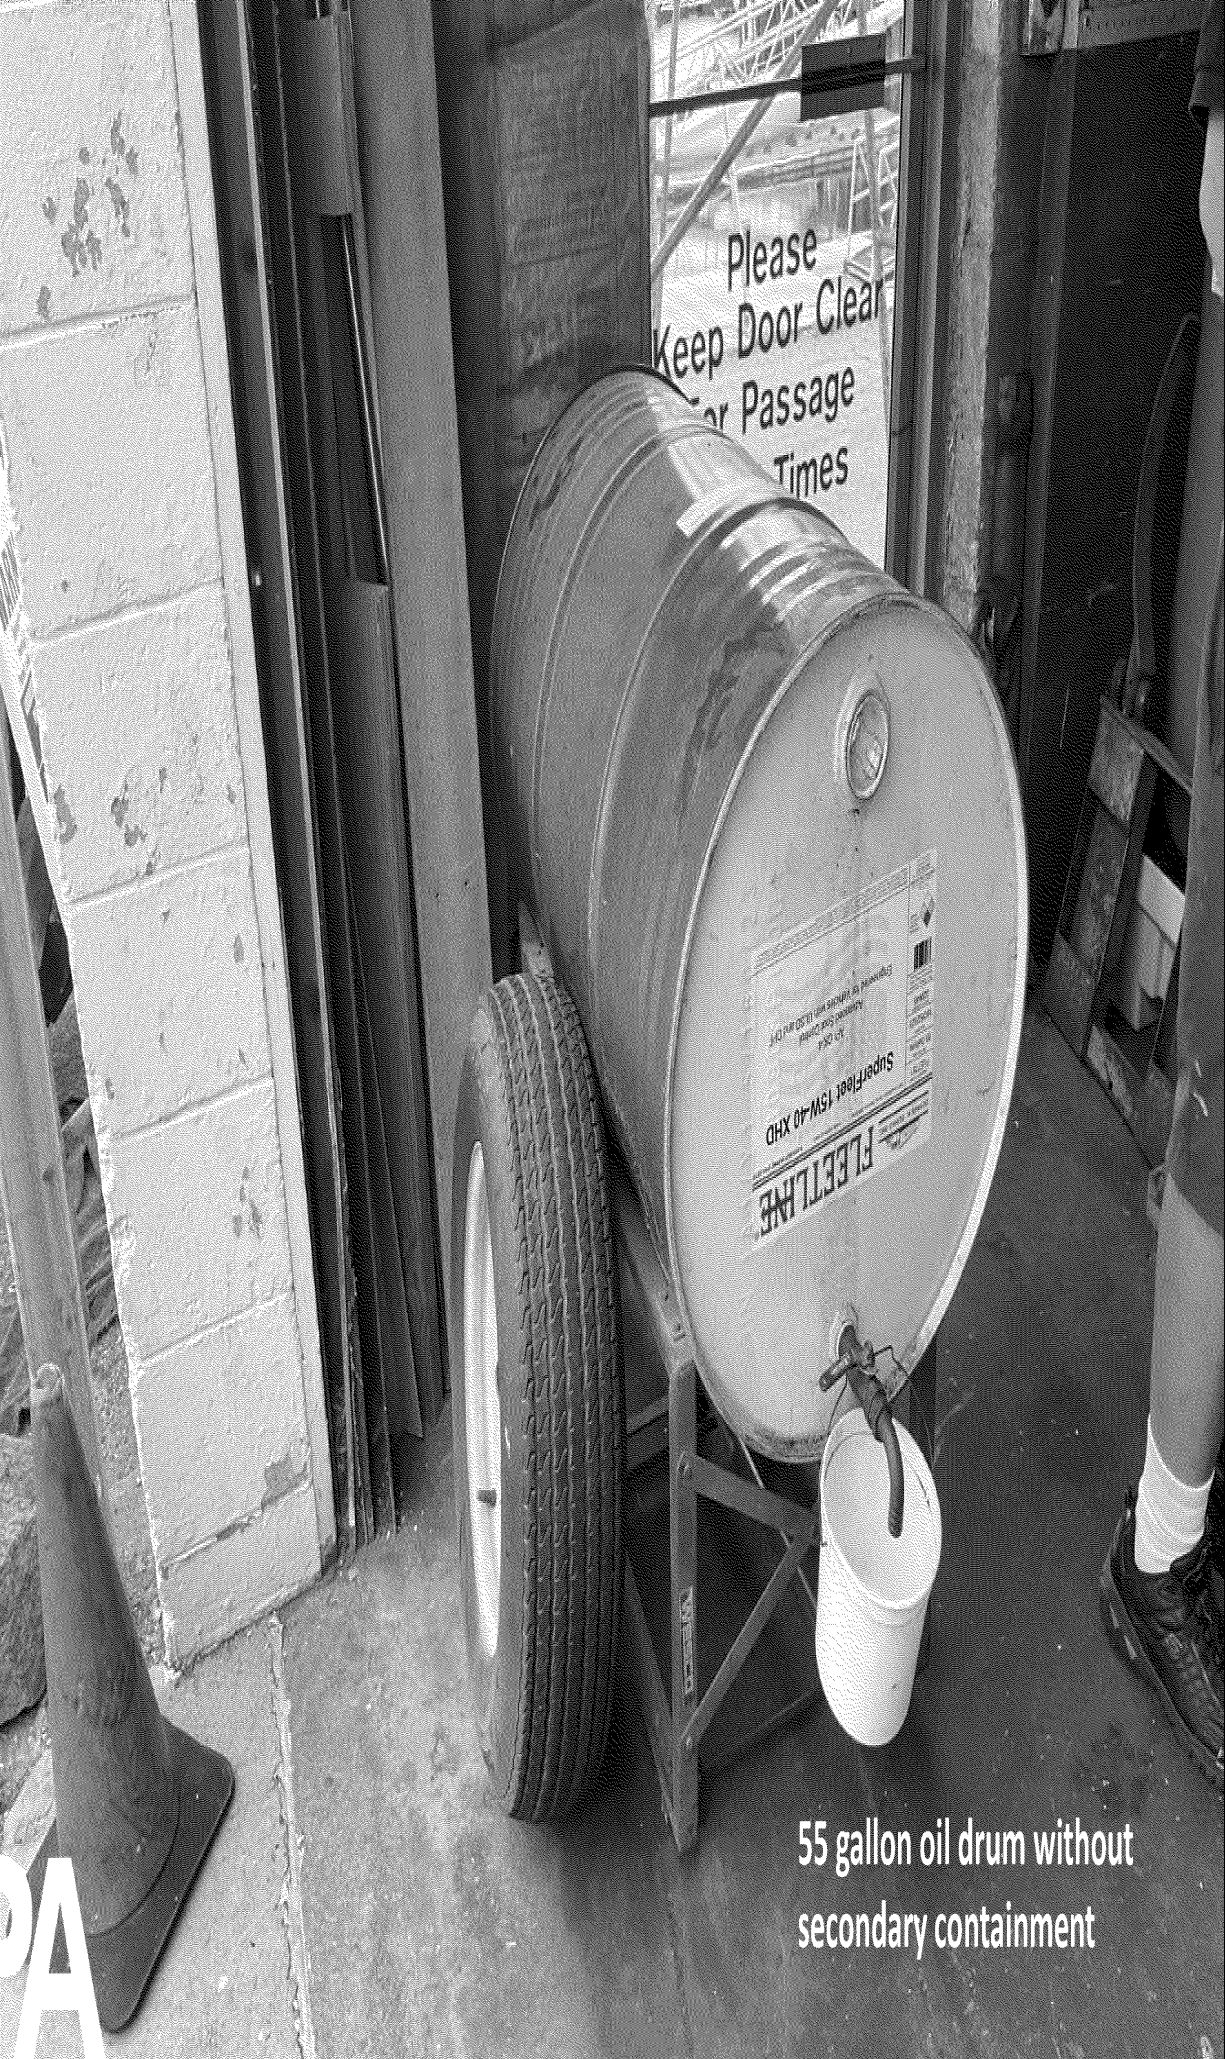
55 gallon oil drum without  
secondary containment

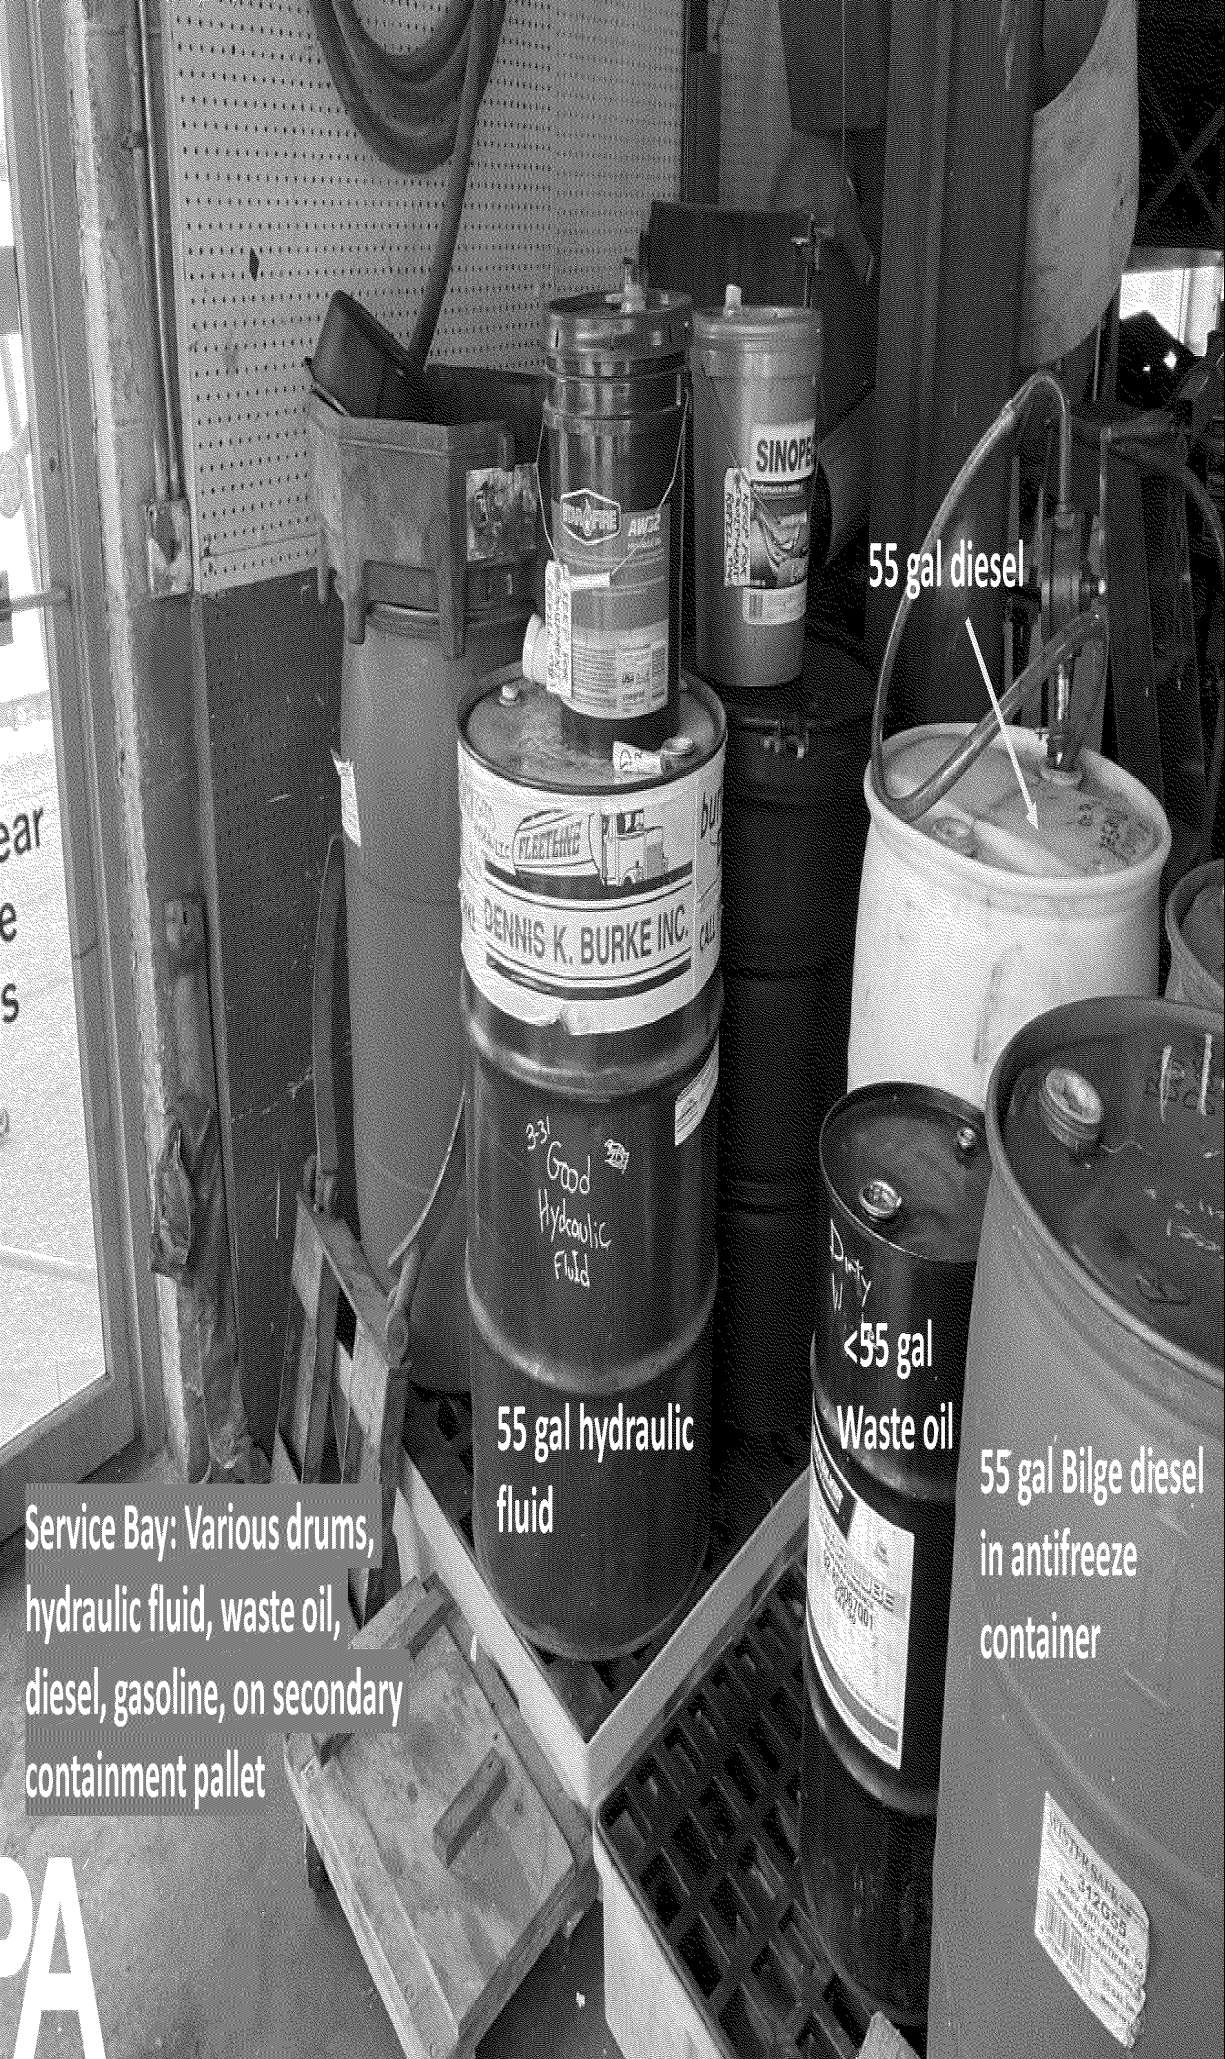
Service Bay: Various drums, hydraulic fluid, waste oil, diesel, gasoline, on secondary containment pallet

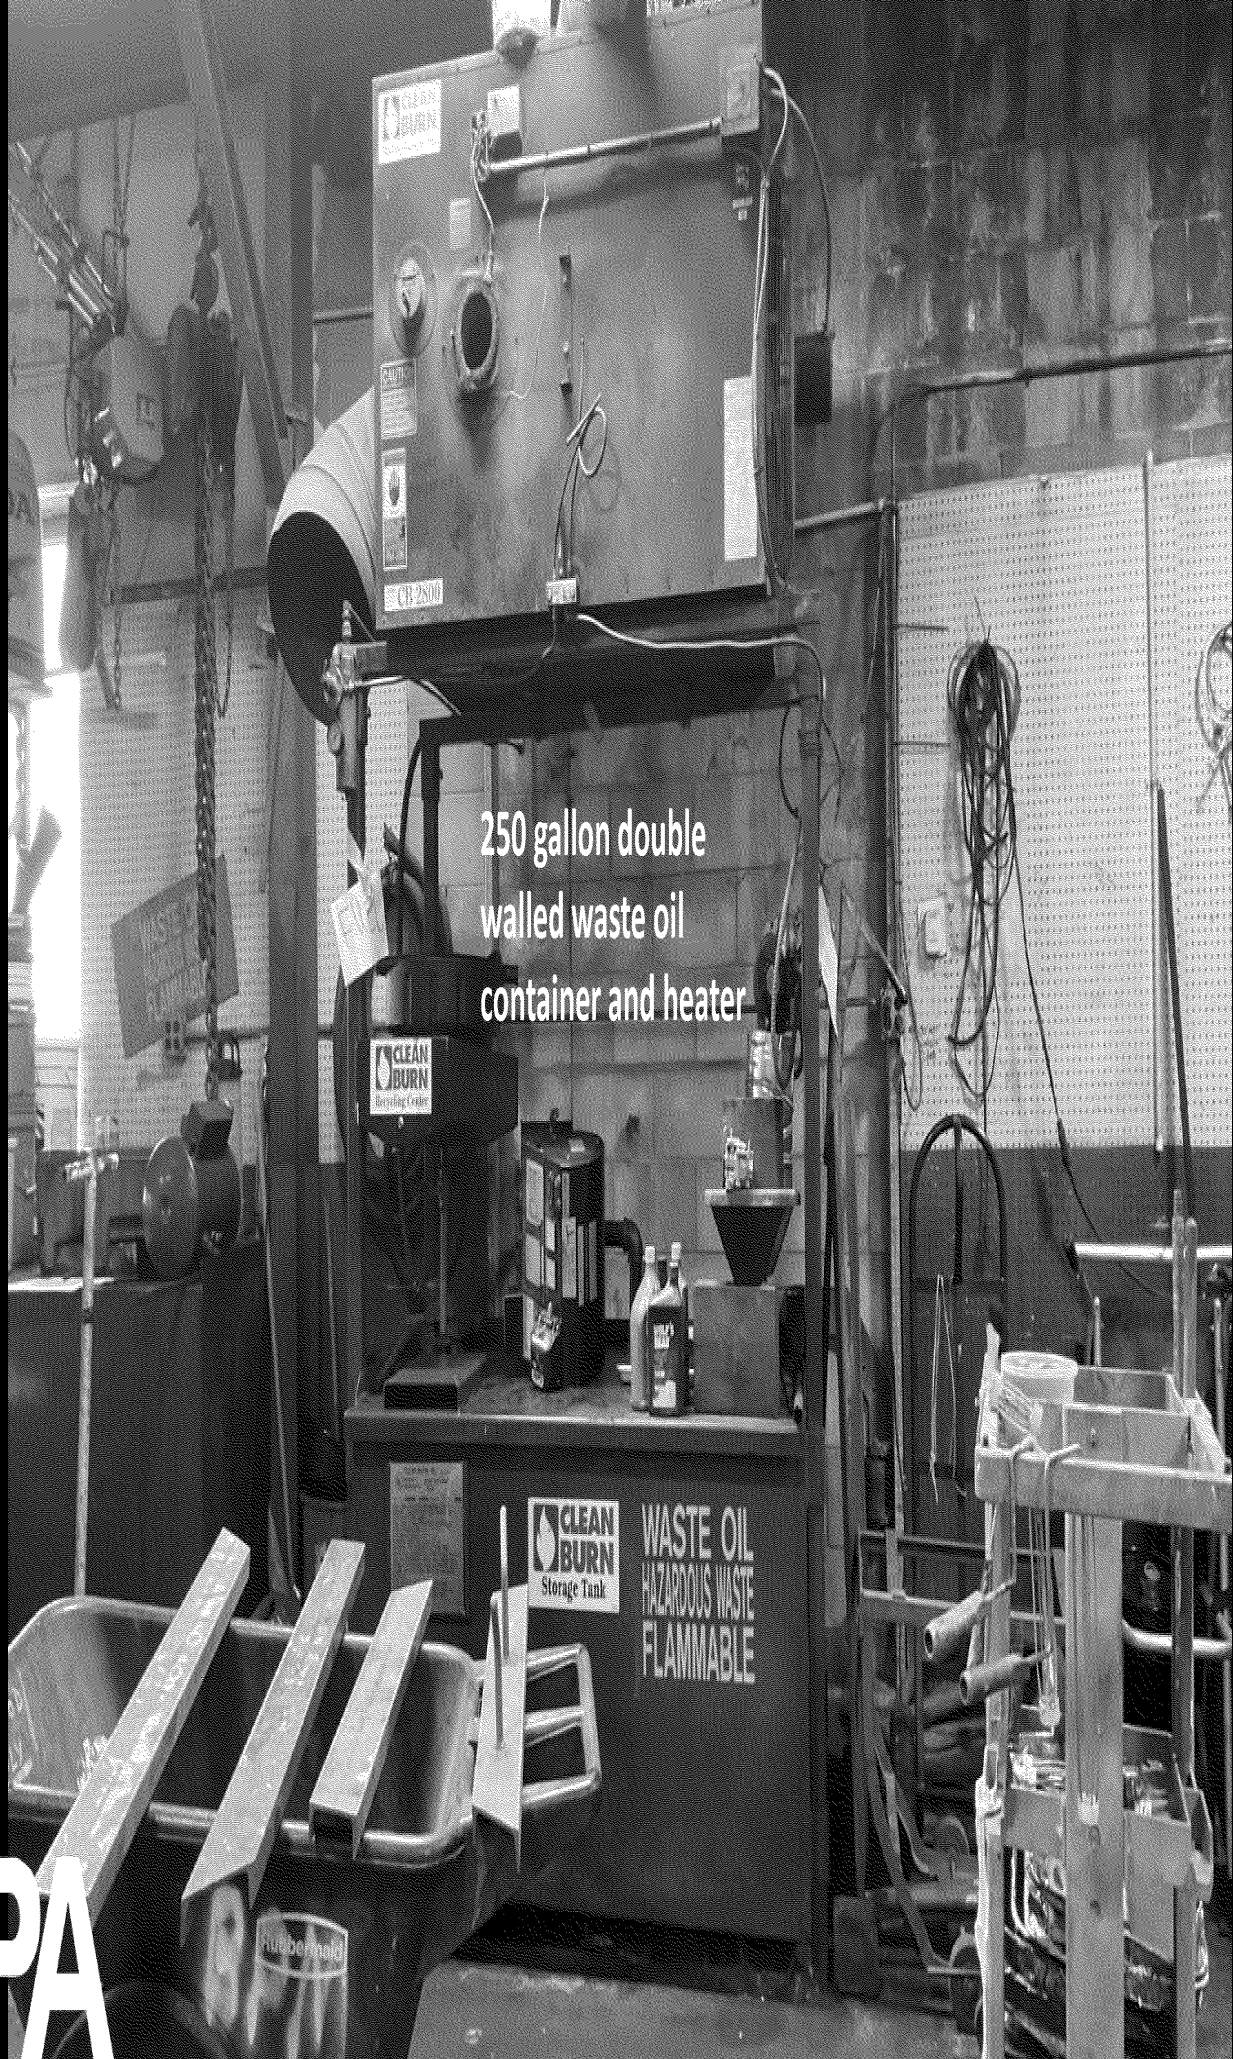
250 gallon double  
walled waste oil  
container and heater
