Beverly Port Marina – EPA Inspection 8/20/2024

Beverly Port Marina

43 Water Street  
Beverly, MA

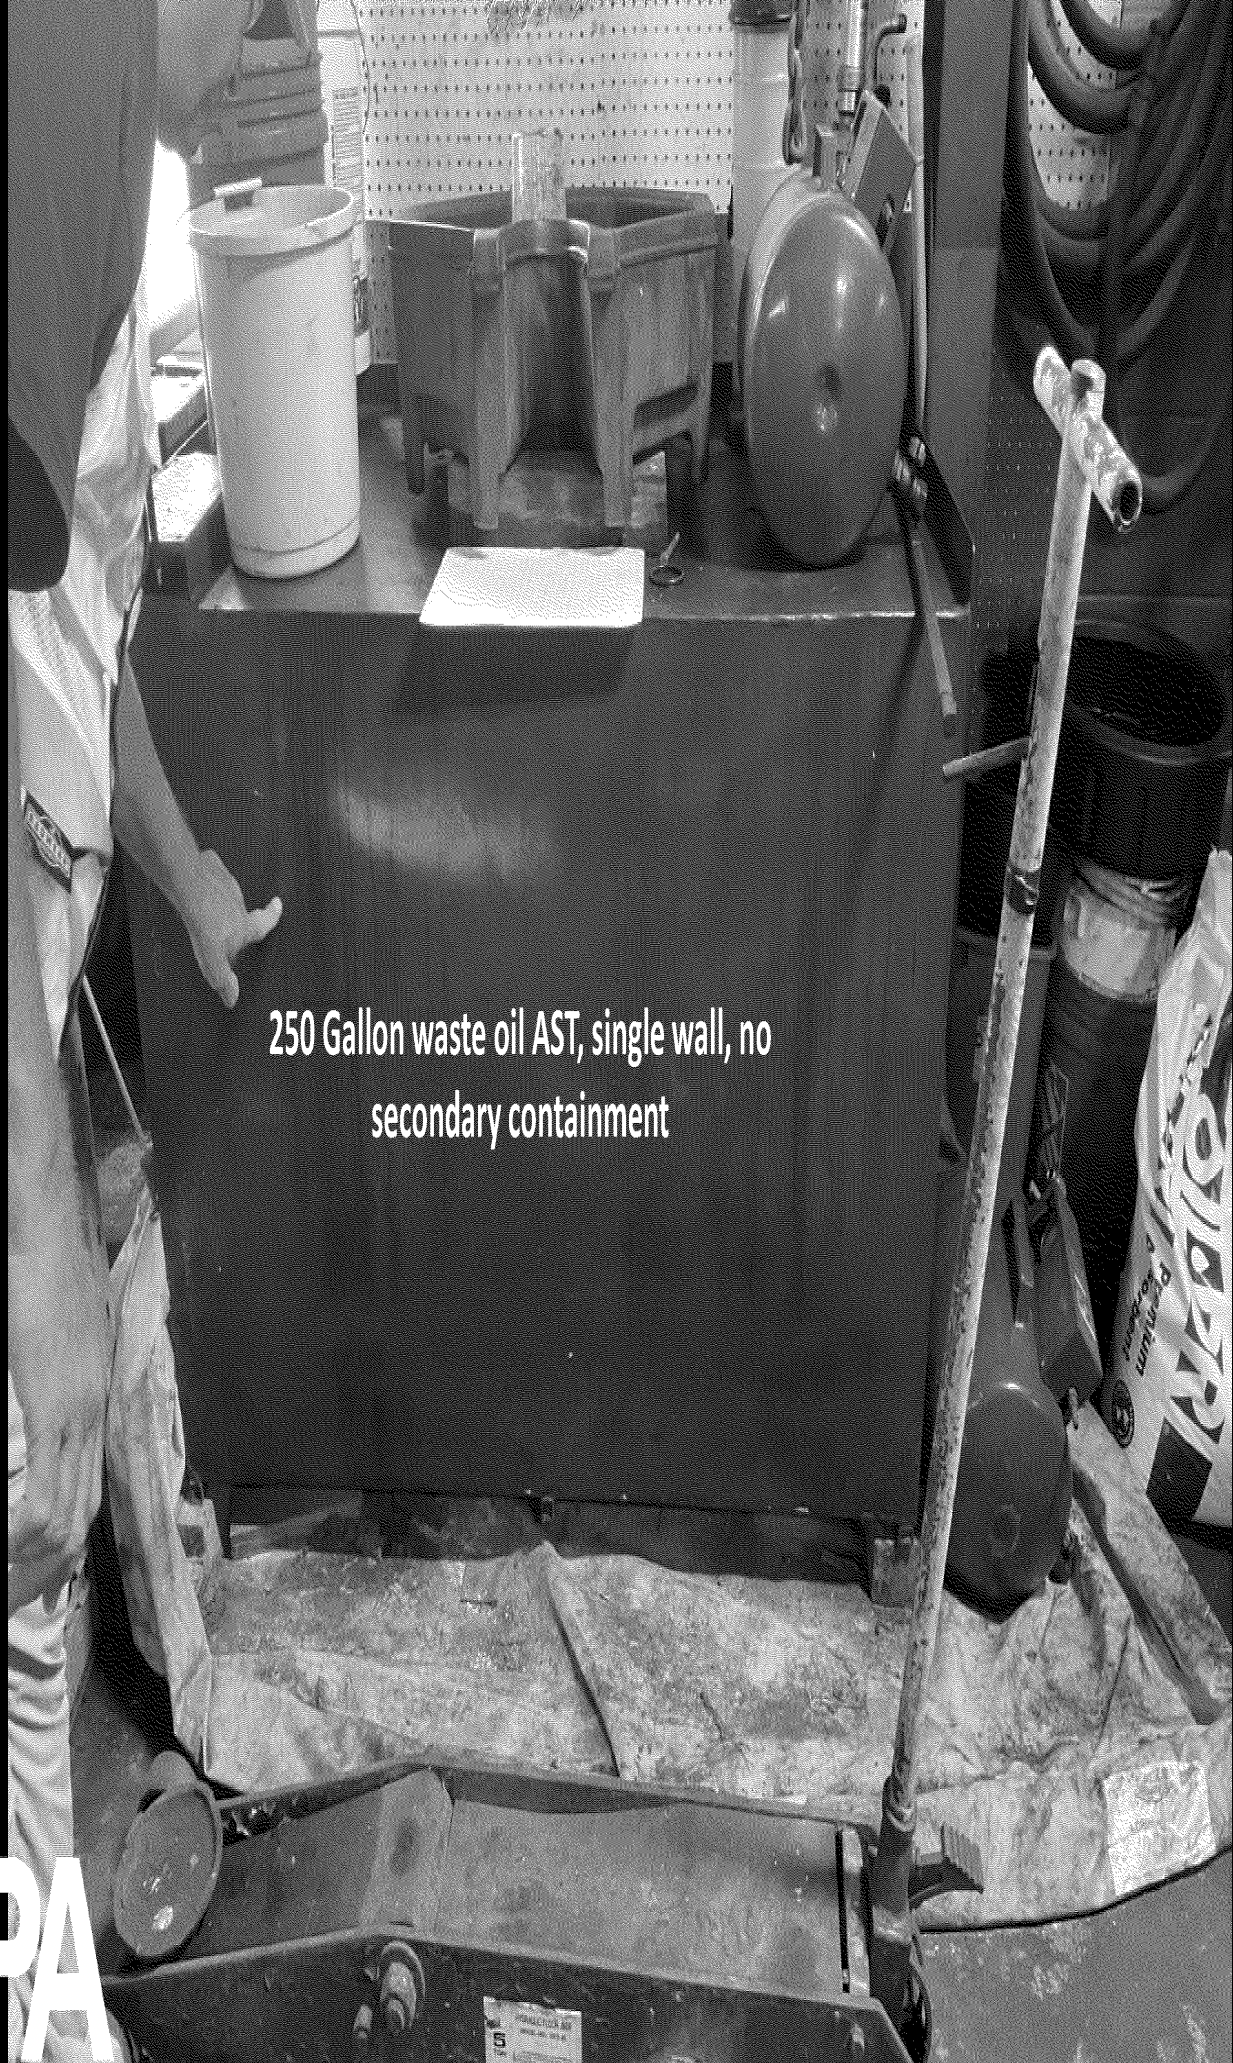
250 Gallon waste oil AST, single wall, no  
secondary containment

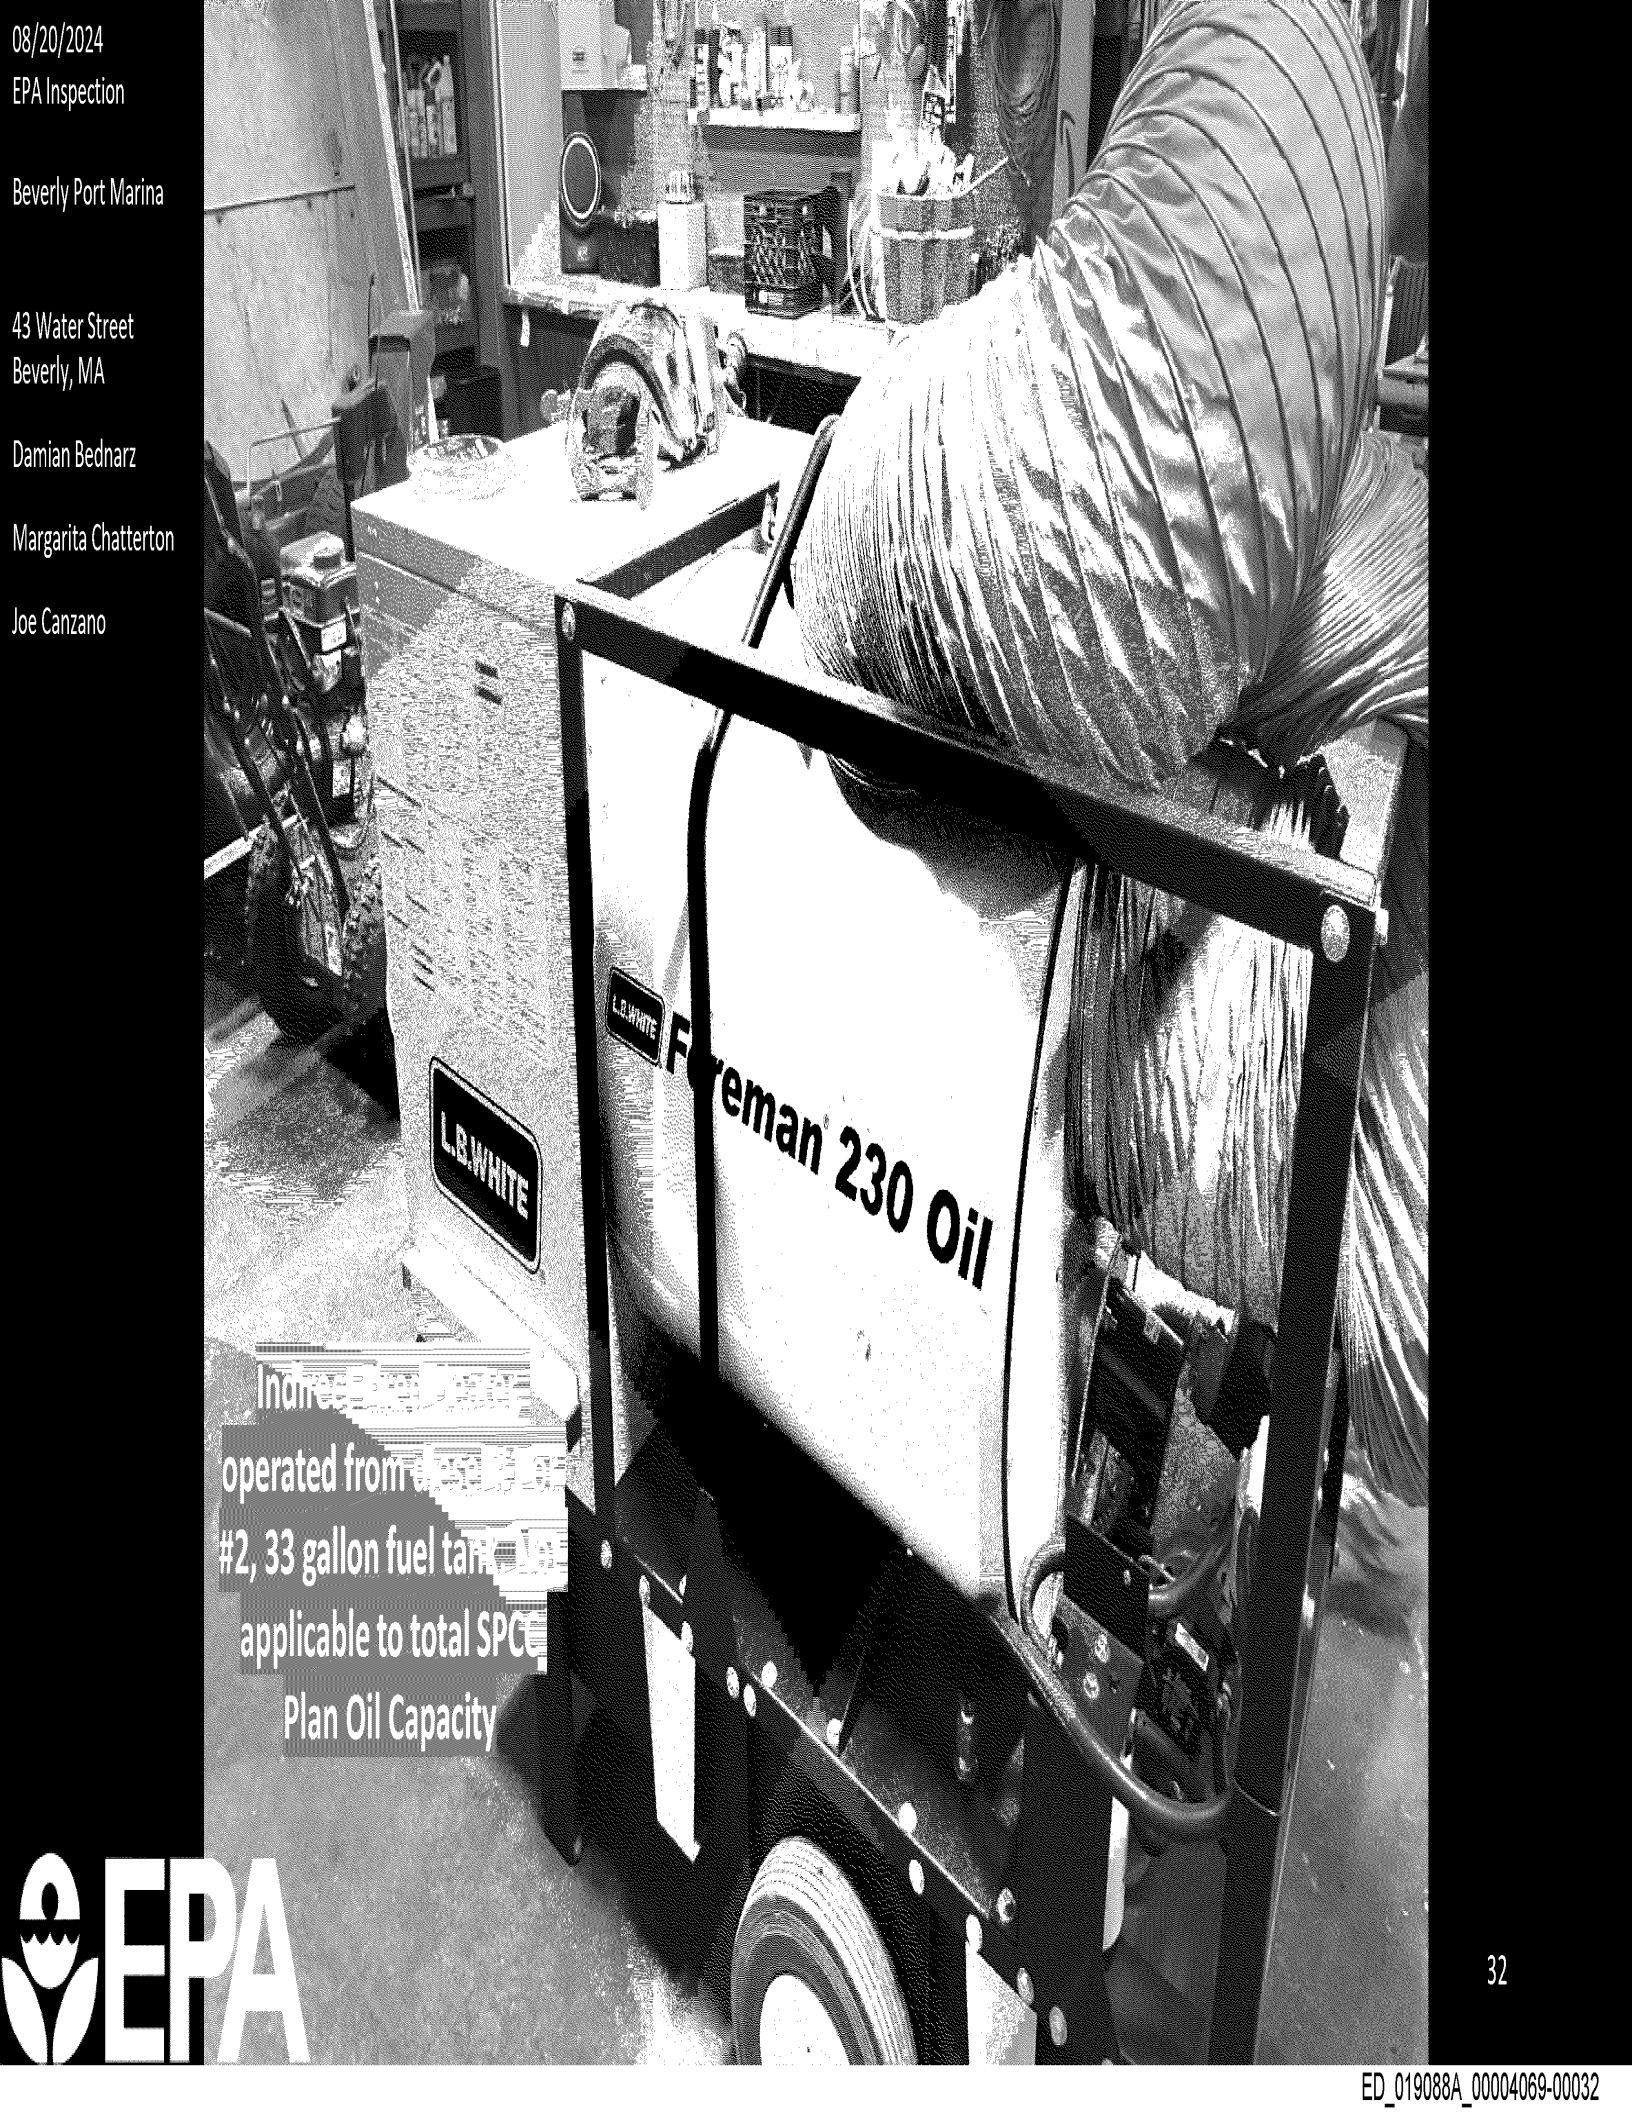
Indirect Fuel Tank  
operated from diesel engine  
#2, 33 gallon fuel tank  
applicable to total SPC  
Plan Oil Capacity

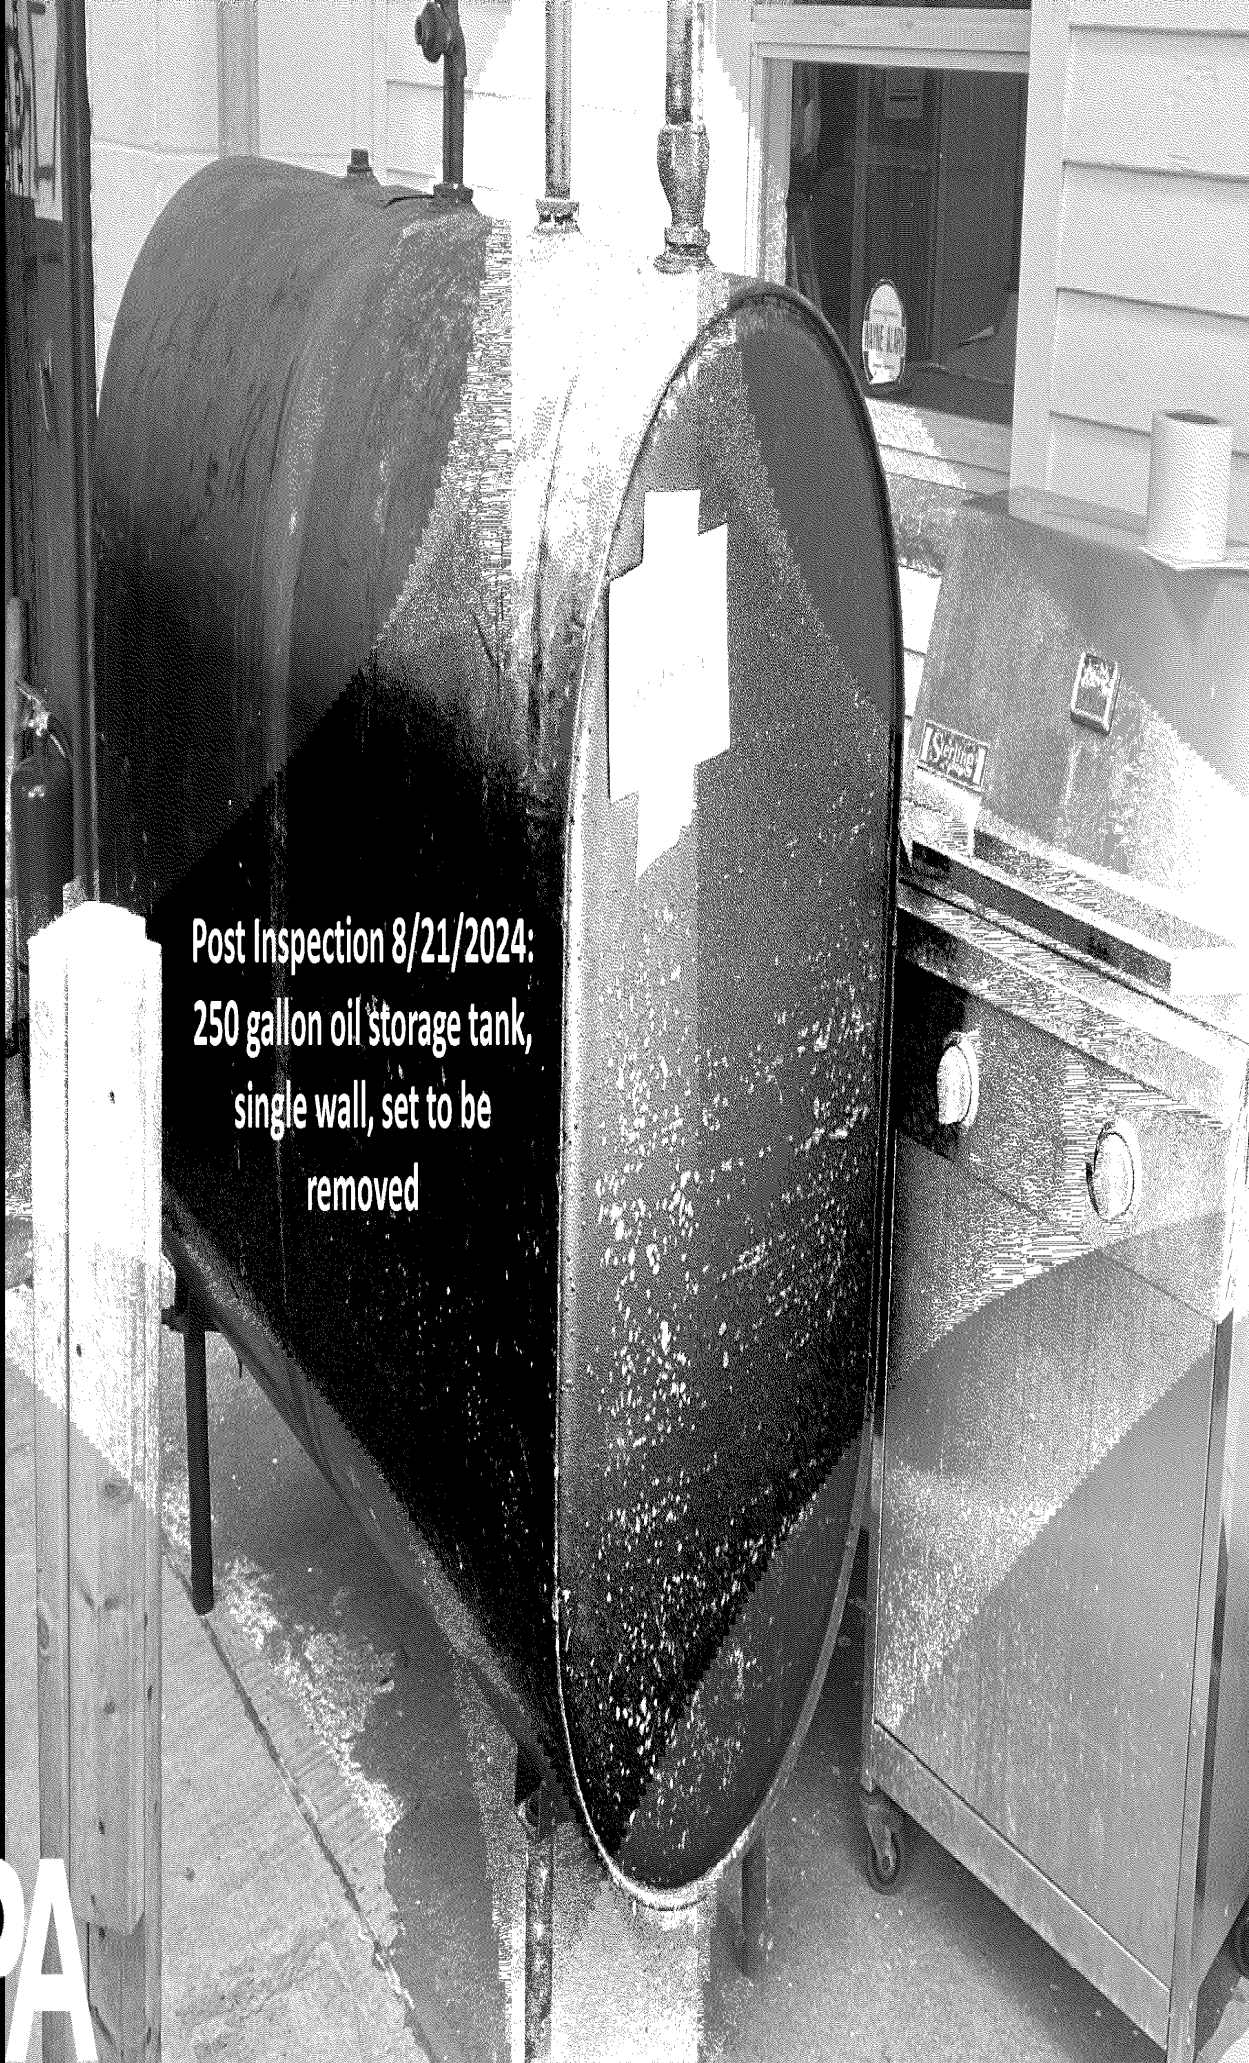
Post Inspection 8/21/2024:  
250 gallon oil storage tank,  
single wall, set to be  
removed

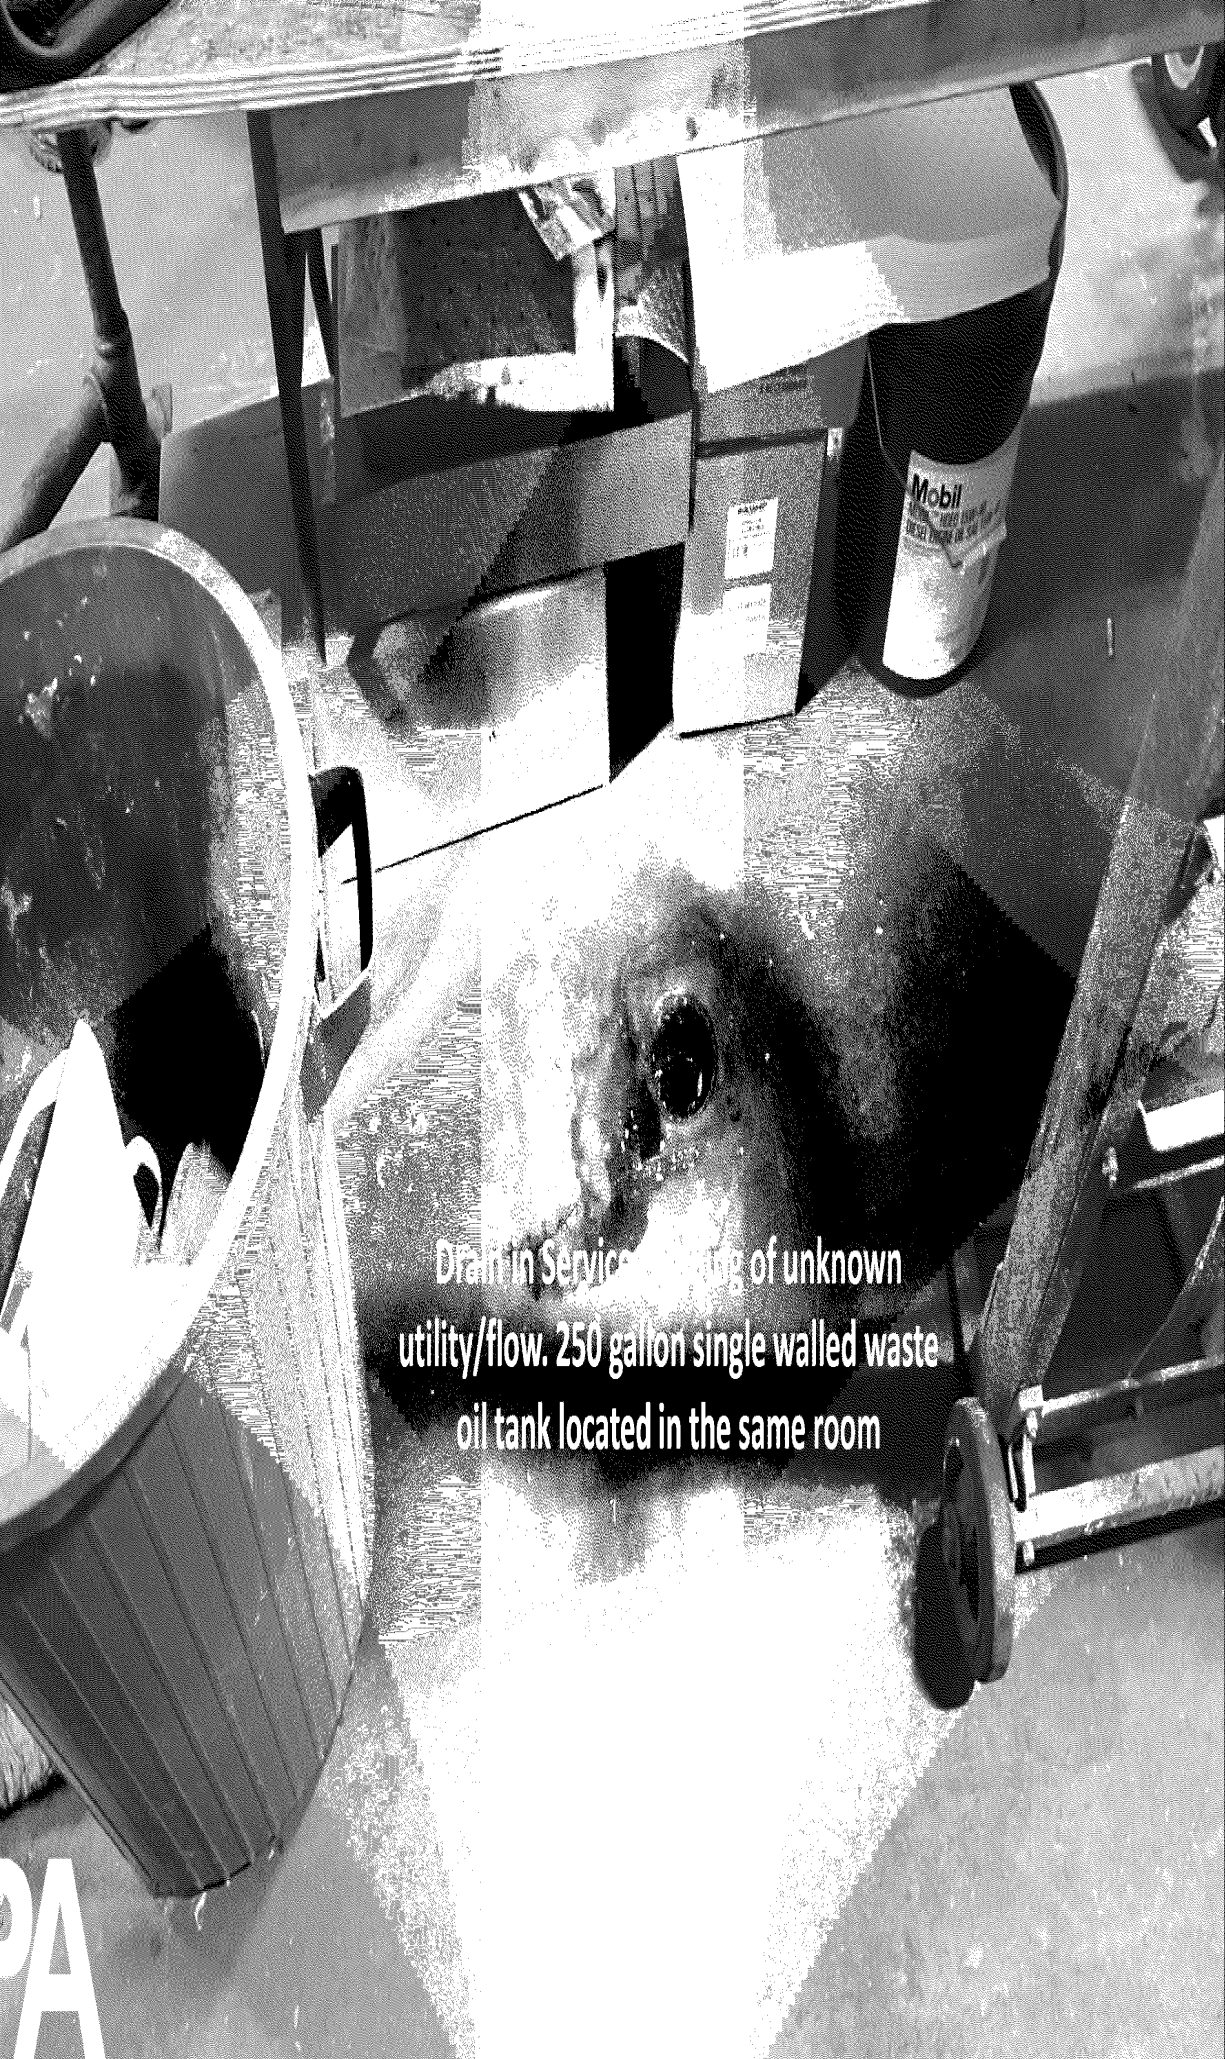
Drain in Service area of unknown utility/flow. 250 gallon single walled waste oil tank located in the same room

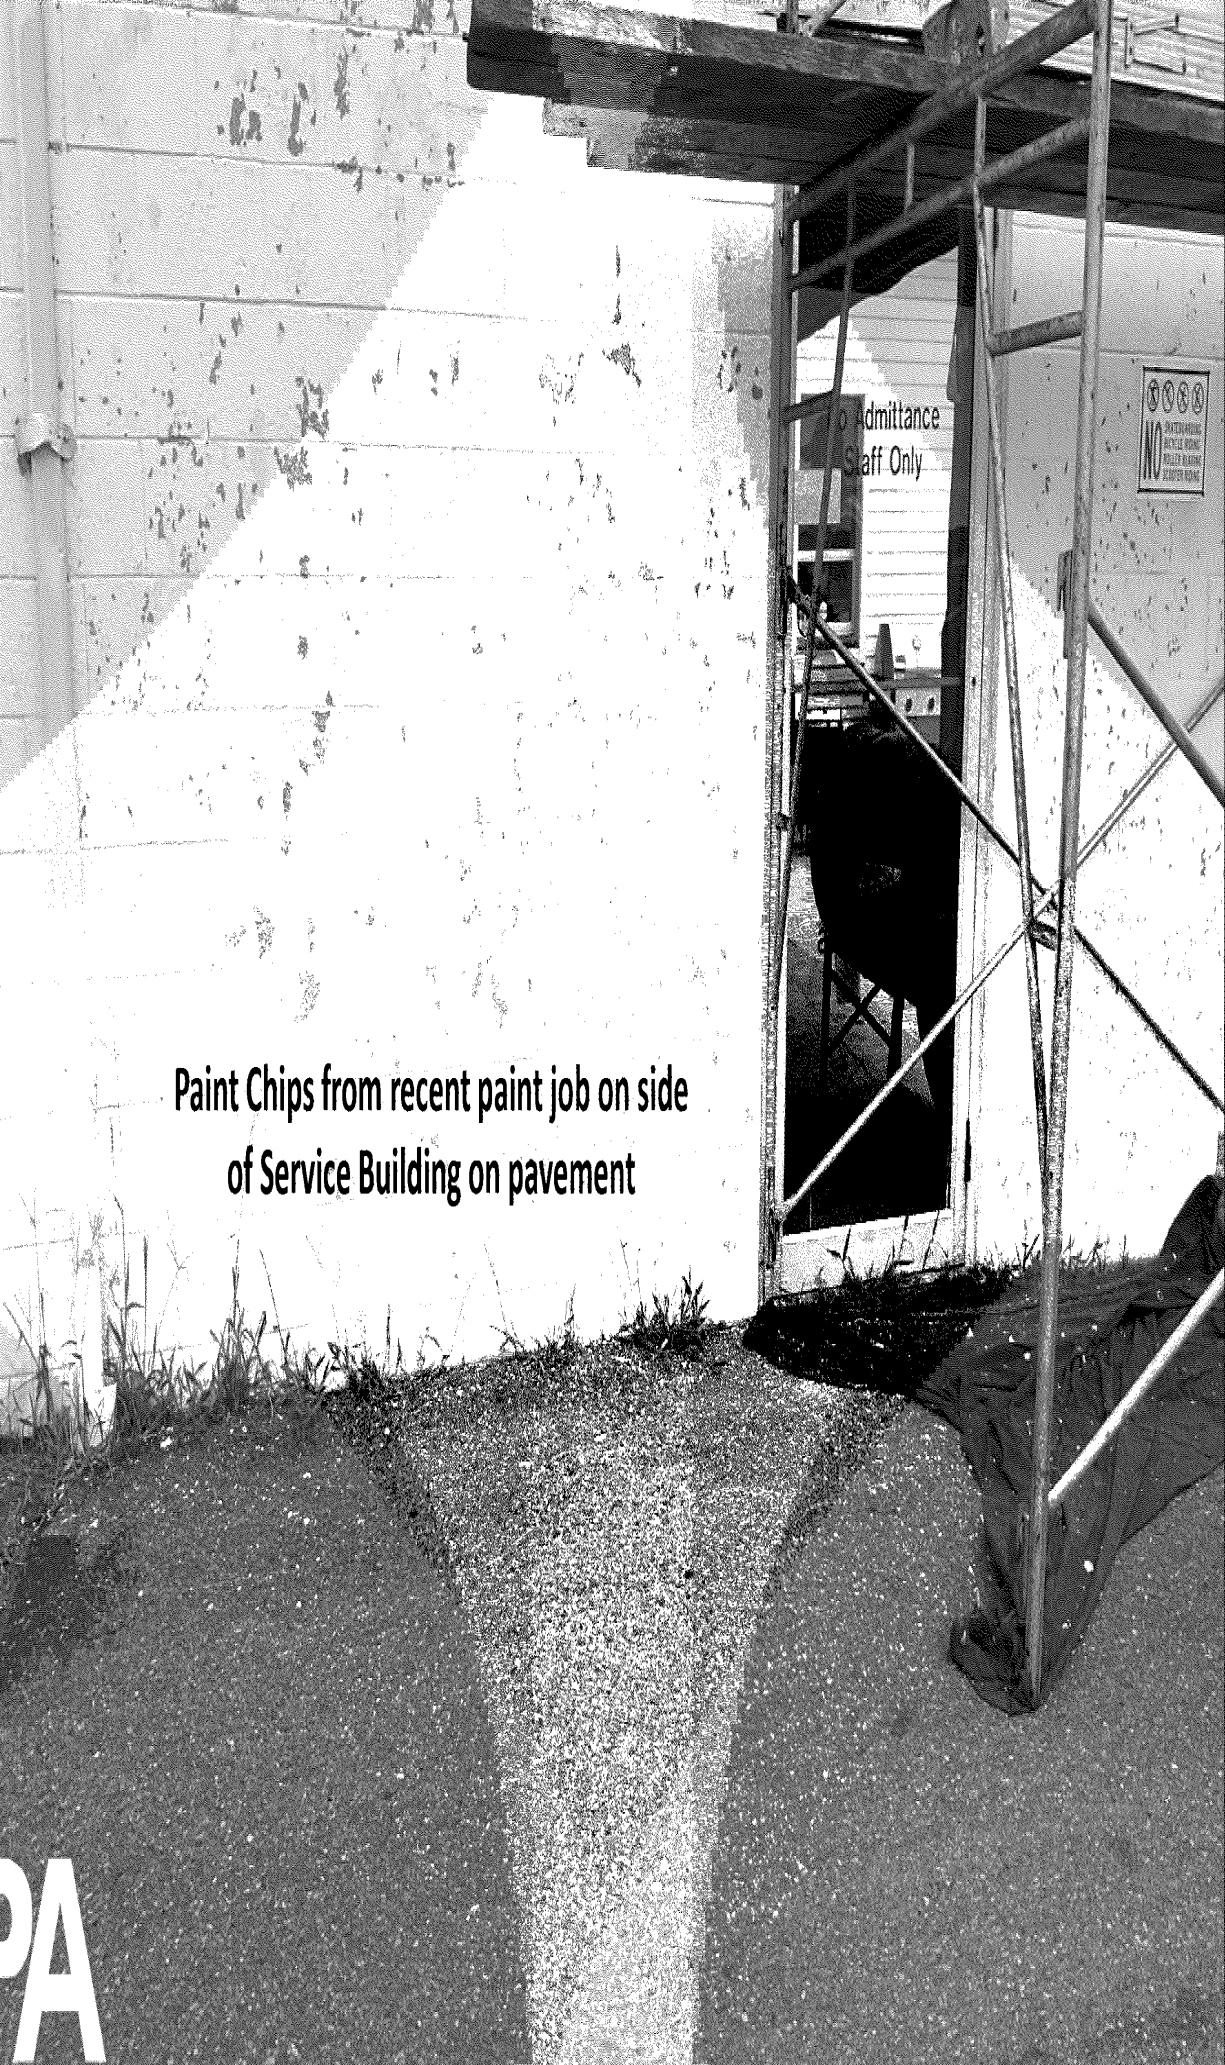
Paint Chips from recent paint job on side  
of Service Building on pavement

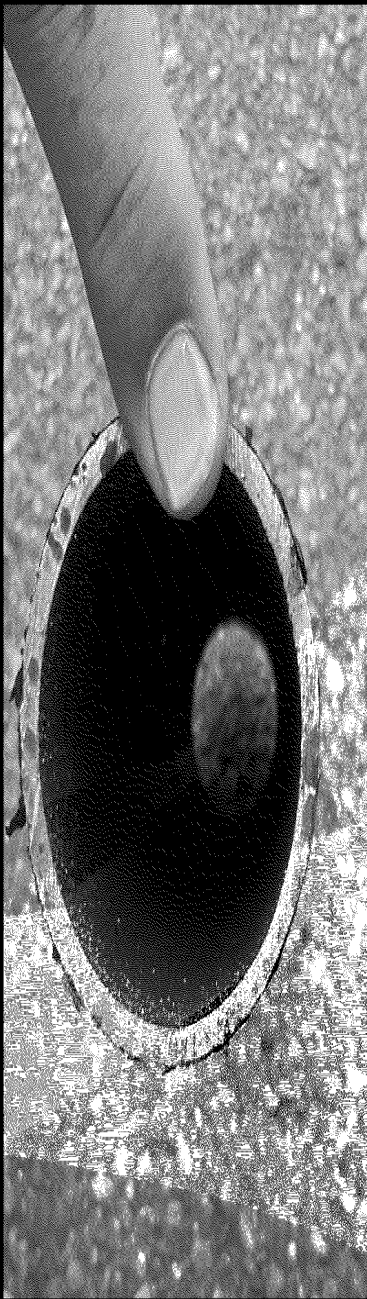
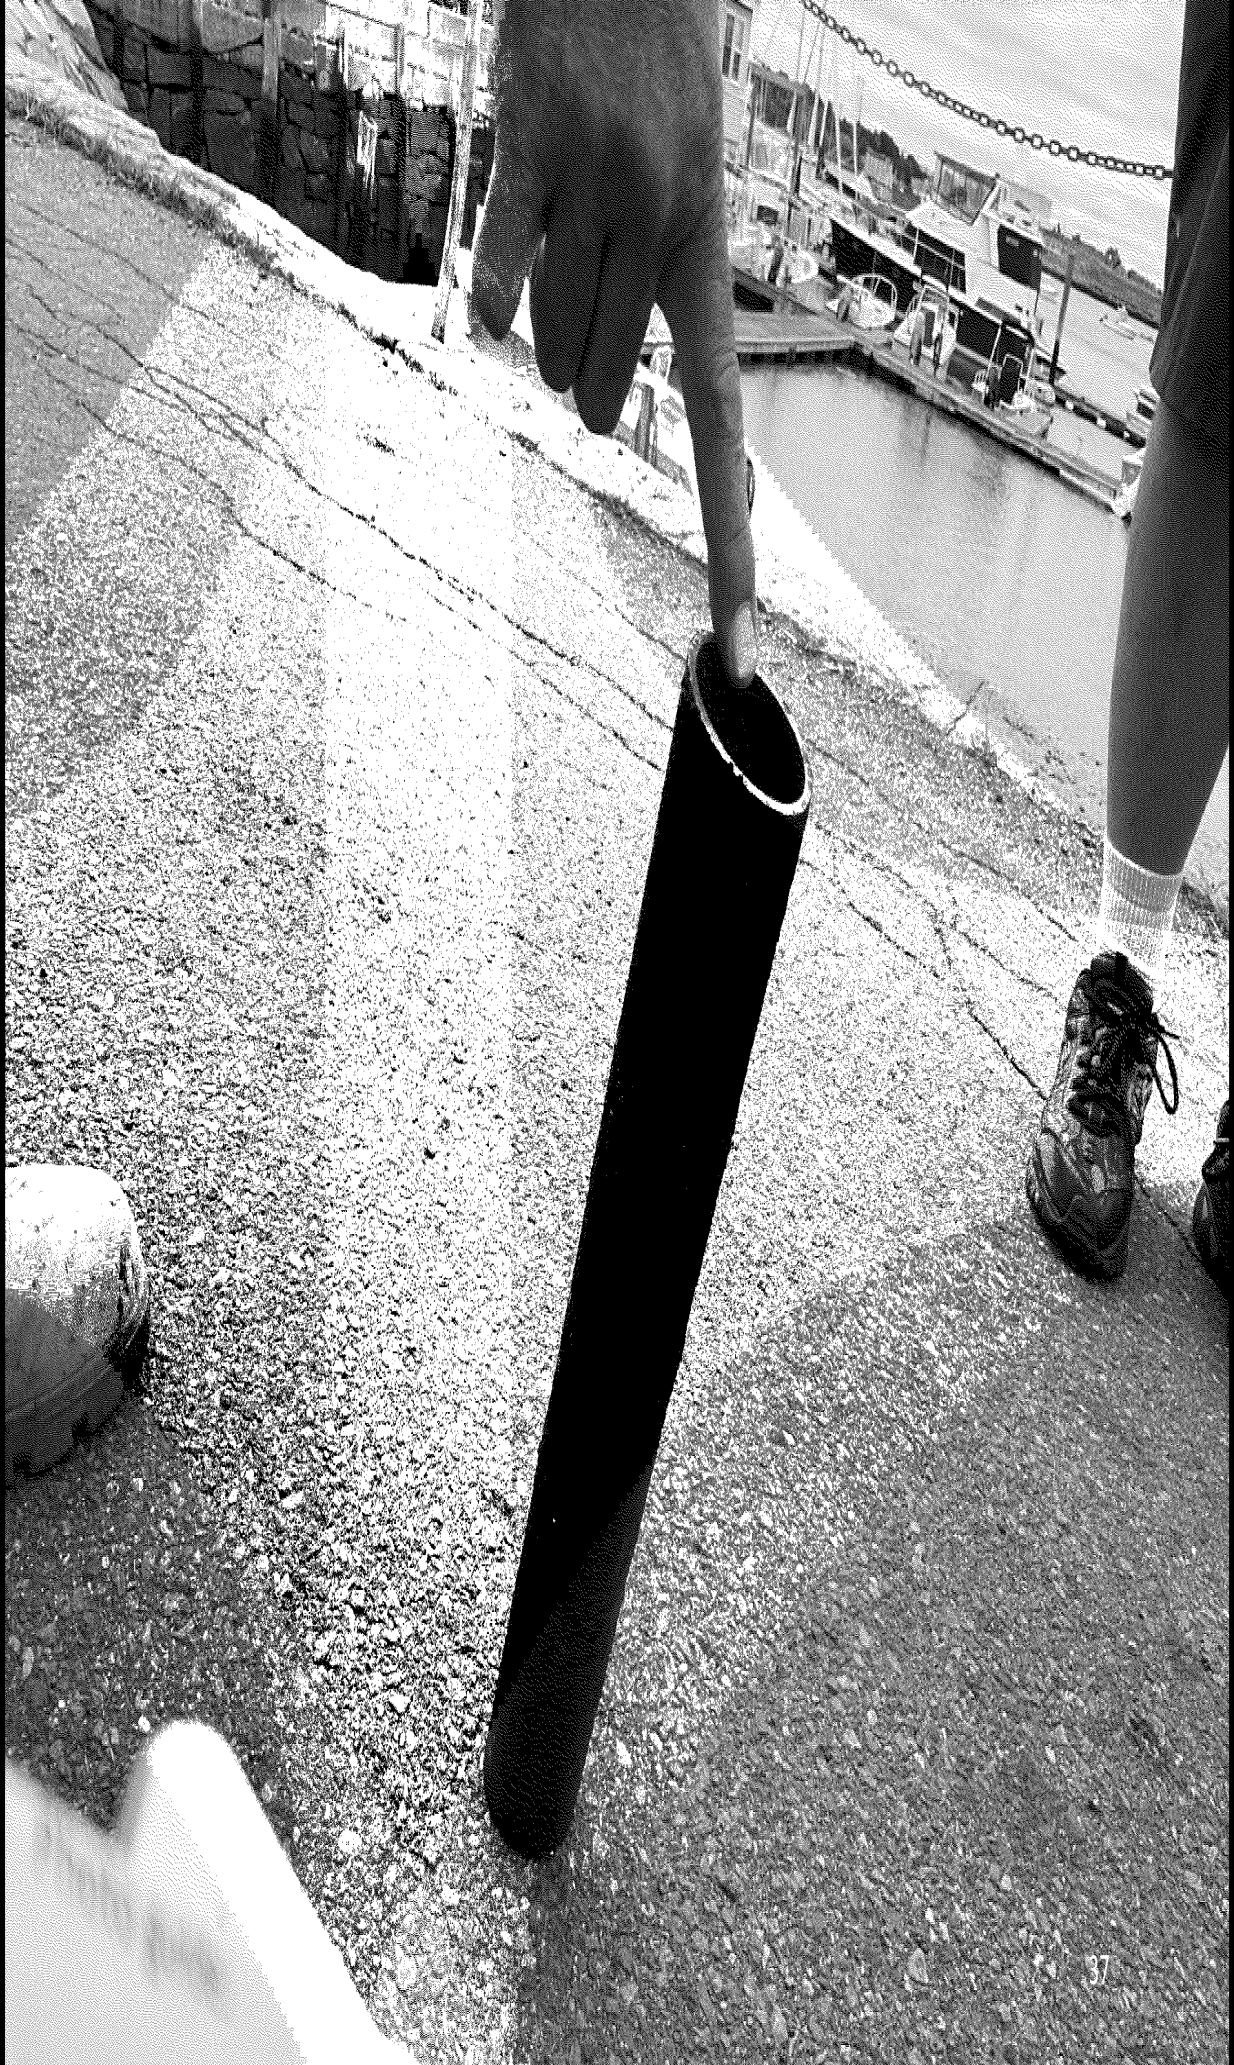
Operator explains fuel piping  
replaced when corrosion is  
evident, however, the inside  
of the pipe often does not  
feature the same extent of  
corrosion

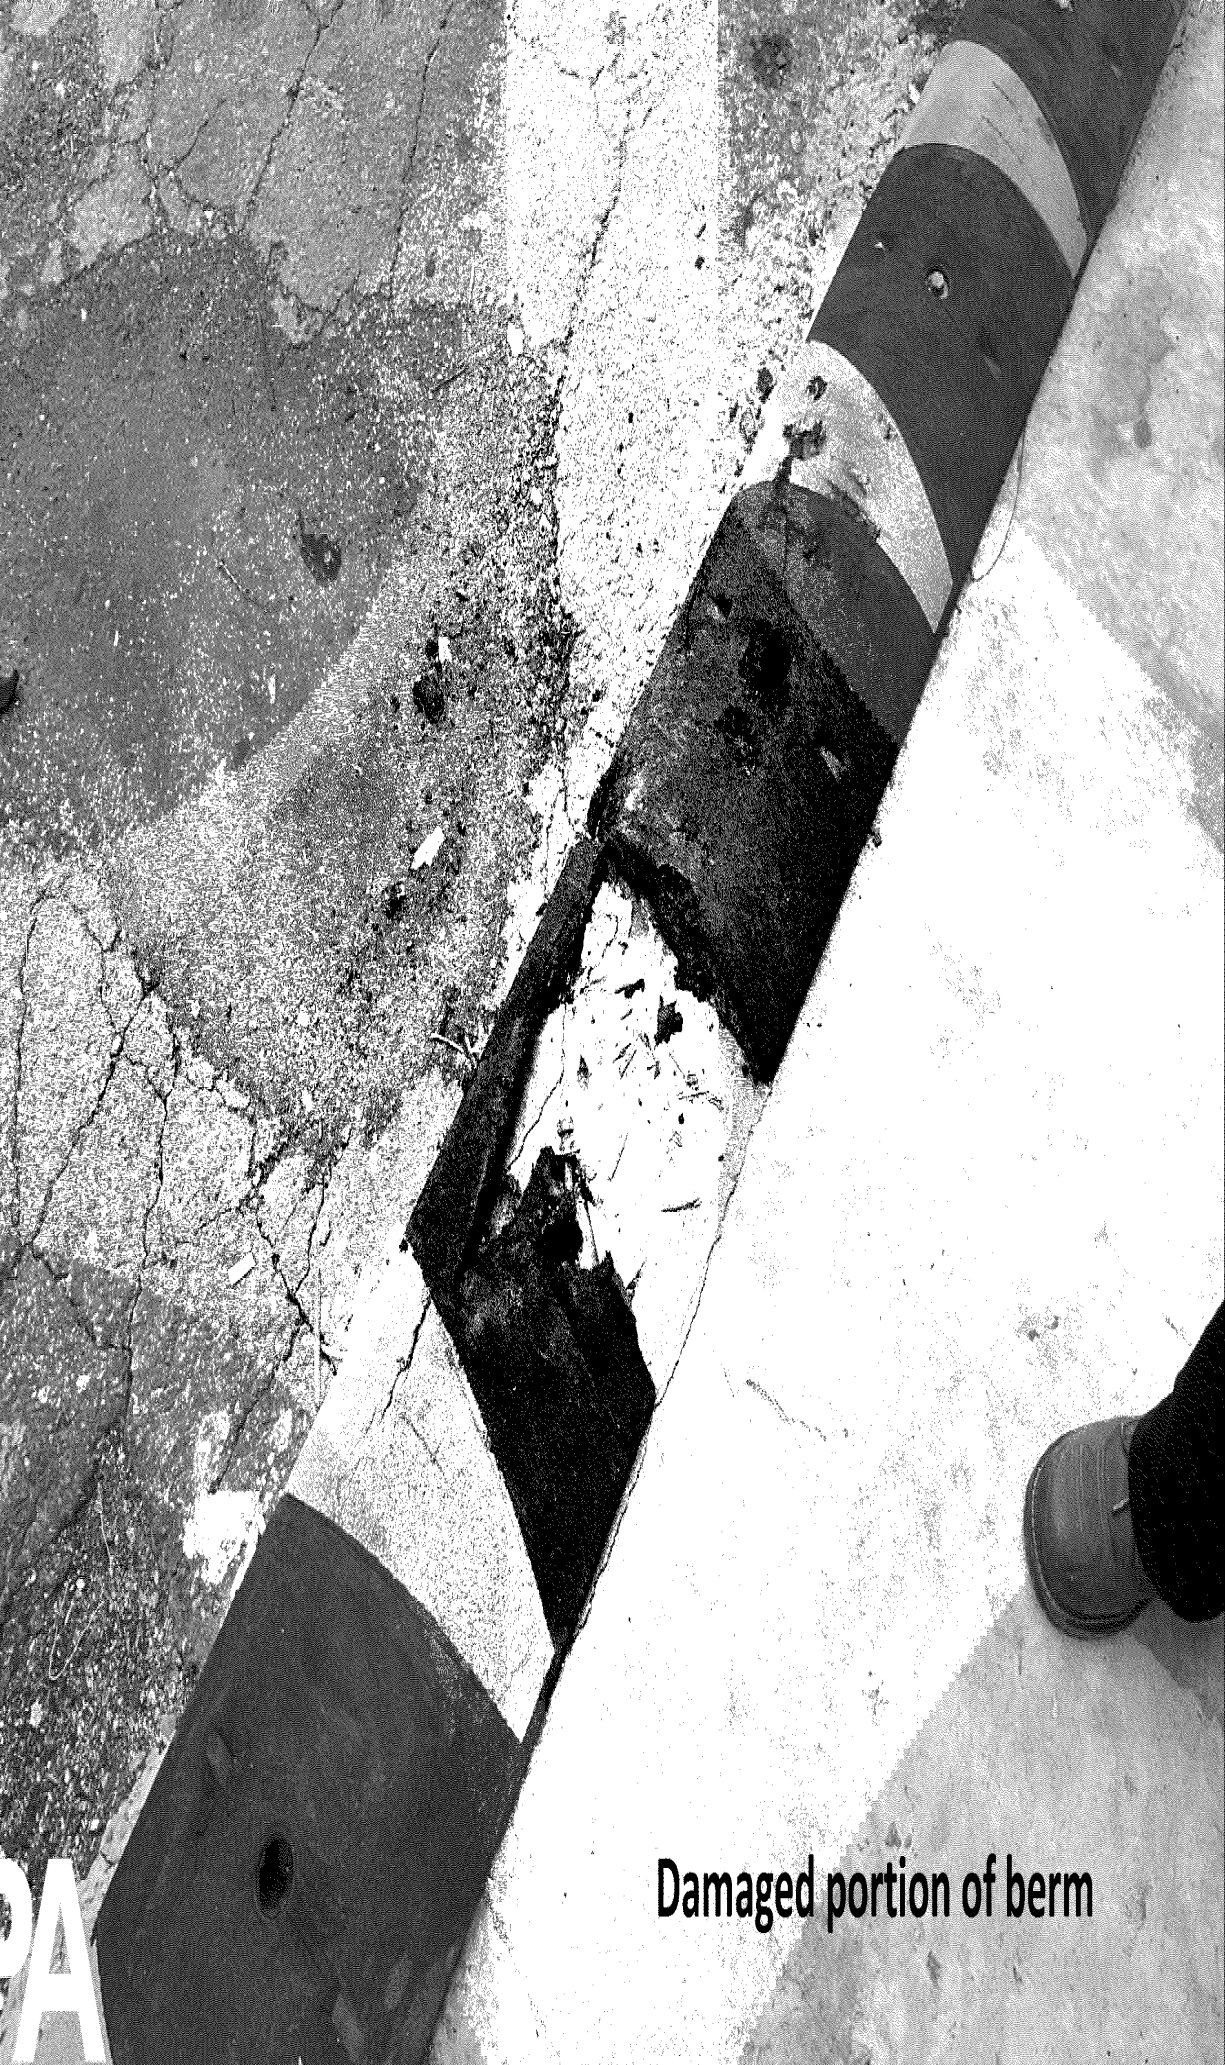
Damaged portion of berm

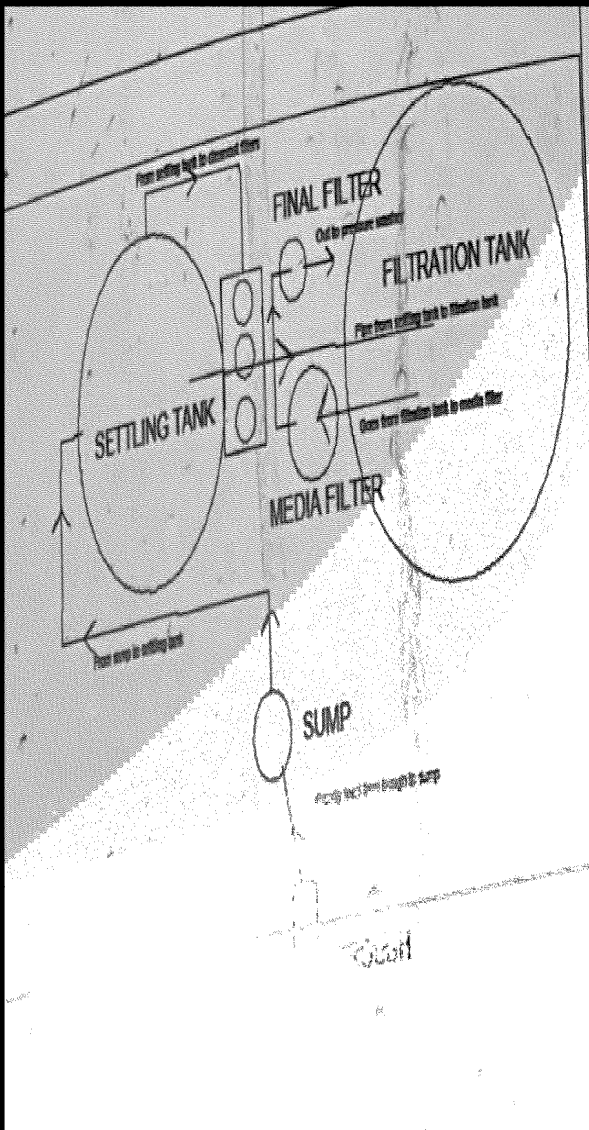
Pressure wash water filtration and settling tanks
