Resource Conservation and Recovery Act (RCRA)
 Compliance Evaluation Inspection

Facility Name:	Patheon Puerto Rico Inc	
EPA ID Number:	PRR000000836	
Date of Inspection:	February 1, 2024	
Generator Status in Record:	Large Quantity Generator (LQG)	
Generator Status at the time of inspection:	Large Quantity Generator (LQG)	
RCRA Permitted:	No	
Basis for Inspection:	Core Program	
Corrective Action:	No	
Facility Physical Location: (Municipality, PR, zip code)	Carr. 670 Km 5.2, Manati, Puerto Rico, 00674.	
Geographical Coordinates:	18.198414, -65.972756	
Facility Contact:	Ms. Lorraine Afanador	787-409-5102
	EHS ¹ Supervisor	
	Email: lorraine.afanador@thermofisher.com	
	Mailing address: P.O. Box 3199 Manati, Puerto Rico, 00674	
Facility Contact:	Xiomara Torres	939-438-8566
	EHS Specialist II	
	Email: xiomara.torres@thermofisher.com	
	Mailing address: P.O. Box 3199 Manati, Puerto Rico, 00674	
Facility Contact:	Mr. Bernardo Jaime	939-610-0621
	EHS Manager	
	Email: bernardo.jaimejimenez@thermofisher.com

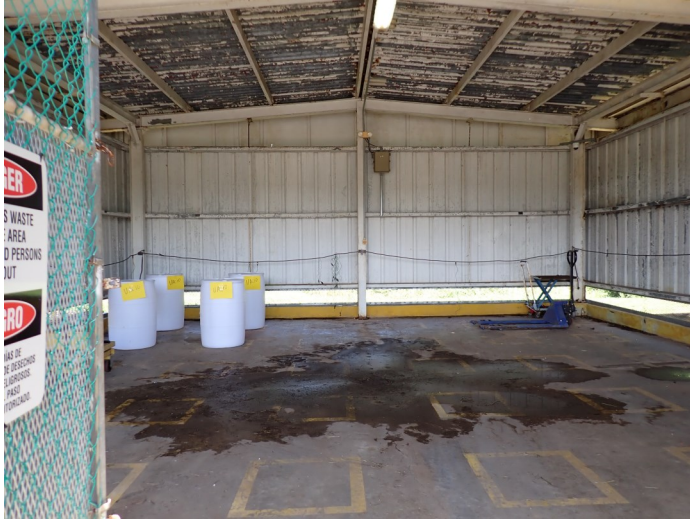
At the time of the CEI, this area was almost empty²³, just two (2) containers and one (1) yellow shelf were observed. This area has available, yellow-painted squares on the floor in order to identify the container location. I asked about the area's container capacity, and Mr. Rossy told me that the maximum quantity of containers at this location is 30 containers (Picture #1). Additional information is as follows:

Picture 1 — 90-day Hazardous Waste Accumulation Area (HWAA) - At the time of the CEI, this area was almost empty, just two (2) containers and one (1) yellow shelf were observed. Also, the area has available yellow-painted squares on the floor in order to identify the container location.

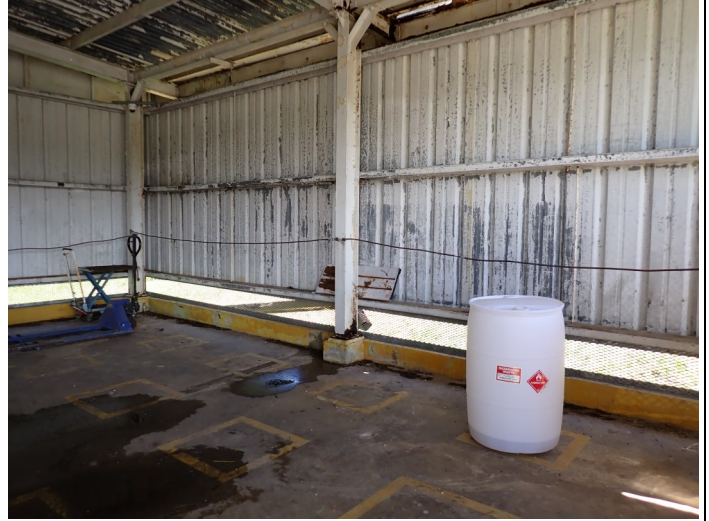
- a. One (1) 55-gallon white plastic container with halogenado. At the time of the inspection, it was observed closed, labeled as hazardous waste, has a pictographic and/or indication of the hazard available, and was dated January 8, 2024. Also, it was observed almost empty, and the container appears to be in good condition (Picture #2).

Picture 2 — 90-day Hazardous Waste Accumulation Area (HWAA) - One (1) 55-gallon white plastic container with halogenado. It was observed closed, labeled as hazardous waste, has a pictographic and/or indication of the hazard available, and was dated January 8, 2024.

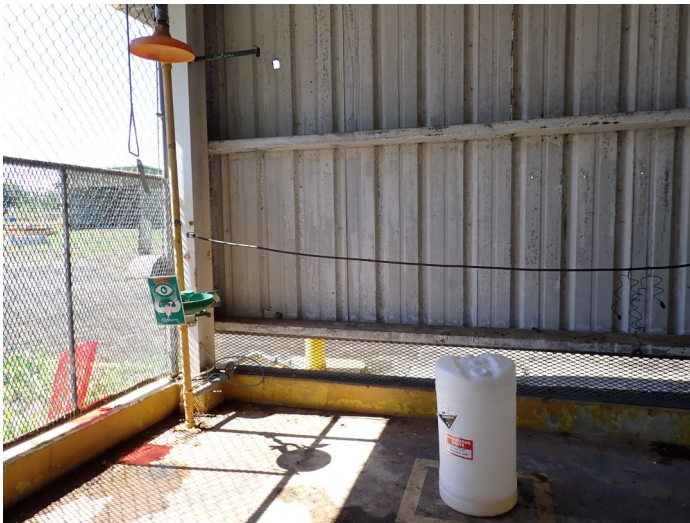
- b. One (1) 15-gallon²⁴ white plastic container with lab-waste basic. At the time of the inspection, it was observed closed, labeled as hazardous waste, has a pictographic and/or indication of the hazard available, and was dated January 24, 2024. The container appears to be in good condition (Picture #3).

Picture 3 — 90-day Hazardous Waste Accumulation Area (HWAA) - One (1) 15-gallon white plastic container with lab-waste basic. It was observed closed, labeled as hazardous waste, has a pictographic and/or indication of the hazard available, and was dated January 24, 2024.

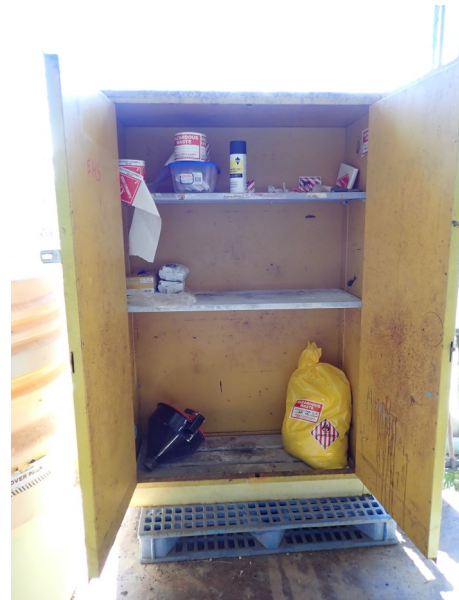
- c. Inside the yellow shelf, a 15-gallon²⁵ yellow plastic bag with paños HPLC²⁶ no halogenado was observed. At the time of the inspection, it was observed closed, labeled as hazardous waste, has a pictographic and/or indication of the hazard available, and was dated February 1, 2023 (Picture #4). I asked Mr. Rossy about this, and he confirmed that it was a typo, and

Picture 4 — 90-day Hazardous Waste Accumulation Area (HWAA) - Inside the yellow shelf, a 15-gallon yellow plastic bag with paños HPLC no halogenado was observed. It was observed closed, labeled as hazardous waste, has a pictographic label available, and was dated February 1, 2023. The typo was addressed.

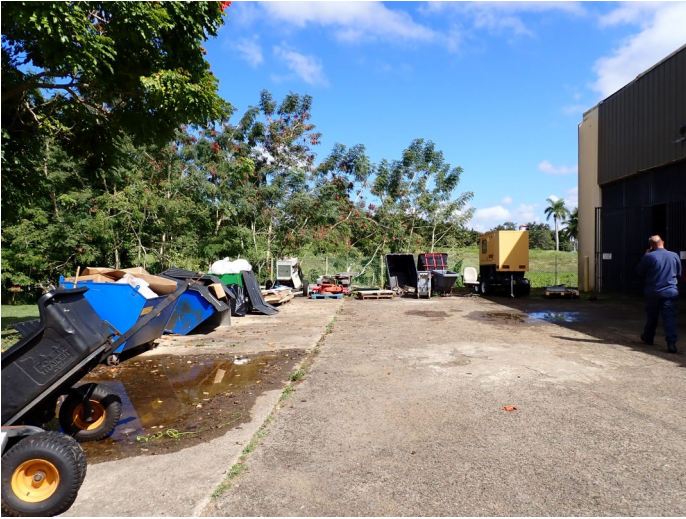
Picture 5 — Light Mechanical Shop Area—Light mechanical works, housekeeping-related activities, and landscaping-related activities are conducted here. It is consist of an open, no-ceiling subarea with a concrete floor. In addition, this area boasts recycling and regular waste cubic yard containers.

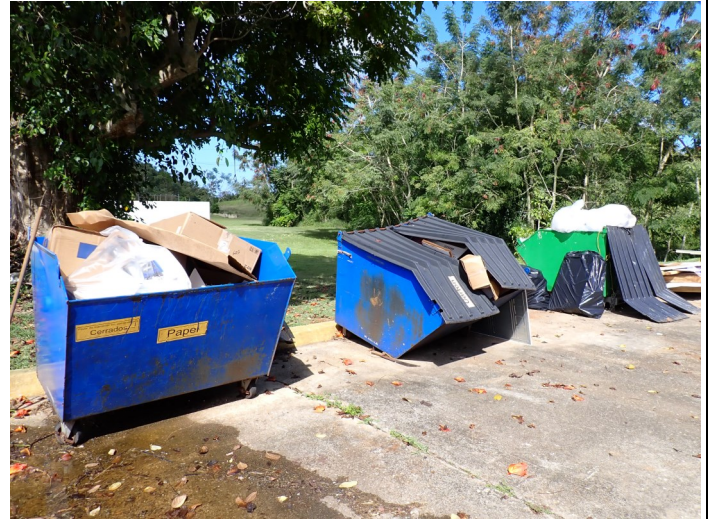
According to the facility representatives, this is the contractor's area. Here, light mechanical works, housekeeping-related activities, and landscaping-related activities are conducted for the site. This area consists of an open, no-ceiling subarea with a concrete floor (Picture #5). In addition, this area boasts recycling and regular waste cubic yard containers. At the time of the inspection, three (3) cubic yard containers were observed (Picture #6). Information on each one is as follows:

Picture 6 — Light Mechanical Shop Area—At the time of the inspection, three (3) cubic yard containers were observed: two (2) cubic yard blue metal containers and one (1) cubic yard green metal container.

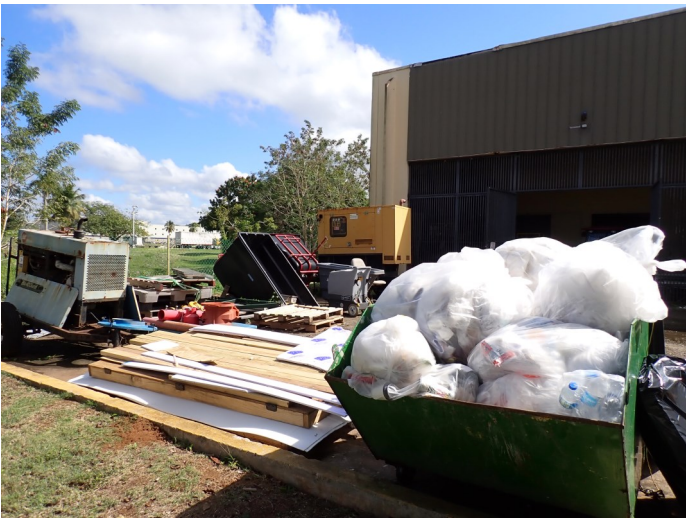
- a. Two (2) cubic yard²⁸ blue metal containers with paper and cardboard. At the time of the CEI, one of them was observed open, labeled and it was full²⁹. The other was observed with a lid, nevertheless, it was not labeled.
- b. One (1) cubic yard³⁰ green metal container with plastic bags that appears to have inside regular trash. At the time of the CEI, it was observed open, and it was full³¹ (Picture #7).

Picture 7 — Light Mechanical Shop Area— At the time of the CEI, the cubic yard green meta container was observed open, and it was full. Additionally, wood pieces, garbage and no operational equipment was observed.

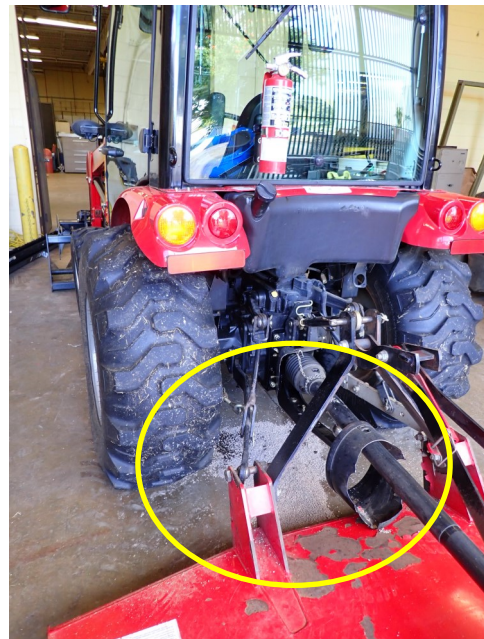
Picture 8 — Light Mechanical Shop Area— At the time of the CEI, one (1) tractor was observed. According to the information provided by the facility representatives, the latter was not in use. Nevertheless, a spill that has been controlled using absorbent material was observed.

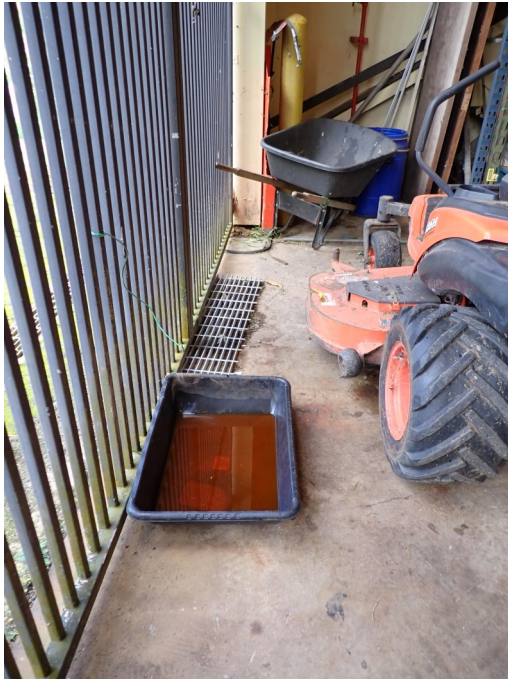
Picture 9 — Light Mechanical Shop Area— Just at the side of the tractor, an open container, not labeled and with an unknown content was observed.

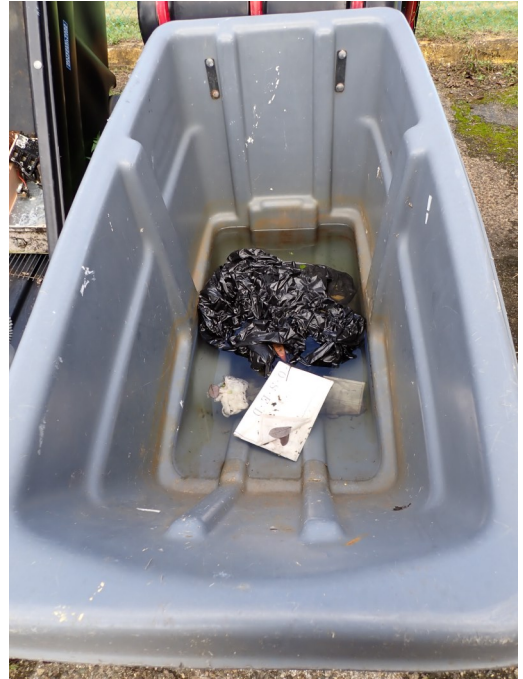
Also, as part of the findings at this subarea, scrap metals were observed inside containers and throughout the subarea, as well as wood pieces, and garbage. Non-operational equipment, such as two (2) forklifts and one (1) tractor were observed. At the time of the inspection, and according to the information provided by the facility representatives, the latter were not in use. Nevertheless, underneath the tractor, a spill that has been controlled using absorbent material was observed³² (Picture #8). Just at the side, an open container, not labeled and with an unknown content was observed (Picture #9). Moreover, since the subarea did not have a ceiling, some of the concrete floor and containers observed throughout it were observed with wet spots or even with an unknown liquid³³ collected inside. I notified the facility representatives that, at least, one of the containers observed, there was what appeared to be mosquitoes' larvae³⁴ (Picture #10). The facility representatives confirmed this observation.

Picture 10 — Light Mechanical Shop Area— Since the subarea did not have a ceiling, some of the concrete floor and containers observed throughout it were observed with wet spots or even with an unknown liquid collected inside.

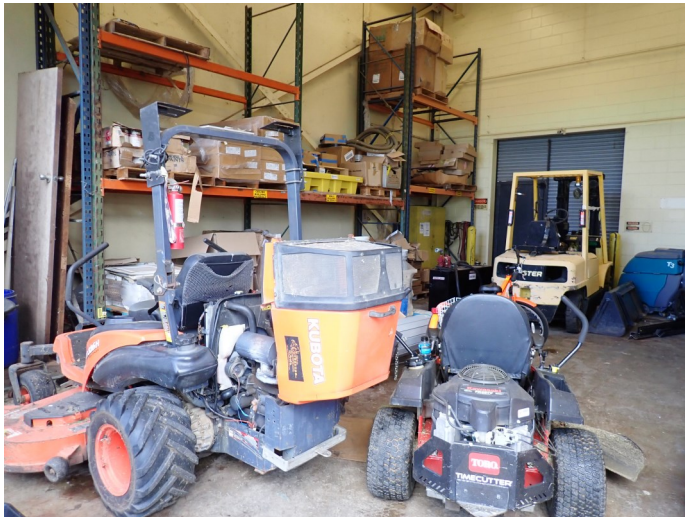
Picture 11 — Light Mechanical Shop Area— Overall observation: a lack of maintenance and/or housekeeping practices throughout this Building, in addition to various containers that the facility representatives did not know if there were products and/or if they would be disposed of, some of them were not labeled, various of those containers were observed rusted, slightly opened, with dents, and with spider webs.

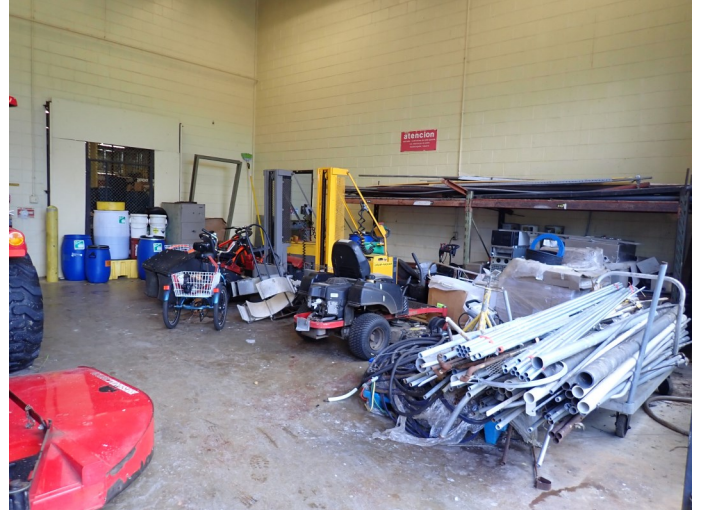
Picture 12 — Light Mechanical Shop Area—Overall observation: a lack of maintenance and/or housekeeping practices throughout this Building, in addition to various containers that the facility representatives did not know if there were products and/or if they would be disposed of, some of them were not labeled, various of those containers were observed rusted, slightly opened, with dents, and with spider webs.

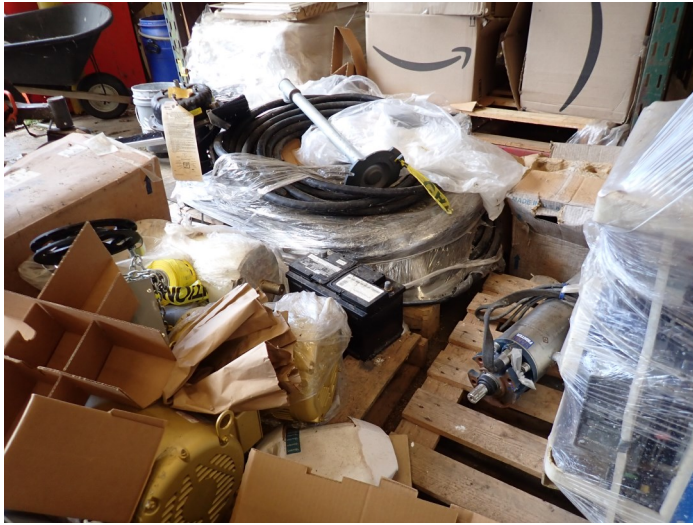
Picture 13 — Light Mechanical Shop Area—Overall observation: a lack of maintenance and/or housekeeping practices throughout this Building, in addition to various containers that the facility representatives did not know if there were products and/or if they would be disposed of, some of them were not labeled, various of those containers were observed rusted, slightly opened, with dents, and with spider webs.

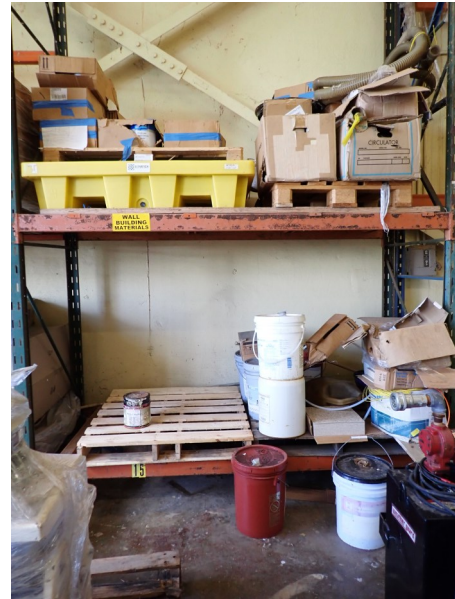
Picture 14 — Light Mechanical Shop Area—Overall observation: a lack of maintenance and/or housekeeping practices throughout this Building, in addition to various containers that the facility representatives did not know if there were products and/or if they would be disposed of, some of them were not labeled, various of those containers were observed rusted, slightly opened, with dents, and with spider webs.

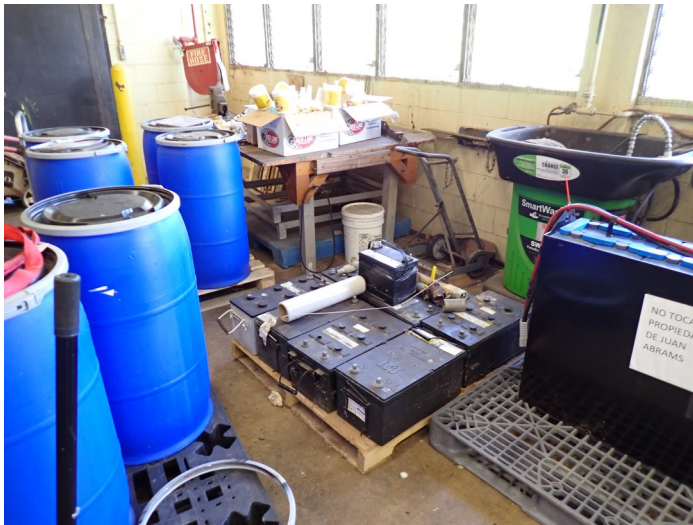
Spent batteries were also observed throughout the subarea, especially in one (1) location, which was a wood pallet (Picture #15). The following information is related to the ones observed in the wood panel³⁷.

- a. Eight (8) spent batteries were observed above a wood panel. At the time of the inspection, none of them were labeled, and/or the area was identified. Some of them were not observed in good condition³⁸ and with materials above them.

Picture 15 — Light Mechanical Shop Area— Spent batteries were also observed throughout the subarea, especially in one (1) location, which was a wood pallet with eight (8) spent batteries above a wood panel.

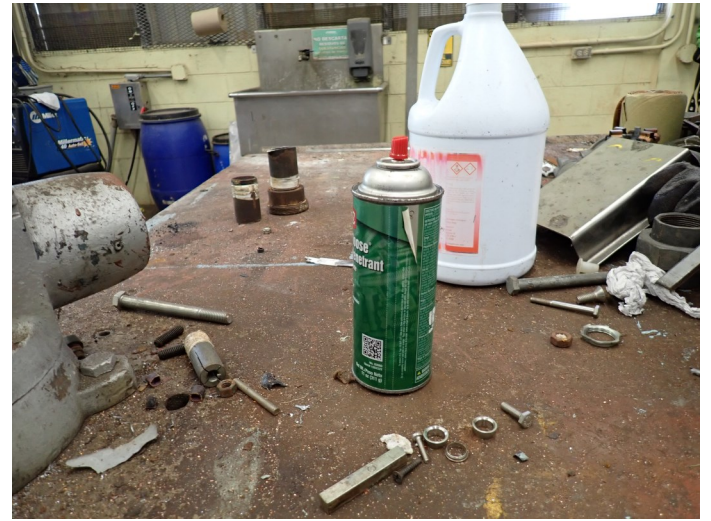
inspection, were dirty, with dust, and/or with rags impacted with an unknown. Aerosol cans were also observed through the walkthrough (Picture #16). I asked the facility representatives about them; and how they handled, stored, and disposed of the latter. Mr. Rossy told me that they have two (2) areas identified where aerosol cans are currently stored. Nevertheless, it was confirmed that none of these areas were located in this subarea. Hence, I asked again about the ones observed in this subarea. The facility representatives told me that they appeared to be in use.

Picture 16 — Light Mechanical Shop Area— Aerosol cans were also observed through the walkthrough.

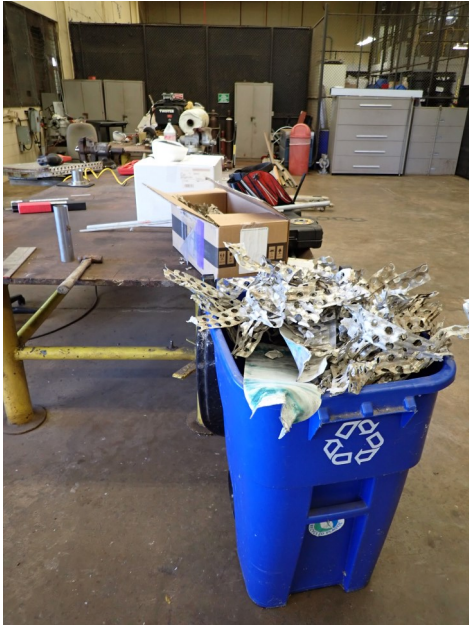
Likewise, I observed some open containers with scrap metal (Picture #17). At the time of the inspection, those containers did not have a label. Moreover, scrap metal was observed to overflow the containers and throughout the subarea. Scrap metal was also observed in some equipment⁴² throughout the subarea, as well (Picture # 18 and Picture #19).

Picture 17 — Light Mechanical Shop Area— At the time of the CEI, some open containers with scrap metal did not have a label. Scrap metal was observed to overflow the containers and throughout the subarea, and in some equipment throughout the subarea, as well.

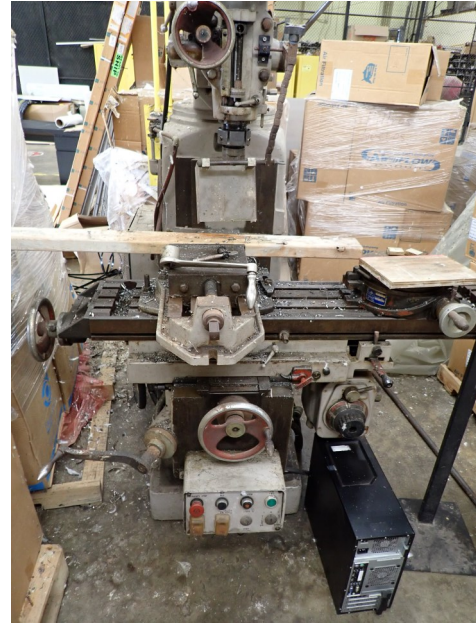
Picture 18 — Light Mechanical Shop Area—At the time of the CEI, some open containers with scrap metal did not have a label. Scrap metal was observed to overflow the containers and throughout the subarea, and in some equipment throughout the subarea, as well.

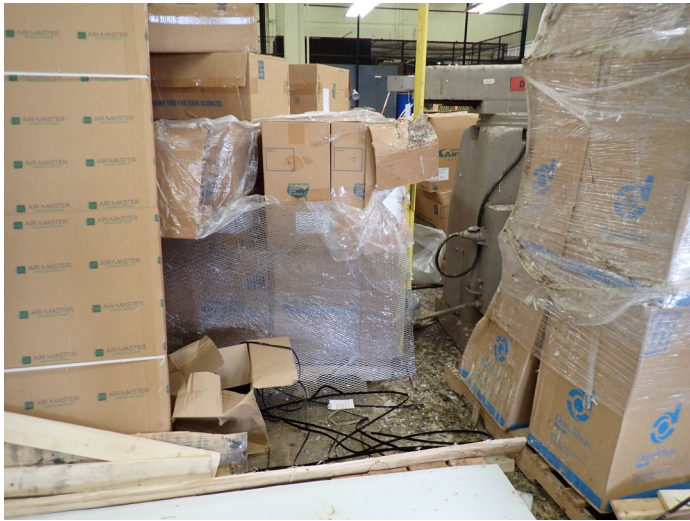
Picture 19 — Light Mechanical Shop Area— At the time of the CEI, some open containers with scrap metal did not have a label. Scrap metal was observed to overflow the containers and throughout the subarea, and in some equipment throughout the subarea, as well.

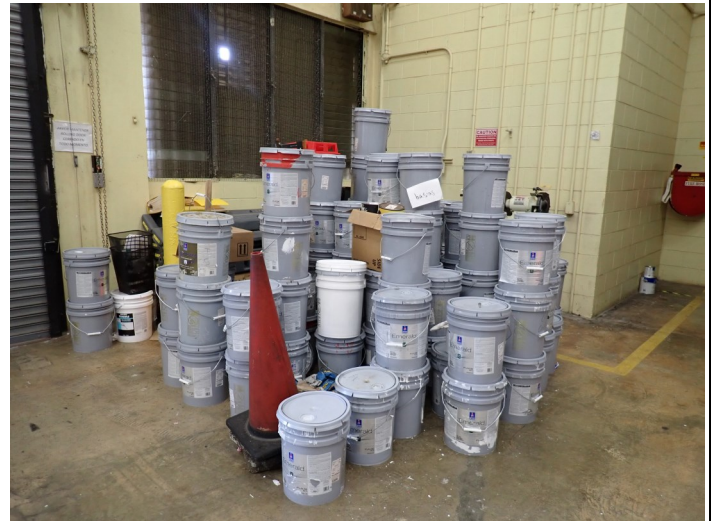
Moving on through this subarea, another location with wood panels, additional equipment, desk, and electronic equipment was observed. Additionally, an unidentified area, with various 5-gallon white plastic containers was observed (Picture #20). I asked the facility representatives about these, and Mr. Prada told me that those containers were paint that is being used as a result of maintenance activities that currently were being conducted at the facility. Nevertheless, information related to which containers were products and which ones were not was not confirmed⁴³. Additionally, just at the inside of the paint containers area, a wood panel with approximately six (6) blacktop repair bags was observed (Picture # 21). Information related to this material⁴⁴ was not able to be gathered as part of the CEI.

Picture 20 — Light Mechanical Shop Area— An unidentified area, with various 5-gallon white plastic containers was observed during the walkthrough.

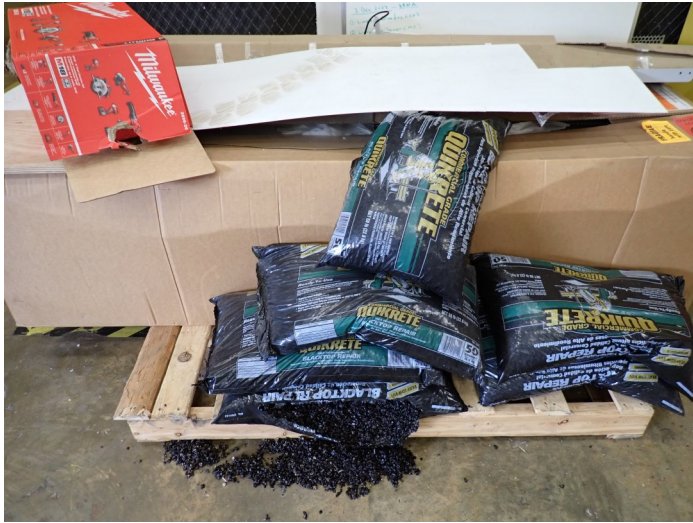
Picture 21 — Light Mechanical Shop Area—Just at the inside of the paint containers area, a wood panel with approximately six (6) blacktop repair bags was observed .

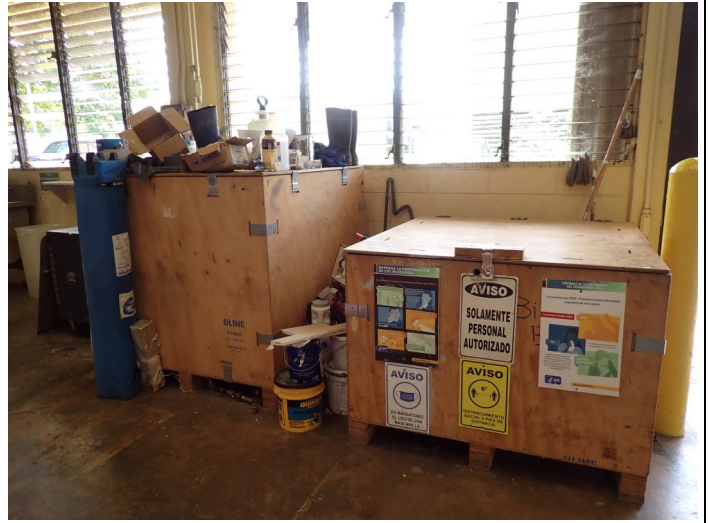
Another subarea was identified during the walkthrough. This one was identified by the facility representatives as the contractor's area. It consists of a wood box-like container which, according to the facility representatives, has materials inside that are used by the facility contractors' personnel. Just at the side of this subarea, additional open, corroded containers, open cardboard boxes, and plastic containers, such as power aid container, were observed (Picture #22).

Picture 22 — Light Mechanical Shop Area—Just at the side of the contractor’s subarea, additional open, corroded containers, open cardboard boxes, and plastic containers, such as power aid container, were observed.

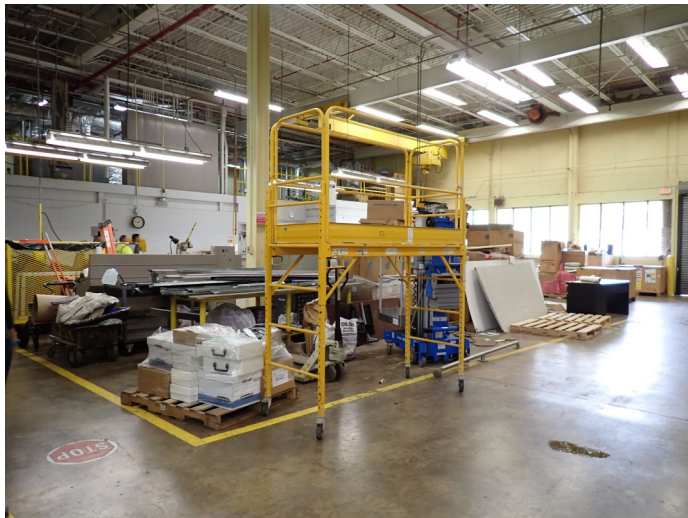
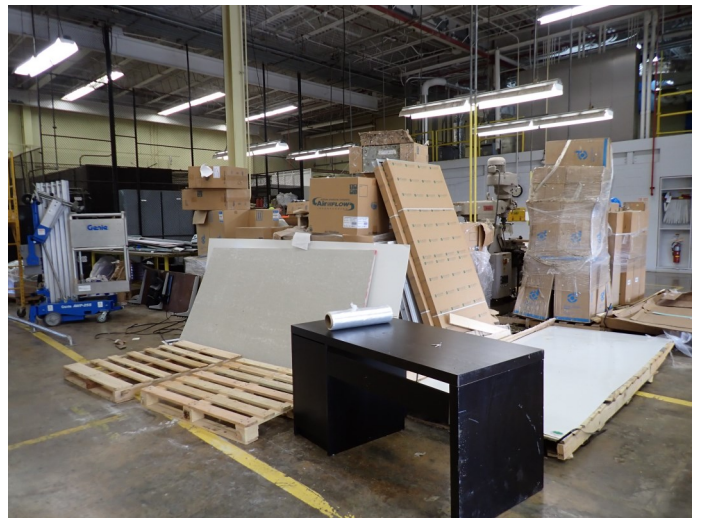
By this point of the subarea walkthrough, it was confirmed that we were heading to the central location of Building 501. The facility representatives told me that they were currently using the latter as a warehouse. At the time of the inspection, I observed the following: no operational equipment; some with scrap metal inside, facility's record-keeping files, electronic equipment, air filters, and metal doors, among others. It was not clear nor confirmed by the facility representatives the purpose of this warehouse⁴⁵ (Picture # 23 and Picture #24).

Picture 23 — Light Mechanical Shop Area— This is the center location of Building 501. According to facility representatives, they are currently using the latter as a warehouse.

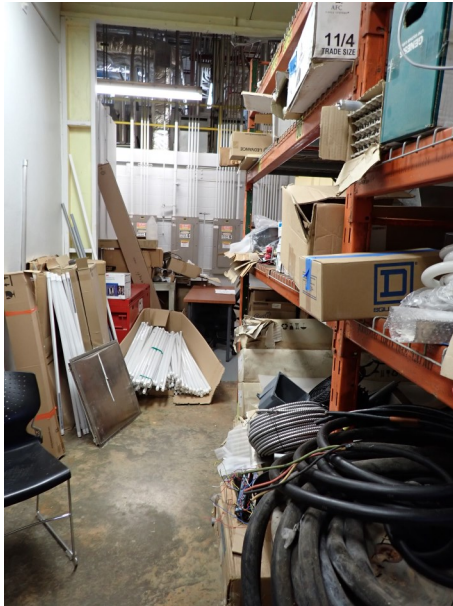
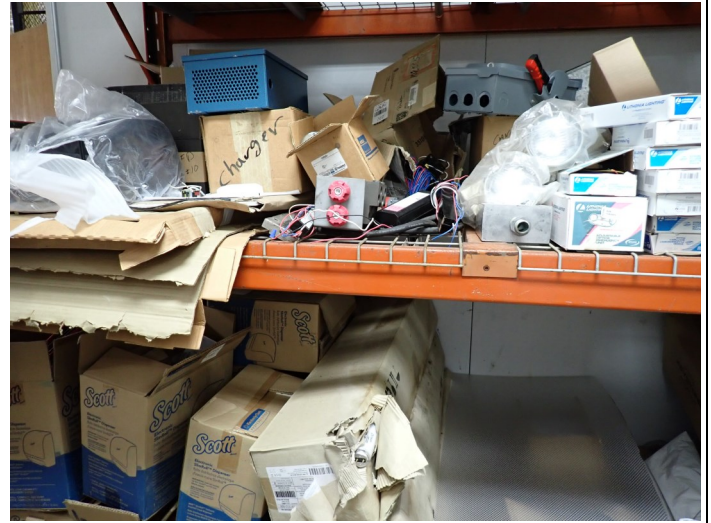
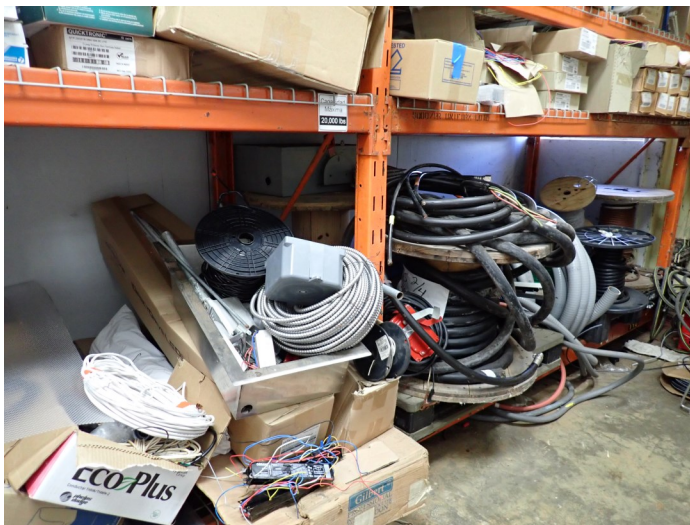
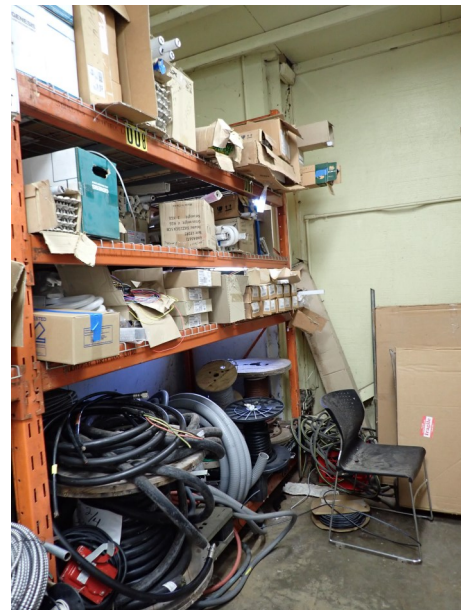
Picture 25 — Light Mechanical Shop Area— Located in the rear part of Building 501, an electrical area was identified. It consists of a hallway-type area with metal shelves with various materials, such as but not limited to cables, cardboard boxes fluorescent lamps, among others. According to the facility representatives, those materials were in use.

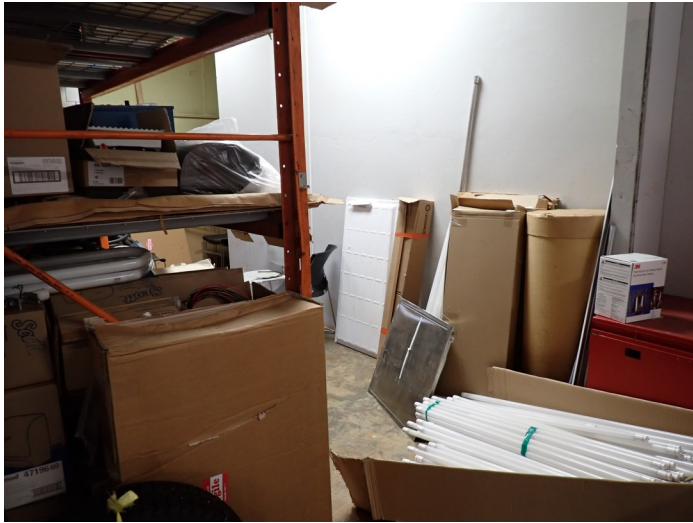
Picture 29 — Light Mechanical Shop Area— Just in front of the metal shelves, various open and broken card boxes were observed with what appeared to be fluorescent lamps. Those were observed to overflow the boxes.

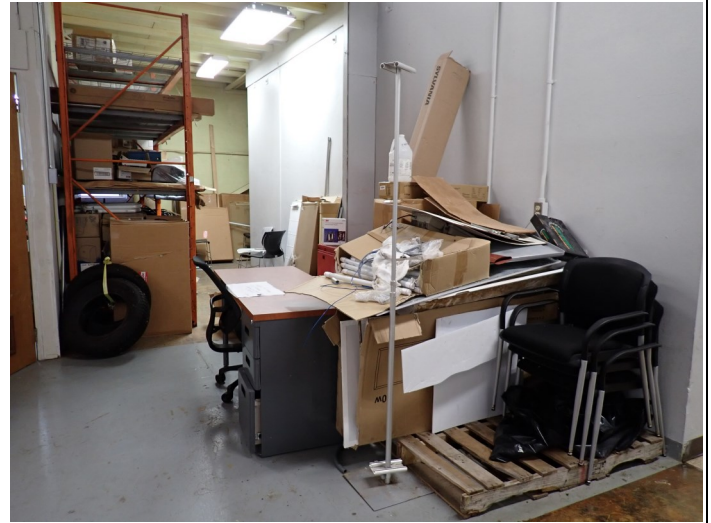
Picture 30 — Light Mechanical Shop Area— In this location, I also observed metal scrap in the surroundings, wood panels, chairs, and broken desk, among others.

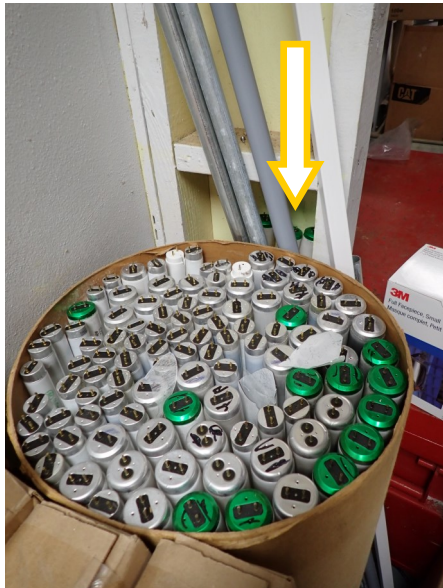
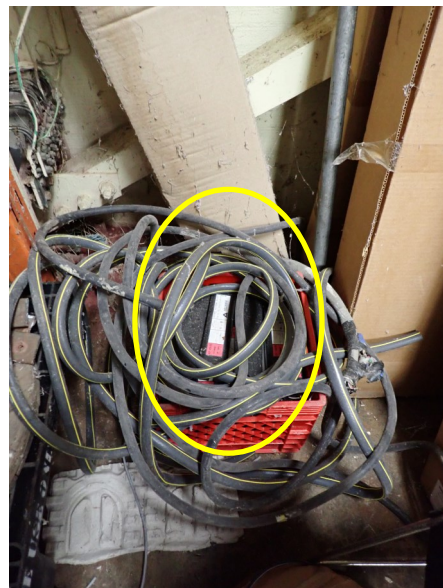
Picture 31 — Light Mechanical Shop Area— One (1) card board box was observed full of spent fluorescent lamps, even broken sections of spent fluorescent lamps. It was observed closed, not labeled as Universal Waste, not dated, was not under the operator’s control, and did not have a pictographic label and/or indication of the hazard. Additionally, three (3) spent fluorescent lamps were observed outside the round cardboard box.

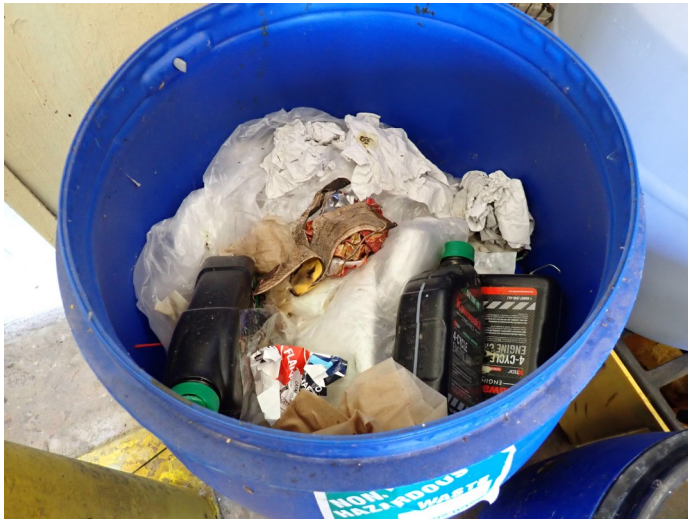
Picture 35 — Light Mechanical Shop Area— One (1) 30-gallon blue plastic container with non-hazardous waste with Pad usados was observed. It was open, labeled as non-hazardous waste, and almost full. Inside, I observed a mix of pad usados, with vegetative material, regular waste, and plastic containers, among others.

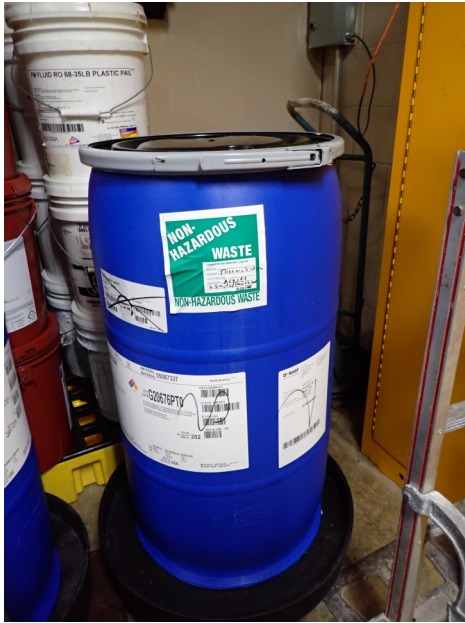
Picture 41 — Maintenance Shop Area— Here, one (1) 35-gallon blue plastic container was observed labeled as aceite usado, nevertheless, when opened, rags impacted with used oil and a hose inside a plastic bag were observed inside. It was closed, labeled as non-hazardous waste, and above a wheel-like round base.

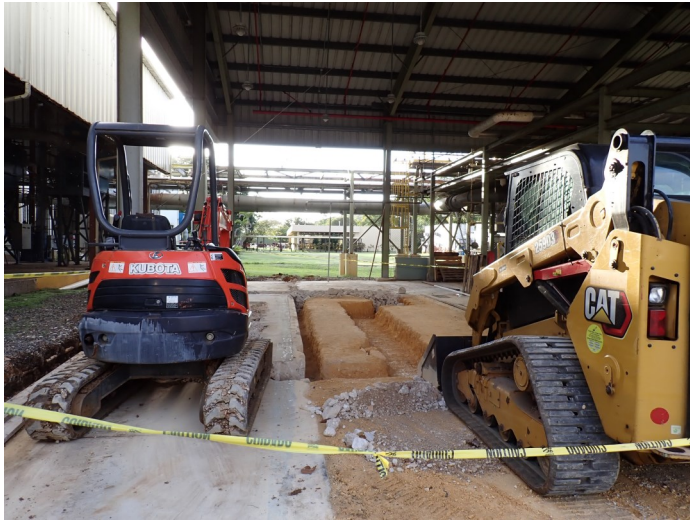
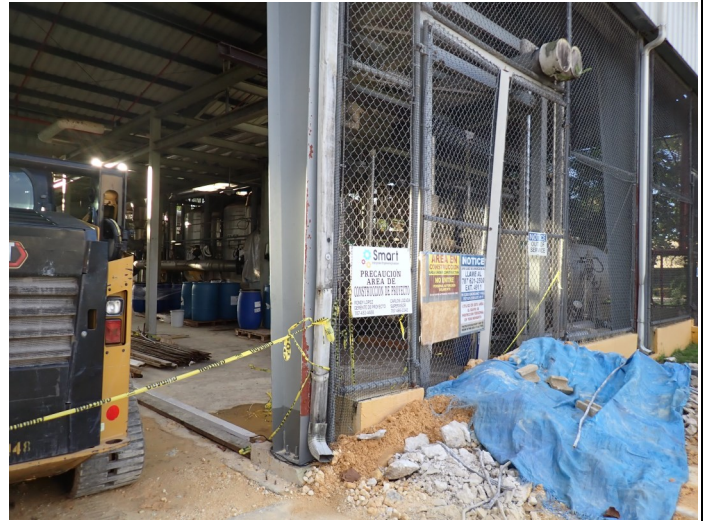
Picture 49 — Former Hazardous Waste Tanks Area—At the time of the CEI, ongoing construction activities were not observed since construction activities were completed by the day. It consists of a high galvalume ceiling with part concrete, and part soil floor. A yellow band that works as a physical barrier in order to control access to the latter was observed.
