1975 - FEDERAL  
OSHA - PEDRICKTOWN

# B. F. Goodrich Chemical Company

| Subject | O.S.H.A. PRELIMINARY SURVEY | | | Date<br>7-21-75 |

VELOMETER READINGS OBTAINED IN MASS RESIN, BUILDING 512

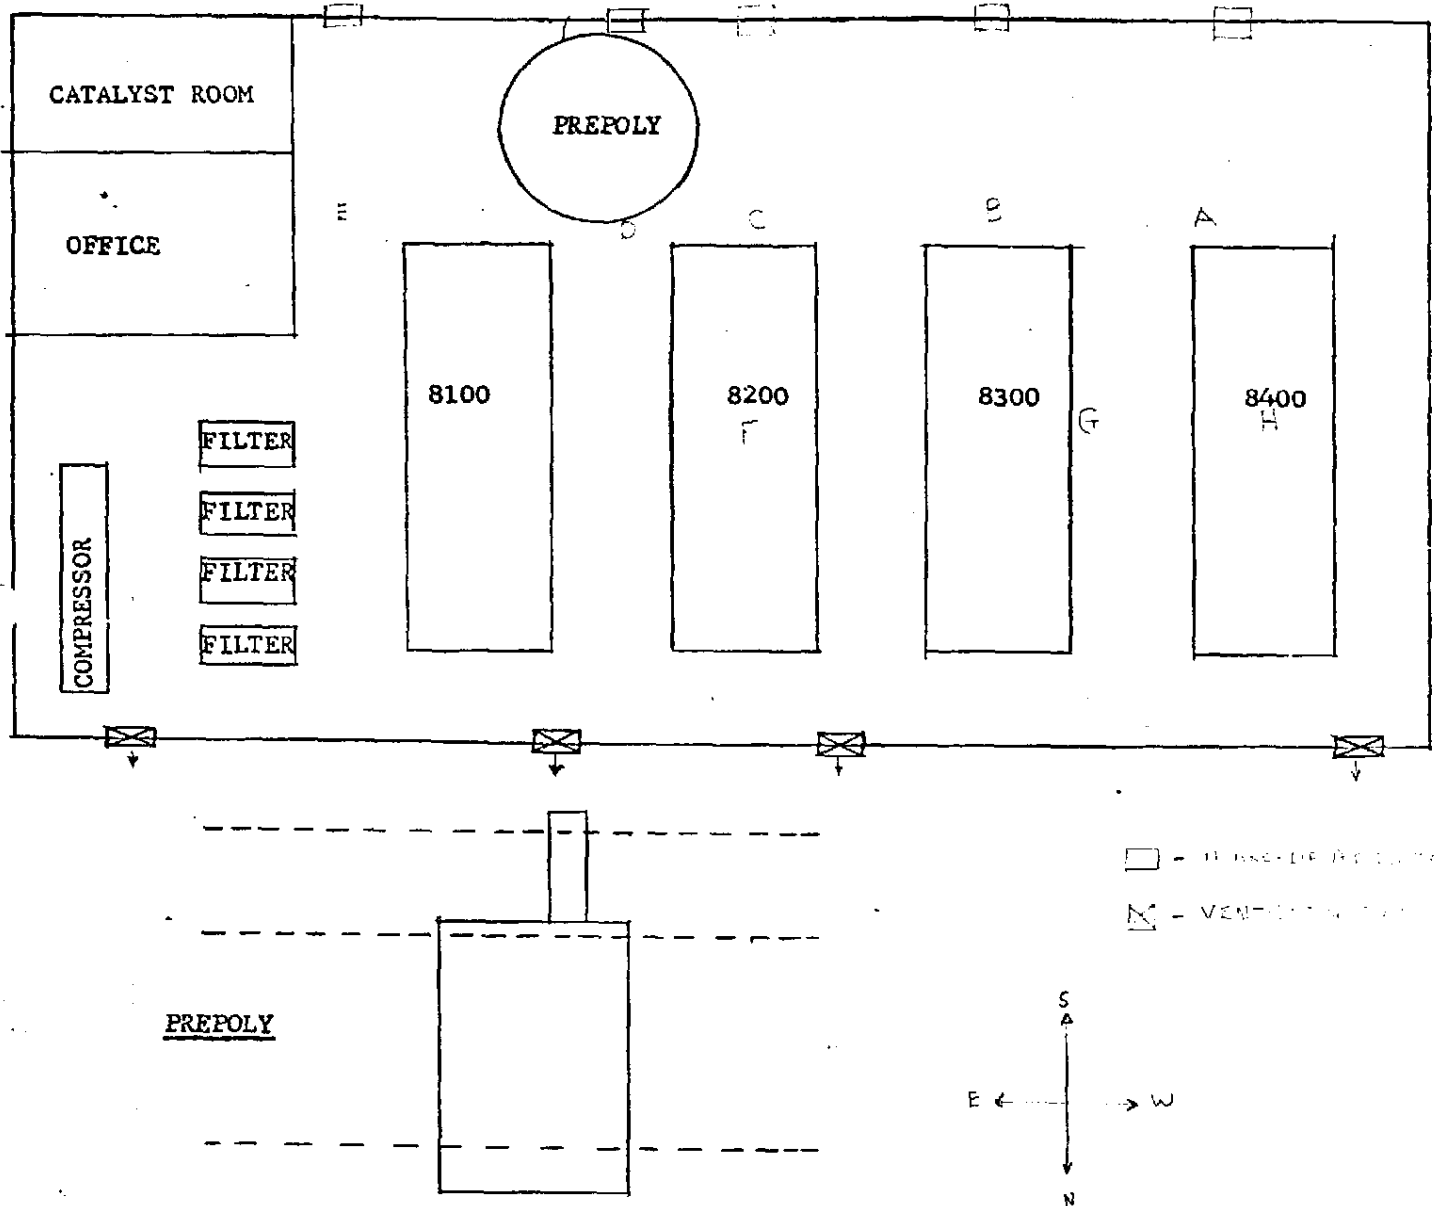
BUILDING 512 - MASS RESIN

| <u>Sample Point</u> | <u>Reading Obtained</u> |
| A | 500 LFM |
| B | 150-200 LFM |
| C | 0-60 LFM |
| D | 50-200 LFM |
| E | 0-150 LFM |
| F | 0 LFM |
| G | 20 LFM |
| H | 0-125 LFM |

The location of each reading is shown on the attached building drawing. Readings A-E were taken on the office level, and readings F-H were taken on the mezzanine above the autoclaves.

A citation was given based upon 1910.134 AI. This resulted from the velometer readings obtained in Bldg. 512. A three month abatement period was established.

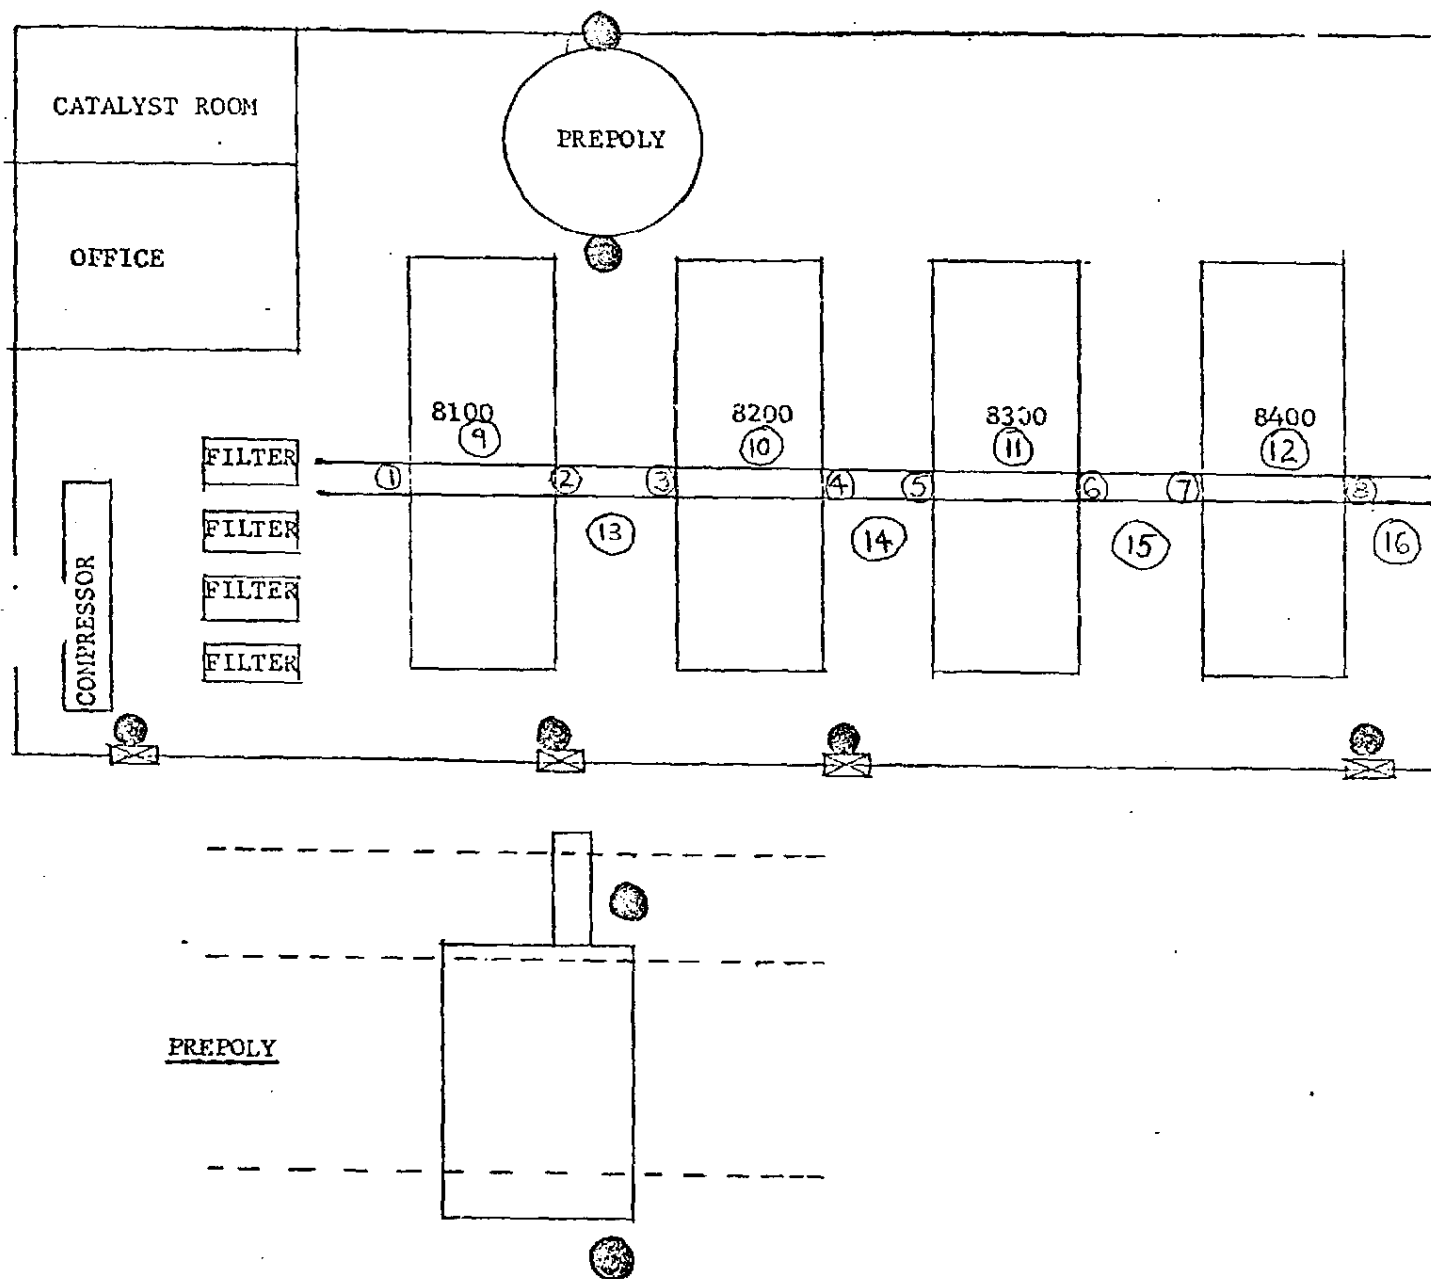
FIGURE 1

The Mass Building has intake air vent units and forced air units to channel outside air through the building from south to north. Data was collected using different combinations of open vent units. The building sampling points are shown in Figure 1. These locations were selected to give a representative cross section of flow in the building. Sampling points 1 through 8 are on the catwalk level by the top of the autoclave condensers, locations 9 through 12 are on top of the autoclaves, and points 13 through 16 are on the ground floor between the reactors. In all cases the two roof fans were running and the ground level fans were on the emergency, summer position. The prepoly fan facing south was off.

None of the trials showed consistent readings of acceptable air flow rates on the catwalk above 8100 and 8200. However, air flow was slightly bettered with the mezzanine level covered, and 2 of the 4 ground floor fresh air vents closed. On subsequent days readings were taken with all fresh air and forced air vents on the ground floor closed. This combination caused turbulence above 8100 and 8200. Also with just the forced air closed, no increased air flow was observed by the catwalk.

Due to the obstruction caused by the prepoly and its piping, flow patterns are altered by 8100 and 8200. Covering the mezzanine level did not improve these conditions significantly. Because increased air flow into this area would still be altered by the prepoly, a viable alternative is to remove air from the condenser level. This would best be achieved through ductwork to the catwalk from the roof ventilation units.
