**Well Inspection**  
**Osage DNR / Environmental Protection Agency**  
**1201 Elm Street, Suite 500**  
**Dallas, Texas 75270**

| <b>Operator Info</b> | great horned owls, LLC | <b>Inventory ID</b> OS3046000 | | | | |
| | Phone: 833-523-3695 | <b>Well ID</b> WILFR14 | | | | |
| <b>Location</b> | NE 03 26N 06E | <b>Status</b> | Inactive | <b>Well Type</b> | Enhanced Recovery | |

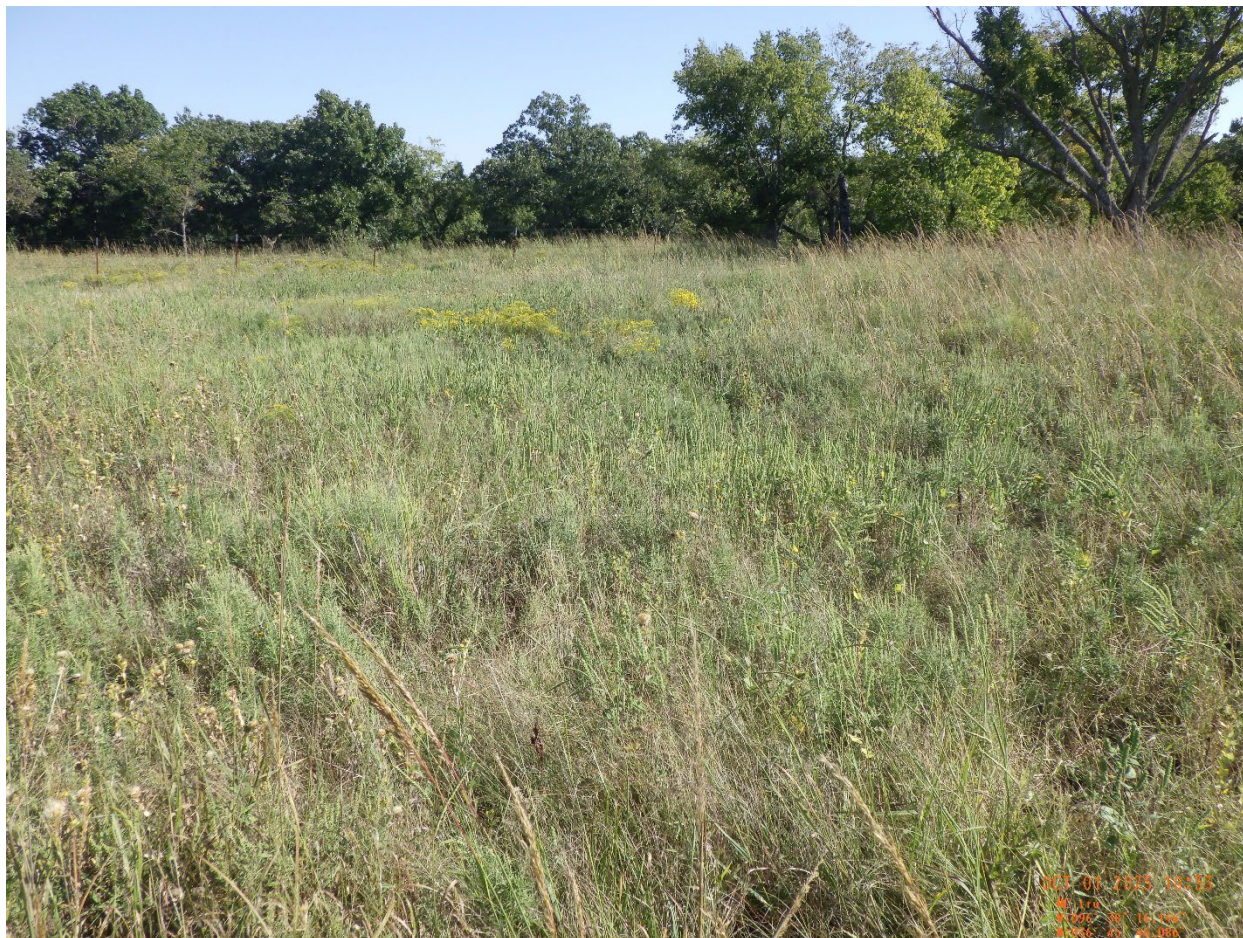
Photo No. 1

| <b>Inspection Comments</b> | | Inspector observed the location for well OS3046000 according to location information on file in the EPA/UIC records. The well appears to have been plugged and the location fully restored. No well present at or near the location. | | | | |

**Description:** This was the location of well OS3046000 according to EPA records. At the time of the inspection there was no well present and the location was restored and fully recovered.
