PPG Industries, Inc.  
Chemical Division - U.S.  
Lake Charles, Louisiana

LD-1873

Vapor Detection Grid Review (P-823)

TECHNICAL REPORT LD-1873  
July 26, 1978

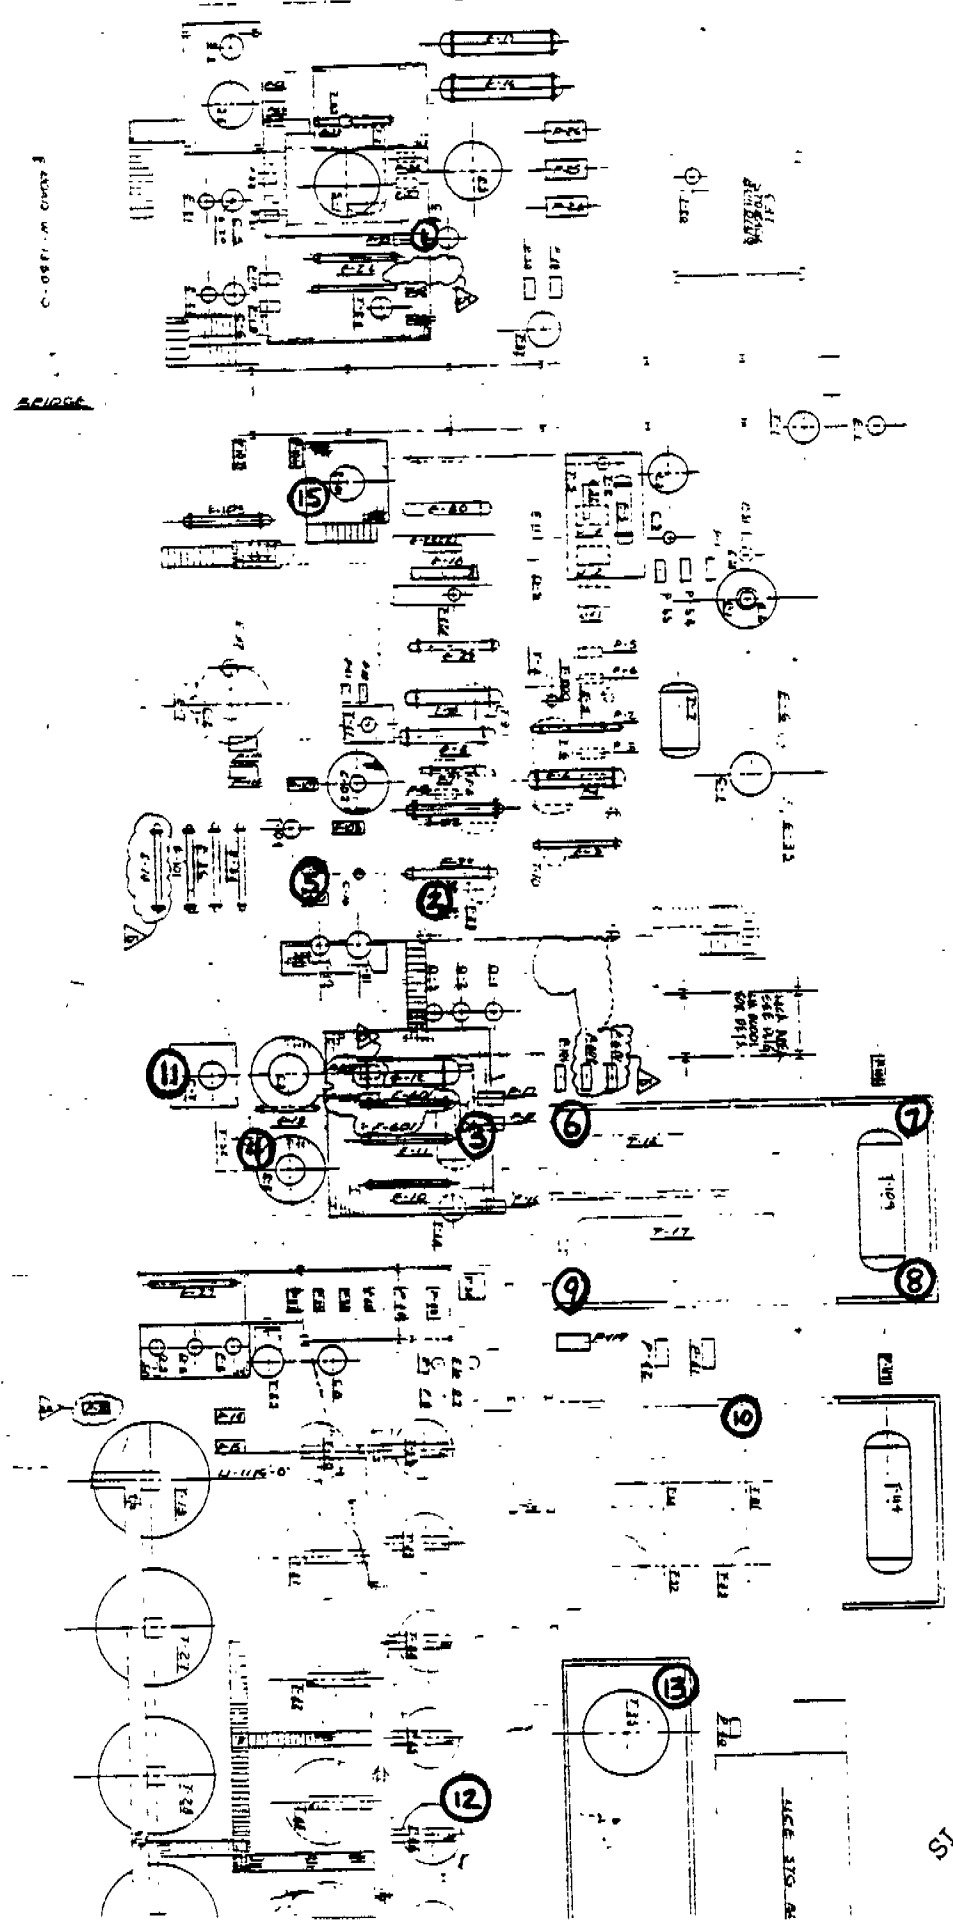
### VDC

VDC. There are many vapor detectors which are not going to be necessary when the "Tri-Ethane" II plant starts up. At that time some of the vapor detectors could be relocated to monitor areas which are marginally protected.

One location which is not protected by vapor detectors is the north VDCM day tank. Otherwise, the VDC plant appears to be well protected. The water sprinkler systems are usually bypassed from the vapor detectors because of erroneous alarms which have sounded due to instrument malfunction or because of detection of vapors from releases to the atmosphere during sampling. Standard operating procedure is to investigate vapor detector alarms when they sound and manually trip the water sprinkler system based on operator judgment.

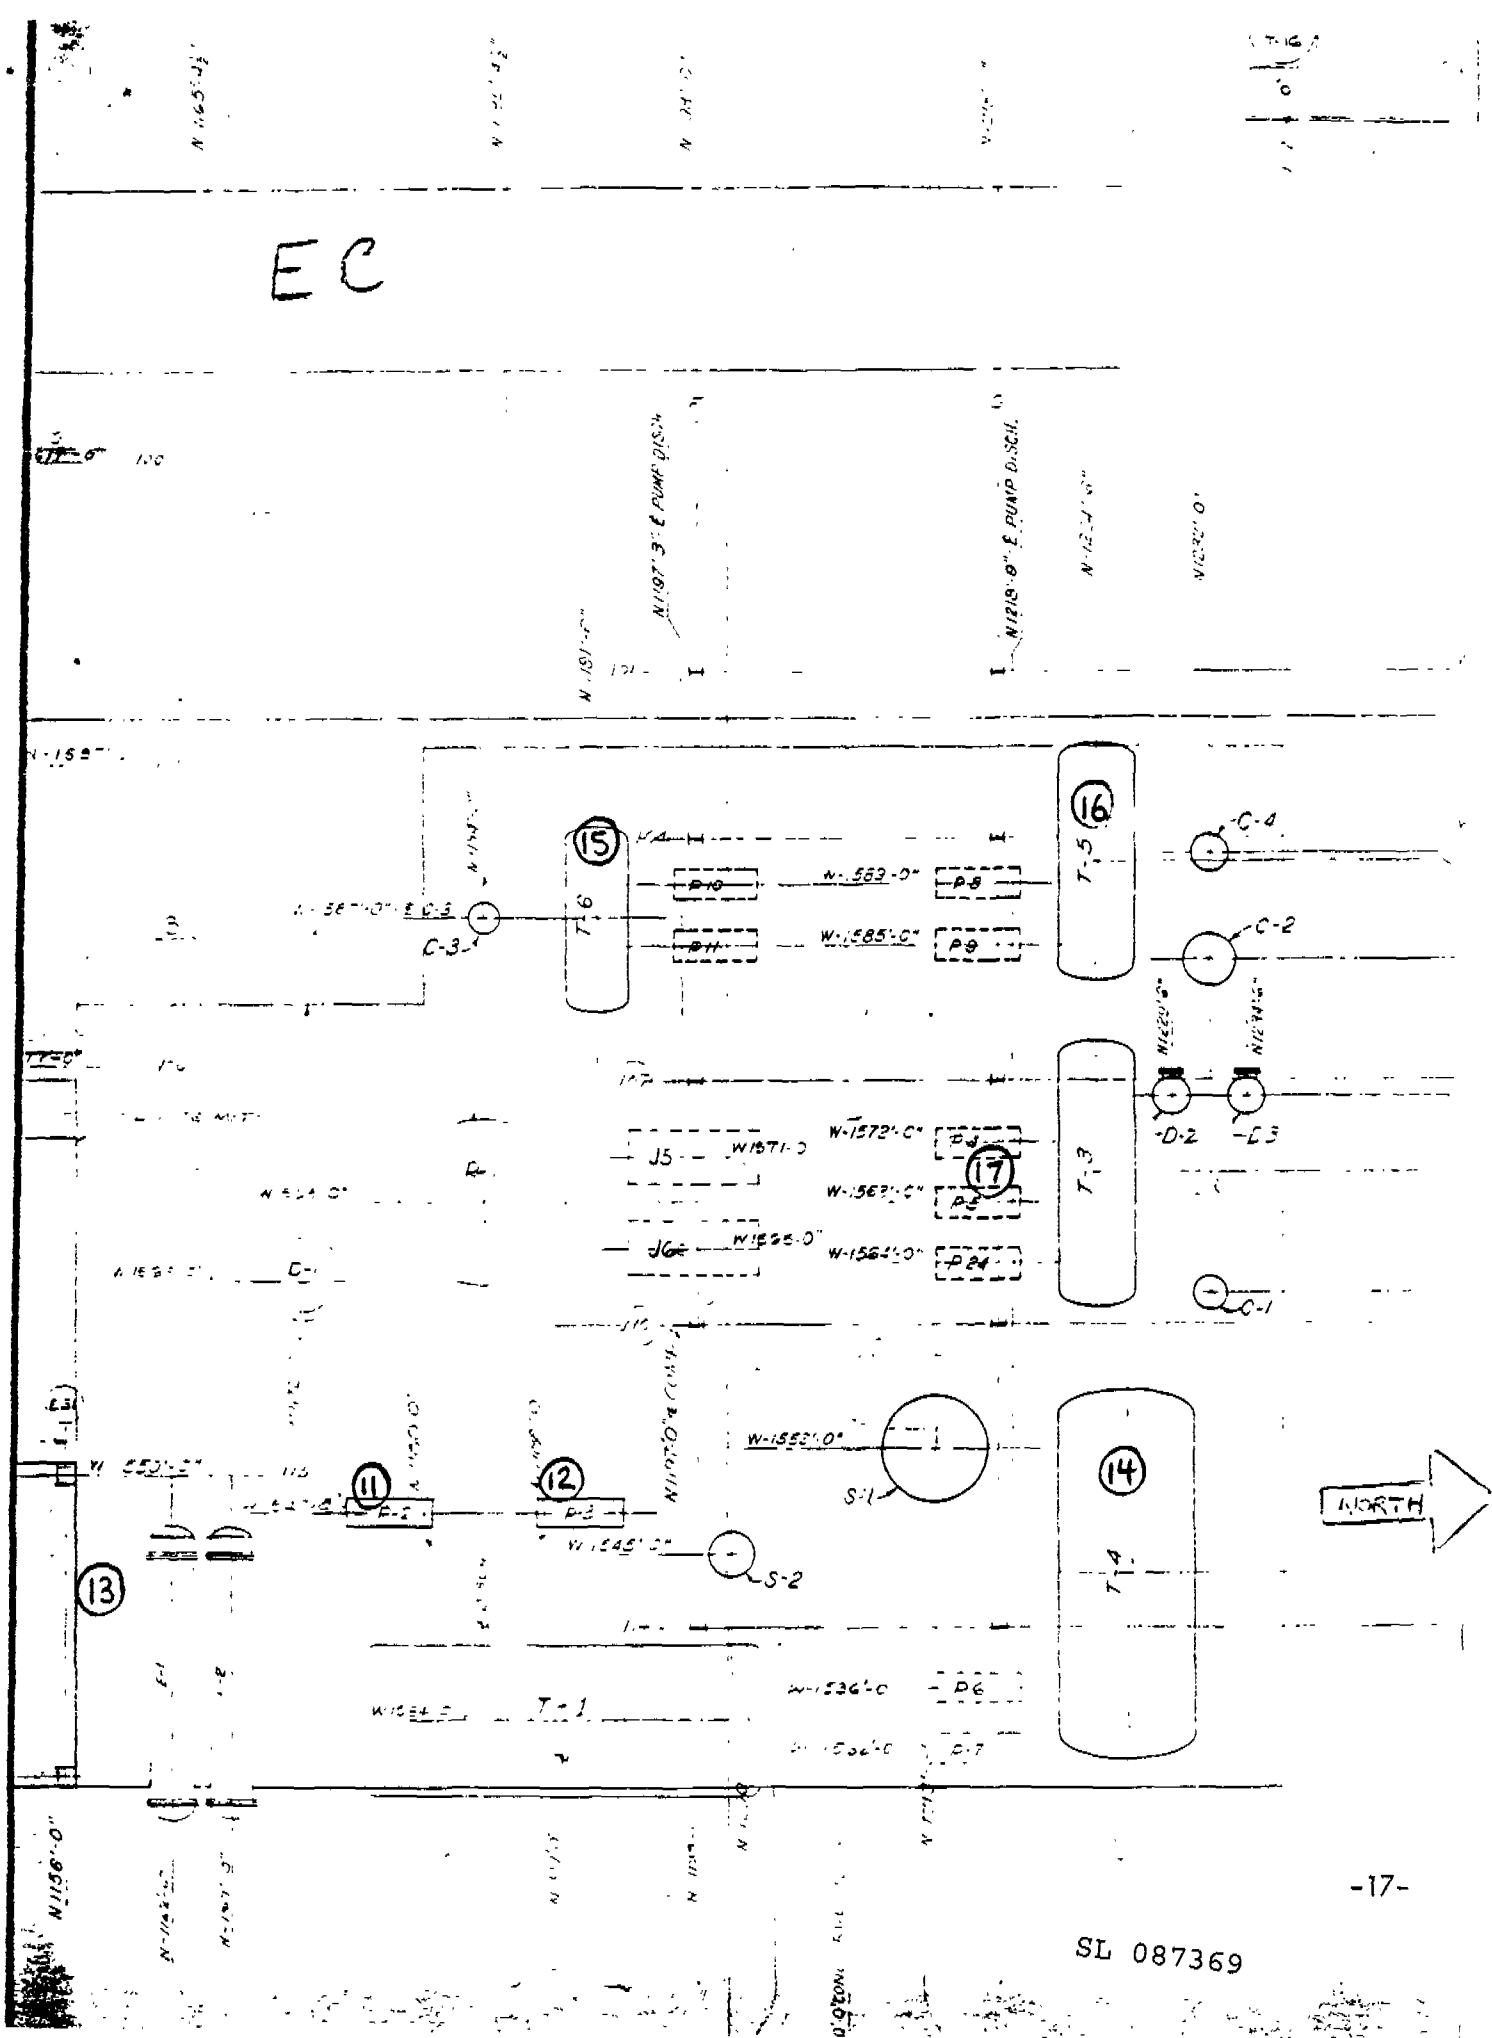
### EC

EC. Ethyl chloride is one of the most flammable chlorinated organics in Plant B. There have been occasions in the past where vapor clouds containing EC have formed which have not been indicated by the vapor detectors. (See appendix - Reports of Abnormal Operating Incidents.) Traffic on Parish Road, located on the north boundary of the EC unit, is a potential ignition source. The prevailing winds out of the south increase the probability that a vapor cloud could cross Parish Road undetected. A perimeter vapor detection system would add protection to the EC unit from this hazardous condition.

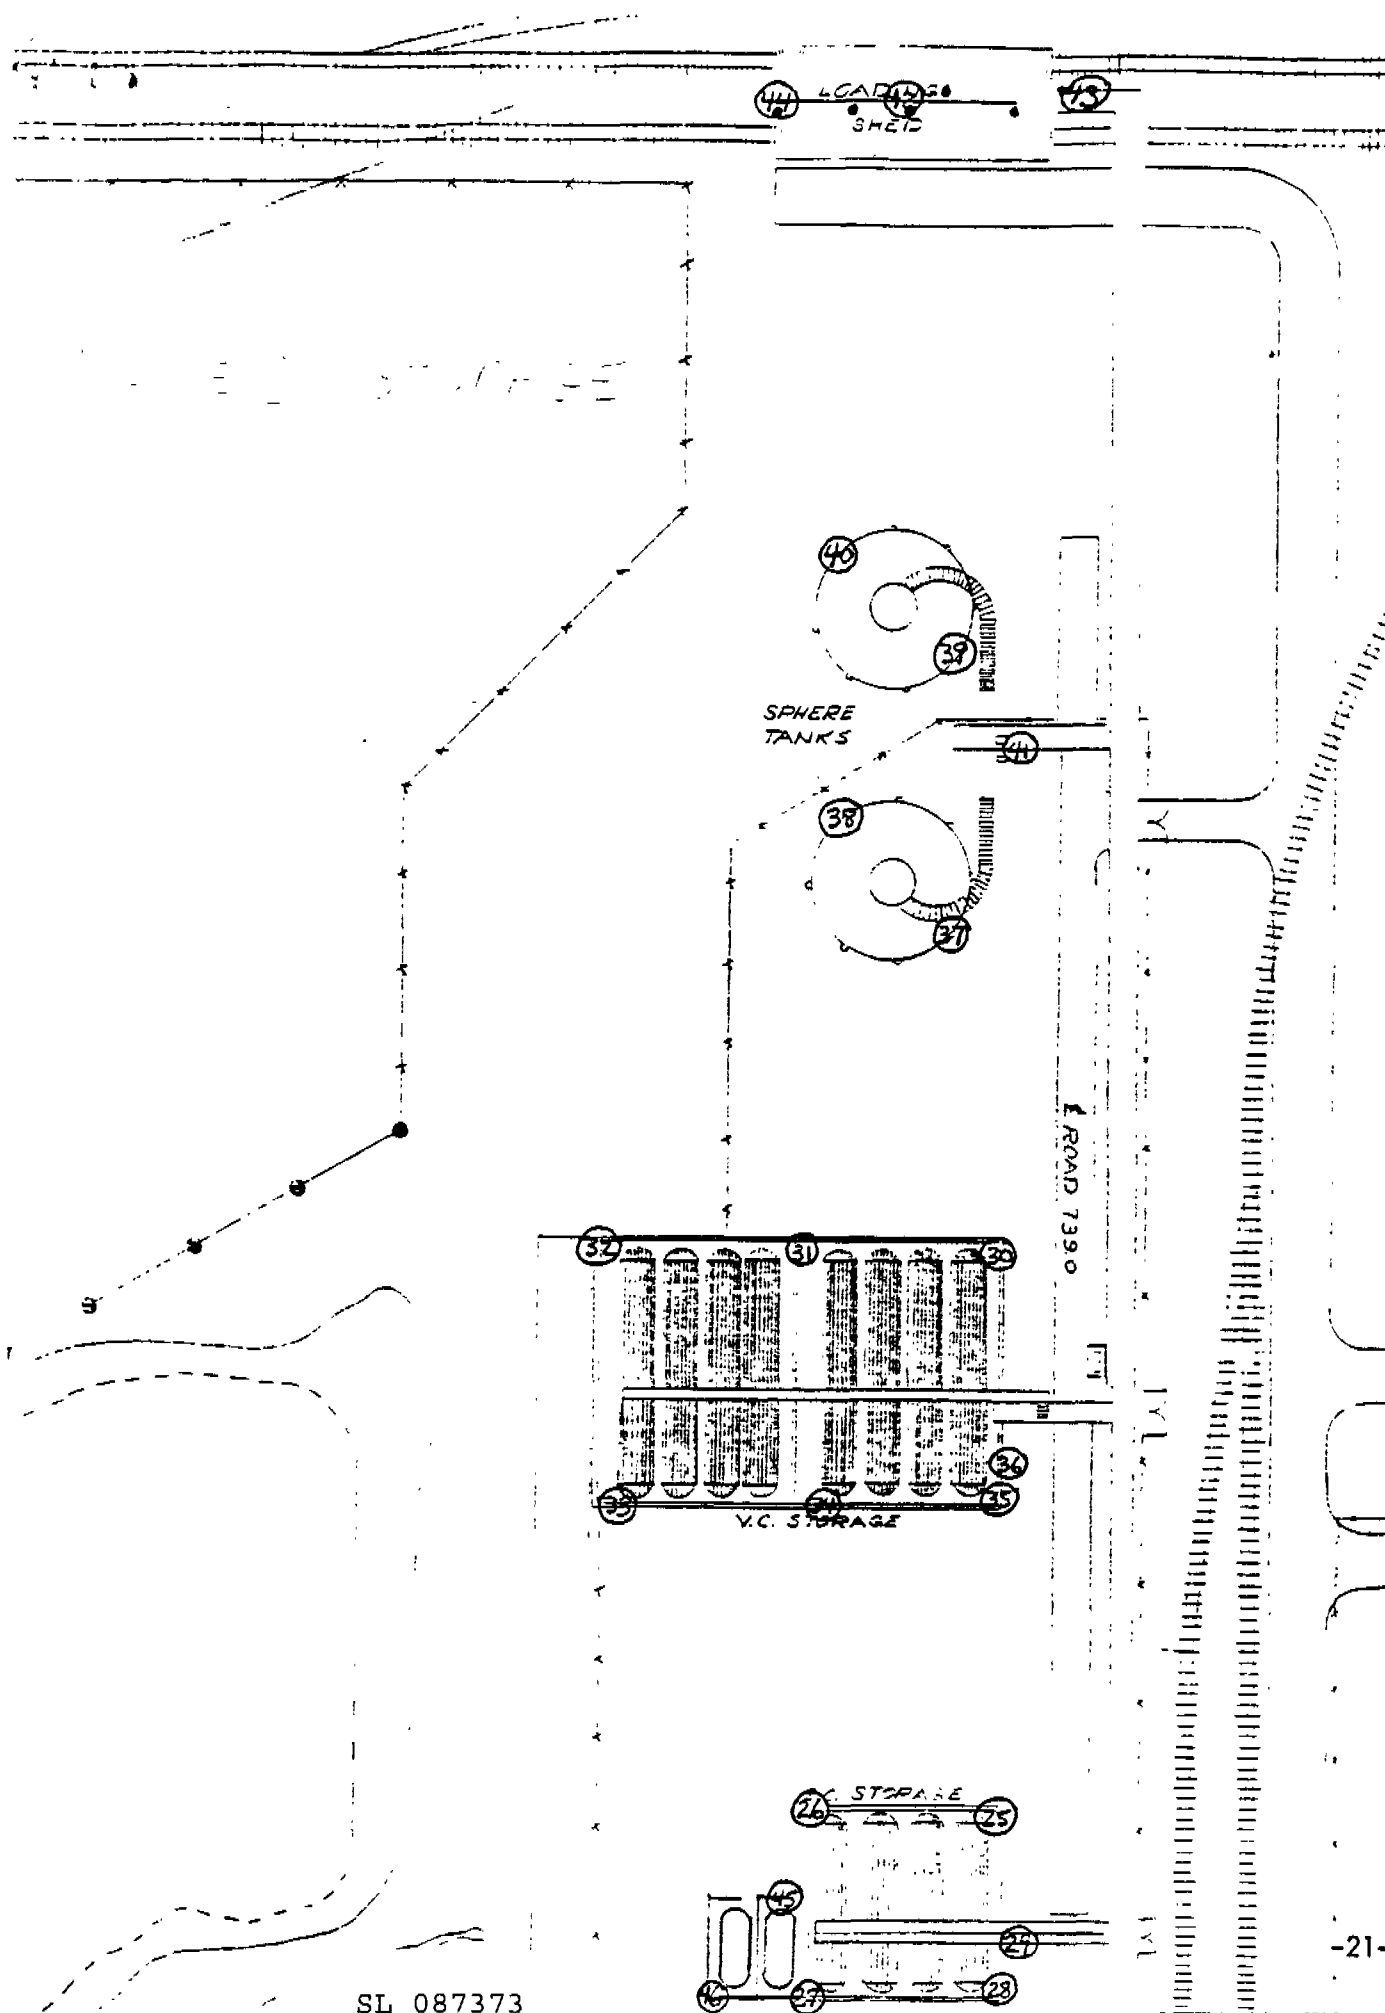
### VC/EC STORAGE

VC/EC Storage. There have been modifications in both the VC and EC storage areas. The area beneath the day tanks has been separated with concrete dividers to direct spills or burning EC or VC out of the area to limit fire or potential fire exposure to a minimum number of day tanks. Previously, the vapor detectors were located along the perimeter of the day tank storage area. Due to the present arrangement, a leak or spill of VC or EC could go undetected for some time. Due to the high specific gravities ( $SG = 2.2$ ,  $air = 1.0$ ) of VC and EC, the vapors from an unprotected compartment would have to overflow into an adjacent equipped compartment in order to be detected. Vapor detectors should be located within the individual compartments or in the common drainage systems.
