**Region 6 - Enforcement & Compliance Assurance Division**  
**INSPECTION REPORT**

| Inspection Date(s): | 03/04/2025 | |
| Company Name: | <b>Hansford County Feeders</b> | |

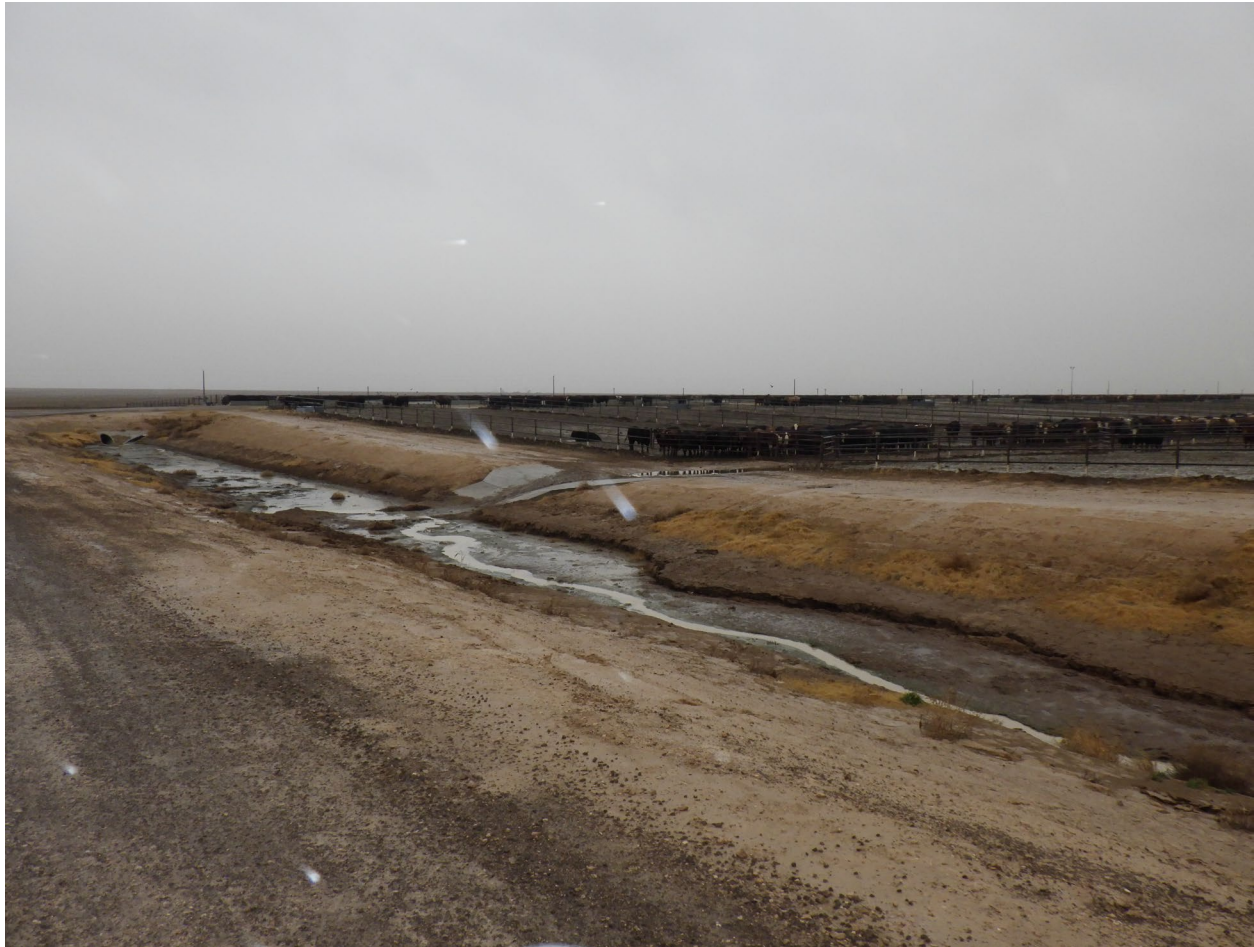
Photo No. 1

All the berms on site were in good condition. Drainage channels were properly routing runoff to the RCSs with the heavy rain event during the inspection without any signs of problems (Appendix 1, Photos 1, 2, 4, 5, 7, 8, 9, & 13).

Description: Drainage channel that receives runoff from pens. Enters settling basin. The culvert connects to RCS7.

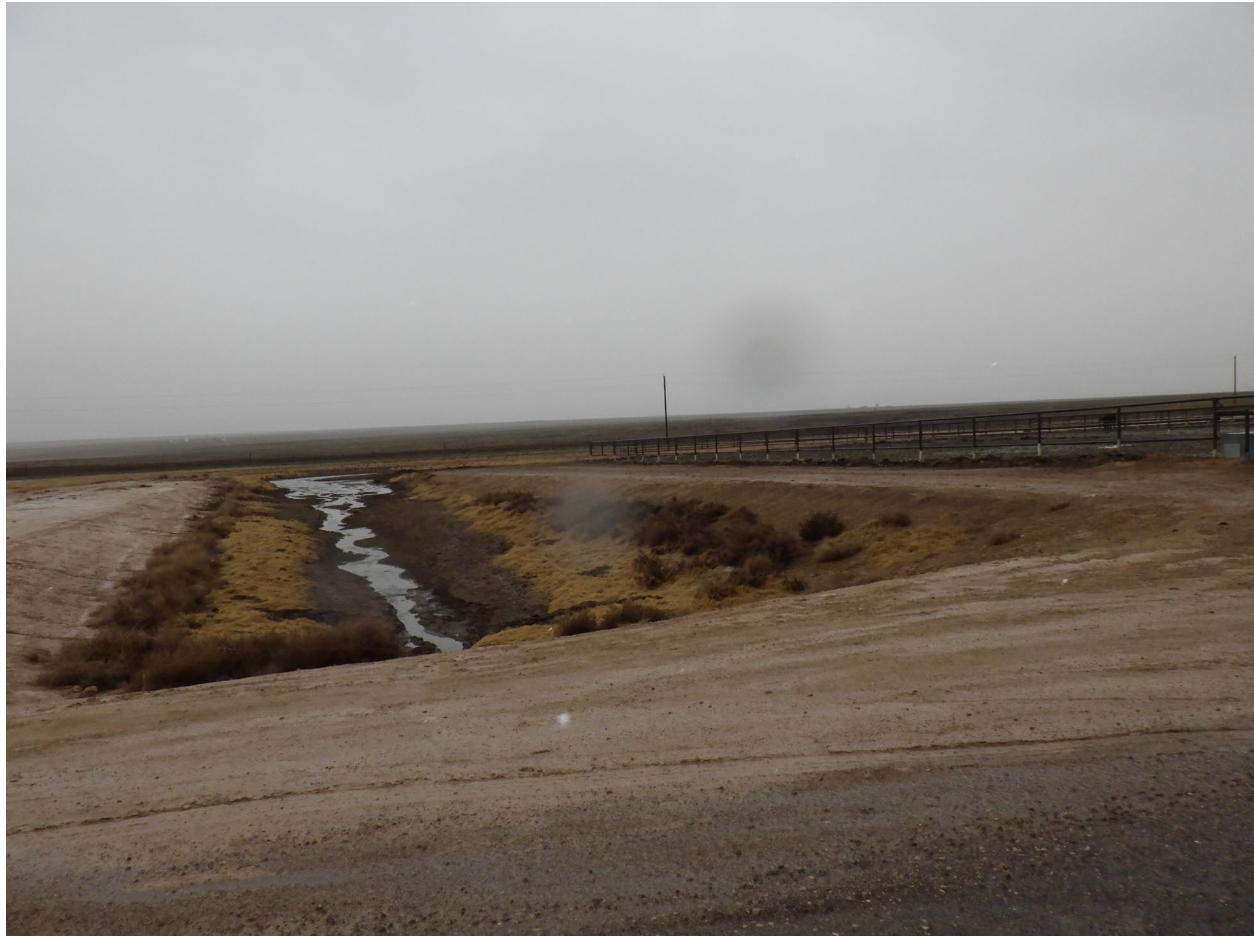
Photo No. 2

Description: Settling catch basin near the northwest pens.

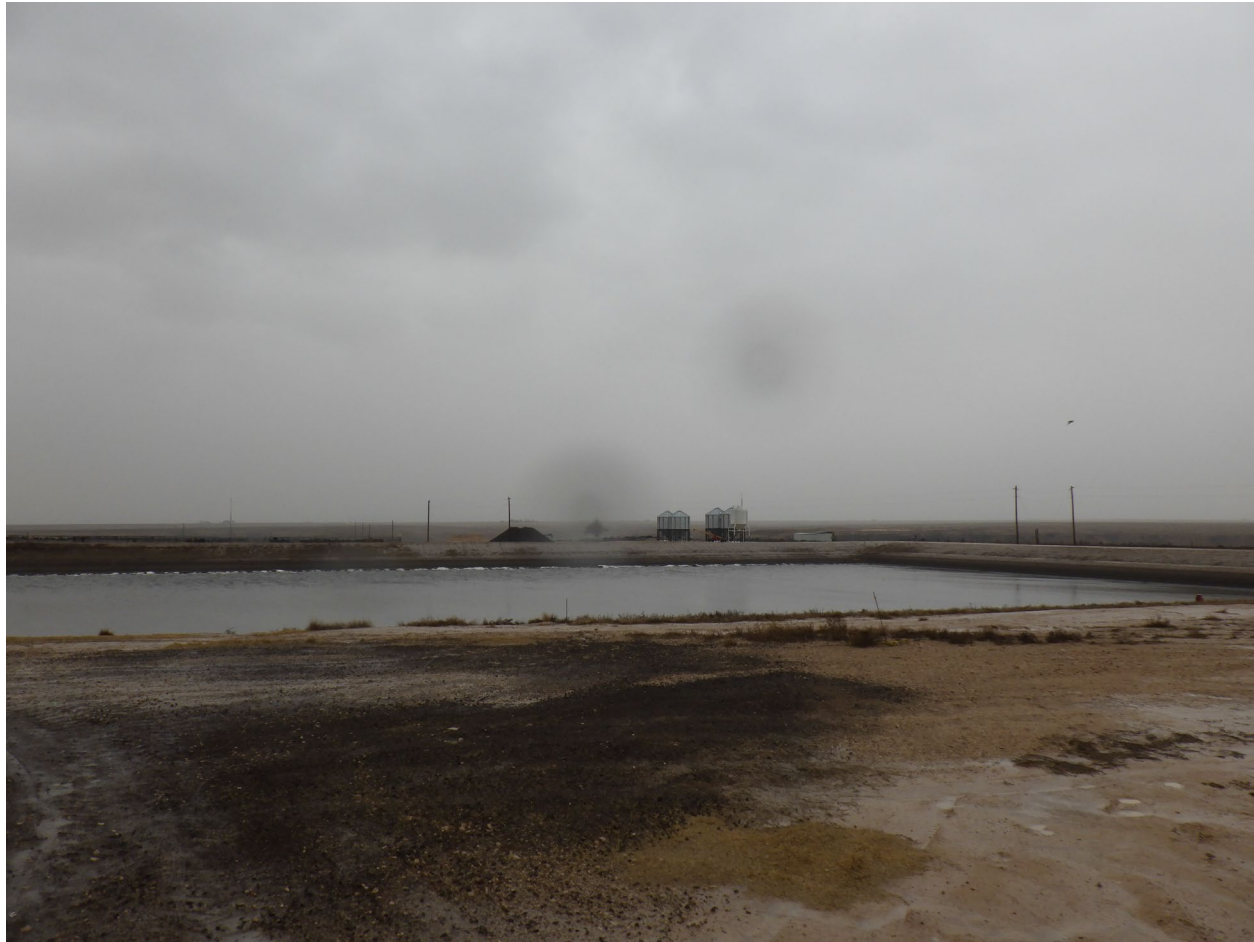
Photo No. 3

It was raining with strong winds during the entirety of the inspection. The open lot pens were clean and without any visible manure piles inside the pens. All manure stockpiles on site were within the drainage of an RCS (Appendix 1, Photos 3 & 8).

Description: RCS 7. On the other side of the catch basin.

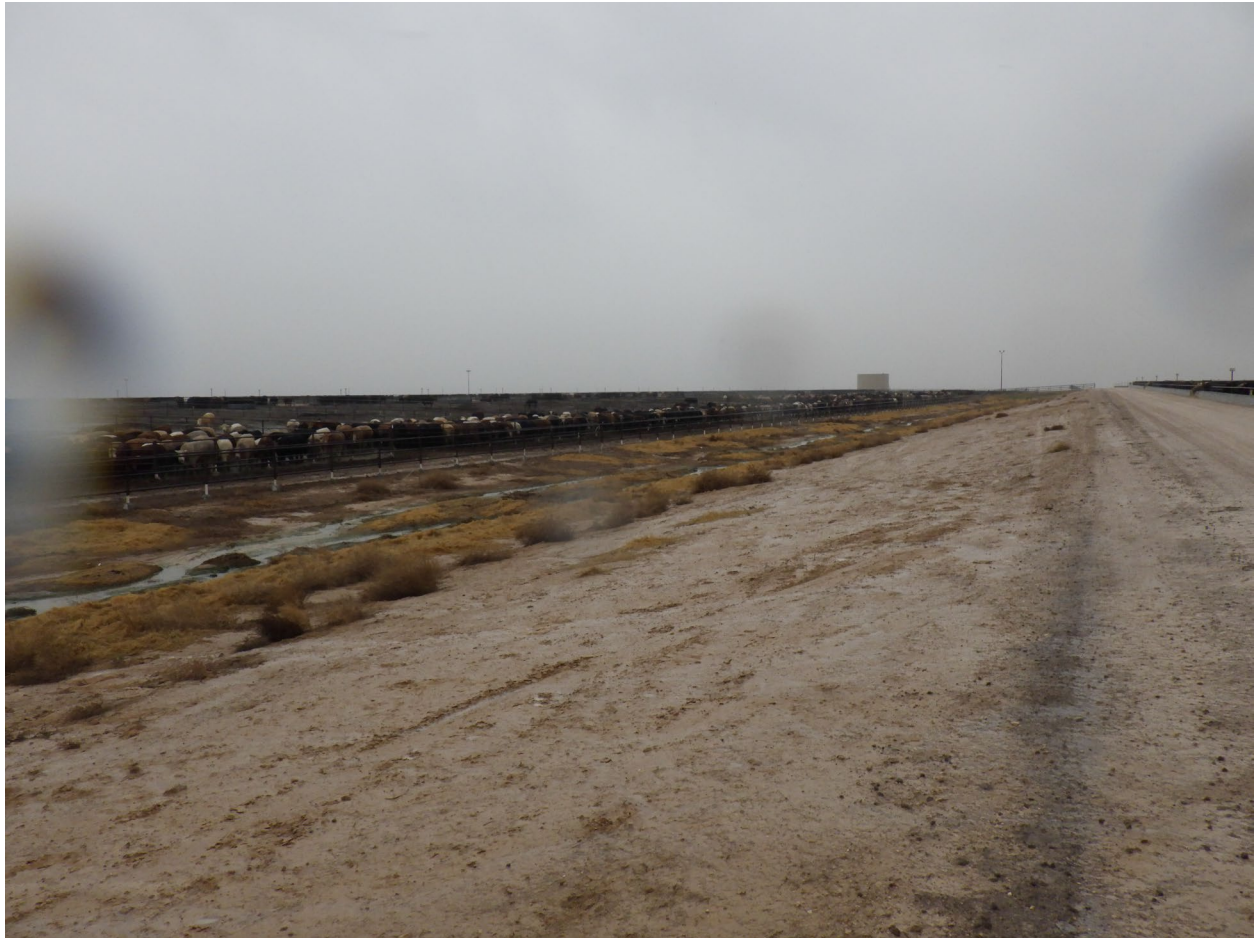
Photo No. 4

Description: Open lot pen drainage channel.

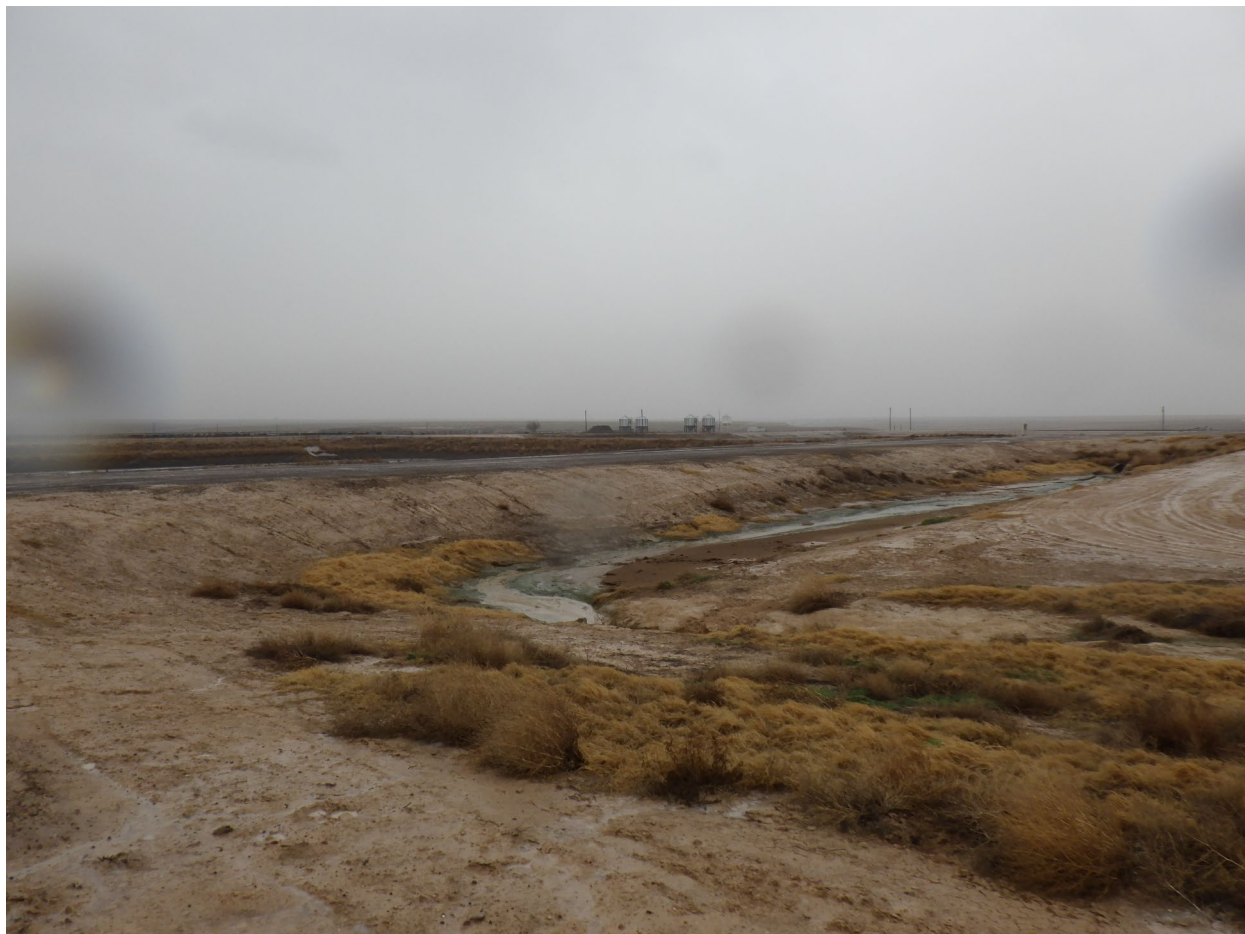
Photo No. 5

Description: Catch basin.

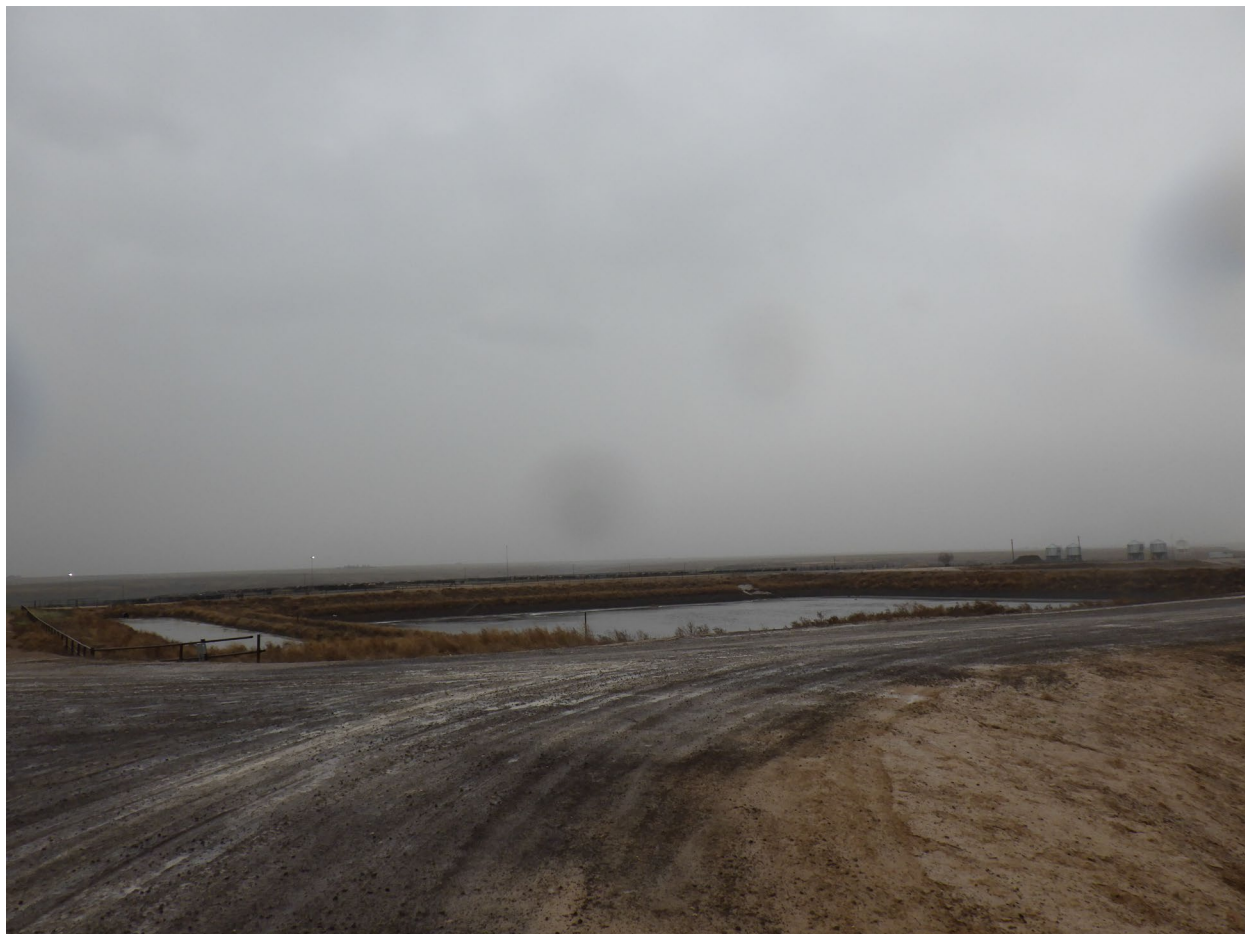
Photo No. 6

Description: View of RCS 8.

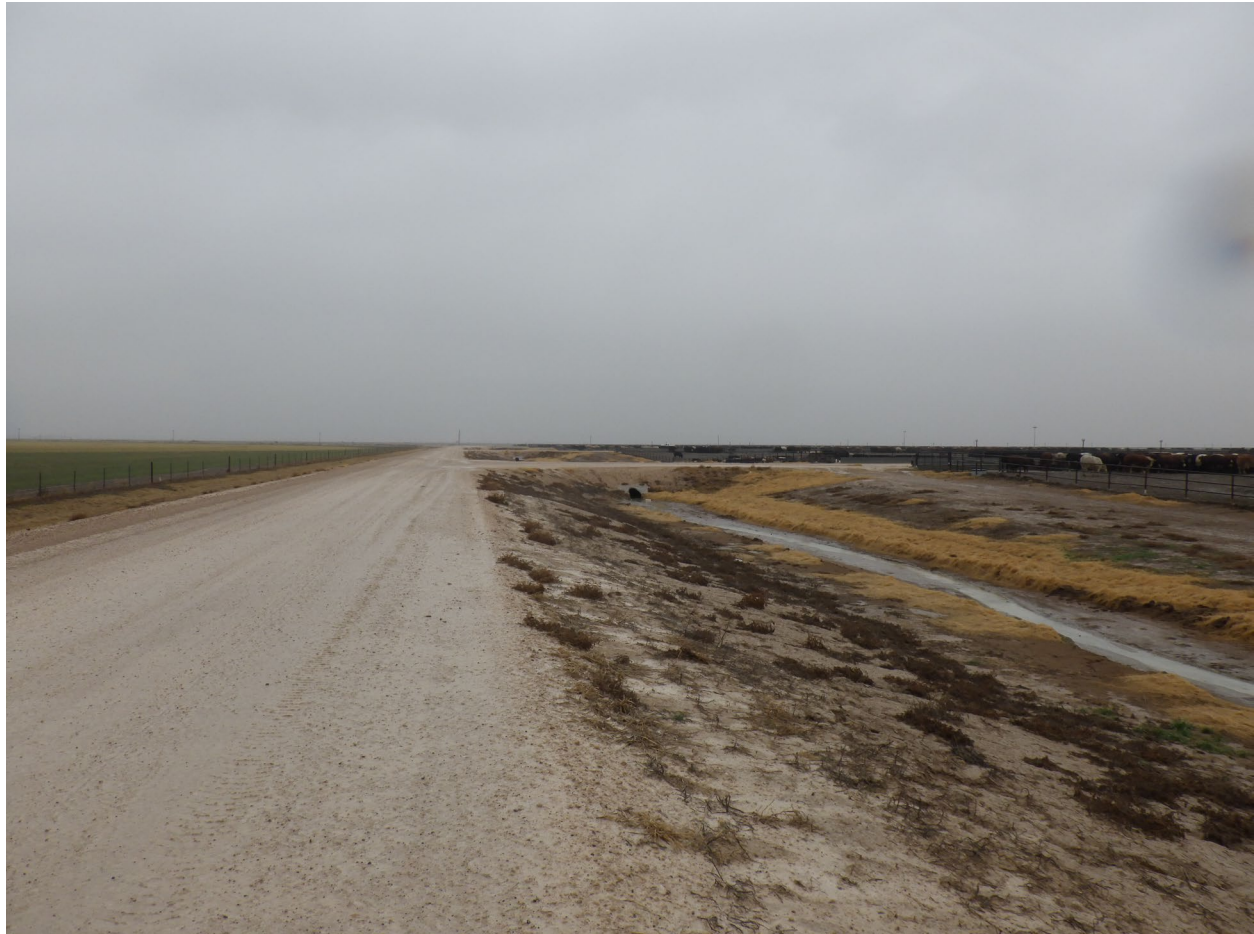
Photo No. 7

Description: View to the east. Berm and drainage channel on northeast side of pens that drains to RCS 9.

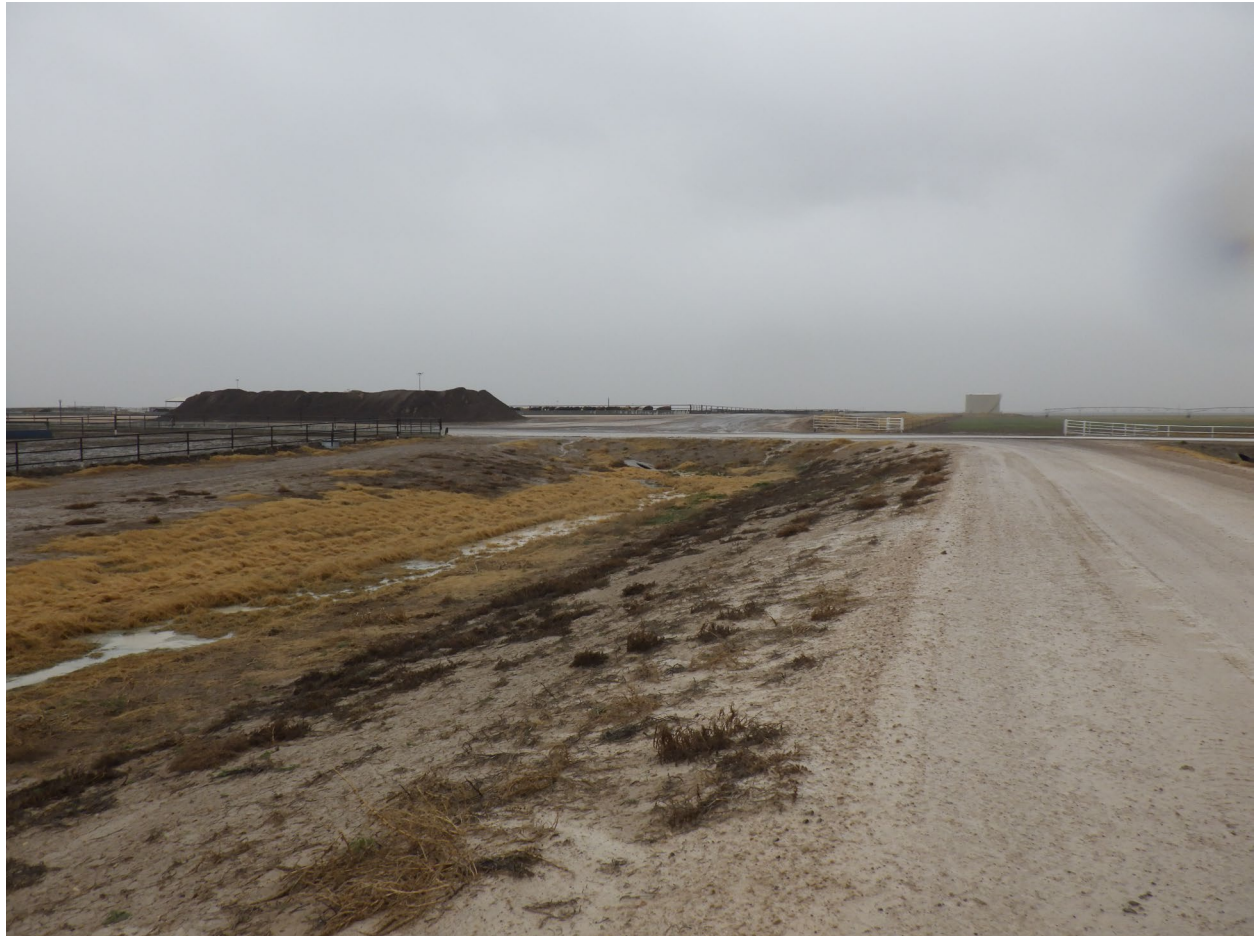
Photo No. 8

Description: View to the west. Opposite direction of drainage channel from photo 7. Manure stockpile within drainage.

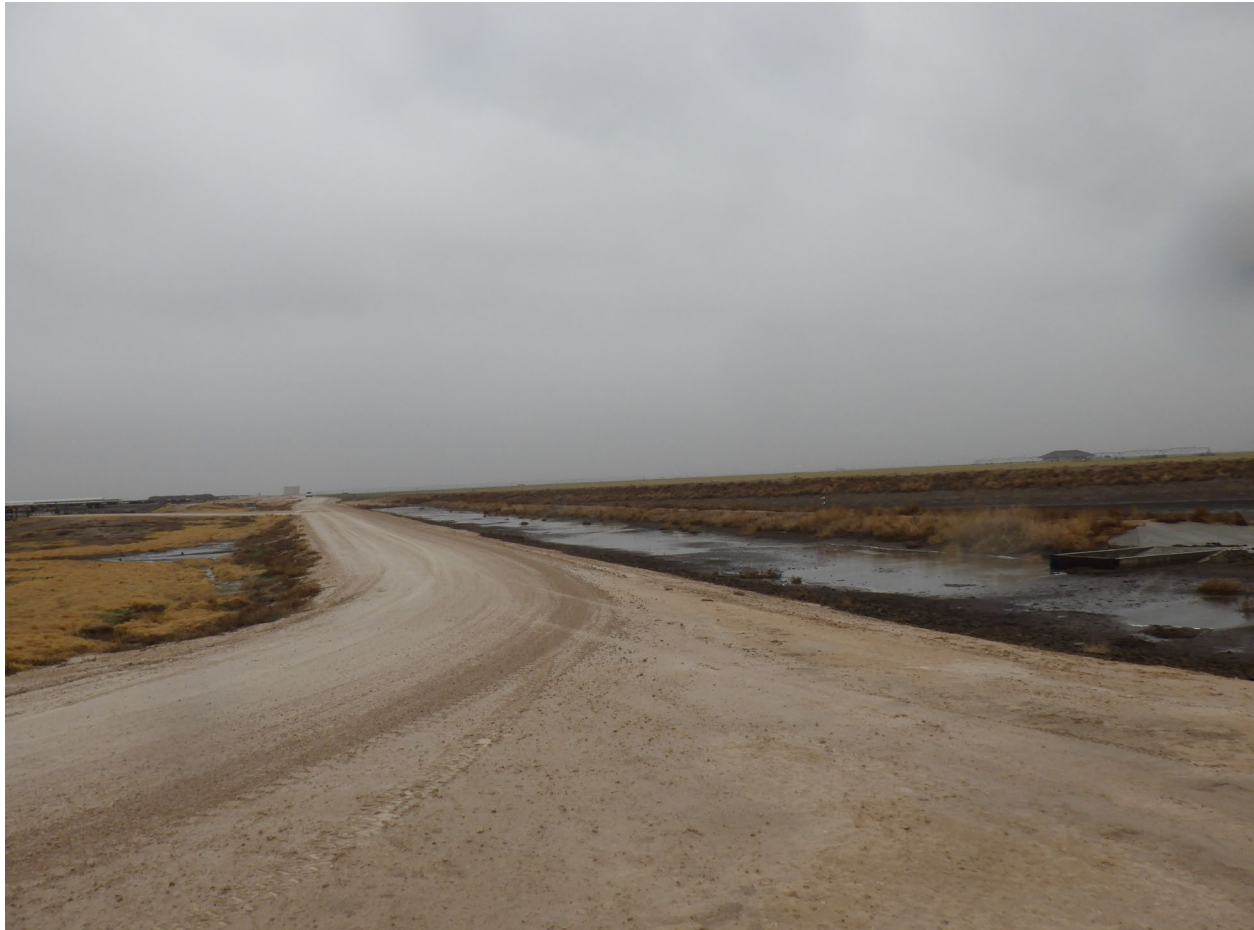
Photo No. 9

Description: Drainage channel from pens.

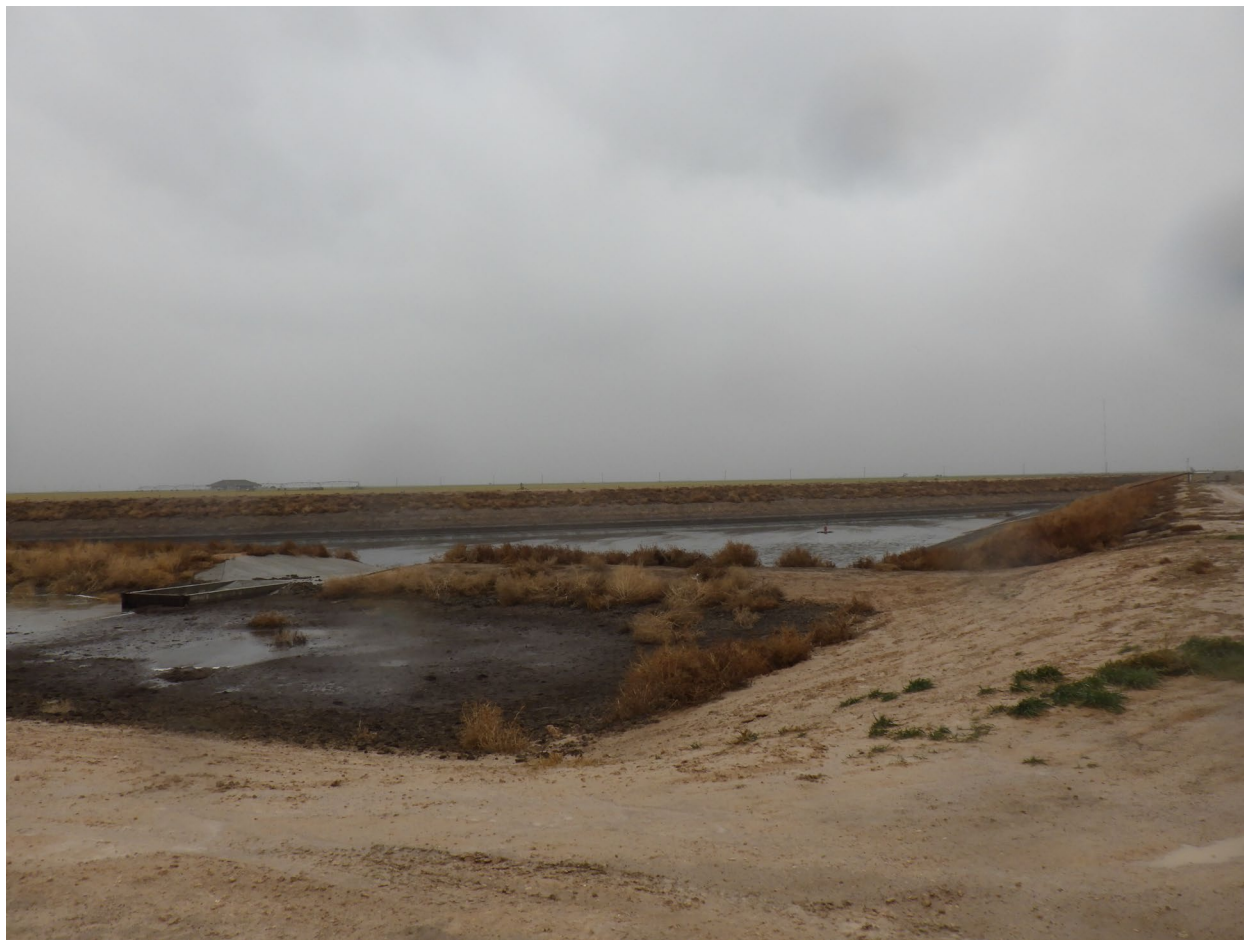
Photo No. 10

minimum requirement of hydraulic conductivities no greater than  $1 \times 10^{-7}$  centimeters per second. The most recent 5-year evaluation of the RCSs was conducted on 02/08/2021 by Benjamin Weinheimer of TCFA. A visual check of the lagoons was conducted and there was adequate freeboard, pole markers, lack of erosion, no solids overloading, and no evidence of unauthorized discharge. However, some RCSs had no fences present (Appendix 1, Photos 10, 14, 15, & 16) (see Areas of Concern 1). No other potential issues were found during the inspection.

1) There is a lack of fencing for some of the RCSs. Part III.A.10.(f)(2) of the TPDES CAFO General Permit requires “Liners must be protected from animals by fences or other protective devices.”

Description: Settling basin next to RCS 9.

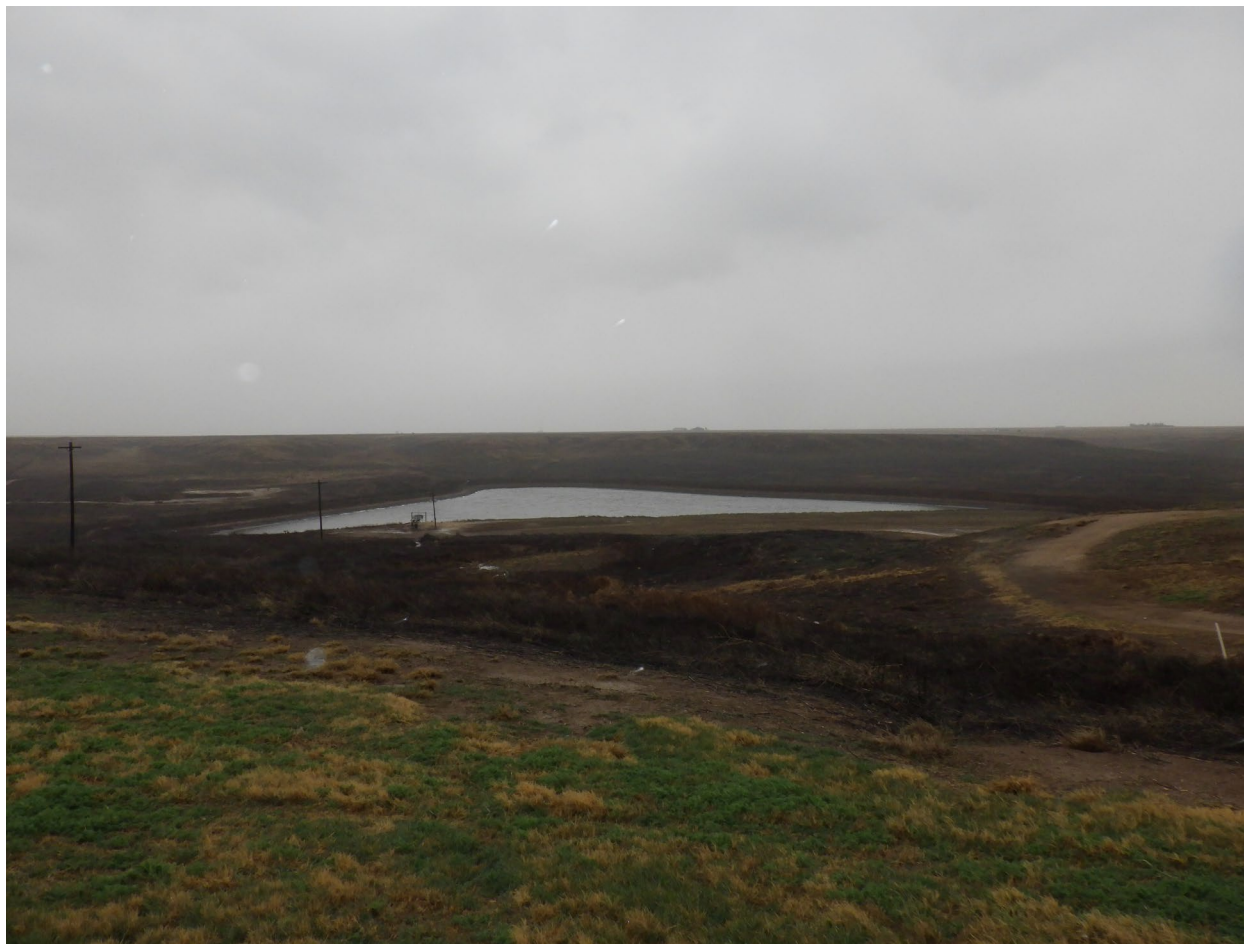
Photo No. 11

Description: View to the southwest. View of RCS 6 on the southern end of the facility.

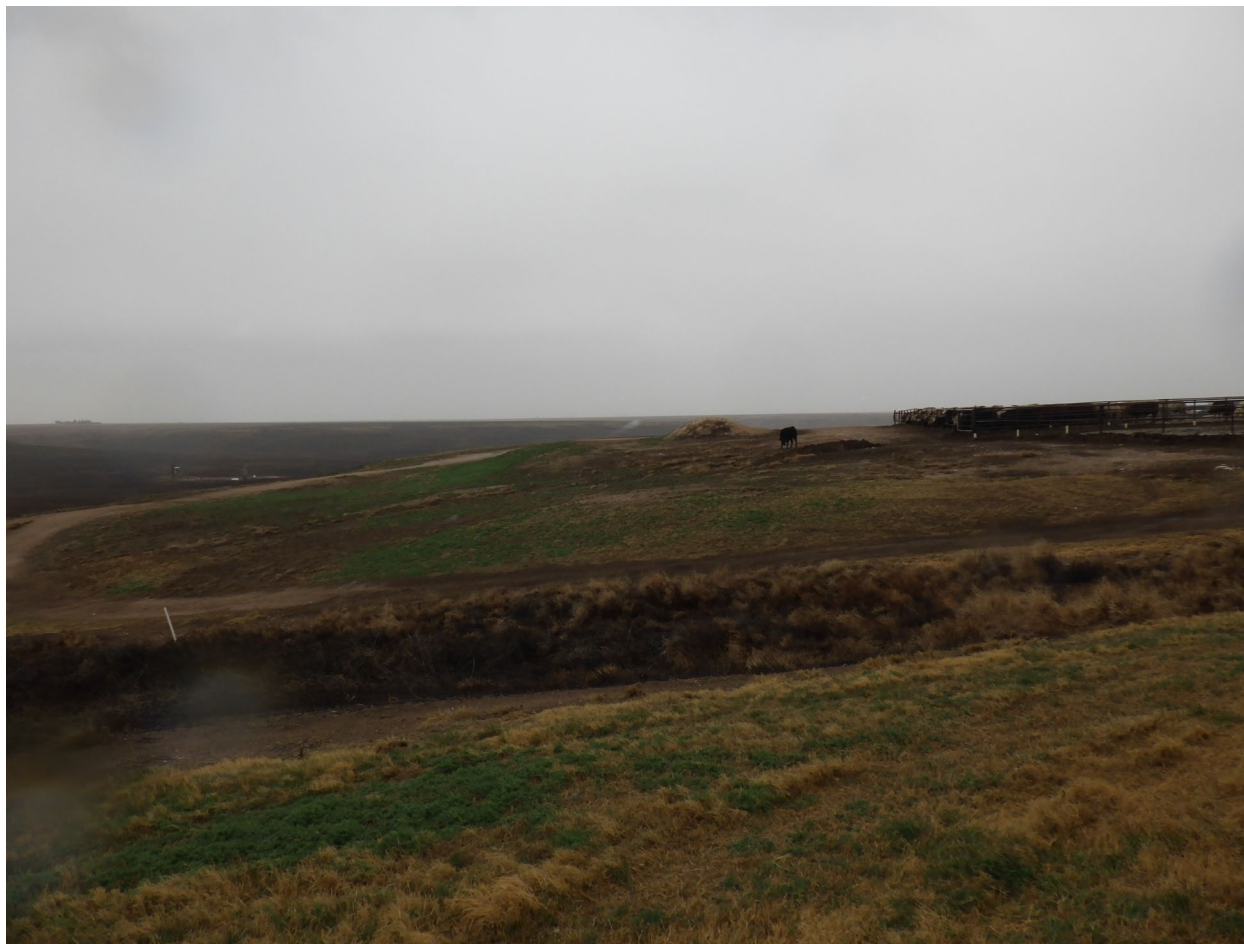
Photo No. 12

Description: View to the east. Slope graded to RCS 6 from pens on the southern edge of the facility.

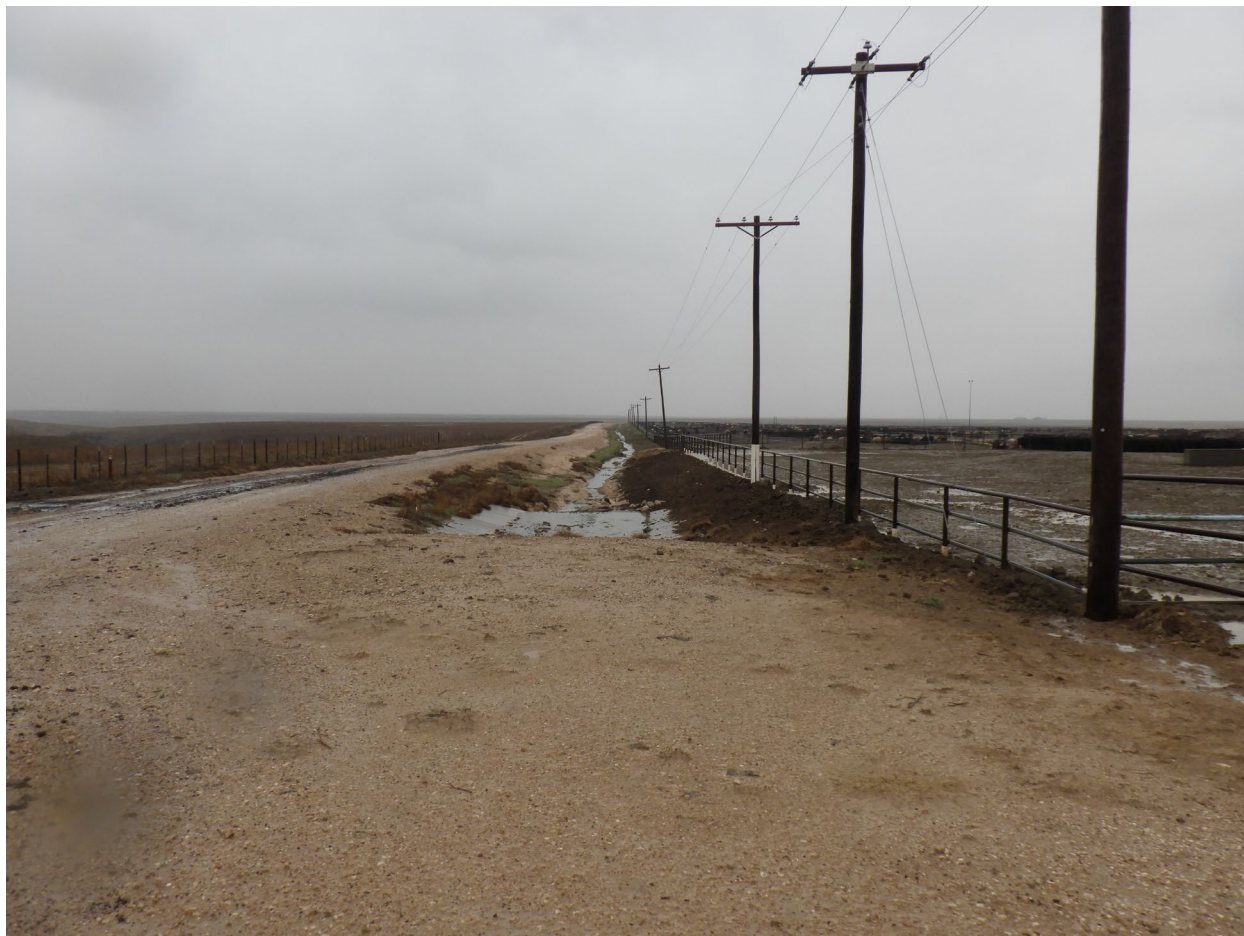
Photo No. 13

Description: View to the south. Drainage channel on east side of pens. Outfall is RCS 6.

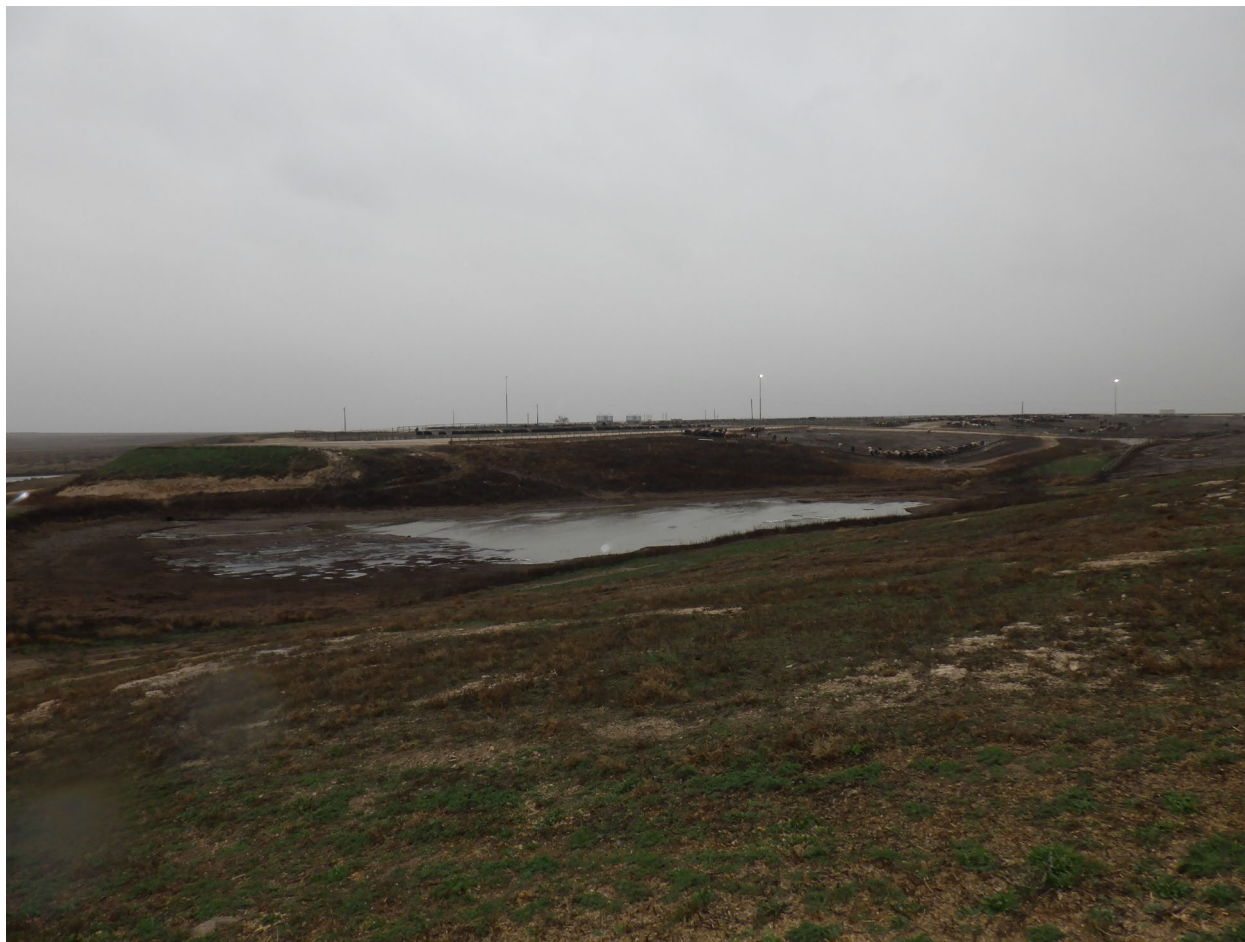
Photo No. 14

Description: View to the northeast. Southwest pens draining to RCS system 1.

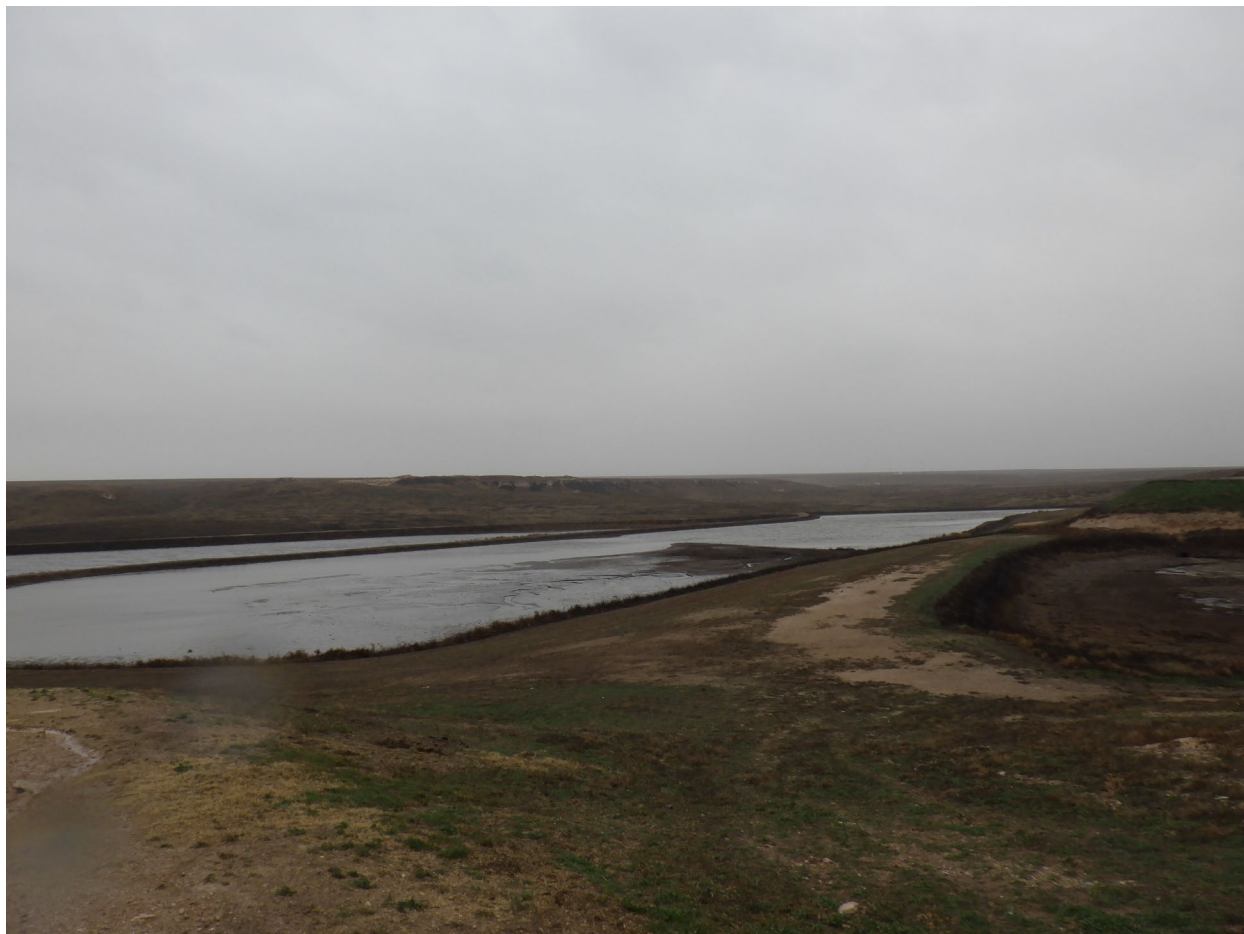
Photo No. 15

Description: View to the southwest. View of RCS 2.

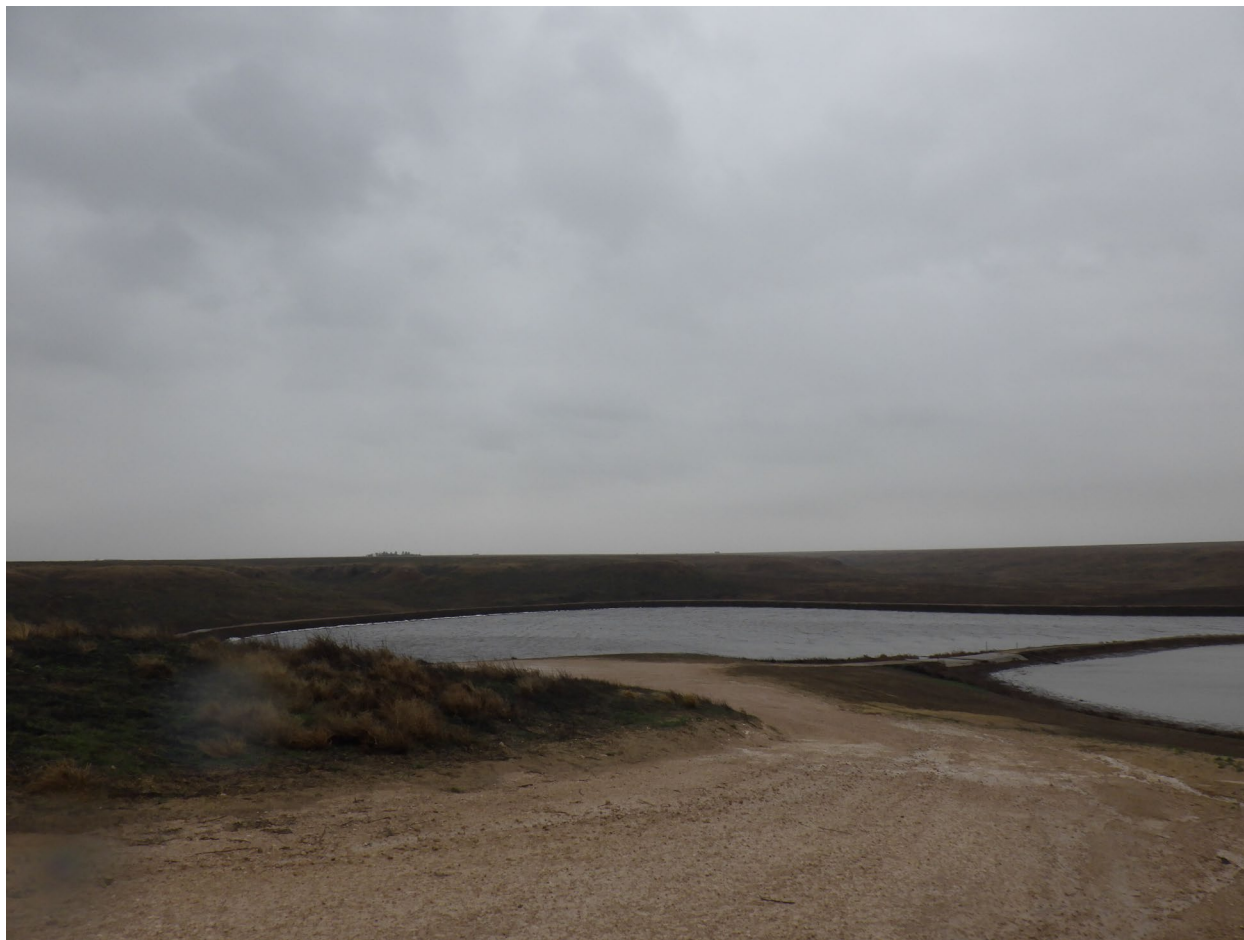
Photo No. 16

Description: View to the southwest. View of RCS 2 and RCS 1 in sequence via gravity flow.
