# NPDES Compliance Inspection Report

**Ultimate RB, Inc.  
McMinnville, Oregon**

**Permit #: ORR237043**

**Inspection Date: December 14, 2021**

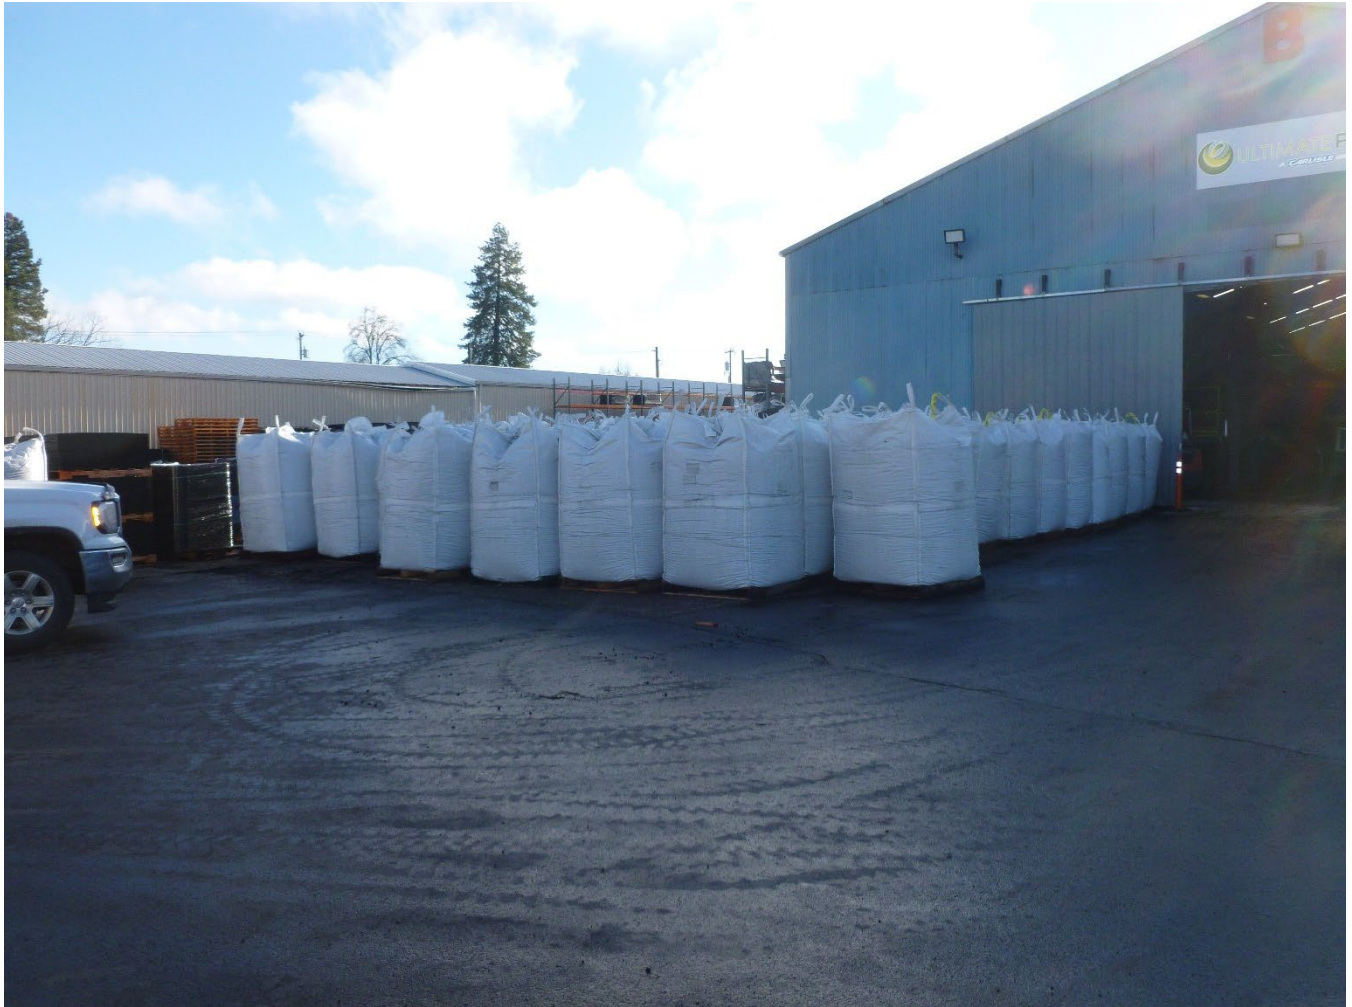
We exited the office. To the south was two of the production buildings, Building C on the western side and Building B to the eastern side. I observed totes of raw material, rubber, lined up in front of the production buildings (**Photo 3**). Adjacent to the office were pallets of finished product that were packaged and staged awaiting ship-out (**Photo 4**).

**Photo 3 / P1010042 – Totes of Raw Material (rubber)**

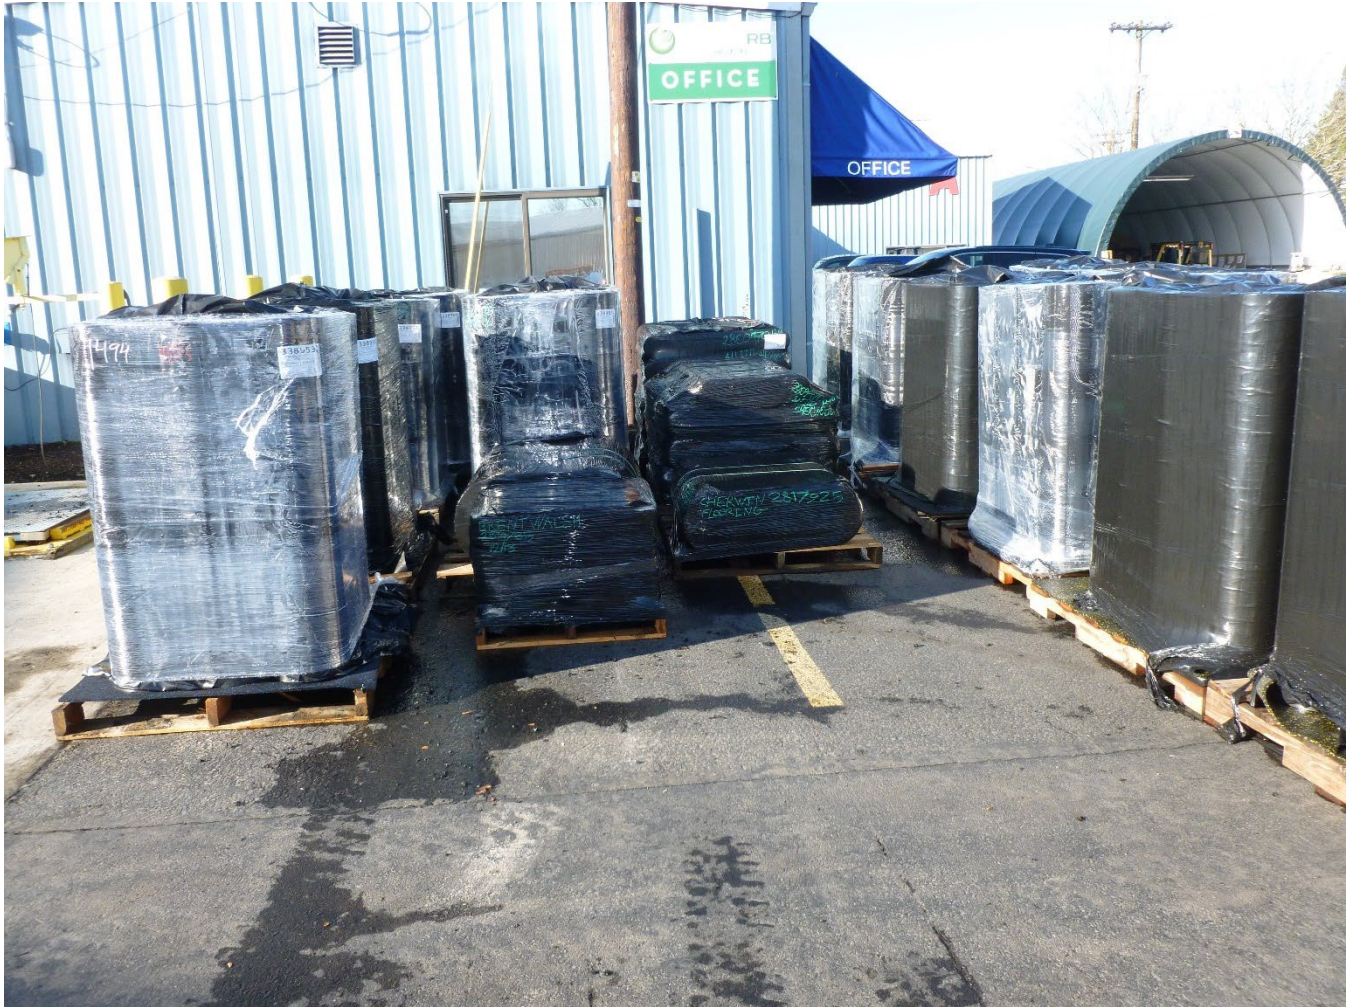
**Photo 4 / P1010043 – Finished Product**

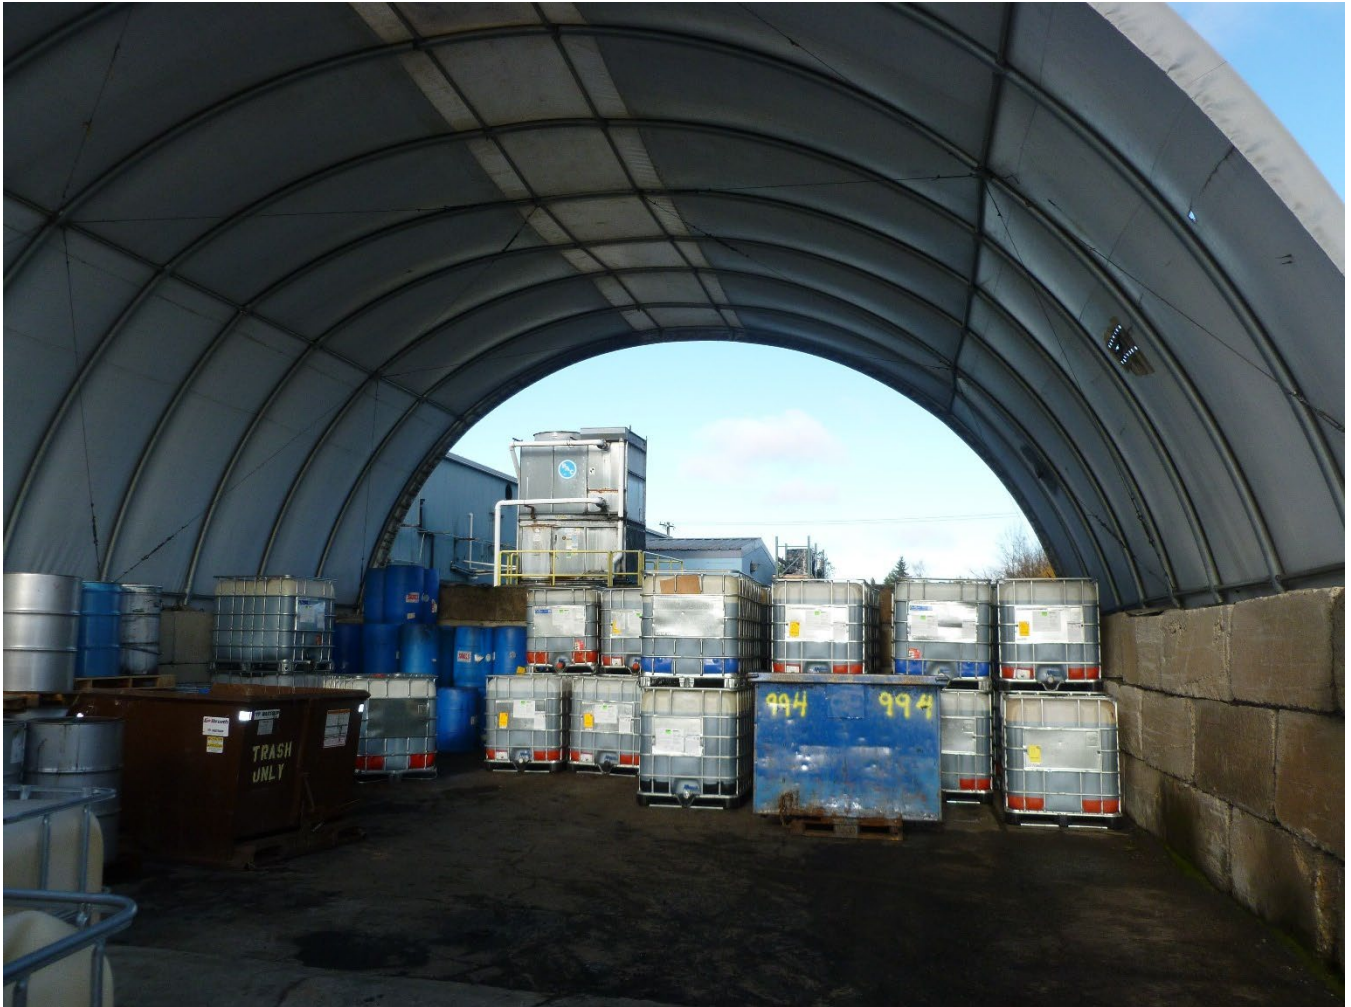
From the street, we headed south to the Quonset Hut that houses containers of urethane (**Photos 5 & 6**). The Quonset Hut has a spill containment berm at the entrance (**Photo 7**) to prevent spills from escaping and stormwater from entering.

**Photo 5 / P1010047 – Urethane Under Cover**

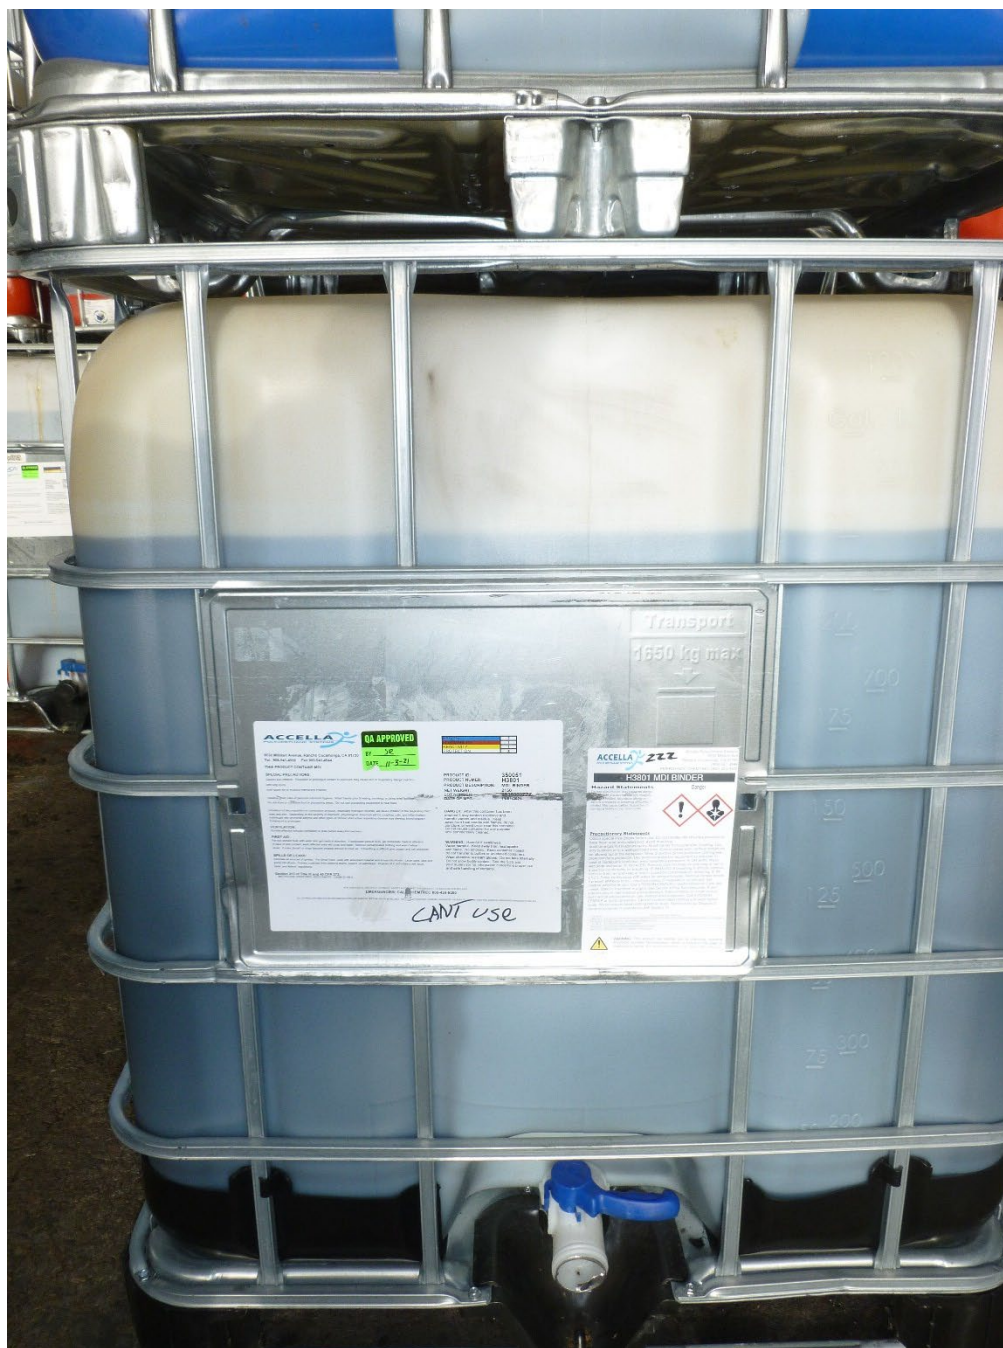
Photo 6 / P1010048 – Urethane Container, close-up

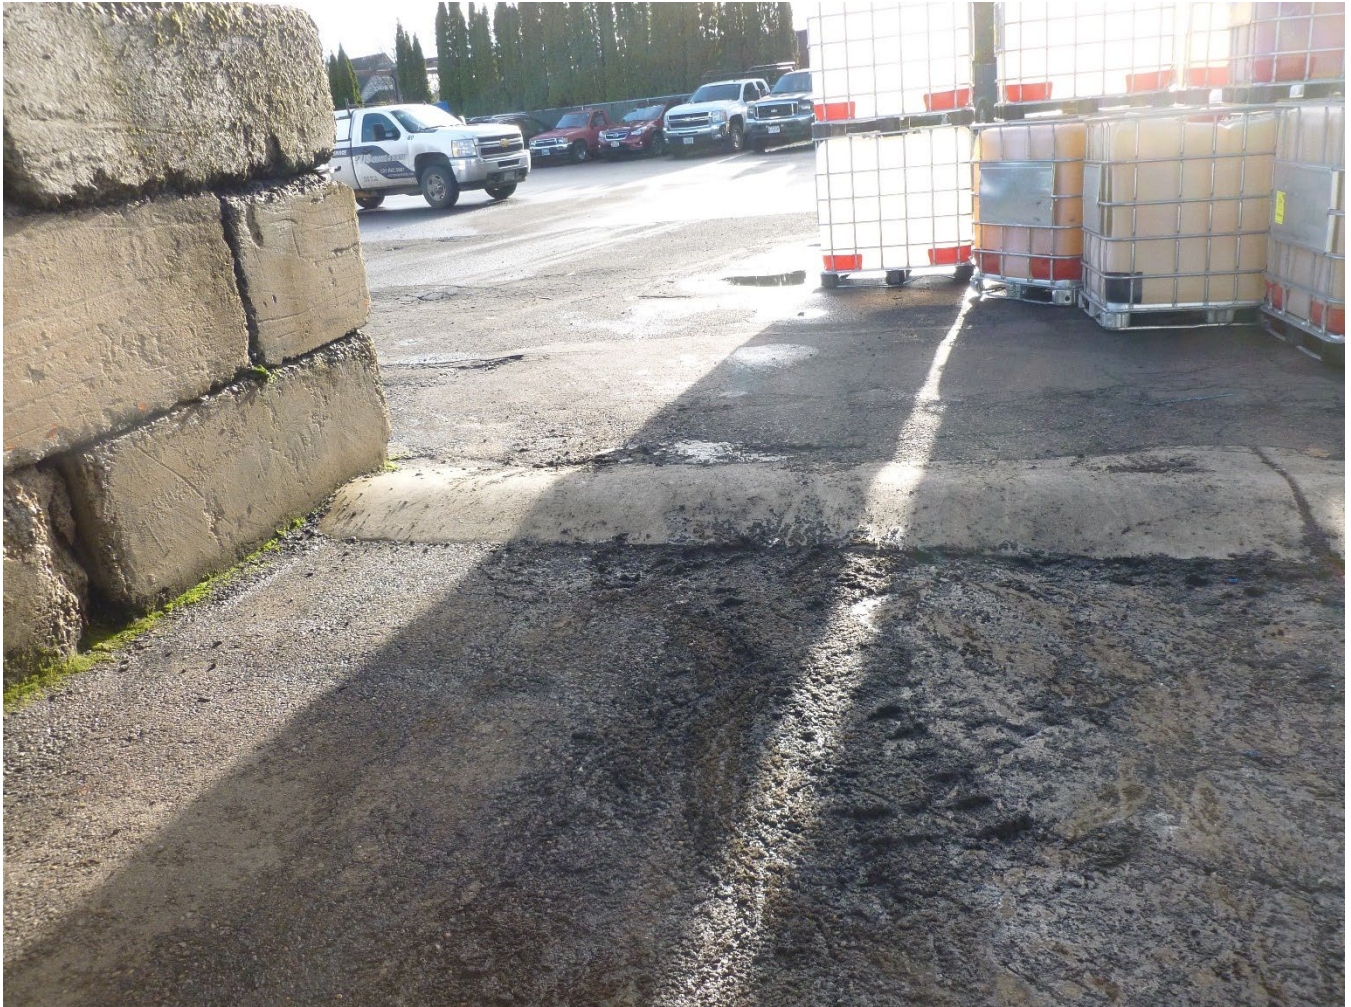
**Photo 7 / P1010049 – Spill Containment Berm**

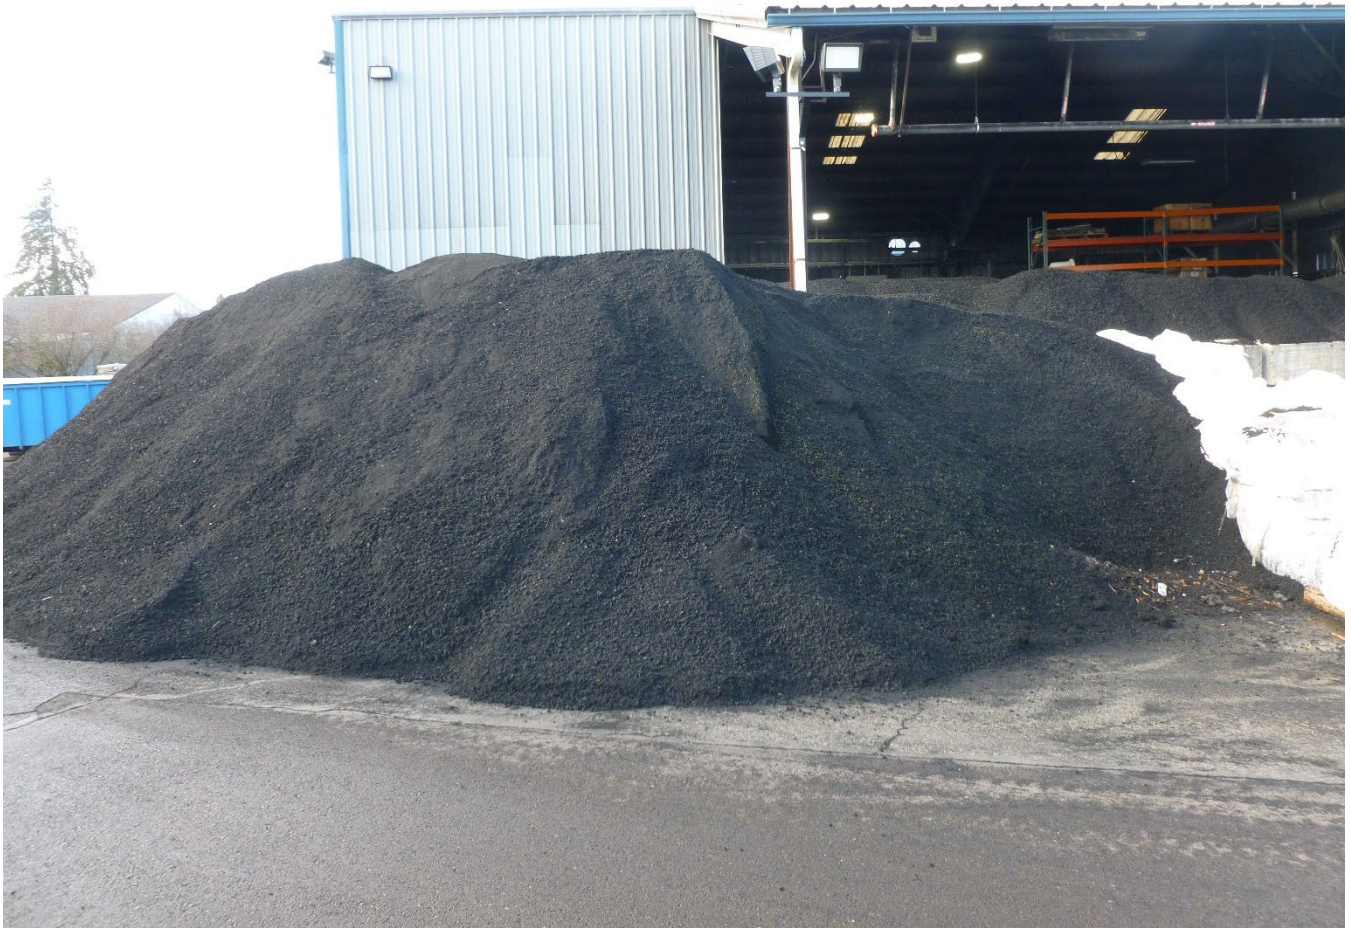
We walked south to the end of the production buildings. As we came to the end of the building, I observed a large pile of crumb rubber outside the building. The pile was uncovered and was fully exposed to the elements (**Photo 8**). Mr. Simpson said the pile of rubber was an unusual, one-time occurrence. He also said the pile represented about one week of rubber necessary for production.

At the time of inspection, I observed a large pile of crumb rubber stored outside of a production building. This piled material was not identified on the site map.

At the time of inspection, I observed a large pile of crumb rubber stored outside of a production building. As shown in Photo 8, the rubber had no protection against exposure to stormwater. The rubber pile was not addressed in the SWPCP.

**Photo 8 / P1010050** – Ground Rubber Pile

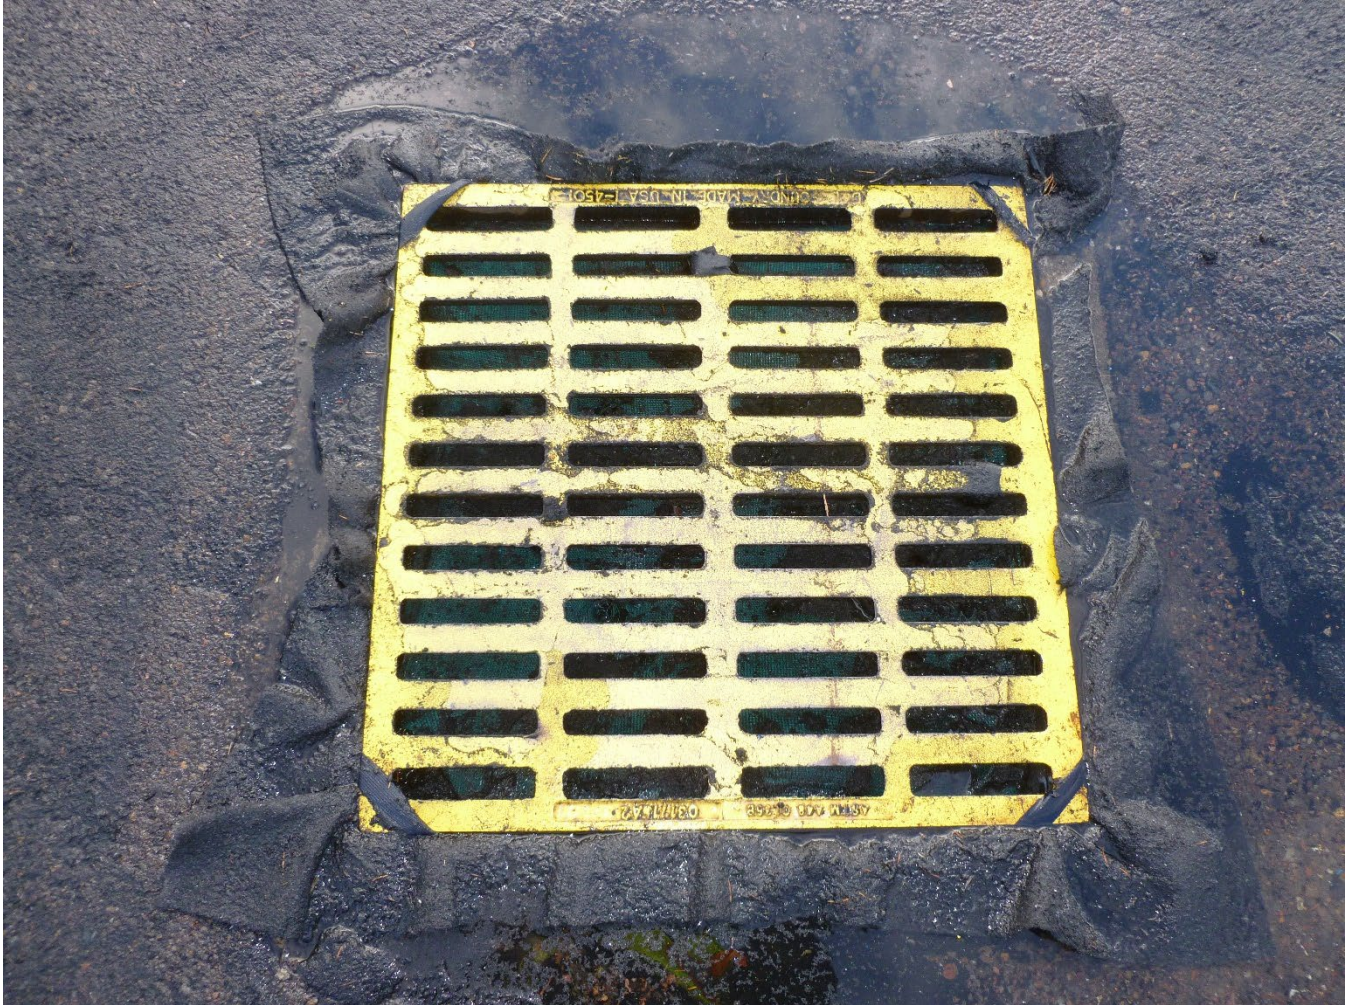
We continued walking south toward Monitoring Location 001, ML001. As we walked, I observed a catch basin with a sodium ion filter (**Photo 9**). Per Mr. Simpson, the facility has two of these catch basins on the southern end of the property. He also said that they are cleaned out once a month by the manufacturer and tested to see how well they are working.

**Photo 9 / P1010053** – Catch Basin with Sodium Ion Filter

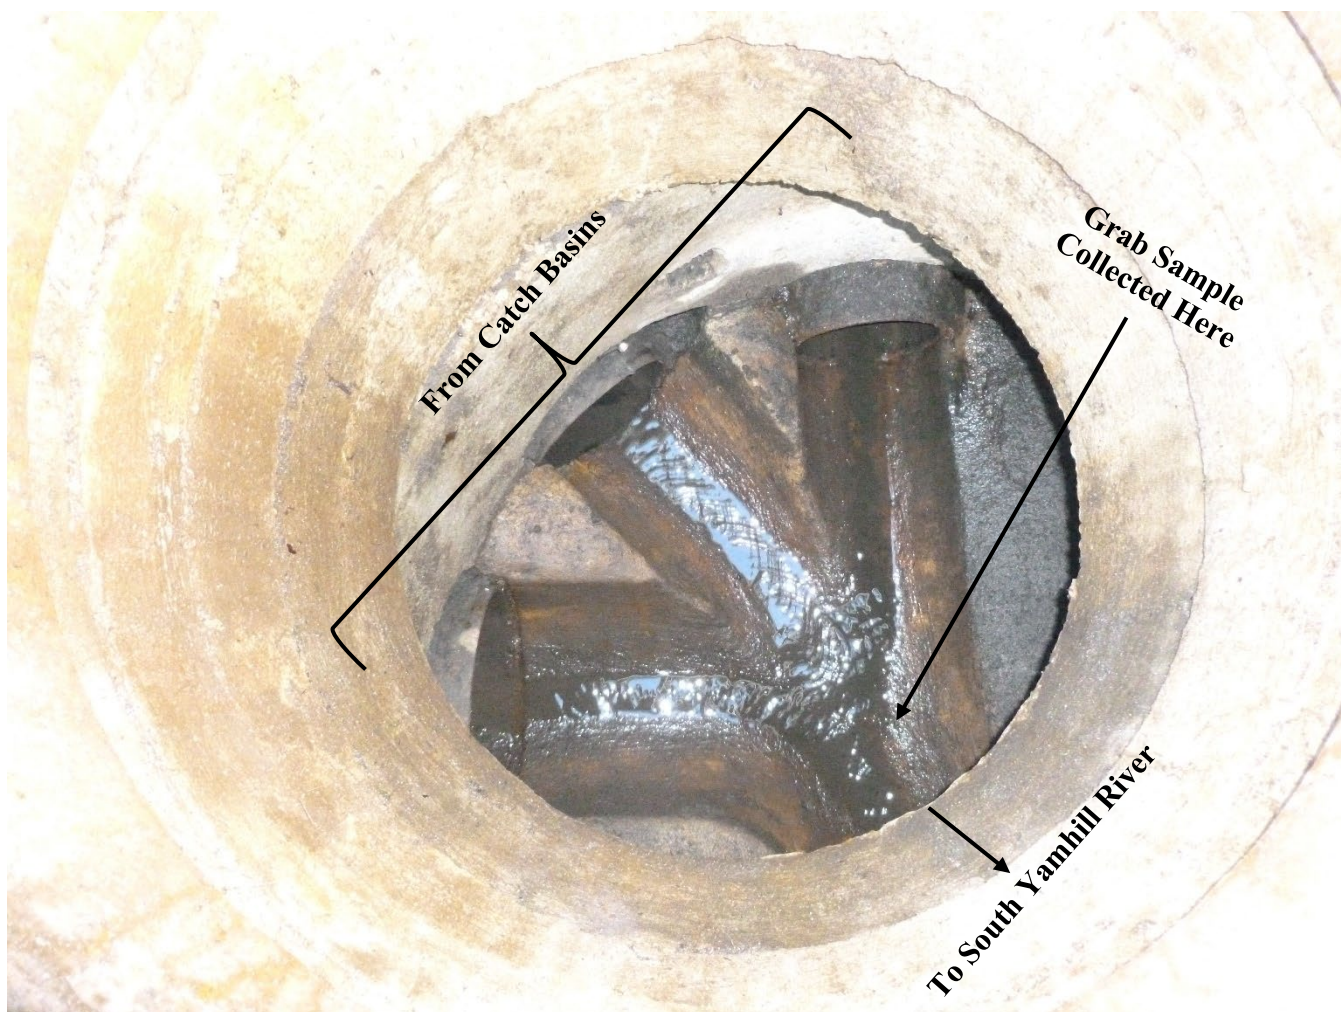
We ended the site tour by proceeding slightly east to ML001. At the ML001, Mr. Simpson pulled the manhole cover so I could take a look inside. The manhole has three lines bringing stormwater from the facility's catch basins and a single line which leads to the discharge into the South Yamhill River (**Photo 10**). The facility collects grab samples from the single line after the three stormwater streams co-mingle.

**Photo 10 / P1010055 – Manhole Interior**
