To J. H. McCulley, Jr.  
From P. L. Fetzer  
Date September 11, 1974  
Subject Ambient Air Analysis - Irene Loading 8-25,26,28,29

## SUMMARY OF RESULTS

IRENE LOADING AUGUST 25, 26, 28, 29

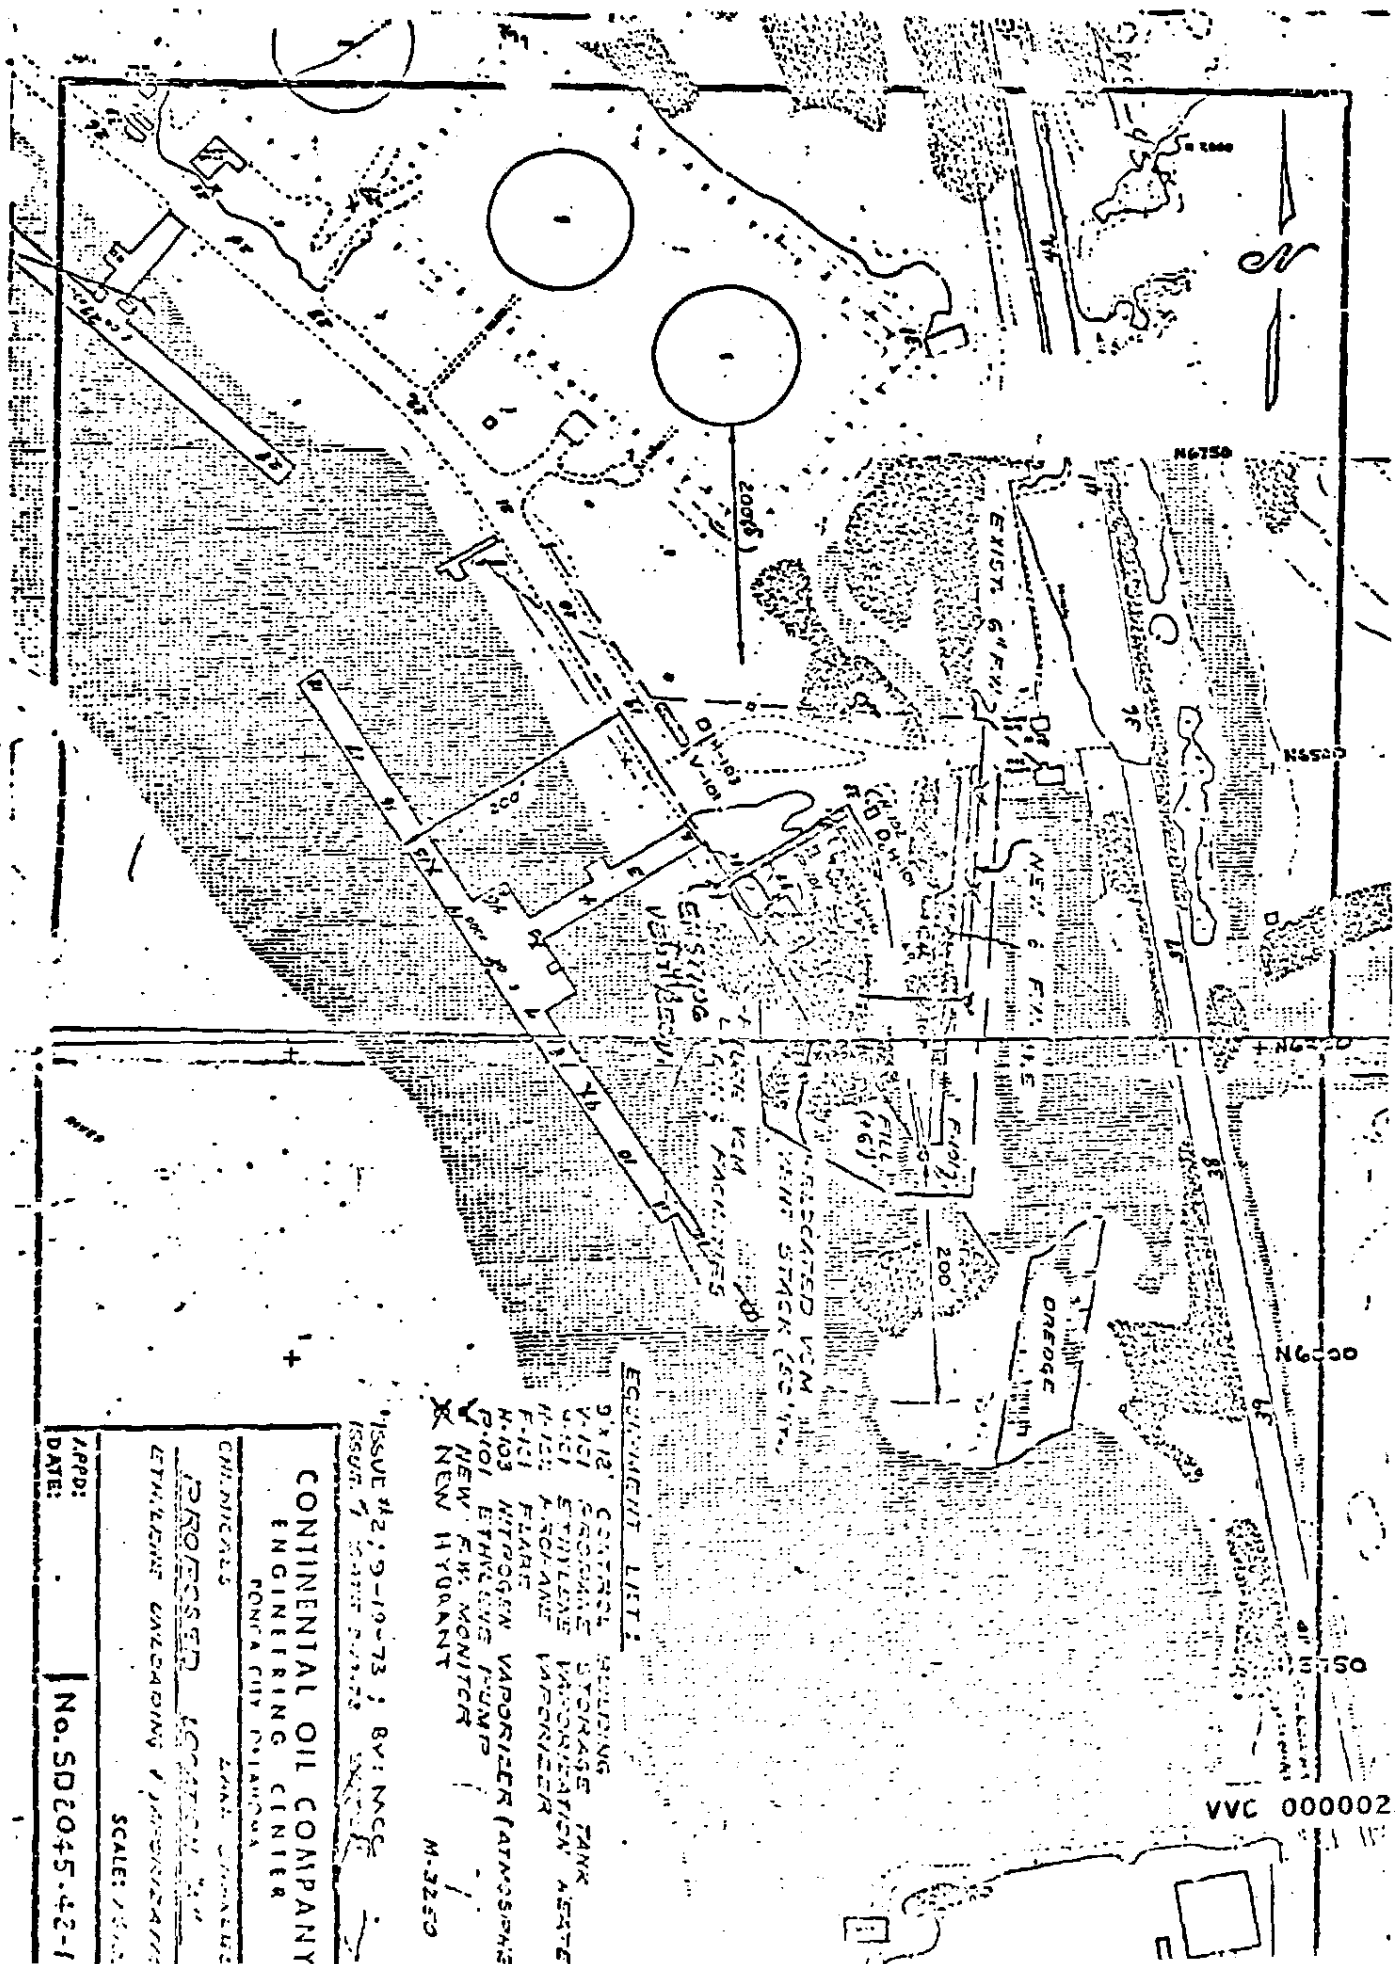
# AREA GRID SURVEY PLOT PLAN

GRID RESULTS  
(SEE ATTACHED PLOT FOR GRID POINTS LOCATIONS)
