INSPECTION REPORT

| Type of Inspection | CAFO - Concentrated Animal Feeding Operation Inspection | |
| Permittee Name | Trillium Farm Holdings LLC, Layer Site 1 | |
| Permit Number(s) (If Applicable) | OH0131121 | |

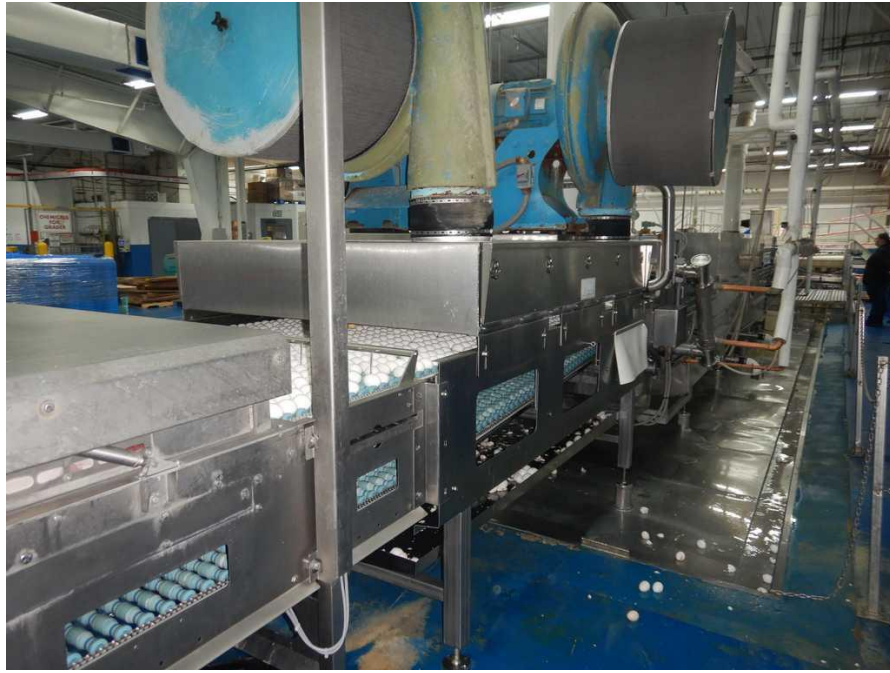
| Egg Wash | DSCN0356.JPG | |

| EPA observed the egg-washing and packaging process that took place in the same area. Water from the egg washing and egg parts from broken eggs were collected via floor drains and sent to the egg-wash lagoon. | | |

| Egg wash and packaging operation inside the egg-wash and packaging barn. Camera looking east. | | |

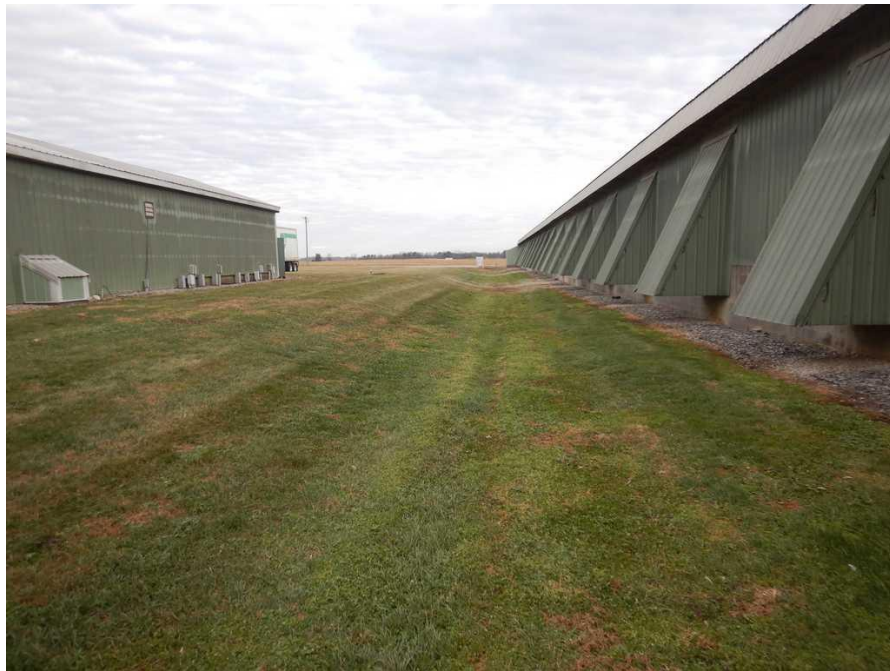
| Grassed channel west of Barn 1 | DSCN0357.JPG | |

| Grassed channel west of Barn 1, facing north. | | |

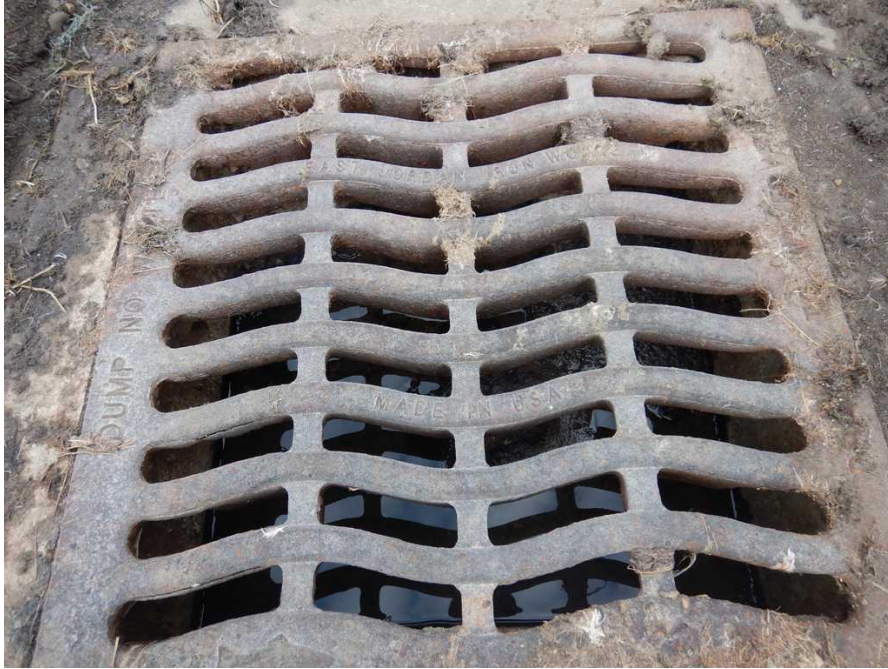
| Catch Basin west of Barn 1 | DSCN0358.JPG | |

| Catch basin that drains the grassed area west of Barn 1. | | |

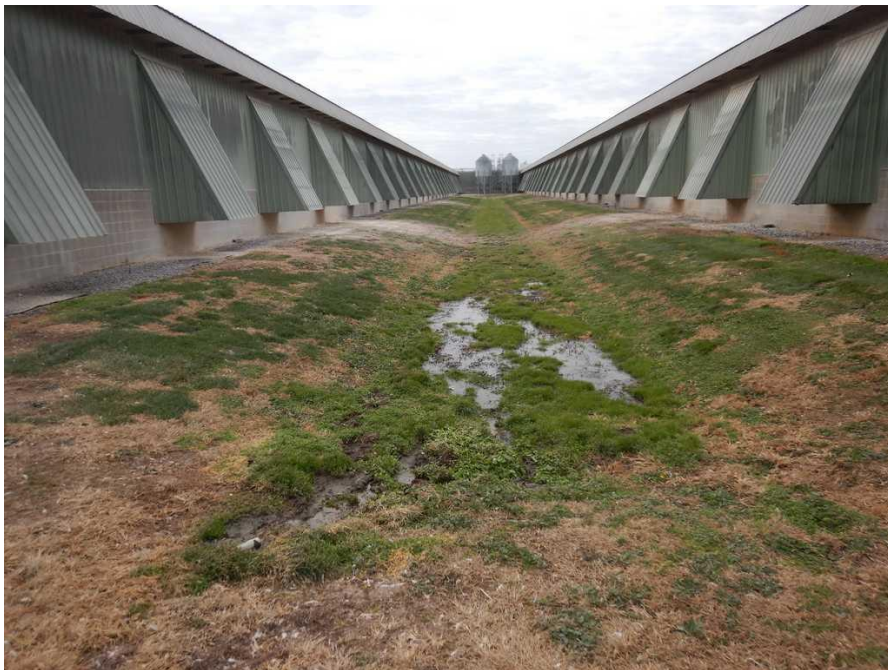
| Grassed area between Barns 1 and 3 | DSCN0359.JPG | |

| Grassed area between Barns 1 and 3, facing south. | | |

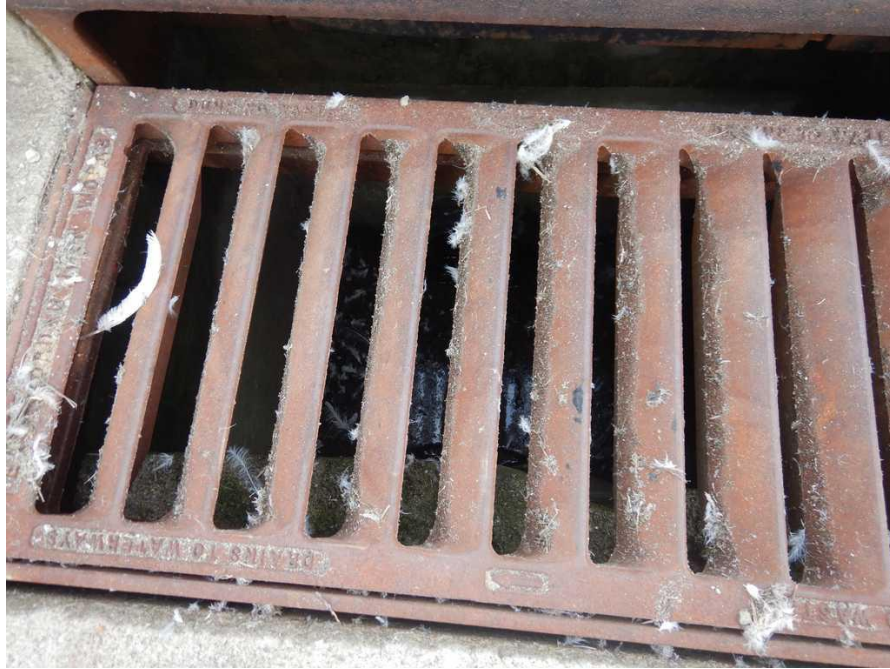
| Storm Sewer | DSCN0360.JPG | |

| Storm sewer grate in the north driveway of the facility between Barns 5 and 7. | | |

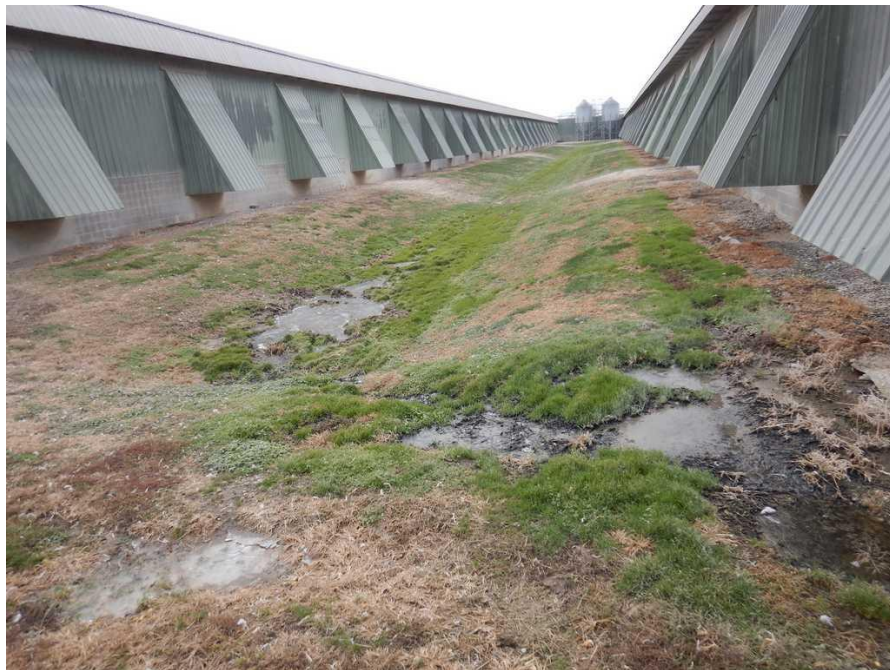
| Grassed area between Barns 5 and 7 | DSCN0361.JPG | |

| Grassed area between Barns 5 and 7, facing south. | | |

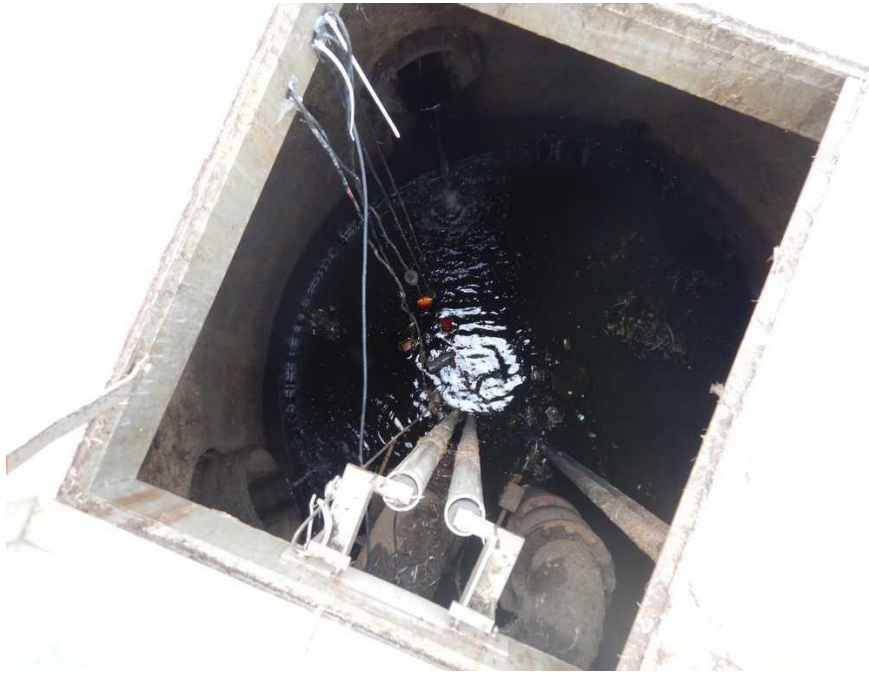
| Lift Station | DSCN0362.JPG | |

| Lift station north of Barn 7. | | |

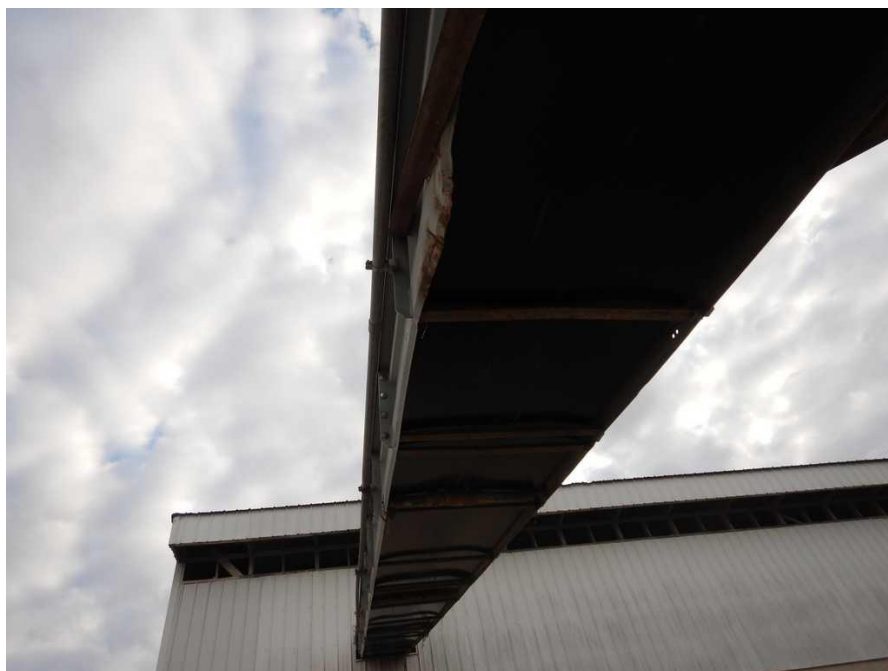
| Belt from Incline Room to MSB | DSCN0363.JPG | |

| Belt going from incline room to Manure Storage Barn. Camera looking east. | | |

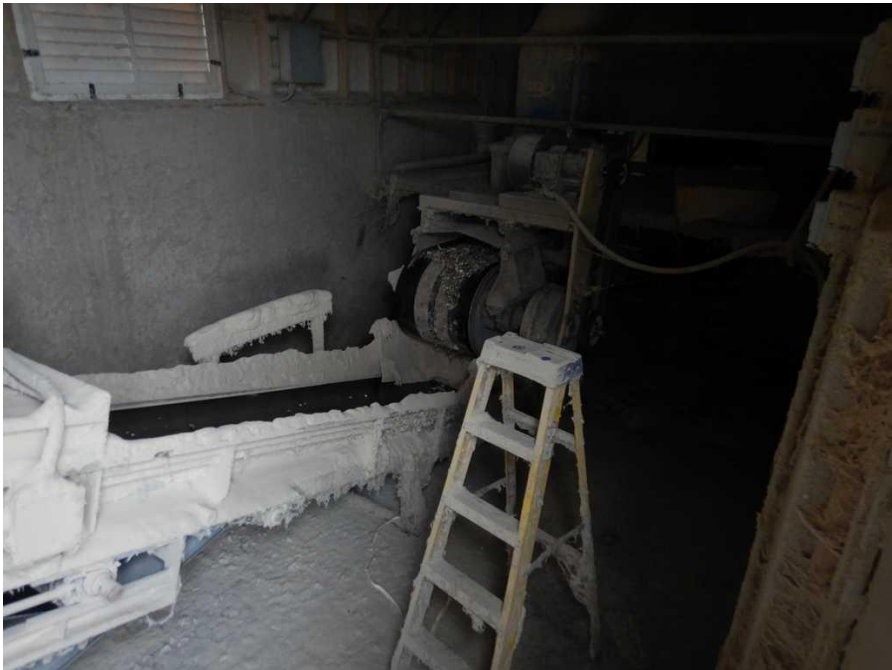
| Inside Manure Incline Room | DSCN0365.JPG | |

EPA observed the incline room, where the manure conveying belt slopes upwards towards the top of the manure barn and observed accumulated manure dust on the ground below the conveyor belt. Facility representatives stated that when water accumulates in the manure conveying tunnel or the incline room, it gets pumped and hauled off-site. EPA observed the two Manure Storage Barns where the north had one pile of manure in it and south one two smaller piles. Photos [DSCN0380.JPG](#) and [DSCN0381.JPG](#). The concrete driveway in front of the two MSB and driveway between the two rows of chicken barns had several stormwater catch basins that drained to the stormwater pond, according to Facility representatives.

| Inside manure incline room. Camera facing southwest. | | |

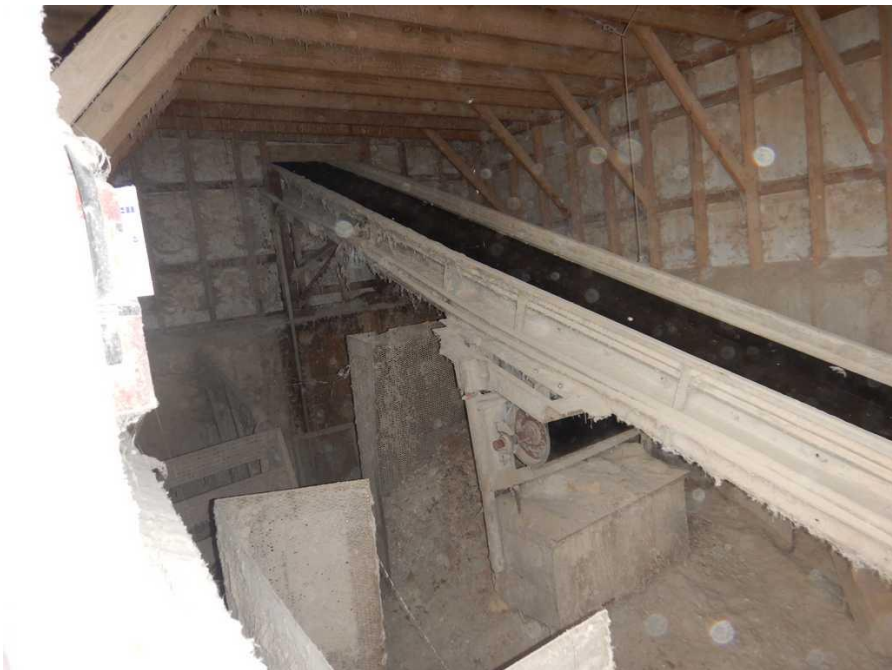
| Manure Incline Room | DSCN0364.JPG | |

| Inside the manure incline room. Camera looking east. | | |

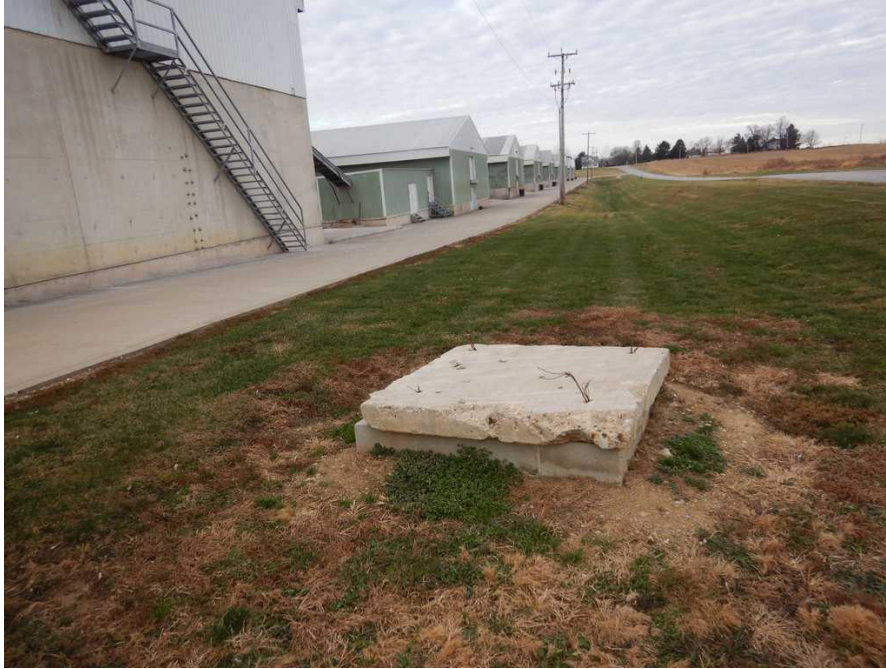
| Diversion Structure | DSCN0366.JPG | |

| Location of the diversion structure (y-shaped pipe) discovered at Layer 1 in June 2021. Camera facing west. | | |

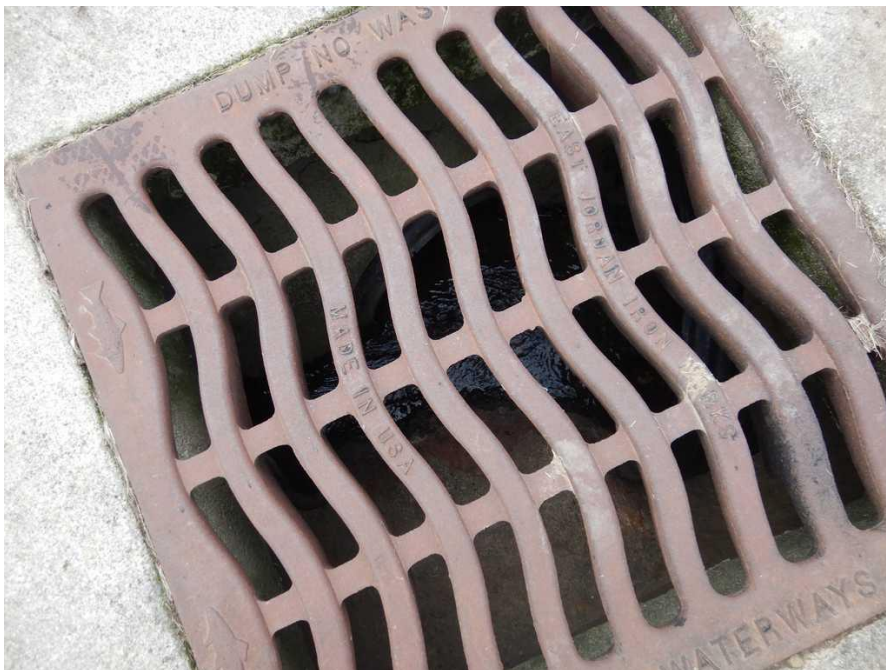
| Catch basin | DSCN0367.JPG | |

EPA observed a catch basin in the grassed area east of each of the Manure Barns. The catch basins routed water east across the east driveway and into other catch basins located next to the Egg-Wash Lagoon. These catch basins routed water north and into the unnamed tributary of the Otter Fork via a catch basin located at the northeast end of the Facility. Photo [DSCN0368.JPG](#). EPA could not observe the outlet pipe from the catch basin because according to Mr. Beer, the pipe goes underground and outlets into the unnamed tributary on a private cropland north of the Facility.

| Catch basin at the northwest corner of the Egg-Wash Lagoon. There are two pipes flowing in it from east and southwest and a pipe that flows out and northwest towards the unnamed tributary of Otter Fork. | | |

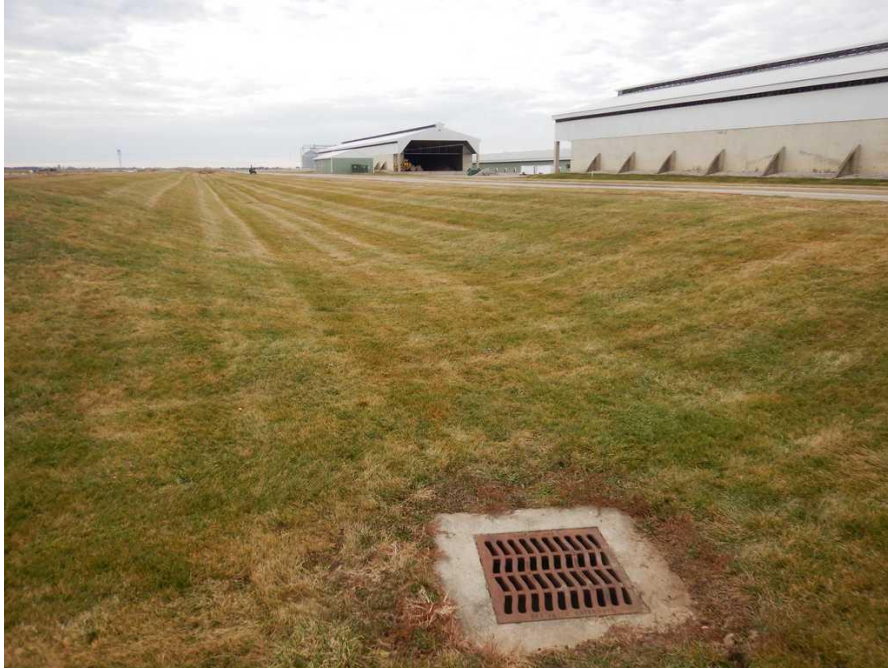
| Catch Basin | DSCN0368.JPG | |

| Catch basin at the northwest corner of the Egg-Wash Lagoon. There are two pipes flowing in it from east and southwest and a pipe that flows out and northwest towards the unnamed tributary of Otter Fork. | | |

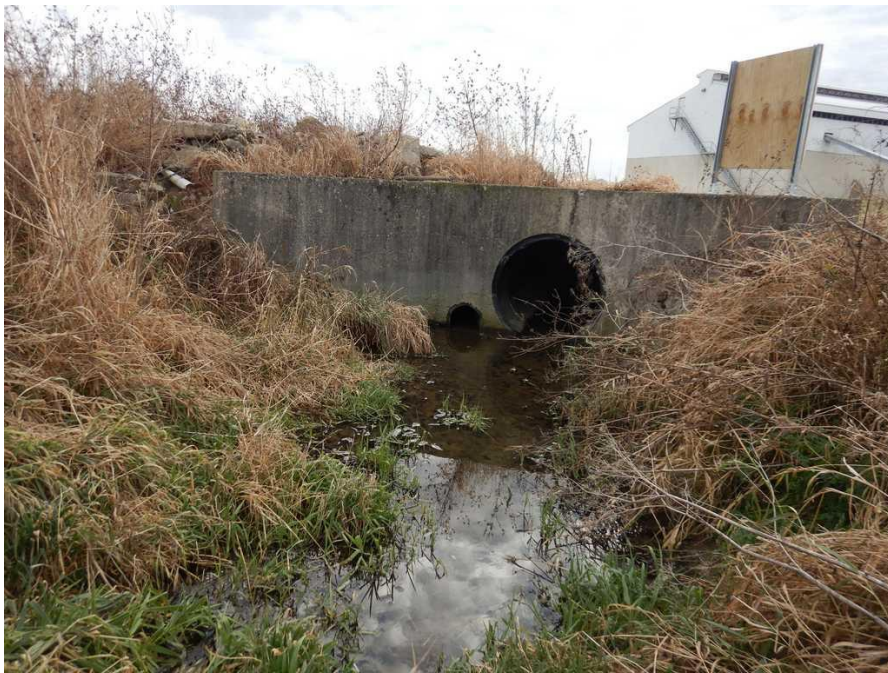
| Outfall 001 | DSCN0369.JPG | |

EPA observed two pipes discharging at outfall 001, a big one from which the samples are taken and a smaller one that Facility representatives were unaware of its function. Photo [DSCN0369.JPG](#).

| <b>AOC Reference #: AH2-OB-004</b> | <b>Location: Outfall 001</b> |
|---|---|
| <b>AOC:</b><br><br>EPA observed two pipes discharging at outfall 001, a big one from which the samples are taken and a smaller one that Facility representatives were unaware of its function or what it was that was discharging. | |

| Two pipes discharging in the unnamed tributary of Otter Fork. The big pipe in the photo is where Facility takes its samples for outfall 001. Camera looking south. | | |

- Discharges from the Facility that did not go through the wastewater treatment system; and
- The need to identify pipes and sources of discharge that drain into the lift stations and stormwater catch basins throughout the Facility.

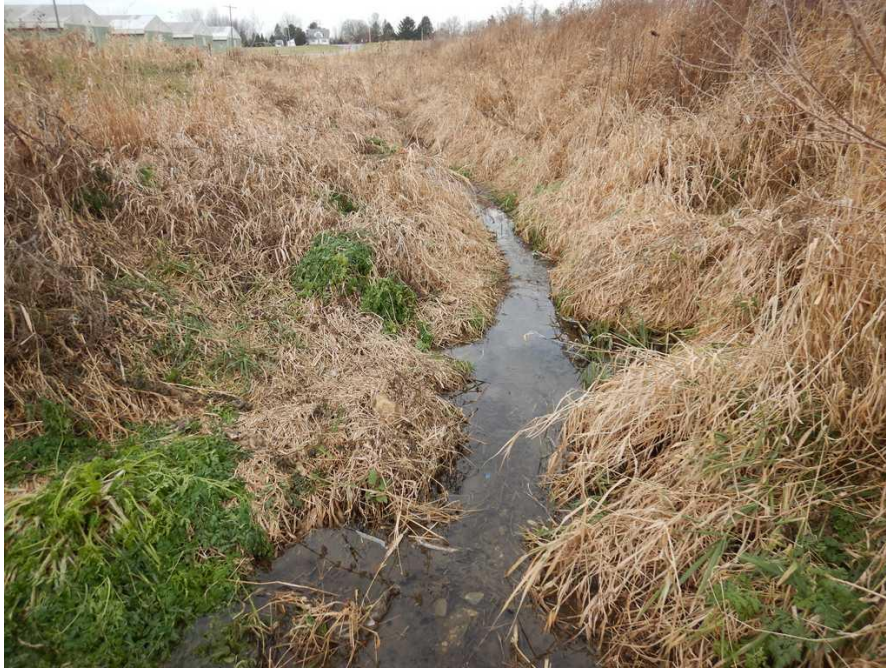
| Unnamed tributary of Otter Fork | DSCN0370.JPG | |

| Unnamed tributary of Otter Fork just west of outfall 001. Camera looking west. | | |

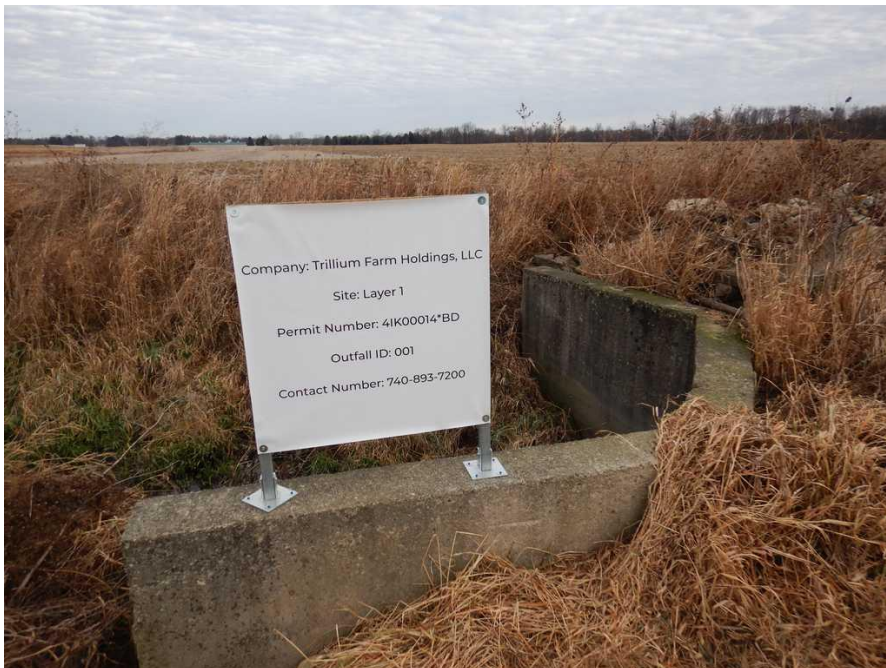
| Outfall 001 Sign | DSCN0371.JPG | |

| Outfall 001 sign, facing north. | | |

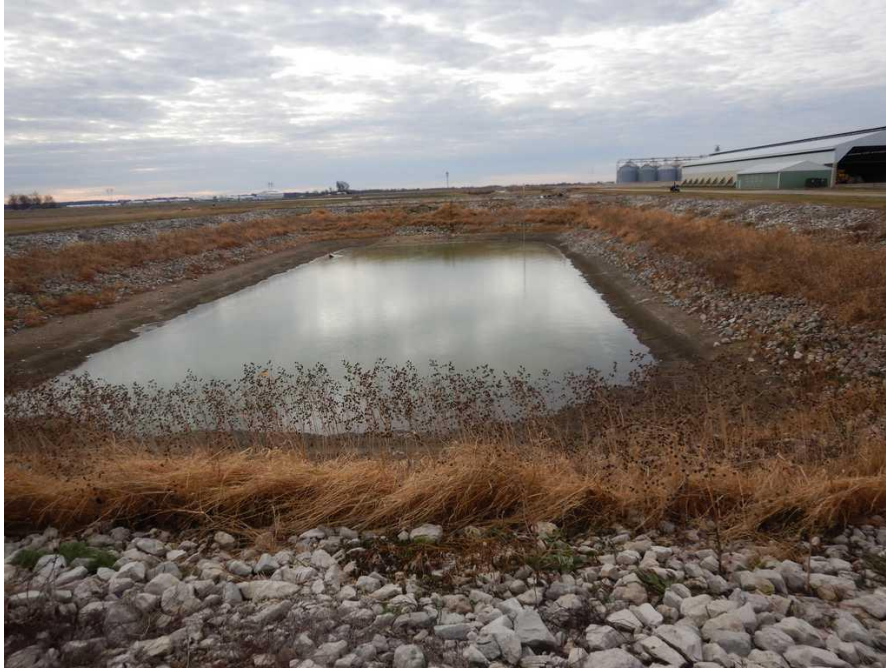
| Egg-Wash Lagoon North Cell | DSCN0372.JPG | |

EPA observed the Egg-Wash Lagoon that was split into two cells, north and south cell. The north cell had very little water in it. Photos [DSCN0372.JPG](#) and [DSCN0374.JPG](#). EPA also observed the stormwater pond and the ETS. The stormwater pond had depth markers in it and there was no pooling water in the ETS, even though the stormwater pond was discharging to the ETS at the time. Photos [DSCN0374.JPG](#) - [DSCN0377.JPG](#).

| The north cell of the Egg-Wash Lagoon, facing south. | | |

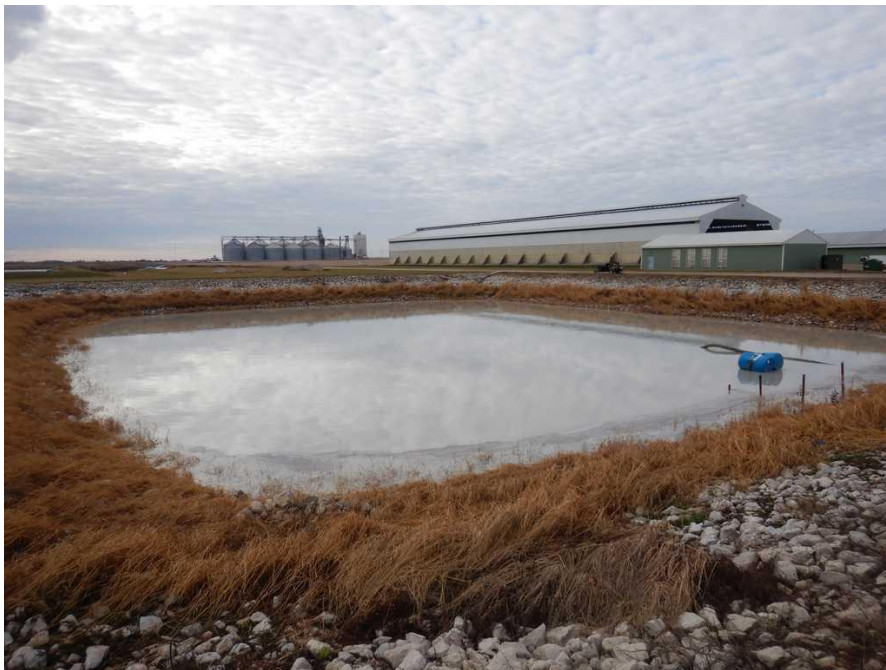
| Egg-Wash Lagoon South Cell | DSCN0373.JPG | |

| South cell of the Egg-Wash Lagoon, facing south. | | |

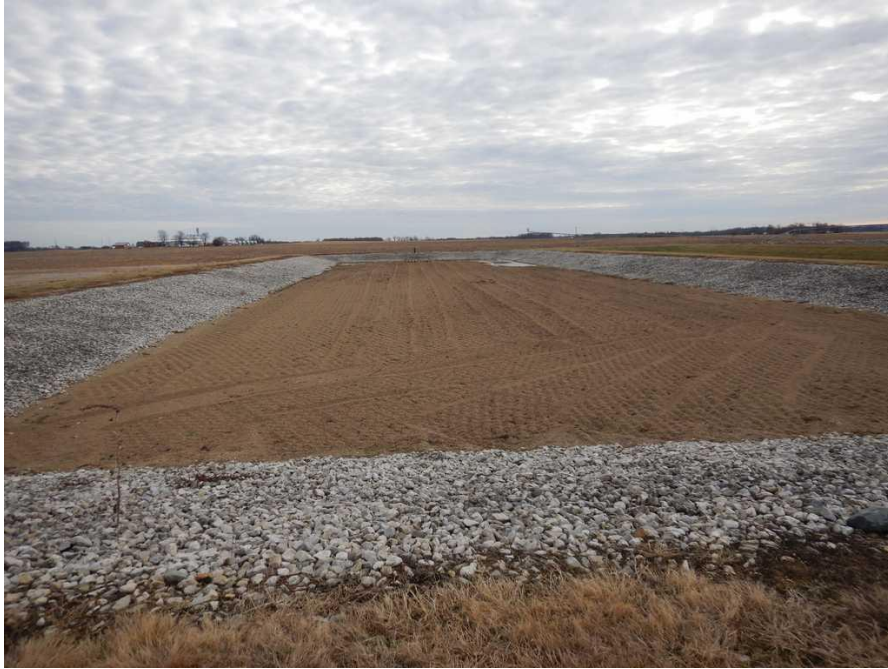
| ETS | DSCN0374.JPG | |

| ETS, facing east. | | |

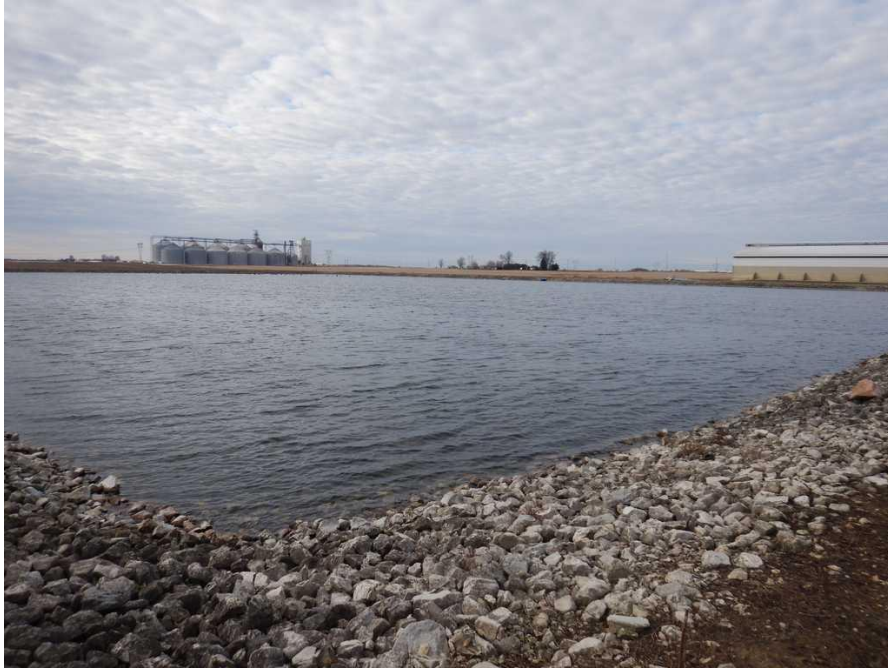
| Stormwater Pond | DSCN0376.JPG | |

| Stormwater pond from northeast corner. Camera facing southwest. | | |

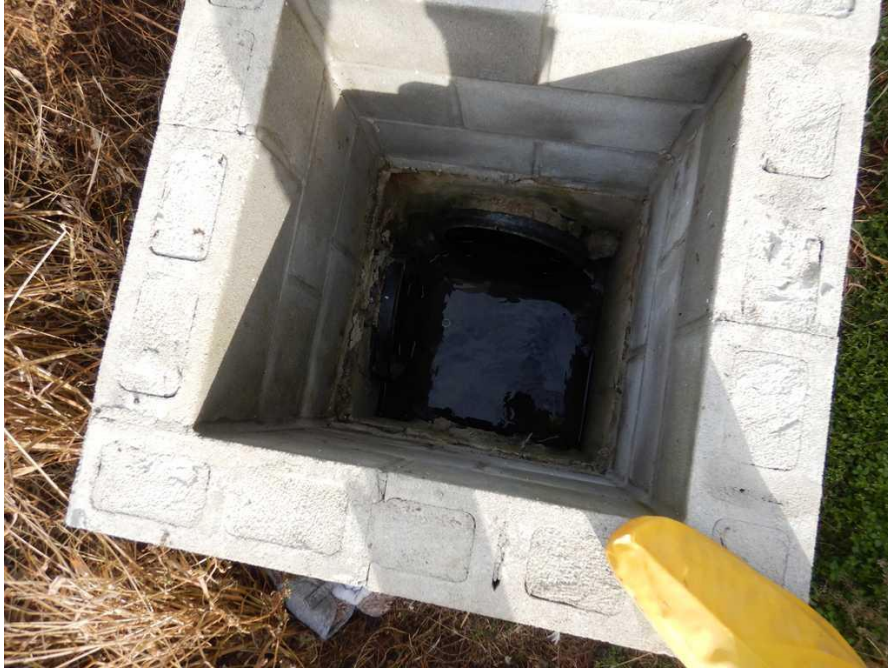
| Drainage Structure | DSCN0378.JPG | |

| Drainage structure (concrete catch basin) between the south MSB and Barn 14A. It has one inflowing pipe from north and an outflowing pipe towards south. | | |

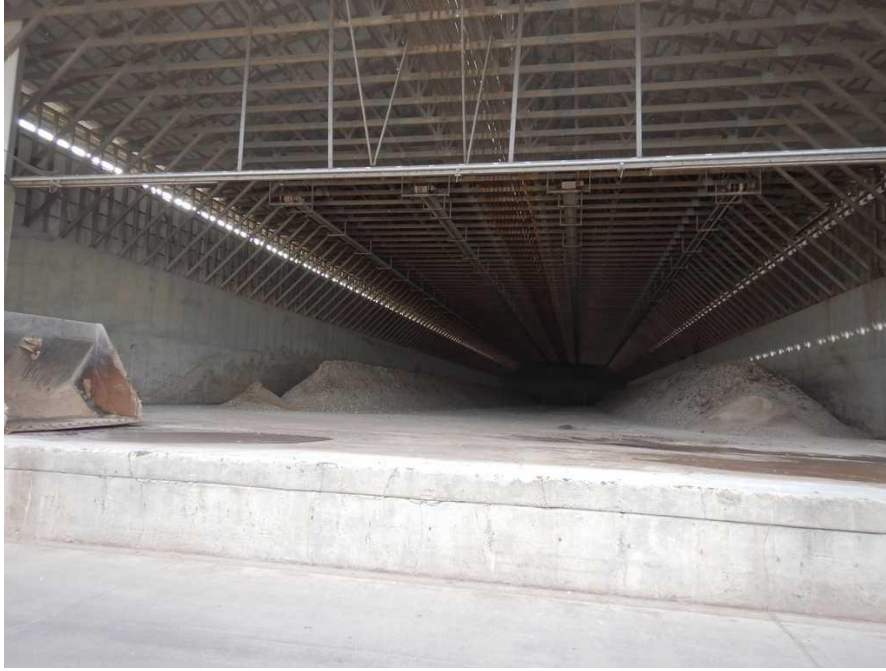
| South Manure Storage Barn | DSCN0380.JPG | |

| South manure storage barn, facing south. | | |

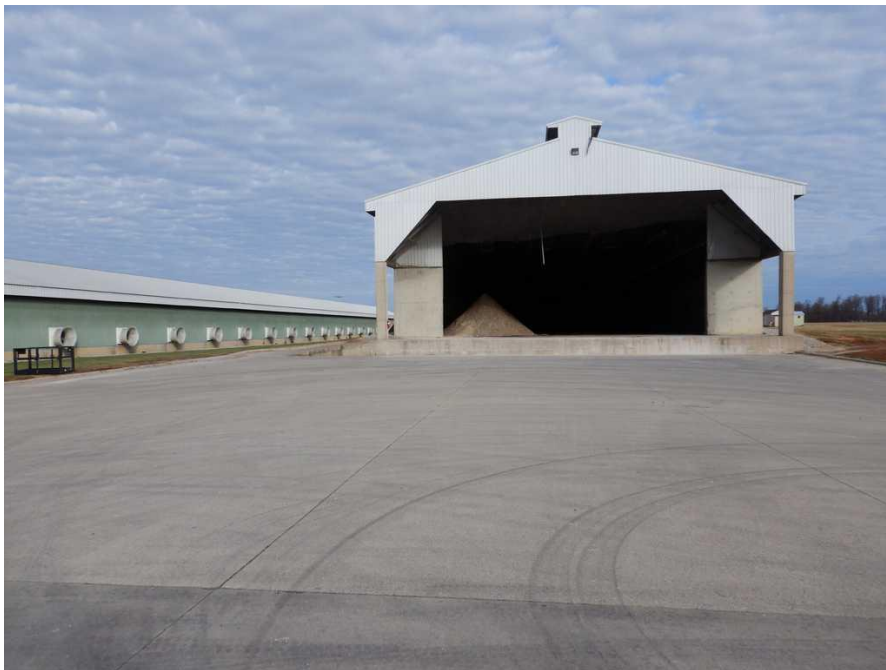
| North Manure Storage Barn | DSCN0381.JPG | |

| North manure storage barn, facing north. | | |

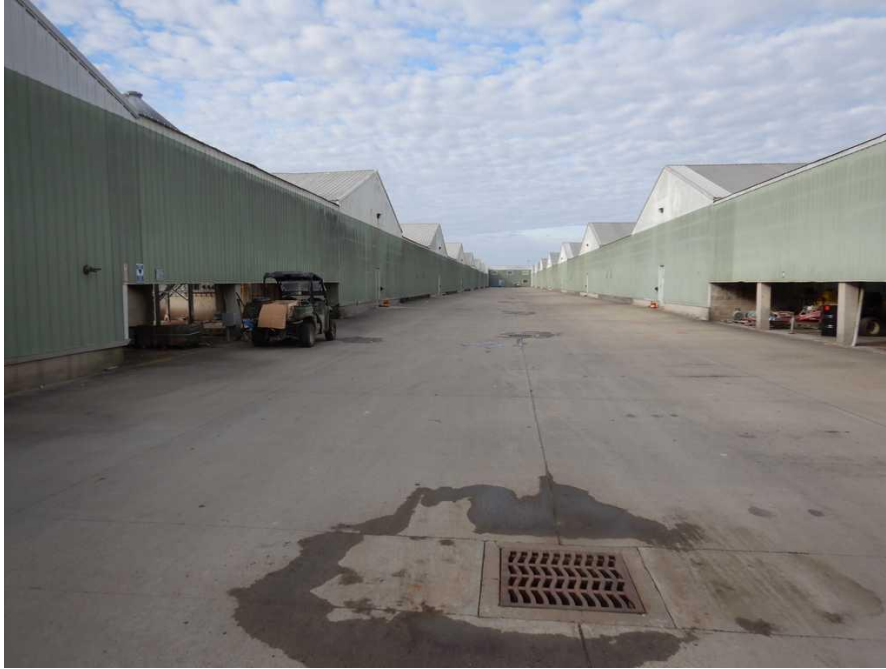
| Driveway between the two barn rows | DSCN0382.JPG | |

| The driveway between the two chicken barn rows has several stormwater catch basins in it. Camera looking west. | | |

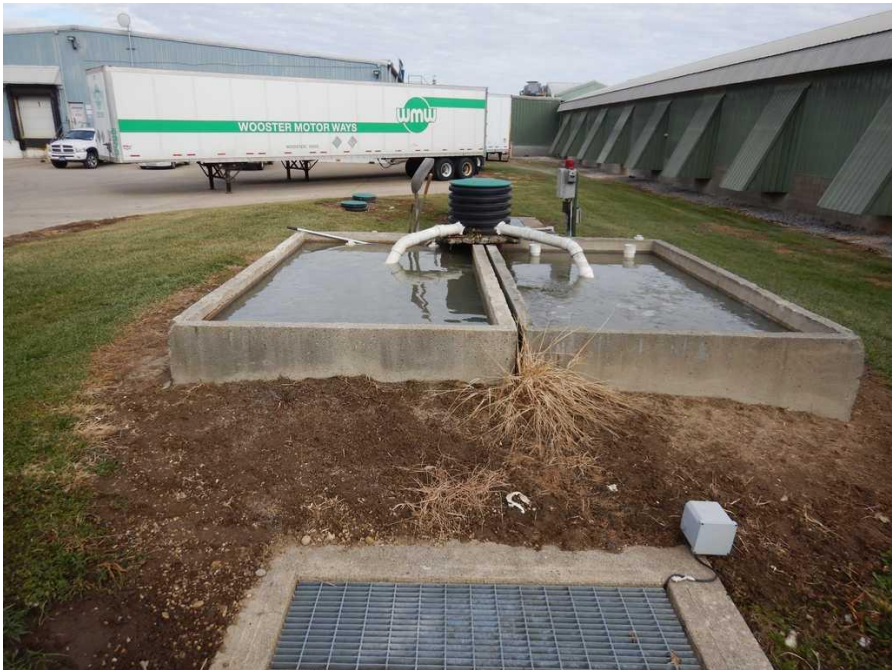
| Egg-Wash Lift Station | DSCN0384.JPG | |

| Egg-Wash water lift station west of chicken barns, facing north. | | |
