## Clean Water Act (CWA) Inspection Report

| <b>Type of Inspection</b> | CEI - Compliance Evaluation Inspection | | | |
| <b>Project or Site Name</b> | Vinje Hill Estates | | | |
| <b>Permit Number</b> | WAR311241 | | | |

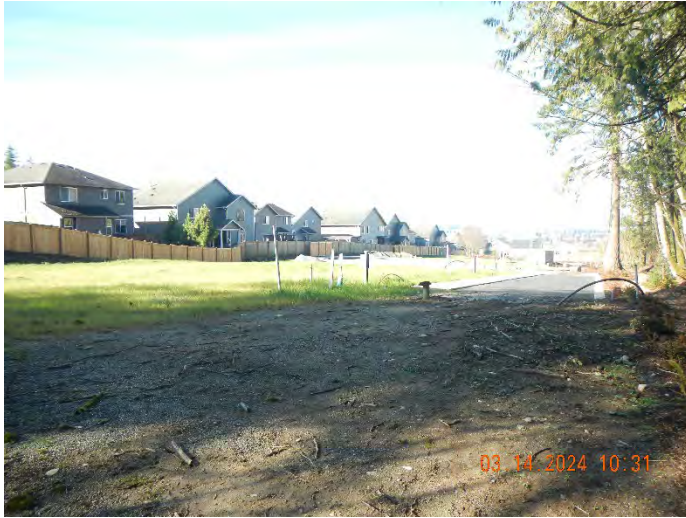
Photo #:01 (DSCN3602)

To reach the northeast corner of the site we first walked upslope through the construction site, via the 72<sup>nd</sup> Ave. SE and "Road B." We arrived at the northeast corner/perimeter; a wooded area that would remain undisturbed. Mr. Acker discussed that this eastern perimeter of the site was generally left as a nature area for the future residents. From this eastern location, we observed the three eastern housing lots located along the southern perimeter (**Photo 1**). The three housing lots were undeveloped and well stabilized after being hydroseeded in 2023.

Description: Facing west, photo from within wooded area of northwest project boundary. Wooded area is being maintained as a walking/pet area. Three lots to the south were undeveloped and well stabilized after being hydroseeded in 2023.

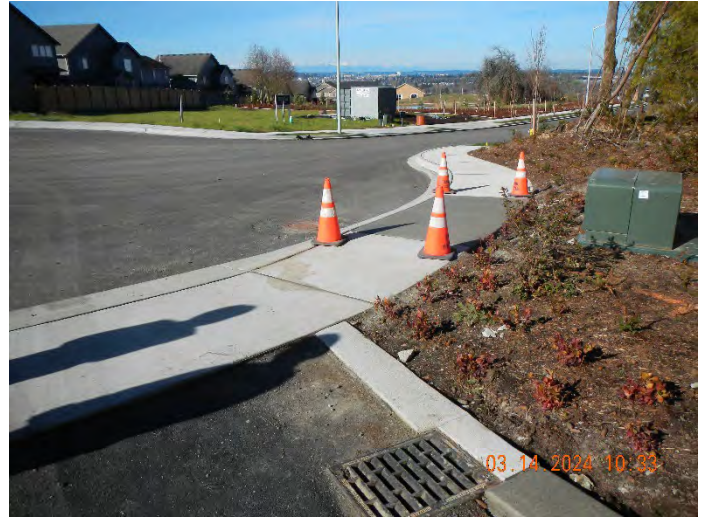
Photo #:02 (DSCN3603)

We then walked west, towards the eastern culdesac loop and observed the Project's easternmost catch-basin (**Photo 2**). Mr. Acker discussed that all catch basins were currently tied into the stormwater drainage system discharging to the local MS4. It was observed that the easternmost catch basin had no inlet protection. Mr. Acker discussed that all catch basins for the Project should be equipped with sediment/filter fabric and that in this instance, it must have recently been removed to perform concrete repair work on the associated curbing. Mr. Acker discussed that he would ensure that the sediment/filter fabric was re-installed. It was noted that the area upslope of the catch basin was either paved or well stabilized.

Description: Facing southwest, photo of easternmost catch basin. Catch basin is located upslope of active construction areas near stabilized landscaping areas. Concrete repair work recently conducted at the location. No inlet protection observed.

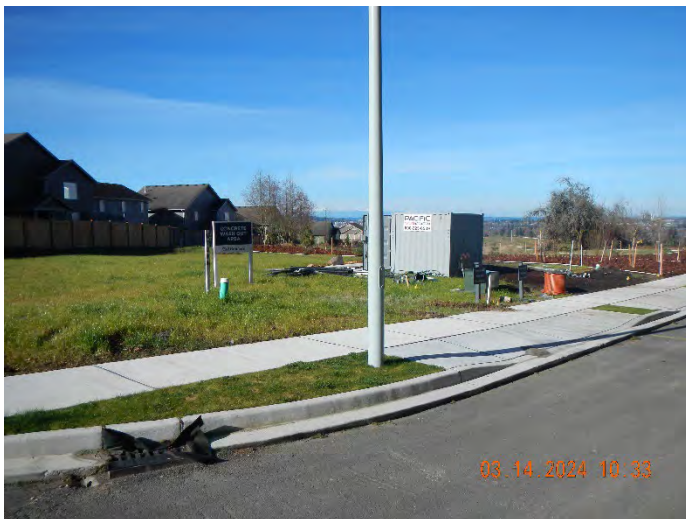
Photo #:03 (DSCN3604)

We continued west along the culdesac loop and observed another roadside catch basin, located on the south side of the road along the western area of the culdesac loop (**Photo 3**). Sediment/filter fabric was installed

Description: Facing west, photo of roadside catch basin located west of the culdesac roadway. Filter fabric installed within the catch basin. Surrounding housing lots well stabilized with hydroseeding/landscaping.

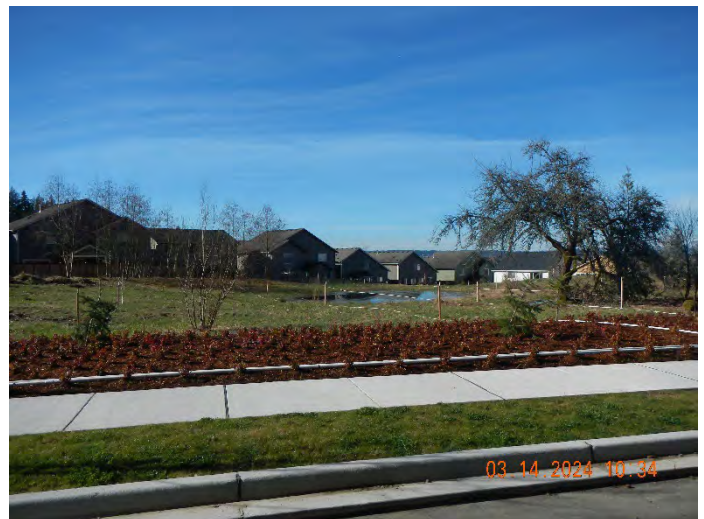
Photo #:04 (DSCN3605)

We continued west along "Road B" and observed the completed landscaped areas to the south. We also observed a wetland area (**Photo 4**) within the Project boundary. Mr. Acker discussed that the wetland area was manmade prior to the Project's development. The Project now maintains the wetland area and has installed temporary irrigation to help establish the newly planted landscaped areas, east of the wetland.

Description: Facing southwest, photo of wetland area near the upper/eastern construction areas Mr. Acker discussed that he had been told the wetland area was manmade. Landscaped area/wetland is irrigated for maintenance.

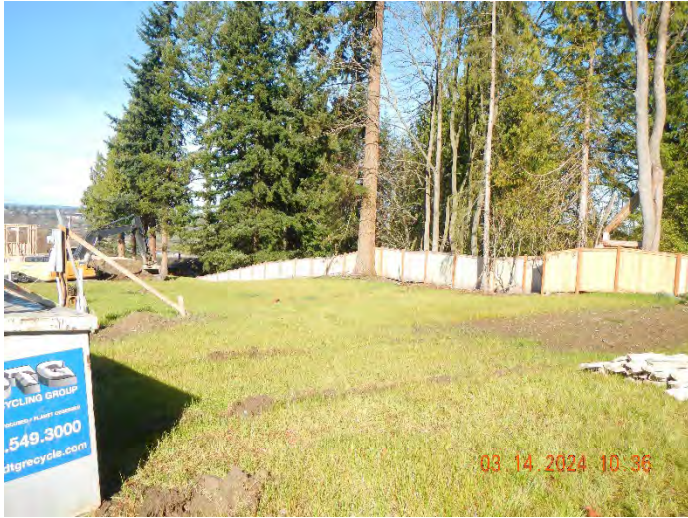
Photo #:05 (DSCN3606)

Within the central construction areas, we then observed the northern perimeter. In general, vacant housing lots north of "Road B" were well stabilized having been hydroseeded in 2023 (**Photo 5**). Existing fencing extended along the northern perimeter within the stabilized areas.

Description: Facing northwest, photo of stabilized north housing lots awaiting construction.

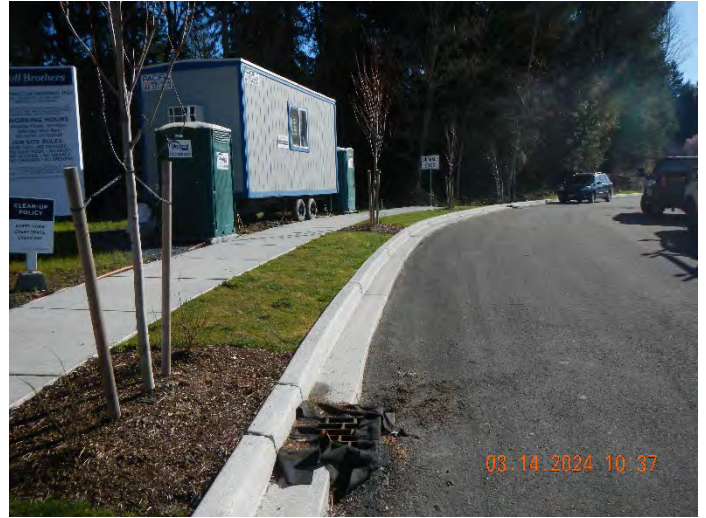
Photo #:06 (DSCN3607)

From this central area, the site begins to slope steeply to the west. We observed the Project's job-site trailer and another roadside catch basin on the north side of "Road B" (**Photo 6**). From this location we also observed the western portions of the site, where much of the active construction was occurring at the time of inspection. Several housing lots had started vertical construction (**Photo 7 & Photo 8**).

Description: Facing east, photo of job-site trailer and roadside catch basin. Catch basin was equipped with inlet protection/fabric filter. Frontage areas landscaped.

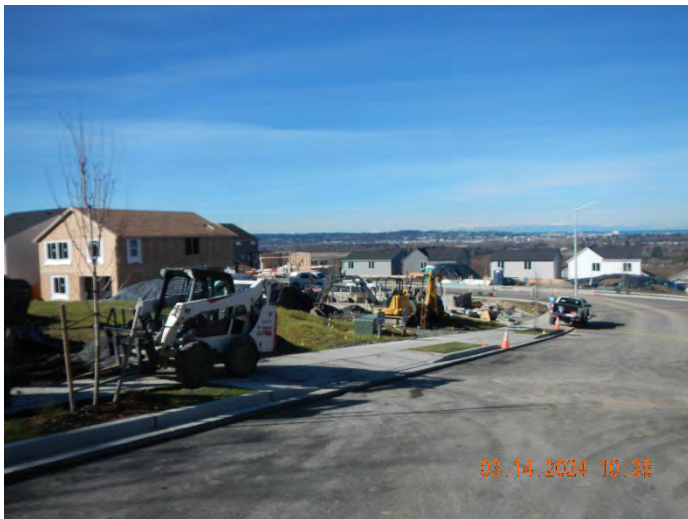
Photo #:07 (DSCN3608)

Description: Facing west, photo of southern in active construction phase.

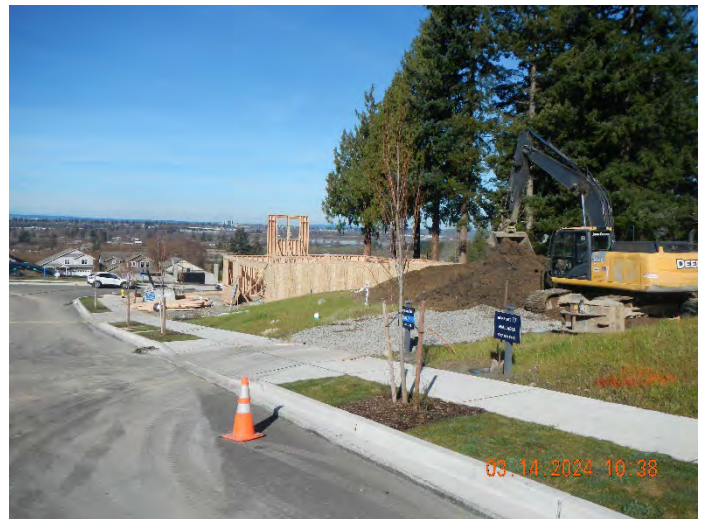
Photo #:08 (DSCN3609)

Description: Facing west, photo of northern lots starting in active construction.

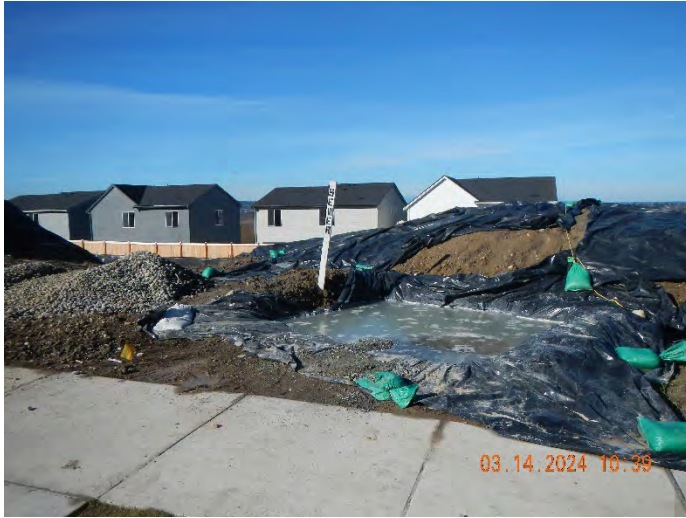
Photo #:09 (DSCN3610)

We then continued west, downslope via "Road B" until we arrived back to 72<sup>nd</sup> Ave SE. and observed the dedicated concrete washout area (**Photo 9**). Mr. Acker discussed that the washout area has worked well but would need to be emptied soon as it was approaching capacity. We observed several material stockpiles in the area covered with plastic sheeting, one area of plastic sheeting was observed to be in need of maintenance to ensure continued coverage.

Description: Facing west, photo of designated concrete washout area.

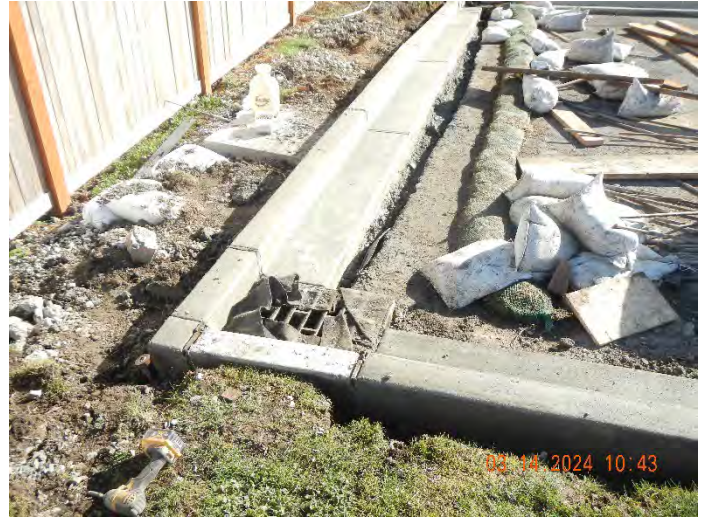
Photo #:10 (DSCN3611)

We then continued north, along 72<sup>nd</sup> Ave SE to the northern perimeter. Mr. Acker discussed that due to the steep slopes within this project area, the area had previously experienced flooding into a neighboring lot. Construction staff was working to improve the curbing, to ensure stormwater is fully captured within two roadside catch basins connecting to the stormwater drainage system (**Photo 10 & Photo 11**).

Description: Facing east, photo of newly constructed curbing to assist with stormwater capture to drainage system. Fiber wattles, sandbags and inlet protection observed at catch basin.

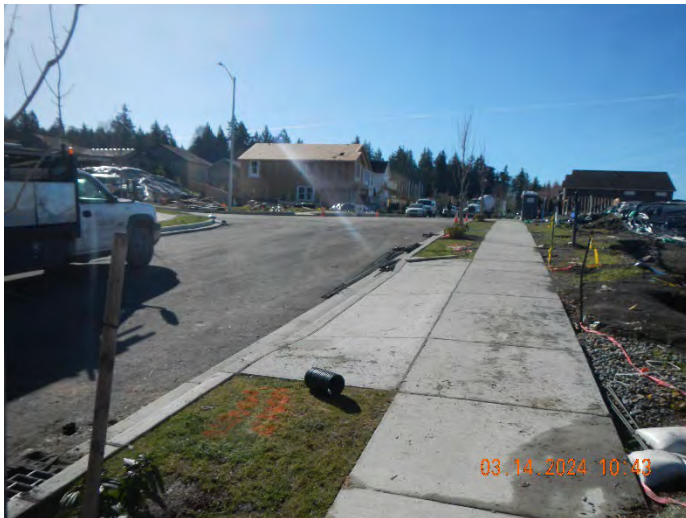
Photo #:11 (DSCN3612)

Description: Facing south, photo of sidewalk and construction areas from the northern perimeter.

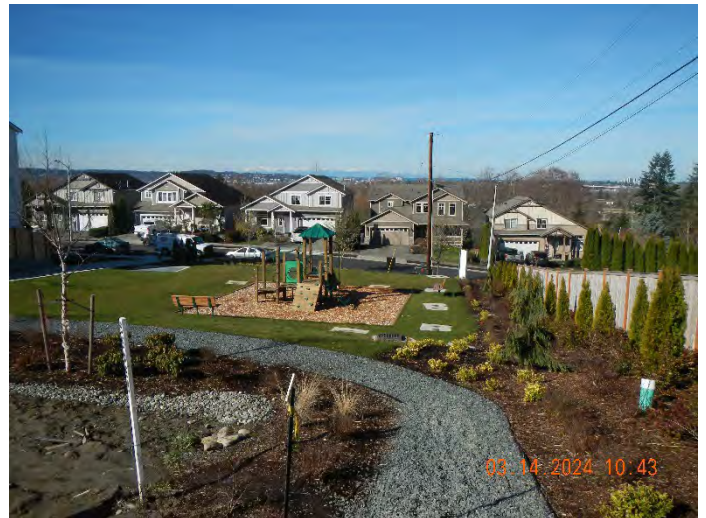
Photo #:12 (DSCN3613)

From this area we also observed the completed construction areas to the west, including the four model homes and constructed park/play structure (**Photo 12**). Mr. Acker discussed that the stormwater vault infrastructure was installed below the park/play structure. We observed various access points to the stormwater vault along the north side of the play structure.

Description: Facing west, photo of constructed park/play structure. Stormwater vaults located underneath the park/play structure to the north. Outfall to the west.

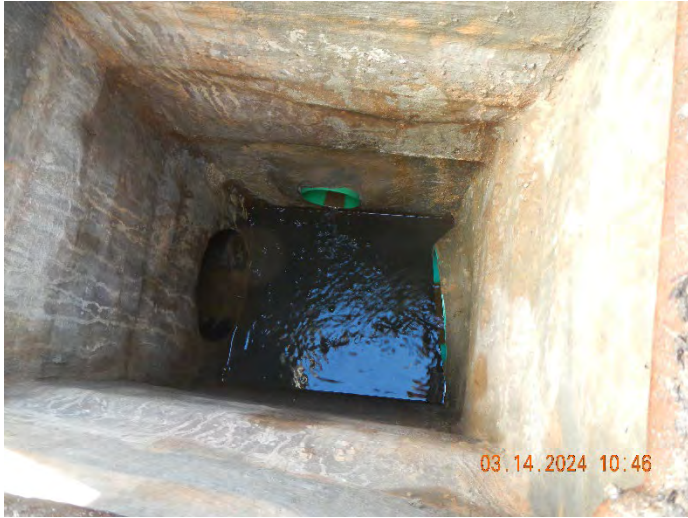
Photo #:13 (DSCN3614)

We observed Project's discharging at the time of inspection, as water was leaving the discharge pipe and entering the MS4 stormwater vault. The discharge was observed to be clear; however, accumulated sediment

was observed within the Project's discharge pipe. Mr. Acker was unsure of when sediment would have been deposited within the discharge piping. It was discussed that no benchmark exceedances had been recorded.

AOC: As discussed earlier within this report, while observing the Project's discharge location. The Project's discharge was observed to be clear; however, accumulated sediment was observed within the Project's discharge pipe (**Photo 13**). Mr. Acker was unsure of when sediment would have been deposited within the discharge piping. It was discussed that no benchmark exceedances had been recorded.

Description: Photo of discharge/monitoring location and connection to Lake Steven's MS4. Discharge observed to be clear at the time of inspection. Accumulated sediment within the discharge pipe.

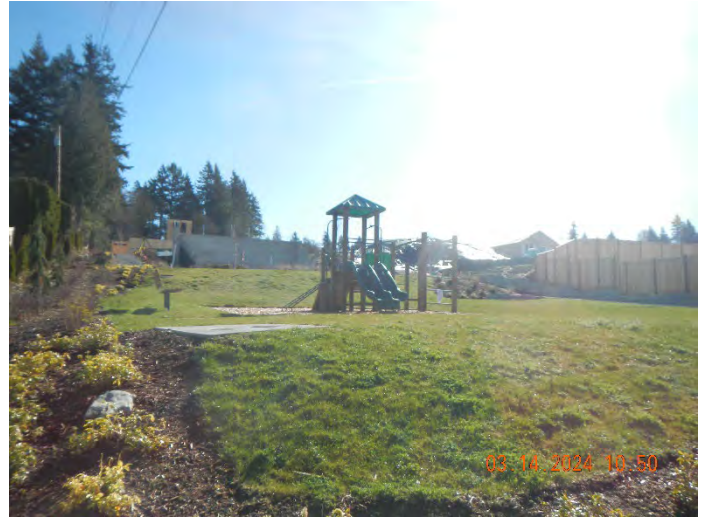
Photo #:14 (DSCN3615)

Description: Facing east, photo of constructed park/play structure located in the northwest corner of the Project.

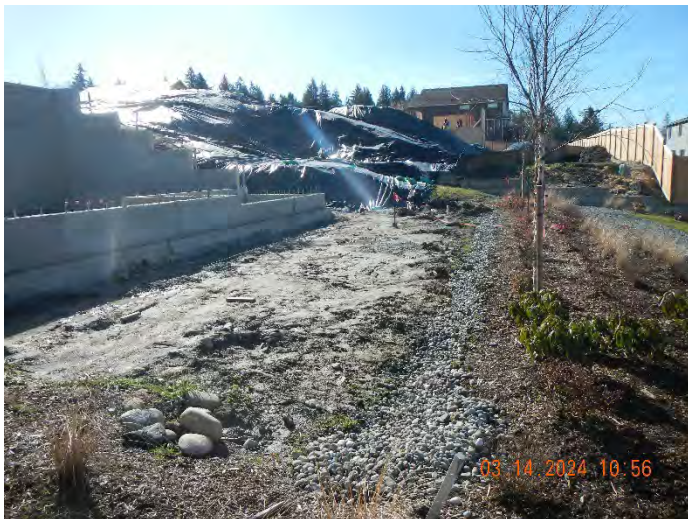
Photo #:15 (DSCN3616)

We returned to the Project's main stormwater vault location (**Photo 14**), and then back to the central construction areas. We observed a foundation to be actively under construction within a housing lot. It was discussed that a French drain was installed belowground, along the western perimeter to capture stormwater (**Photo 15**). Mr. Acker discussed that the French drain system was connected to the stormwater vault/collection system. I discussed that BMPs should be considered for the unworked/exposed soils at the location, due to the proximity of the French drain.

Description: Facing south, photo of housing lot foundation under construction. French drain installed underground, west of the foundation. French drain connected to stormwater collection system.

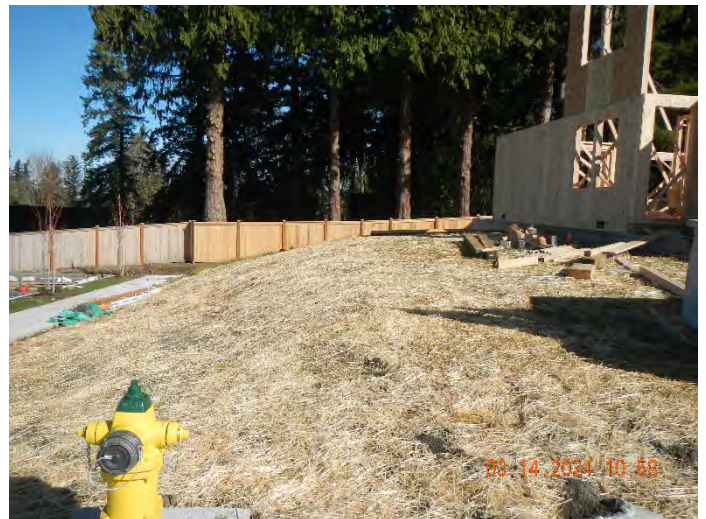
Photo #:16 (DSCN3617)

We continued back upslope to the east and observed another housing lot under active construction. Straw had been applied to exposed soils (**Photo 15**). The inspection walk-through concluded as we arrived back at the Project's job-site trailer to conduct the records review.

Description: Facing north, photo of straw coverage on unstabilized portion of newly constructed housing lot.

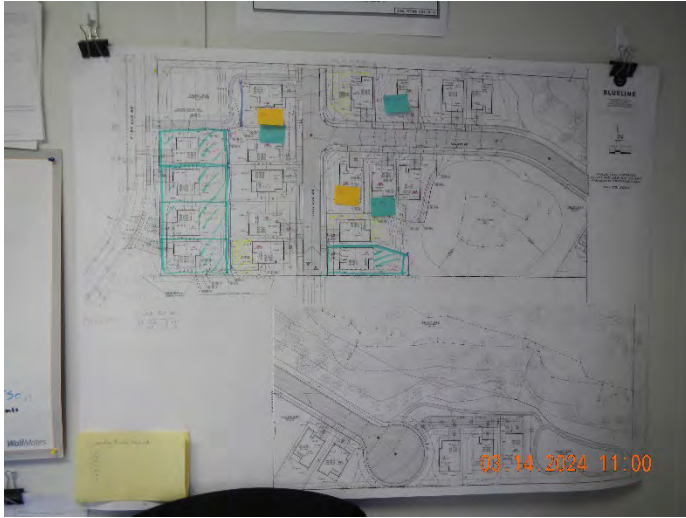
Photo #:17 (DSCN3618)

The Project's Site Map was located on the wall within the job-site trailer (**Photo 16**). The Site Map included numerous BMP locations as well as BMP implementation dates. It was noted that the sampling/monitoring location and the concrete washout area were not identified within the Site Map. We discussed the permit requirements associated with the Site Map and the tracking of BMP implementation and maintenance.

Description: Photo of the SWPPP Site Map within the Project's job-site trailer.
