## Region 6 - Enforcement & Compliance Assurance Division

### INSPECTION REPORT

| Company Name: | <b>Enerco Operating Corporation</b> | |
| Facility Name: | <b>Beauford Su-Tokio Tank Battery and Beauford Armstrong-1, BSU-2, Beauford A-2, Tokio 6-4, 8-1, Armstrong B-2 Tank Battery</b> | |

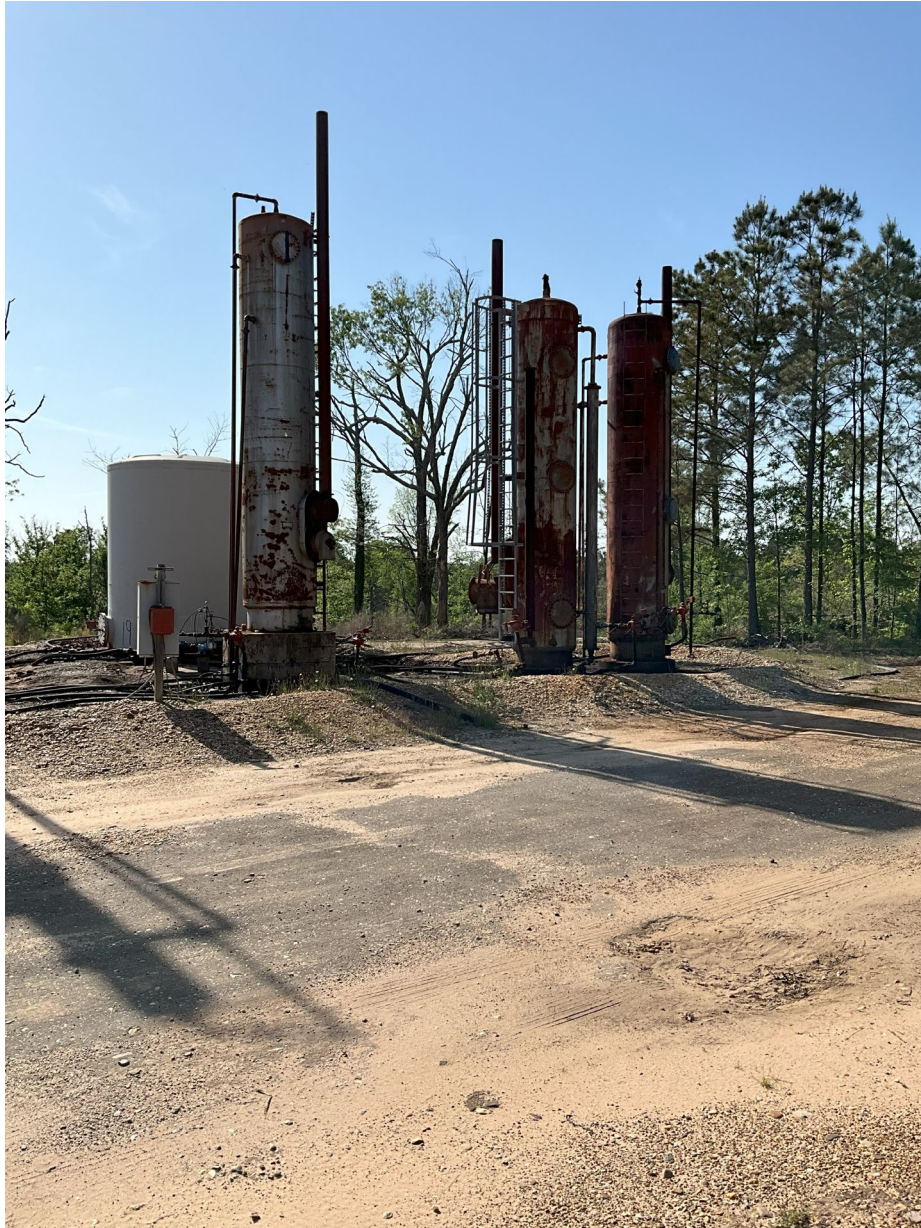
Photo No. 5

I observed low spots on the secondary containment berm for the separators, see Photo No. 5. Inside secondary containment for the separators, I observed loose oil on the ground and a separator that was out of service but not labeled or marked “out of service,” see Photo No. 6. I also observed a pipe that was leaking, see Photo No 7; oil staining was present in the area beneath the leaking pipe. I observed a missing pipe support under the dump valve, see Photo No. 8.

**Description:** Looking northwest, this photo shows low spots on the secondary containment berm for the separators.

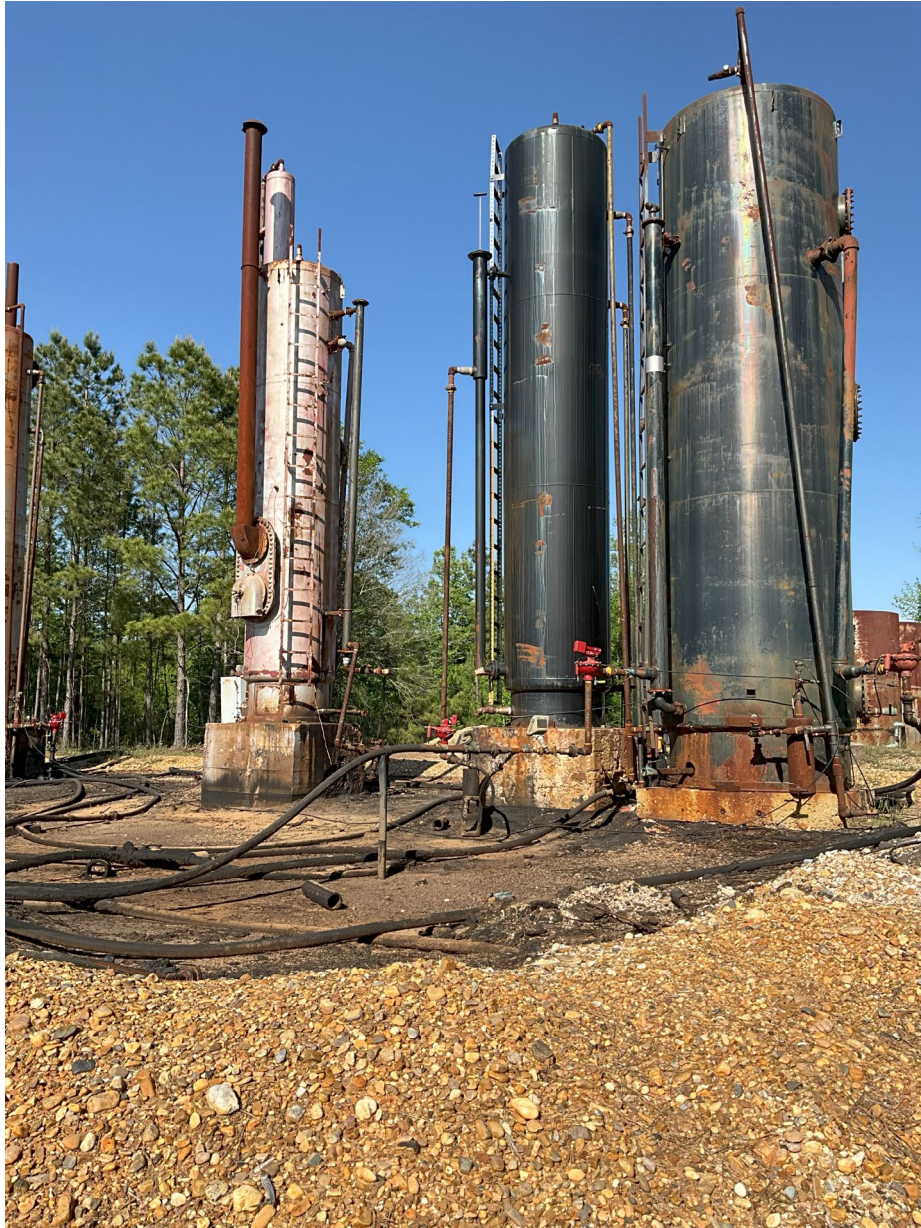
Photo No. 6

**Description:** Looking east, this photo shows the separators with loose oil on the ground inside secondary containment. The separator on the left side of photo is out of service, but not labeled.

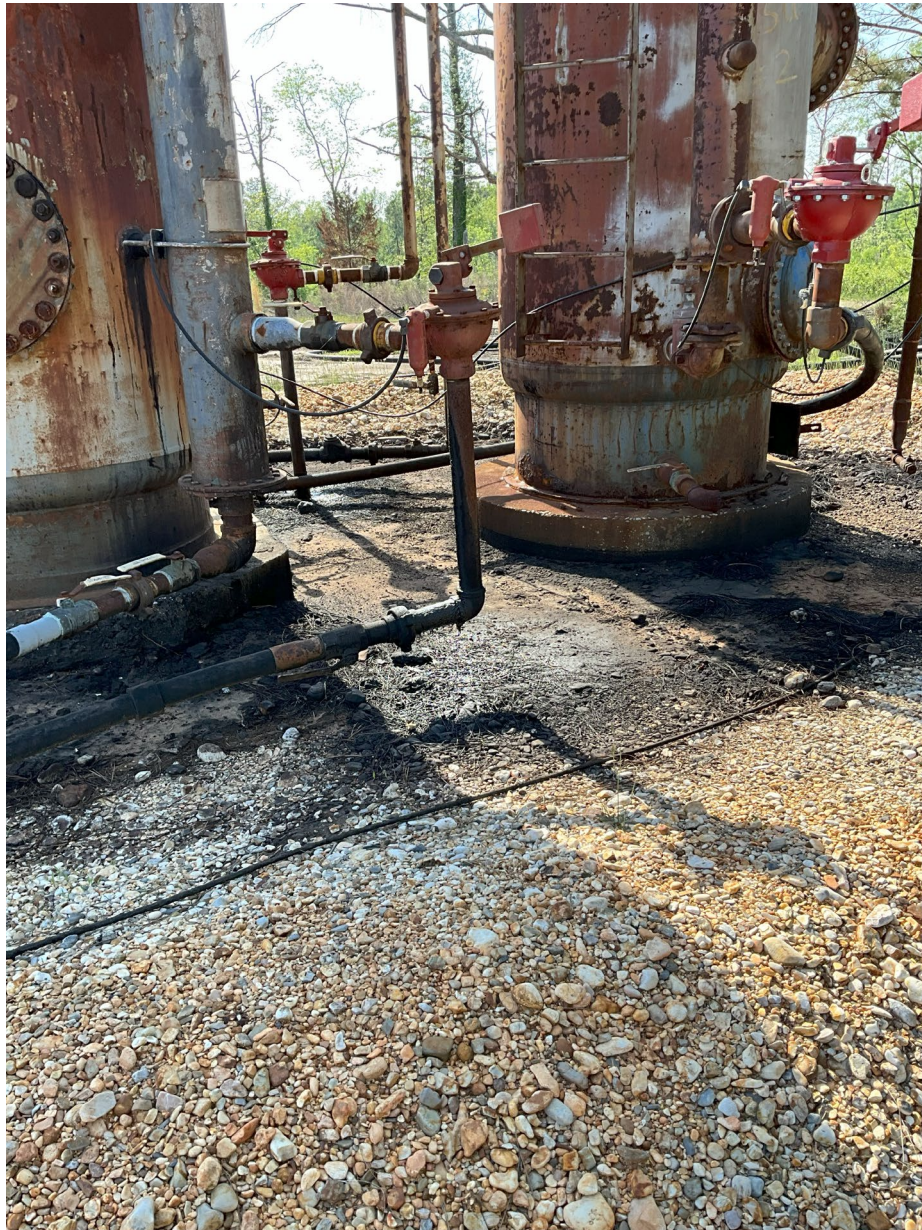
Photo No. 7

**Description:** Looking northwest, this photo shows a leaking pipe from a separator. Oil staining is present below the leaking pipe.

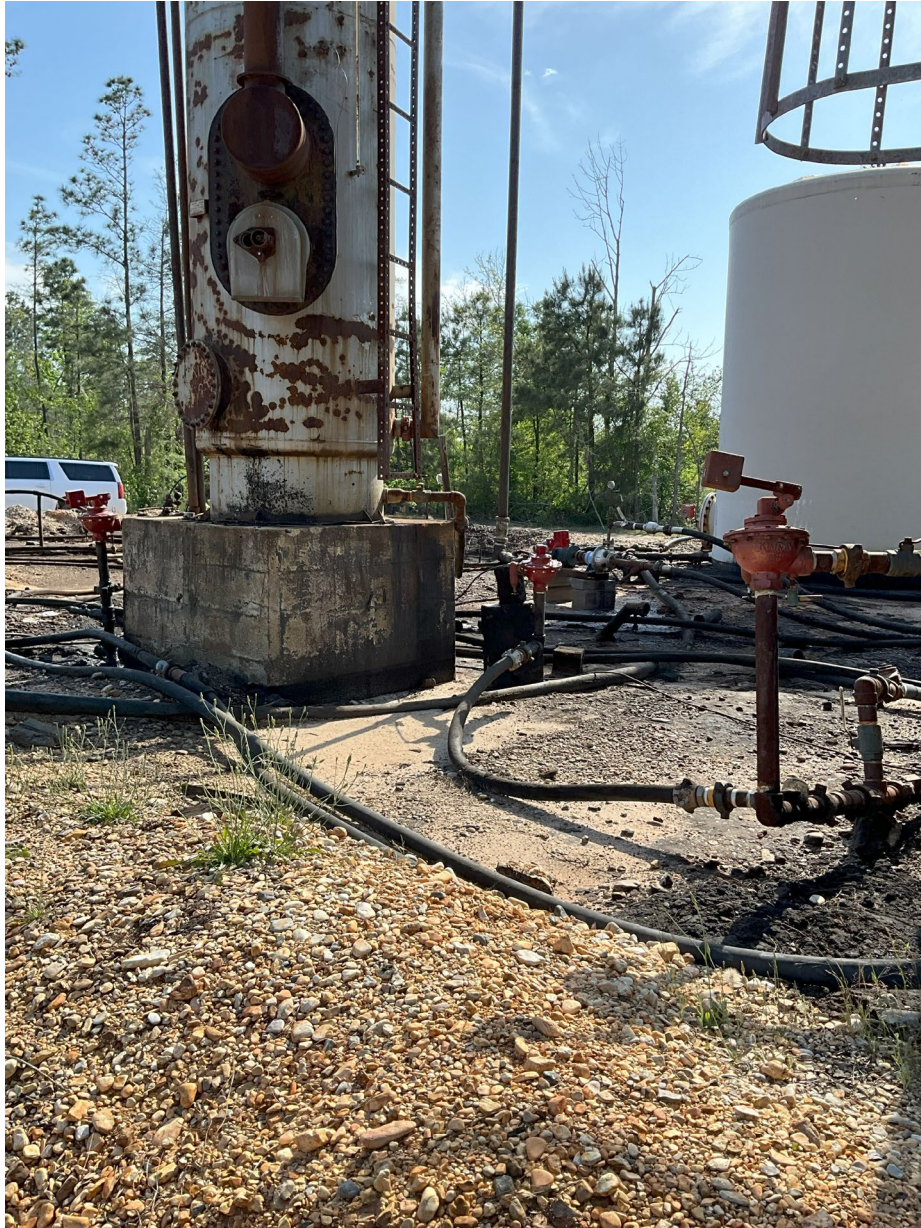
Photo No. 8

**Description:** Looking southwest, this photo shows a missing pipe support under the dump valve.

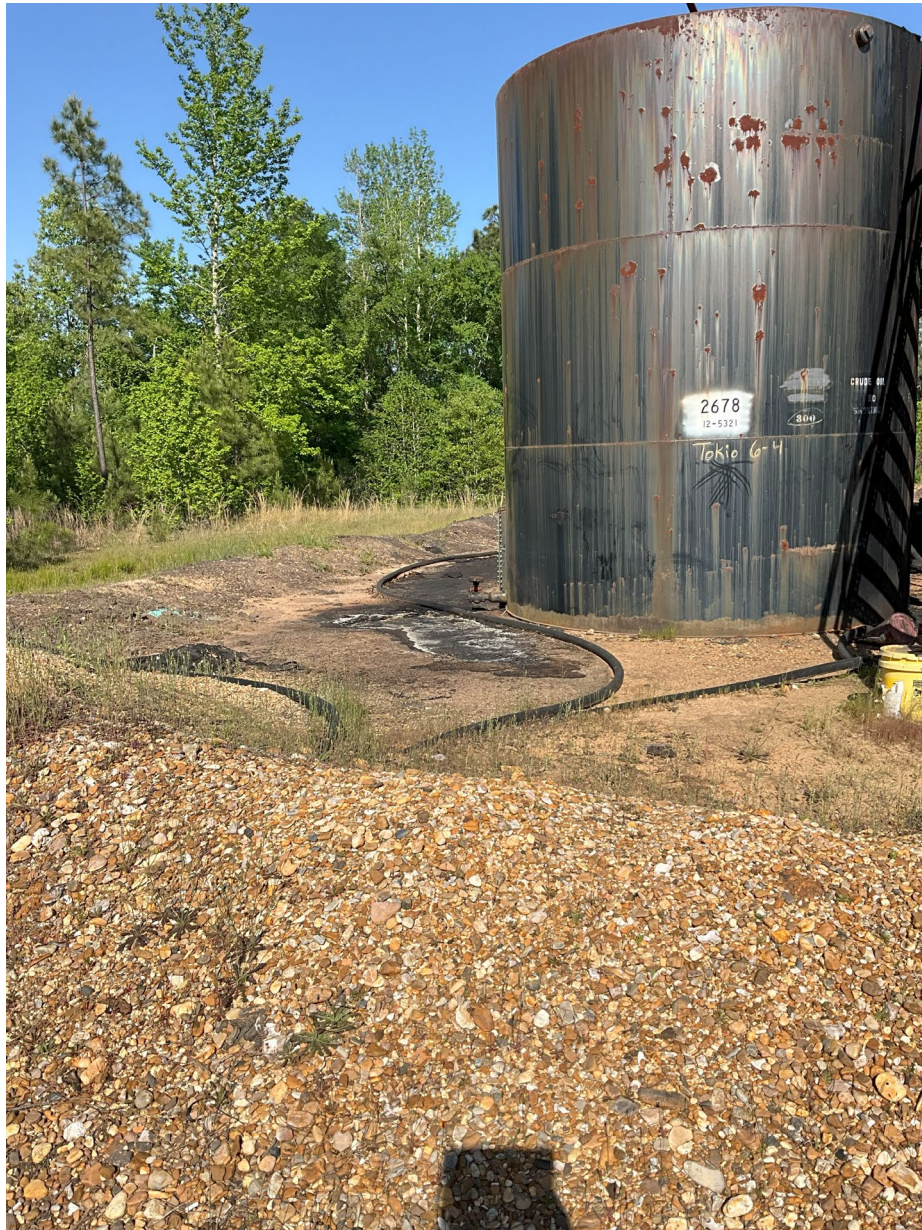
Photo No. 9

I observed low spots on the secondary containment berm for the tanks, see Photo No. 10. Inside secondary containment for the tanks, I observed loose oil and salt on the ground, see Photo No. 9, No. 11, and No. 12. I observed a pipe that was leaking from a tank, see Photo No 11. I also observed gaps under a tank, see Photo No. 12.

**Description:** Looking northeast, this photo shows loose oil on the ground inside secondary containment for the storage tanks.

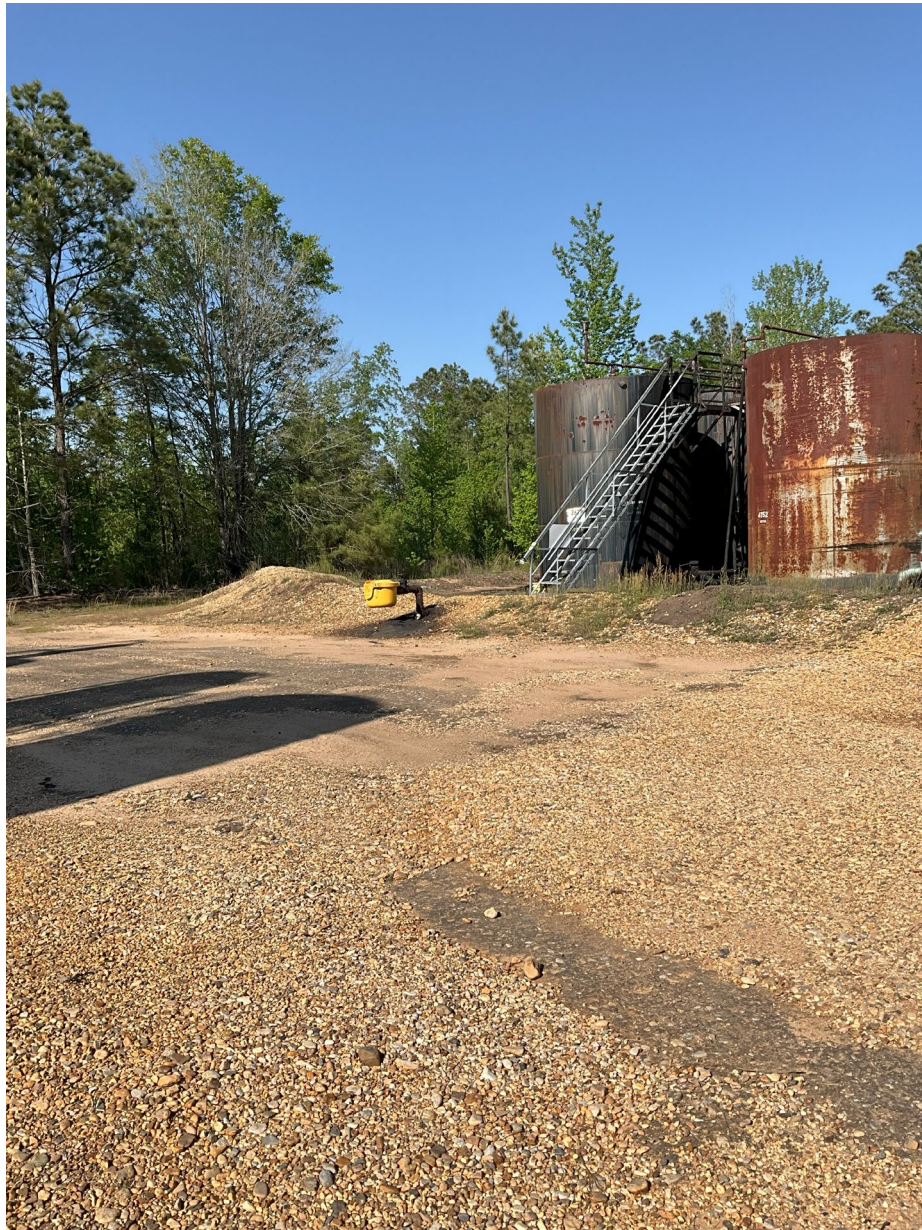
Photo No. 10

**Description:** Looking east, this photo shows lows spots on the secondary containment berm for the storage tanks.

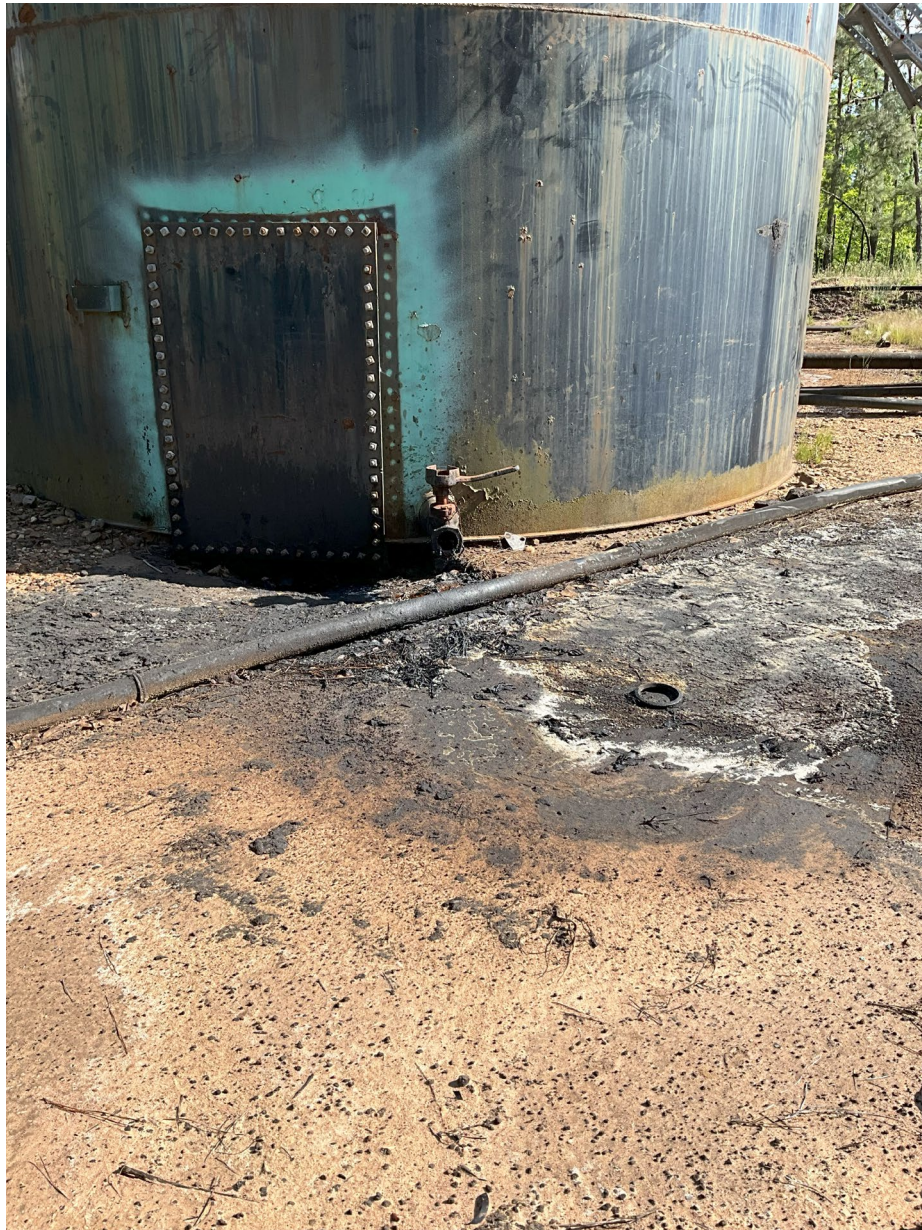
Photo No. 11

**Description:** Looking south, this photo shows a leaking pipe at a storage tank. The photo also shows loose oil and salt on the ground inside secondary containment for the storage tanks.

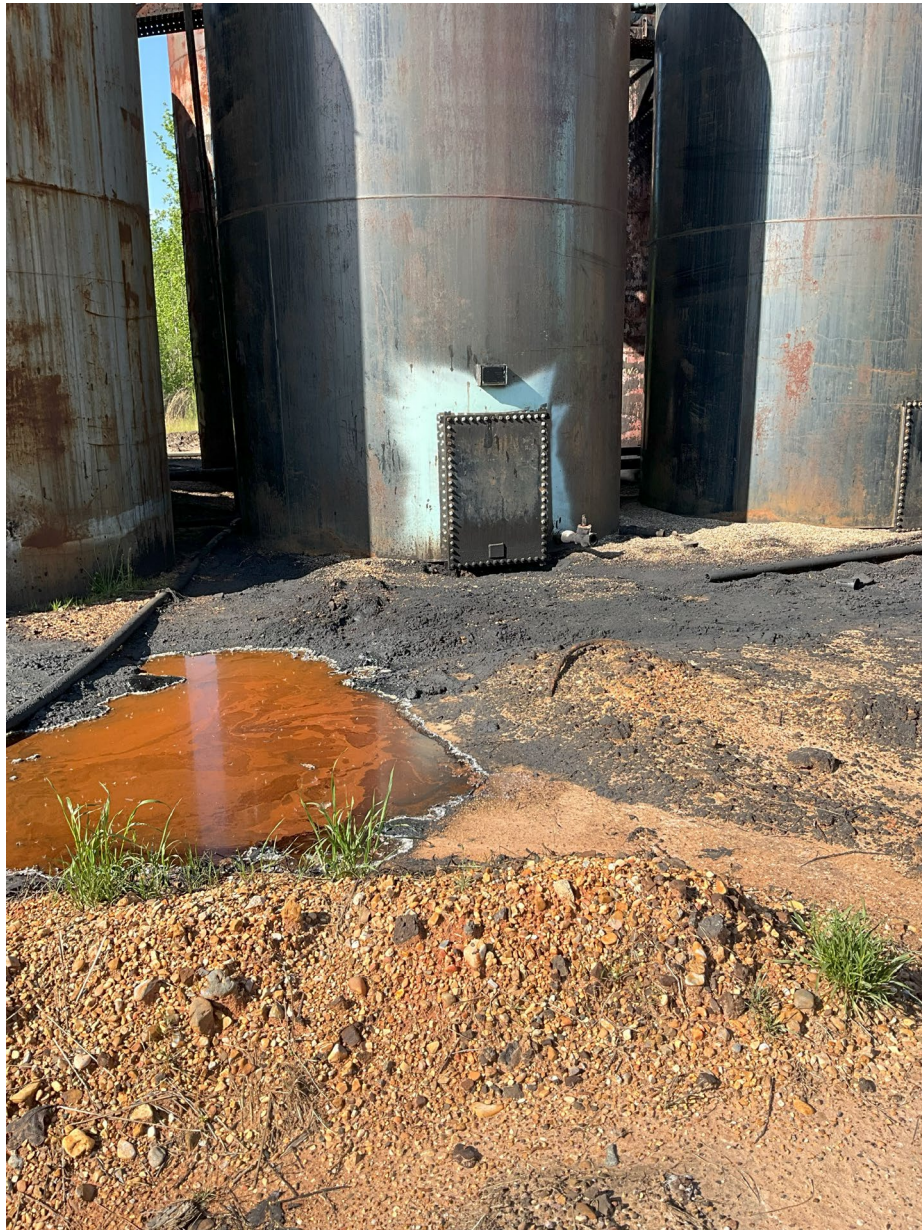
Photo No. 12

**Description:** Looking east, this photo shows a gap under a storage tank that extends under the tank and loose oil and produced water inside secondary containment for the tanks.
