**Region 6 - Enforcement & Compliance Assurance Division**  
**INSPECTION REPORT**

| Inspection Date(s): | 02/13/2024 | |
| Facility Name: | <b>The Goodyear Tire &amp; Rubber Company Beaumont Chemical Plant</b> | |

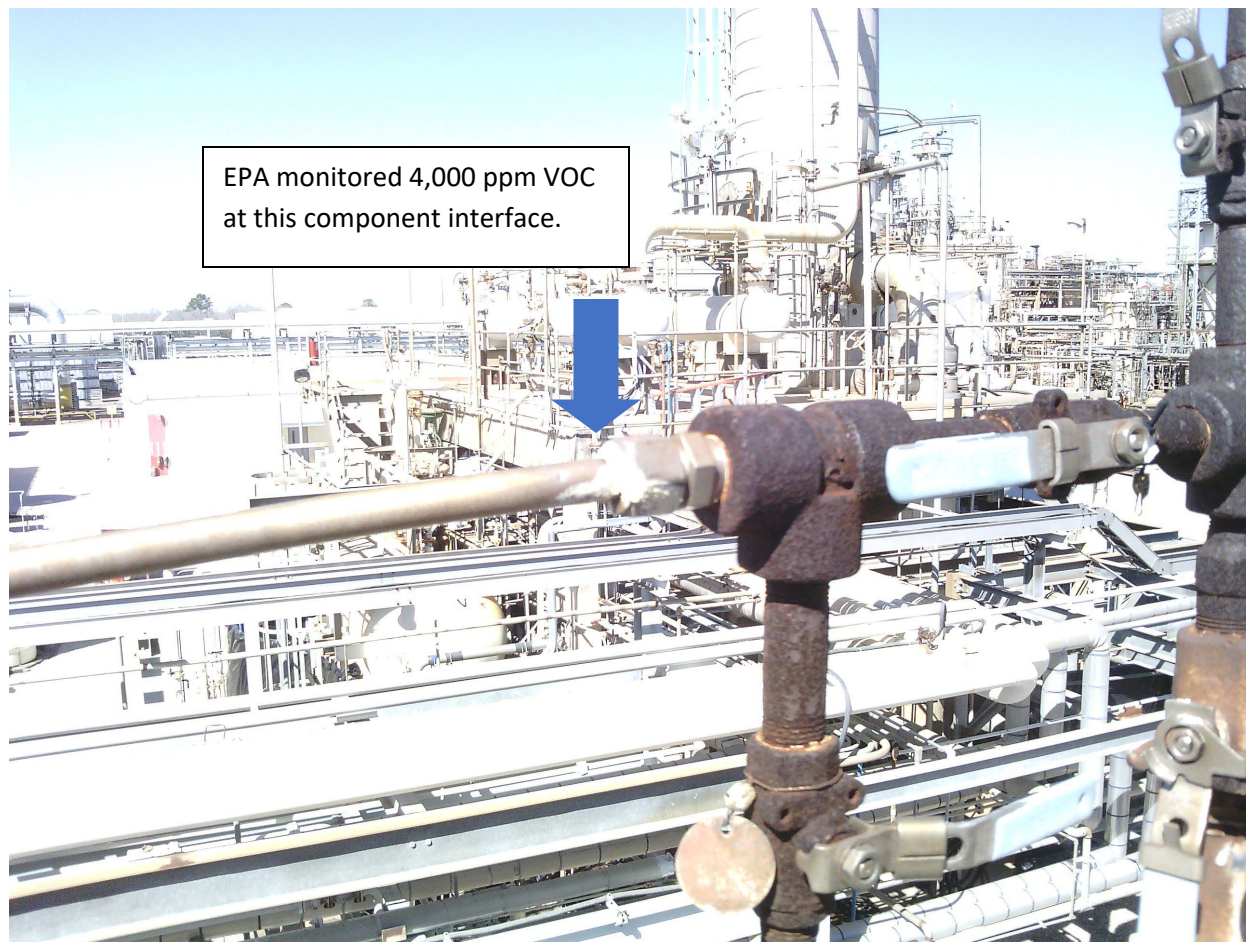
Photo No. 1

Description: Leak at piping connection.

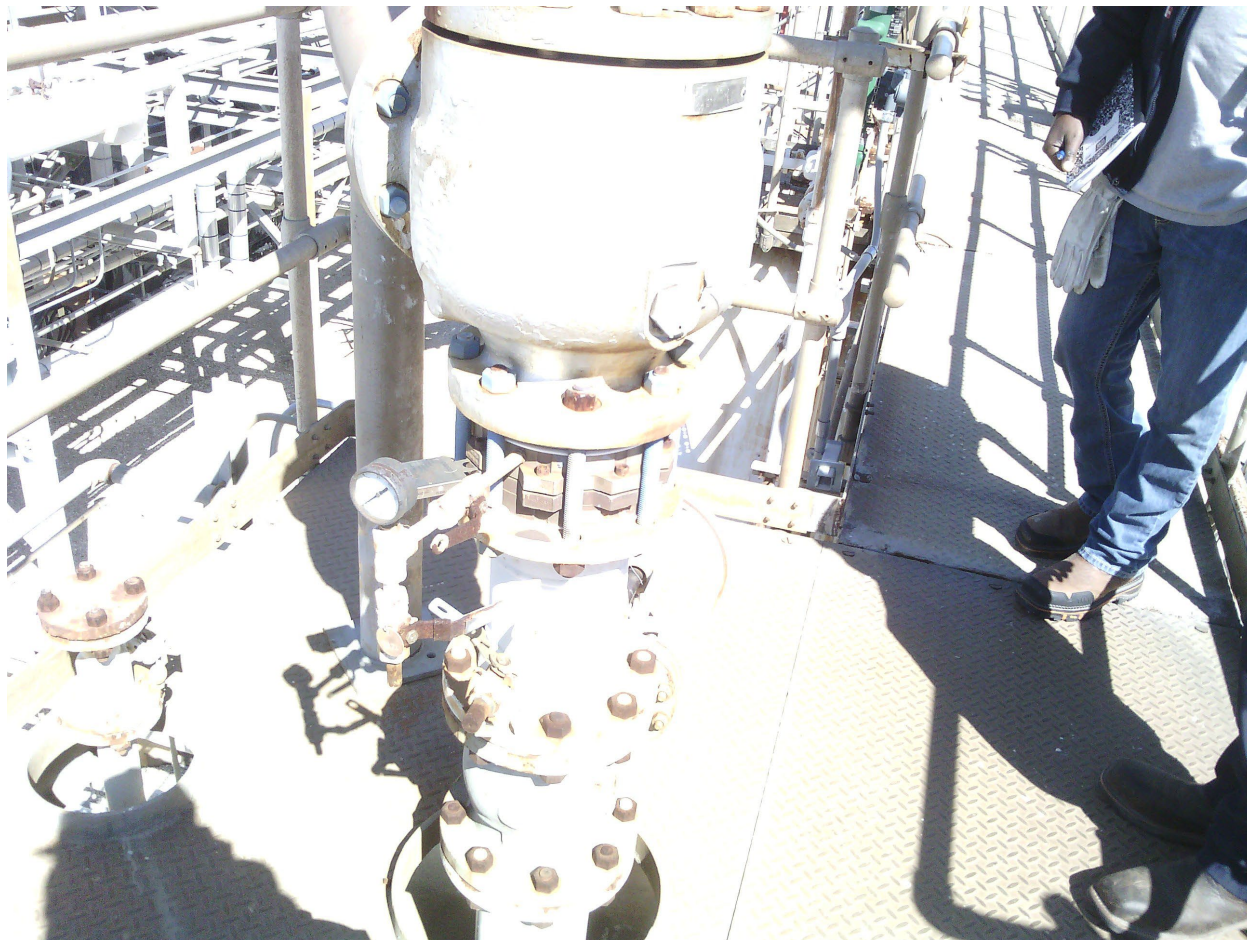
Photo No. 2

Description: Rupture disk with pressure gauge.

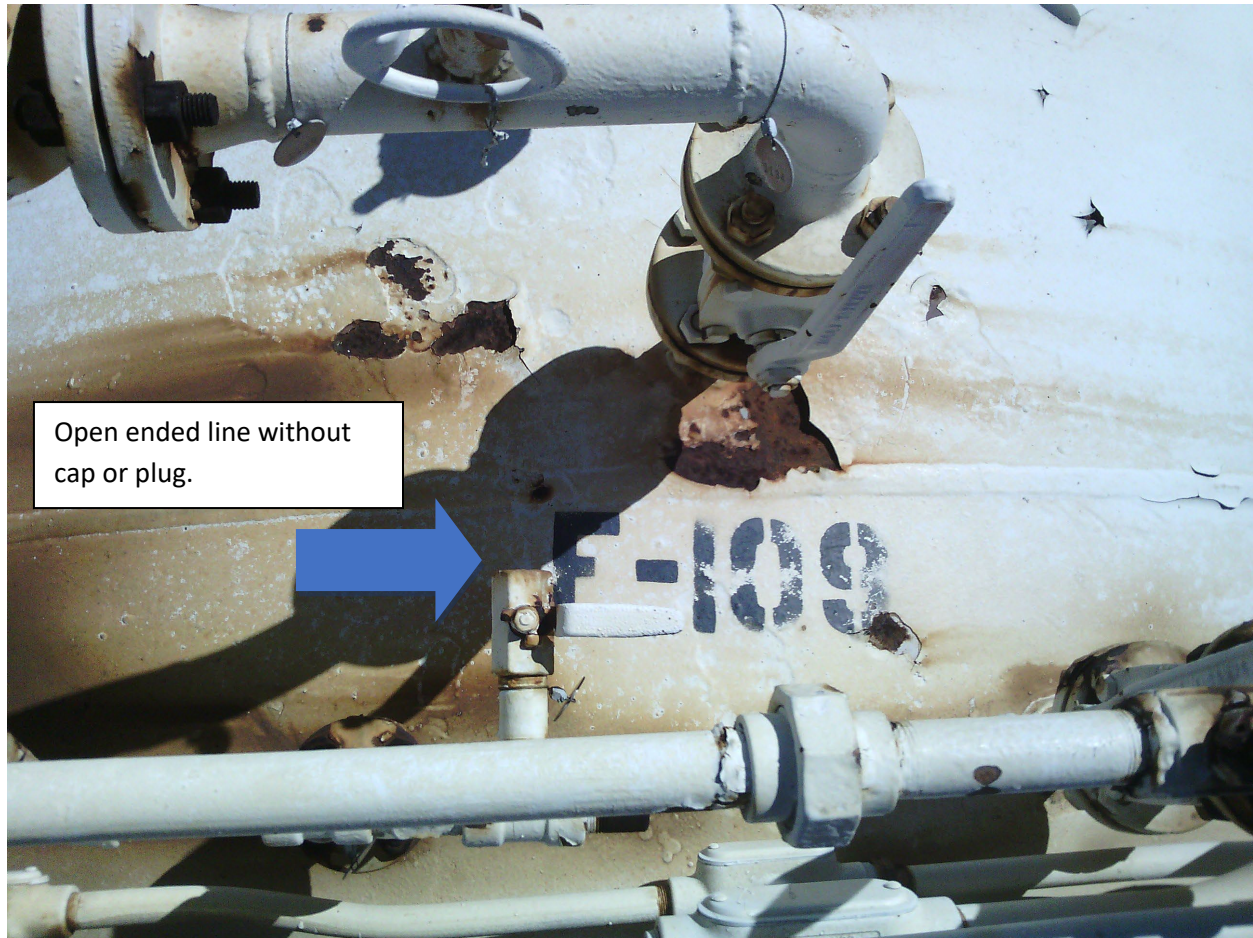
Photo No. 3

1) Goodyear failed to equip an open-ended line on tank F-109 with a cap, blind flange, plug, or second valve.

The Natsyn Unit is subject to the MON. Hexane, a HAP, is stored in a battery of tanks within the Natsyn Unit. The hexane tanks operate in series and gradually concentrate it for use as a solvent in the process. Because the predominant use of the hexane tanks is associated with a miscellaneous organic chemical manufacturing process unit ("MCPU"), they must be assigned to that MCPU. 40 CFR 63.2435(d). Table 6 of the MON lists requirements for leaks from equipment in HAP service that is part of any MCPU. MCPUs in HAP service must comply with the requirements of NESHAP subpart UU, or 40 CFR Part 65 Subpart F. 40 CFR 63.1033(b)(1) requires each open-ended valve or line to be equipped with a cap, blind flange, plug, or a second valve.

Description: Open ended line off F-109.

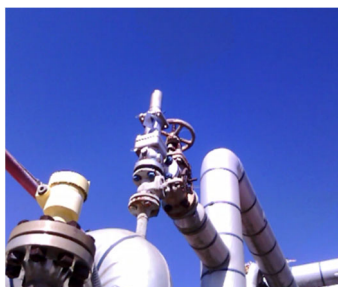
Video File Name: FLIR0042.mp4  
 Date of Video: 2/13/2024  
 Time of Video: 13:30 pm  
 Videographer: James Haynes  
 Description: Visualized hydrocarbon emissions observed from under the insulation around the elbow in the piping. Propane supply to 9E513. EPA FID measurement 25,000 ppm VOC.

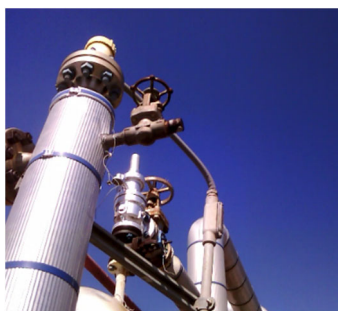
Video File Name: FLIR0044.mp4  
 Date of Video: 2/13/2024  
 Time of Video: 13:35  
 Videographer: James Haynes  
 Description: Visualized hydrocarbon emissions from leaking valve, Tag #6882.

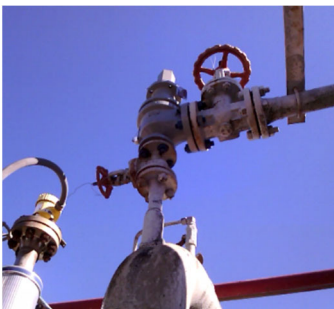
Video File Name: FLIR0047.mp4  
 Date of Video: 2/13/2024  
 Time of Video: 13:50  
 Videographer: James Haynes  
 Description: Visualized hydrocarbon emissions from a valve/flange leak.

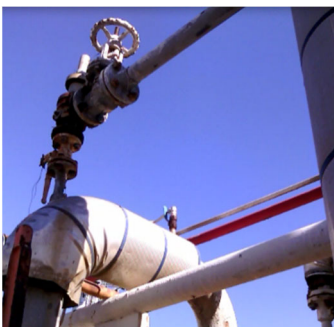
Video File Name: FLIR0048.mp4  
 Date of Video: 2/13/2024  
 Time of Video: 13:55  
 Videographer: James Haynes  
 Description: Visualized hydrocarbon emissions from valve. EPA FID measurement 40,000 ppm VOC.

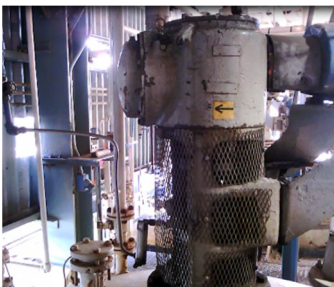
Video File Name: FLIR0049.mp4  
 Date of Video: 2/13/2024  
 Time of Video: 15:45  
 Videographer: James Haynes  
 Description: Visualized hydrocarbon emissions from F 306 agitator. EPA FID measurement 1,900 ppm VOC.
