**CWA COMPLIANCE EVALUATION INSPECTION REPORT  
U.S. ENVIRONMENTAL PROTECTION AGENCY, REGION 5**

**Facility:** Highview Custom Fabricating Inc.  
3369 Bay Ridge Court  
Hobart, Wisconsin 54155

**NPDES Permit Number:** WIR05IA06

**Date of Inspection:** April 17, 2024

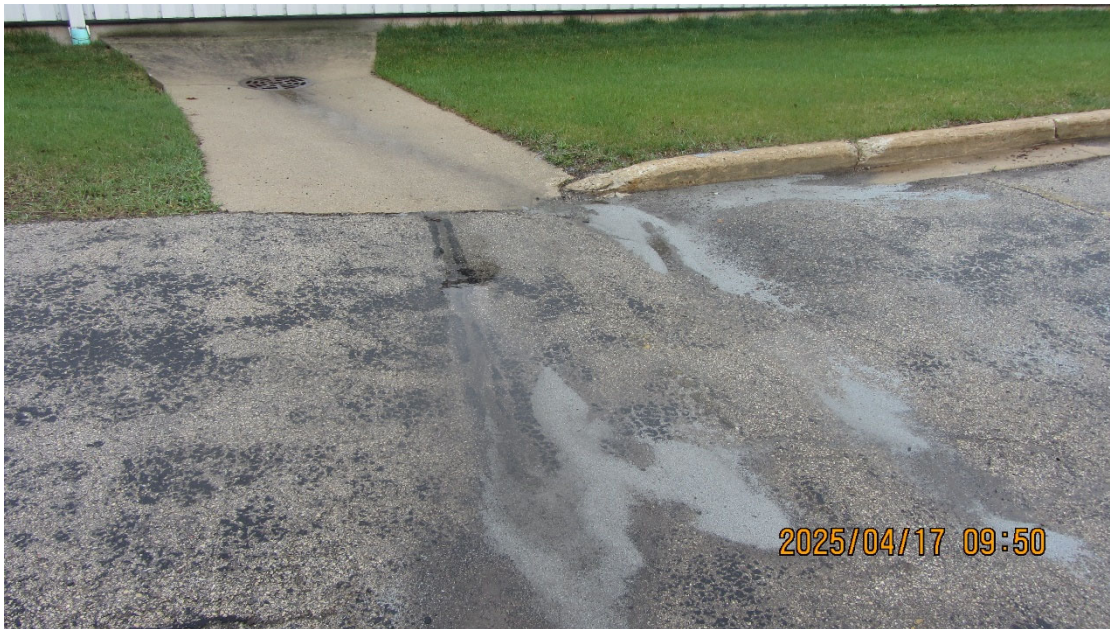
1: IMG\_0979

Description: Runoff from Parking Lot to Discharge Point 002

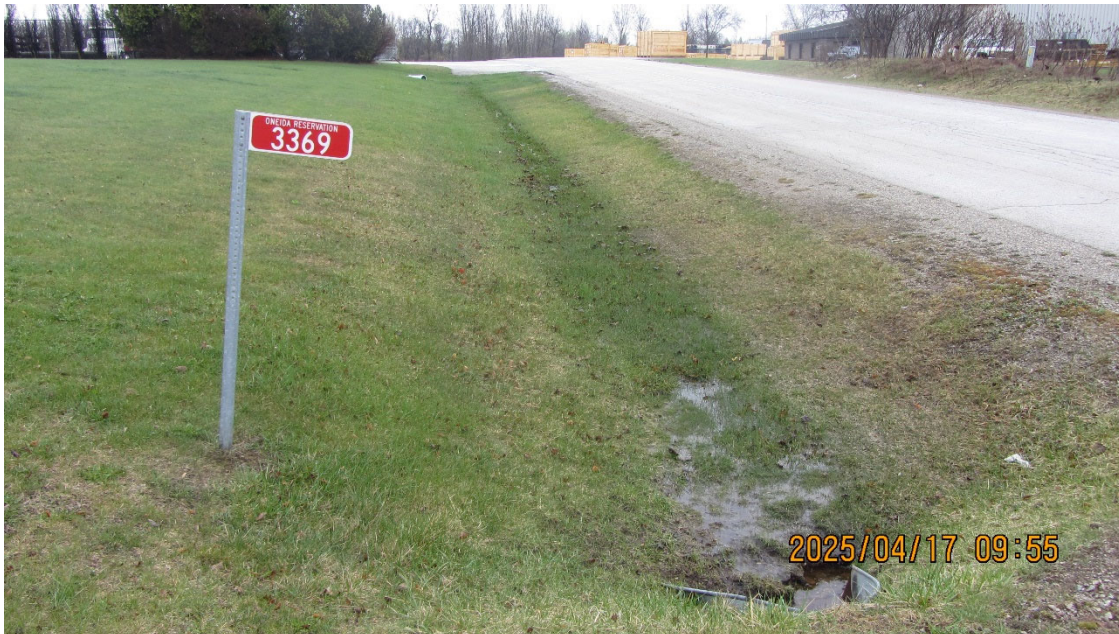
3: IMG\_0981

Description: Stormwater Ditch Downstream of Roof Downspout/Discharge Point 001

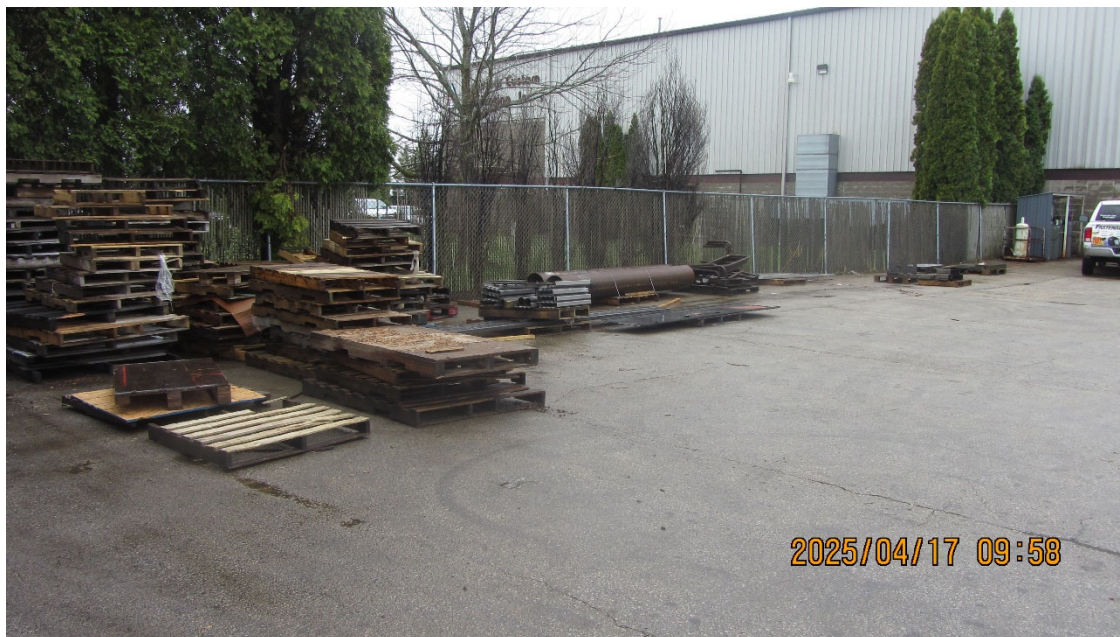
5: IMG\_0983

- c. Table 2-1 in the SWPPP:
    - i. During EPA's inspection, EPA observed pallets and the storage of metal material in the loading dock area east of the main production building (see Photographs 5 and 7 in Attachment A). Table 2-1 in the SWPPP does not indicate metal storage or wooden pallet storage in this area of the facility.

- d. Site Map (Figure 2 of the SWPPP):
  - i. During EPA's inspection, EPA observed pallets and the storage of metal material in the loading dock area east of the main production building (see Photographs 5 and 7 in Attachment A). The storage/presence of these materials is not identified in the SWPPP's site map.
  - ii. EPA learned during the inspection that the facility uses argon, oxygen, carbon dioxide, and nitrogen in its metal fabrication production and those compounds are stored in the loading dock area east of the main production building (Photograph 7 in Attachment A). The storage of these materials is not shown in Figure 2 of the SWPPP.

Description: Pallet and Material Storage – East of Main Production Building

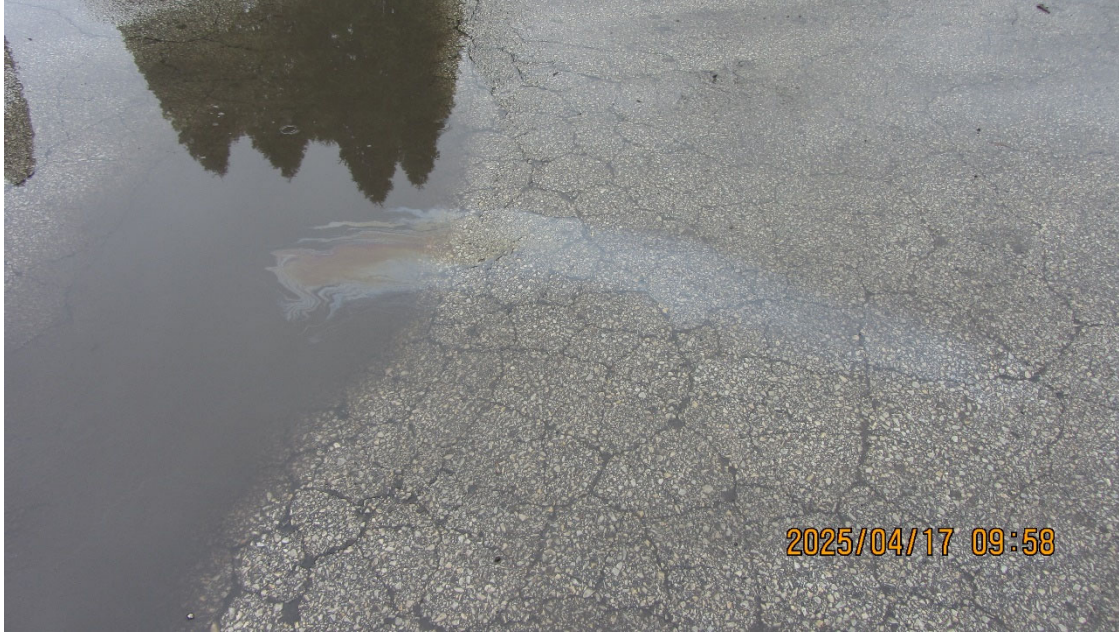
6: IMG\_0984

1. Housekeeping Issues: During the inspection, EPA observed the following housekeeping issues:
  - a. Uncovered scrap metal dumpster and roll-off boxes near main production area and the machine shop. Part 2.1.2.2.c requires dumpster lids closed when not in use. Note that for dumpsters and roll off boxes that do not have lids and could leak, the facility would need to ensure that discharges have a control (e.g., secondary containment, treatment). EPA is unclear if those dumpsters/roll boxes could leak.
  - b. During the inspection, EPA observed an oil sheen east of main production building (Photograph 6 in Attachment A). EPA is unclear when this oil was

leaked from a vehicle or other facility equipment. Note that Part 2.1.2.2 requires the facility to keep clean all exposed areas that are potential sources of pollutants.

Description: Oil Sheen

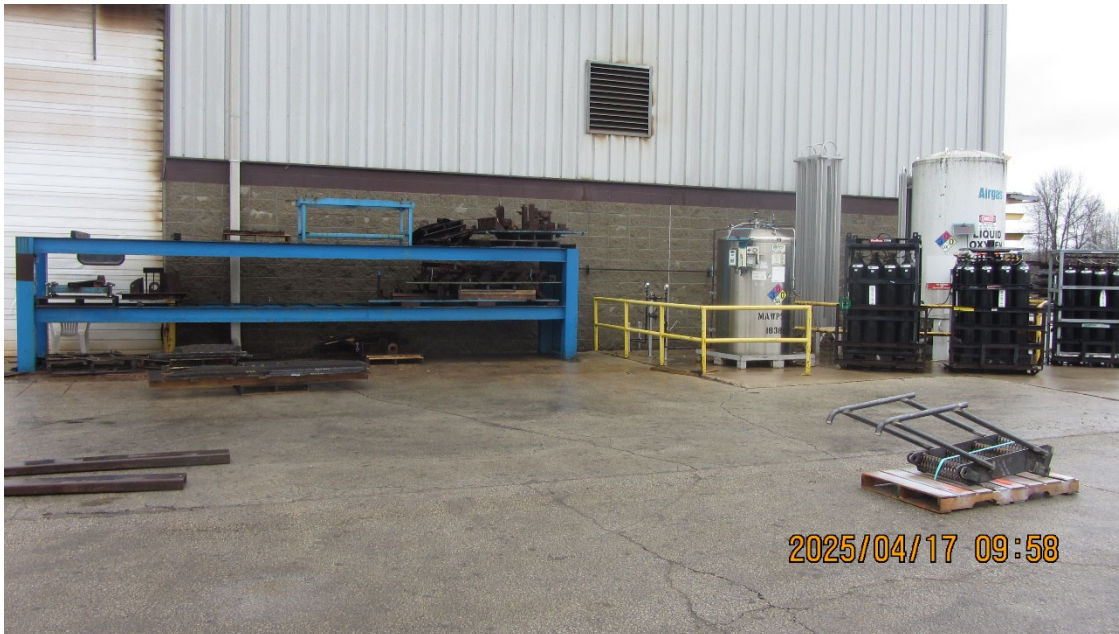
7: IMG\_0985

Description: Liquid Oxygen and Other Production Materials Storage Tanks

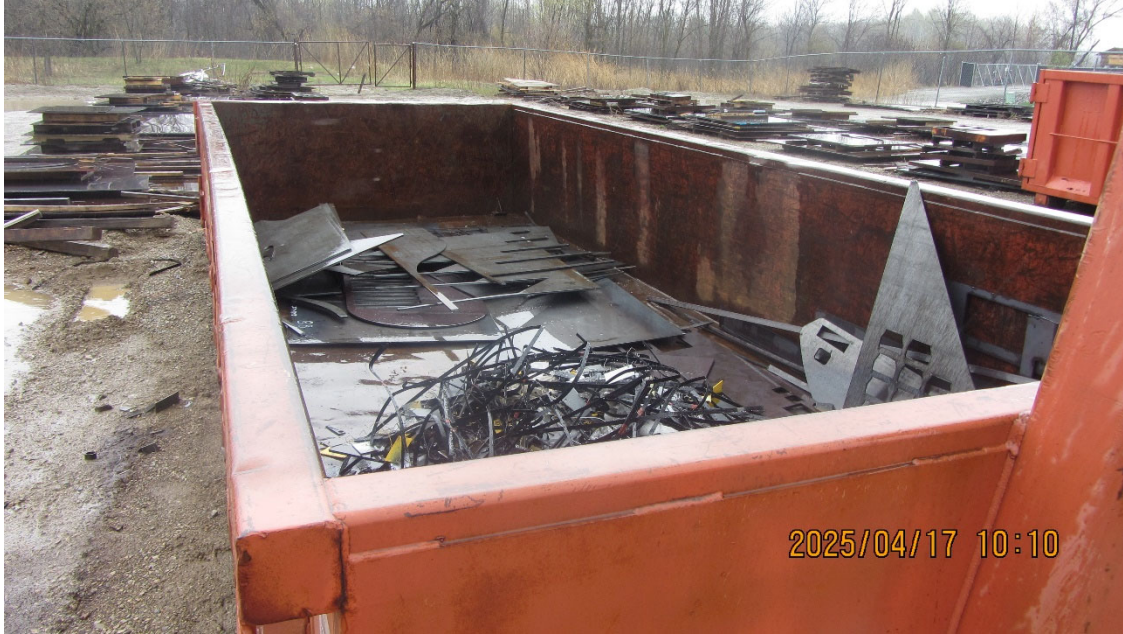
14: IMG\_0992

Description: Scrap Metal Storage Roll-off Box

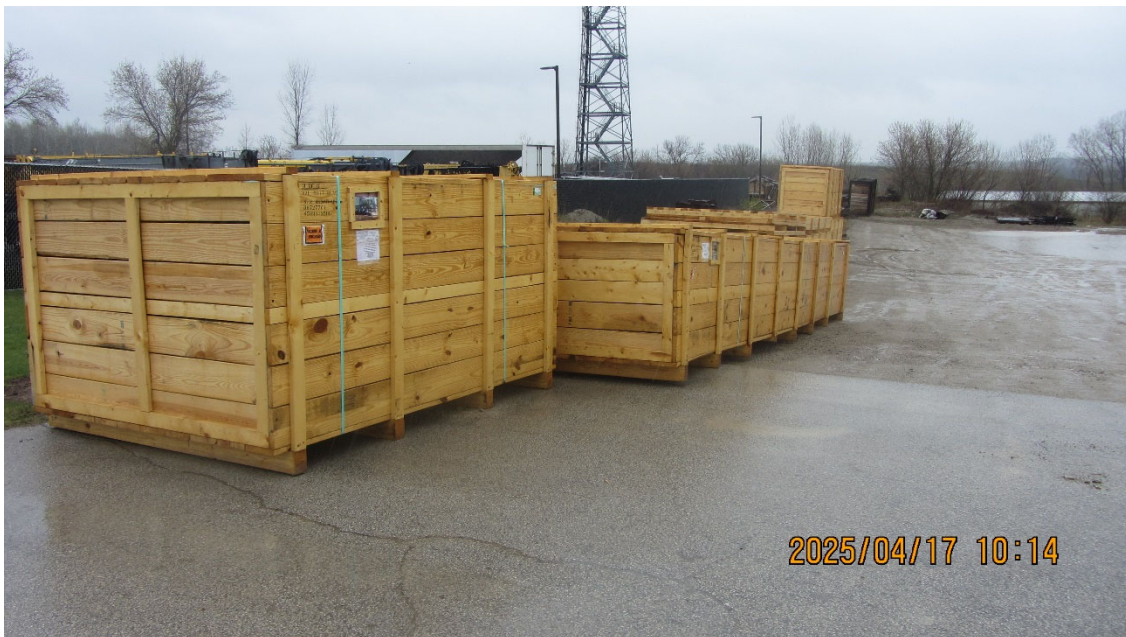
17: IMG\_0995

When reaching the north outdoor storage area of the machine shop, EPA noticed large wooden crates (Photograph 17 in Attachment A). Highview representatives informed EPA that these crates are used for shipping finished fabricated products. EPA continued walking east along the north side of the machine shop, observing pallets and other metal products stored west of the large wooden grates (Photograph 18 in Attachment A). This storage area was almost entirely gravel (with the entrance to this storage area paved). The slope of the area was towards the middle of the material storage area where nothing was stored, although given the amount of rain occurring during the inspection, EPA observed some of this runoff flowing from the ponded area to the west (Photograph 19 in Attachment A). EPA and Highview representatives then walked through a vegetated area on the east side of the machine shop, observing a small ditch than ran on the far east side of the property (Photograph 20 in Attachment A). Next, EPA and Highview representatives observed the discharge coming from the machine shop's roof downspout on the southeast corner of the site (Photographs 21, 22, and 23 in Attachment A). The quarterly visual sample and any other stormwater sample for Discharge Point 003 is taken from the roof downspout, shown in Photograph 22 in Attachment A). From here, the runoff combines with the stormwater ditch that runs on the east property boundary and flows to the stormwater detention pond to the south (Photograph 24 in Attachment A).

Description: Gate – Shipping Crate Storage Area

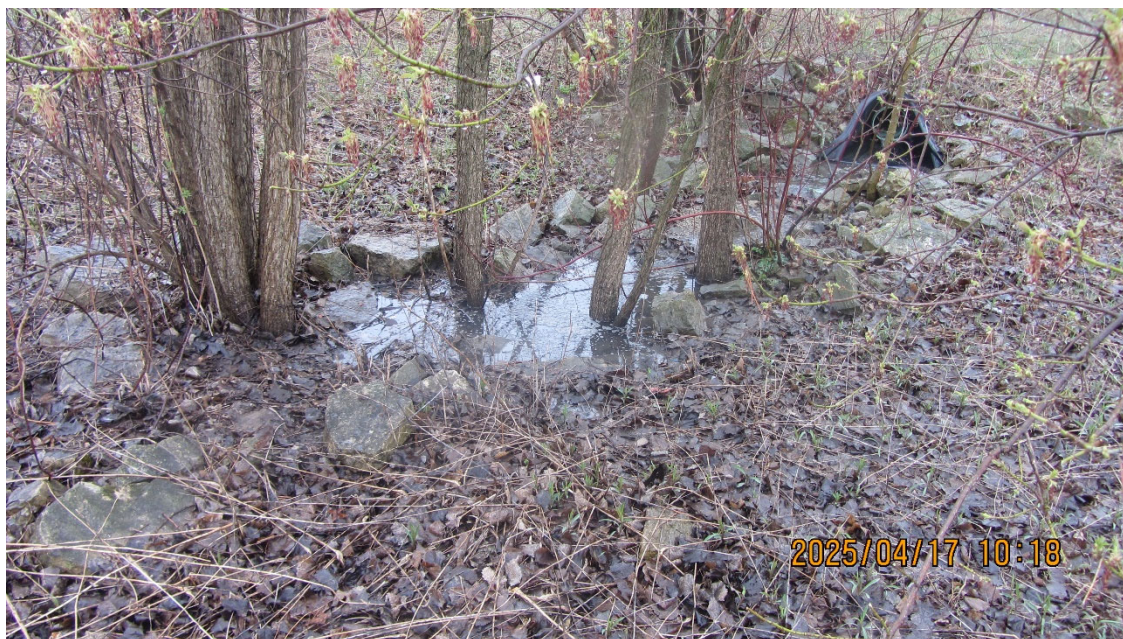
21: IMG\_0999

Description: Flow from Machine Shop Roof Downspout/Discharge Point 003

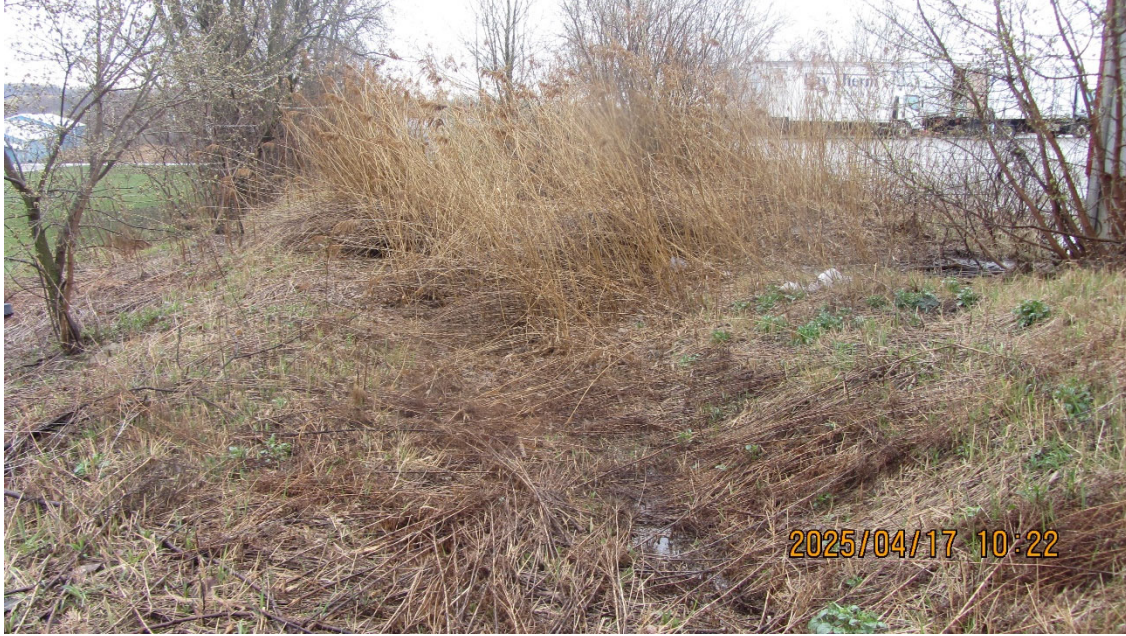
24: IMG\_1002

Description: Flow Path Downstream of IMG\_1001 to Stormwater Pond

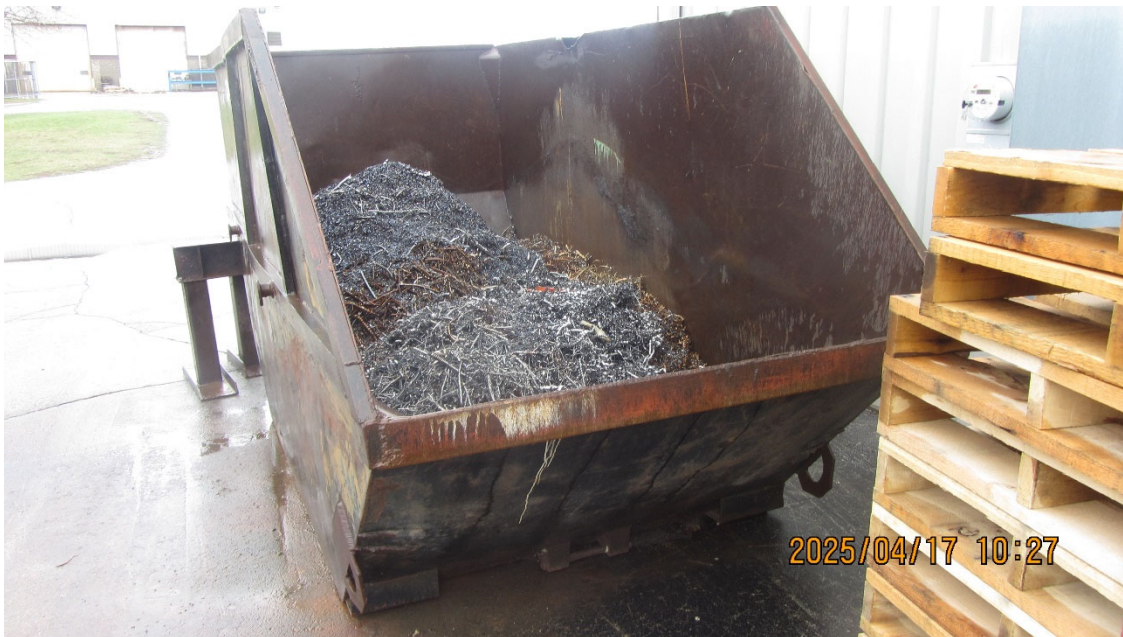
27: IMG\_1005

EPA and Highview representatives then walked to the west to walk-through the southern portion of the machine shop. This area of the outdoor storage was gravel, except for the entrance from Bayview Drive. In this location, EPA observed additional shipping material and finished product storage, all exposed to stormwater (Photograph 25 in Attachment A). In the low point of this storage area, the facility had constructed a stormwater inlet (Photograph 26 in Attachment A) to drain the area to the roof downspout shown in Photograph 22 in Attachment A). EPA also observed an uncovered scrap metal dumpster in this area shown in Photograph 27 of Attachment A).

Description: Gate – Scrap Metal Dumpster

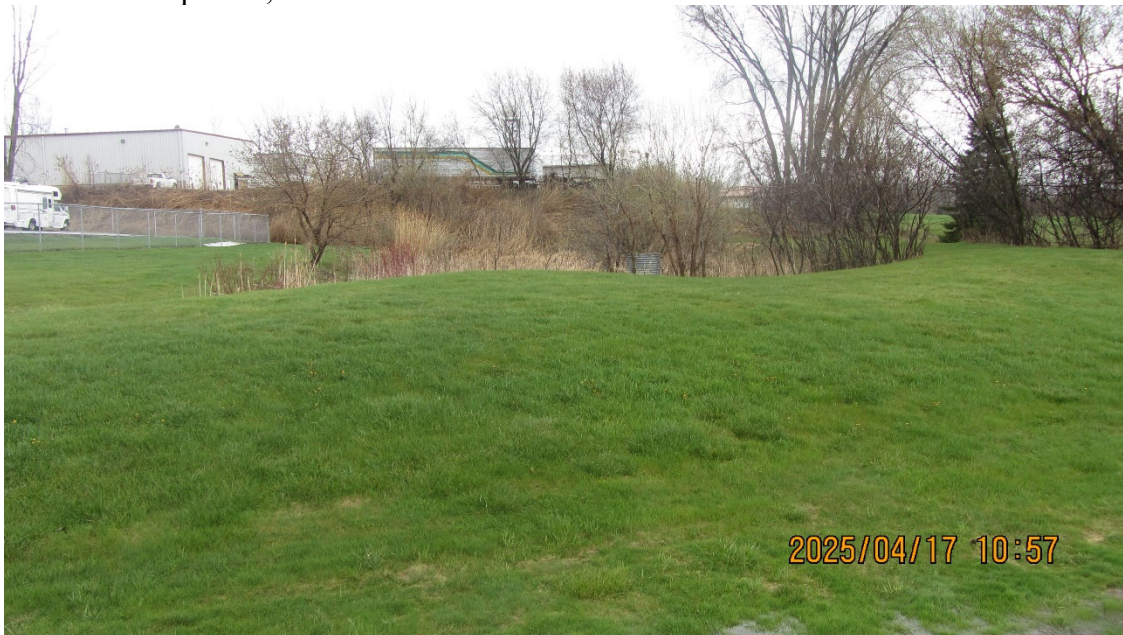
33: IMG\_1011

Court, EPA observed the stormwater detention pond north of Wisconsin State Route 54 (Photograph 33 in Attachment A). EPA observed that the stormwater ditch along Wisconsin State Route 54 did not flow into the stormwater detention pond. The discharge pipe from the stormwater detention did flow into the stormwater ditch (Photographs 34 and 35 in Attachment A). From this point, it appeared that the roadside stormwater ditch continued along Wisconsin State Route 54 to the east.

3. Stormwater Pond: During the inspection, EPA learned that the stormwater runoff from the Discharge Area 003 drains into a stormwater pond, constructed in 2007. EPA is unsure whom owns and maintains this stormwater pond.

Description: Stormwater Pond
