# **NPDES Reconnaissance Inspection Report**

**Superior Systems, Inc.**

**EPA Unpermitted No. WAU000671**

**Reconnaissance Inspection Date: September 12, 2023**

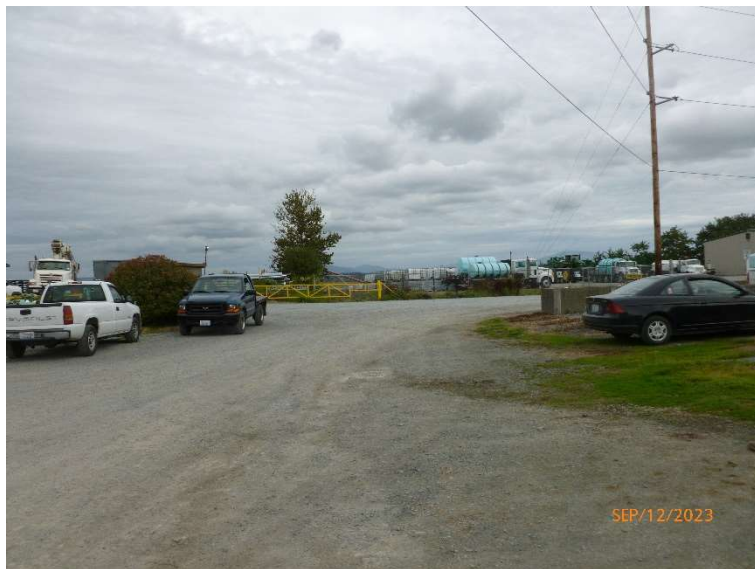
Photo 1: P1010483

The SSI Facility truck entrance is located near the CB-A3 portion of the WEC's CB A1-A3 stormwater drainage system segment that drains and discharges under the SSI-area access road to the WEC biofiltration swale located on the north side of the SSI access road (**Photo 1**).

WEC West Boundary – Catch Basin A2 (center) – Looking north

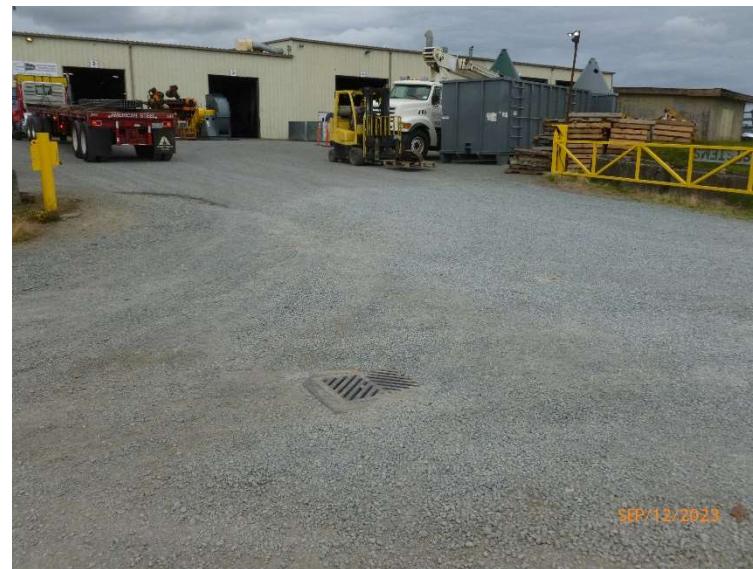
Photo 2: P1010484

We walked down the asphalt-surfaced SSI Facility truck entrance that drains toward the WEC CB-A3 (**Photo 2**). Photo 2 also details what inspectors observed on-site – Facility roof downspouts can be observed on the industrial portion of the building which downspouts outlet and discharge to the eastern sloping area towards the WEC property line.

SSI Truck Entrance – WEC Catch Basin A3 – Looking West

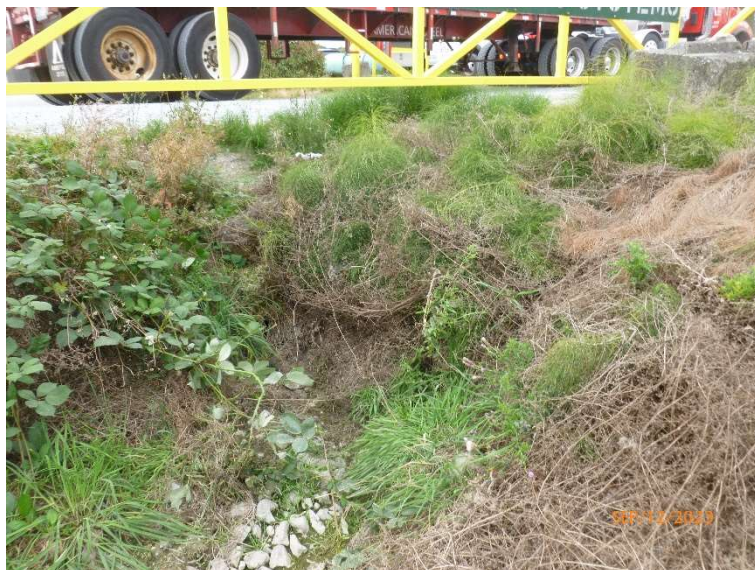
Photo 3: P1010485

We walked down into the infiltration swale where I showed Mr. Wolfe the large discharge culvert pipe extending and discharging from a westerly direction from the east-facing swale embankment of the SSI Facility (**Photo 4**). At this junction of the two biofiltration swale segments (**Photo 3**), the swale flows in an easterly direction (**Photo 5**) and **Photo 6** shows the western biofiltration swale segment, with the chain-link fence on the SSI/WEC border along the western swale segment.

Catch Basins A1-A3 Confluence with Biofiltration Swale – Looking South/SW

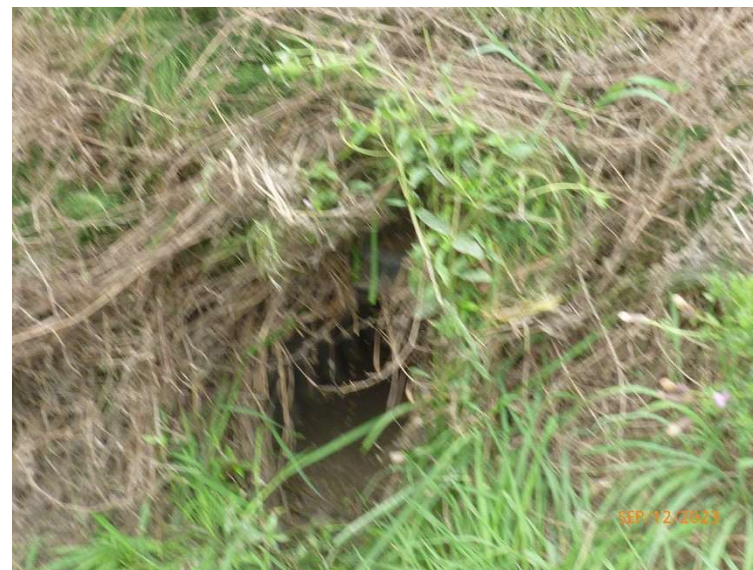
Photo 4: P1010486

Sheet 5 shows an existing 8" diameter culvert entering the existing north-side road access swale from a southerly direction which is likely the outlet culvert for the WEC's CB A1-A3 stormwater discharge system segment. Sheet 5 also shows an existing 24" diameter culvert entering the existing north-side road access swale from a westerly direction (i.e., east-facing embankment) from the SSI Facility site (**Photo 4**).

Discharge Pipe from East-facing Swale Embankment on Superior Systems' Side –  
Looking west

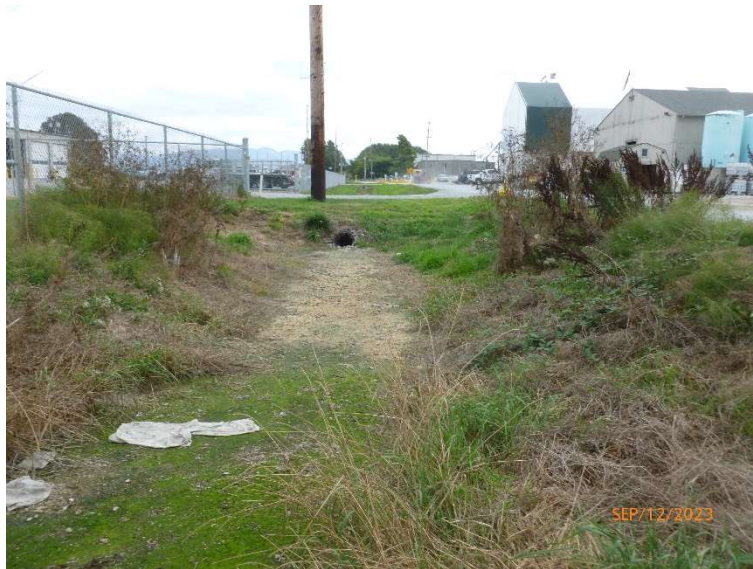
Photo 5: P1010487

Biofiltration Swale at Junction with Swale's North Leg - Looking east

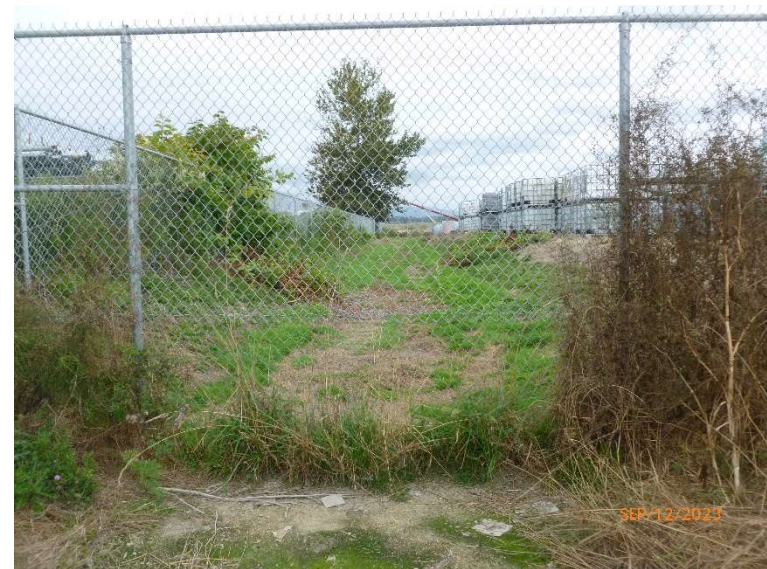
Photo 6: P101488

WEC Biofiltration Swale on WEC/SSI Border – Looking north

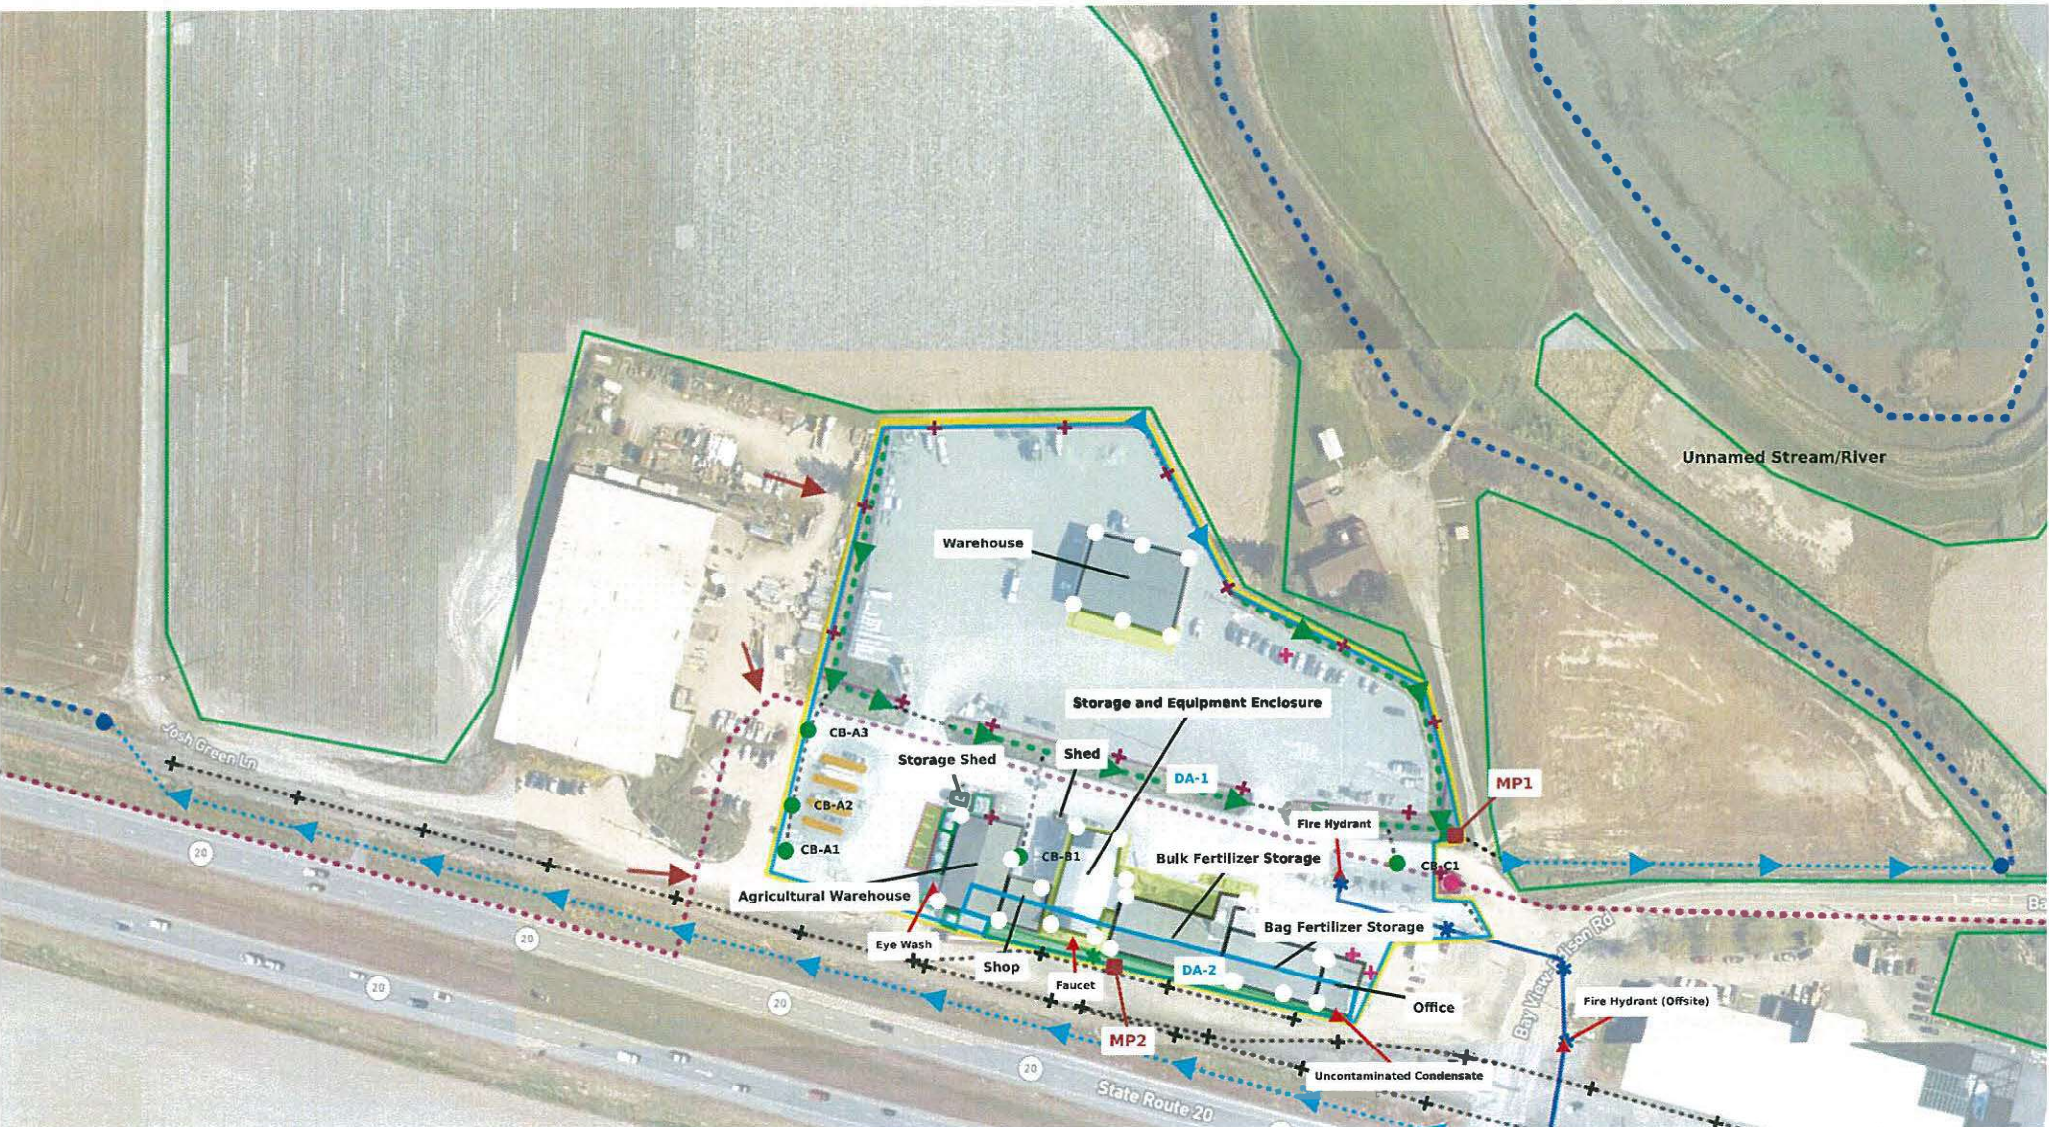
**ATTACHMENT B – WEC 2020 SWPPP, Figure 2 – Site Layout**

The WEC's Site Layout map also three large red arrows on the SSI Facility facing in a generally easterly or southeasterly direction from the SSI Facility towards the WEC facility. The Site Layout map legend identifies these red arrows as depicting potential SSI Facility stormwater run-on to the WEC facility. As additional background, the WEC's August 2020 SWPPP, Part 2.2.2, Discharge Locations (p.11), includes the following narrative:

Potential run-on to the western portion of the [WEC] Facility may occur from the adjacent industrial facility: Superior Systems Inc. This run-on may include potential pollutants including solids/turbidity, oil sheen, and metals. Site grading generally prevents potential run-on from other areas of the [WEC] Facility.

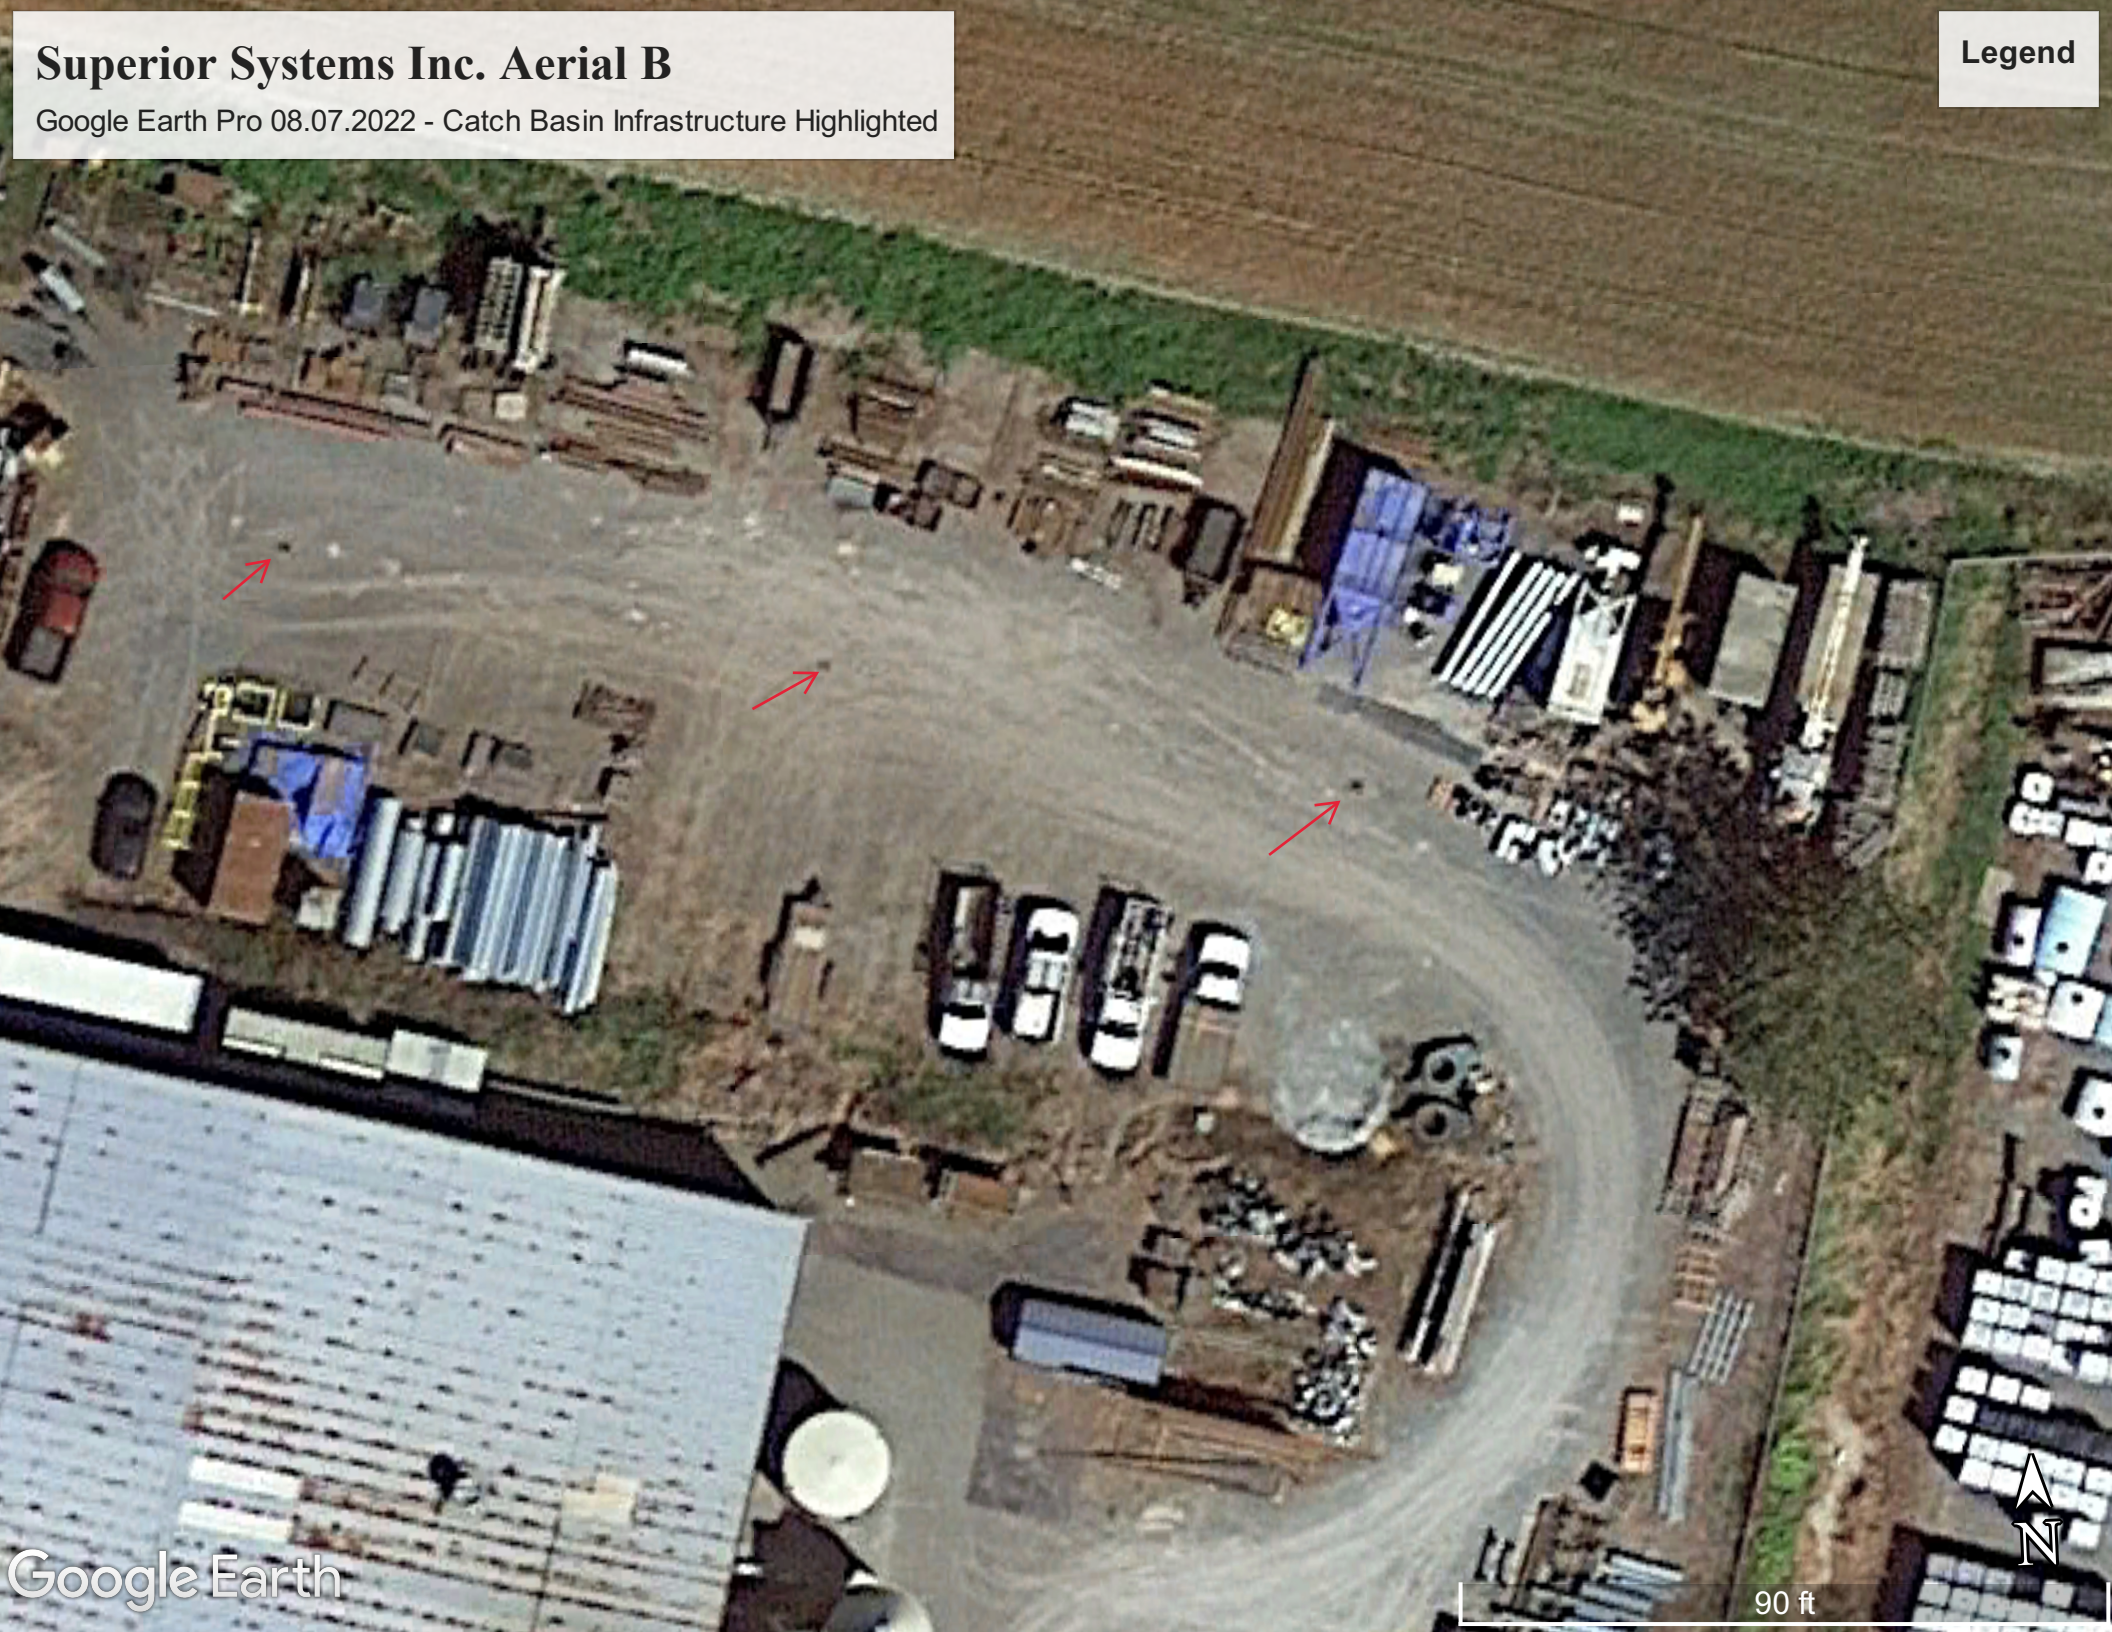
We also walked the northern area of the Facility site, along the northern-located equipment and material storage areas. We observed 3 stormwater catch basins (CB), spaced approximately 75 feet apart, running in an east-west direction along the gravel travel area of the SSI Facility's northern material storage areas. *See*, Attachment C, Superior Systems Inc. Aerial B (three red arrows pointing to CB locations (Google Earth Pro 08.07.2022)).

I observed that the first CB located on the western end of this 3-CB segment appeared to have no inlet pipe on the south, west and north sides and only one outlet on the east side of the basin. Additionally, the eastern most CB appeared to be about 75 feet from the SSI Facility's eastern chain link fence line abutting the WEC biofiltration swale. I walked to the eastern edge of the SSI Facility, just south of the large tree pictured in Photo 6, and viewing the grade through tall, stalked weed growth, there is an approximate 4'-5' downward slope (i.e., gradual drop-off) towards and then under the fence to the base of the WEC biofiltration swale bottom.
