**Report Title:** Clean Water Act, Section 404 Inspection Report, Groff  
**Inspection Date(s):** September 19, 2023  
**Start Time:** 9:10 AM **End Time:** 1:45 PM  
**Regulatory Program(s):** Clean Water Act, Sections 308 & 404 (33 U.S.C. §§ 1318 & 1344)

**Site Name:** Groff Site  
**Site Location:** 100 Mill Road, Turbotville, PA 17772 (Montour County)  
**Latitude:** 41.095859 **Longitude:** -76.727306  
**County/Parish:** Montour

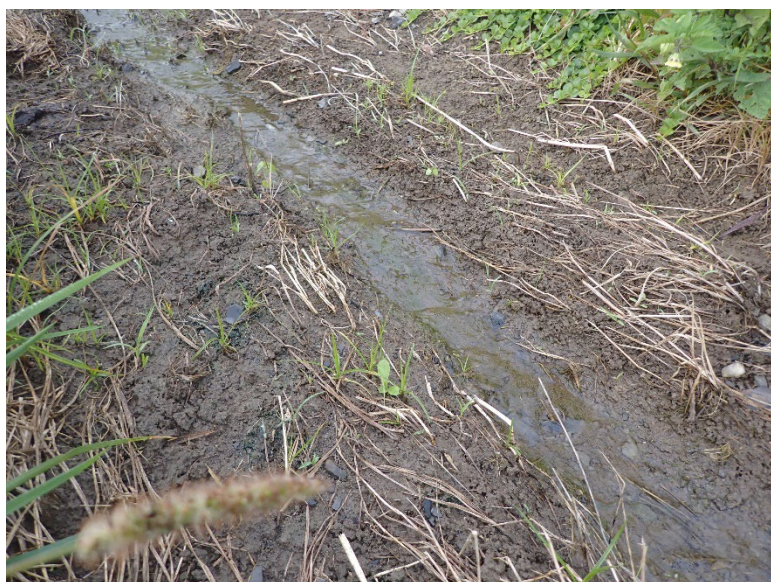
An active cornfield, that appeared to be treated with herbicide, was situated directly west of Mill Road (Photograph I.A). Flowing water containing algae was observed along the eastern edge of the corn field (Photographs I.B – I.D). Further south, the flowing water connected to an artificial swale situated on the northwest corner of Wetland 19 (Photograph I.E).

**Photograph I.C.** Flowing water between corn field and Mill Road.

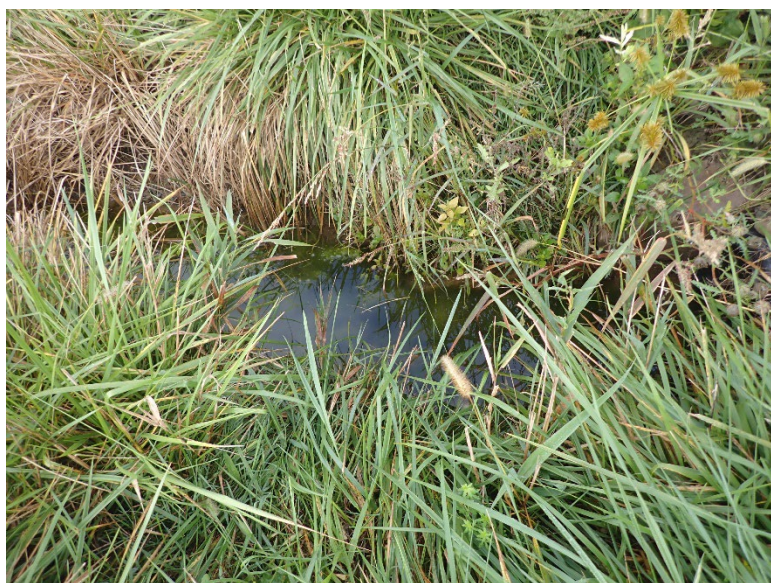
**Photograph I.D.** Flowing water with algae between corn field and Mill Road.

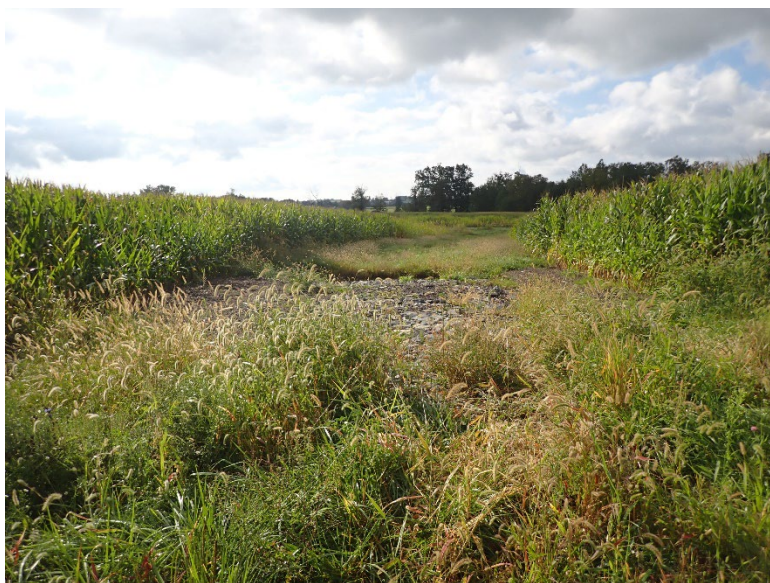
**Photograph II.A.** Swale at northwest corner of Wetland 19. Facing South.

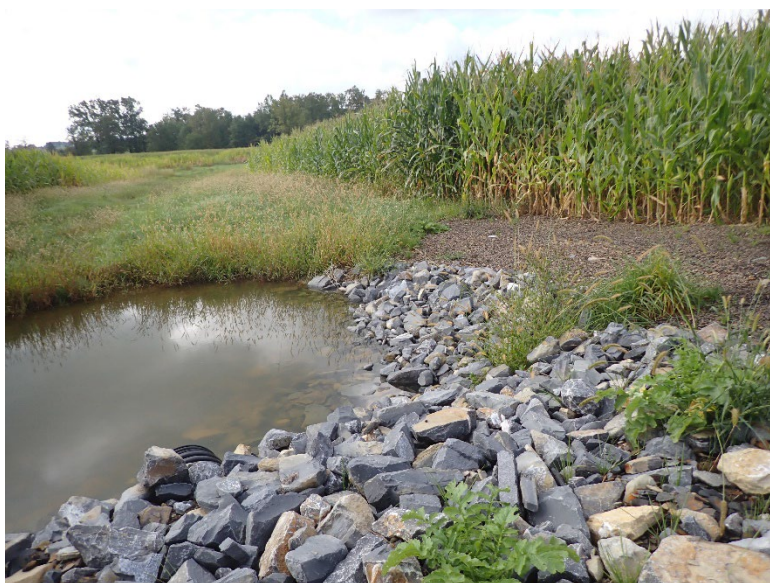
**Photograph II.C.** Swale at northwest corner of Wetland 19. Facing South.

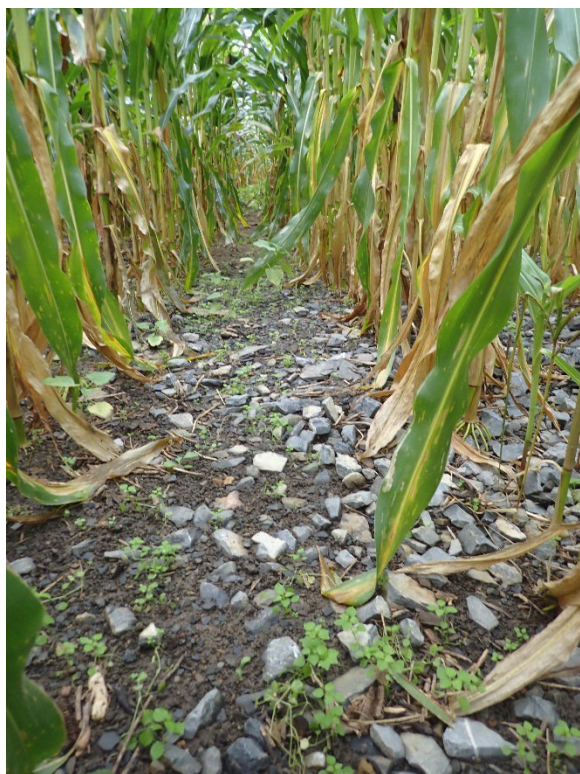
Small fish and the end of a culvert were observed in the artificial swale. Evidence of herbicide application and earth-moving activities, including tree-clearing, grubbing, and grading were observed, as Wetland 19, both east and west of the artificial swale, had been significantly disturbed and converted into an active corn field. Within the interior of the cornfield, shale fragments, adventitious roots, and a lack of tree stumps were observed (Photograph II.E – II.F).

**Photograph II.F.** Grubbed and graded interior of corn crops planted in Wetland 19.

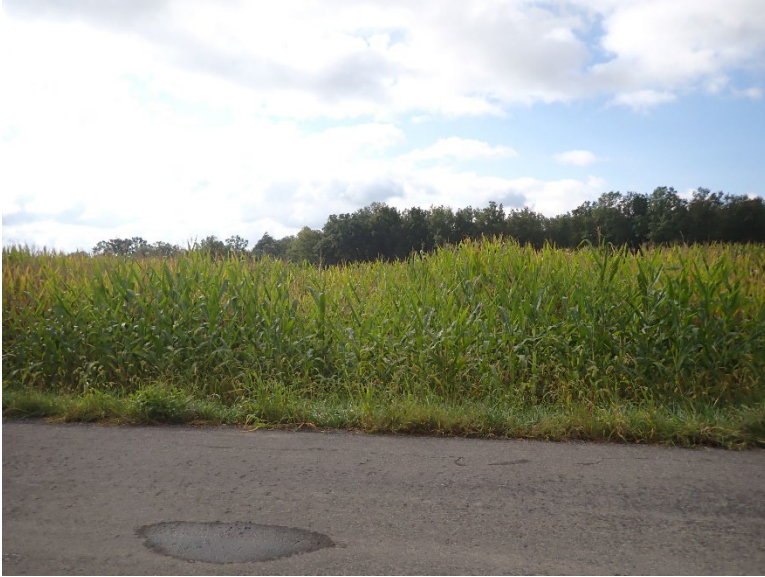
Evidence of herbicide application and earth-moving activities, including tree-clearing, grubbing, and grading were observed as Wetland 16 had been significantly disturbed and converted into an active cornfield. Stunted corn crops were also observed within Wetland 16 (Photograph III.A– III.C).

**Photograph III.B.** Active corn field within Wetland 16, facing south from Mill Road. Patches of stunted corn crops were observed.

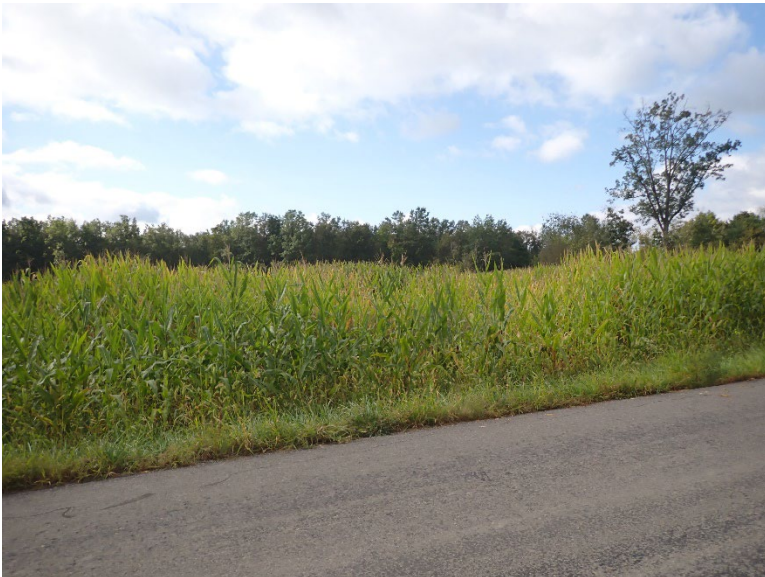
**Photograph III.C.** Active corn field within Wetland 16, facing south from Mill Road. Patches of stunted corn crops were observed.

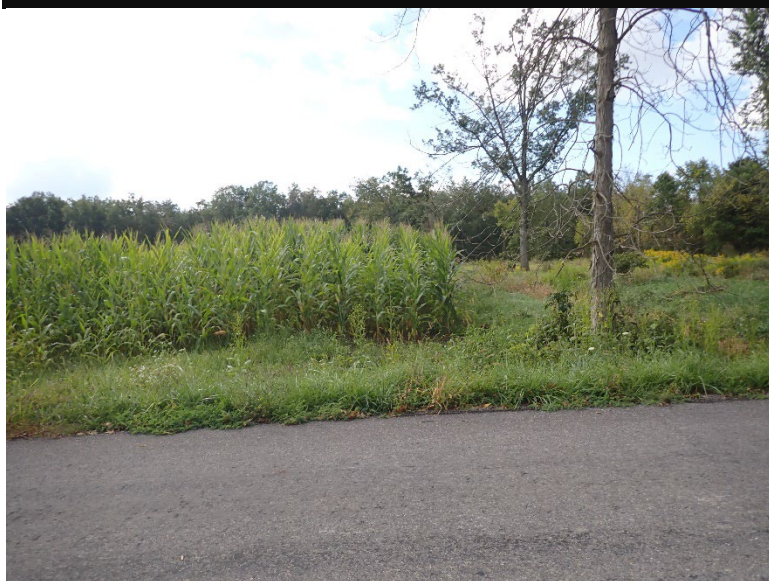
An excavated tributary, presenting exposed banks and wrack lines, flowing south along the western edge of Wetland 16, connected via a culvert situated under Mill Road, was observed (Photograph IV.A – IV.D). Reed canary grass (*Phalaris arundinacea*) and jewelweed (*Impatiens*

**Photograph IV.A.** Northwest corner of Wetland 16. Facing south from Mill Road.

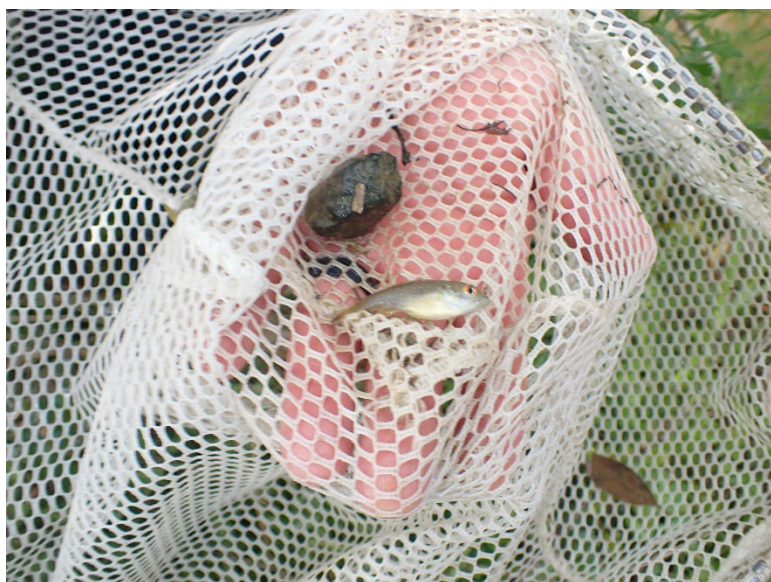
**Photograph IV.F.** Fish observed in excavated Wetland 16 tributary.

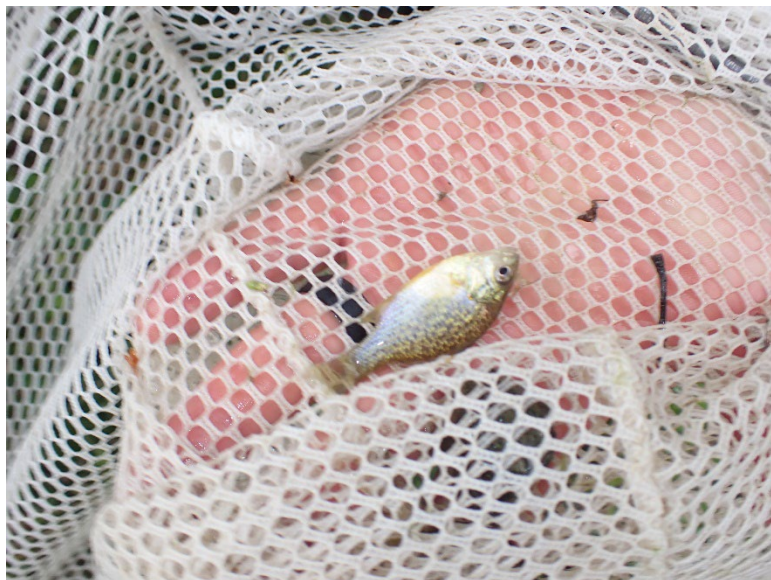
**Photograph IV.G.** Fish observed in excavated Wetland 16 tributary.

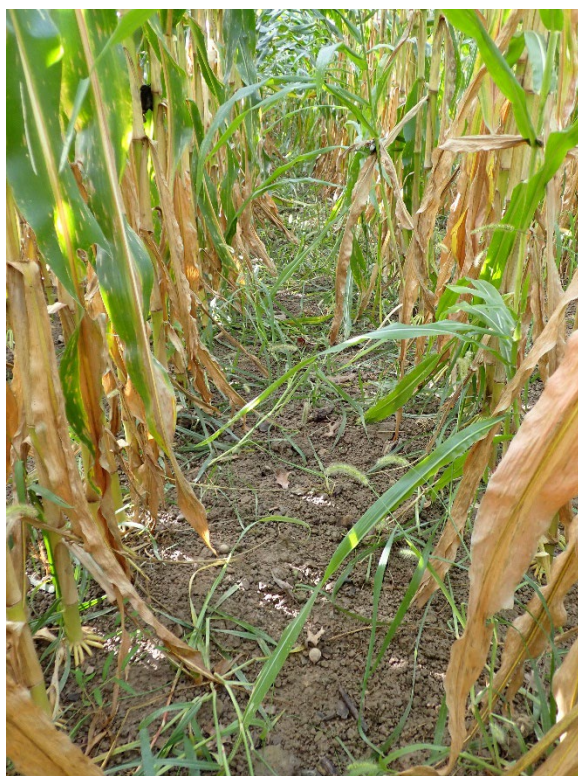
Evidence of herbicide application and earth-moving activities, including tree-clearing, grubbing, and grading were observed as Wetland 16 had been significantly disturbed and converted into an active cornfield. Surface water, adventitious corn (*Zea mays*) roots, and stunted corn crops were observed (Photograph IV.H – IV.M).

**Photograph IV.H.** Evidence of grubbing and grading within interior of corn crops planted in Wetland 16.

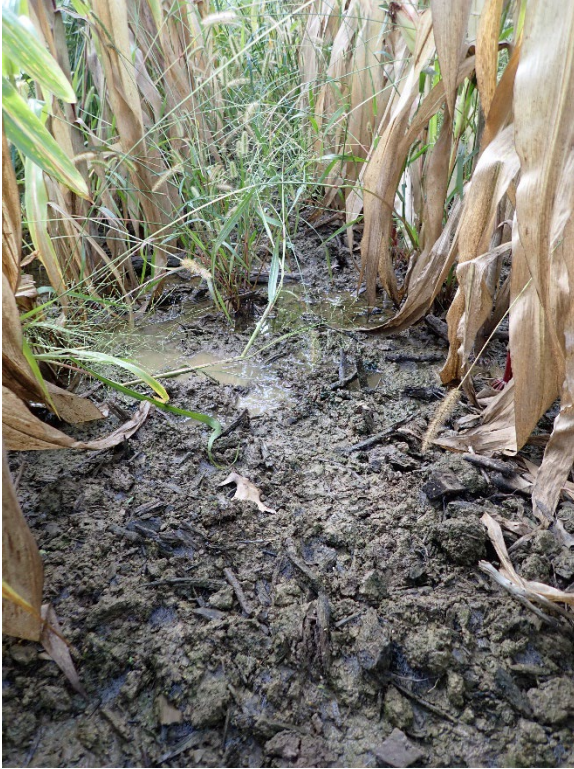
**Photograph IV.I.** Evidence of grubbing, grading, and saturated soil observed within interior of corn crops planted in Wetland 16.

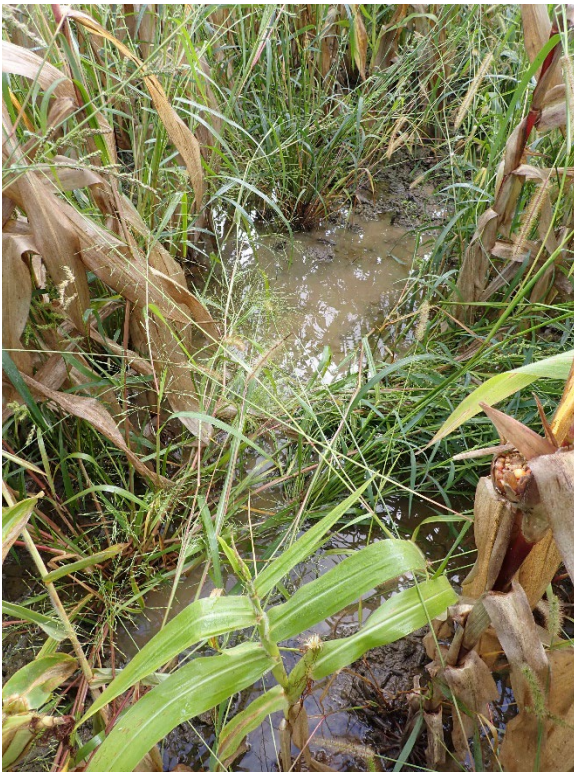
**Photograph IV.J.** Evidence of grubbing, grading, and saturated soil observed within interior of corn crops planted in Wetland 16.

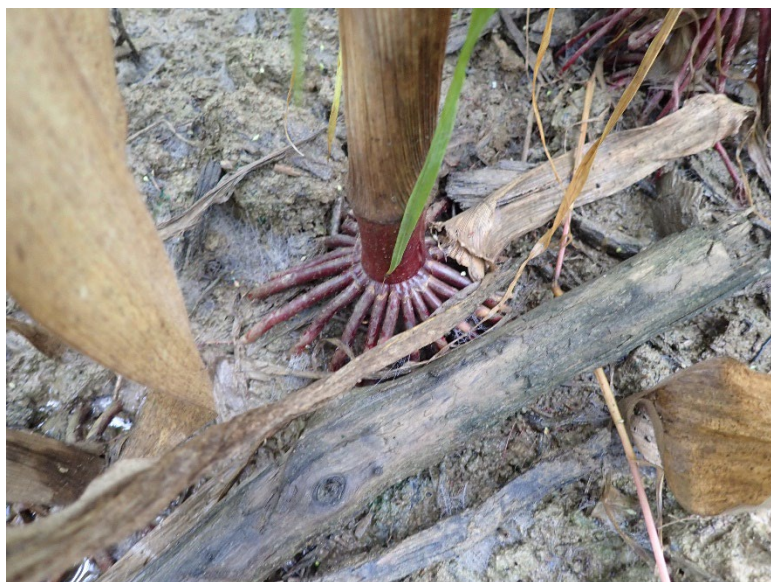
**Photograph IV.K.** Adventitious corn crop roots observed within Wetland 16.

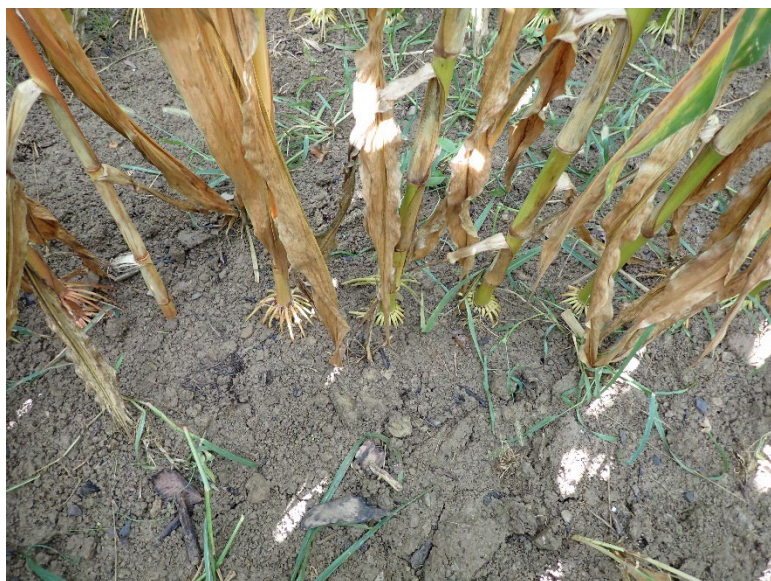
**Photograph IV.L.** Adventitious roots and dying corn crops observed within Wetland 16.

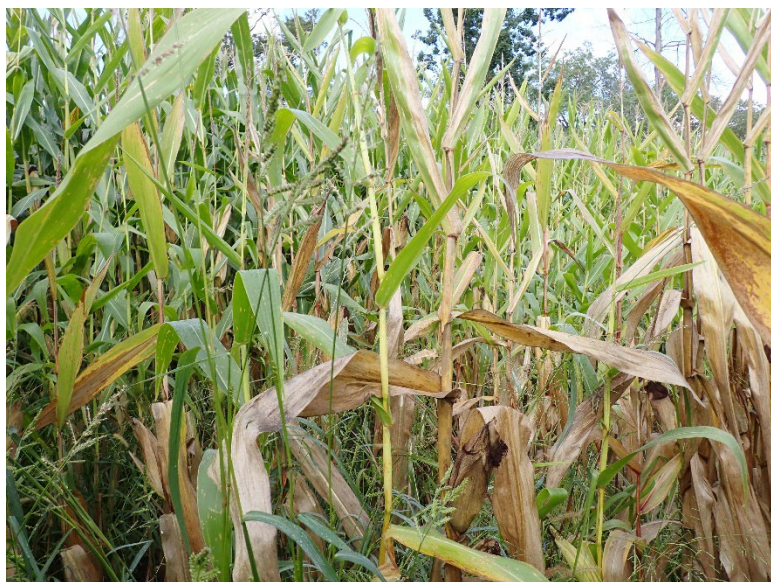
**Photograph IV.M.** Dying corn crops planted in Wetland 16.

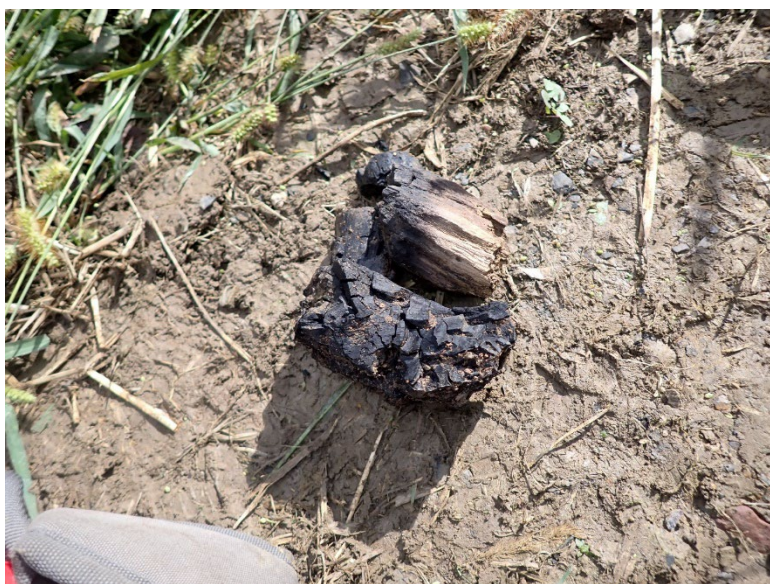
Benthic invertebrates, fish, algae, wrack lines, water-stained vegetation, and floating pondweed (*Potamogeton natans*) were observed along the excavated tributary (Photograph V.A – V.F). Evidence of earth-moving activities, including tree-clearing, grubbing, and grading were observed as burned bits of tree stumps were found within the corn field populating Wetland 16 (Photograph V.G).

**Photograph V.G.** Burned bits of tree stumps observed in Wetland 16.

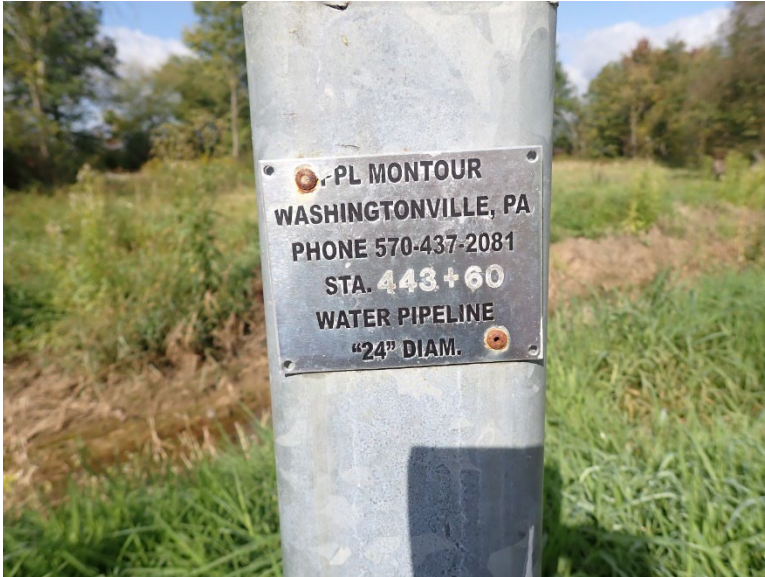
Corn crops were observed to be growing in the pipeline easement, situated directly between the southern border of Wetland 16 and the Railroad tributary. The boundary of the pipeline easement was marked by a water pipeline post (Photograph V.H – V.I).

**Photograph V.H.** Water pipeline post, marking the boundary of the easement, at south end of excavated Wetland 16 tributary.

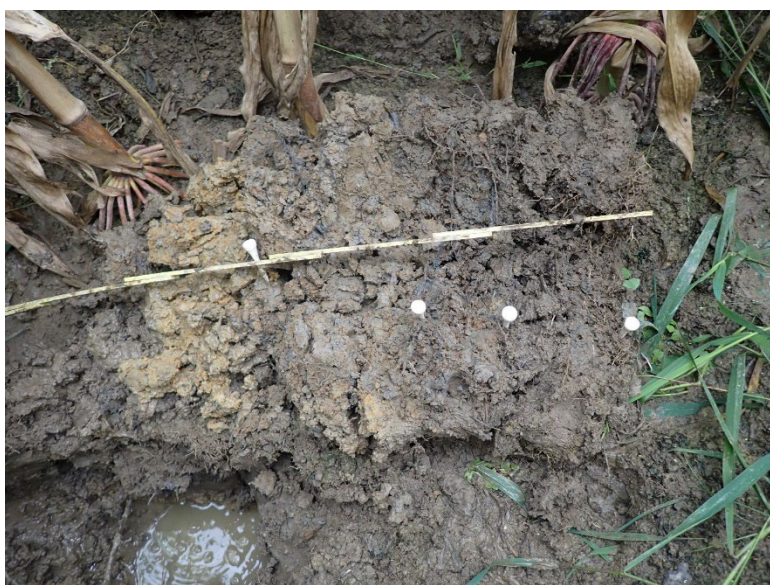
- [0-5 inches] 100% 10YR 5/2 silty soil containing many fine roots
- [5-7 inches] mixed matrix, 75% 10YR 5/1 with 25% 7.5YR 4/6 redoximorphic concentrations and oxidized rhizospheres on living roots
- [7-13 inches] mixed matrix, 65% 10YR 5/1, and 35% 7.5YR 5/6 redoximorphic concentrations and oxidized rhizospheres on living roots
- [13-18 inches] mixed matrix, 50% 10YR 5/1, and 50% 10YR 5/8 redoximorphic concentrations

**Photograph VI.F.** DP2: Soil profile.

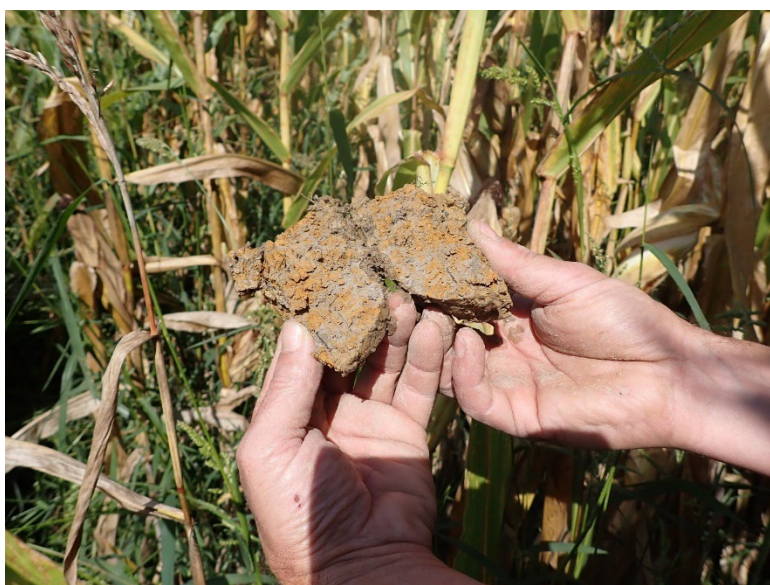
**Photograph VI.H.** DP2: Redoximorphic concentrations.

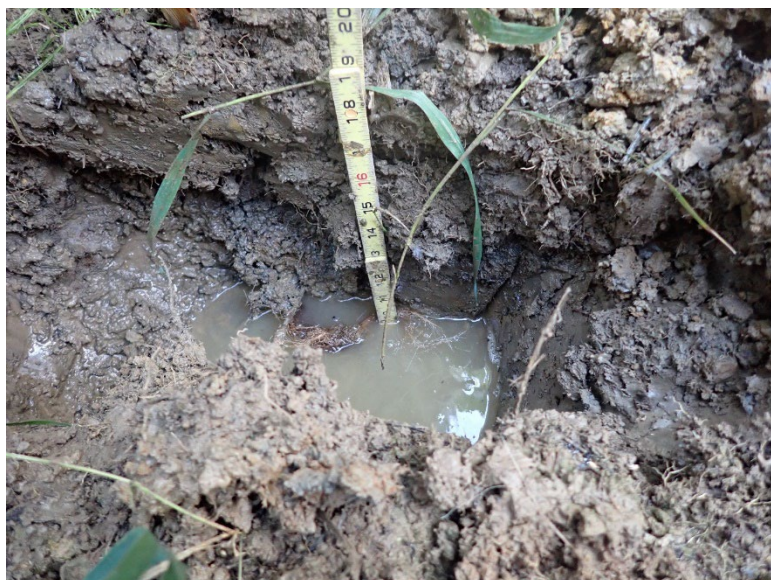
Primary indicators of wetland hydrology were observed, including a high-water table and surface water at a depth of 9.5 inches from the soil surface (Photograph VI.I – VI.J). The soil profile met the technical definition of a hydric soil (Indicator F3). The corn and rough barnyard grass (*Echinochloa muricata*) dominated the herbaceous stratum. All three parameters (i.e., vegetation, soil, and hydrology) were significantly disturbed by land clearing, grubbing, and grading.

**Photograph VI.I.** DP2: High water table observed in soil profile location.

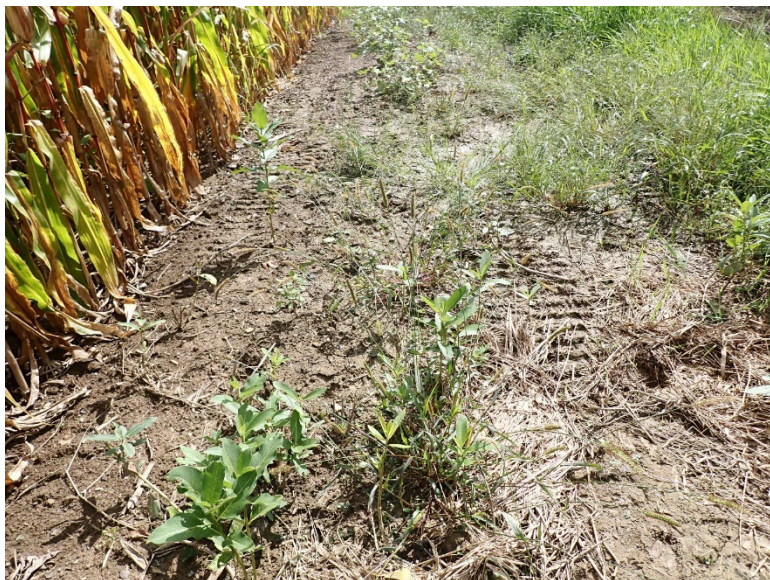
**Photograph VII.E.** Tire tracks observed in easement.

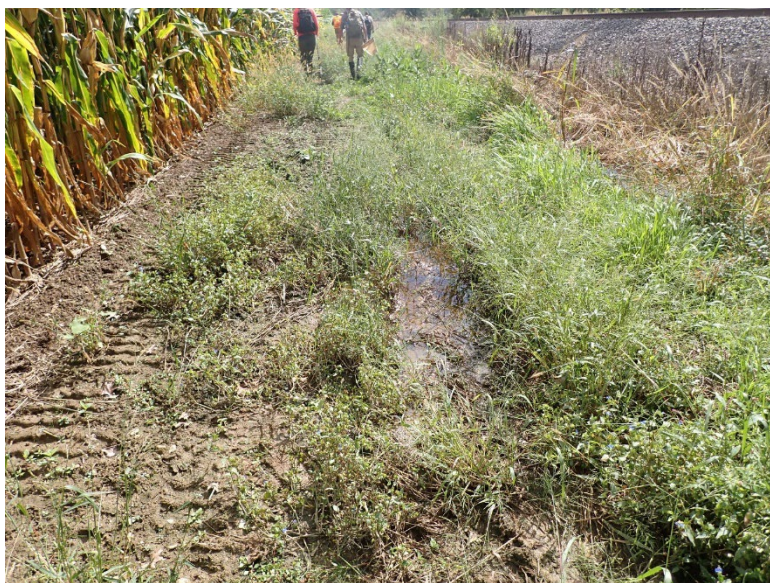
**Photograph VII.F.** Tire tracks observed in easement.

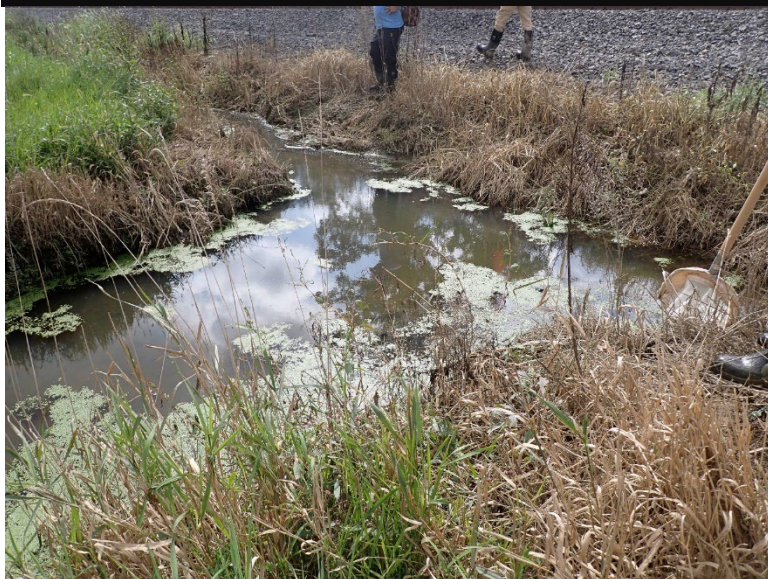
A direct connection between the two water bodies was documented in Photograph VIII.A. Flowing water, wrack lines, algae, and plow lines were observed in the area, as well as dying and stunted corn crops within Wetland 19 (Photograph VIII.B – VIII.I).

**Photograph VIII.A.** Confluence of Railroad tributary and excavated Wetland 19 tributary. Facing south.

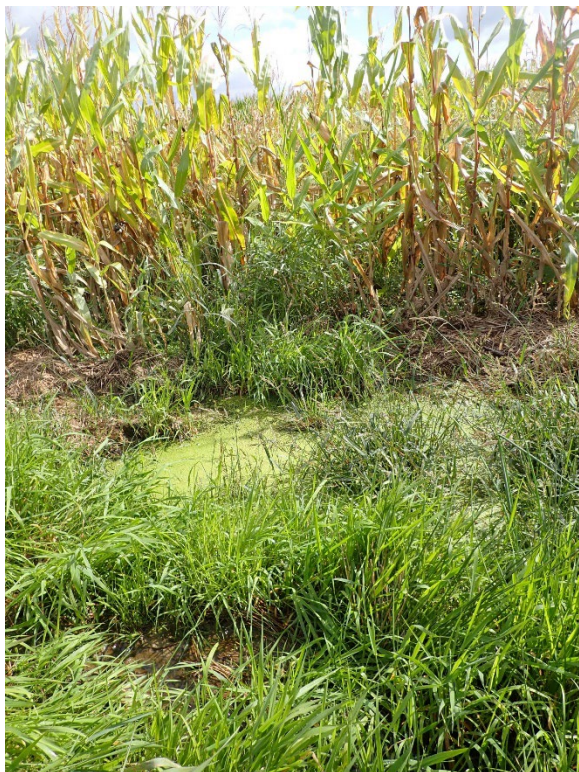
**Photograph VIII.G.** Surface water and algae observed along corn crops planted in Wetland 19.

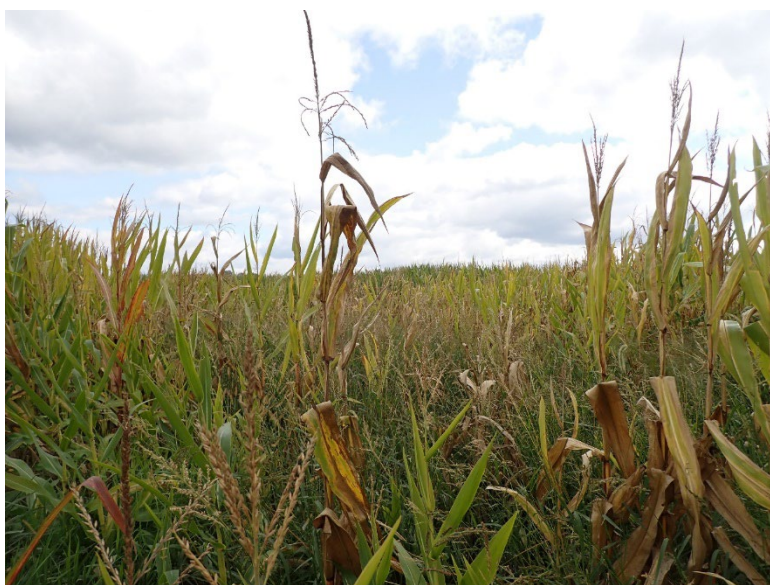
**Photograph VIII.H.** Dying and stunted corn crops planted in Wetland 19.

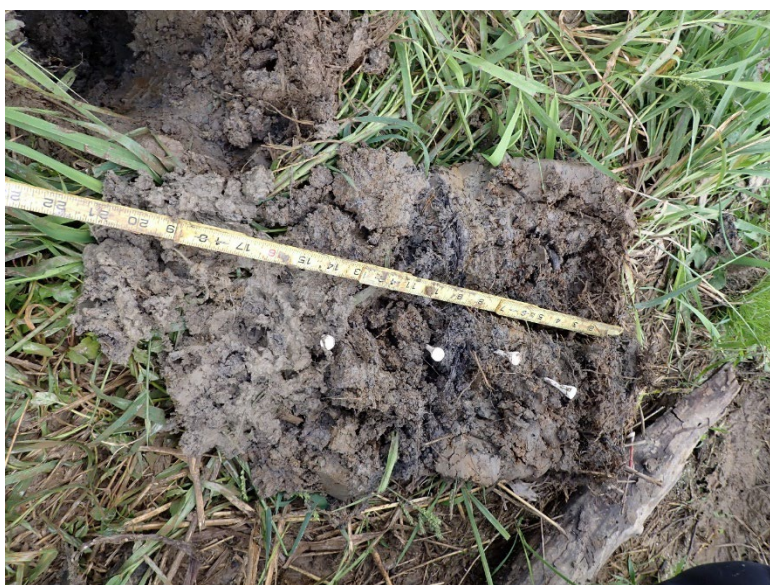
- [0-4 inches] mixed matrix: 70% 10YR 5/1 and 30% 10YR 5/6 redoximorphic concentrations with many fine roots;
- [4-7 inches] mixed matrix: 75% 10YR 5/1 and 25% 7.5YR 4/6 redoximorphic concentrations, oxidized rhizospheres on living roots, and woody debris;
- [7-10 inches] mixed matrix: 70% 10YR 5/1, 20% 7.5YR 4/6 redoximorphic concentrations, and 10% 10YR 4/1 depletion
- [10-13 inches] mixed matrix: 70% 10YR 5/1 and 30% 7.5YR 5/6 redoximorphic concentrations;
- [13-20 inches] mixed matrix, 80% 10YR 5/1 and 20% 7.5YR 5/6 redoximorphic concentrations.

**Photograph VIII.J.** DP3: Soil profile.

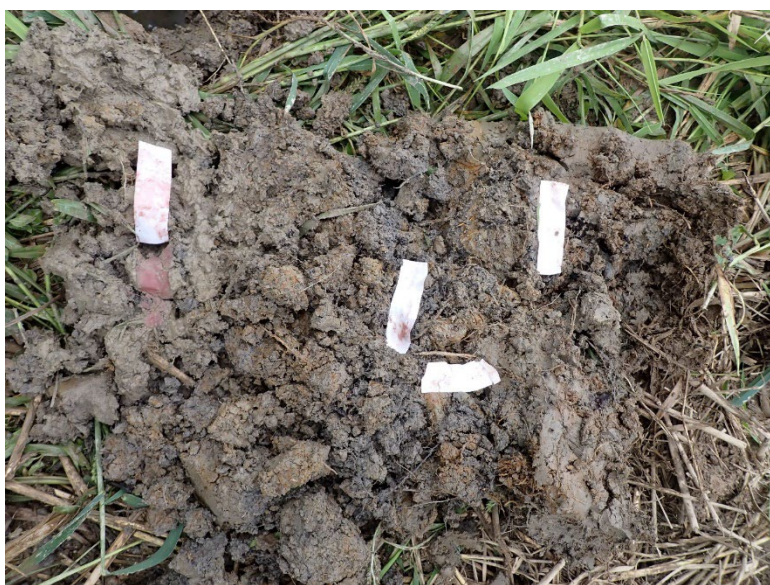
The presence of reduced iron in the soil was observed through the use of Dipyriddy paper strips on the soil profile (Photograph VIII.L – VIII.M); this satisfies the presence of reduced iron (C4) indicator for wetland hydrology. Primary indicators of wetland hydrology were observed, including a high-water table and surface water at a depth of 10 inches from the soil surface (Photograph VIII.N). The soil profile met the technical definition of a hydric soil (Indicator F3). Reed canary grass (*Phalaris arundinacea*) dominated the herbaceous stratum. All three parameters (i.e., vegetation, soil, and hydrology) were significantly disturbed by land clearing, grubbing, and grading.

**Photograph VIII.L.** DP3: Dipyrityl paper strips indicating the presence of iron in soil profile.

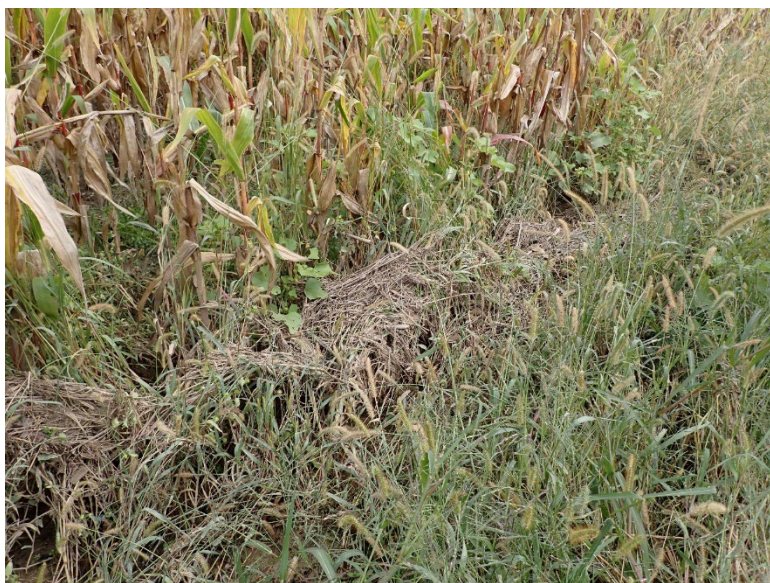
**Photograph X.F.** Wrack lines and dying corn crops observed along UNT-1.

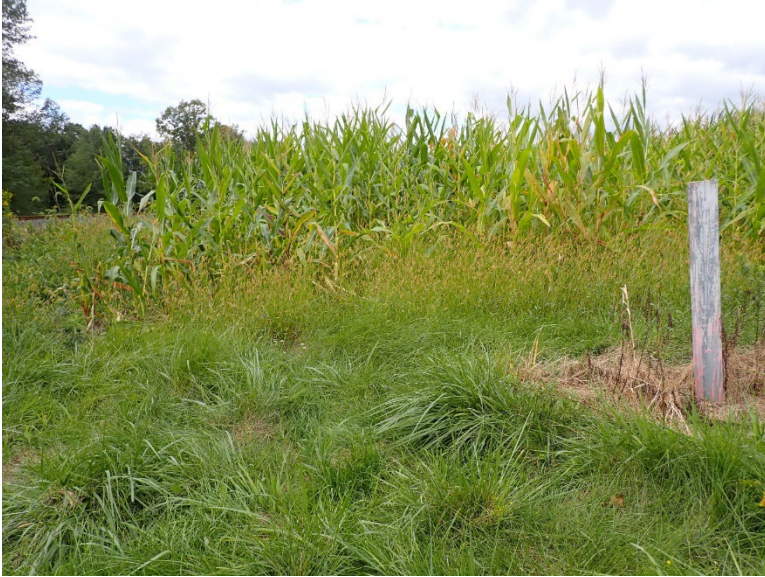
**Photograph X.G.** Active corn field planted in Wetland 19 extending into the conservation easement. Facing west from UNT-1.

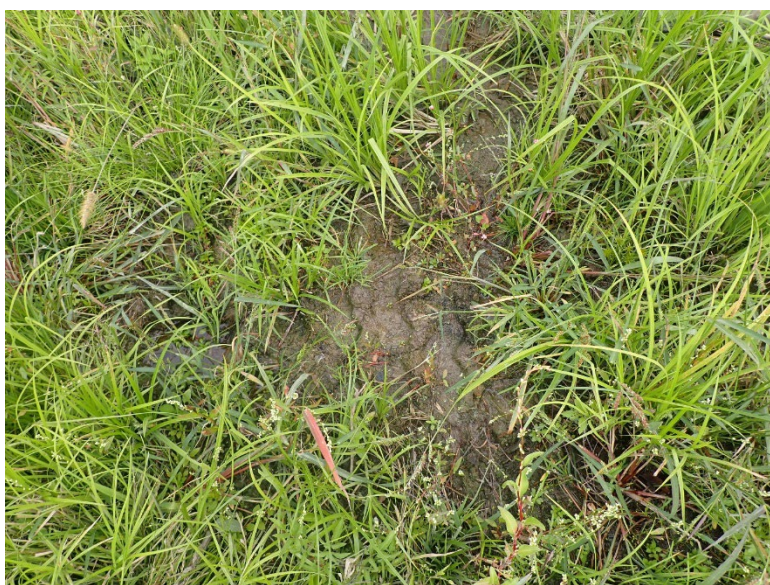
**Photograph XIII.H.** Wetland 8: tire tracks.

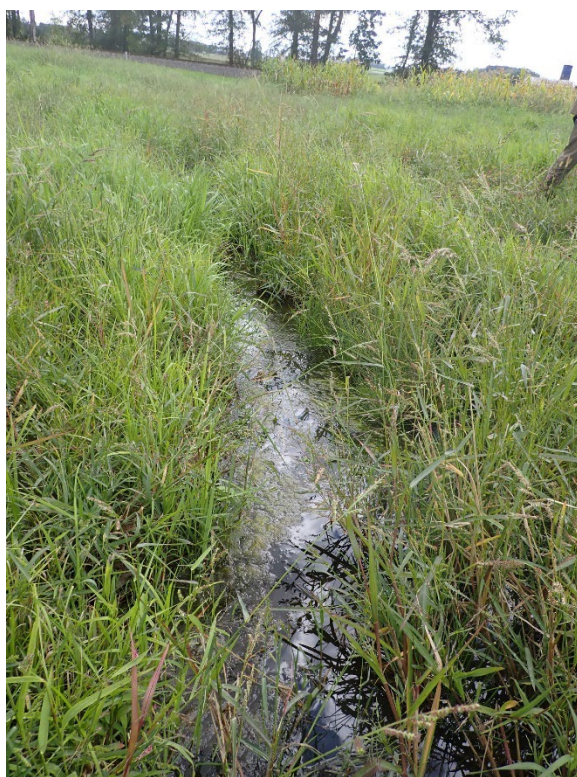
**Photograph XIII.J.** Drain line through Wetland 8. Facing south.

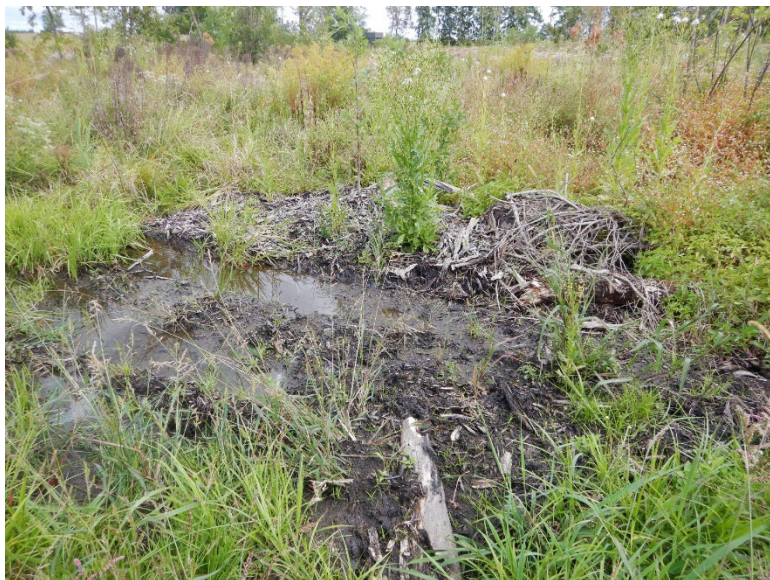
**Photograph XIII.K.** Wetland 8. Wrack lines and burned tree stumps. Facing east.

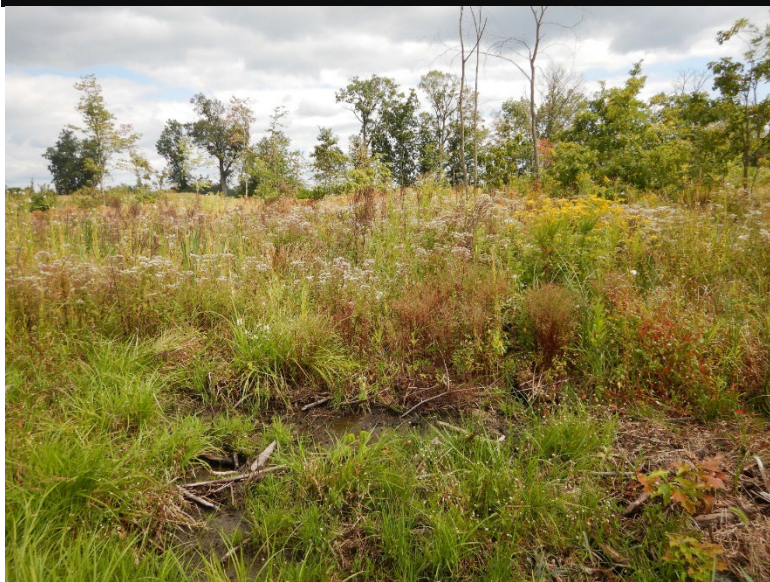
The inspection walkthrough continued to P7: the northwest boundary of Wetland 8. Evidence of tree clearing was apparent, as Wetland 8 was sparsely vegetated (Photograph XIV.A). Broadleaf cattail (*Typha latifolia*), burned tree stumps, and iron deposits in standing surface water were observed (Photograph XIV.B – XIV.E).

**Photograph XIV.A.** Evidence of tree-clearing in sparsely forested Wetland 8. Facing east.

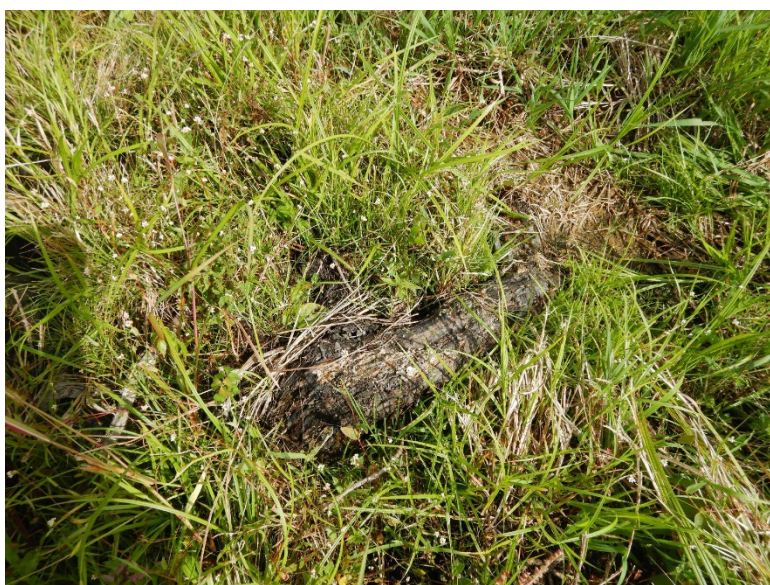
**Photograph XIV.C.** Burned tree stumps in Wetland 8.

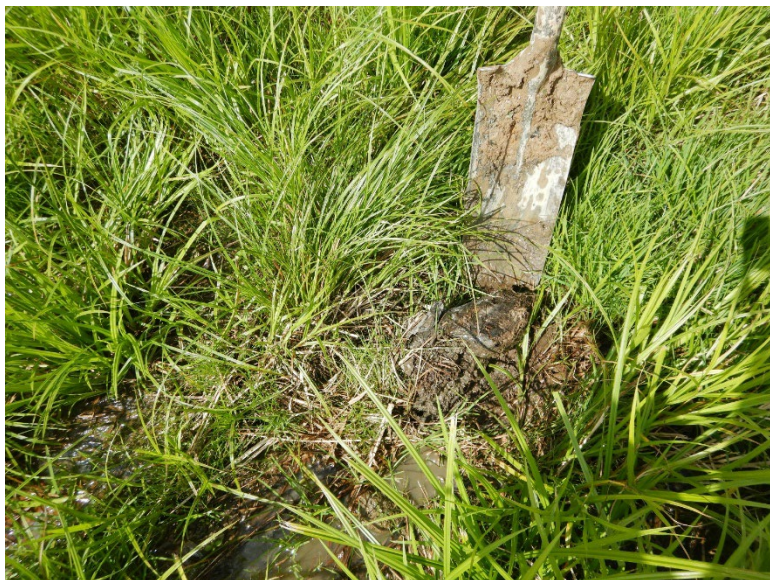
**Photograph XIV.D.** Burned tree stumps in Wetland 8.

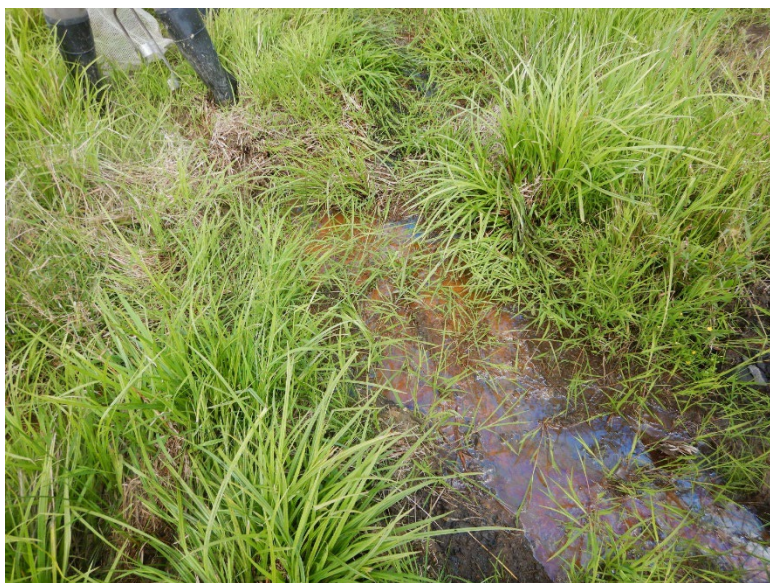
**Photograph XIV.E.** Presence of iron deposits on surface water in Wetland 8.

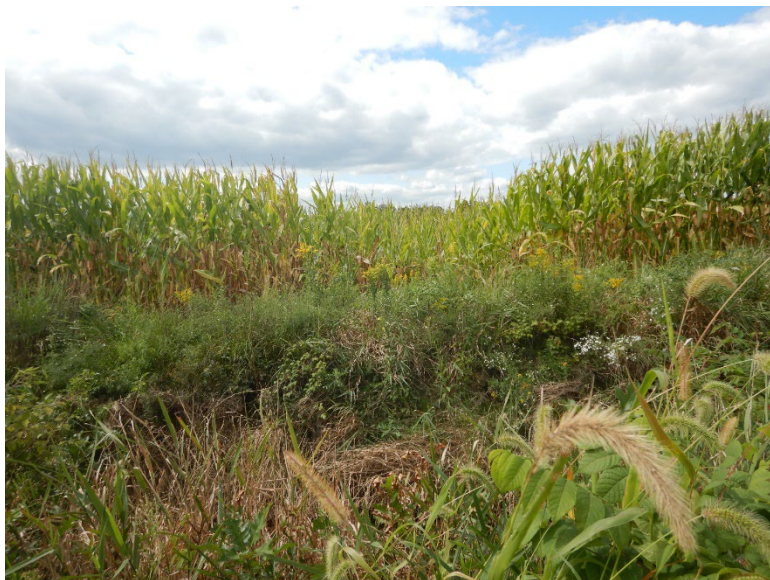
The inspection walkthrough continued to P8: the eastern side of the confluence of the Railroad tributary and UNT-1. Flowing water, wrack lines, and stunted corn crops planted in Wetland 19 were observed (Photograph XV.A – XV.E). Evidence of herbicide application and earth-moving activities, including tree-clearing, grubbing, and grading were observed as Wetland 19 had been significantly disturbed and converted into an active cornfield.

**Photograph XV.E.** Stunted corn crops planted in Wetland 19. Facing west from UNT-1.
