King Ranch, Inc./King Ranch Feedyard  
Inspection Date 09/19/2022

**Region 6 - Enforcement & Compliance Assurance Division**  
**INSPECTION REPORT**

| Facility Name: | <b>King Ranch Feedyard (27.516069, -97.972834)</b> | |

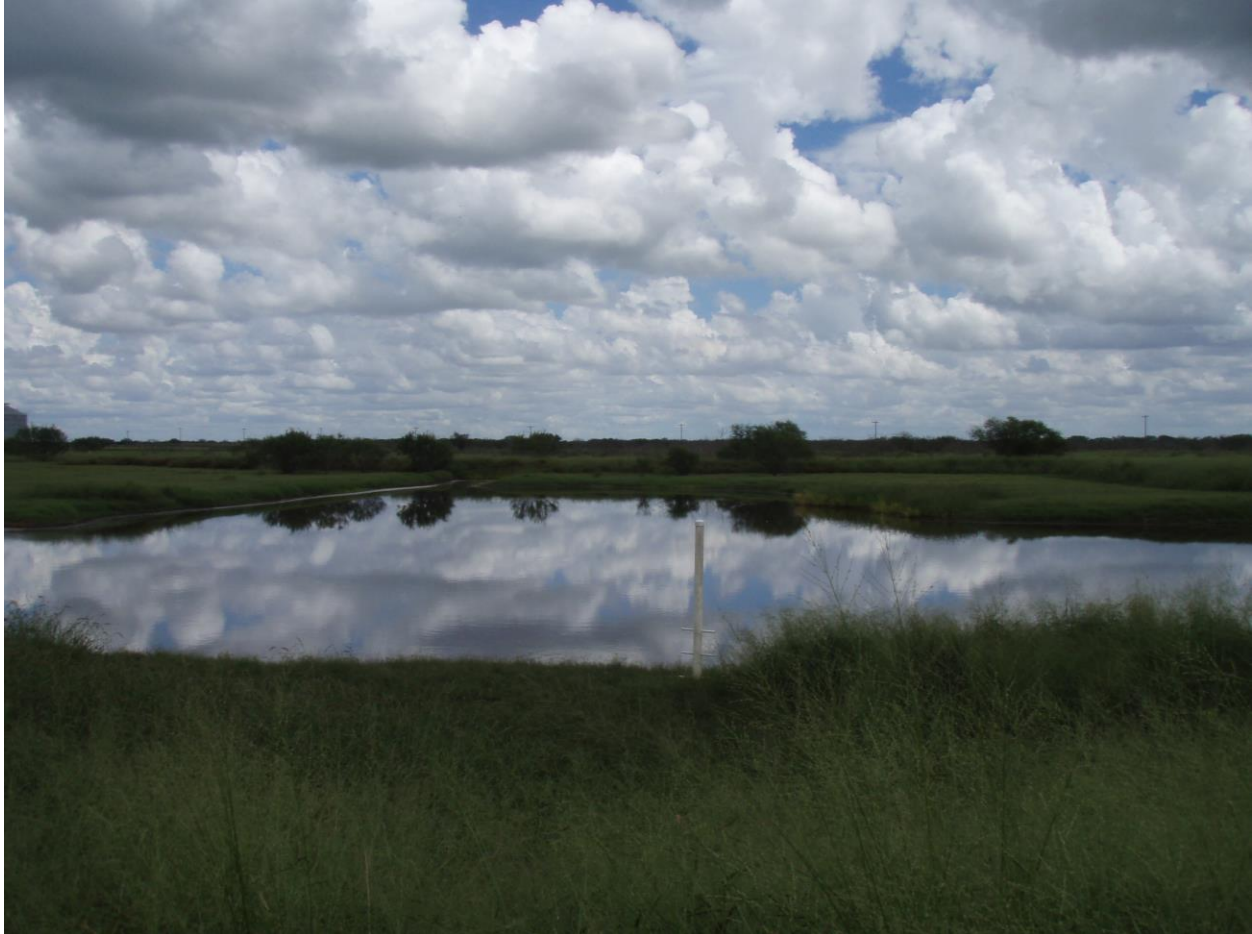
Photo No. 1

Description: Looking east at RCS 1. Unit has a pole marker and no trees are growing on the embankment.

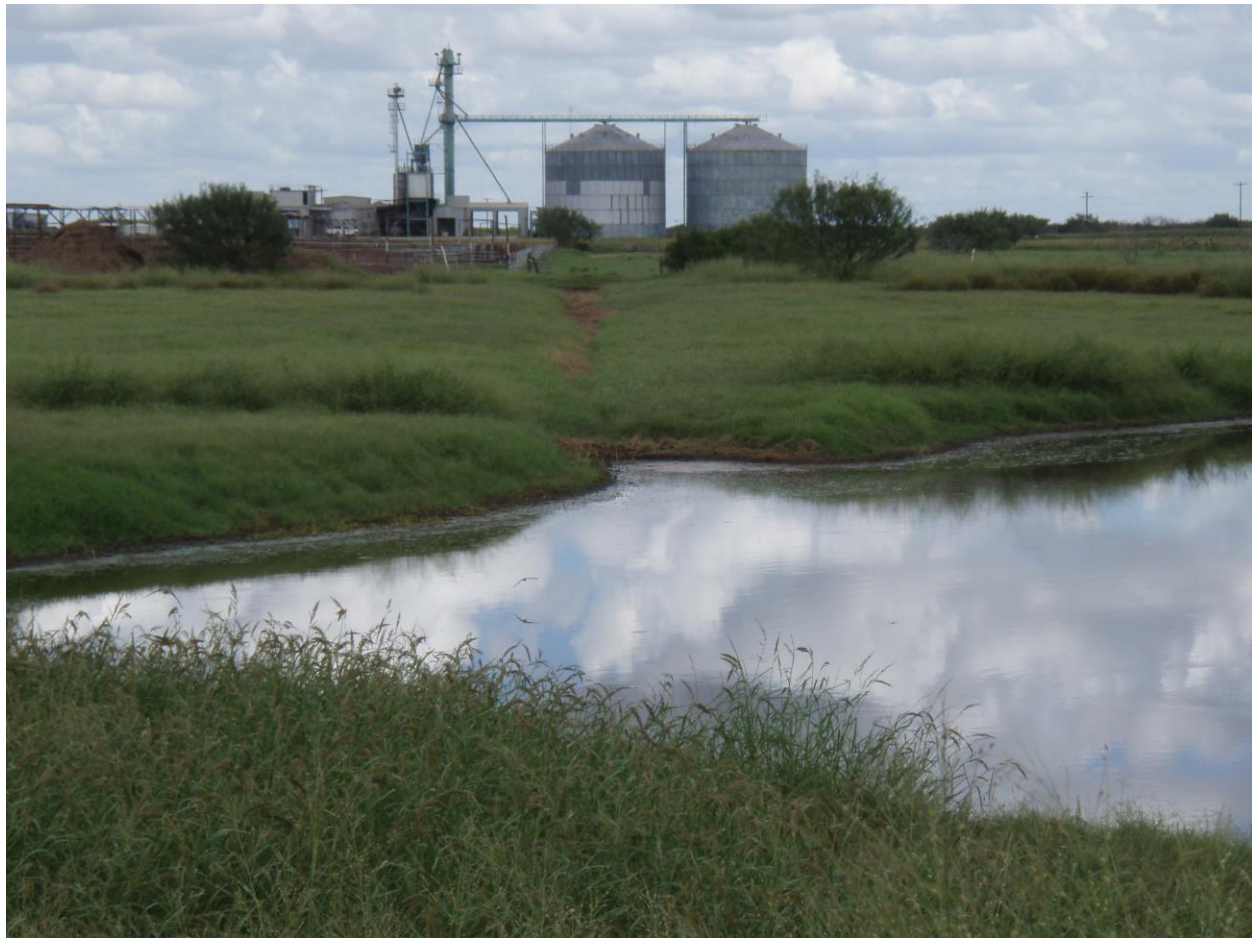
Photo No. 2

Description: Looking northeast at RCS 1 and the drainage channel (the brown colored ditch) leading from the production area (pens and feed mill) to the RCS. No trees are growing on the embankment. The embankments are well covered in vegetative grasses (buffelgrass) with no indications of erosion.

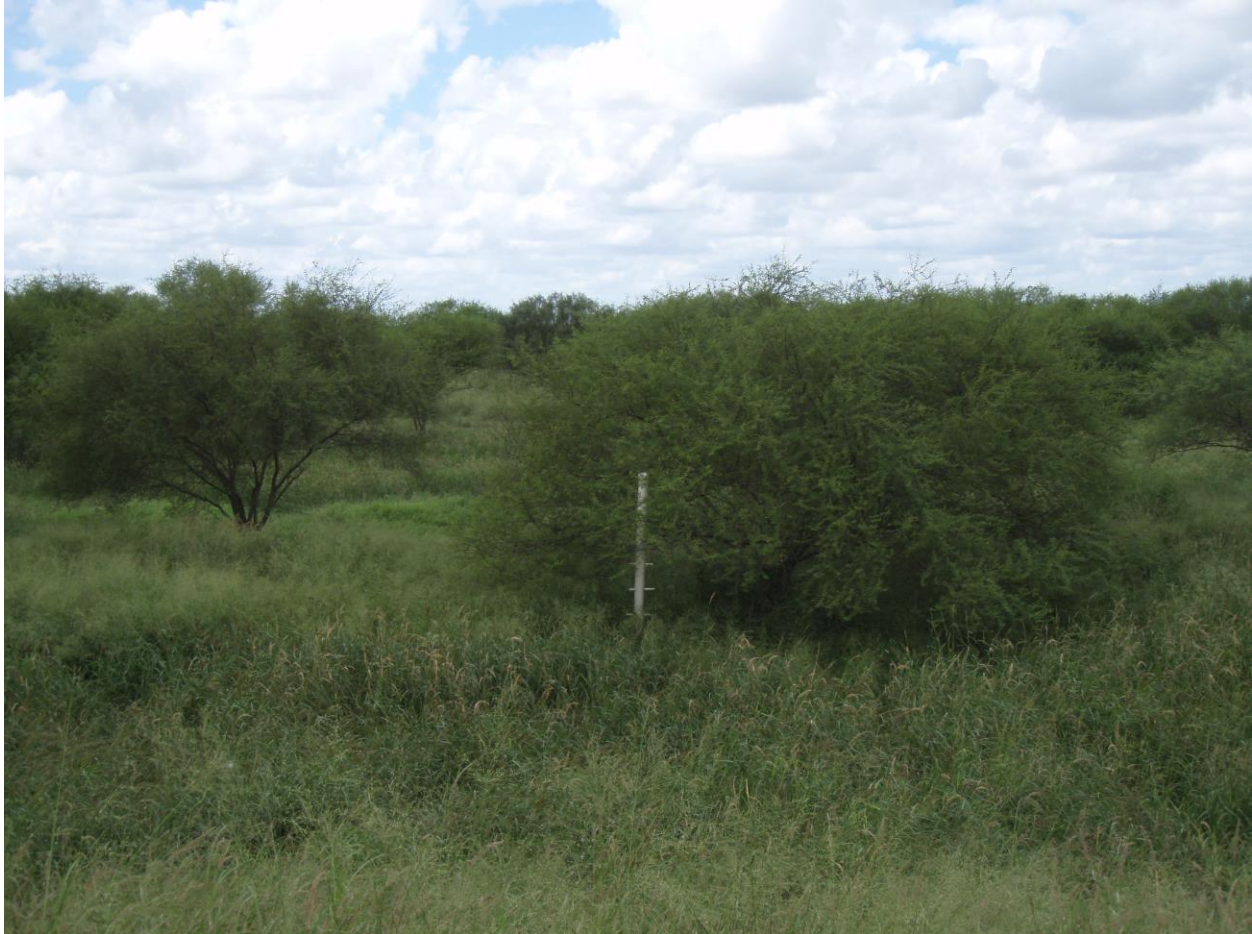
Photo No. 3

First, the RCS 2 playa lake has a significant number of large trees growing within the RCS. Photo 3 of the photolog found in Appendix 1 shows the pole marker for RCS 2 located within a wooded area of RCS 2. Also note the feedyard aerial photographs and topographic maps found in Appendix 1 showing the location of RCS 2 relative to the cattle pens and the trees within RCS 2.

AOC 1: RCS 2 (the playa lake) is located within a heavily wooded area. Prior Google Earth photos obtained from 1995, 2003, 2011, and 2015 show the playa lake conditions over time. In 1995, the year after the CAFO was first permitted by the TCEQ (its predecessor agency TNRCC), the RCS 2 playa lake was heavily wooded (see Appendix 3 – Historical Google Earth Aerials of RCS 2 Playa Lake). Then in 2003 the aerial shows the playa lake to be devoid of trees. In 2011 and 2015 the playa lake was beginning to grow back trees on the eastern side of the RCS and a few in the center by the water. Otherwise, most of the RCS 2 playa lake was devoid of trees. Trees have continued to spread and grow up to the time of the inspection as shown in the photolog and aerials contained within Appendix 1. Part III.A.10.(f).(3) of the TCEQ CAFO general permit states that “No tree shall be allowed to grow such that the root zone would intrude or compromise the structure of the liner or embankment.”

Description: RCS 2 is a playa lake with large trees. The unit has a pole marker and the playa lake is significantly wooded. The view is toward the west-southwest.

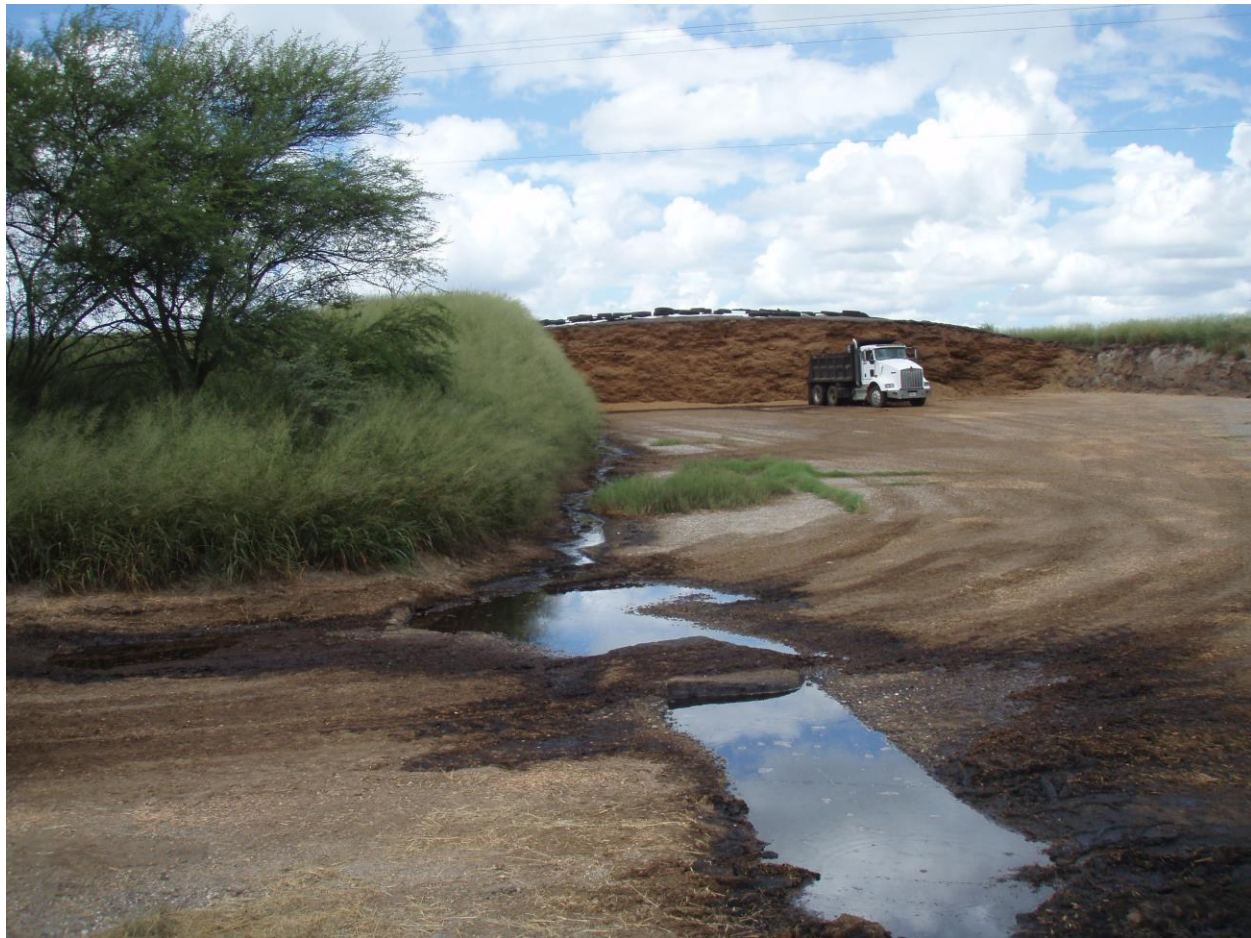
Photo No. 4

Second, there was a discharge of silage leachate from the silage bunker that flowed into an open pasture which did not appear to discharge into the watershed of an RCS. See photos 4 and 5.

AOC 2: There was a discharge of silage leachate going into a large pasture at the time of the inspection. Per Part III.4.(a) of the TCEQ CAFO general permit, Potential pollutant sources include "...silage stockpiles...". Furthermore, "An evaluation of potential pollutant sources shall identify the sources, "and indicate all measures that will be used to prevent contamination from the pollutant sources." Also, per Part III.5.(a).(2). "Manure, sludge, and wastewater generated by a CAFO shall be retained and used in an appropriate and beneficial manner as provided in this general permit." Additionally, the facility NMP requires that production area runoff be discharged into an RCS.

Description: The silage storage bunker had a discharge of dark liquor that was running off-site. The view is toward the west-northwest.

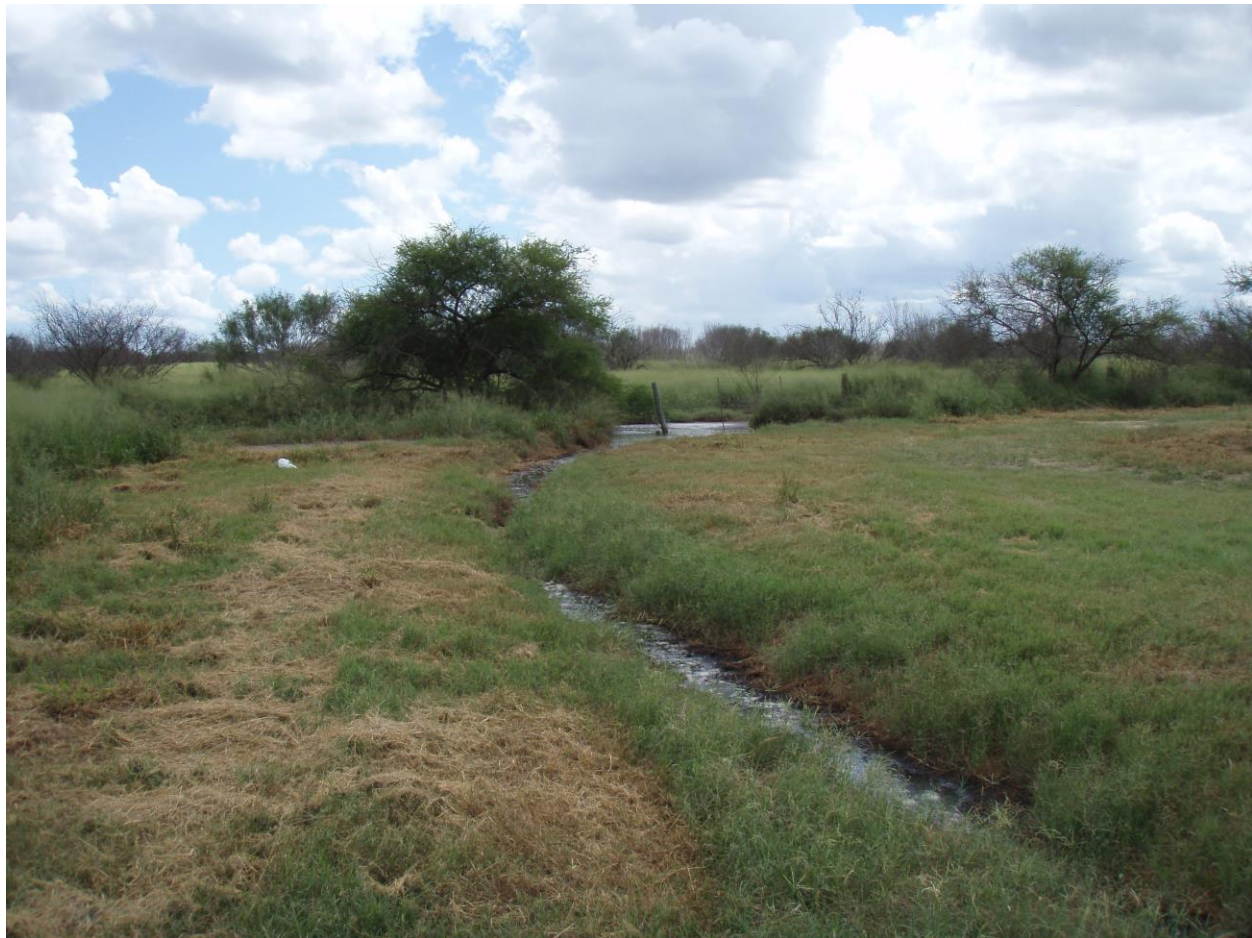
Photo No. 5

Description: The discharging leachate from the silage storage bunker is discharging thru a ditch into a ponded area in an open pasture. It does not appear that this discharge goes into the drainage area of an RCS. The view is toward the east-southeast.

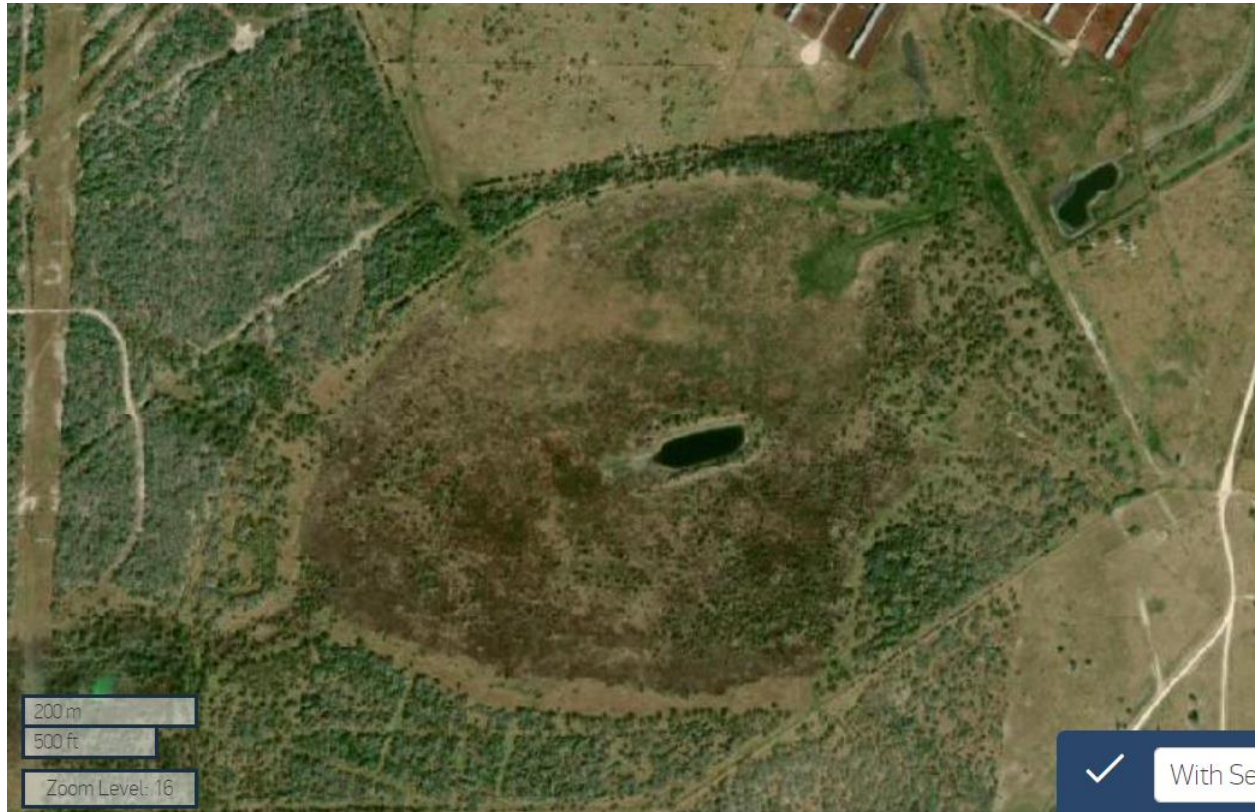
Photo No. 7

King Ranch Feedyard DigitalGlobe aerial from 6/27/22, RCS 2 close-up view

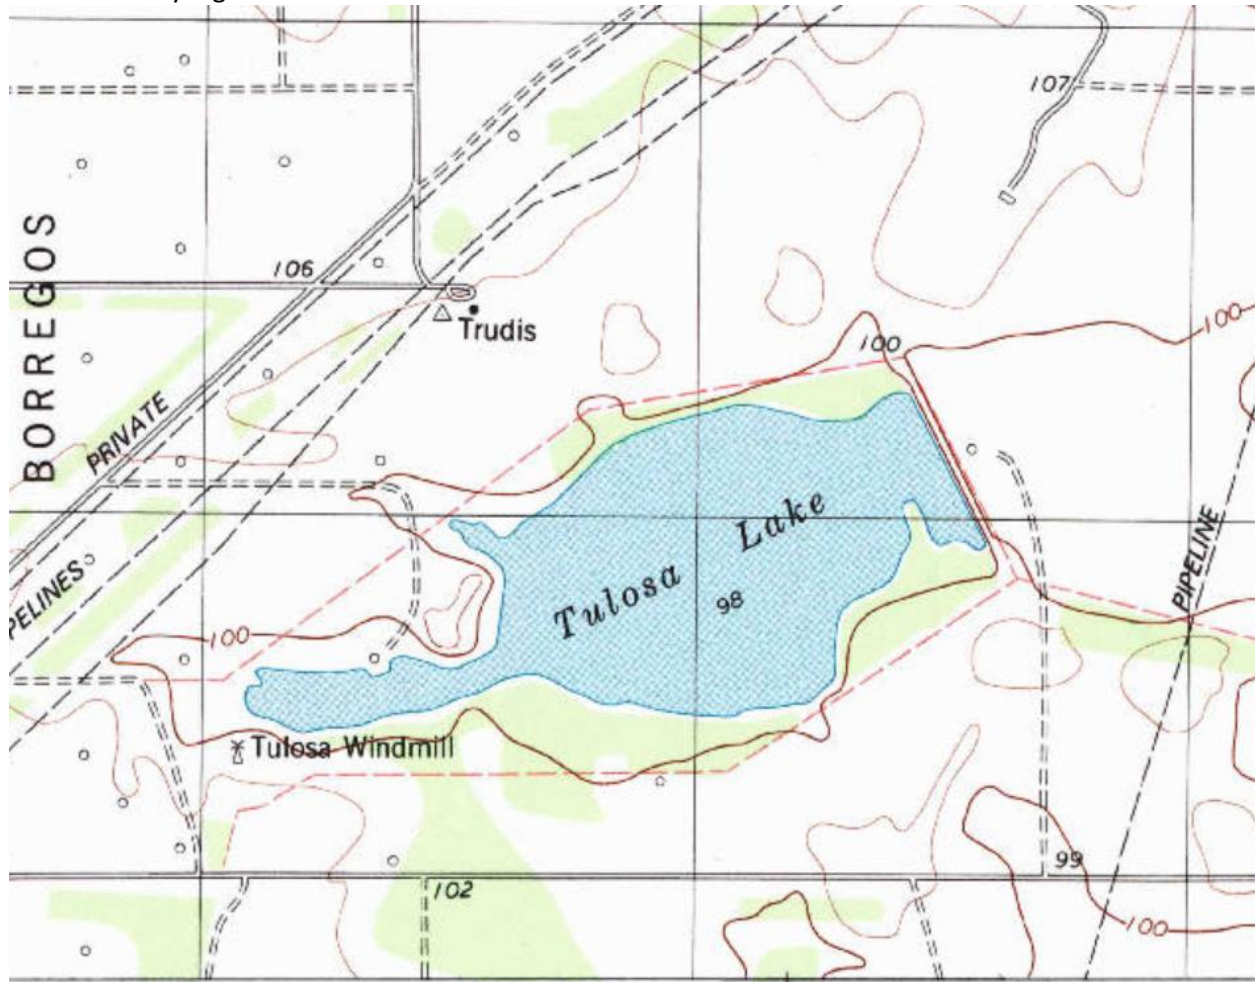
Photo No. 11

The USGS topographic maps found in Appendix 1 show the playa lake formation from 1979 (prior to the existence of the feedyard which was first permitted in 1994). This topographic map shows the surrounding elevations around the playa lake which are higher than that of the playa lake. There is also a topographic map from 2022 showing the playa lake RCS relative to the approximate locations of the cattle pens.

1979 USGS Topographic Map prior to the permitting of the feedyard in 1994. The playa lake is surrounded by higher elevation land.

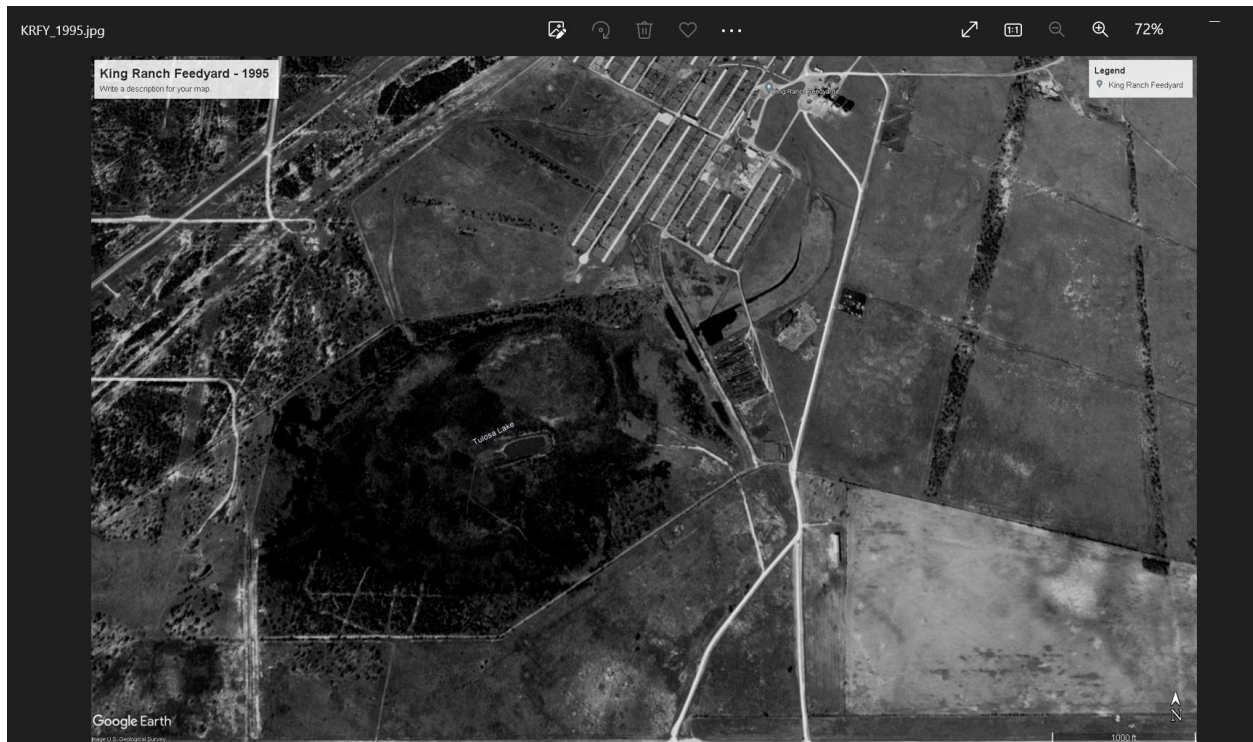
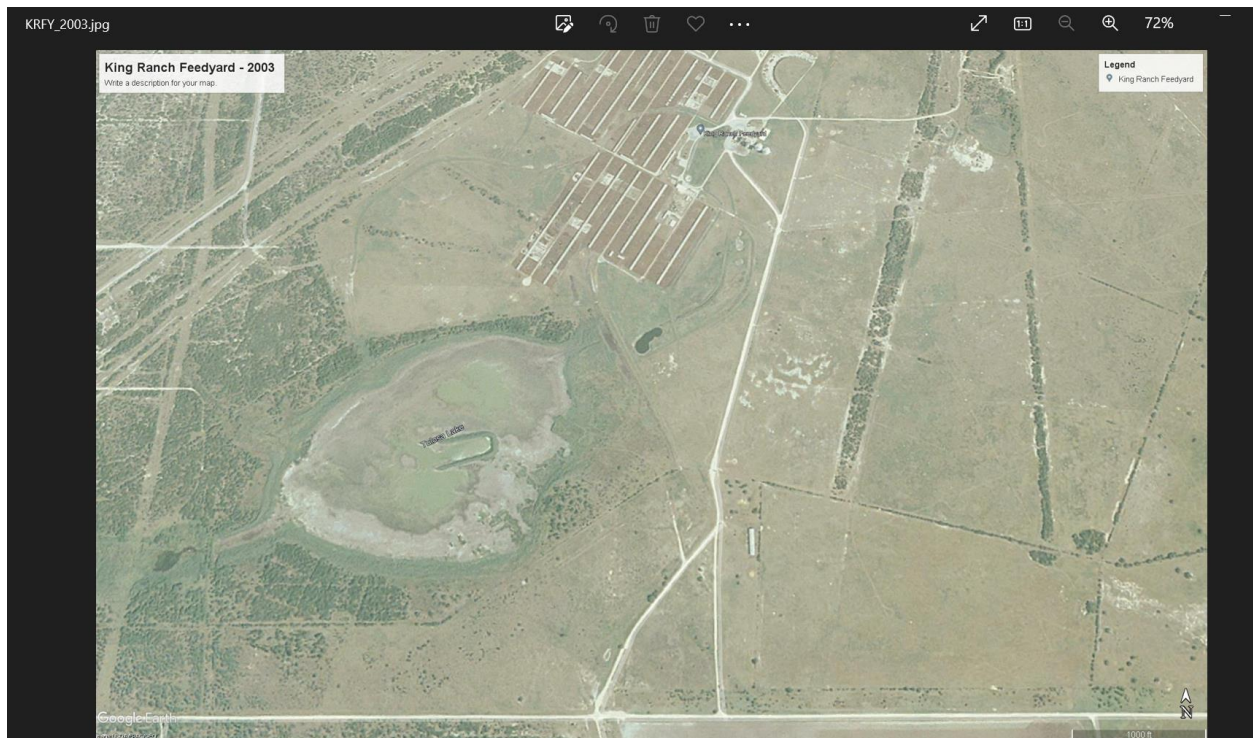
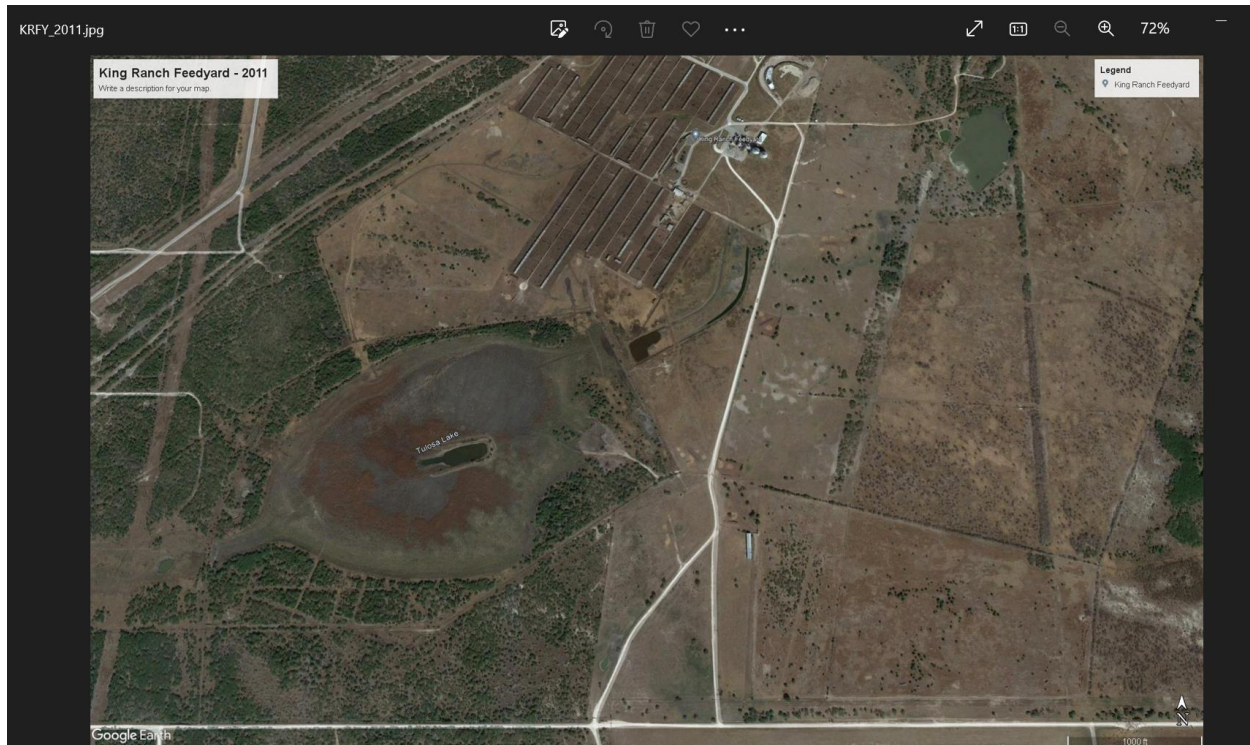
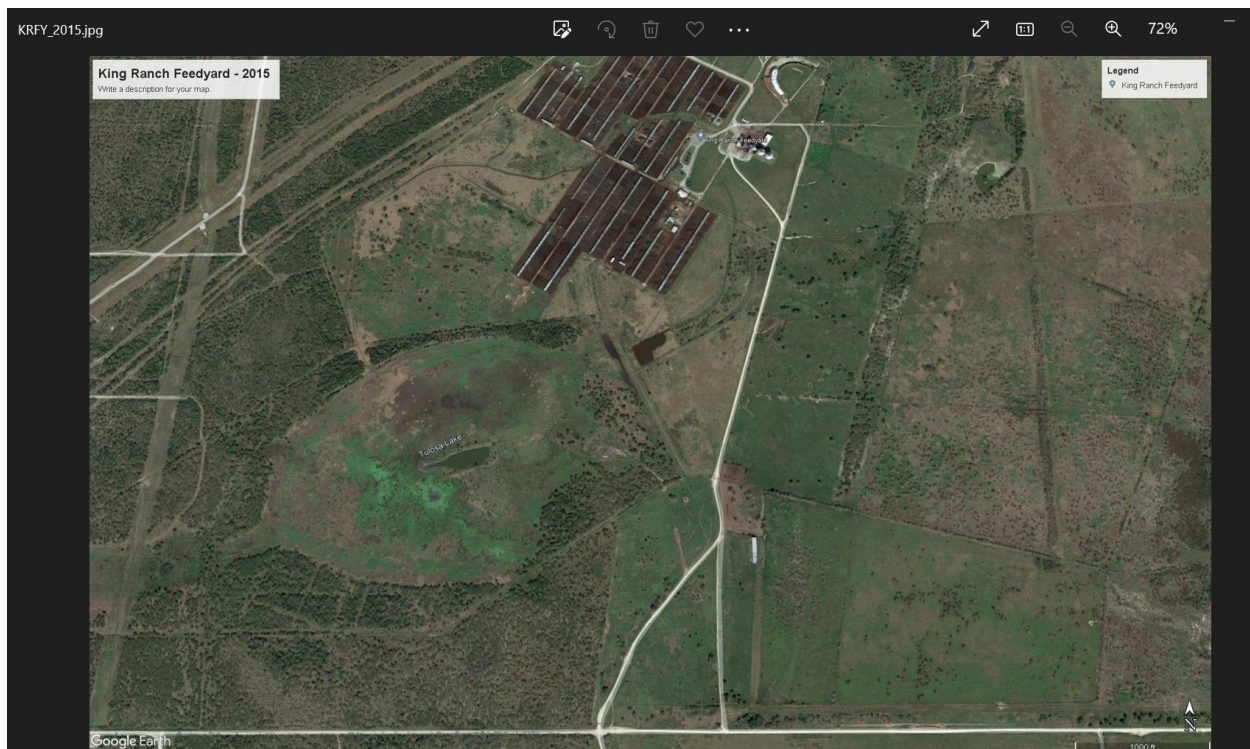
### Historical Google Earth Aerials of RCS 2 Playa Lake

Finally, the historical aerial photographs from Google Earth contained in Appendix 3 shows the varying degrees of tree cover and growth over a period of 20 years, from 1995 to 2015. In 1995 the playa lake is covered with trees. Then in 2003 all the trees have been removed. In 2011 and 2015 a few of the trees are growing back, and as shown in the photolog (photo 3) and 2022 DigitalGlobe aeriels the trees are again becoming established within RCS 2.
