## EPA Region 10 Enforcement and Compliance Assurance Division

## Clean Water Act (CWA) Inspection Report

| Type of Inspection | CEI - Compliance Evaluation Inspection | | | |
| Permittee Name | Trails End Recovery | | | |

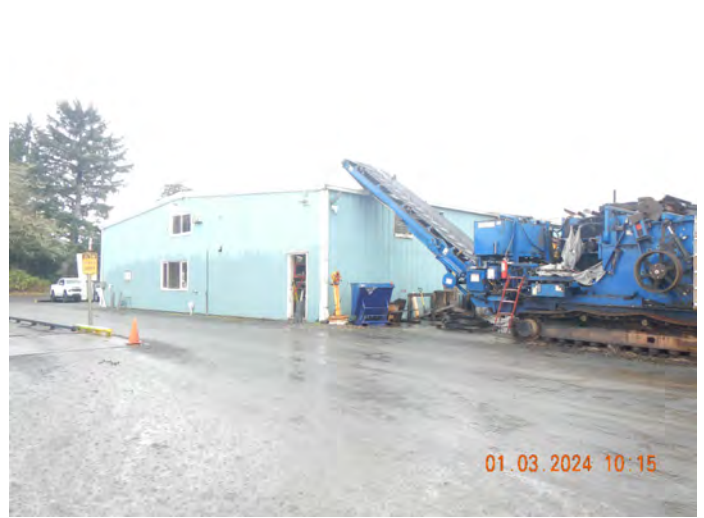
Photo #:01 (DSCN3450)  
Description: Facing east, photo of the main office building and truck scale/entry.

We first observed the main scale area within Sub-Basin 1 (SB-1) (**Photo 1**), Mr. Raichl discussed that each incoming/delivery load is required to stop at the scale and the driver is required to provide certified "paperwork" (a completed asbestos survey) for construction debris/demolition loads. It was discussed that the Facility primarily receives materials for recycling from a local waste management company, Recology (approximately 3-

12 trucks/bins each day), as well as materials from local contractors and the general public. At the time of inspection, stormwater near the scale generally appeared to infiltrate within the permeable areas around the scale and office area. No staining/sheens were observed.

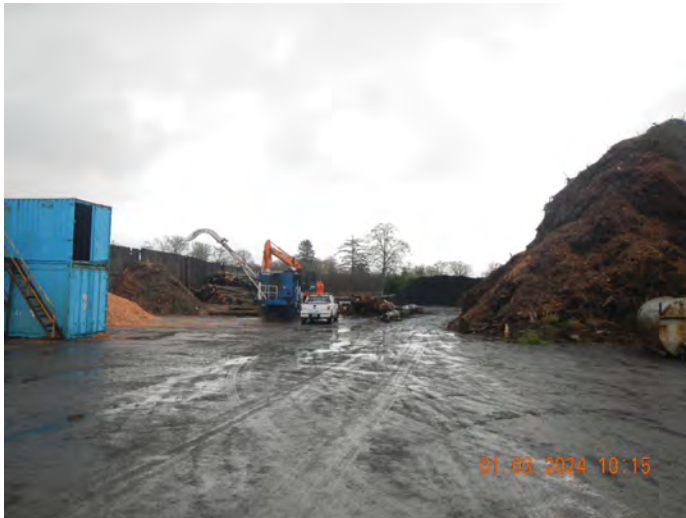
North of the scale area within SB-1, we observed the Facility's maintenance shop. Mr. Raichl discussed that the maintenance shop is shared with a separate entity but same ownership, Custom Excavating by Dean Larson, Inc., located north of the of Facility. We observed a "chipper" that was parked on the concrete pad to the west of the maintenance shop (**Photo 2**). According to Mr. Raichl, the "chipper" was being temporarily staged awaiting a new/replacement engine. No staining/sheens were observed around the staged equipment. Stormwater was generally observed to infiltrating within the permeable areas south of the concrete pad, a few small areas of ponding were also observed.

Photo #:02 (DSCN3451)  
Description: Facing northwest, photo of the maintenance building (shared with Dean Larson Excavation). Woodchipper was staged outdoors awaiting engine replacement.

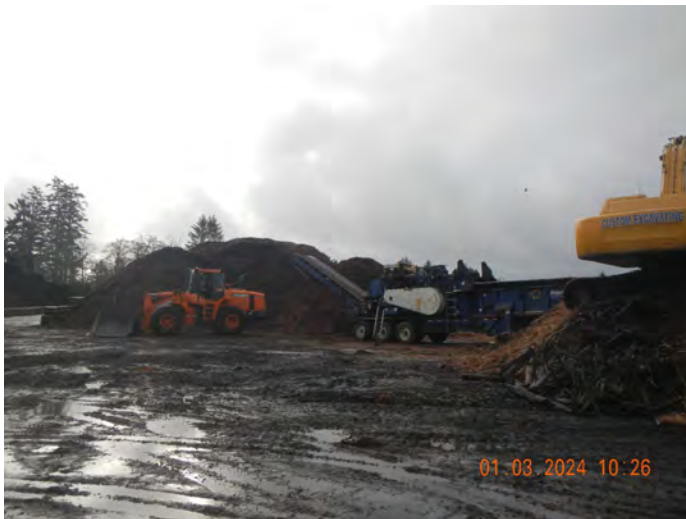
We continued east through the "chipping area" and observed the concrete pad (**Photo 5**) and permeable areas south of the pad, including portions of the hogfuel processing/stockpile area (**Photo 6 & Photo 7**). The Facility can process approximately 500 yards/day of hogfuel which also gets hauled to the paper mill in Wauna, Washington. Bark is received from a nearby lumber mill and is screened/processed as economy park and then wholesaled. Mr. Raichl discussed that when received, creosote/treated lumber is now kept in bins temporarily and returned to Recology during the next delivery (likely the same day).

Photo #:06 (DSCN3455)  
Description: Photo of wood debris storage/processing area. The wood product is brought in from Recology and processed on-site as hog fuel and hauled daily to a paper mill in Wauna, WA.

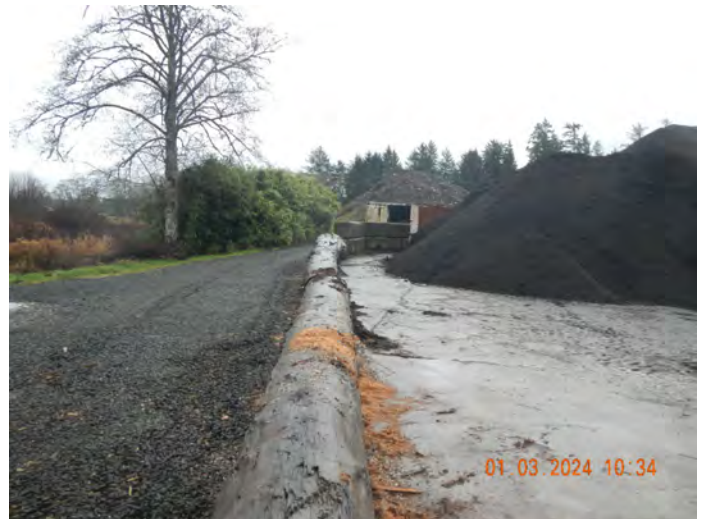
Photo #:07 (DSCN3456)  
Description: Facing south, photo of the hog fuel processing area.

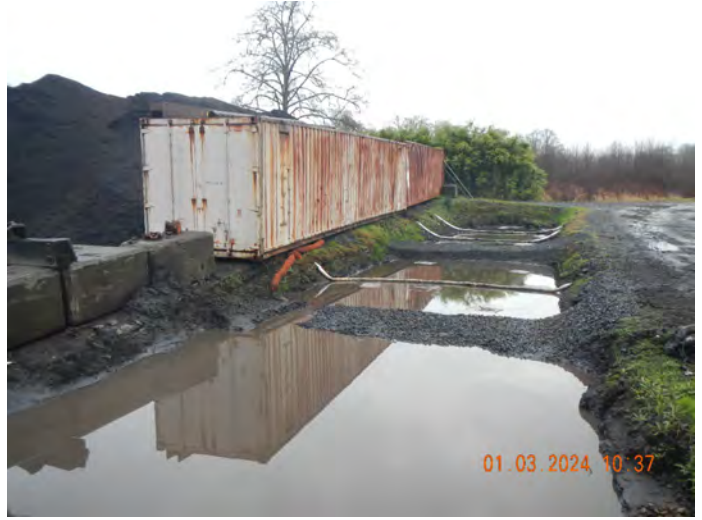
At the time of inspection, Pond 1 was receiving stormwater as sheet flow from the areas north of the hogfuel processing/stockpile area, influent stormwater was observed to be turbid as it entered the pond. A "bio-bag" had been placed in the influent channel (southwest corner).

Photo #:09 (DSCN3458)  
Description: Facing west, photo of the western inlet to Pond 1.

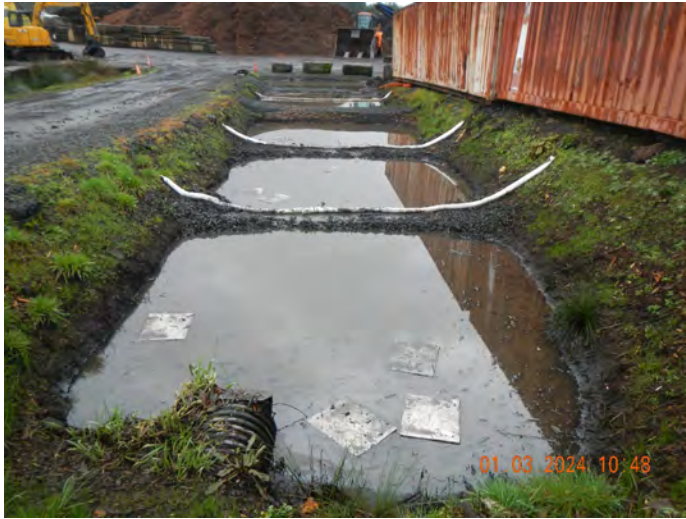
We also observed the northern perimeter (**Photo 8**), which includes an access road separating the industrial areas from an unnamed slough (permitted receiving water to the north). East of the concrete/impervious pad, we observed Pond 1 (**Photo 9 – Photo 11**). Pond 1 was observed to be constructed with rows of rock/gravel extending across the pond, separating the pond into five separate chambers. Oil absorbant "snakes" were extended across the pond to remove floatable oil/grease, a "bio-bag" and mesh guard was placed around the pond's discharge pipe. I also observed oil absorbant pads placed within the cells.

Photo #:10 (DSCN3459)  
Description: Facing north, photo of the Pond 1 cells/chambers.

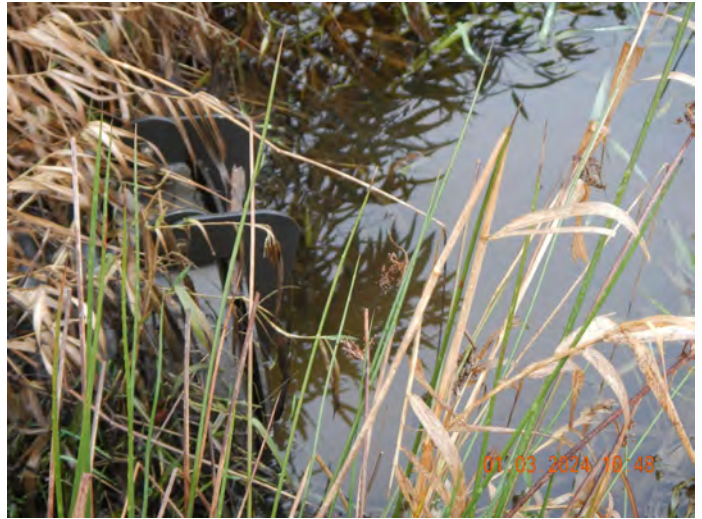
Photo #:11 (DSCN3462)  
Description: Facing south, photo of the Pond 1 cells/chambers.

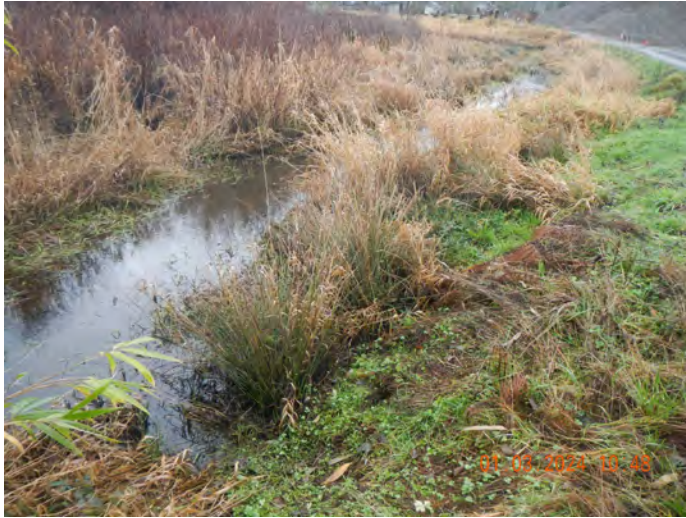
Mr. Raichl believed the Facility had most recently performed maintenance on Pond 1 the week prior. Maintenance was believed to include replacing the absorbant materials and fixing the bio-bag associated with the discharge pipe. Mr. Raichl discussed that the recent maintenance would've been documented in the most recent facility inspection report, which would be available within the Facility office. We then crossed the access road to the north and observed the Pond 1 discharge/monitoring location (DP001). DP001 appeared to be discharging slightly, the discharge was observed to be clear with no sheen (**Photo 12 & Photo 13**).

Photo #:12 (DSCN3460)  
Description: Facing west, photo of the Pond 1 discharge/outfall to unnamed slough. No sheen was observed at the time of inspection, discharge from the outfall was observed to be clear.

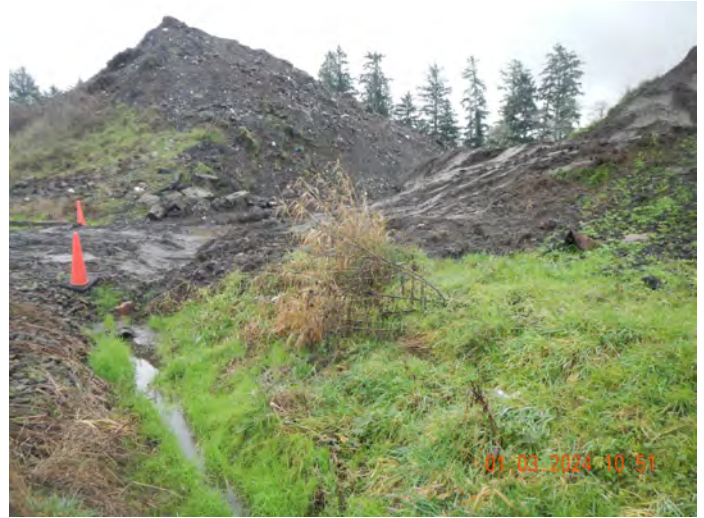
Photo #:13 (DSCN3461)

Description: Facing east, photo of the Pond 1 discharge/outfall to unnamed slough. No sheen was observed at the time of inspection, discharge from the outfall was observed to be clear.

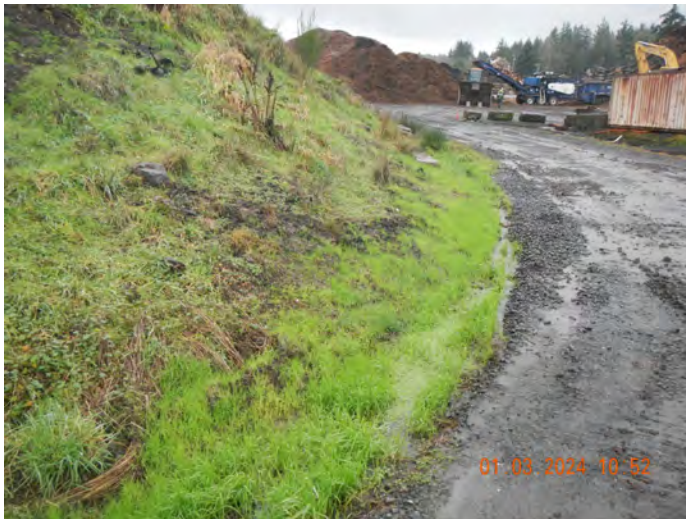
Photo #:14 (DSCN3463)

We continued the walk-through east along the access road and observed the northern portion of topsoil and inert storage areas. The Facility maintains a vegetated (grass) channel along the north end of the piles as a best management practice (BMP), a channel separates the two stockpiles (**Photo 14 – Photo 16**). Stormwater not infiltrating within these areas was directed towards the southeast corner of Pond 1.

Description: Facing east, photo of the north end of the topsoil storage area. Facility maintains the vegetated area as a BMP.

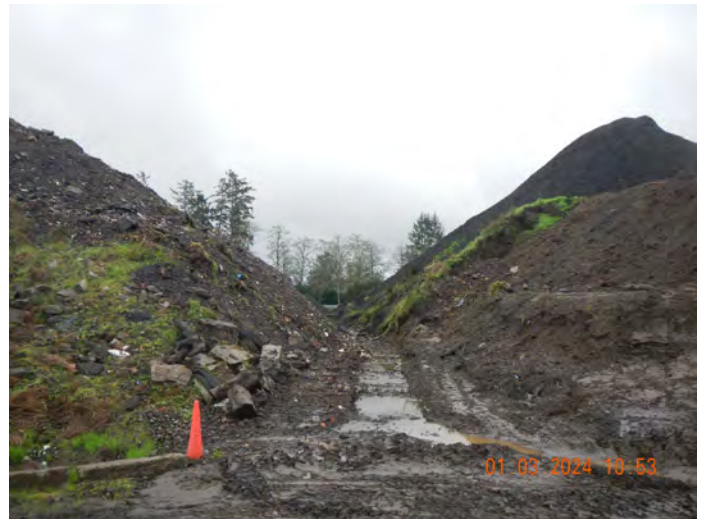
Photo #:15 (DSCN3464)

Description: Facing southwest, photo of the north/northwest end of the topsoil storage area. Facility maintains the vegetated area as a BMP.

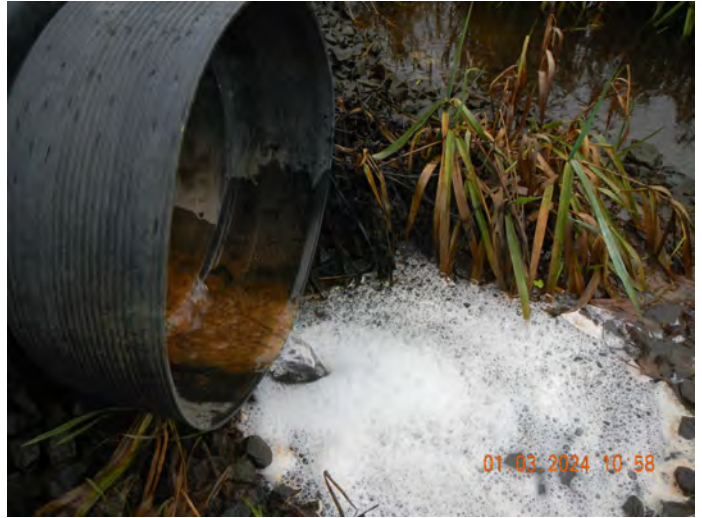
Photo #:21 (DSCN3470)

We then crossed the access road to the north and observed the Pond 4 discharge/monitoring location (DP004). DP004 was discharging slightly, the discharge was observed to be clear with no sheen, foam was present at the immediate discharge point (**Photo 21 & Photo 22**).

Description: Facing east, photo of the Pond 4 discharge to the unnamed slough. No sheen observed, clear discharge. Foam observed at immediate discharge point.

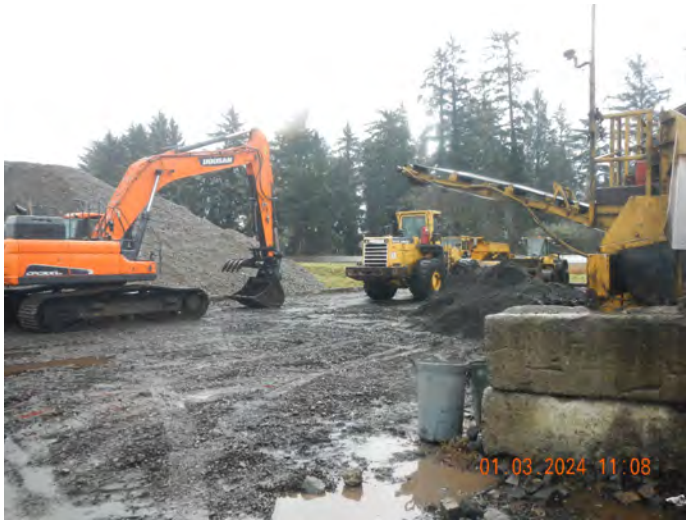
We continued the walk-through southwest, into Sub-Basin 2 (SB-2). SB-2 generally includes Pond 2 and the southeast industrial areas of the Facility, primarily material stockpiles and a designated screening area. We first observed a rock/gravel stockpile area within the eastern portion of SB-2 (**Photo 24**) as well as another stockpile area east of Pond 2 (**Photo 25 & Photo 26**). We continued west and observed the southern perimeter (**Photo 27**) and processing screening area west of Pond 2. Staining/sheens were observed on the surface near a front loader that was parked at the location (**Photo 28 & Photo 29**).

Photo #:28 (DSCN3477)  
Description: Facing southeast, photo of sheen/staining observed near a front loader east of Pond 2.

Small leak from the 500 loader was cleaned up, the machine hoses were capped and it was moved to the shop for repairs.

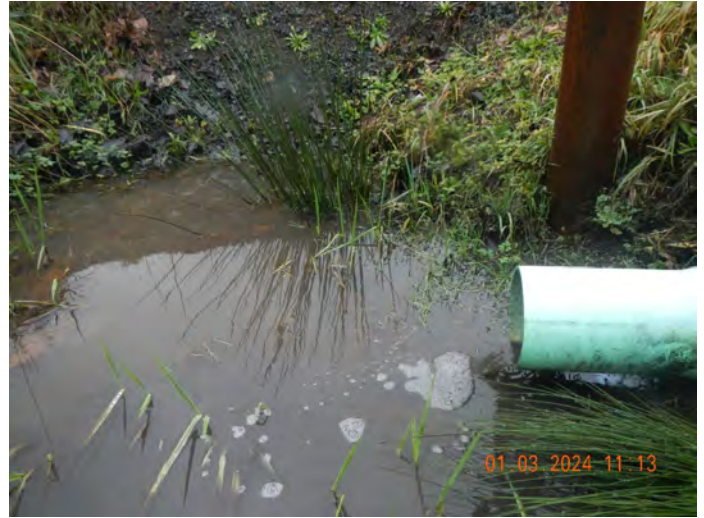
Photo #:33 (DSCN3482)  
Description: Facing west, photo of Pond 2 outlet cell,

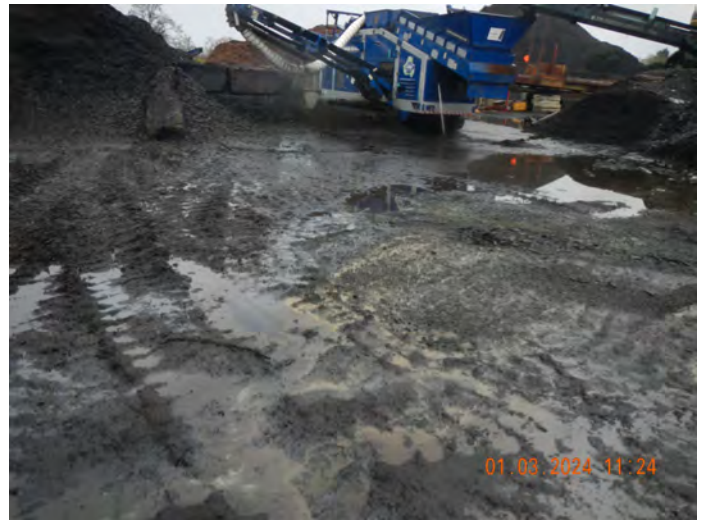
Photo #:42 (DSCN3491)

Description: Facing northeast, photo of the air separator and processing area downslope of the air separator. Sheen/staining observed.

Sheen from the recent oil change on the Edge Air Screener (adjacent to inlet to Pond 3) was cleaned up with absorbent pads. Additional rock was added around Pond 3.

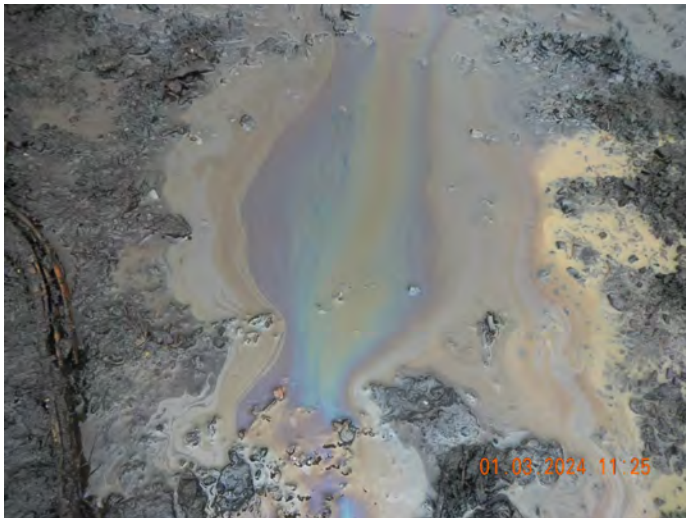
Photo #:43 (DSCN3492)

Description: Sheen/staining observed downslope of the air separator/processing area. Stormwater flowing towards Pond 3.

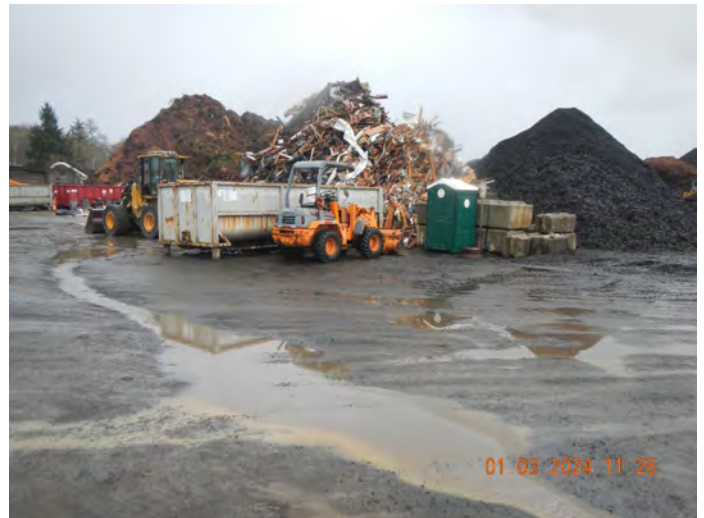
Photo #:44 (DSCN3494)

As discussed earlier in this report, during the walk-through within Sub-Basin 3, turbid stormwater from the receiving/sorting area was observed to be ponded or traveling downslope into Pond 3 as sheet flow (**Photo 44, Photo 51**). Turbid stormwater and sheens were also observed near the separating area (air separator) and was observed to flowing towards Pond 3. Stormwater entering/exiting Pond 3 was observed to be turbid.

Absorbent "snakes" and absorbent pads contained within the pond appeared in need of maintenance. According to the SWPCP, wood staked bio-bags are to be installed along the north end of Pond 3, no bio-bags were observed at Pond 3 at the time of inspection. According to the December 2023 Site Inspection Report, "soakers" were last replaced in Pond 3 on 12/12/2023, additional oyster shells were added to Pond 3 on 12/28/2023.

Description: Facing north, photo of stormwater flowing as sheet flow from the sorting/receiving area towards Pond 3.

Friday 1/5/24 we dug out Pond 3a chamber and changed the absorbent pads again, dugout and replaced the inlet rock, and added rock to the road. Cleaned up small amount of sheen adjacent to Pond 3a.
