**Clean Water Act (CWA) Inspection Report**

| <b>Program:</b> Industrial Stormwater | <b>Inspection Type:</b> Compliance Evaluation Inspection (CEI) | |
| <b>Permittee Name:</b> Weber Auto & Truck Parts | <b>NPDES/ICIS No.:</b> NHR053298 | |
| <b>Facility Inspected:</b> Weber Auto & Truck Parts<br>135 Pond Island Road, Derry, NH 03038 | <b>Lat, Long:</b> 42.8684°, -72.2602°<br><b>NAICS / SIC Code:</b> 5015 – Motor Vehicle Parts, used; 5093 – Scrap & Waste Materials; 3341 – Secondary Smelting and Refining of Nonferrous Metals | |

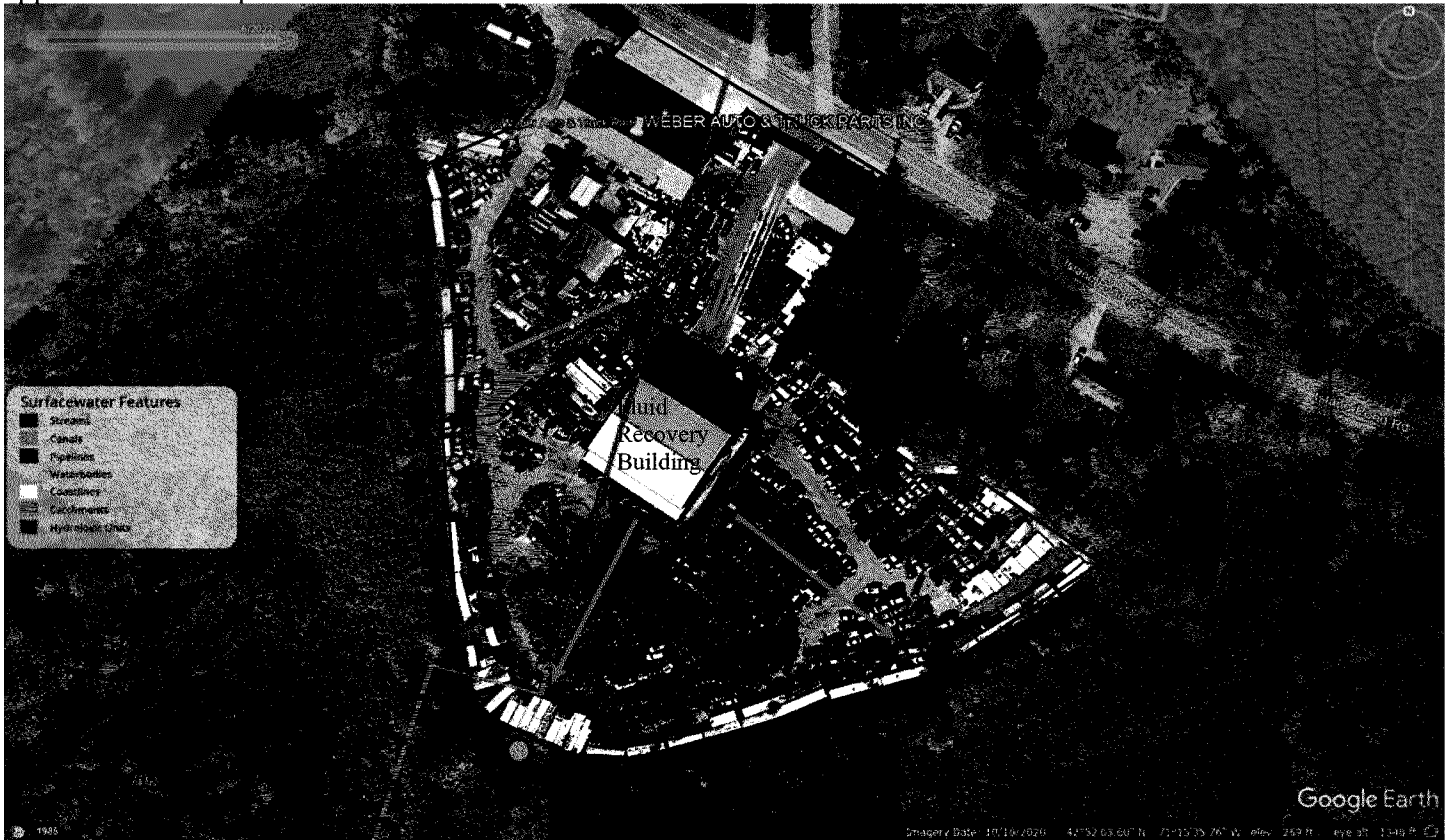
The EPA Inspector observed that stormwater would flow from the center of the Facility toward the perimeters, consistent with the flow arrows on the SWPPP site map. The SWPPP site map shows a berm constructed around the Facility to contain stormwater on-site. The EPA Inspector observed the Facility perimeter consisted of school bus bodies and trailers (refer to [Appendix A, Photographs 5 and 10](#)). Due to safety concerns, the EPA Inspector was not able to observe if a berm was present beyond the bus and trailer perimeter; however, [Photograph 10](#) shows a portion of a berm between the Facility and the surface water to the east. The EPA Inspector was not able to verify if the berm was continuous around the Facility's perimeter because the school buses, trailers, and material stockpiles along the Facility's perimeter were not safe to cross.

The SWPPP Site Map shows Discharge Point 001 at the southernmost part of the berm. Facility stormwater discharges would flow through Discharge Point 001 toward the unnamed surface water through the NWI-mapped wetland areas (refer to [Figure 1](#) and [Photographs 15, 16, 17, and 18](#)).

**Figure 1.** Google Earth aerial view with the EPA WATERS feature layer of the Facility. The blue arrows depict observed flow patterns, the red line is the approximate Facility perimeter. The approximate location of Discharge Point 001, through the perimeter berm, is depicted with the blue circle – the location was obtained from the SWPPP Site Map.
