SUBJECT: CLEAN AIR ACT INSPECTION REPORT
Prarie View Recycling and Disposal, Wyatt, IN

Facility Name: Prairie View Recycling and Disposal

Date of Inspection: July 20th, 2021

Facility Type: Municipal solid waste landfill

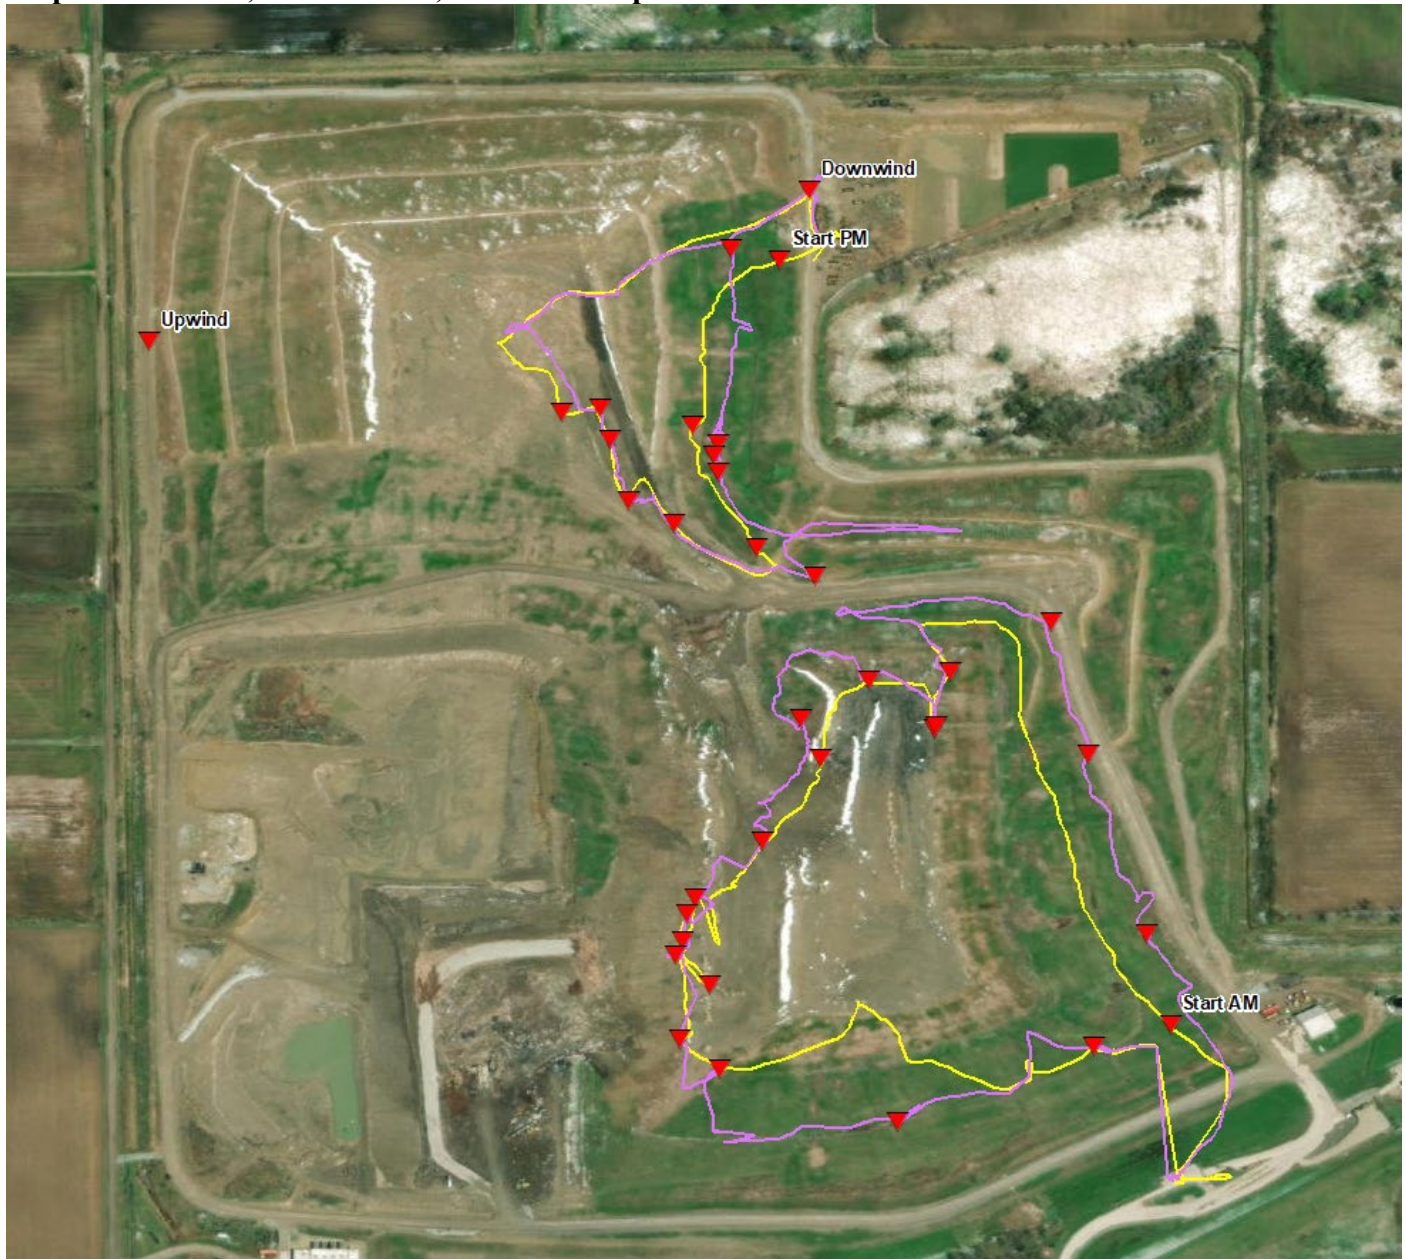
Map of GPS Path, Exceedances, and Follow-up Points

Exceedance ID	Latitude, Longitude	Description	Reading 1	Reading 2
EL1	41.497084, -86.167078	Header pipes 10 ft south of Manhole 1	842	779
EL2	41.498579, -86.16756	GW-30	1.40%	6600
EL3	41.499695, -86.167876	GW-84	799	701
EL4	41.498793, -86.168848	GW 32TR	5200	888
EL5	41.498822, -86.168842	Erosion 15 ft north of GW-32TR	700	1300
EL6	41.498884, -86.169962	Exposed trash on west slope of south hill	2000	1700
EL7	41.49738, -86.170845	Erosion on west slope of south hill between cells 5B and 5A, 20 ft NW of GW-15	1200	1000
EL8	41.497257, -86.17092	50 ft SW downslope of GW-15	668	700
EL9	41.496907, -86.171015	20 ft SW downslope of GW-117	590	600
EL10	41.496208, -86.170981	Erosion 200 ft SW downslope of GW-13	800	600
EL12	41.496148, -86.167516	25 ft NW upslope of GW-3, final cover dead vegetation	1000	2000
EL14	41.502804, -86.170546	20 ft W upslope of GW-49	1500	1400
EL15	41.501177, -86.170656	50 ft NNE of GW-108	610	1200

EL16	41.501087, -86.17069	GW-108	8000	2300
EL17	41.500937, -86.170655	50 ft SSE of GW-108	700	2000
EL18	41.500066, -86.169854	GW-38, also elevated readings 10ft W of GW-108	635	1800
EL19	41.500704, -86.171404	GW-135	5040	1500
EL20	41.501481, -86.171647	Marker pipe, also elevated readings 10 ft north	995	700
K1	41.499275, -86.168718	GW-43B	1%	2.10%
K4	41.4992, -86.169392	N hill 400 ft E of solidification plant	617	4.90%
K5	41.498543, -86.169803	GW-28TR	1900	1200
K6	41.497854, -86.170283	GW-23	1.70%	3000
K8	41.496657, -86.170724	GW-13	2000	1300
K9	41.495957, -86.17064	GW-9TR	1%	1.03%
K10	41.501337, -86.170867	Old vacuum line at GW-44	1200	700
K12	41.500507, -86.171028	Erosion gully on N hill	2200	1200
K13	41.501216, -86.17156	GW-136	780	888
K14	41.501437, -86.171966	GW-142	1500	2.80%

ID	Latitude, Longitude	Location Description
EL-11	41.495517, -86.169157	GW-6
K-7	41.497024, -86.170959	GW-117
K-11	41.50031, -86.170337	Top of marker pipe

The purple path was taken by Emma Leeds and Vicky Mei with TVA A56584. The yellow path was taken by Sasha Letuchy and Karina Kuc with TVA A56575. Unlabeled red arrows indicate locations with TVA readings that exceeded 500 ppm methane, and three additional follow-up points.

Prairie View personnel confirmed that they would re-monitor the above follow-up locations and correct any exceedances found as needed.
