Clean Water Act Section 404: Site Visit/Case Development

Site Name	James Marquis Property	Start Date	September 9, 2022
		End Date	September 9, 2022
Inspection Purpose	Initial site visit		
Opening Conference			
<input checked="" type="checkbox"/> Presentation of Inspector Credentials			
Name and Title (Use N/A if owner/operator not available to join the inspection)			
Credentials were presented to Mr. James Marquis (property owner)			
<input checked="" type="checkbox"/> Opening Conference			
Name of person authorizing access if applicable			
I corresponded with the property owner over e-mail to arrange the inspection.			
Notes from Opening Conference			
EPA discussed the area that it was looking to inspect. Mr. Marquis explained the history of the property to EPA. Mr. Marquis followed EPA during most of the inspection.			
<input type="checkbox"/> Access Issues if Any			
Describe			
N/A			
Inspection Observations and Sample Collection			
Site Owner* (Name, title and contact information)

CWA 404 Inspection
James Marquis Property
26 Evy Lane
Milton, Marlborough, NY

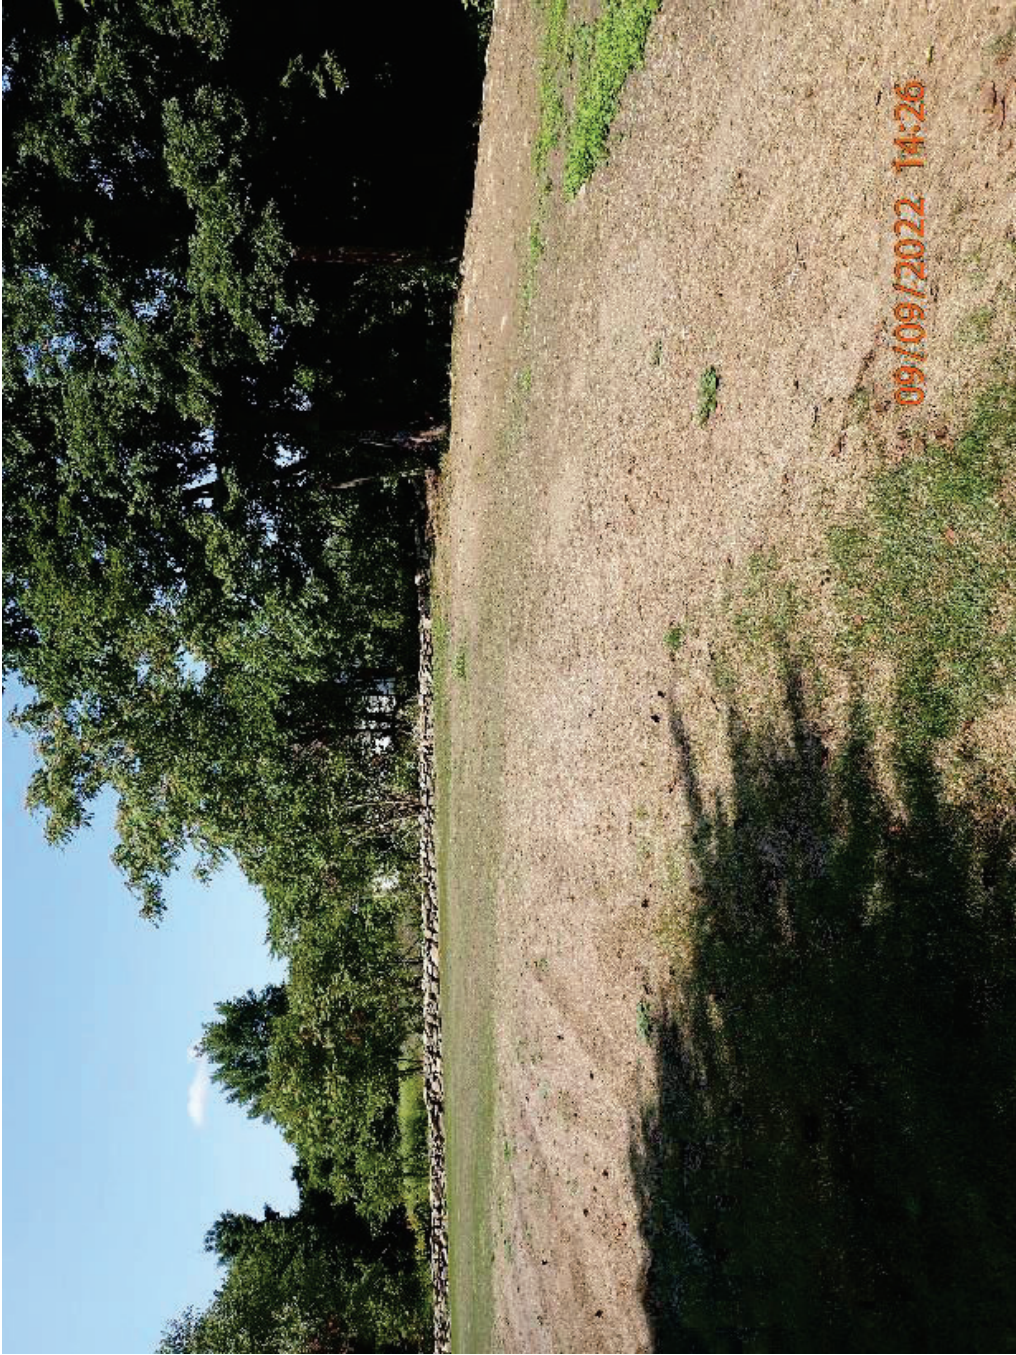
Date: 9/9/2022
Time: 2:26 PM
Photographer: SSA
Photo ID: 1 – P9090488

Mr. Marquis showed EPA an area in the backyard where a pile of dirt and shale had been removed to create flat land. According to Mr. Marquis, these materials were moved a month ago to the southeastern corner of the parcel along with a fallen tree and associated mulch. The materials were separated into piles and placed in an area designated by the Corps during its September 14, 2009 site visit as wetland. Mr. Marquis stated that the pile of slate was being temporarily stockpiled at that location and that he planned to use the shale pile for the construction of a driveway at another one of his properties.

Former location of hill of shale
in the backyard of residence

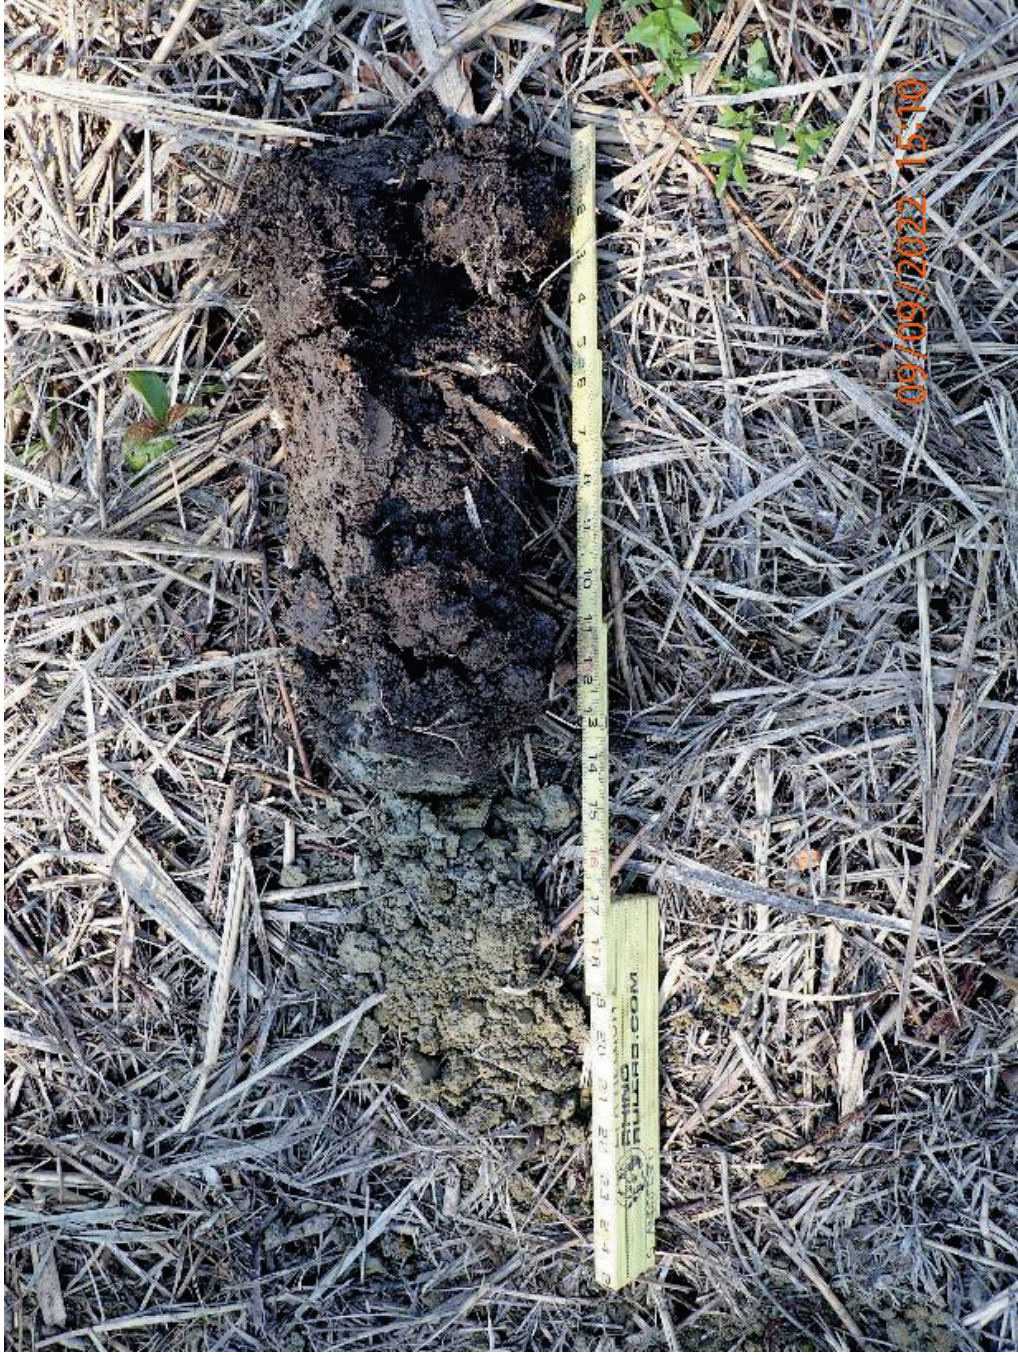
Date: 9/9/2022
Time: 3:10 PM
Photographer: SSA
Photo ID: 2 – P9090489

GPS points were recorded around the recent piles of fill material and at a soil sampling location adjacent to the shale piles. Vegetation, soils, and hydrology data confirmed that the location of the sampling location was in a wetland. The wetland area had been recently mowed but vegetation was growing back. Returning vegetation was dominated by common reed (*Phragmites australis*) and purple loosestrife (*Lythrum salicaria*).

Description:
SS1 Soil Profile

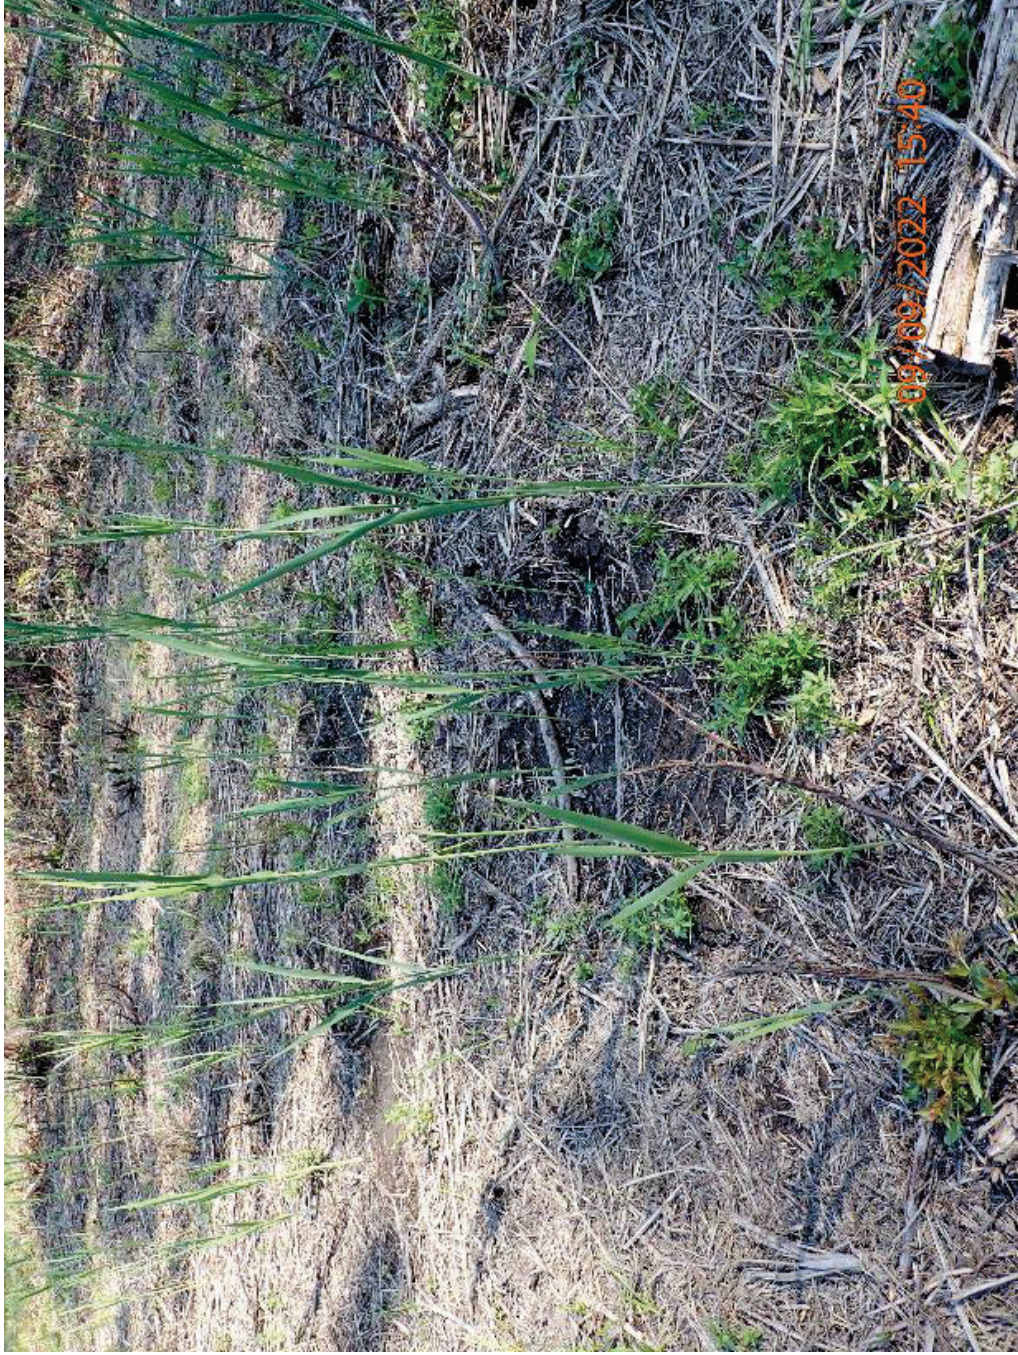
Date: 9/9/2022
Time: 3:40 PM
Photographer: SSA
Photo ID: 3 – P9090490

Area surrounding SS1 had been recently mowed

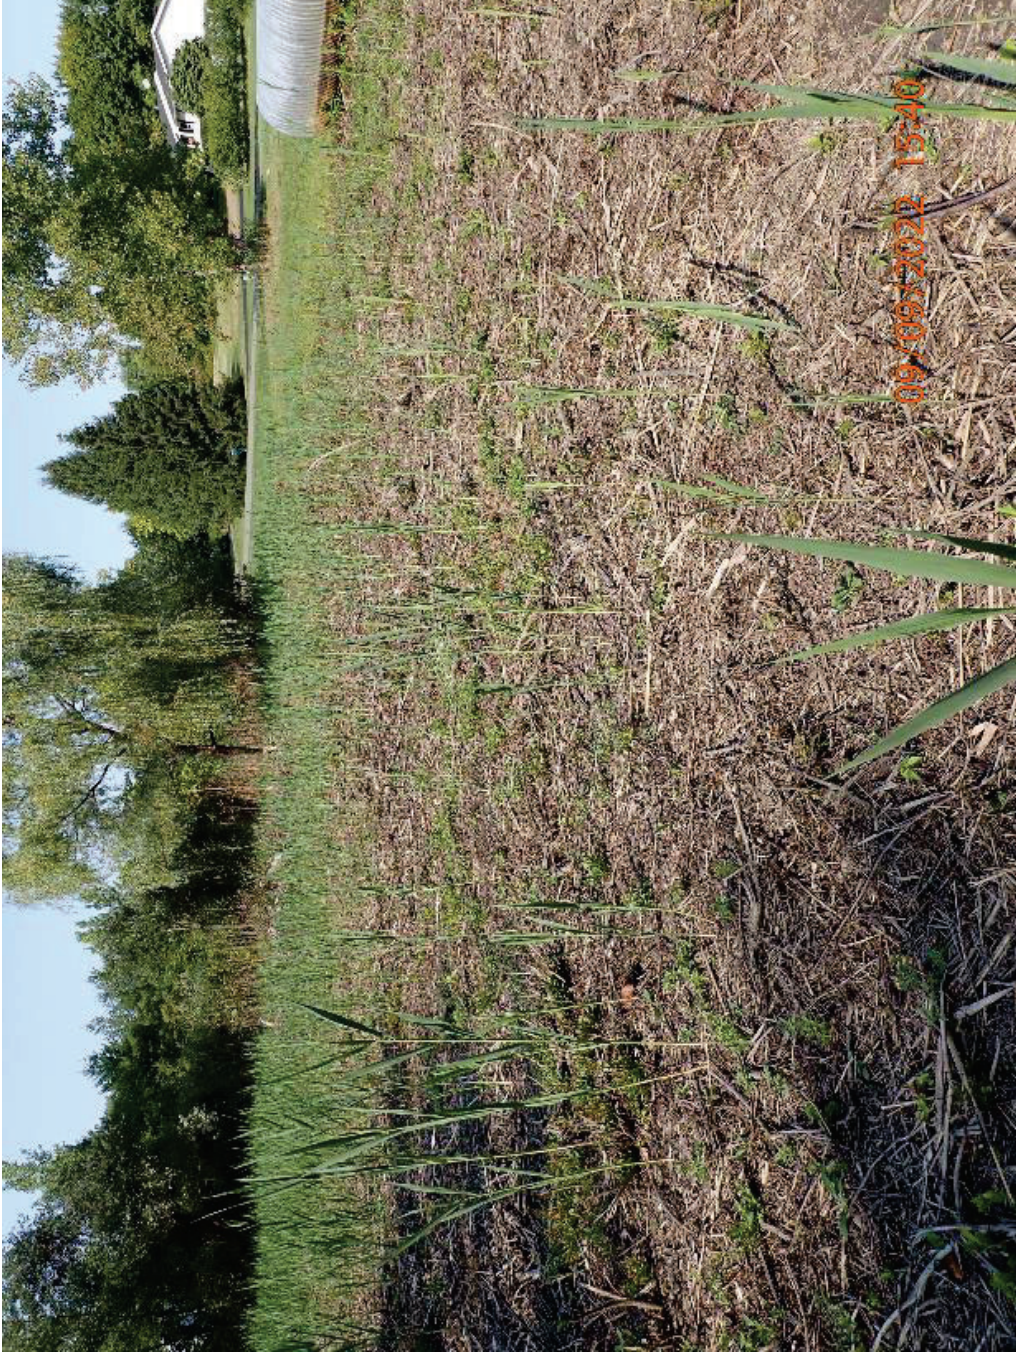
Date: 9/9/2022
Time: 3:40 PM
Photographer: SSA
Photo ID: 4 – P9090491

Description:
Area surrounding SS1 had been recently mowed

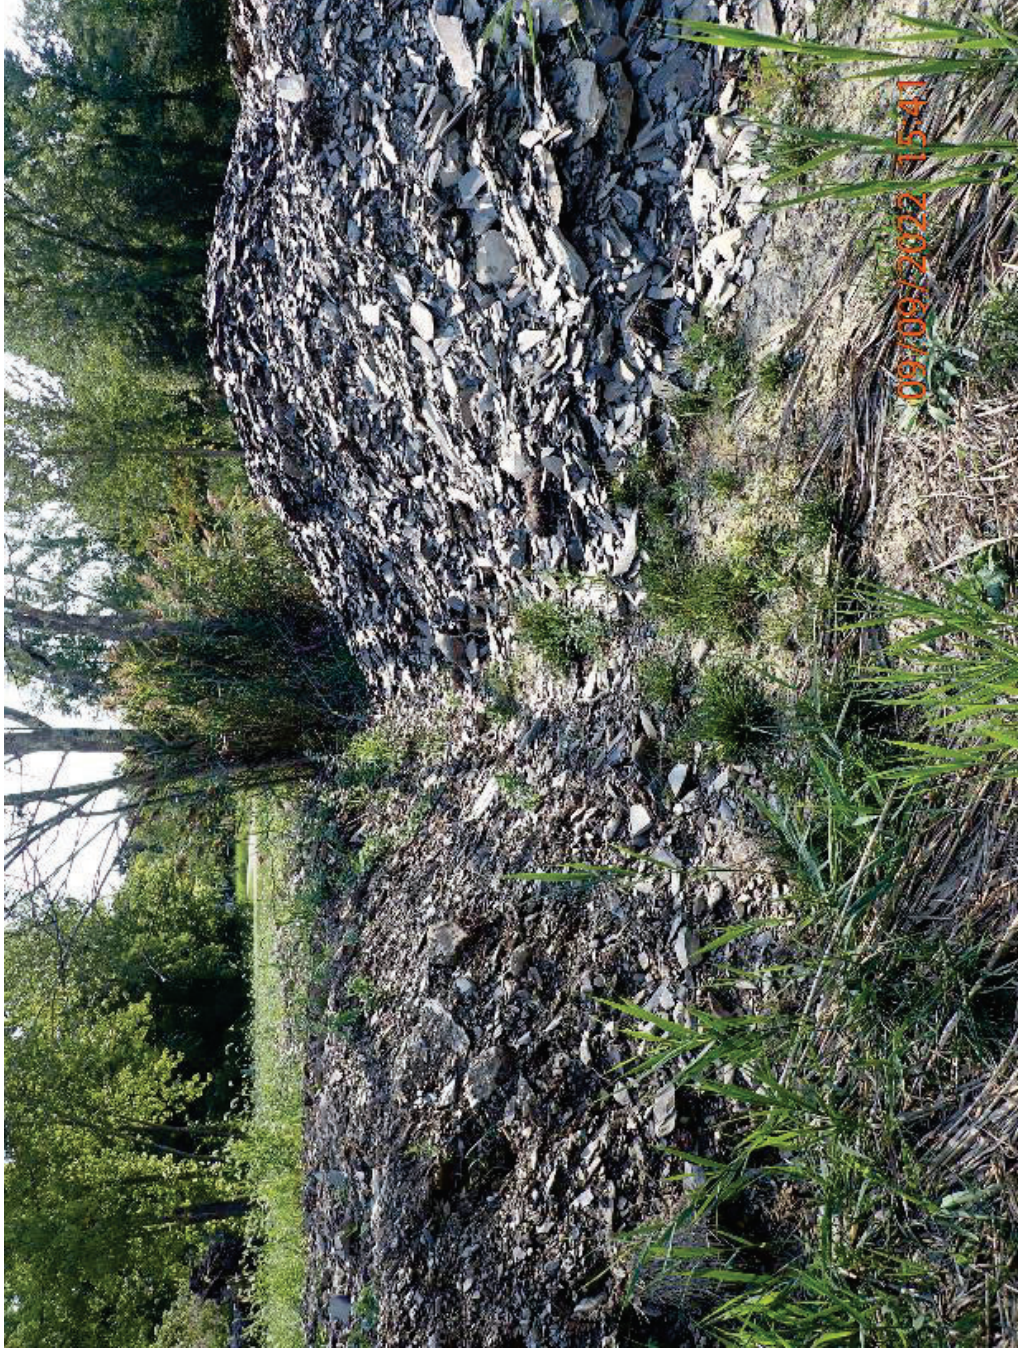
Date: 9/9/2022
Time: 3:41 PM
Photographer: SSA
Photo ID: 5 – P9090492

Fill material has been potentially discharged into wetland areas.

Two piles of fill – dirt and shale pieces (left) and shale (right); unmowed vegetation and trees located behind fill piles

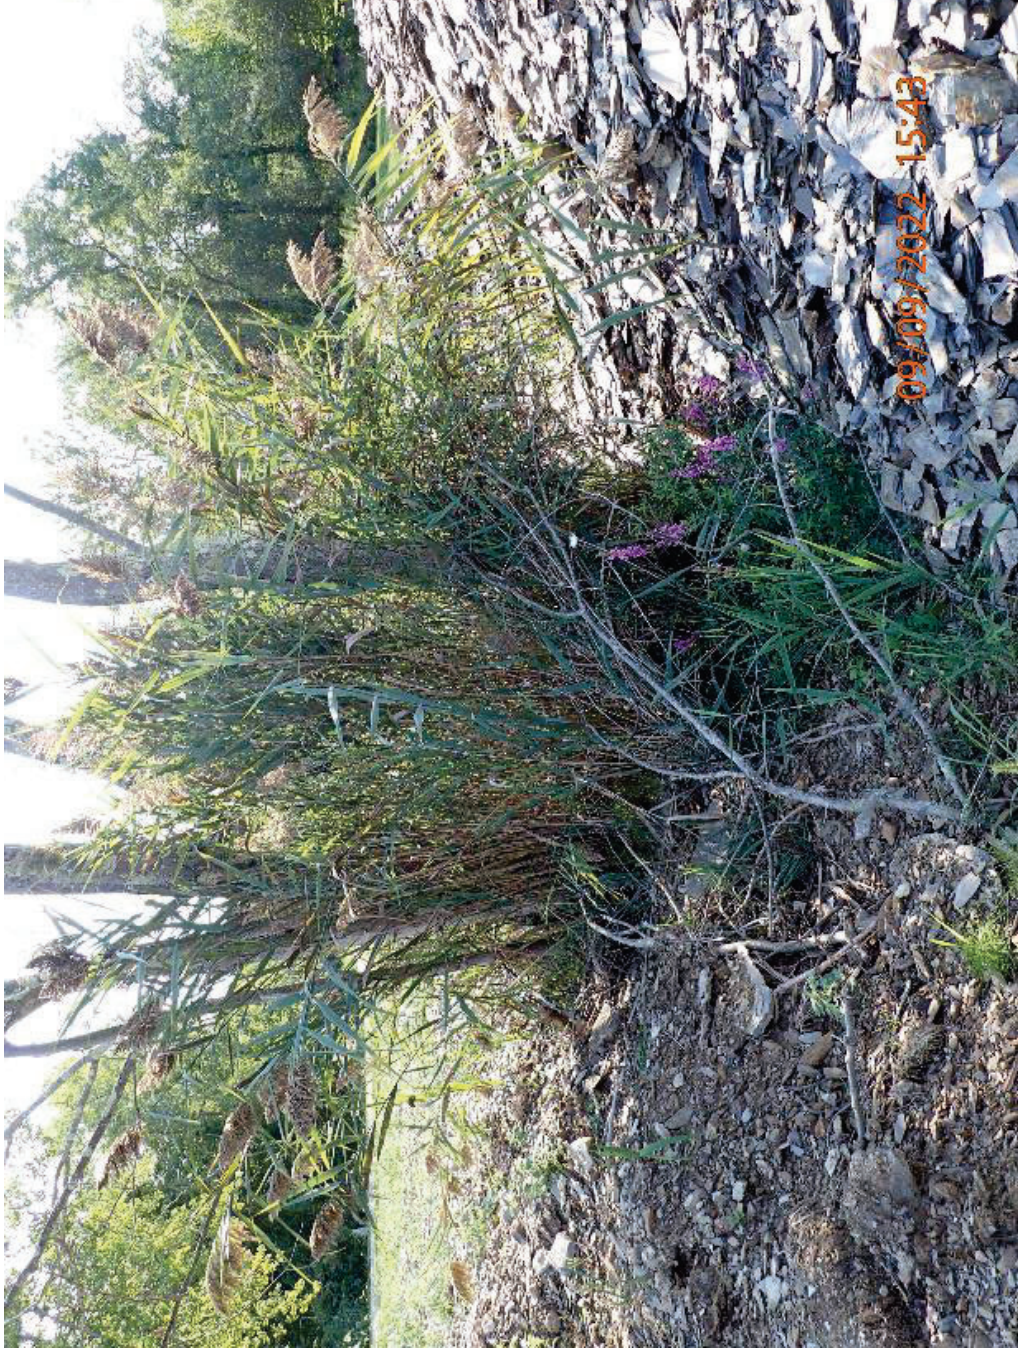
Date: 9/9/2022
Time: 3:43 PM
Photographer: SSA
Photo ID: 6 – P9090493

Description:
Unmowed vegetation and trees
located next to fill piles
Phragmites australis and
Lythrum salicaria

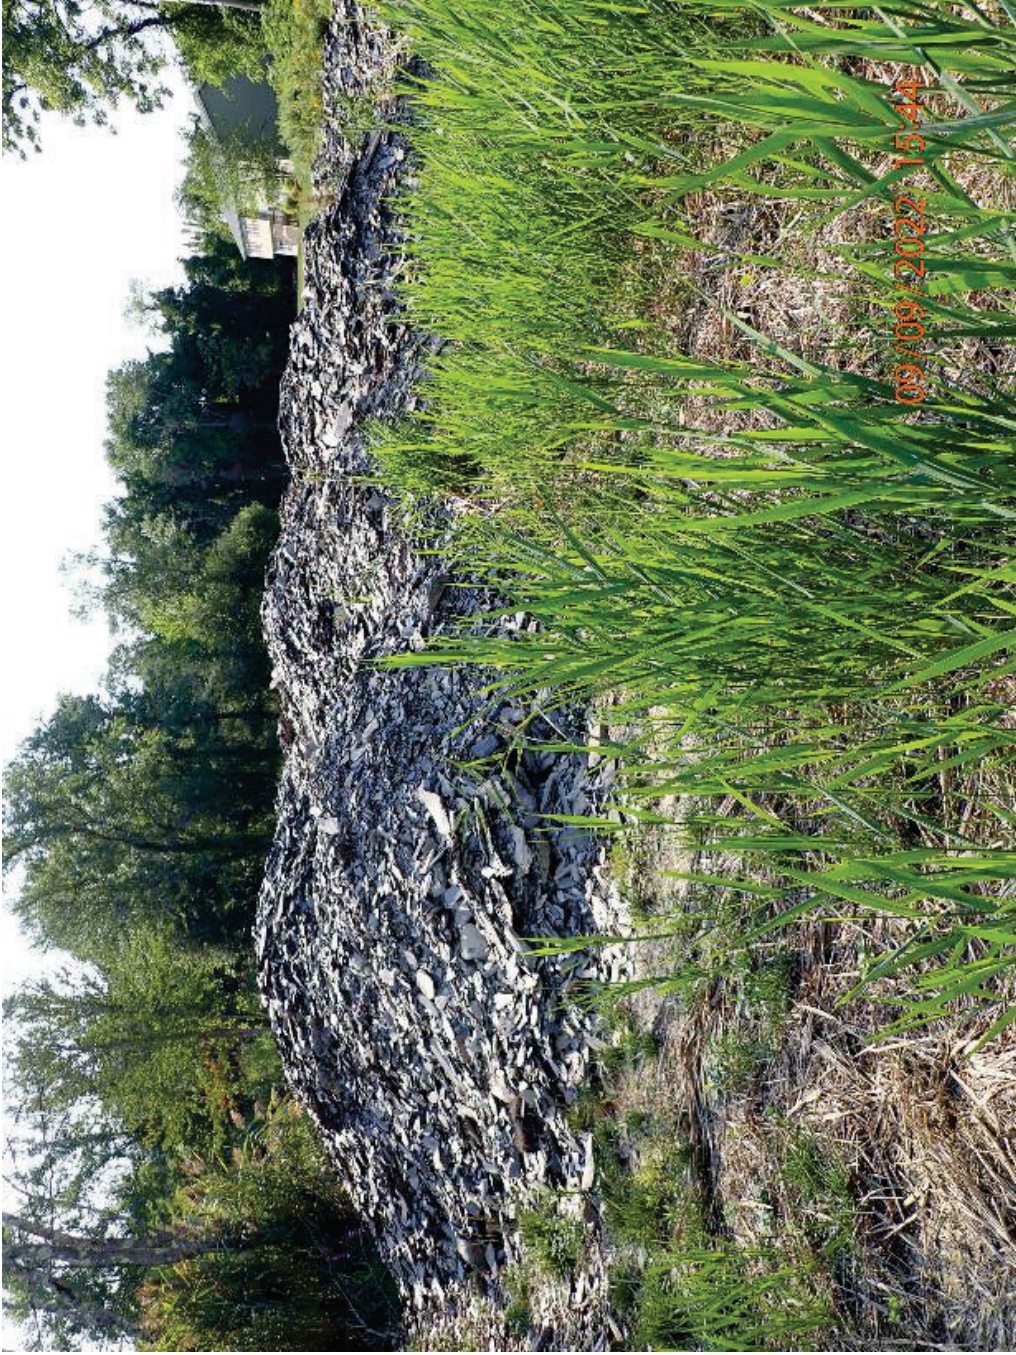
Date: 9/9/2022
Time: 3:44 PM
Photographer: SSA
Photo ID: 7 – P9090494

Pile of shale from removed backyard hill

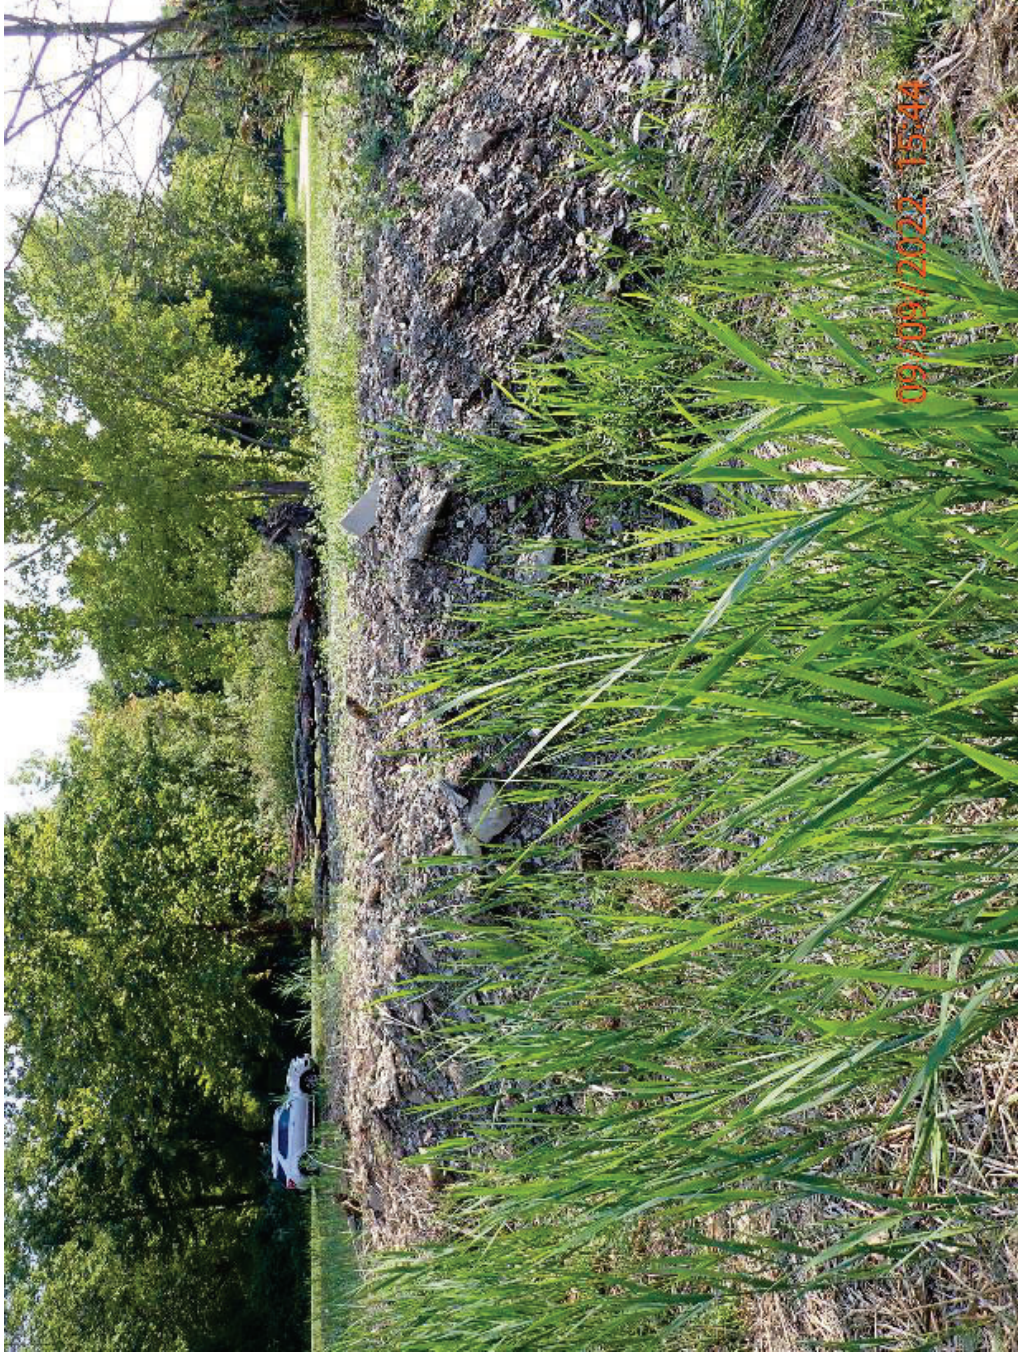
Date: 9/9/2022
Time: 3:44 PM
Photographer: SSA
Photo ID: 8 – P9090495

Description:
Pile of dirt and shale from removed backyard hill

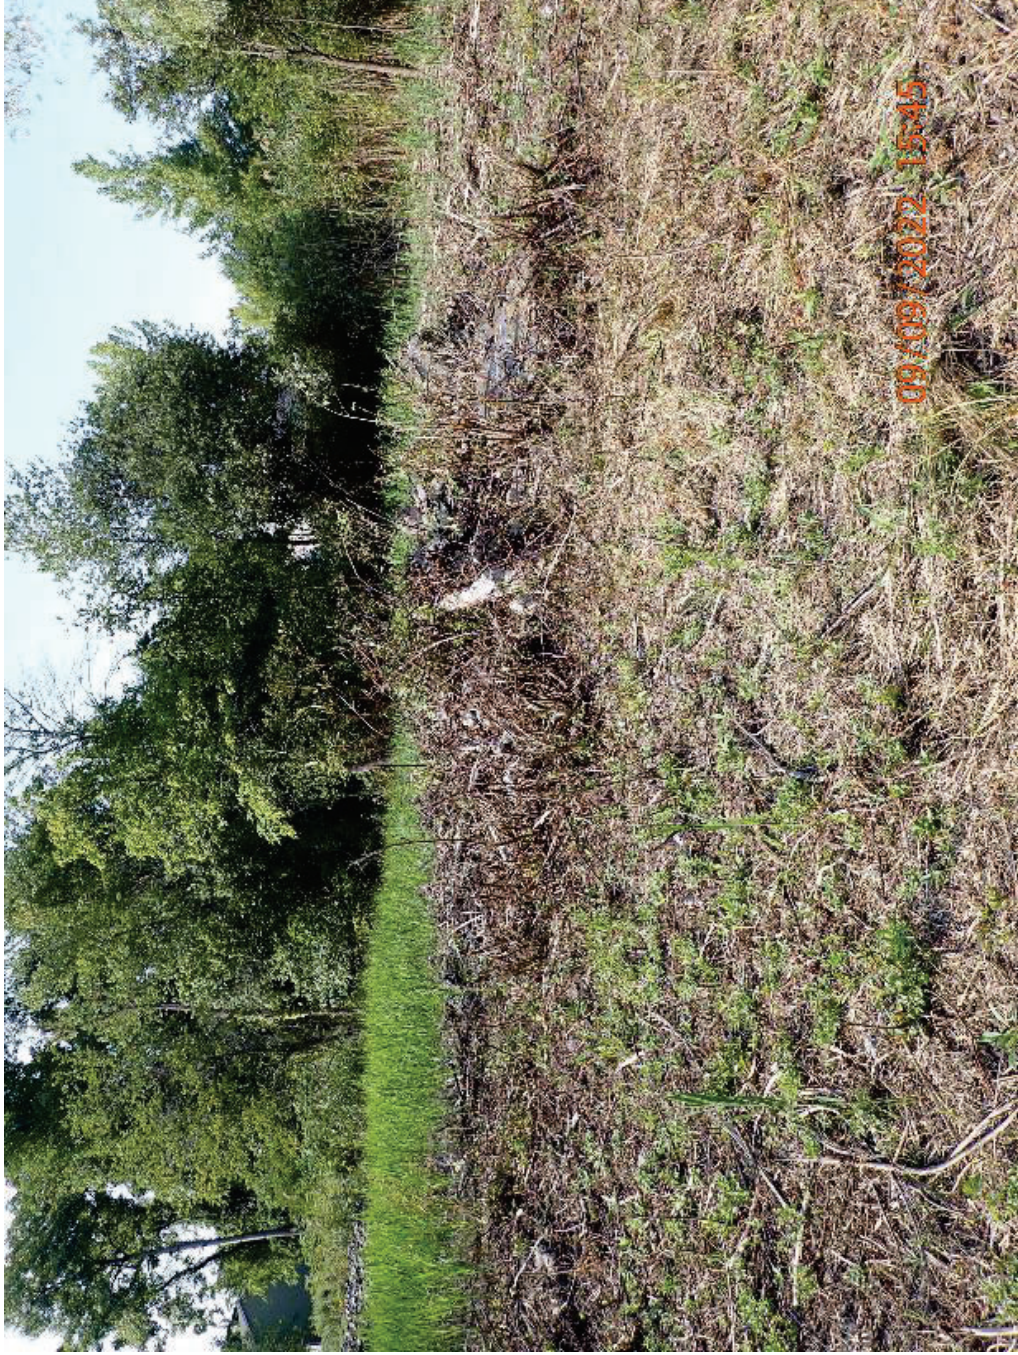
Date: 9/9/2022
Time: 3:45 PM
Photographer: SSA
Photo ID: 9 – P9090496

Description:
Pre-existing pile of concrete

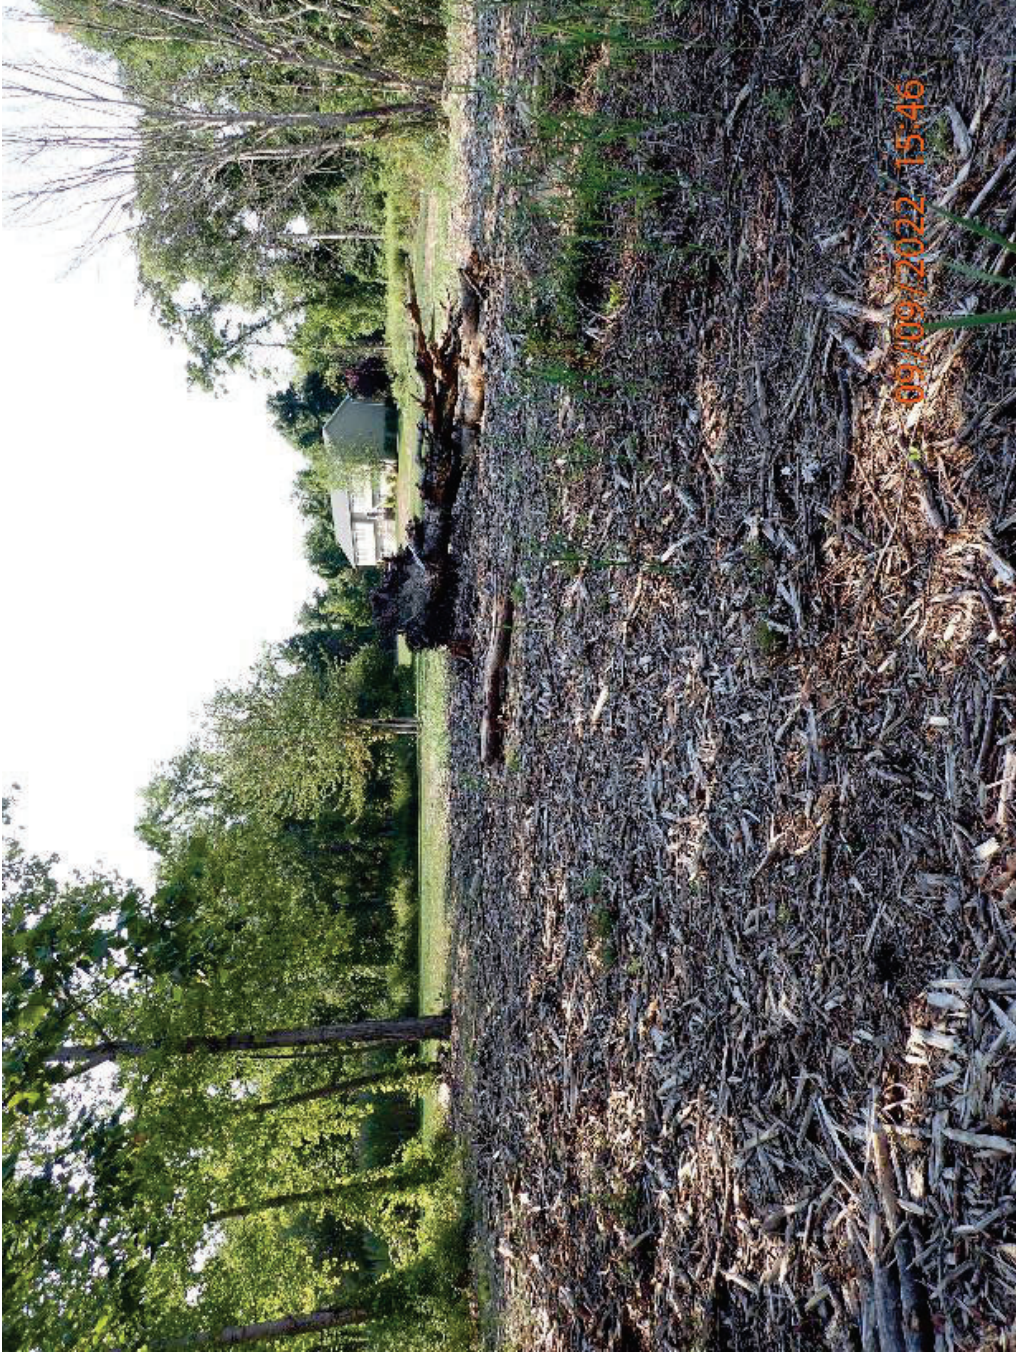
Date: 9/9/2022
Time: 3:46 PM
Photographer: SSA
Photo ID: 10 – P9090497

Mulch fill from tree that had fallen near residence
