**Region 6 - Enforcement & Compliance Assurance Division**  
**INSPECTION REPORT**

| Company Name: | Haw Farms, LLC | | |
| Facility Name: | Haw Farms | | |
| Identification/Permit Number: | NM0030716 | | |

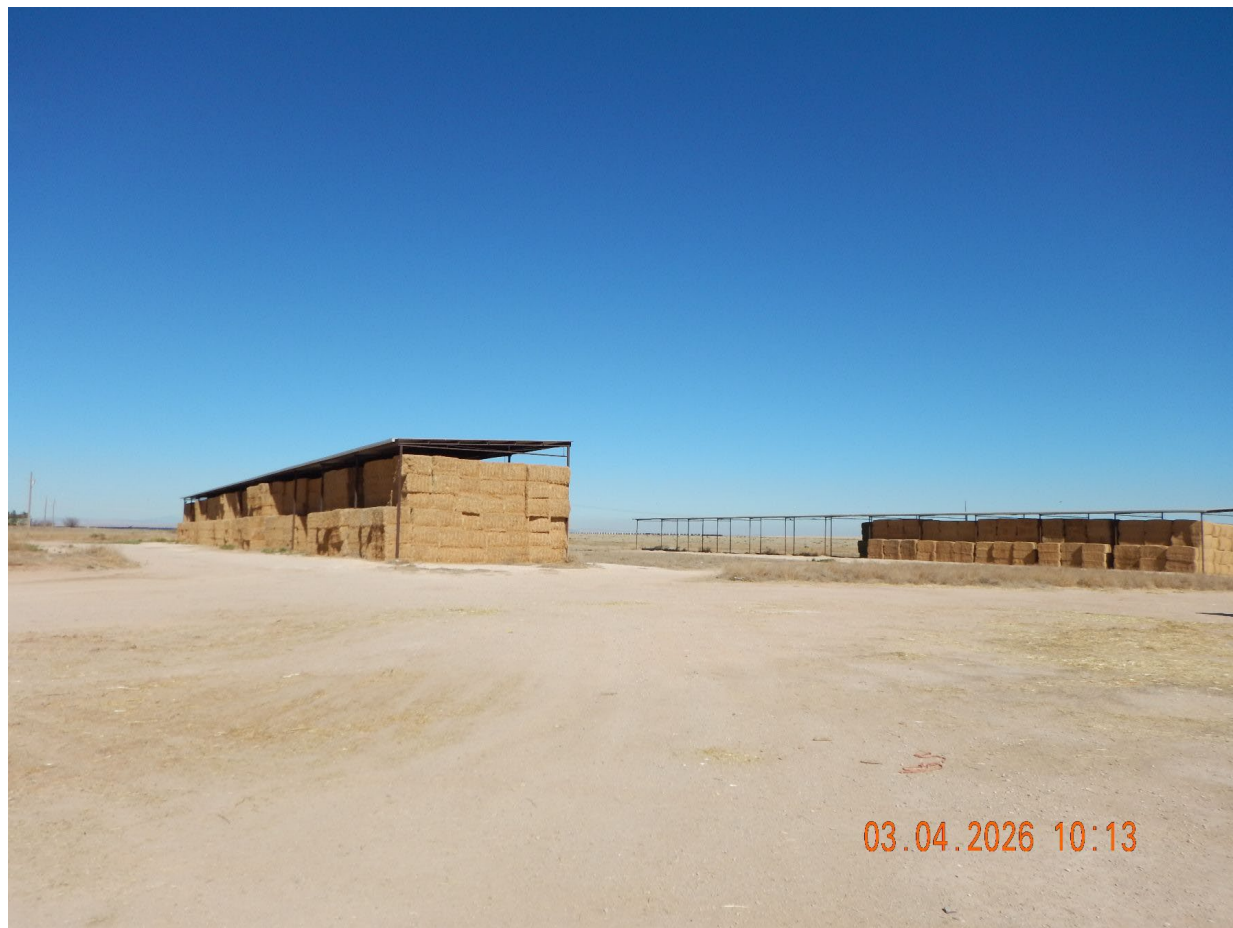
## Photo No. 1

The facility reports using alfalfa, corn silage, some grains, and minerals for feed. All feed commodities are stored under cover (Appendix 1, Photos 1 and 2).

| Description: | View to the northwest. Hay storage under roof. | | | | |

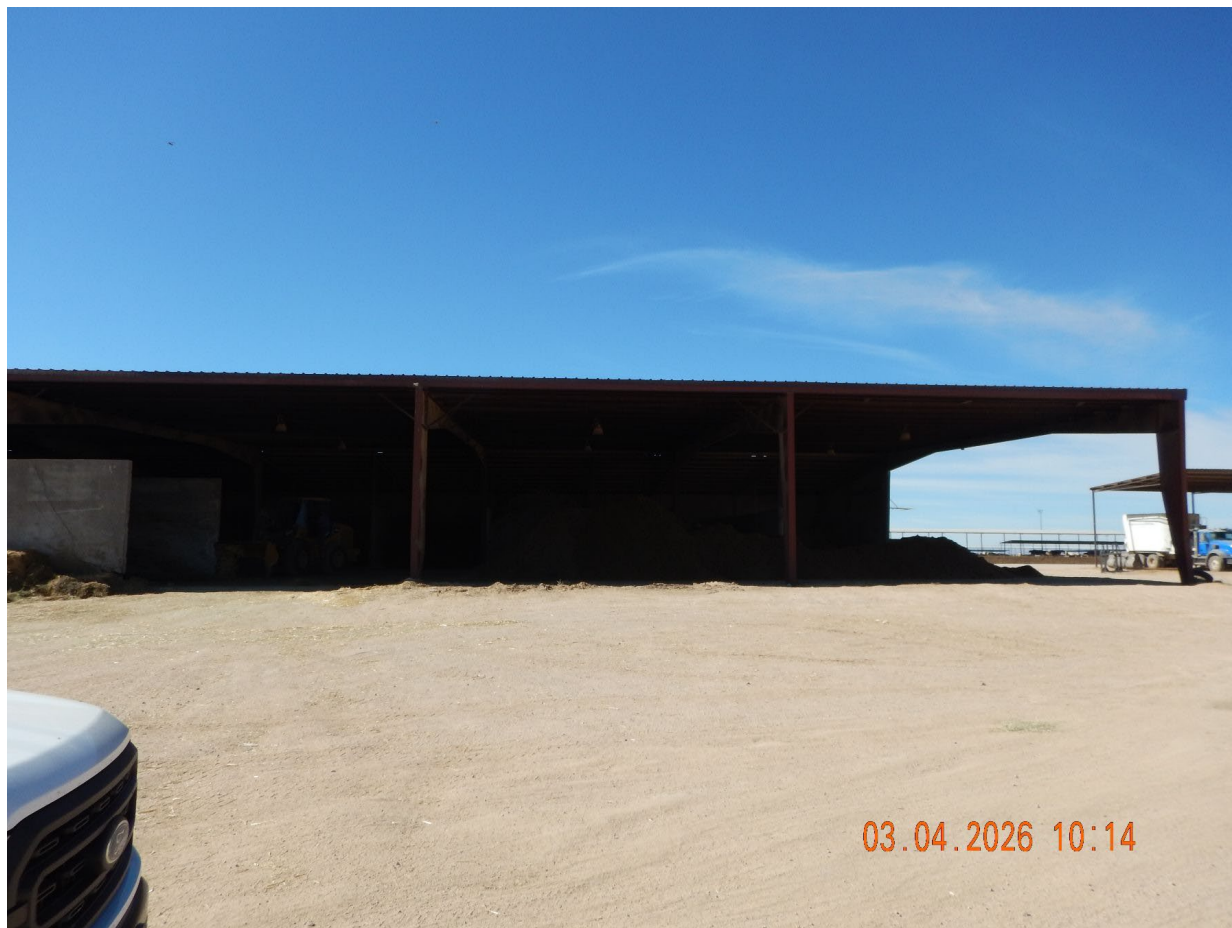
Photo No. 2

| Description: | View to the south. Commodity bunkers under roof. | | | | |

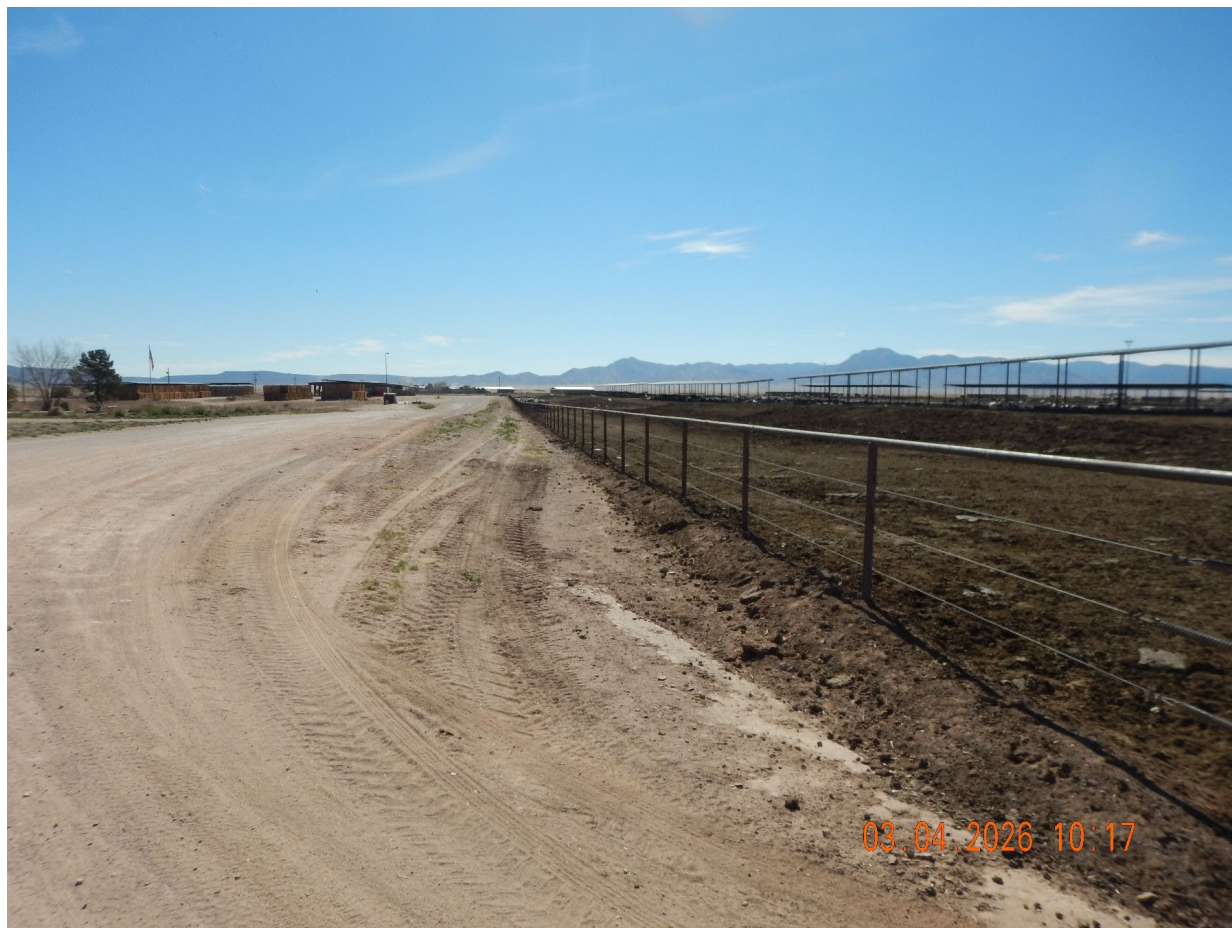
Photo No. 3

Weather at the time of the inspection was sunny; no precipitation had occurred in the preceding week. No active discharges were observed (Appendix 1, Photos 3 and 4).

| Description: | View to the southeast. Eastern perimeter of the open lot pens. | | | | |

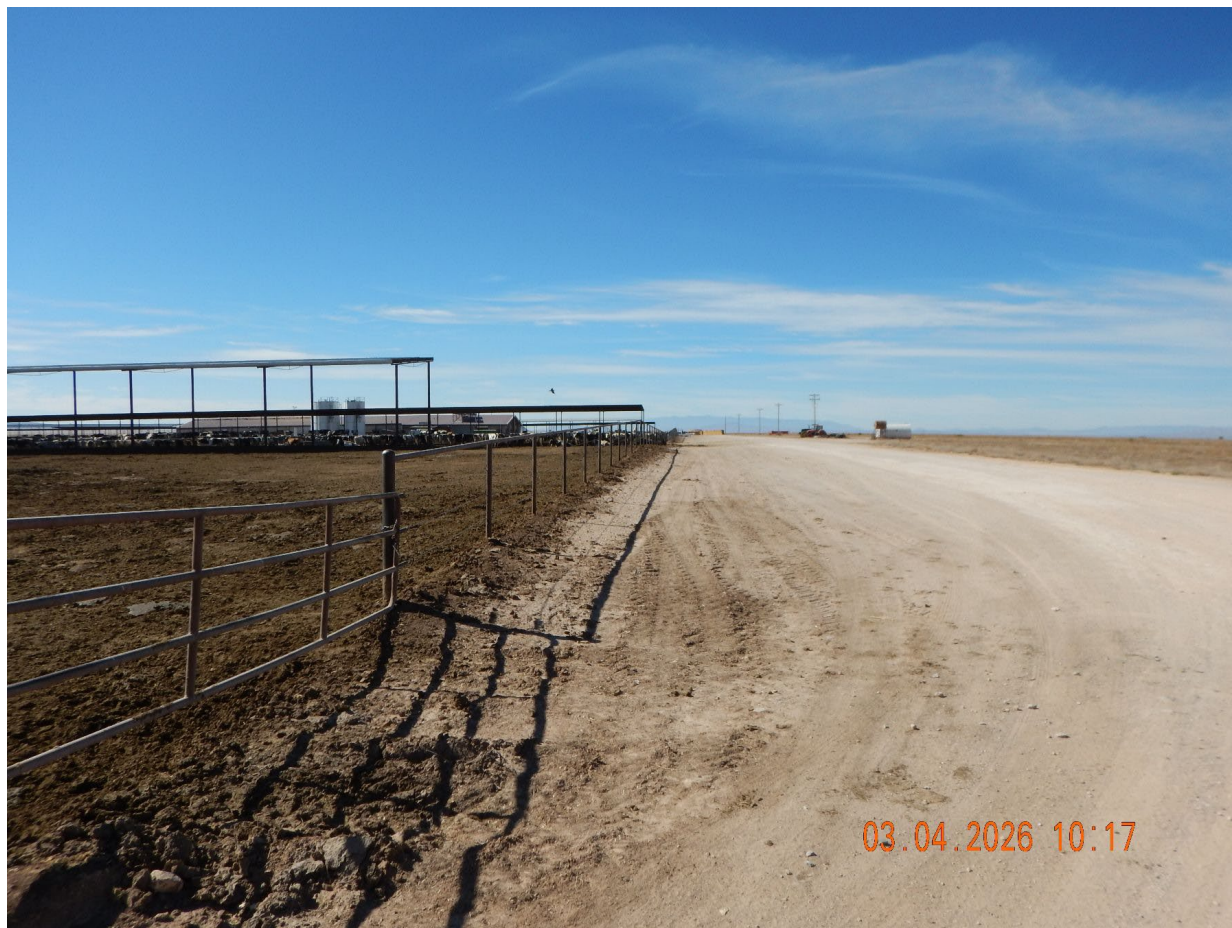
Photo No. 4

| Description: | View to the southwest. Northern perimeter of the open lot pens. | | | | |

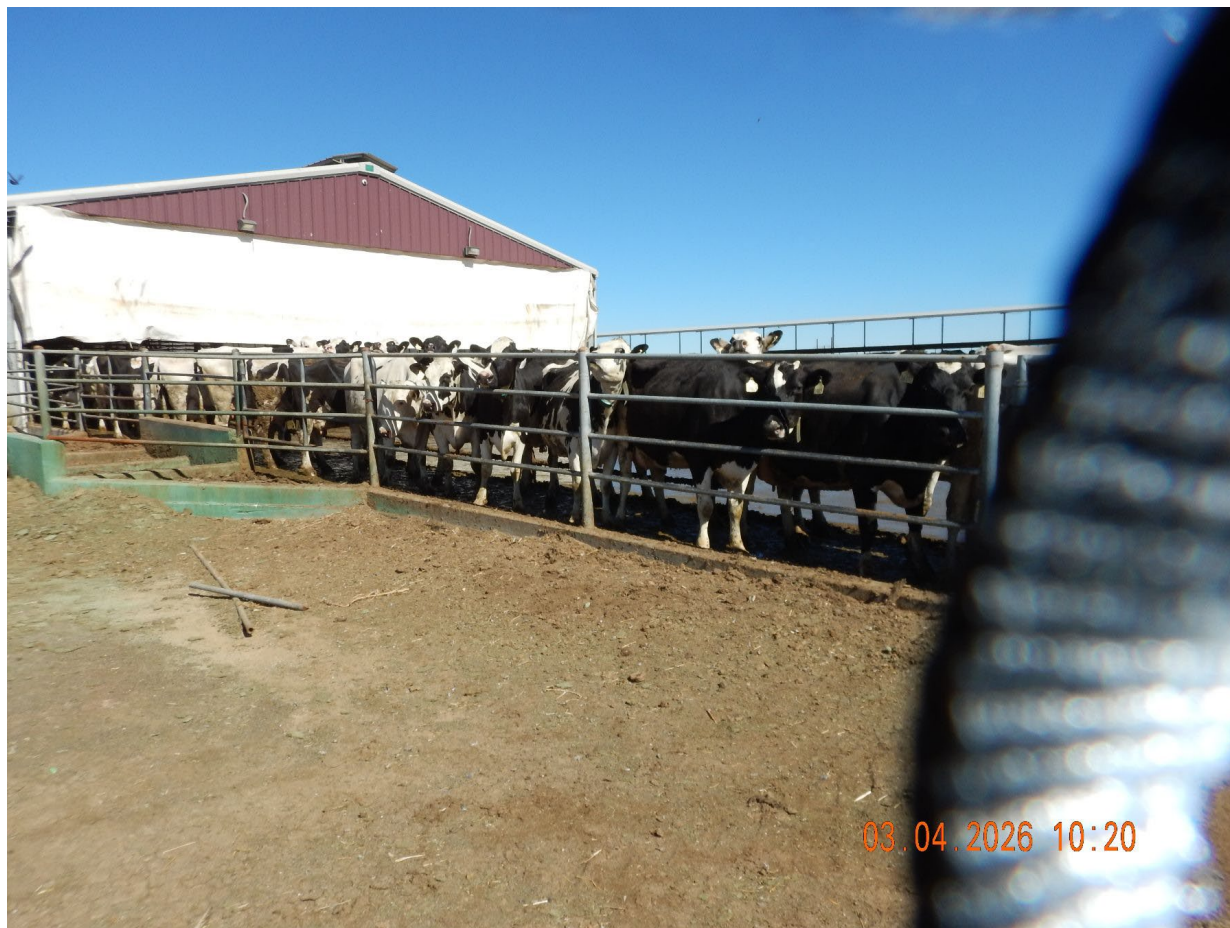
Photo No. 5

| Description: | View to the north. Path leading to milking parlor. | | | | |

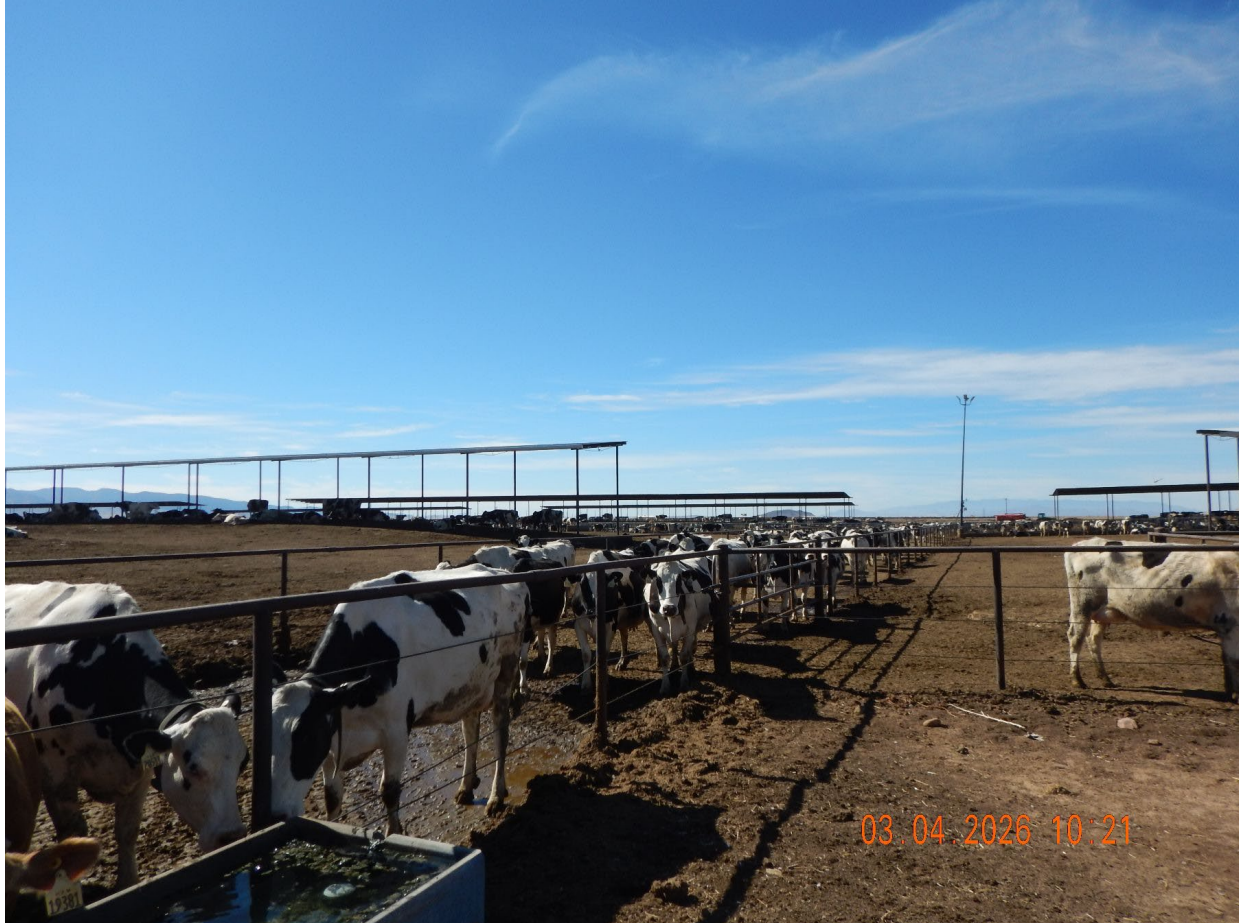
Photo No. 6

The pens were in good condition, with no signs of manure buildup or stockpiles in the pens. Pens are cleaned via scraping as needed. Manure solids are stockpiled above the drainage to the RCSs (Appendix 1, Photo 11). All pens are graded and sloped to drain to the RCSs (Appendix 1, Photos 6, 14, and 15).

| Description: | View to the south. Path leading from milking parlor. | | | | |

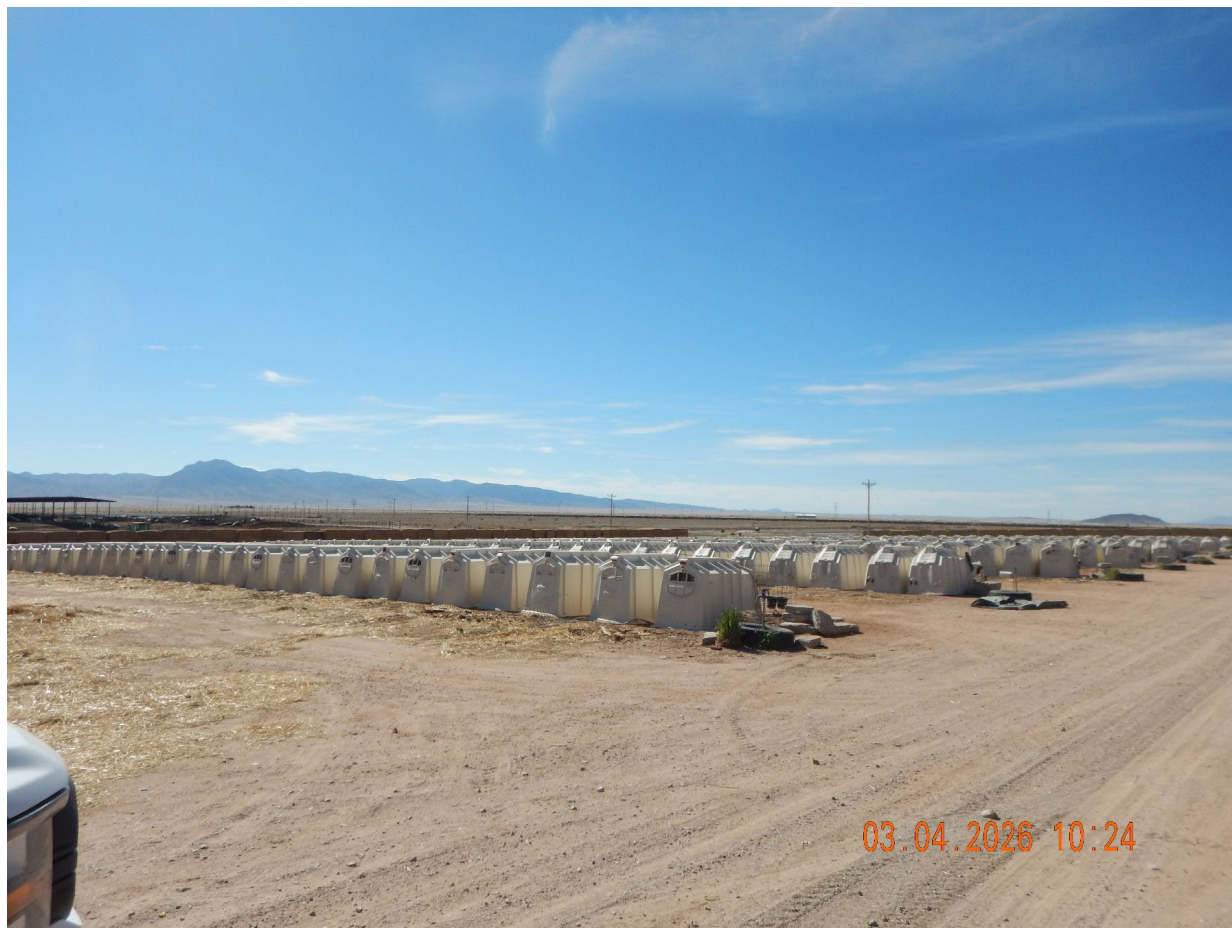
### Photo No. 7

| Description: | View to the south. Calf hutches graded to the RCS in background. | | | | |

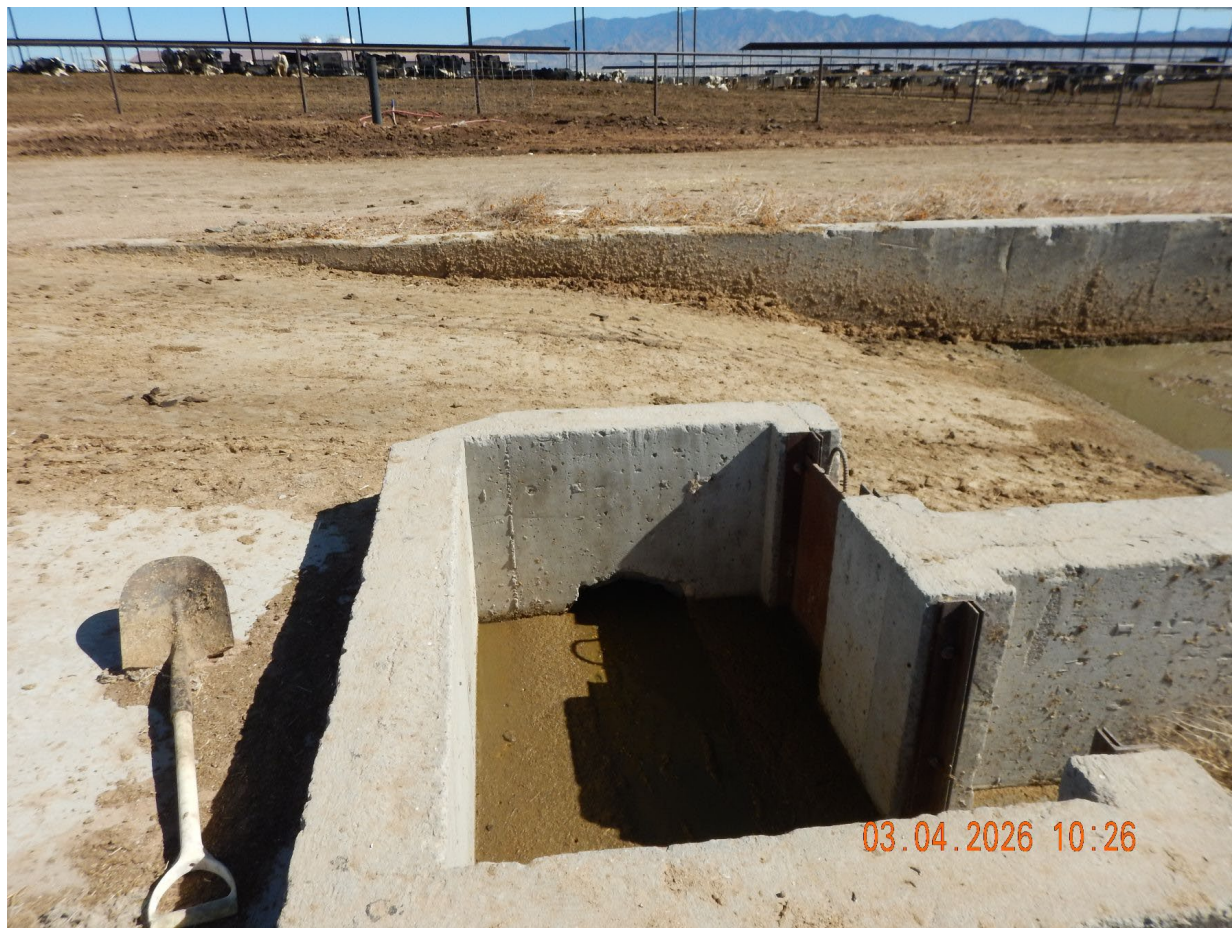
Photo No. 8

| Description: | View to the northeast. Pipe outfall for wastewater coming from the milking parlor as it enters the settling basins. | | | | |

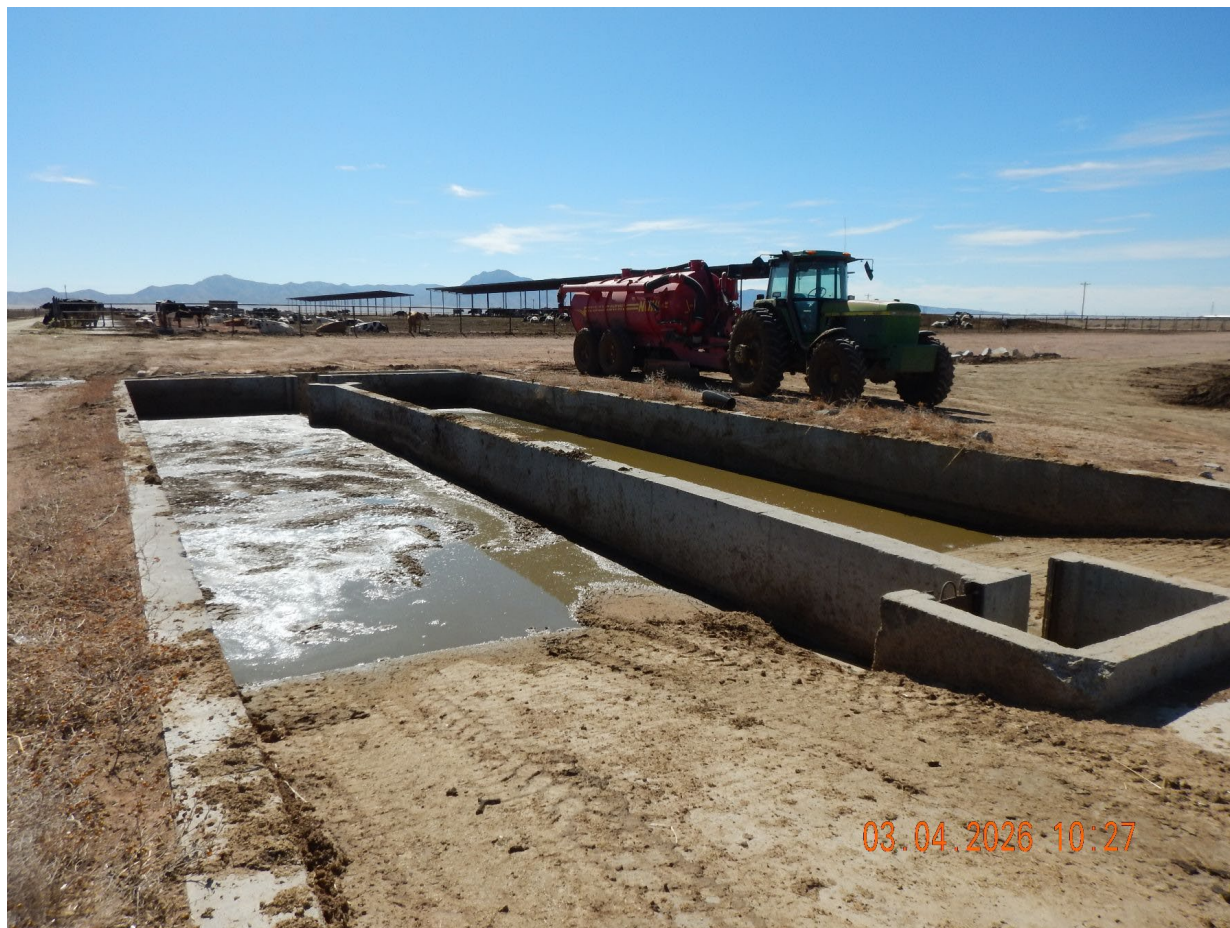
Photo No. 9

| Description: | View to the east. Concrete solid settling basins. | | | | |

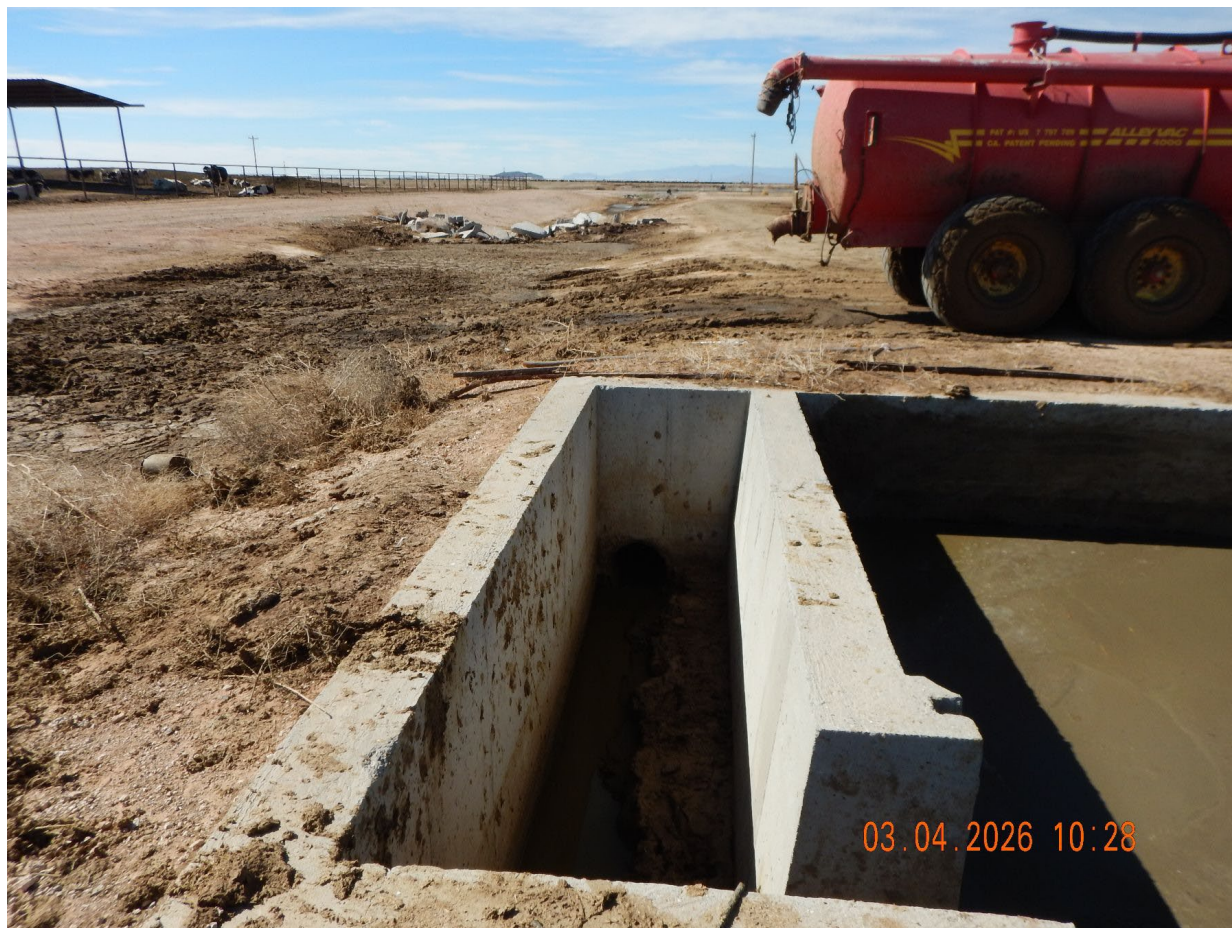
Photo No. 10

| Description: | View to the south. Pipe from settling basins to RCS. | | | | |

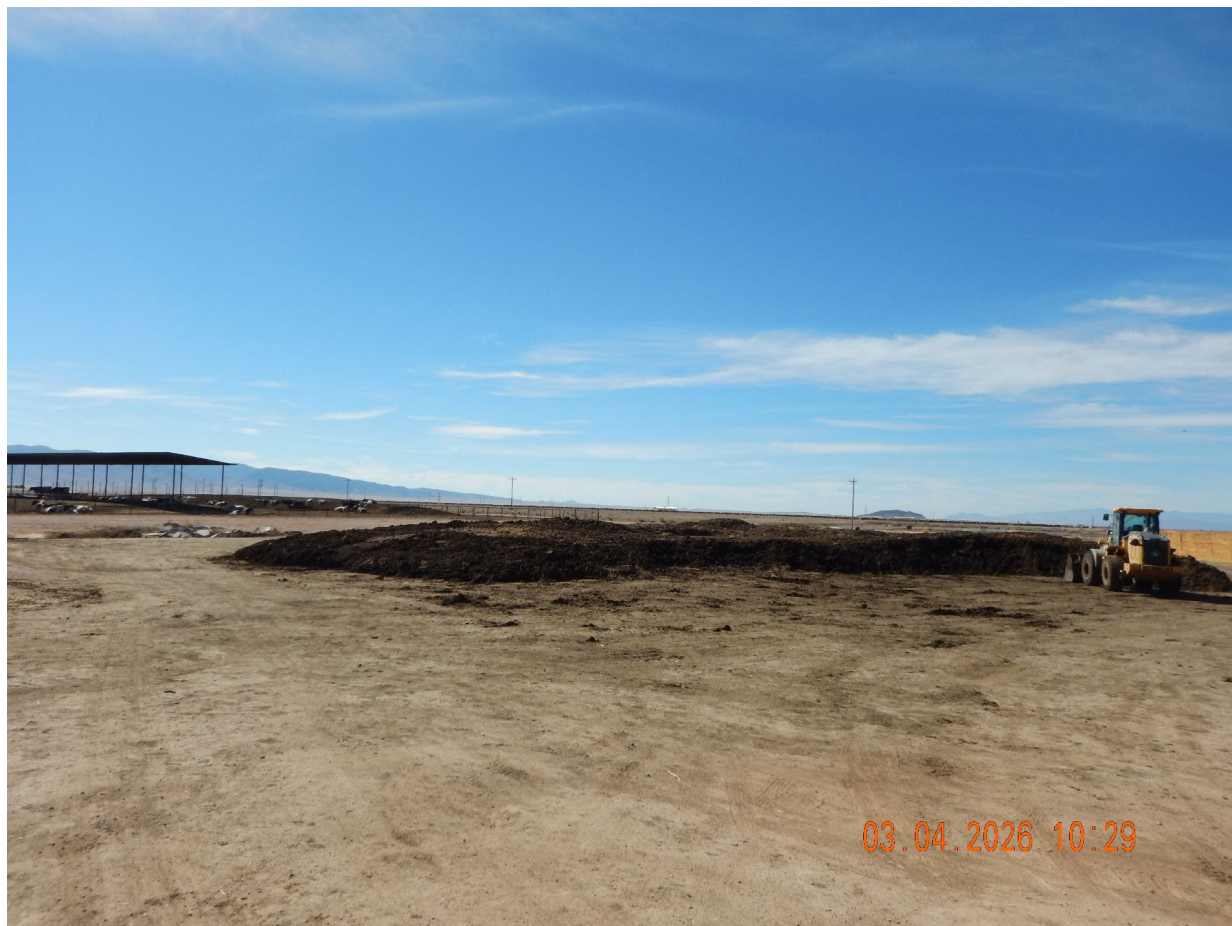
## Photo No. 11

| Description: | View to the southeast. Manure stockpile within the drainage of the RCS in background. | | | | |

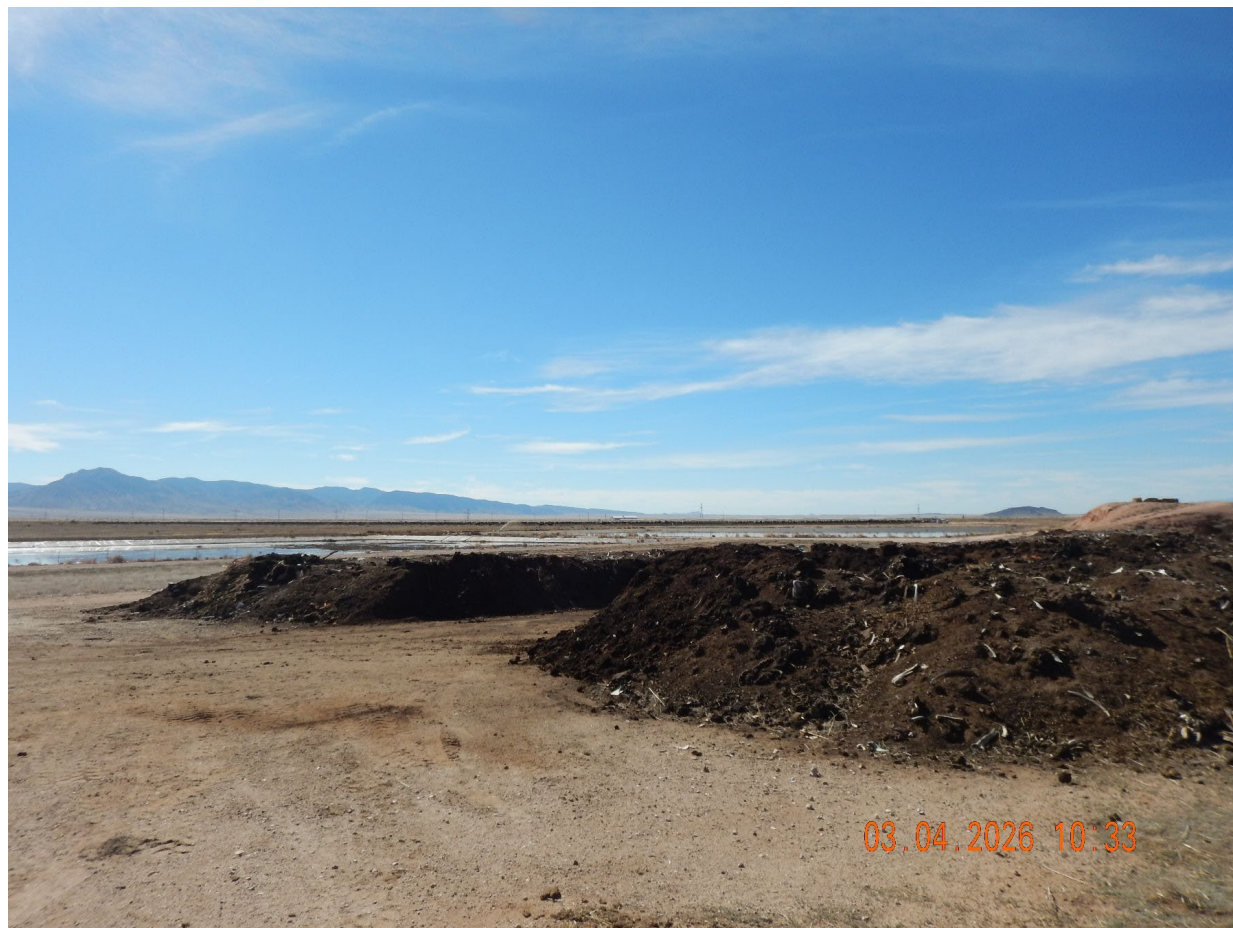
### Photo No. 12

Animal mortalities are composted on the western perimeter of the site within the drainage of RCS-1 and RCS-2 (Appendix 1, Photo 12).

| Description: | View to the southeast. Mortality composting with drainage to RCS in background. | | | | |

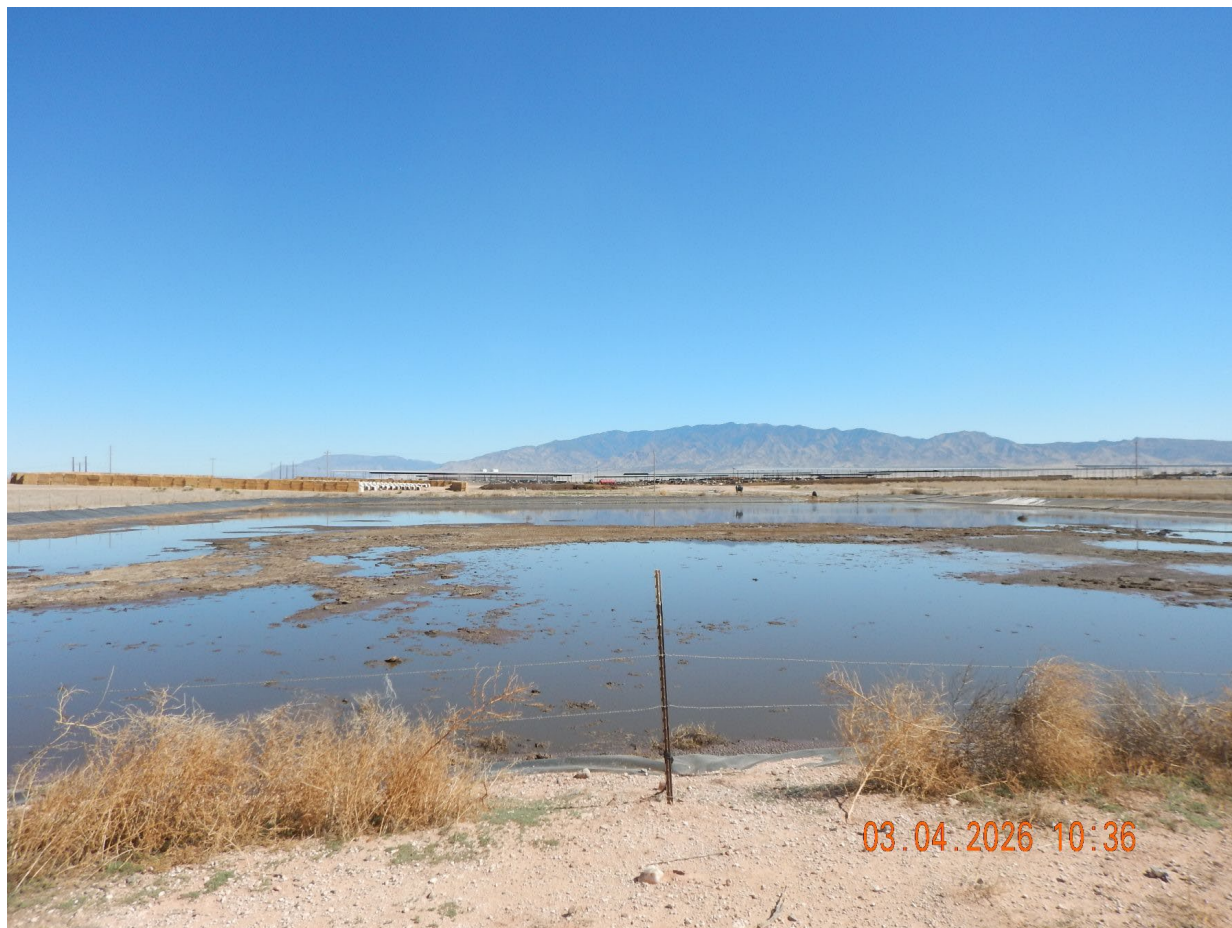
Photo No. 13

The facility contains two retention control structures (RCSs): RCS-1 and RCS-2 (Appendix 1, Photos 13 and 14). The settling basins are located southwest of the milking parlor, with RCS-1 and RCS-2 farther southwest. Wastewater from the milking parlor is piped to the settling basins and then flows by gravity to RCS-1 and finally to RCS-2 (Appendix 1, Photos 8-10). Both RCSs are designed as total-evaporative ponds. Site runoff is conveyed by gravity, and manure solids are provided to third parties.

below the berm crest, with a design surface area of 5.33 acres. At the time of the inspection, both RCSs were fenced, liners appeared intact, approximately 4 feet of freeboard were observed, and no evidence of erosion or discharge was noted. The facility was actively aerating the RCSs.

| Description: | View to the northeast. RCS 1 with pens in background. | | | | |

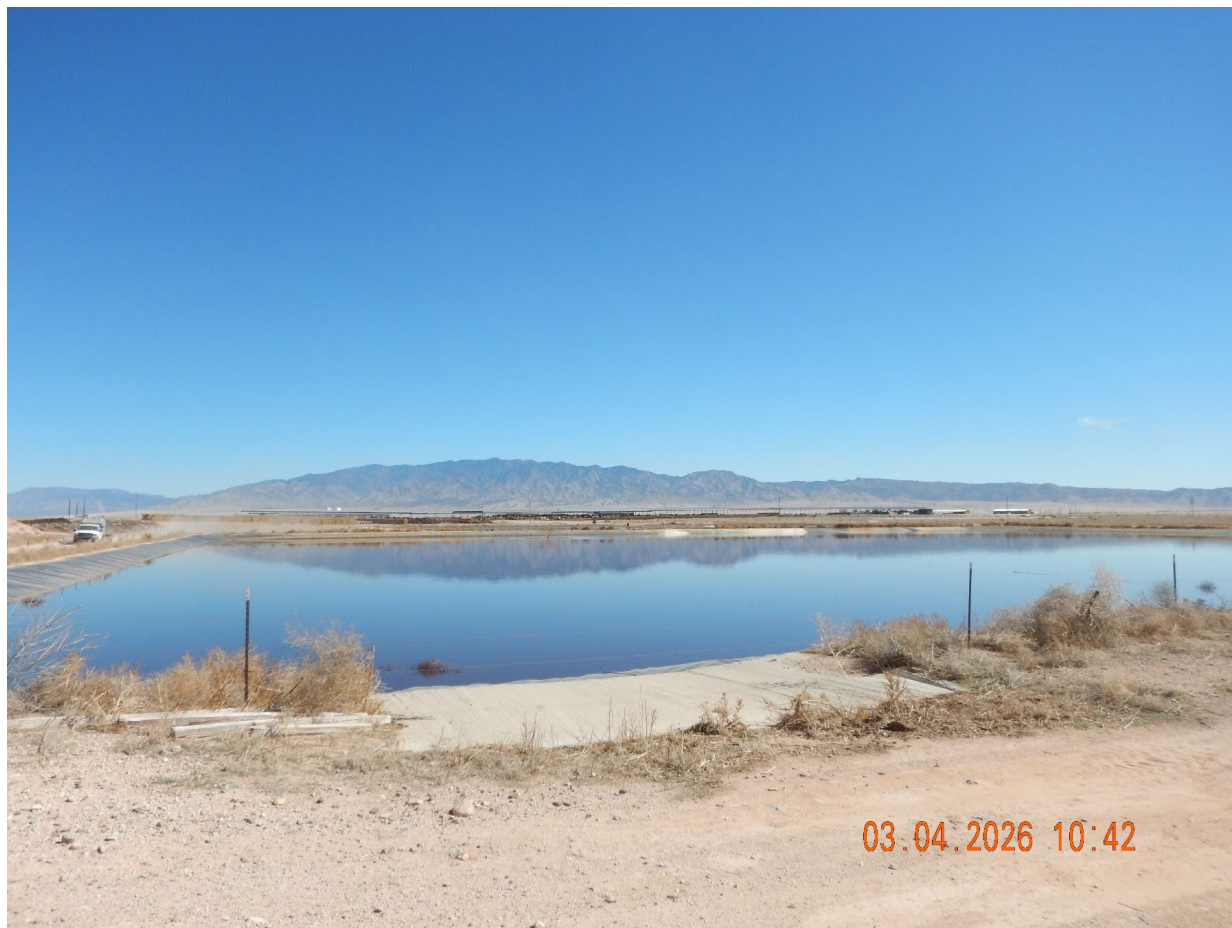
## Photo No. 14

| Description: | View to the northeast. RCS 2 with RCS 1 and pens in background. Drainage channel outfall to RCS 2 in foreground. | | | | |

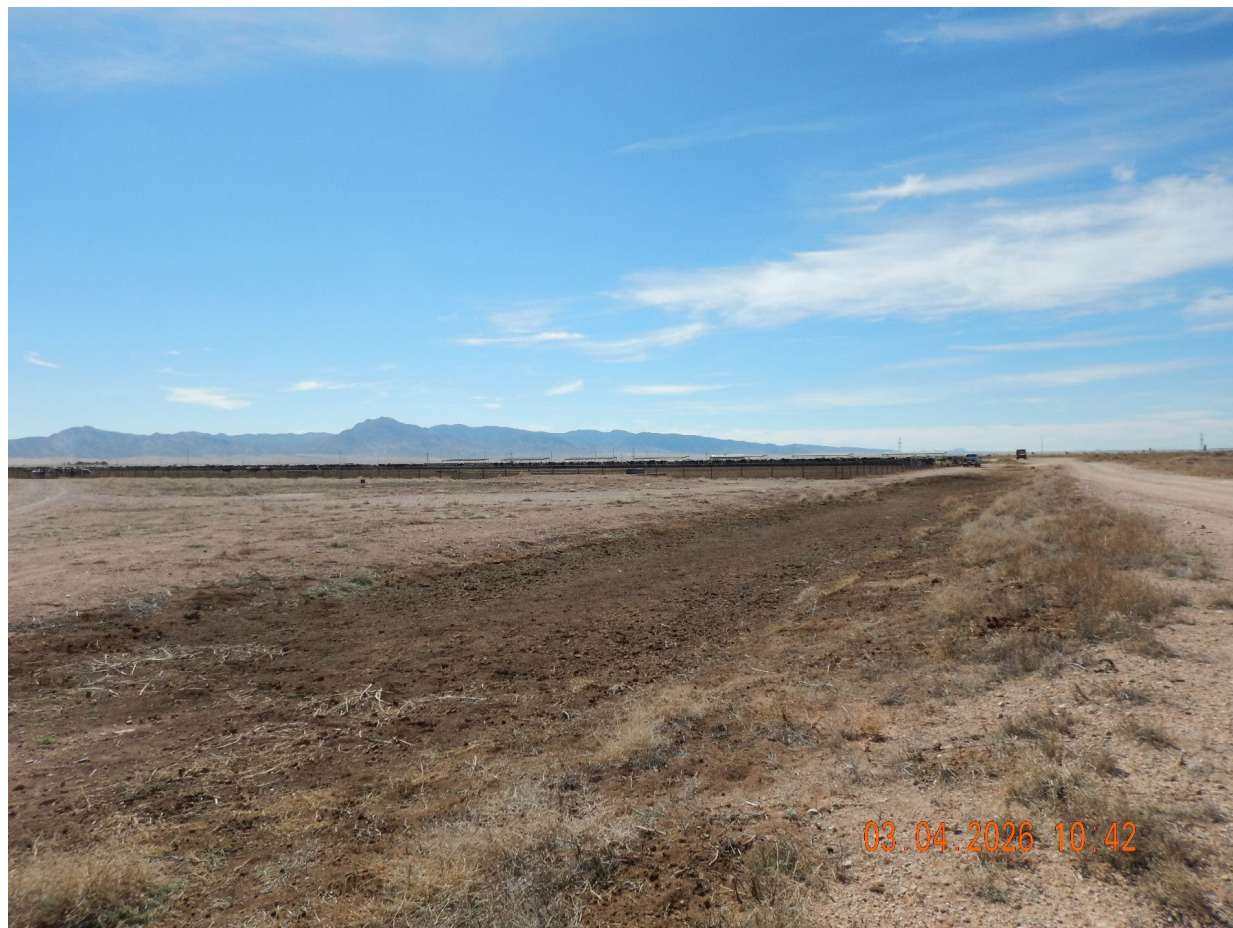
## Photo No. 15

| Description: | View to the south. Drainage channel leading from Dry Cow pens to RCS 2. | | | | |
