## Region 6 - Enforcement & Compliance Assurance Division

### INSPECTION REPORT

| Company Name: | <b>MidAmerica Environmental Holdings, LLC</b> | |
| Facility Name: | <b>Hutcheson B-2 SWD Commercial</b> | |

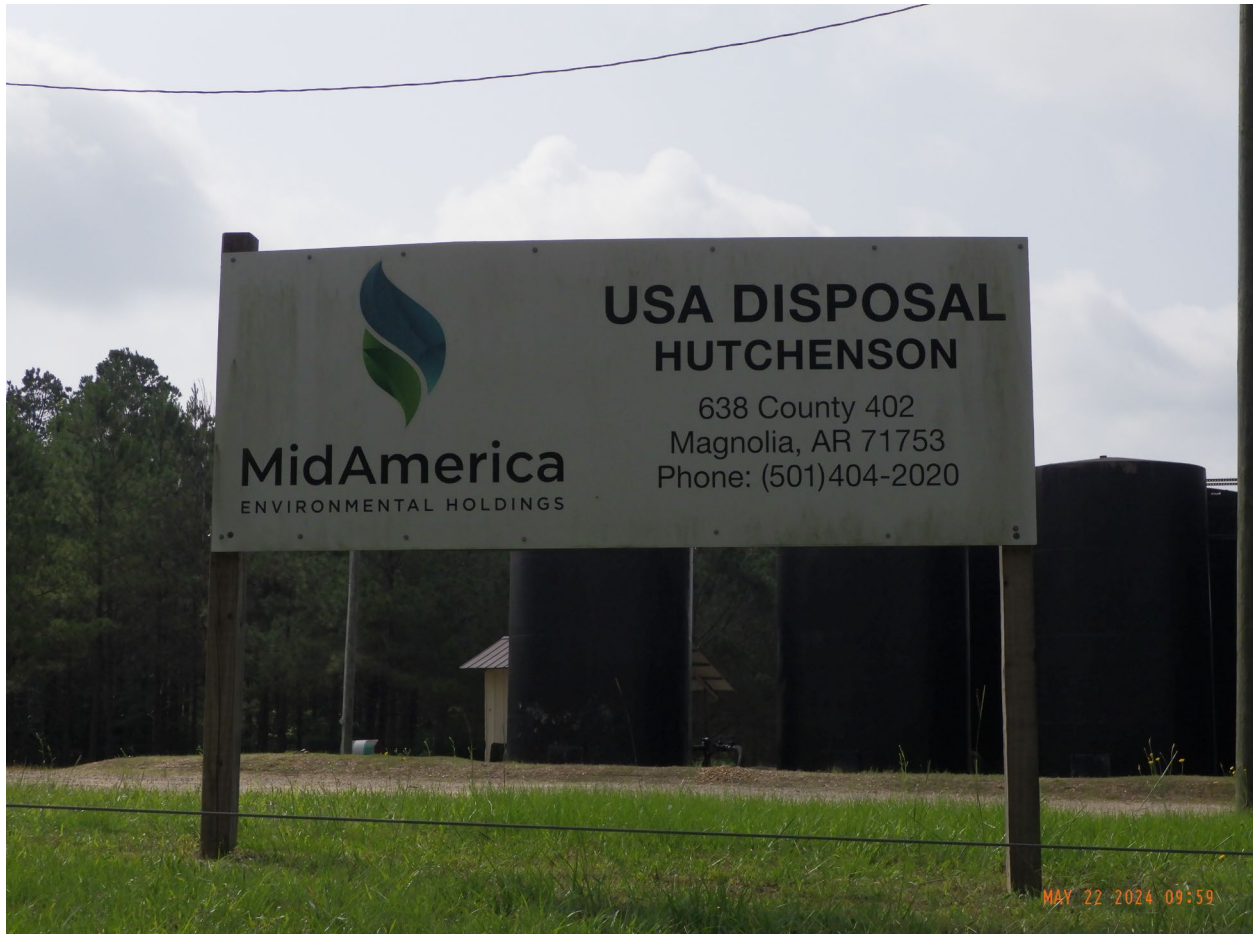
I observed the facility sign, secondary containment, pipes and valves, and storage tanks located at the facility; see Appendix 1 (Photograph Log), Photo No. 1 and No. 2. For additional GPS location and photo metadata, see Appendix 1.

**Description:** Looking SE, this photo showed the signage at the facility.

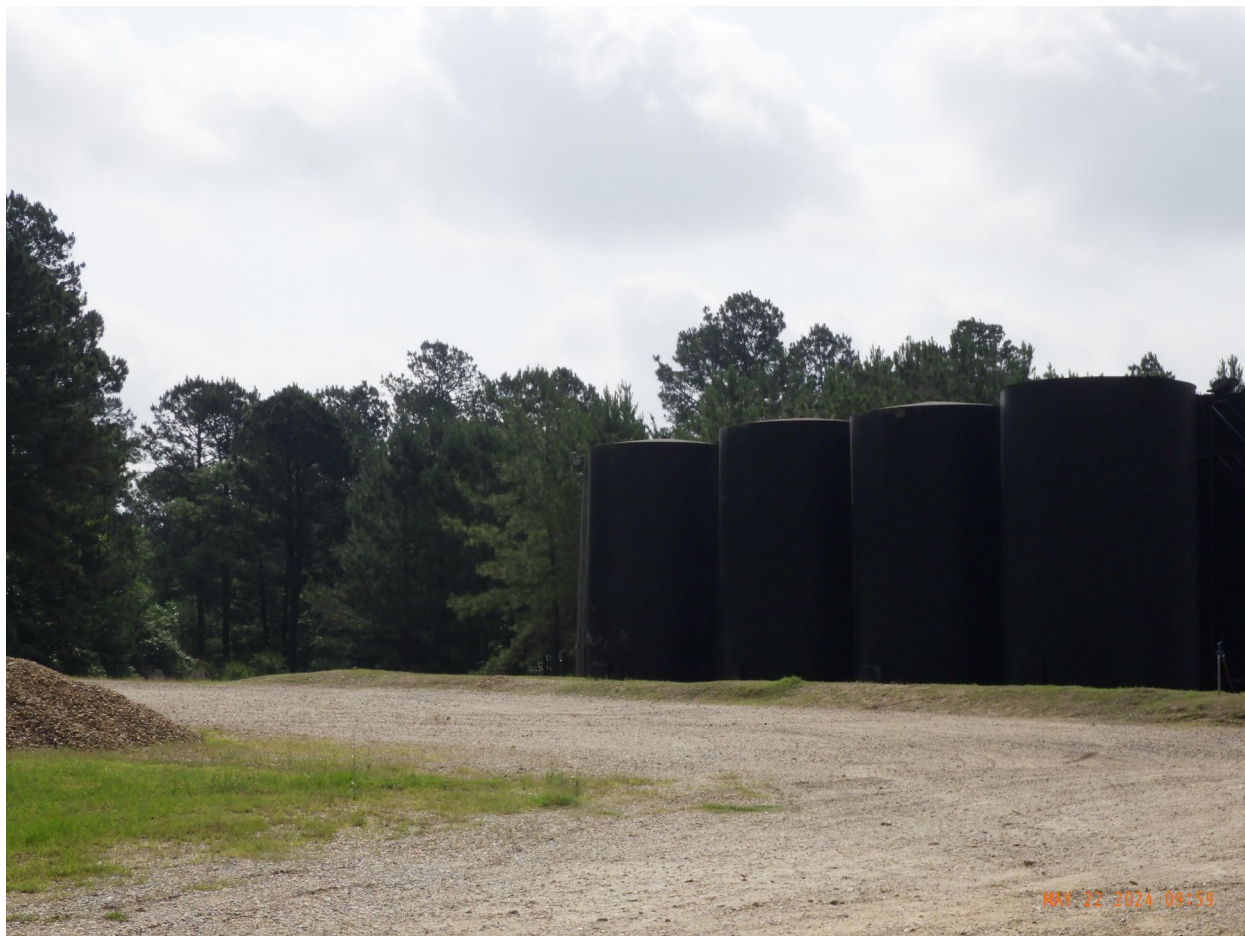
Photo No. 2

**Description:** Looking E, this photo showed the overview of the facility.

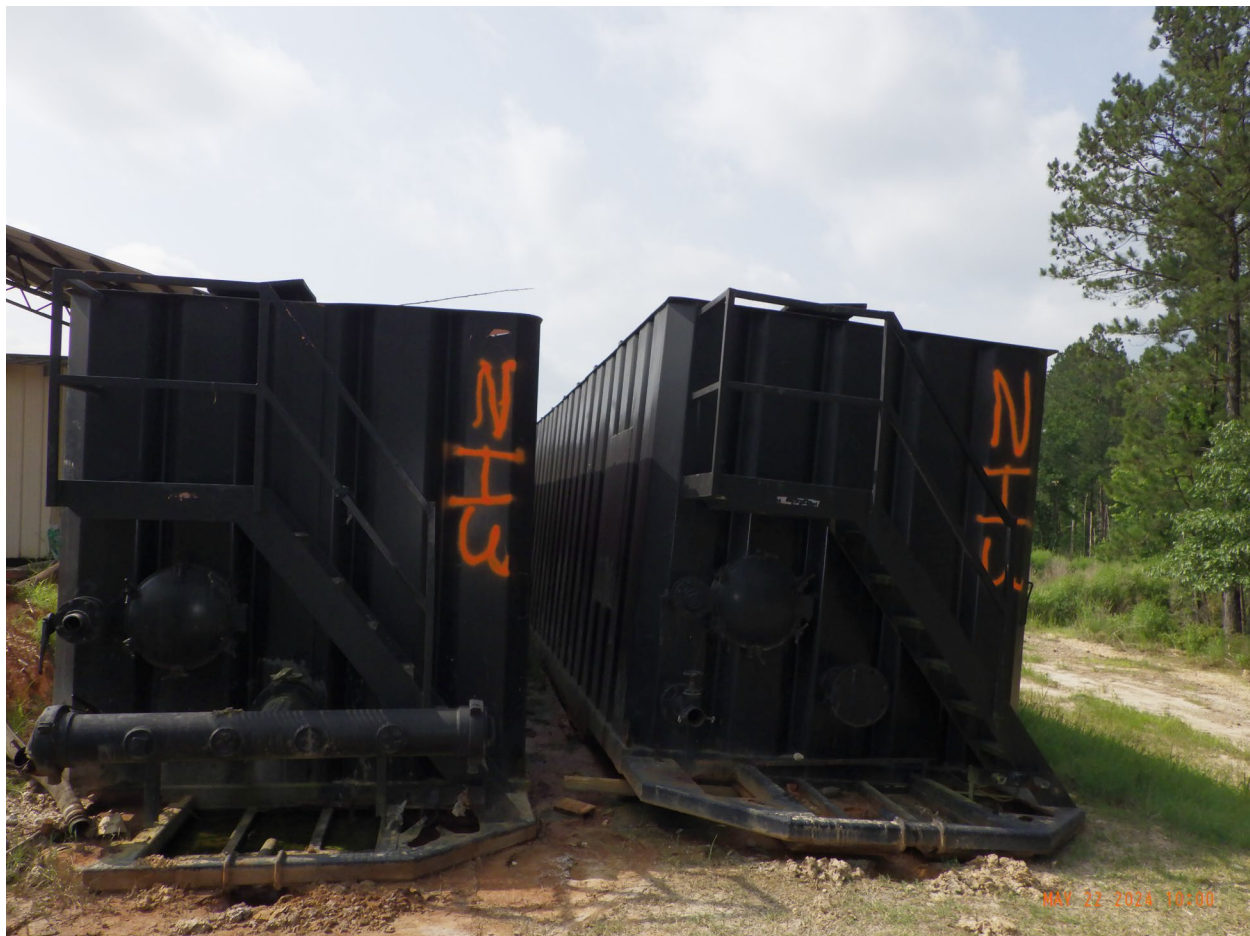
Photo No. 3

I observed two (2) frac tanks used for storage outside secondary containment. The frac tanks were marked with "NIU" for "not in use." Mr. Kirk Brown stated that the frac tanks had been emptied. See Photo No. 3.

**Description:** Looking S, this photo showed two frac tanks labeled "NIU" for "not in use." The operator, Kirk Brown, stated the frac tanks had been emptied.

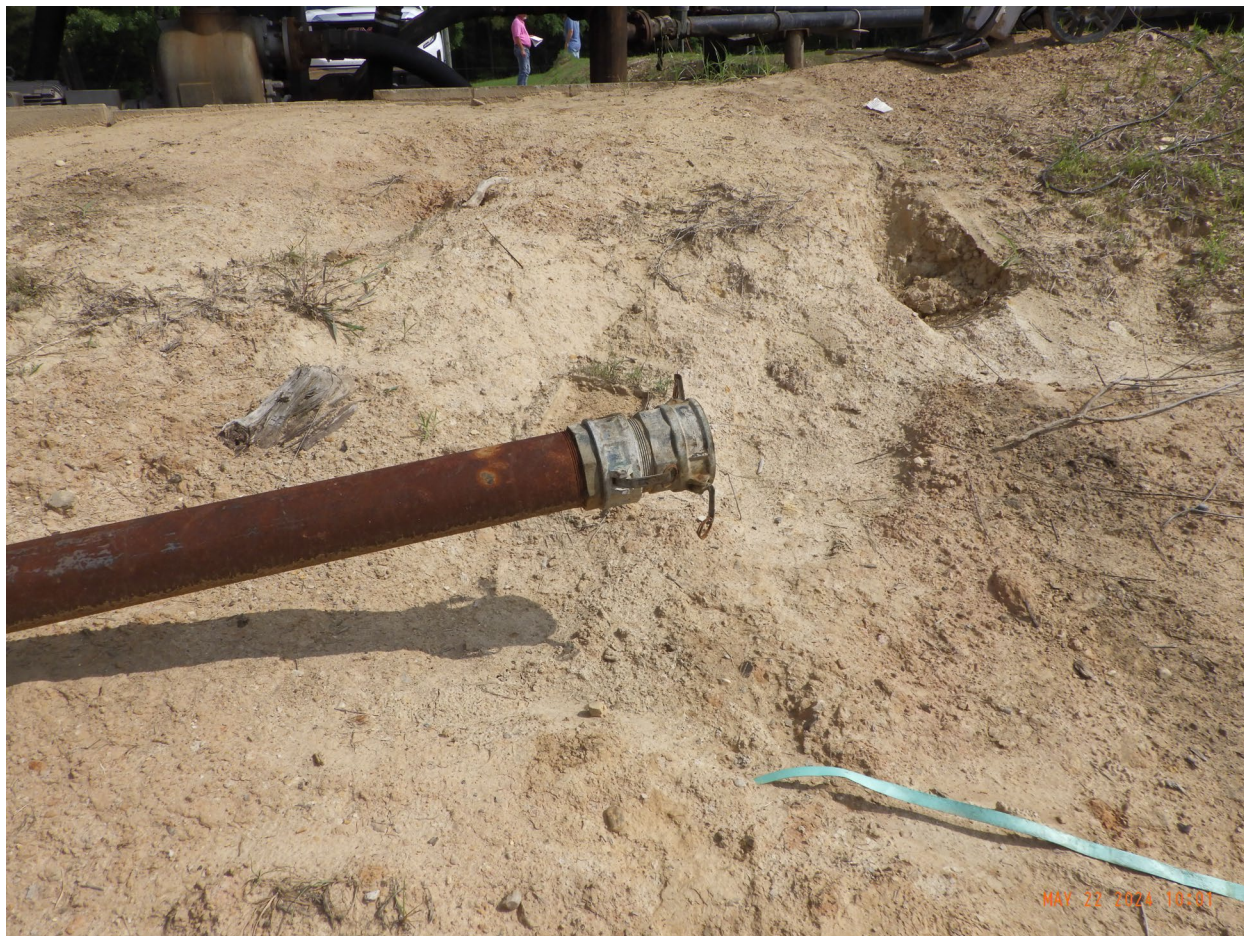
Photo No. 4

I observed a pipe without a cap connected to the two (2) frac tanks in Photo No. 3. See Photo No. 4.

**Description:** Looking N-NW, this photo showed a connector pipe without a cap connected to hosing for the frac tanks in Photo No. 3.

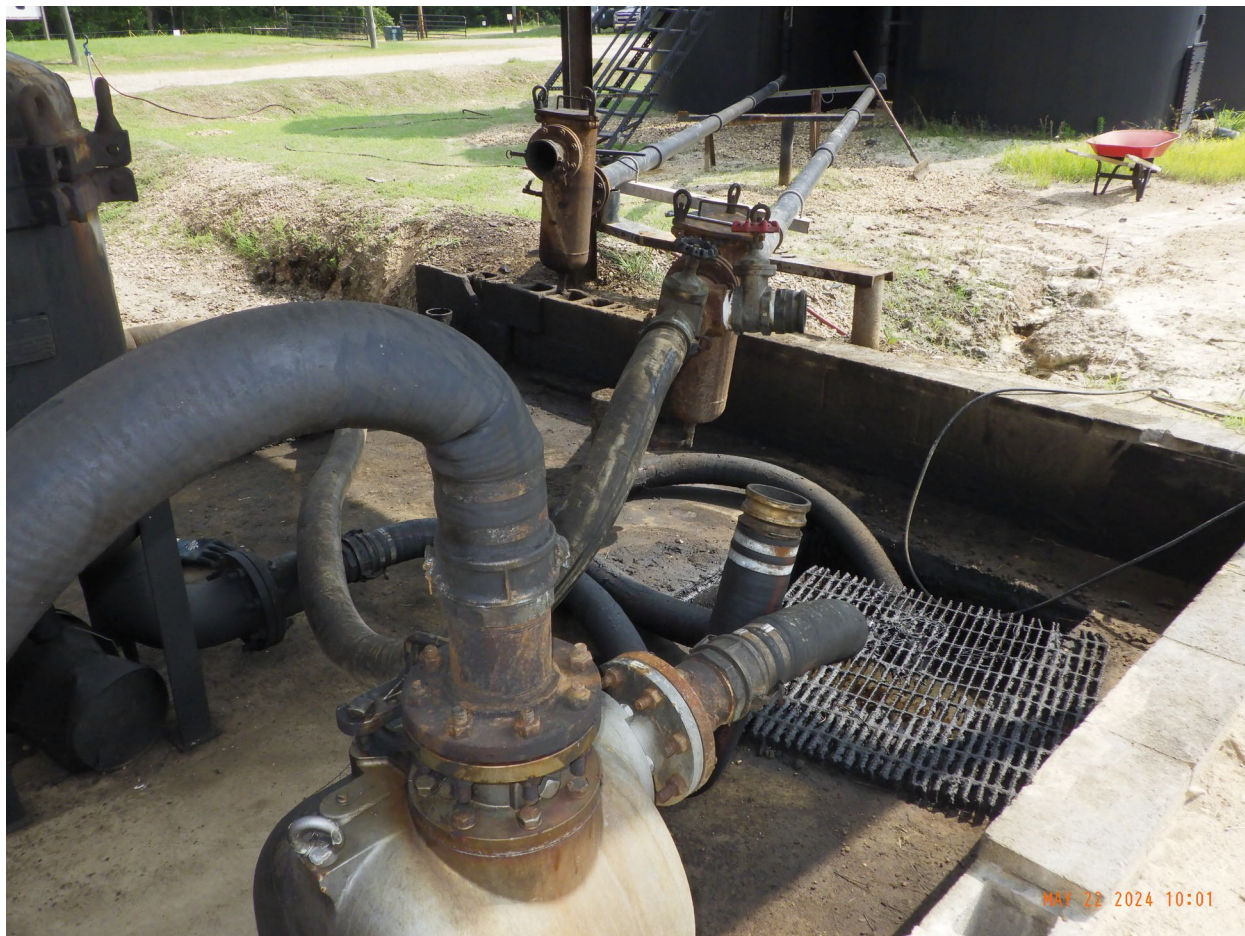
Photo No. 5

I observed the pump and sump area used for transferring wastes to the tanks in the tank battery. See Photo No. 5.

**Description:** Looking N-NE, this photo showed the pump and sump area used for transferring wastes to the tanks in the tank battery.

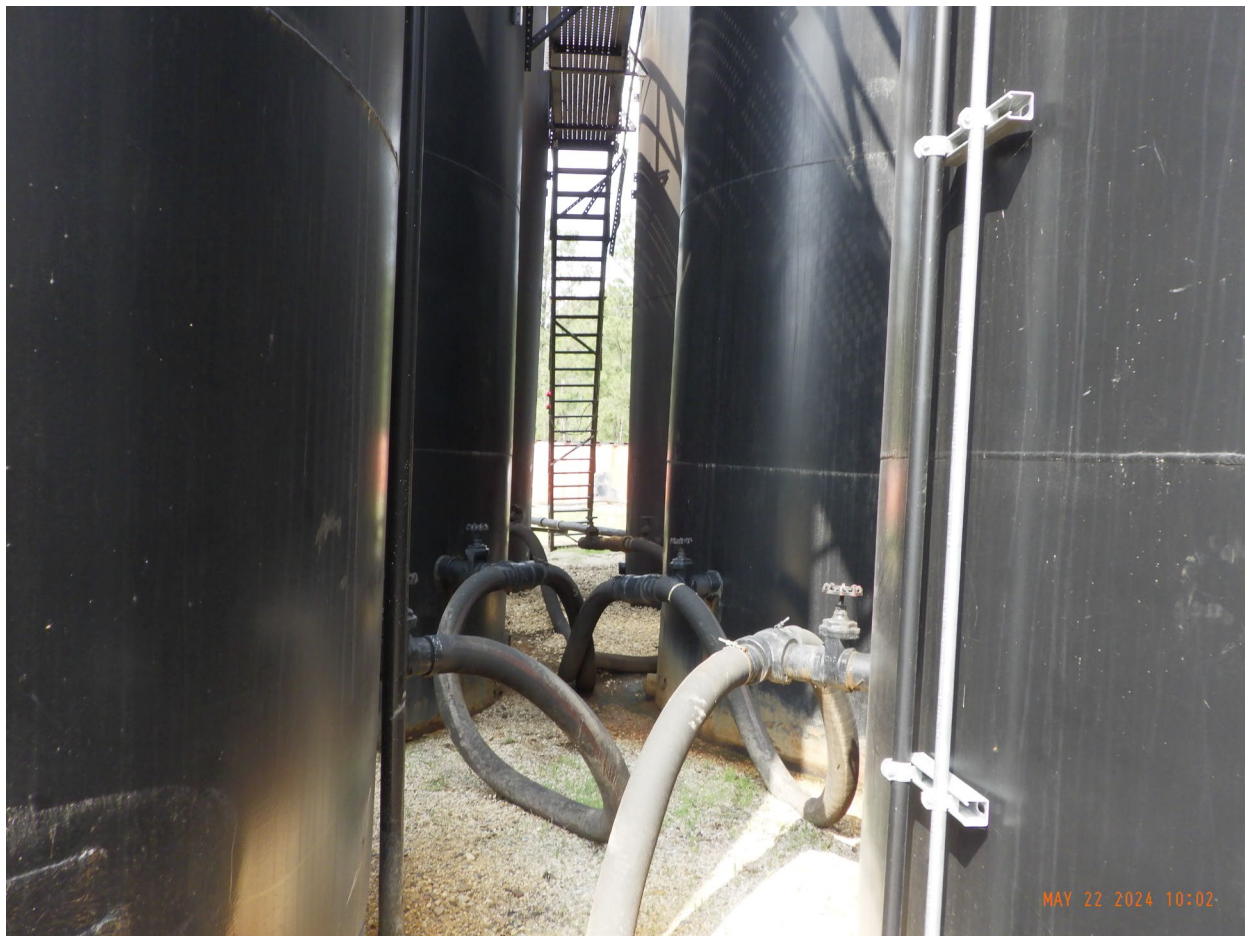
Photo No. 6

I observed the tanks, inside secondary containment, manifolded to each other. See Photo No. 6.

**Description:** Looking W-SW, this photo showed the tanks, inside secondary containment, manifolded to each other.

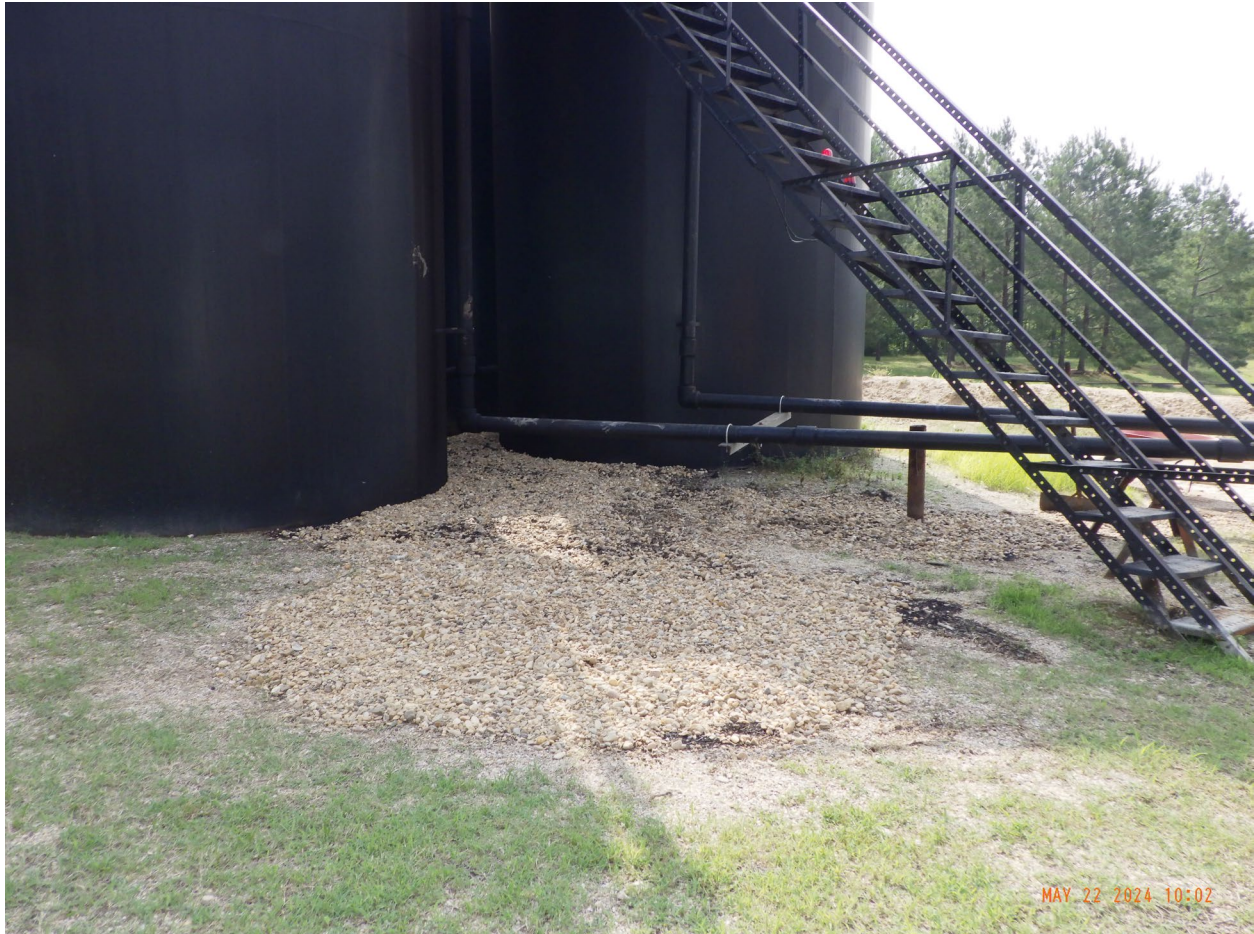
Photo No. 7

I observed an area, inside secondary containment, where crude oil had been covered by gravel substrate. See Photo No. 7.

**Description:** Looking SE, this photo showed an area, inside secondary containment, where crude oil had been covered by gravel substrate.

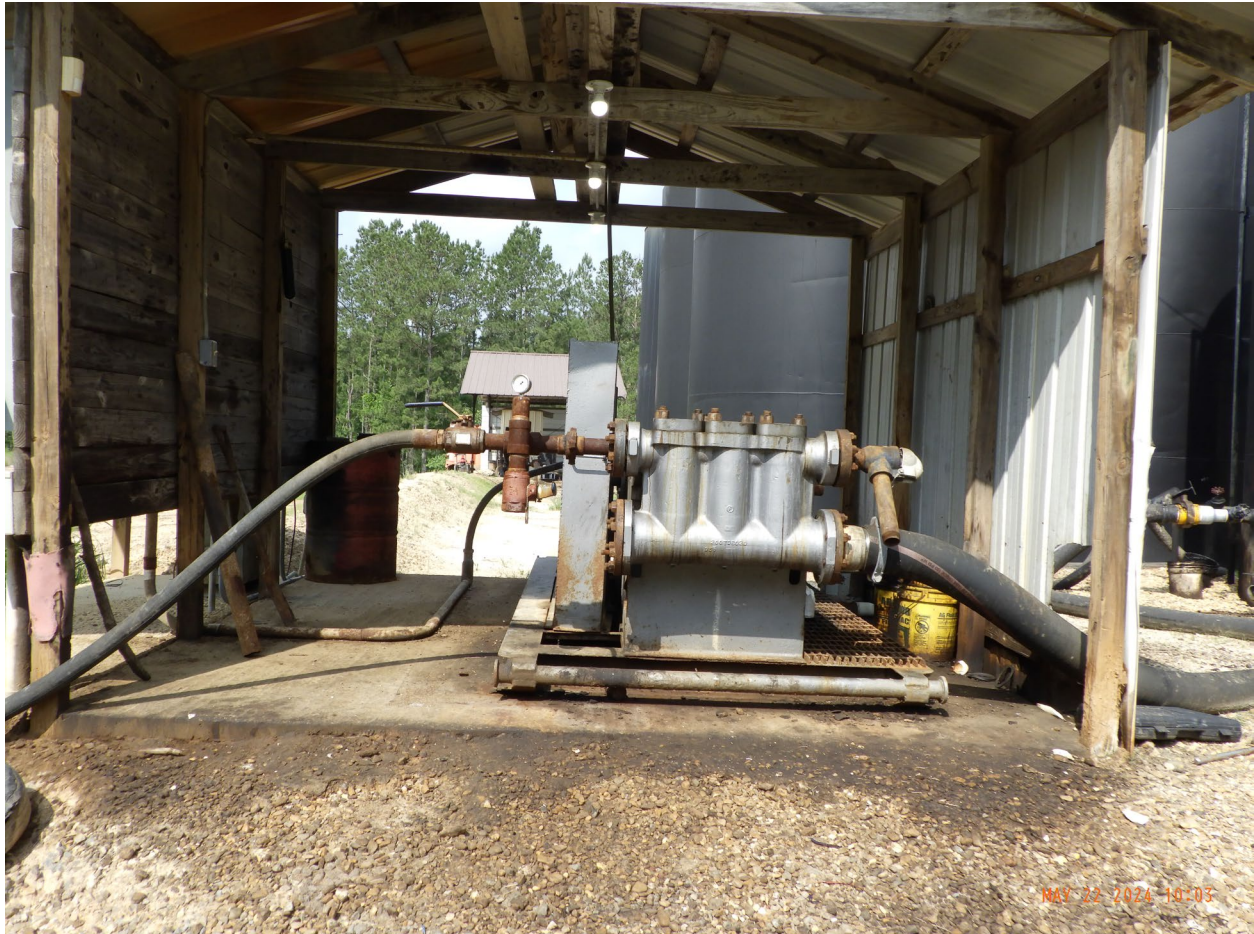
Photo No. 8

I observed the pump for the Saltwater Disposal (SWD) commercial well with staining on the ground. The SWD well (not pictured) was noted outside secondary containment. See Photo No. 8.

**Description:** Looking W, this photo showed the pump for the Saltwater Disposal (SWD) commercial well with staining on the ground. The SWD well (not pictured) was noted outside secondary containment.
