**Well Inspection**  
**Osage DNR / Environmental Protection Agency**  
**1201 Elm Street, Suite 500**  
**Dallas, Texas 75270**

| <b>Operator Info</b> | CapturePoint, LLC | <b>Inventory ID</b> | OS4674000 | | |
| | Allen, TX 75013 | <b>Well ID</b> | J-W15 | | |
| <b>Inspection Reason</b> | Plugging Witnessed | <b>Responsible Company at Time of Inspection</b> | CapturePoint, LLC | | |

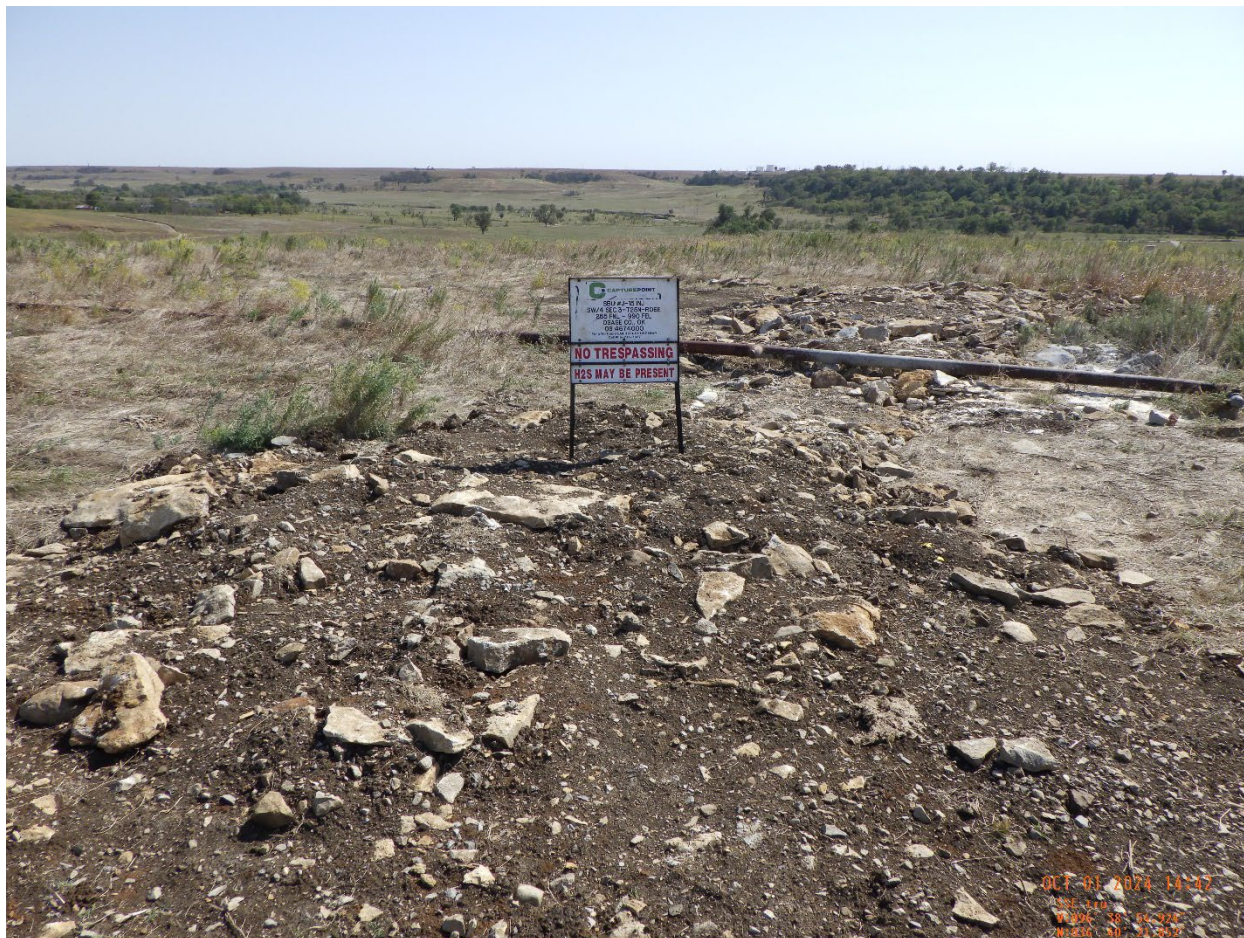
Photo No. 1

**Description:** This was the location for well OS4674000 with surface restoration completed.
