**CWA COMPLIANCE EVALUATION INSPECTION REPORT  
U.S. ENVIRONMENTAL PROTECTION AGENCY, REGION 5**

Compliance Evaluation Inspection

Pilkington North America, Inc.  
300 20<sup>th</sup> Avenue  
Ottawa, Illinois 61350  
LaSalle County  
41.330620202591625, -88.87690647116492

March 13, 2025

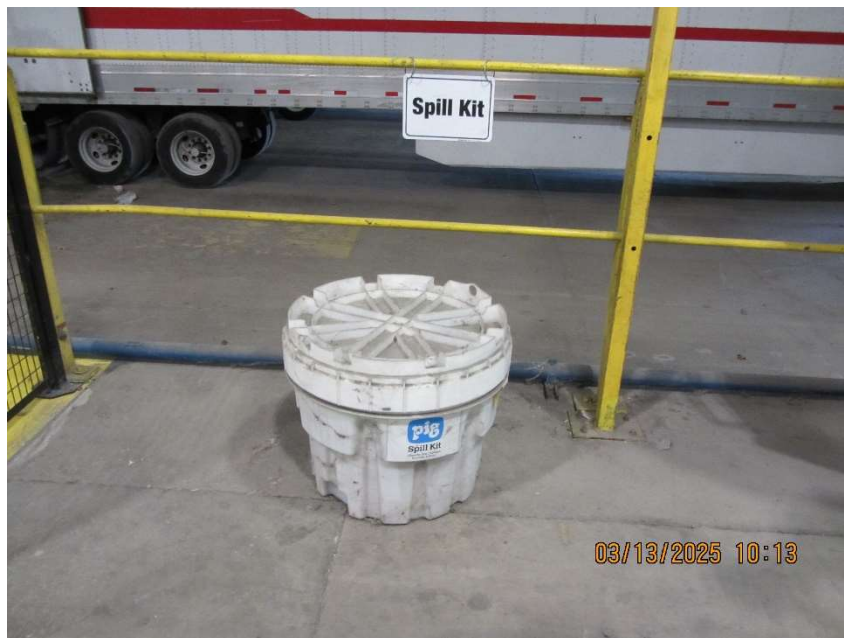
1: IMG\_0178

Description: Spill Kit located in transfer hall.

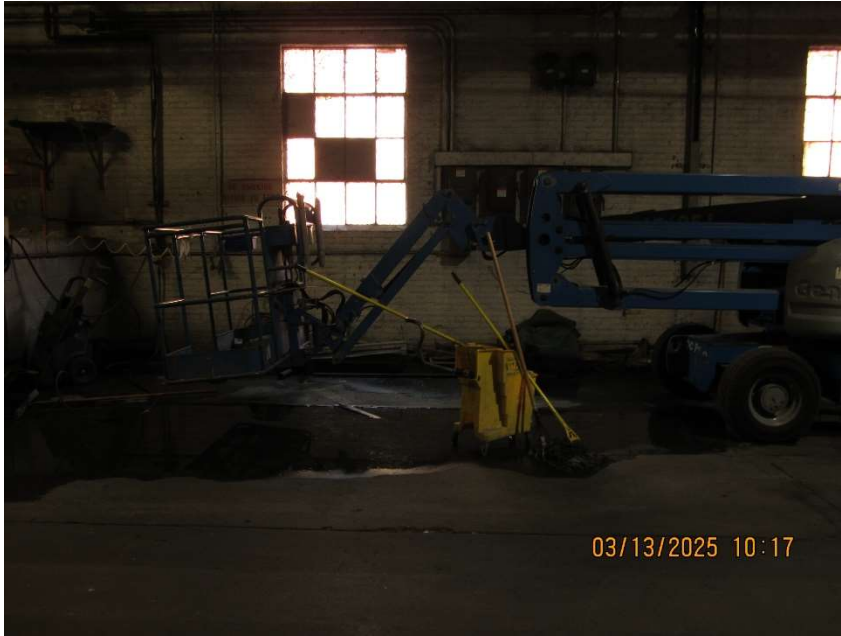
2: IMG\_0179

Description: Water flowing from washed down equipment to a drain inside the facility.

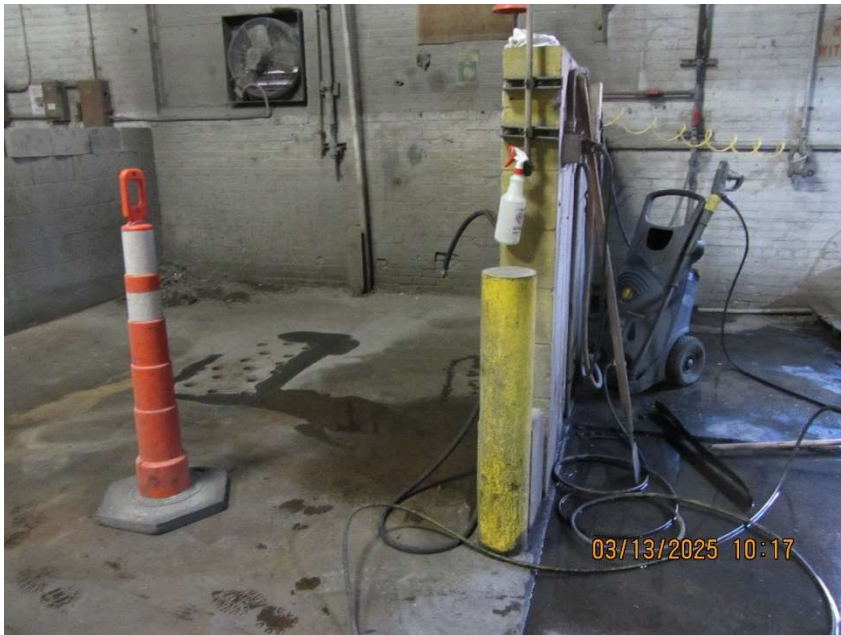
3: IMG\_0180

Description: Water flowing from washed down equipment to a drain inside the facility.

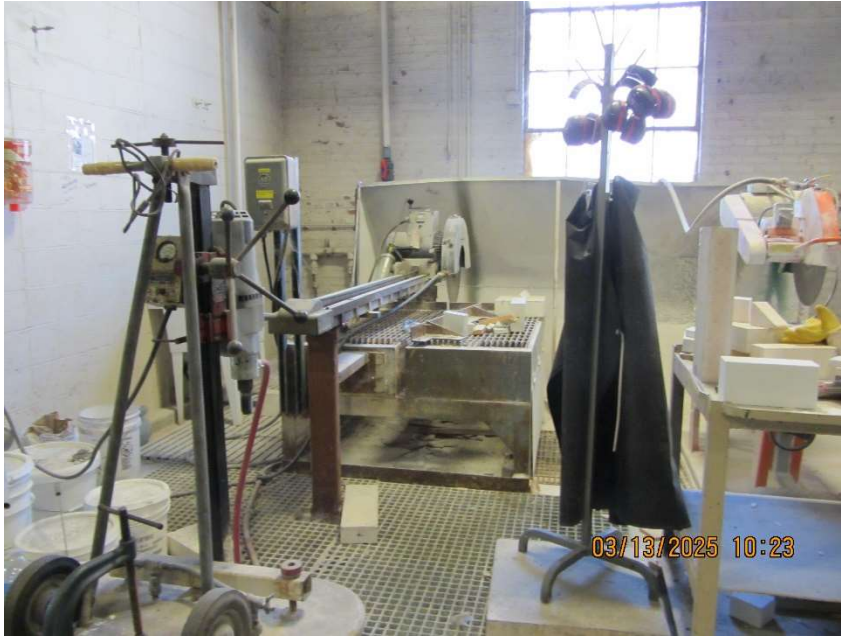
6: IMG\_0183

contained parts washer (photos 4 and 5). The Inspectors continued walking south and observed a brick cutting area for refractory brick with wet saws. EPA observed floor drains below the saws with standing water (photos 6 and 7). Adjacent to the brick cutting area, the Inspectors observed a storm water sewer manhole cover and questioned if the wet saw drains were connected to the storm water sewer. The facility inspector stated that he believed all internal drains were connected to the sanitary sewer (photo 8).

Description: Wet brick cutting area with drain below.

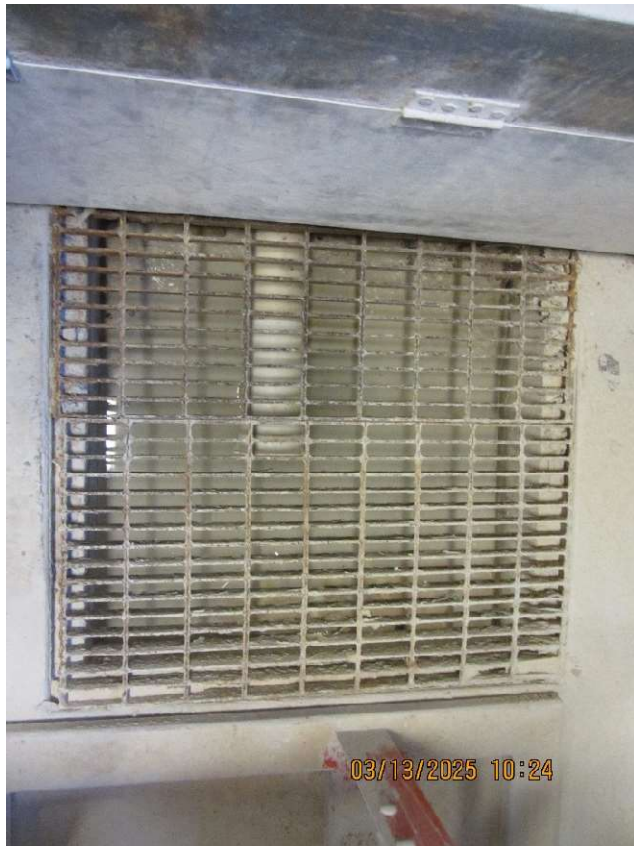
7: IMG\_0184

Description: Drain with standing water below wet brick cutting area.

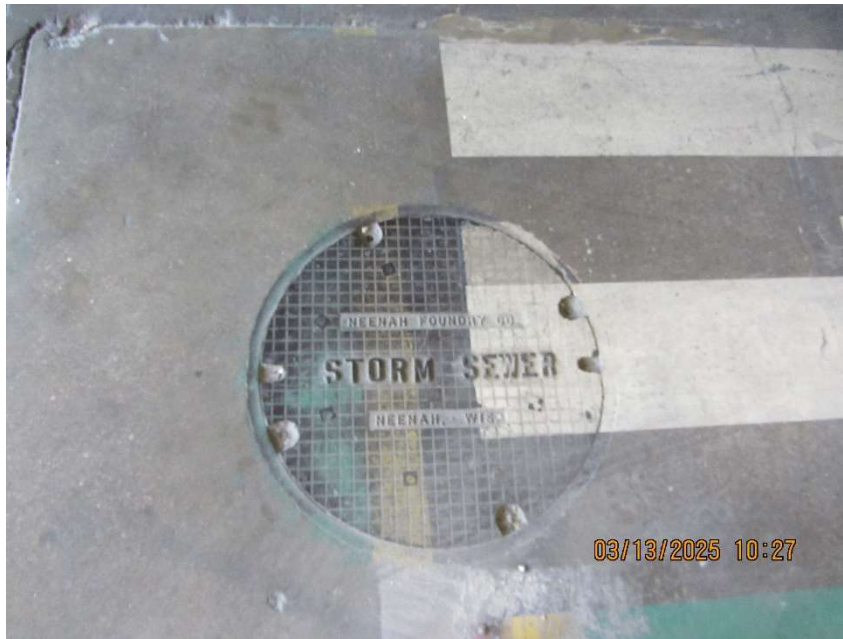
8: IMG\_0185

1. EPA observed white powder around the bulk batch building including in the road, around storm water drains, and on the concrete embankment, and up to the edge of the Illinois River.
2. EPA observed non-stormwater discharges from the outfalls 003, 004, and 005 occuring during dry weather.
3. EPA observed the proximity of the brick cutting wet saw collection drain to a storm water manhole.

Description: Storm sewer manhole adjacent to brick shop.

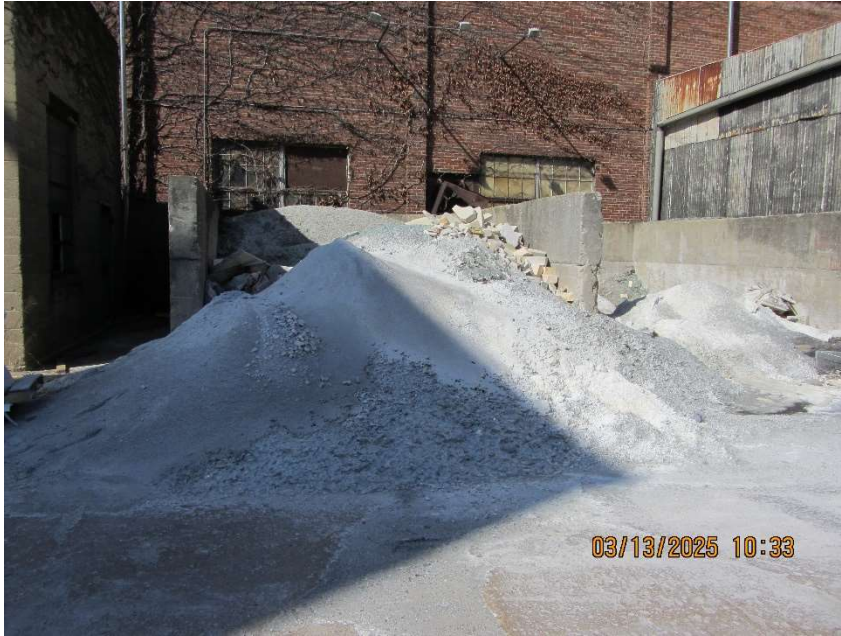
10: IMG\_0187

The Inspectors continued walking south and observed a pile of cullet and debris in the area identified as Hogan's Alley (photo 10). The Inspectors then walked south and observed storm water drains in a loading dock and outside of the southwest corner of Building 5 (photos 11 and 12).

Description: Landfill-bound cullet and other debris.

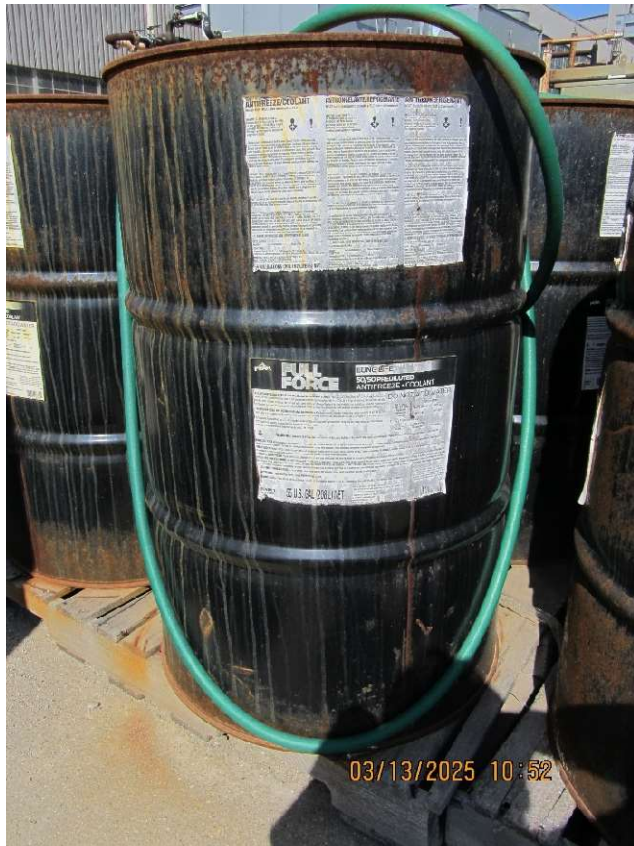
16: IMG\_0193

Description: Drums of antifreeze near cullet yard.

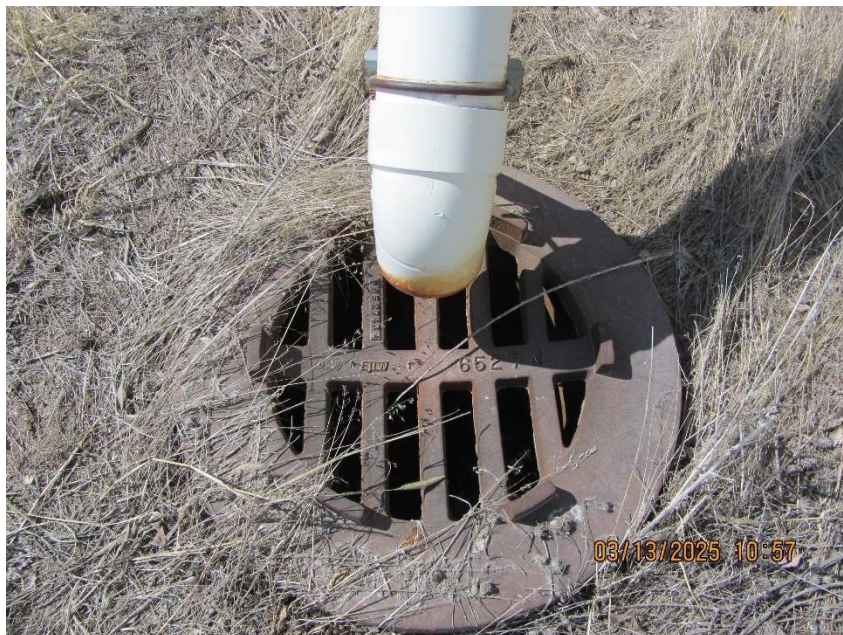
18: IMG\_0195

The Inspectors then walked northeast to the fin fans and cooling water tower. The Inspectors observed a pipe from the cooling water tower that was routed down to a storm water drain (photos 18 and 19). The Inspectors observed multiple storm water drains around the fin fans as well as a leaking pipe (photos 20-25).

Description: Pipe entering drain from cooling water tower.

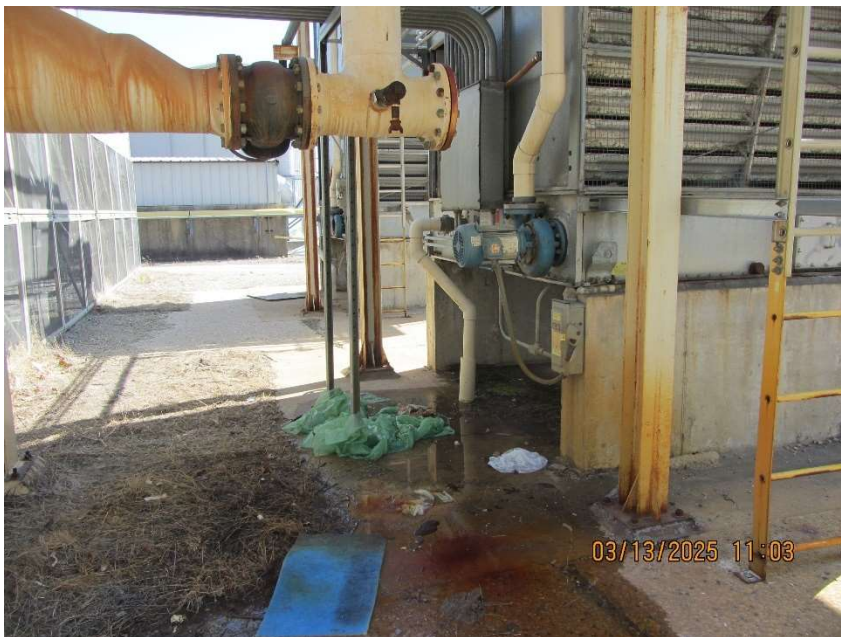
25: IMG\_0202

Description: Water dripping from cooling water pipe to fin fans.

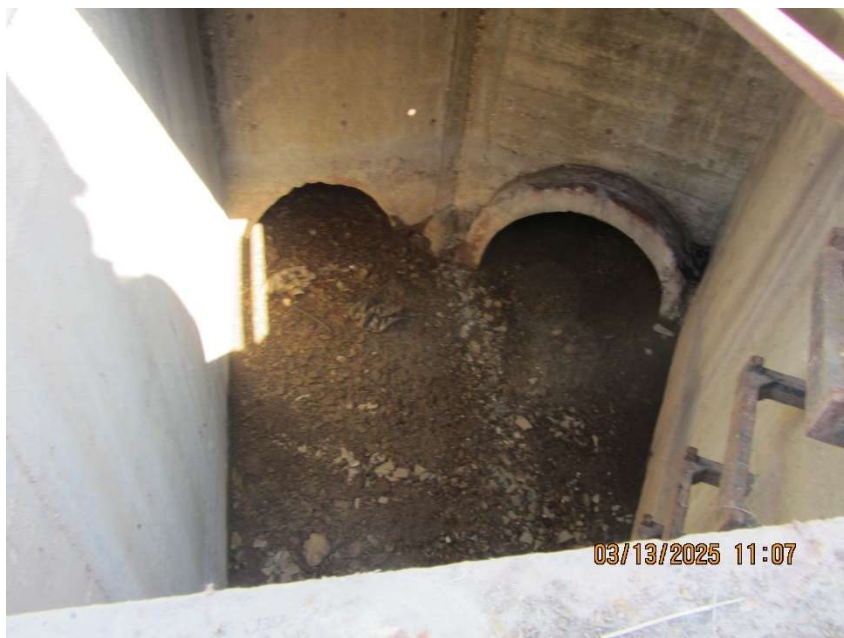
26: IMG\_0203

The Inspectors walked southwest to the south side of the hazardous material building and observed a concrete structure in the ground with a metal lid. The Inspectors looked inside and observed storm water pipes. The Inspectors noted that the pipes were approximately half filled with sediment and glass fragments (photos 26 and 27).

Description: Underground pipes filled about halfway with sediment and glass pieces.

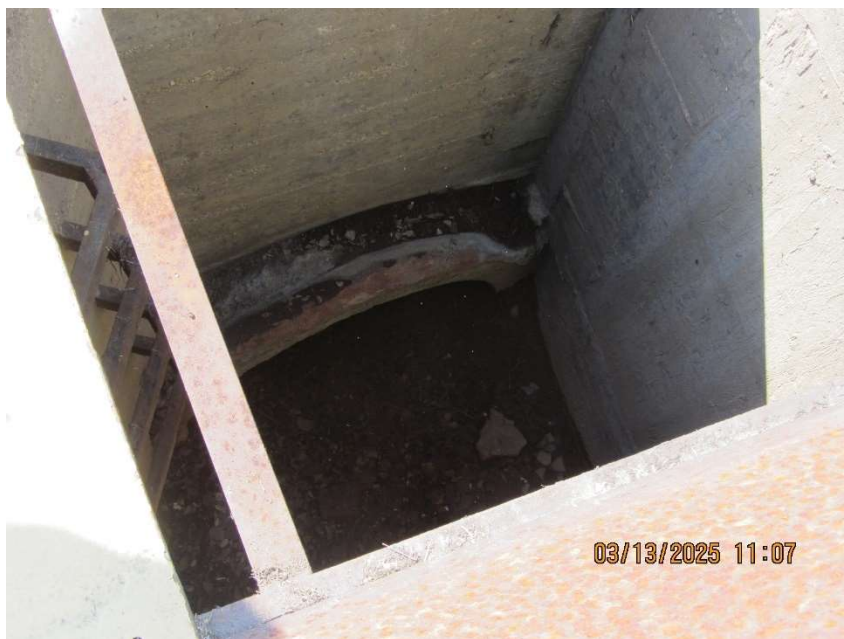
27: IMG\_0204

Description: Underground pipes filled about halfway with sediment and glass pieces.

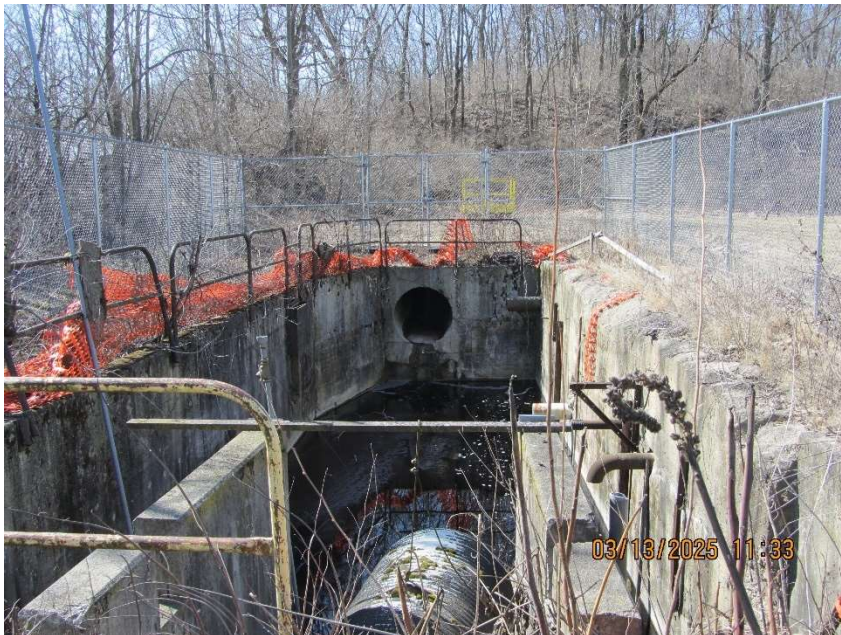
33: IMG\_0210

Description: Pit on west side of lift station with water flowing in.

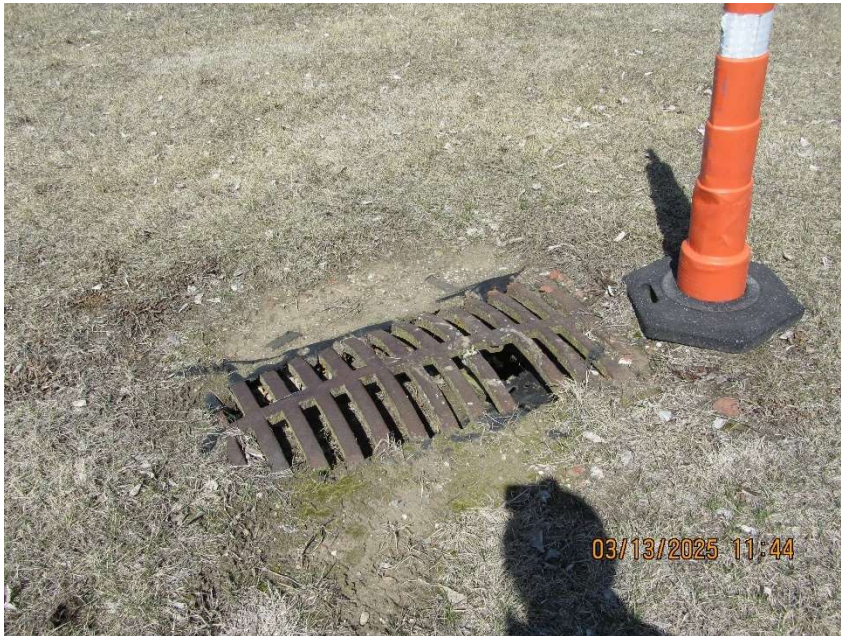
38: IMG\_0215

Description: Drain north of Outfall 003 with audible water.

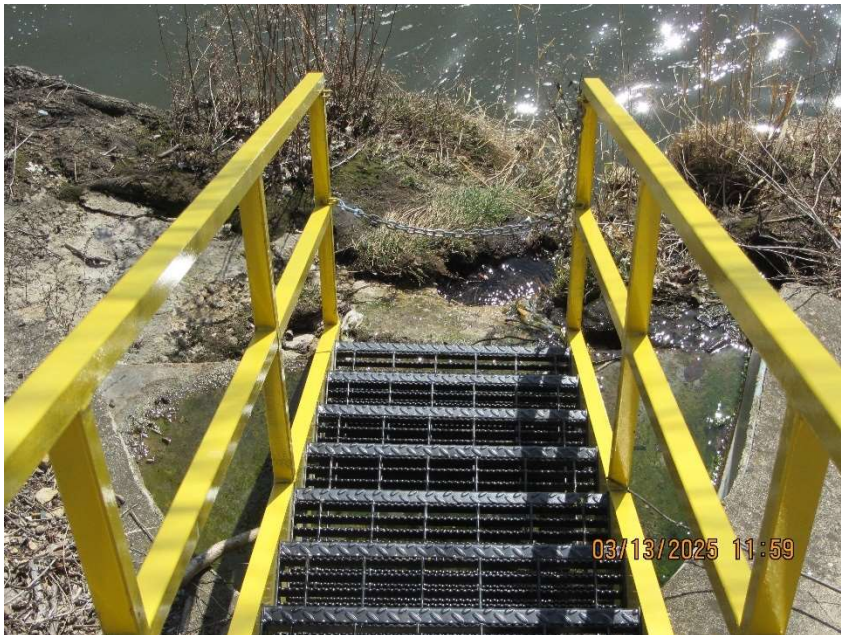
41: IMG\_0218

The certification in the SWPPP does not include the method used or the dates of the testing. Additionally, EPA observed non-storm water discharges from outfalls 003, 004, and 005 during the inspection.

Description: : Identified as Outfall 003 during inspection. Later clarified as actually being Outfall 004. EPA observed flowing water from the outfall.

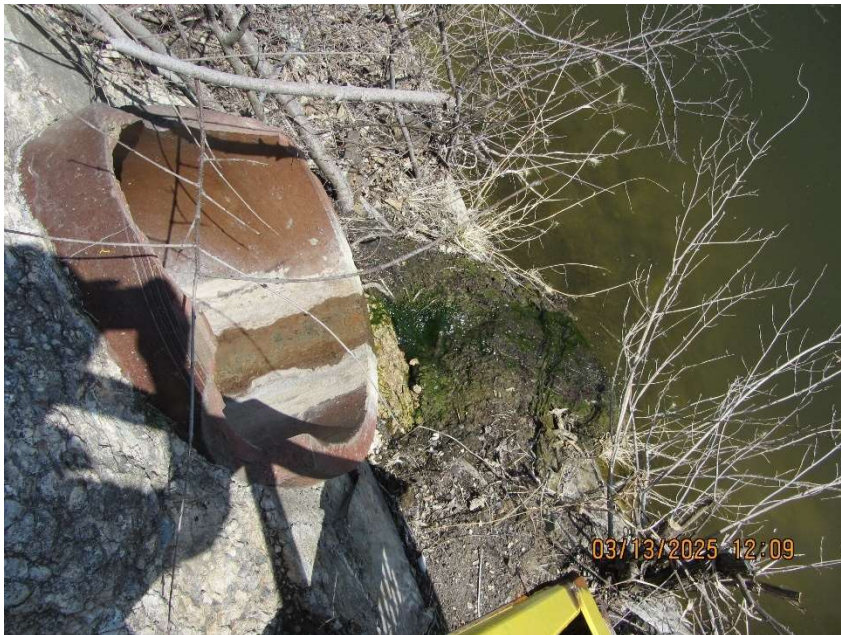
43: IMG\_0220

Description: Outfall 005 with very light flow and groundwater flow beneath the pipe.

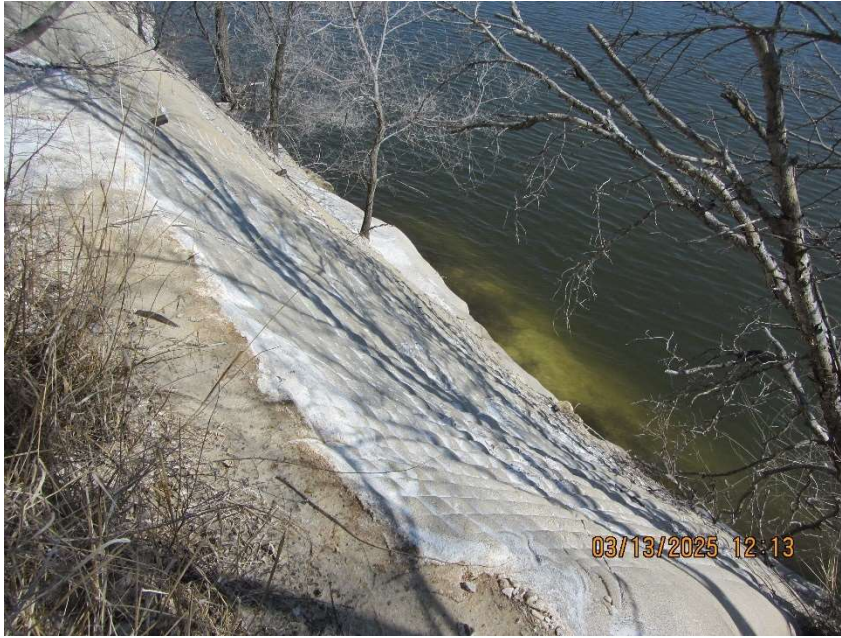
44: IMG\_0221

EPA observed white powder around the bulk batch building including in the road, around storm water drains, and on the concrete embankment, and up to the edge of the Illinois River which had not been properly and promptly cleaned.

EPA observed white powder around the bulk batch building including in the road, around storm water drains, and on the concrete embankment, and up to the edge of the Illinois River which is not achieving the general objective of controlling pollutants in storm water discharges.

Description: White powder on concrete slope down to Illinois River.

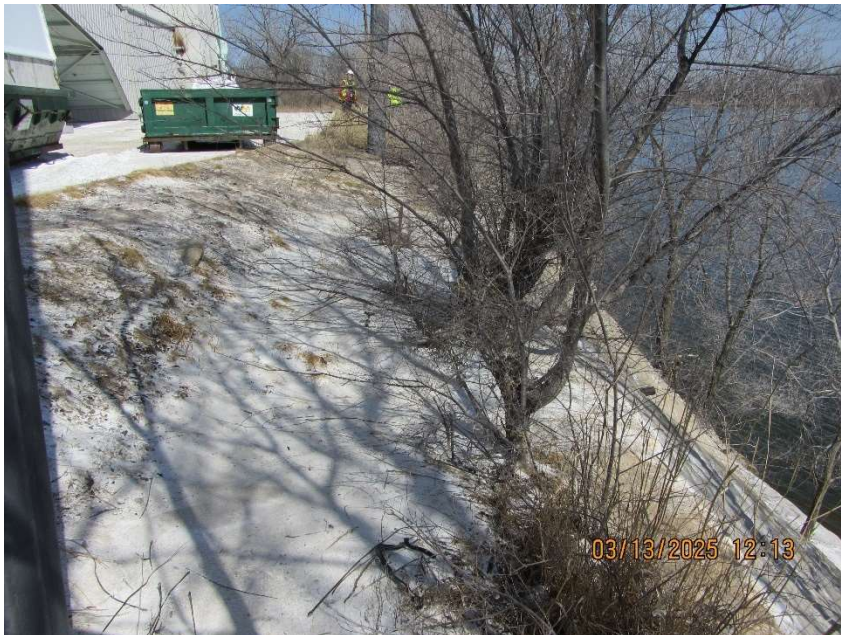
45: IMG\_0222

Description: White powder on road, ground, and concrete slope down to Illinois River.

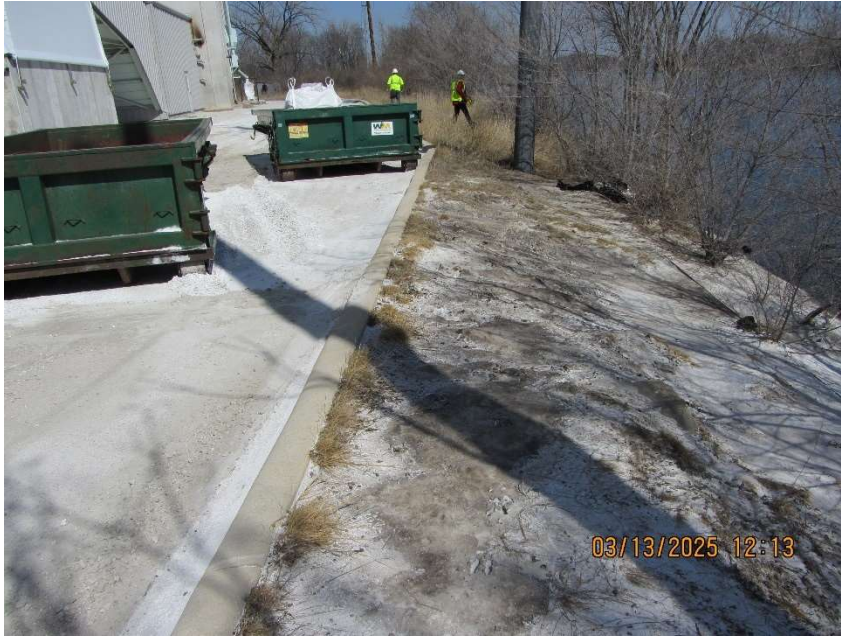
46: IMG\_0223

Description: White powder on road, ground, and concrete slope down to Illinois River.

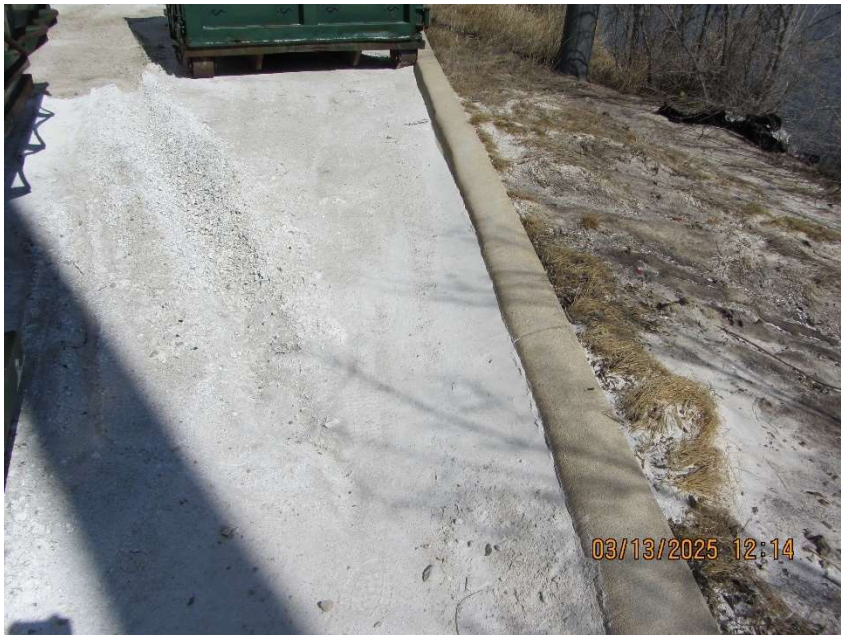
47: IMG\_0224

Description: White powder on road, ground, and concrete slope down to Illinois River.

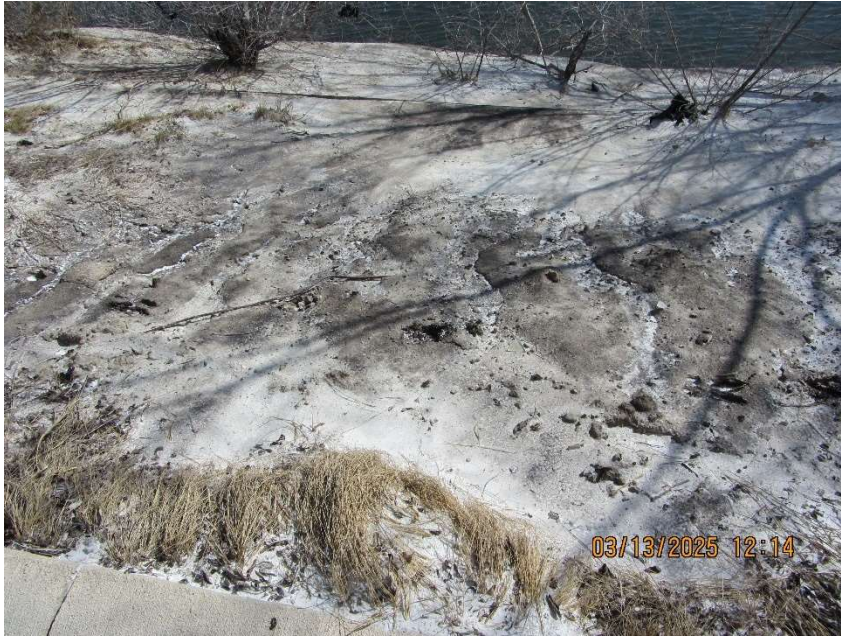
48: IMG\_0225

Description: White powder on road, ground, and concrete slope down to Illinois River.

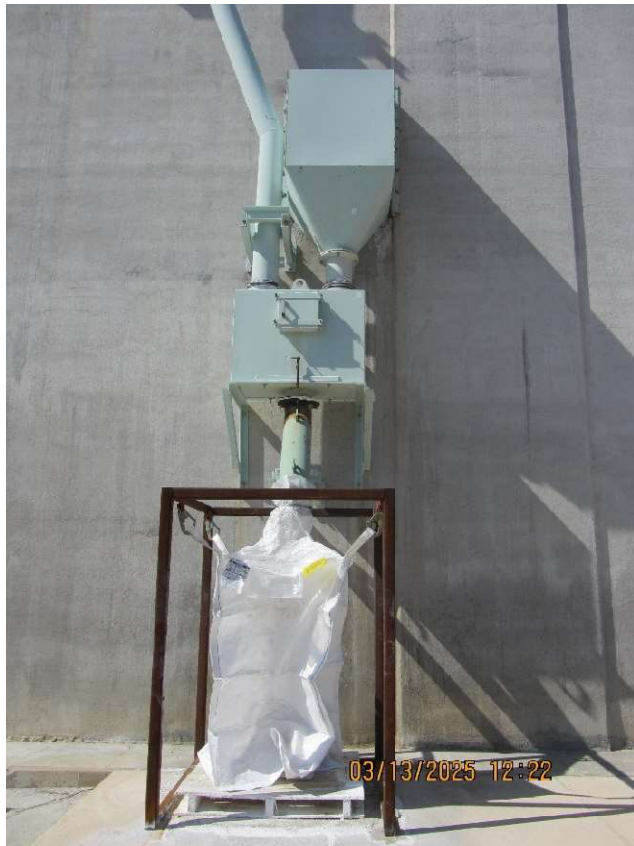
53: IMG\_0230

Description: Bag receiving material to be discarded on the east side of the bulk batch building.  
Note white powder around the base.

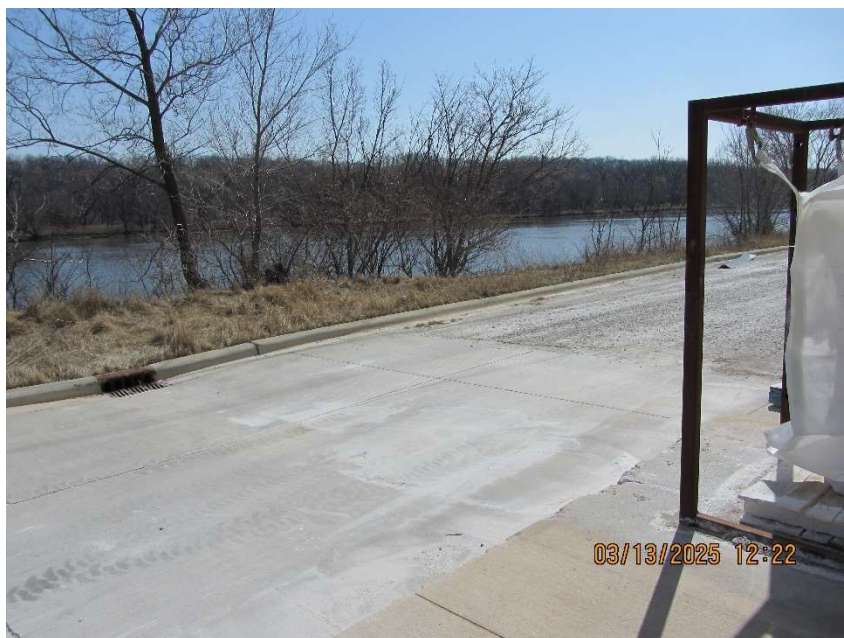
54: IMG\_0231

Description: Possible flow path from bulk batch bag to storm water drain.

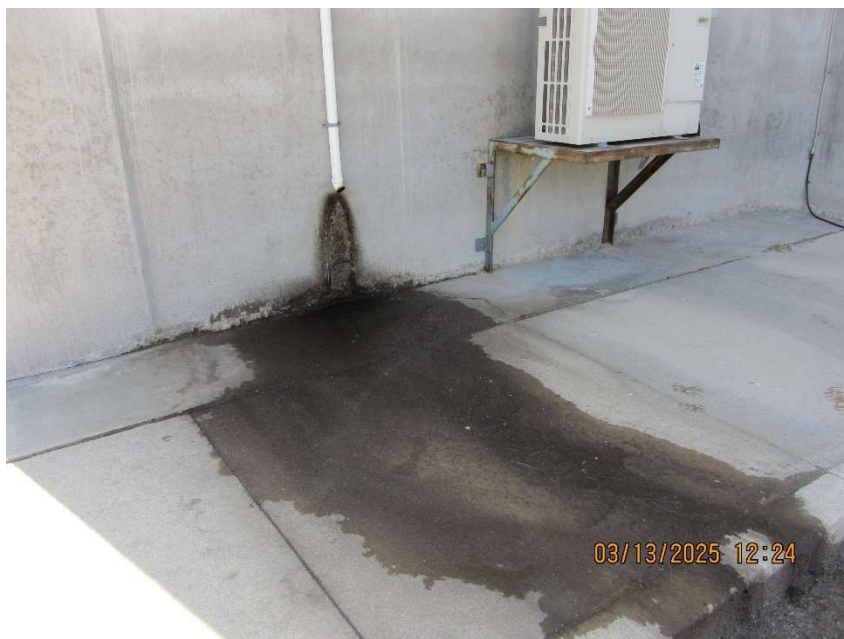
55: IMG\_0232

Description: Water draining from pipe on northeast corner of bulk batch building.

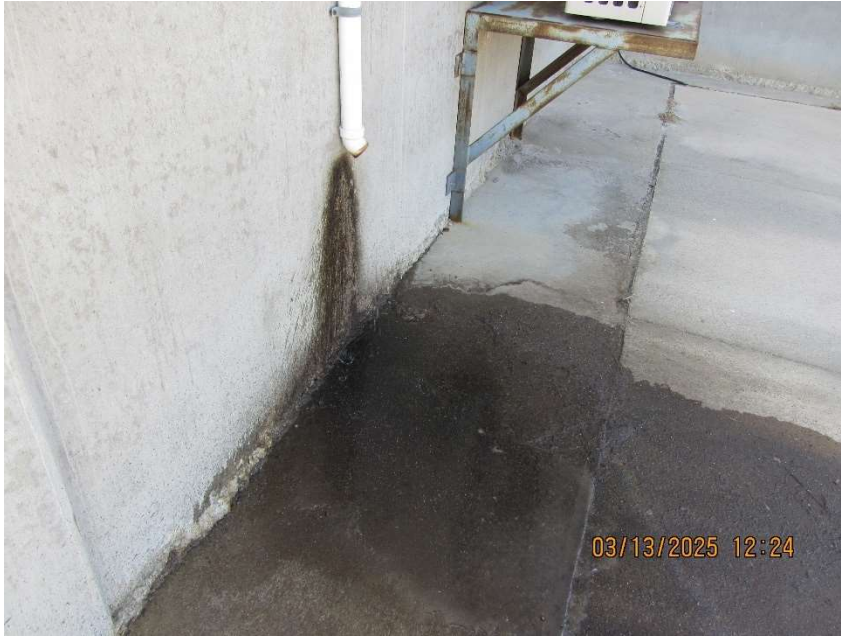
56: IMG\_0233

Description: Water draining from pipe on northeast corner of bulk batch building.

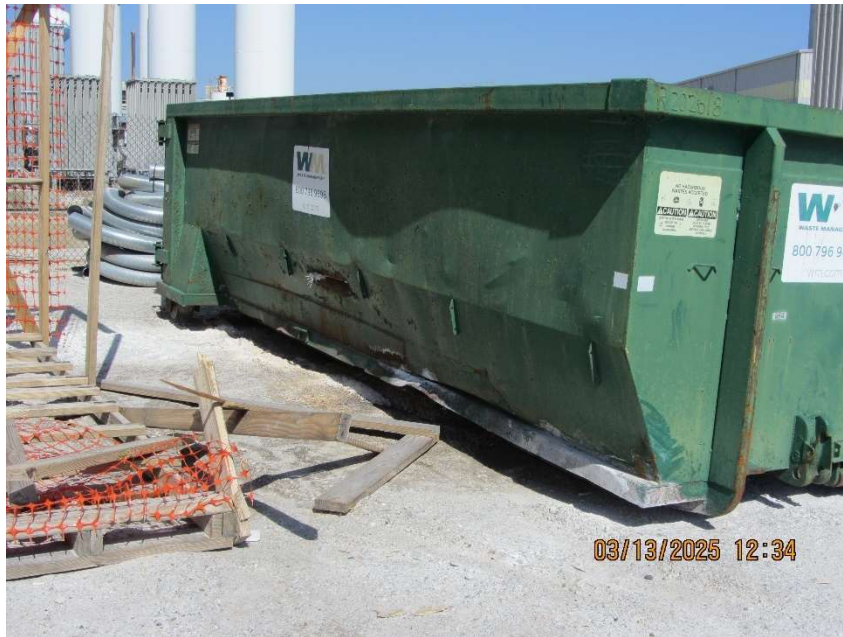
60: IMG\_0237

Description: Dumpster with holes in the bottom east of the furnace building.

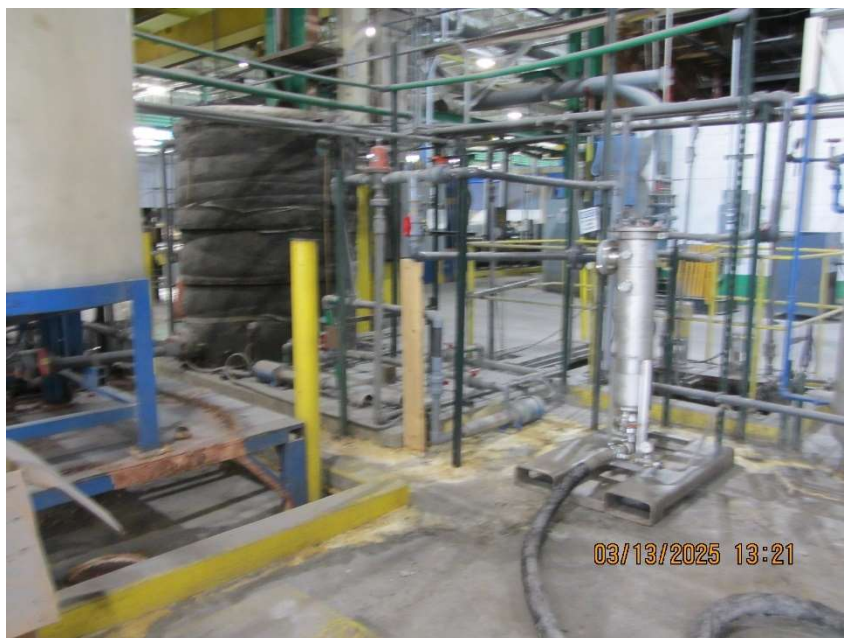
71: IMG\_0248

Description: Acids and solids outside of berm.
