INSPECTION REPORT

<b>Inspection Date(s):</b>	05/10/2022 - 05/10/2022	Announced: No			
<b>Time:</b>	Entry: 01:35 PM (ET)	Exit: 03:35 PM (ET)			
<b>Media:</b>	Water				
<b>Statute(s)/Program(s):</b>	Clean Water Act, NPDES, WWTP				
<b>Type of inspection:</b>	CEI - Compliance Evaluation Inspection				
<b>Access:</b>	Granted				
<b>Permittee Name:</b>					
Scioto County Commissioners (Wheelersburg WWTP)					
<b>Facility or Site Name:</b>					
Wheelersburg WWTP SD NO 2					
<b>Facility/Site Physical Address:</b>					
2974 Hayport Road					
<b>(City, state, zip code)</b>					
Wheelersburg, OH 45694					
<b>County/Parish:</b>					
Scioto County					
<b>Facility GPS Coordinates:</b>

38.72017, -82.86147					
<b>Mailing address:</b>					
(If different)					
<b>(City, state, zip code)</b>					
<b>Facility/Site Identifier:</b>					
Wheelersburg WWTP					
<b>Permit Number:</b>					
OH0050016					
<b>SIC or NAICS:</b>					
4952					
<b>Persons Participating in Inspection:</b>					
<b>Title</b>	<b>Name</b>	<b>Phone</b>	<b>Email</b>	<b>Present at Opening Conf.</b>	<b>Present at Closing Conf.</b>
Lead Inspector	Andi Hodaj	3123534645	hodaj.andi@epa.gov	Yes	Yes
Inspector	Ray Cullen	(312) 886-0538	c

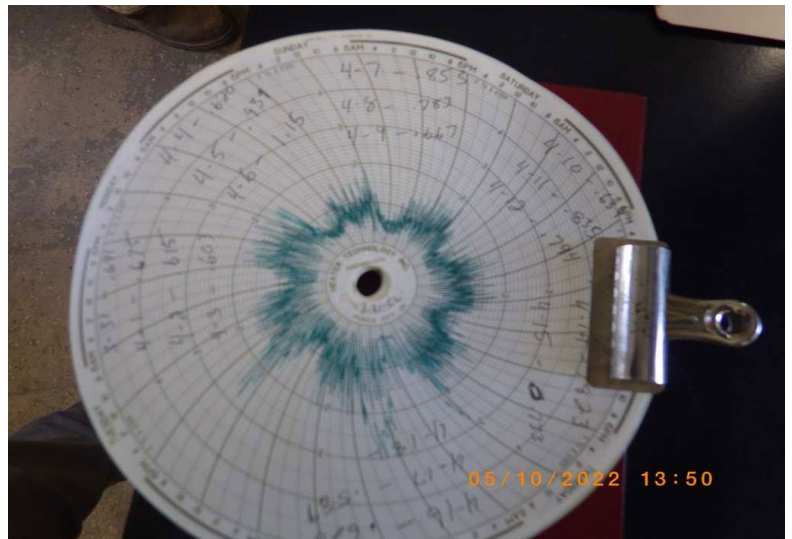
Circular chart recorder  
 RIMG2712.JPG  
 05/10/2022 14:50 (ET)  
 Andi Hodaj  
 [Unit/Area]  
 No CBI  
 No PII  
 EPA observed the circular chart recorder for flow for the month of April 2022.

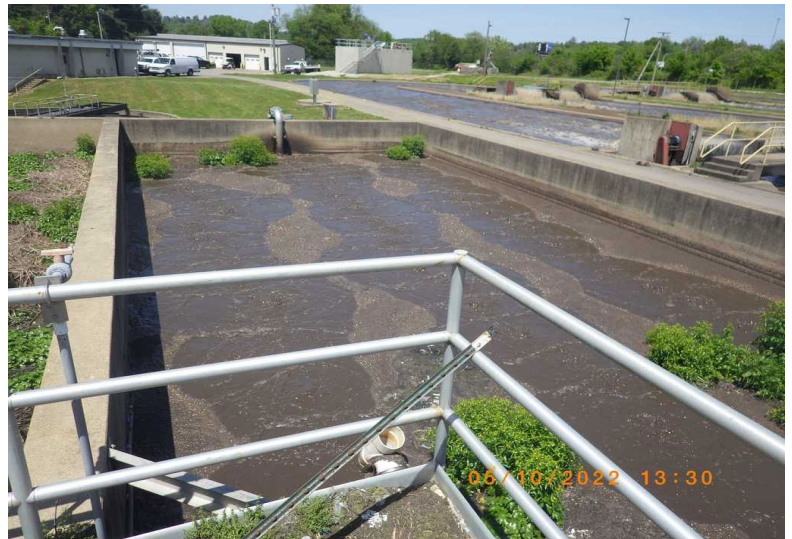
Solids from the clarifiers are pumped into the two aerobic digesters. The digesters had plants growing in them and at least one of them was almost fully covered with plants growing on top of it. EPA observed the belt press, not operating, in a covered shed just south of the digesters. According to Mr. Schackart, the belt press is operated as needed and belt press leachate is pumped back to the headworks. Next to the belt presser there was the dry sludge storage shed. EPA observed sludge overflowing from the covered shed and exposed to stormwater.

East digester  
 RIMG2702.JPG  
 05/10/2022 14:30 (ET)  
 Andi Hodaj  
 Digesters  
 No CBI  
 No PII  
 The east aerobic digester had plants growing on its surface. There was an aerator in operation at the digester at the time as the water was being agitated. Camera looking northeast.

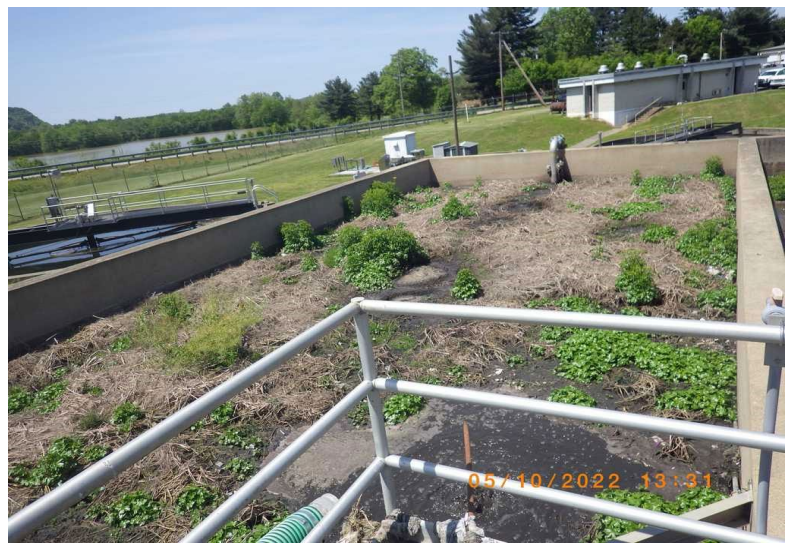
East digester  
 RIMG2703.JPG  
 05/10/2022 14:31 (ET)  
 Andi Hodaj  
 Digesters  
 No CBI  
 No PII  
 Half of the east aerobic digester was almost entirely covered with living plants. Camera looking northwest.

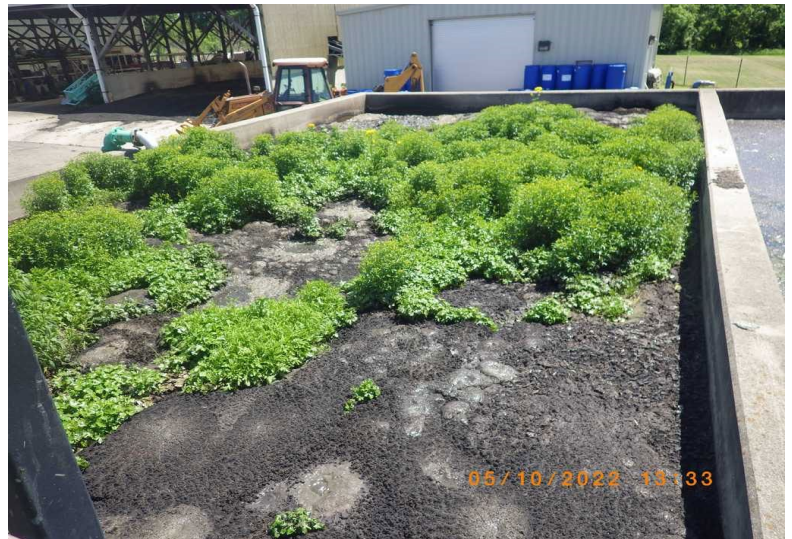
West digester  
 RIMG2705.JPG  
 05/10/2022 14:33 (ET)  
 Andi Hodaj  
 Digesters  
 No CBI  
 No PII  
 Part of the west aerobic digester was also covered with living plants. Camera looking south.

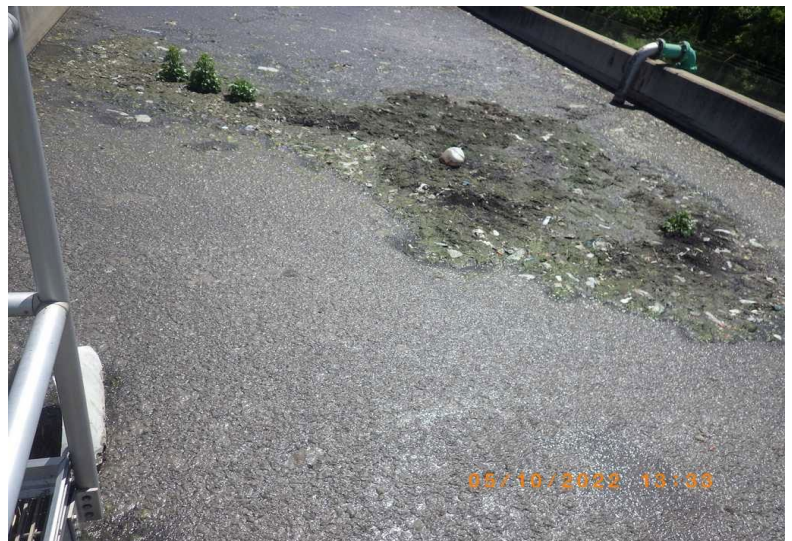
West digester  
 RIMG2707.JPG  
 05/10/2022 14:37 (ET)  
 Andi Hodaj  
 Digesters  
 No CBI  
 No PII  
 Trash floating at the top of the west digester. Camera looking southwest

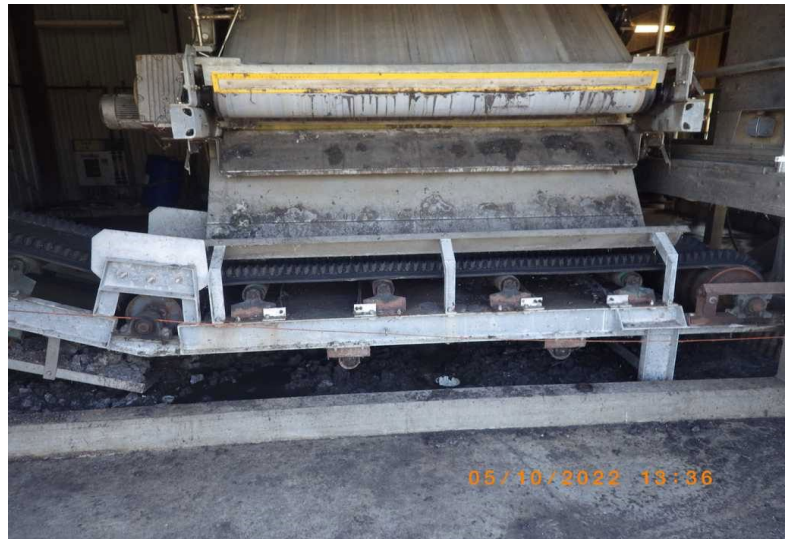
Sludge belt press
RIMG2708.JPG
05/10/2022 14:36 (ET)
Andi Hodaj
Digesters
No CBI
No PII
The sludge belt press was not in operation at the time of the inspection. Camera looking south.

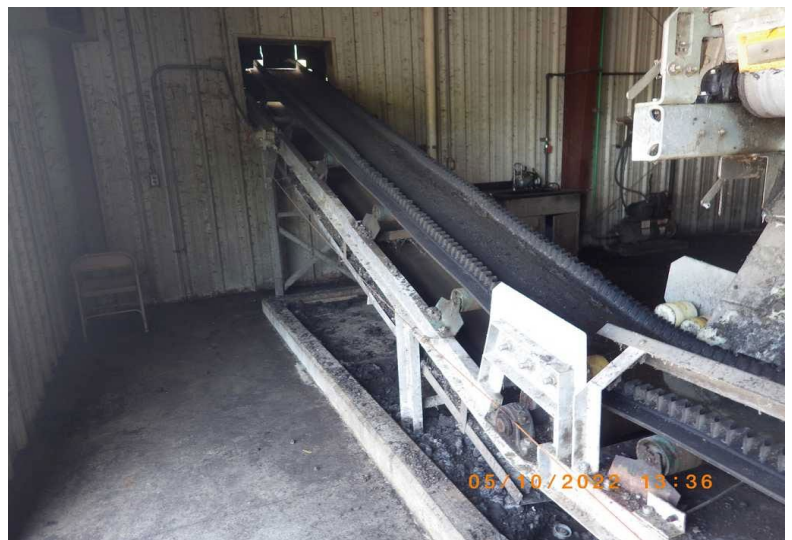
Sludge belt press
RIMG2709.JPG
05/10/2022 14:36 (ET)
Andi Hodaj
Digesters
No CBI
No PII
Conveyer belt of the belt press. Camera looking southeast.

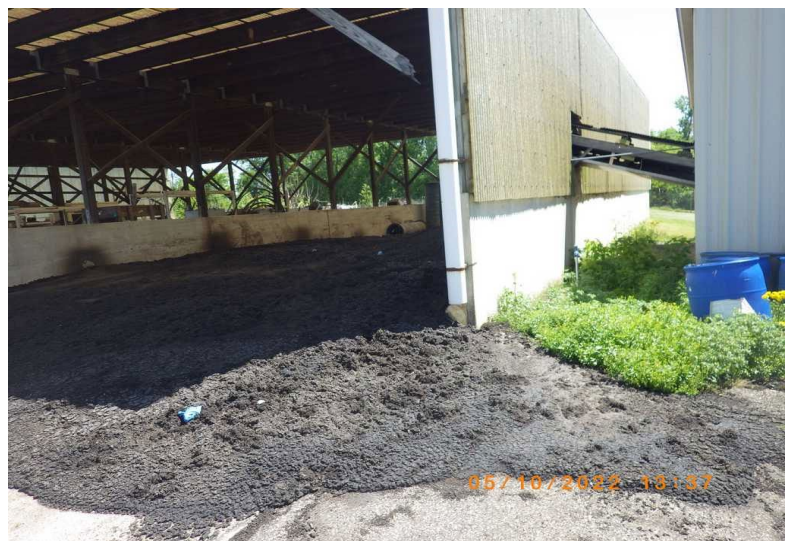
Dry sludge storage
RIMG2710.JPG
05/10/2022 14:37 (ET)
Andi Hodaj
Digesters
No CBI
No PII
Dry sludge from the belt press was stored in a covered shed next to the belt press. Sludge was spread outside of the shed area at the time of the inspection. Camera looking south.

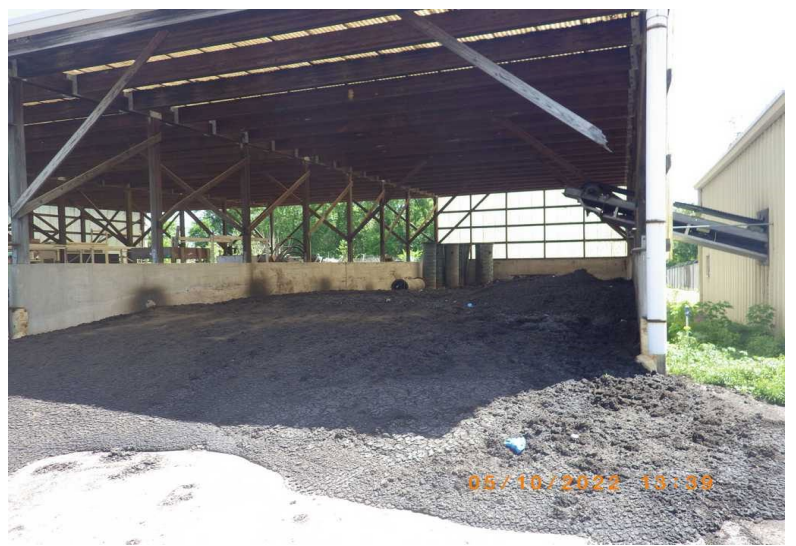
Dry sludge storage  
 RIMG2711.JPG  
 05/10/2022 14:38 (ET)  
 Andi Hodaj  
 Digesters  
 No CBI  
 No PII  
 Dry sludge from the belt press was stored in a covered shed next to the belt press. Sludge was spread outside of the shed area at the time of the inspection. Camera looking south.

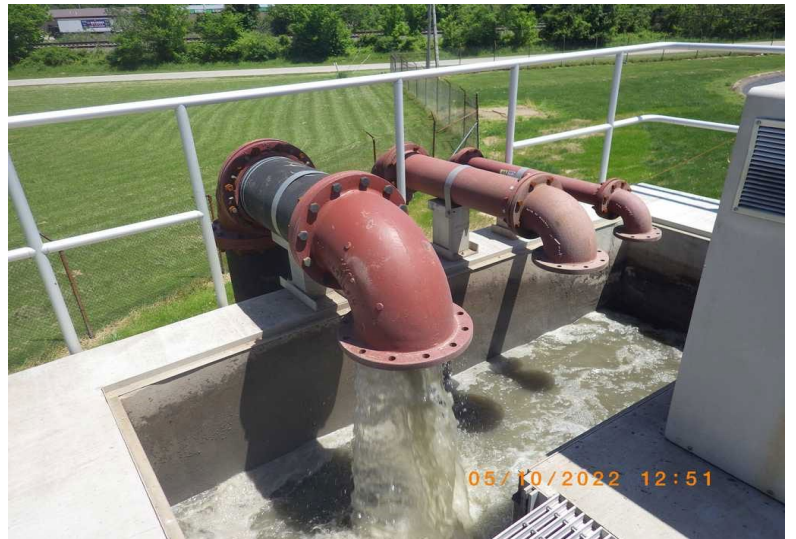
Influent pipes  
 RIMG2684.JPG  
 05/10/2022 13:51 (ET)  
 Andi Hodaj  
 Primary treatment  
 No CBI  
 No PII  
 The influent pipes at the headworks of the WWTP. Camera looking east.

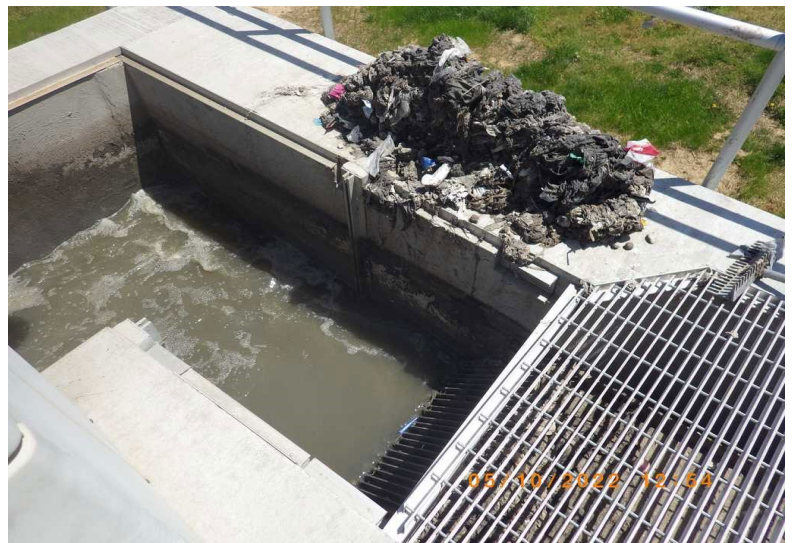
EPA started the tour of the facility at the headworks. EPA observed three influent pipes, of which one was discharging. Mr. Schackart stated that the one discharging was influent from the city of Wheelersburg and the other two were influent from Franklin Furnace and return leachate from the digesters. The trash rake was not working at the time of the inspection. There was a trash screen and trash were hand-collected and placed on the side of the inflow channel.

Influent channel  
 RIMG2685.JPG  
 05/10/2022 13:54 (ET)  
 Andi Hodaj  
 Primary treatment  
 No CBI  
 No PII  
 Influent channel and the bar screen at the headworks of the WWTP. Trash was manually collected and set on side of the channel. Camera looking south

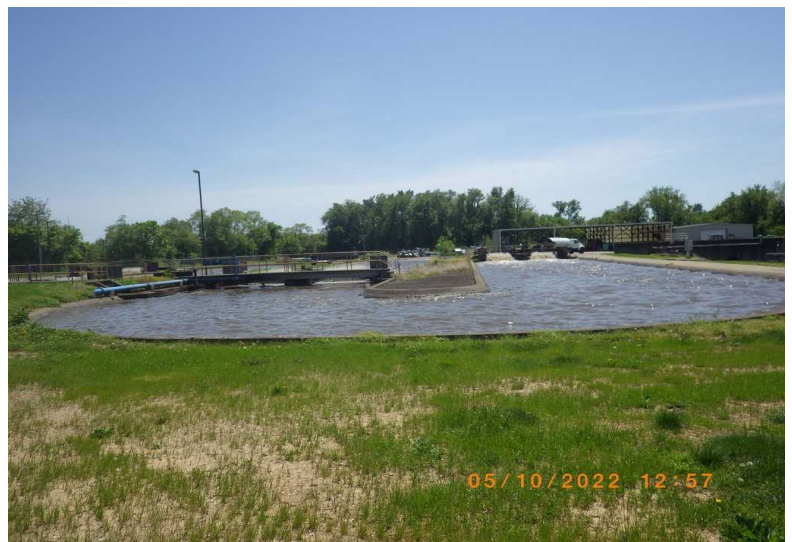
Oxidation ditches  
 RIMG2686.JPG  
 05/10/2022 13:57 (ET)  
 Andi Hodaj  
 Secondary treatment  
 No CBI  
 No PII  
 Oxidation ditches with four rotors in operation.  
 Camera looking south.

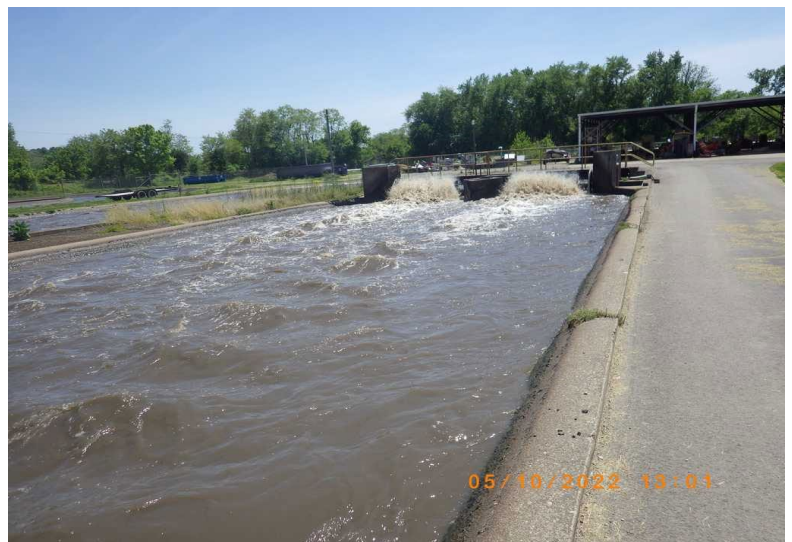
Oxidation ditch  
 RIMG2687.JPG  
 05/10/2022 14:01 (ET)  
 Andi Hodaj  
 Secondary treatment  
 No CBI  
 No PII  
 Rotors at work in the west oxidation ditch.  
 Camera looking south.

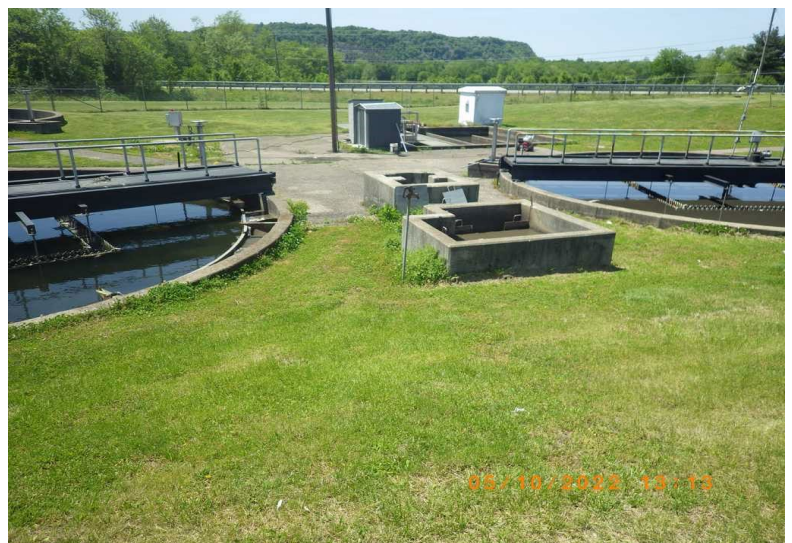
Clarifier splitter box  
 RIMG2691.JPG  
 05/10/2022 14:13 (ET)  
 Andi Hodaj  
 Secondary treatment  
 No CBI  
 No PII  
 The splitter box that routes wastewater from the oxidation ditches to the three clarifiers. Camera looking northwest.

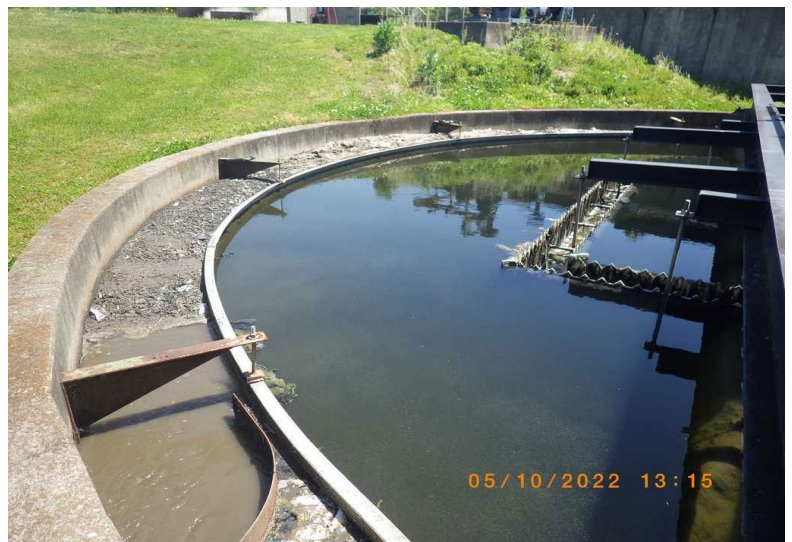
EPA observed a lot of trash and build-up in all three clarifiers.

Southeast clarifier
RIMG2692.JPG
05/10/2022 14:15 (ET)
Andi Hodaj
Secondary treatment
No CBI
No PII
The southeast clarifier had trash and build-up in it. Camera looking south.

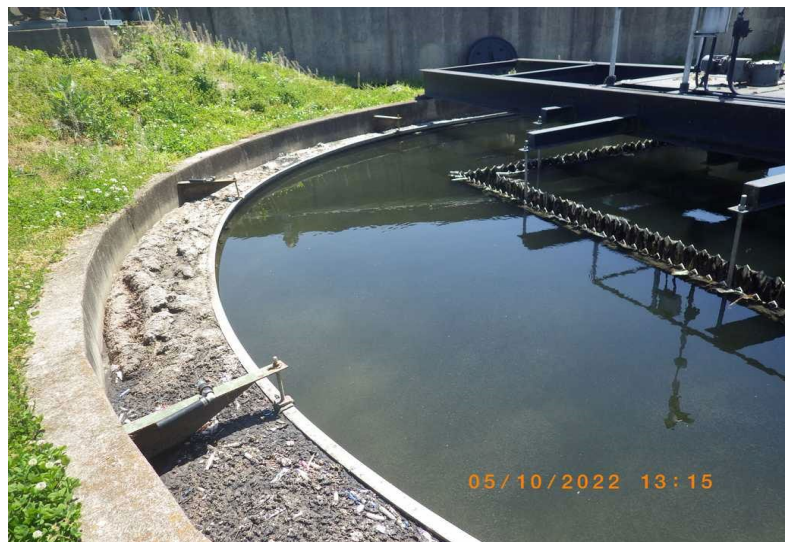
Southeast clarifier
RIMG2693.JPG
05/10/2022 14:15 (ET)
Andi Hodaj
Secondary treatment
No CBI
No PII
The southeast clarifier with a lot of trash in its perimeter. Camera looking southeast.

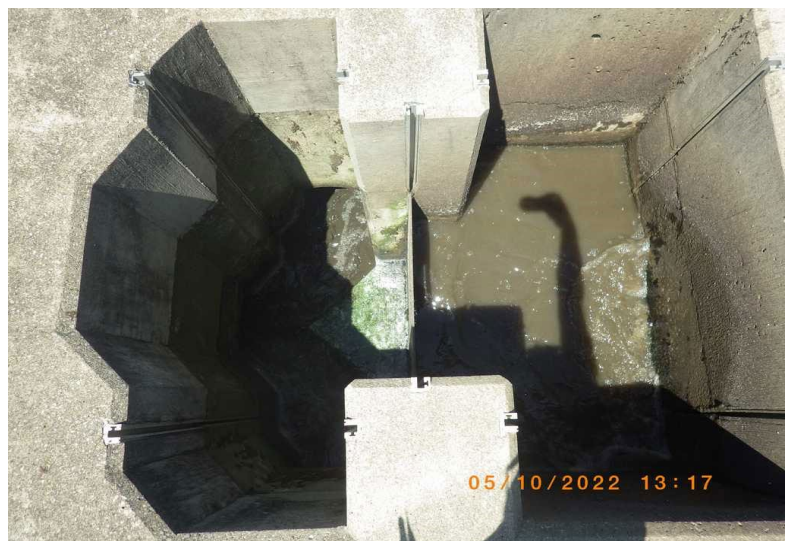
Clarifier splitter box
RIMG2694.JPG
05/10/2022 14:17 (ET)
Andi Hodaj
Secondary treatment
No CBI
No PII
View of the inside of the splitter box for the clarifiers. Camera looking down.

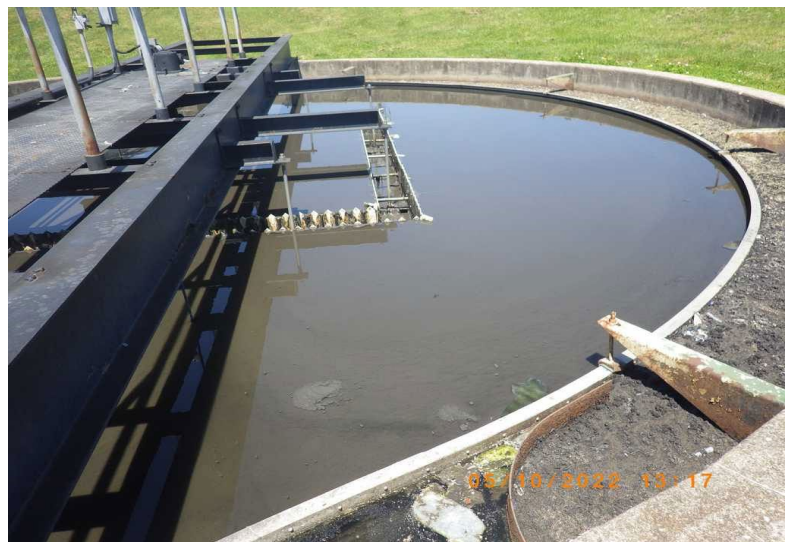
Northeast clarifier  
 RIMG2695.JPG  
 05/10/2022 14:17 (ET)  
 Andi Hodaj  
 Secondary treatment  
 No CBI  
 No PII  
 Similar to the southeast clarifier, the northeast clarifier had a lot of trash in it. Camera looking northeast.

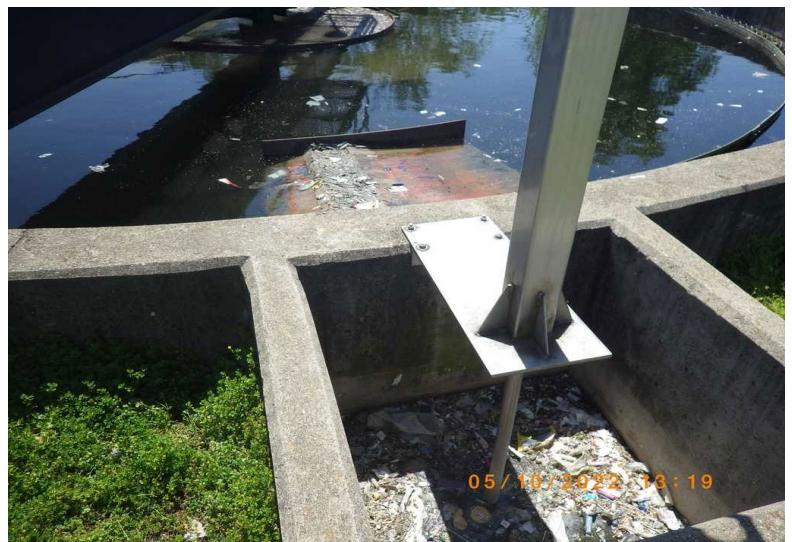
Southwest clarifier  
 RIMG2697.JPG  
 05/10/2022 14:19 (ET)  
 Andi Hodaj  
 Secondary treatment  
 No CBI  
 No PII  
 Trash chamber at the southwest clarifier. Camera looking southwest.

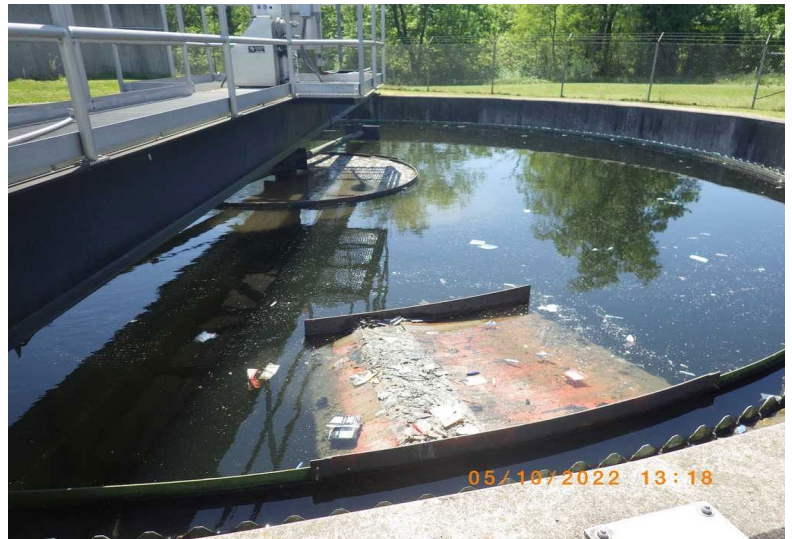
Southwest clarifier
RIMG2696.JPG
05/10/2022 14:18 (ET)
Andi Hodaj
Secondary treatment
No CBI
No PII
Trash floating at the southwest clarifier. Camera looking southwest.

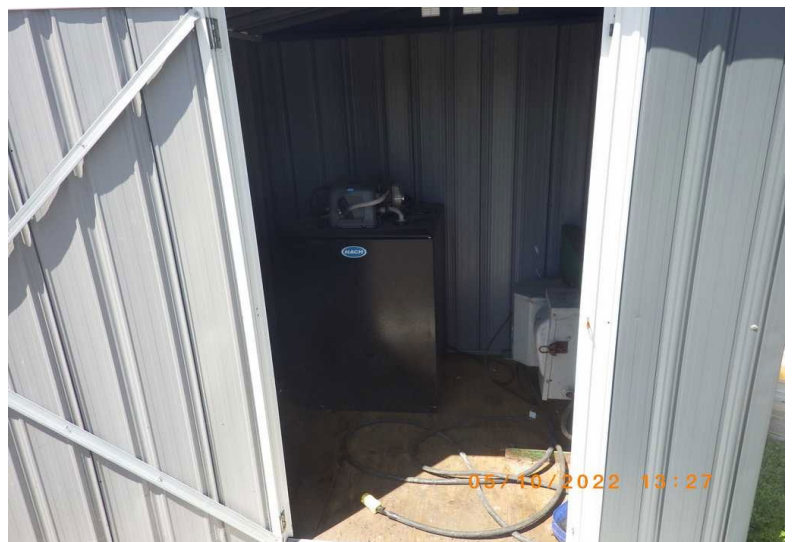
Effluent autosampler
RIMG2701.JPG
05/10/2022 14:27 (ET)
Andi Hodaj
Secondary treatment
No CBI
No PII
The effluent autosampler was located in a shed next to the discharge channel. Camera looking north.

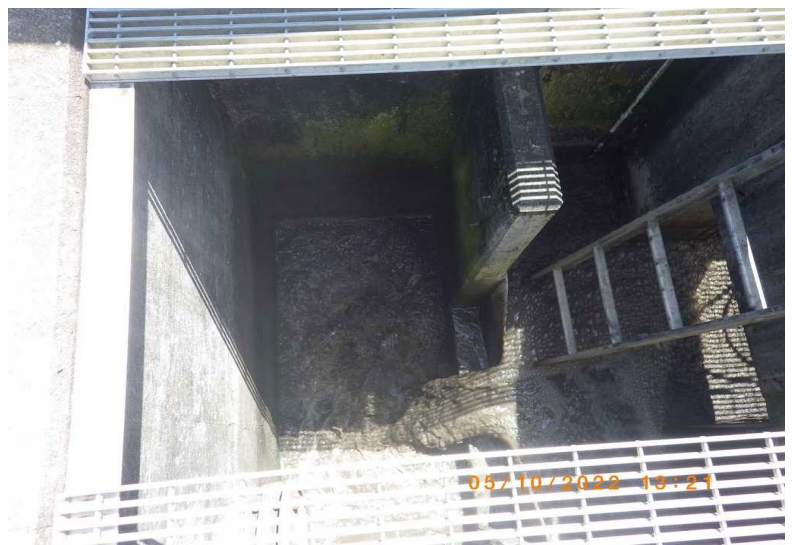
<b>Unit:</b>
<b>AH2-RR-003</b>
EPA reviewed DMR reports for the period January 2019 through April 2022 and found that the facility has exceeded its effluent limits 44 times during this period. Parameters for which limits were exceeded included ammonia, E. coli BOD5 and copper with ammonia being the most common.
<b>Unit:</b> Digesters
<b>AH2-OB-003</b>
The digesters had plants growing in them and at least one of them was almost fully covered with plants growing on top of it.
Next to the belt presser there was the dry sludge storage shed. EPA observed sludge overflowing from the covered shed and exposed to stormwater.
<b>Unit:</b> Secondary treatment
<b>AH2-OB-002</b>
EPA observed a V-notch weir at the outlet of the UV channel, and where effluent flow was measured according to Mr. Schackart, but could not see a depth sensor.
Wastewater in the UV channel was dark grey with a lot of sediment and trash in it.

Discharge channel
RIMG2699.JPG
05/10/2022 14:21 (ET)
Andi Hodaj
Secondary treatment
No CBI
No PII
View inside of the discharge channel. Photo shows the flow over the V-notch weir inside the discharge channel. EPA could not find a depth sensor in the channel. Camera looking down.
