## **PURPOSE OF INSPECTION**

The purpose of the inspection by the U.S. Environmental Protection Agency (USEPA) at Bellaire Harbor Services LLC (Bellaire Harbor or Facility) was to describe, evaluate, and document compliance with the Clean Water Act (CWA) and their National Pollutant Discharge Elimination System (NPDES) permit.

Bellaire Harbor’s industrial activities and stormwater discharges at the 470 Landing location are covered by the Ohio Environmental Protection Agency (OEPA) Industrial Stormwater General Permit (Permit) (OEPA Facility ID # 0GR00472\*CG; Federal NPDES Identifier # OHR000007). The Permit’s coverage has an Effective Date of August 9, 2022, and an Expiration Date of May 31, 2027.

**Bellaire Harbor Services LLC**  
**EPA Inspection February 23, 2023**  
**All photos taken by Jake Berger, Physical Scientist, U.S. EPA**  
**Camera: Olympus Tough TG-6**

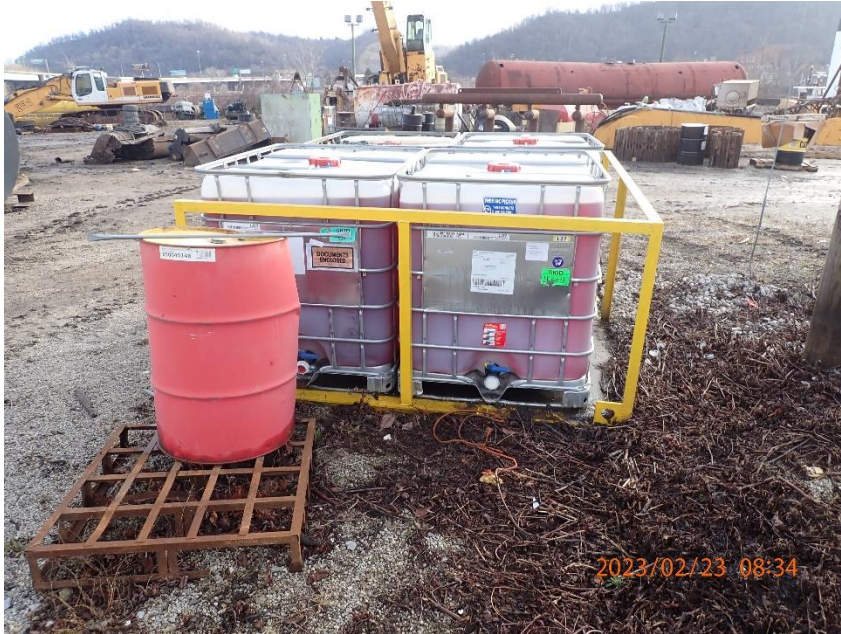
1: P2230043

- Storage totes stored outside lacked secondary containment at the 470 Landing location (Photos 1, 3, 4, and 16) and at the Marine Ways location (Photos 22, 23, and 24).

Description: Used diesel stored in totes

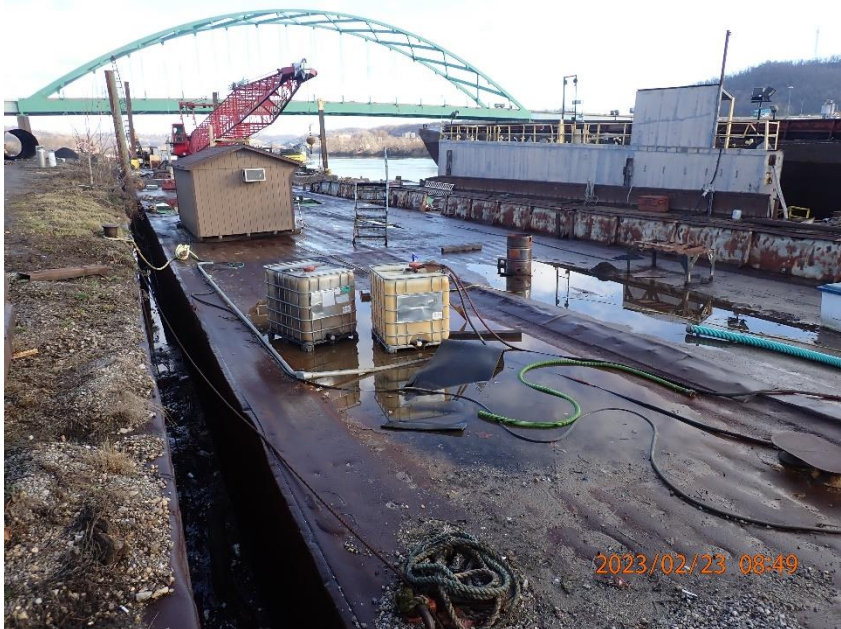
3: P2230045

- No stormwater control mechanisms are being implemented to prevent stormwater that comes in contact with materials or pollutant sources from entering the Ohio River along the edges of the property at the 470 Landing location (Photos 3 – 16, 20, and 21). Section 2.1 of the Permit requires you to select, design, install, and implement control measures.

Description: Dock area, pooled water around empty totes. A series of 5 30-foot wide defunct barges are attached to the natural shore/property edge on the river to use as the dock area.

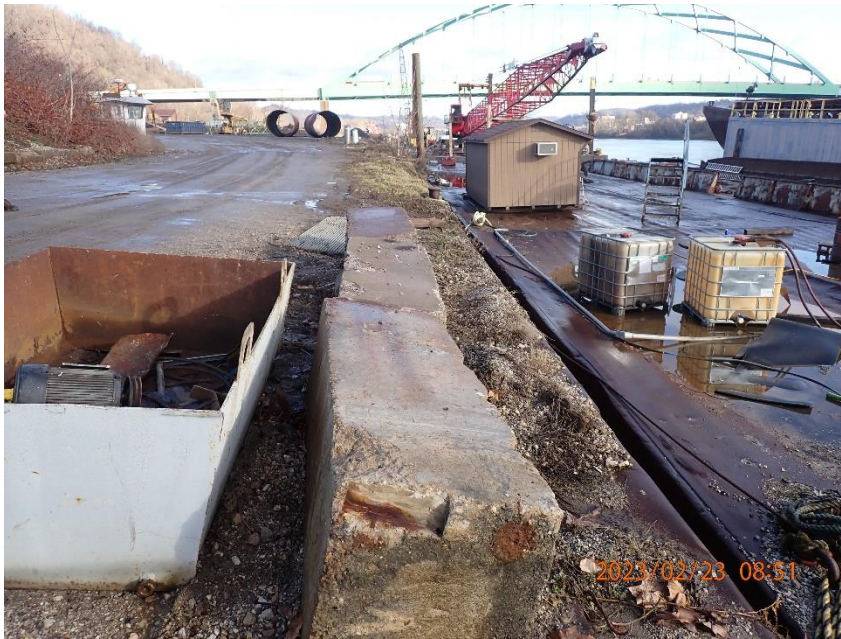
4: P2230046

Description: Concrete blocks at the edge of the dock area

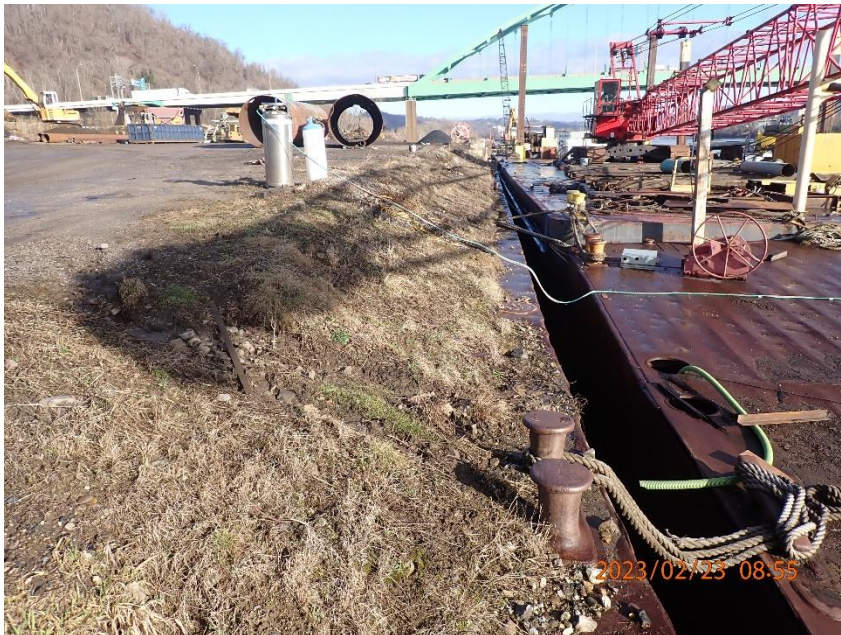
5: P2230047

Description: Dock area north of Photo 3

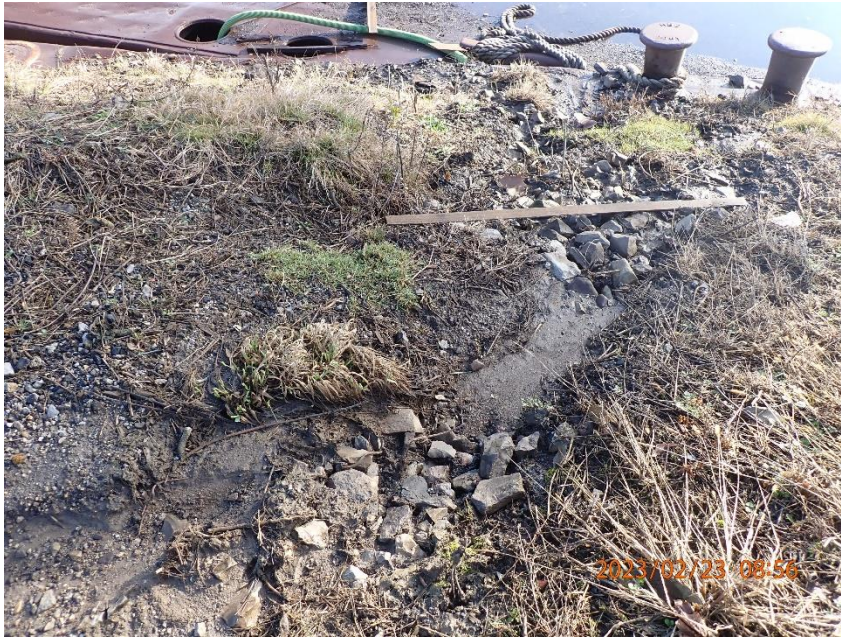
6: P2230048

- Stormwater runoff gullies that lead into the Ohio River are evident at the 470 Landing location, indicating a lack of stormwater control (Photos 6, 7, 9, 10, 11, and 15).

Description: Stormwater gully draining down into the dock area

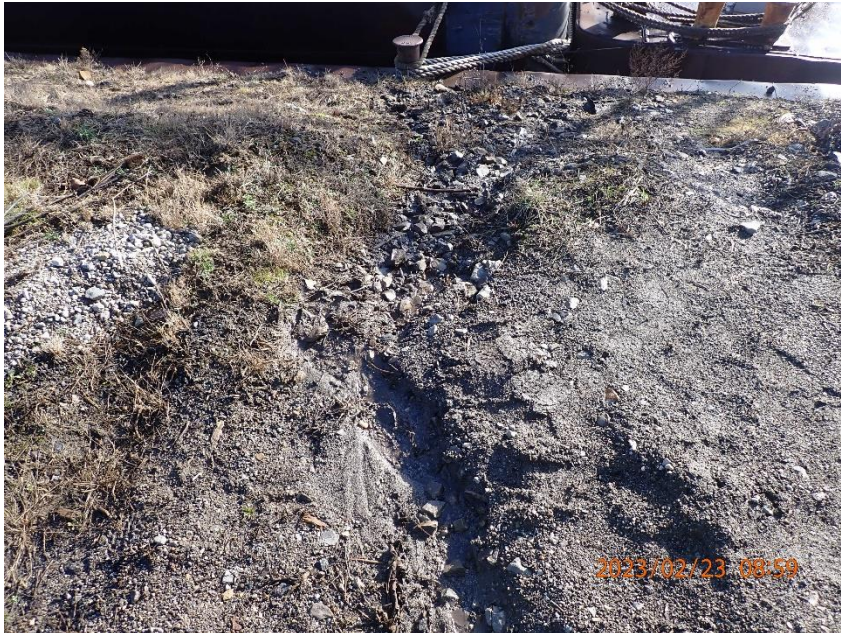
7: P2230049

Description: Stormwater gully draining down into the dock area

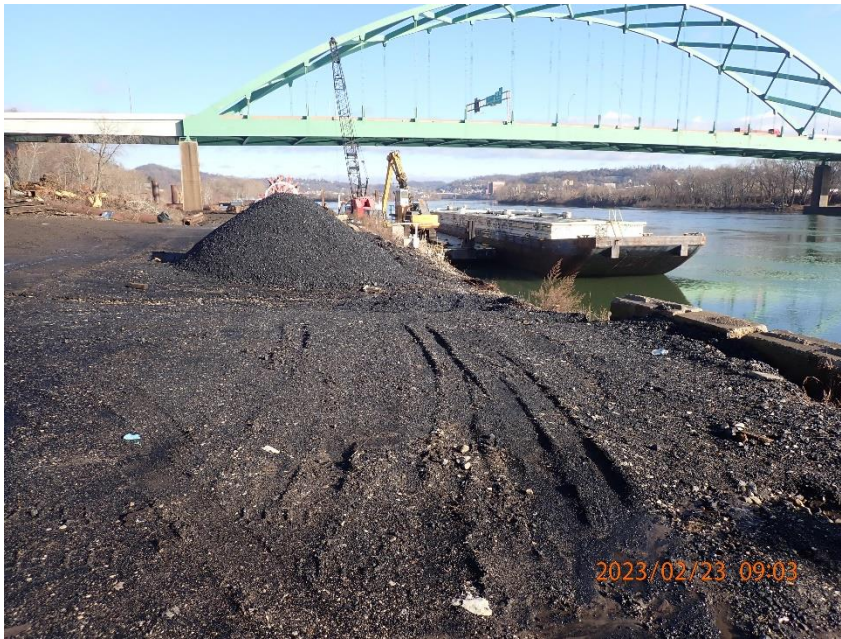
8: P2230050

- Materials such as pig iron, coal, and dirt are stored in large, uncovered piles directly at the edge of the Ohio River at the 470 Landing location. There are no barriers or stormwater control mechanisms around these piles, and there is no containment along the edge of the property/Ohio River to prevent the material from easily spilling into the river (Photos 8 – 15).

Description: Coal pile north of the docks. Coal is emptied out of the barges that are being worked on and is stored outside and uncovered.

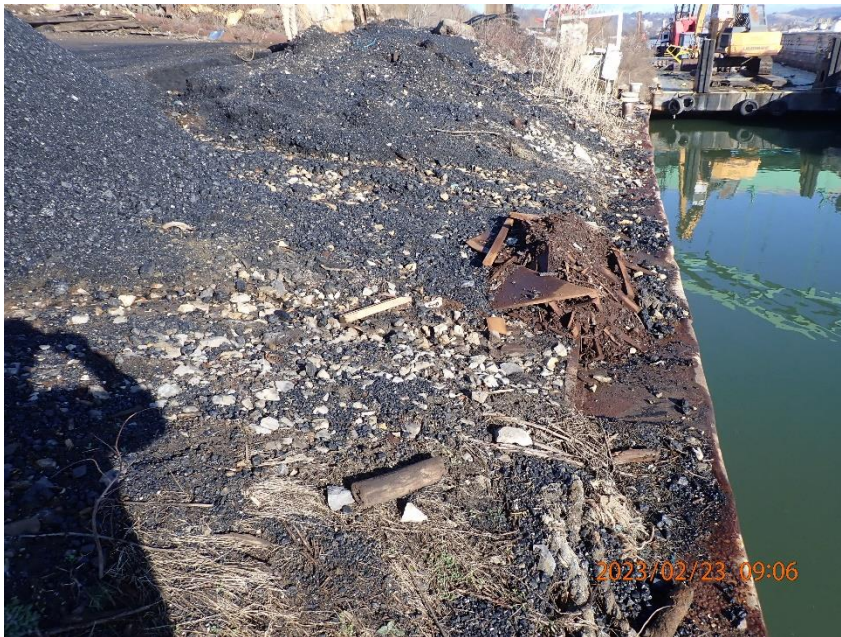
9: P2230051

Description: Coal on the edge of the river wall

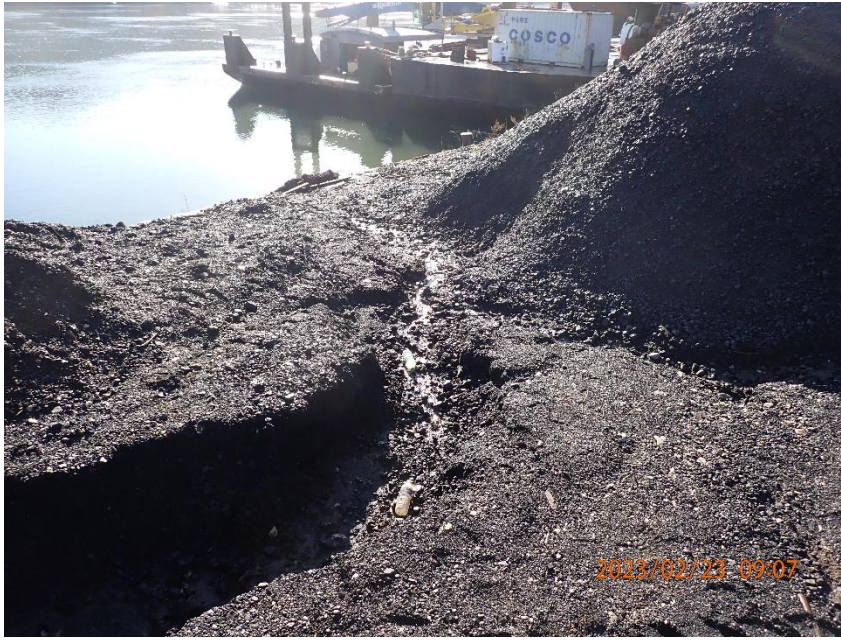
10: P2230052

Description: Coal pile; channelized runoff draining into the Ohio River

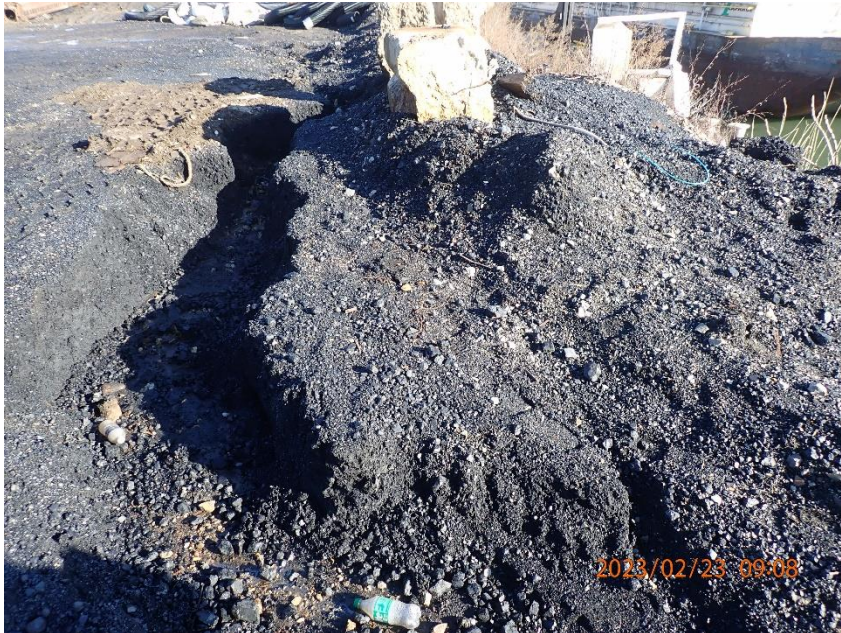
11: P2230053

Description: Coal pile and runoff channel next to the Ohio River

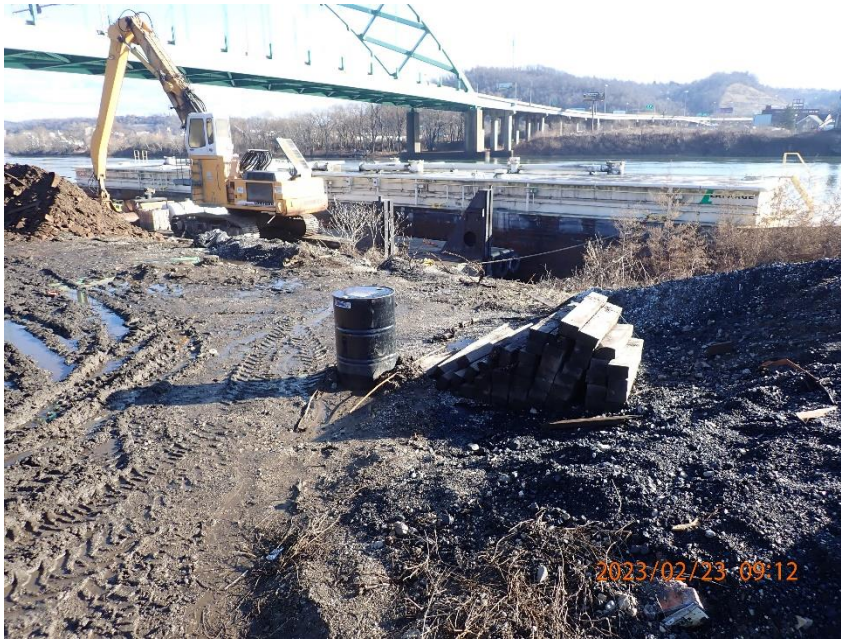
12: P2230054

Description: Hydraulic oil drum next to the Ohio River

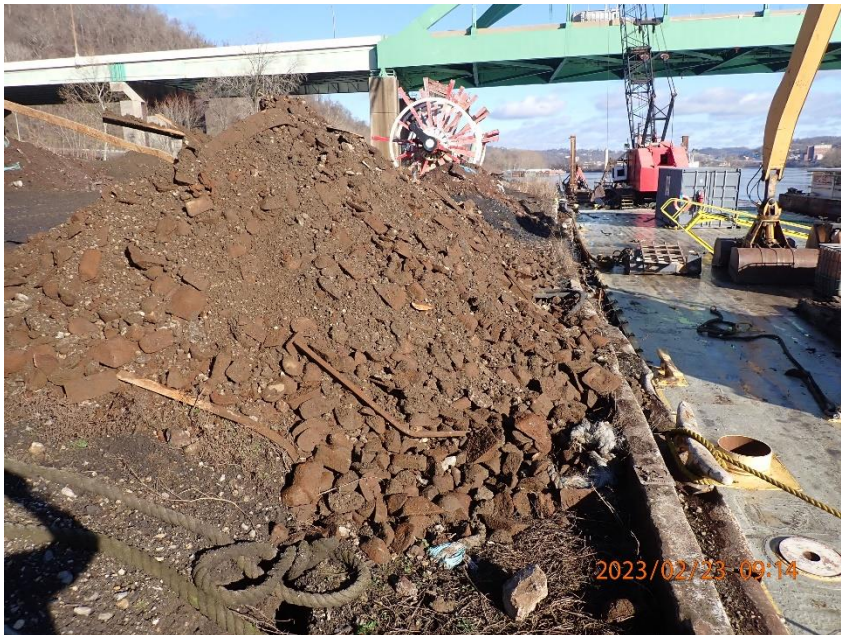
13: P2230055

Description: Pile of pig iron and dirt stored next to the Ohio River with material seen on top of the wall edge.

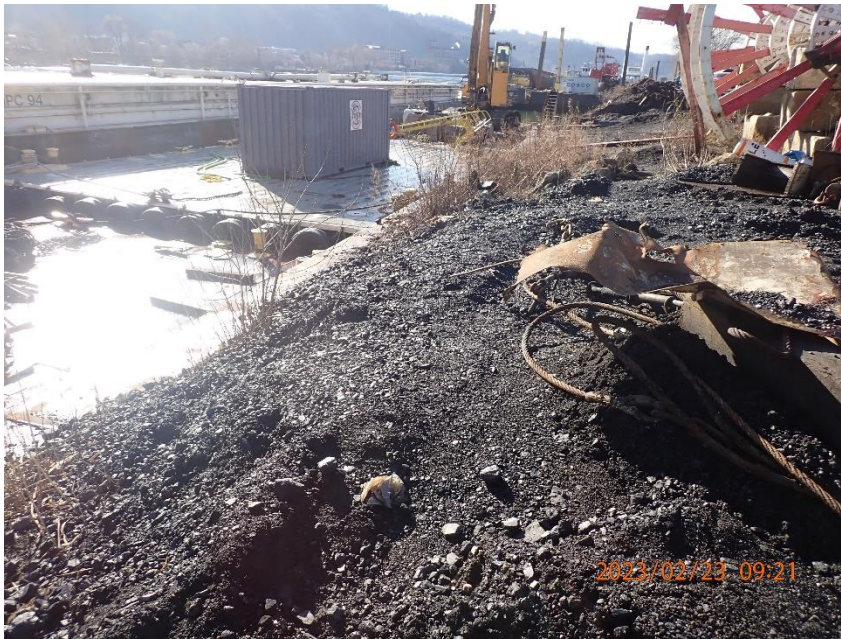
14: P2230056

Description: Coal remaining from a recently moved coal pile next to the Ohio River

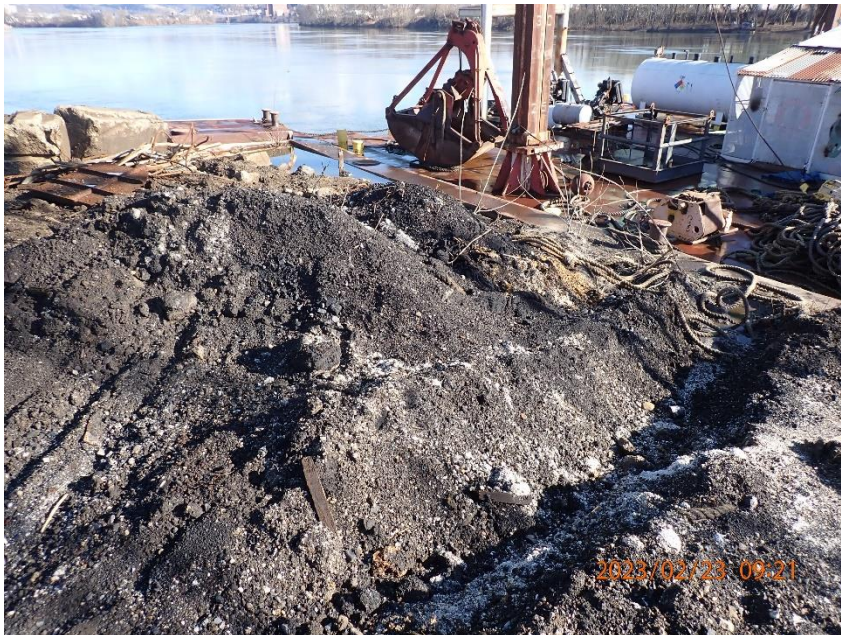
15: P2230057

Description: Stormwater gully in a mixture of dirt and coal draining into the Ohio River

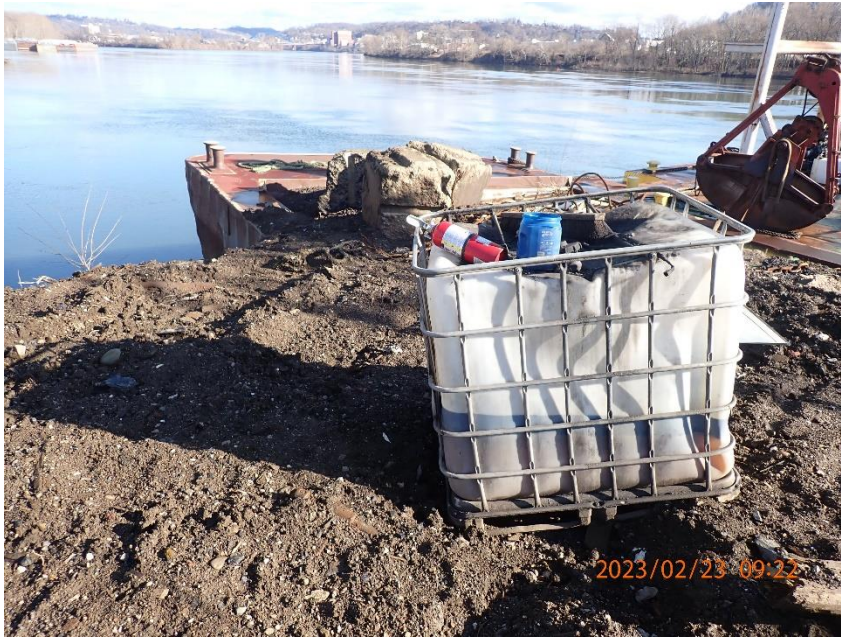
16: P2230058

Description: Spent oil tote with no secondary containment near the Ohio River

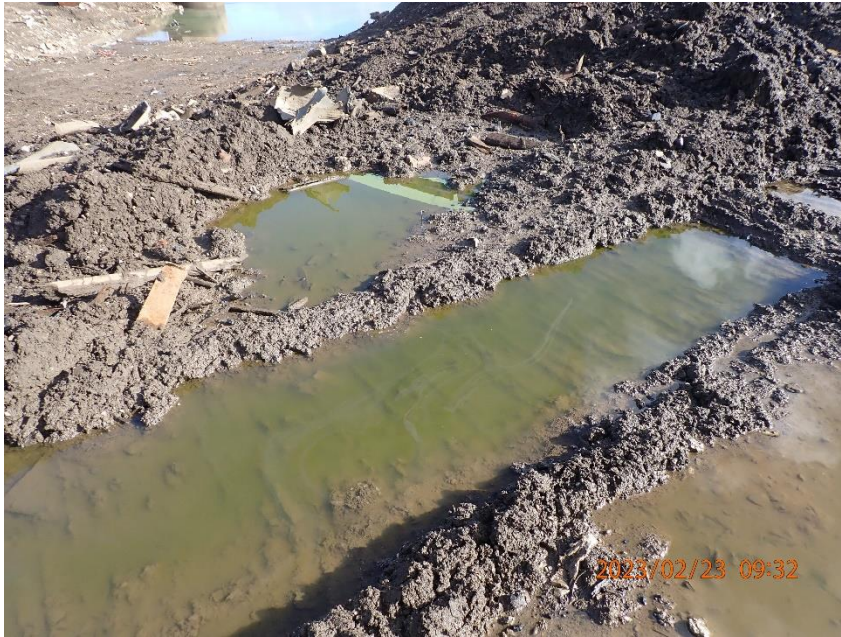
18: P2230060

Description: Pooled water above the ramp with a visible oil sheen on it

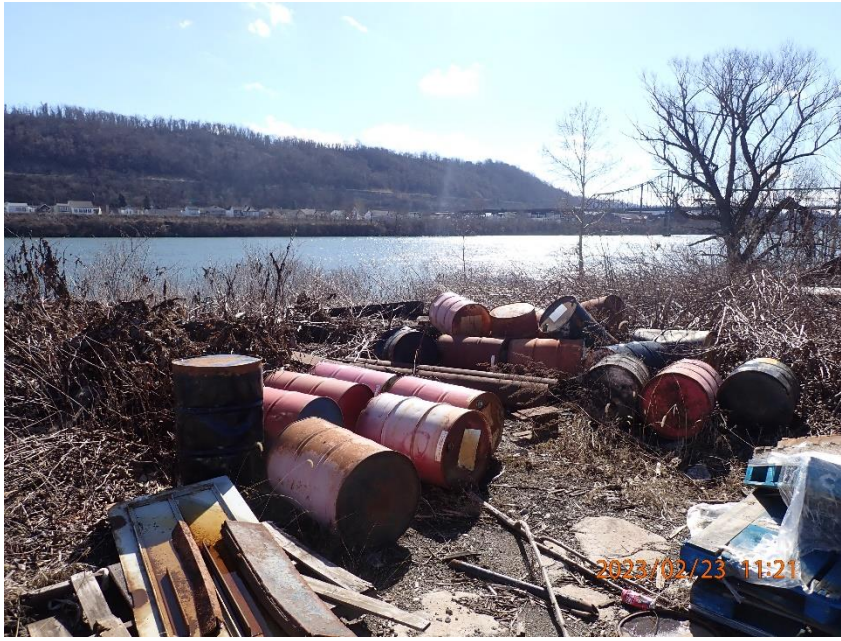
20: P2230062

Description: Empty barrels by the Ohio River at the southeast end of the property

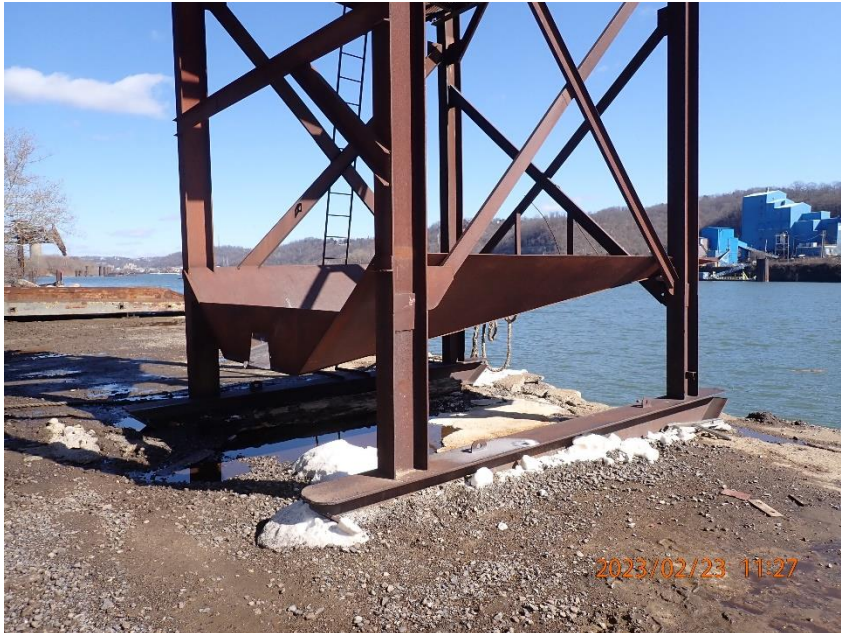
21: P2230063

- Urea that is spilled at the loading dock is left in small piles near the Ohio River underneath the loading conveyor system at the Marine Ways location (Photo 21).

Description: Urea loading dock with piles of urea on the edge of the Ohio River

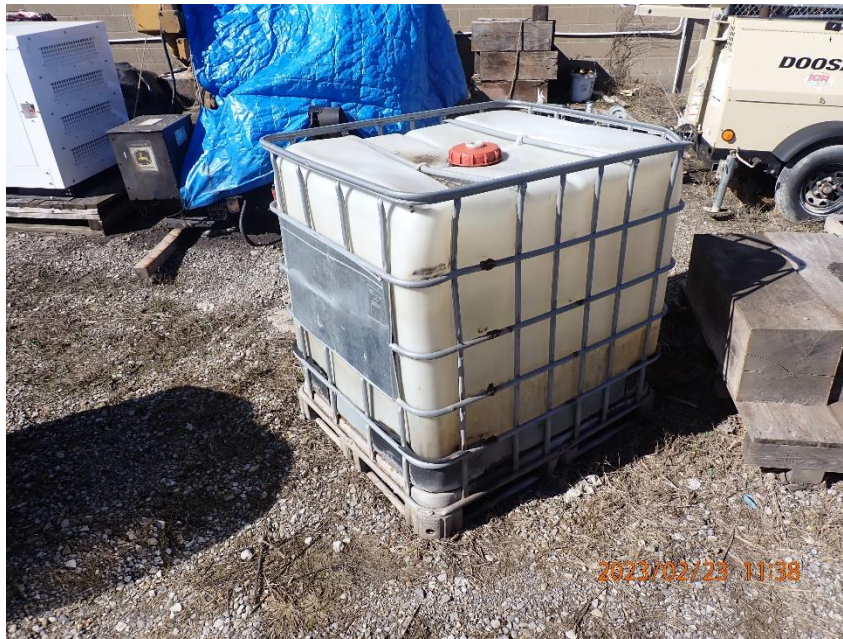
22: P2230064

Description: Container with used oil north of the entrance

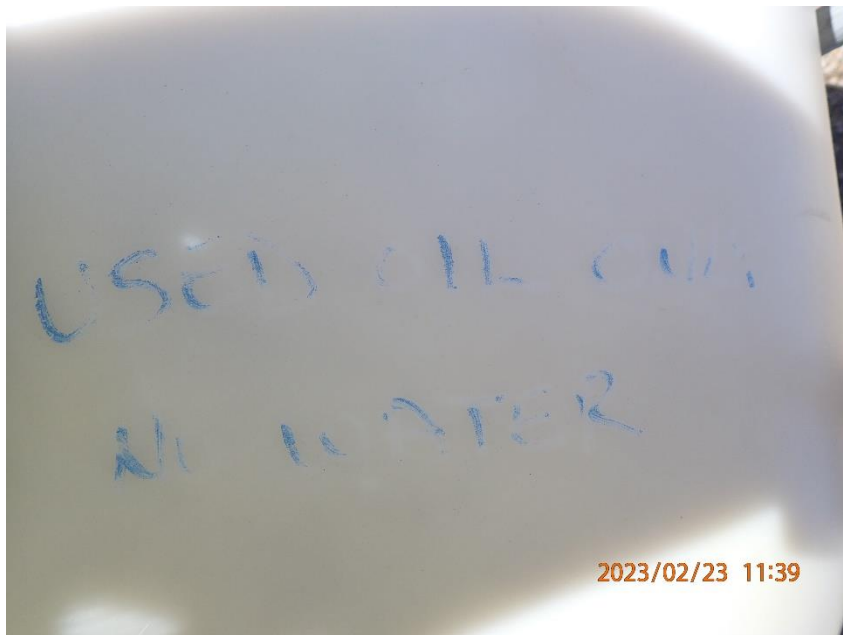
23: P2230065

Description: Text on used oil container in Photo 22

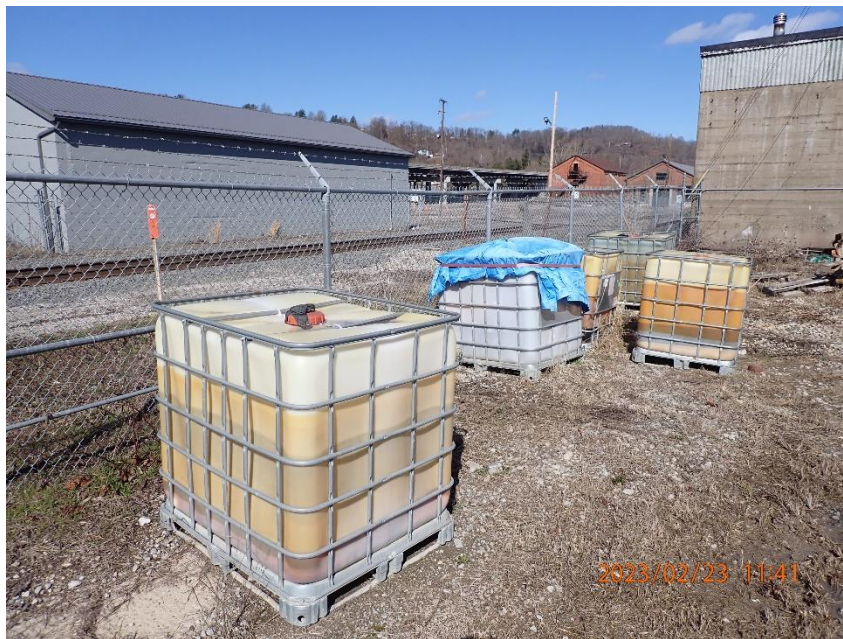
24: P2230066

Description: Totes containing spent oil near the entrance gate
